May 2nd, 2024

Re: Follow-up Report Spill #2024-126 – Release of 10 L of Lubricant at the Meliadine Gold Mine, Lake B5 Waterbody

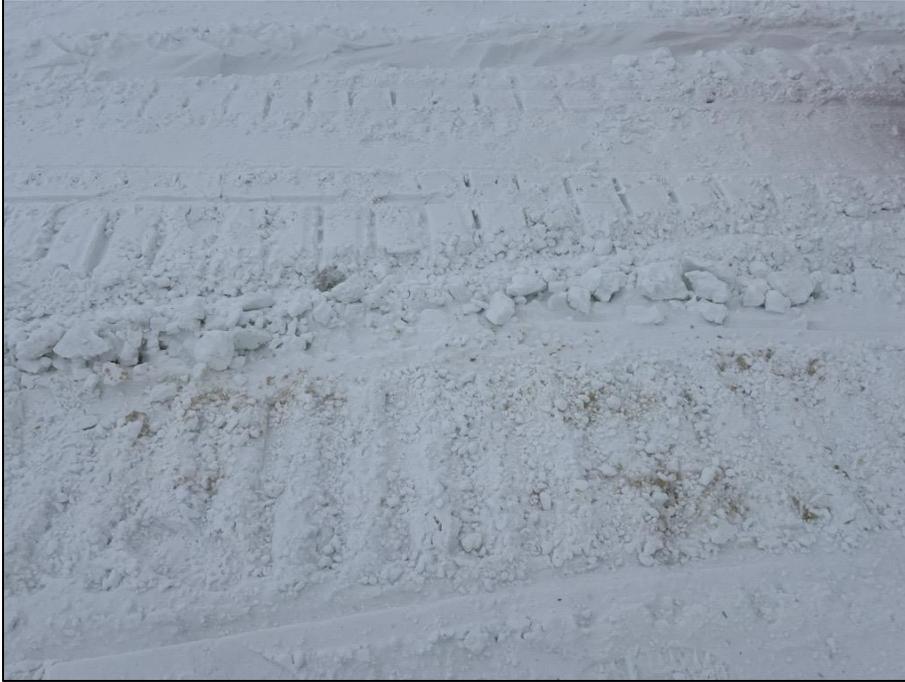
On April 25th, 2024, at 12:30 pm, a dozer being operated by Orbit Garant Drilling was pulling a freshwater sea-can to a drill rig when the sea-can slid into the back of the dozer. The dozer began slowly leaking lubricant while completing the sea-can move. When the leak was noticed, approximately 10 L of lubricant was estimated to have been released onto the snow on the frozen surface of Lake B5, approximately 1.8 kilometers west of the Meliadine Gold Mine industrial pad. The location of the spill is shown in Figure 1.

Due to the leak from the dozer not being noticed right away, the spill was spread along the 1-kilometer path leading to a regional exploration drilling site. Orbit Garant workers retraced the path of the dozer to hand excavate a portion of the contaminated snow into drums. The remaining contaminated snow along the path was removed using a skid steer. The contaminated snow was disposed of in the contaminated snow cell on site.

Photo 1: Spill location along the dozer path.

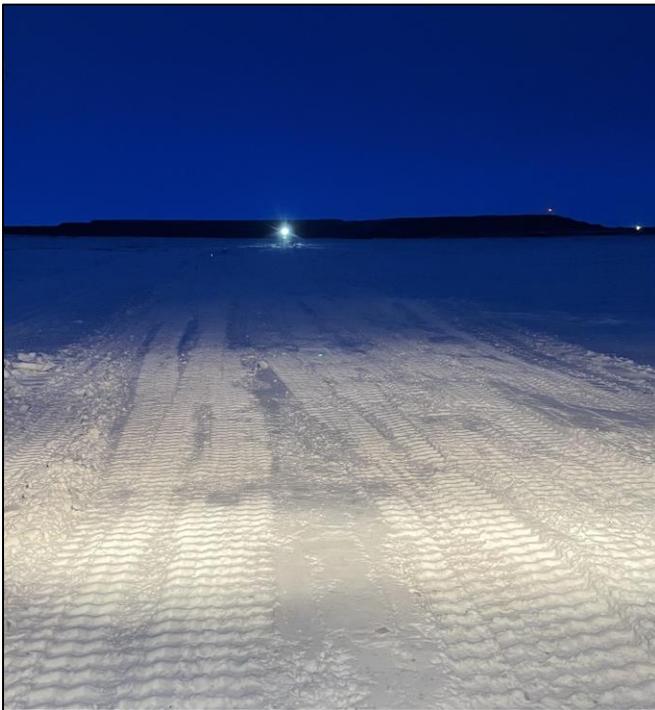
Photo 2: Spill area post remediation.
