**WATER LICENCE INSPECTION FORM**☒ Original  
☐ Follow-Up Report

Licensee	Licensee Representative
Agnico Eagle Mines Ltd.	David Frenette
Licence No. / Expiry	Purpose
2BE-MEP1828	Exploration
Land Authorization No. / Expiry	Project Name
IOL	Meliadine East Project
Date of Inspection	Inspector
September 21 <sup>st</sup> , 2021	RMO C. Wilson
Activities Inspected	
<input type="checkbox"/> Camp	<input checked="" type="checkbox"/> Drilling
<input type="checkbox"/> Roads/Hauling	<input type="checkbox"/> Mining
	<input type="checkbox"/> Construction
	<input type="checkbox"/> Reclamation
	<input type="checkbox"/> Fuel Storage
	<input type="checkbox"/> Other:

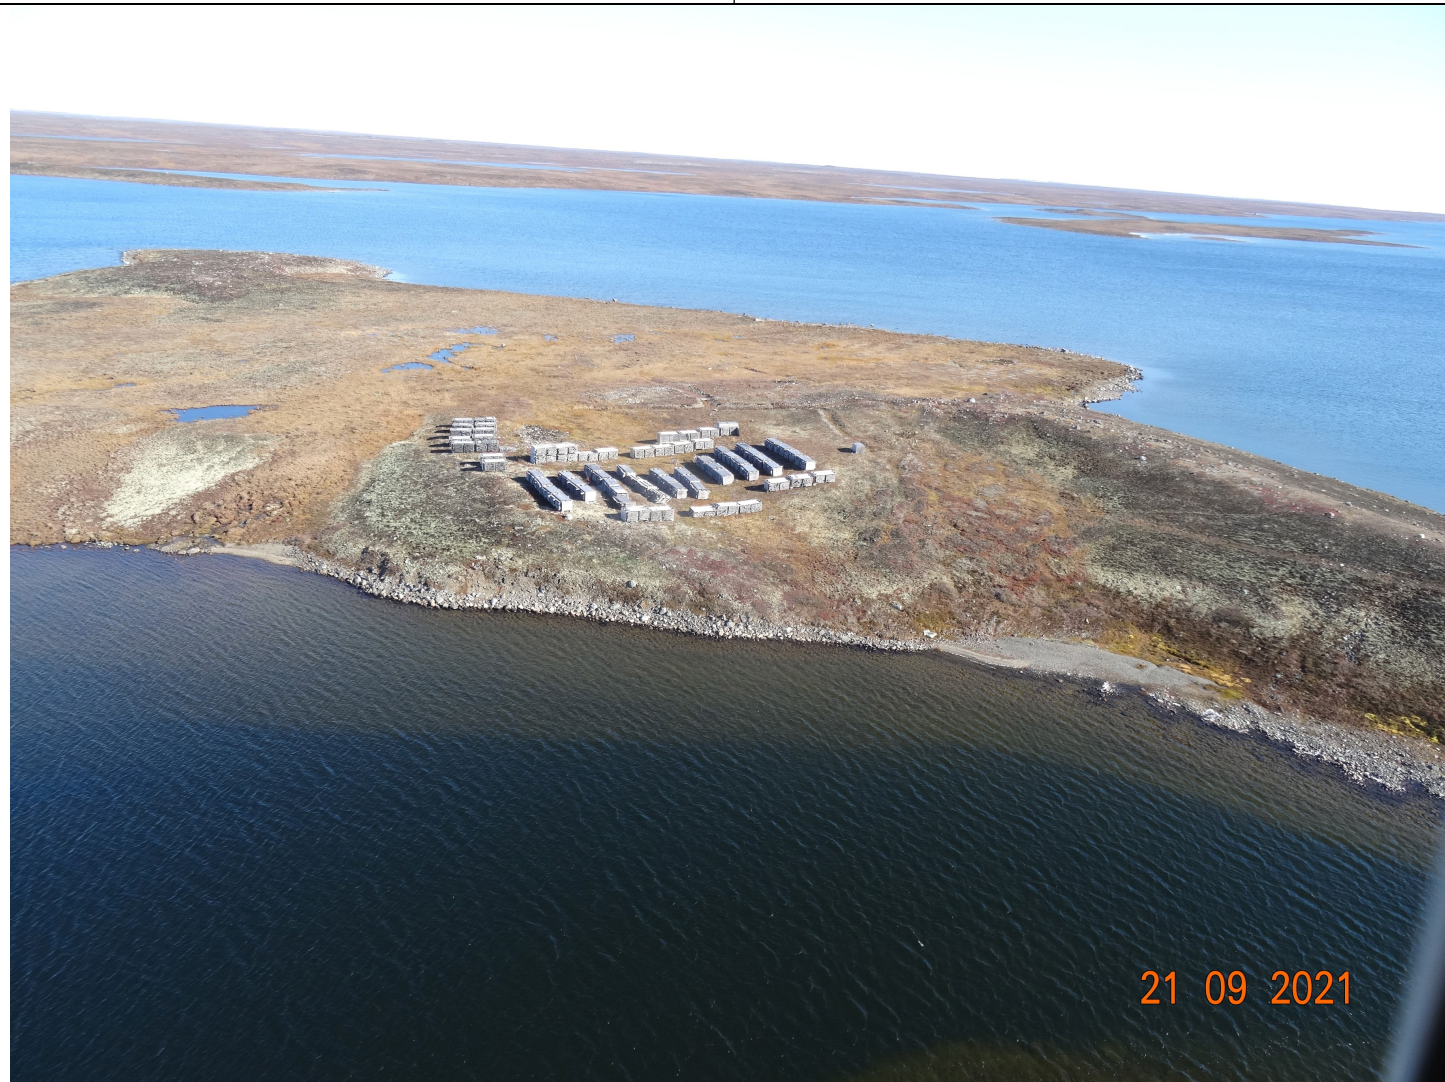
Description:
Meliadine East, reclaimed camp 1

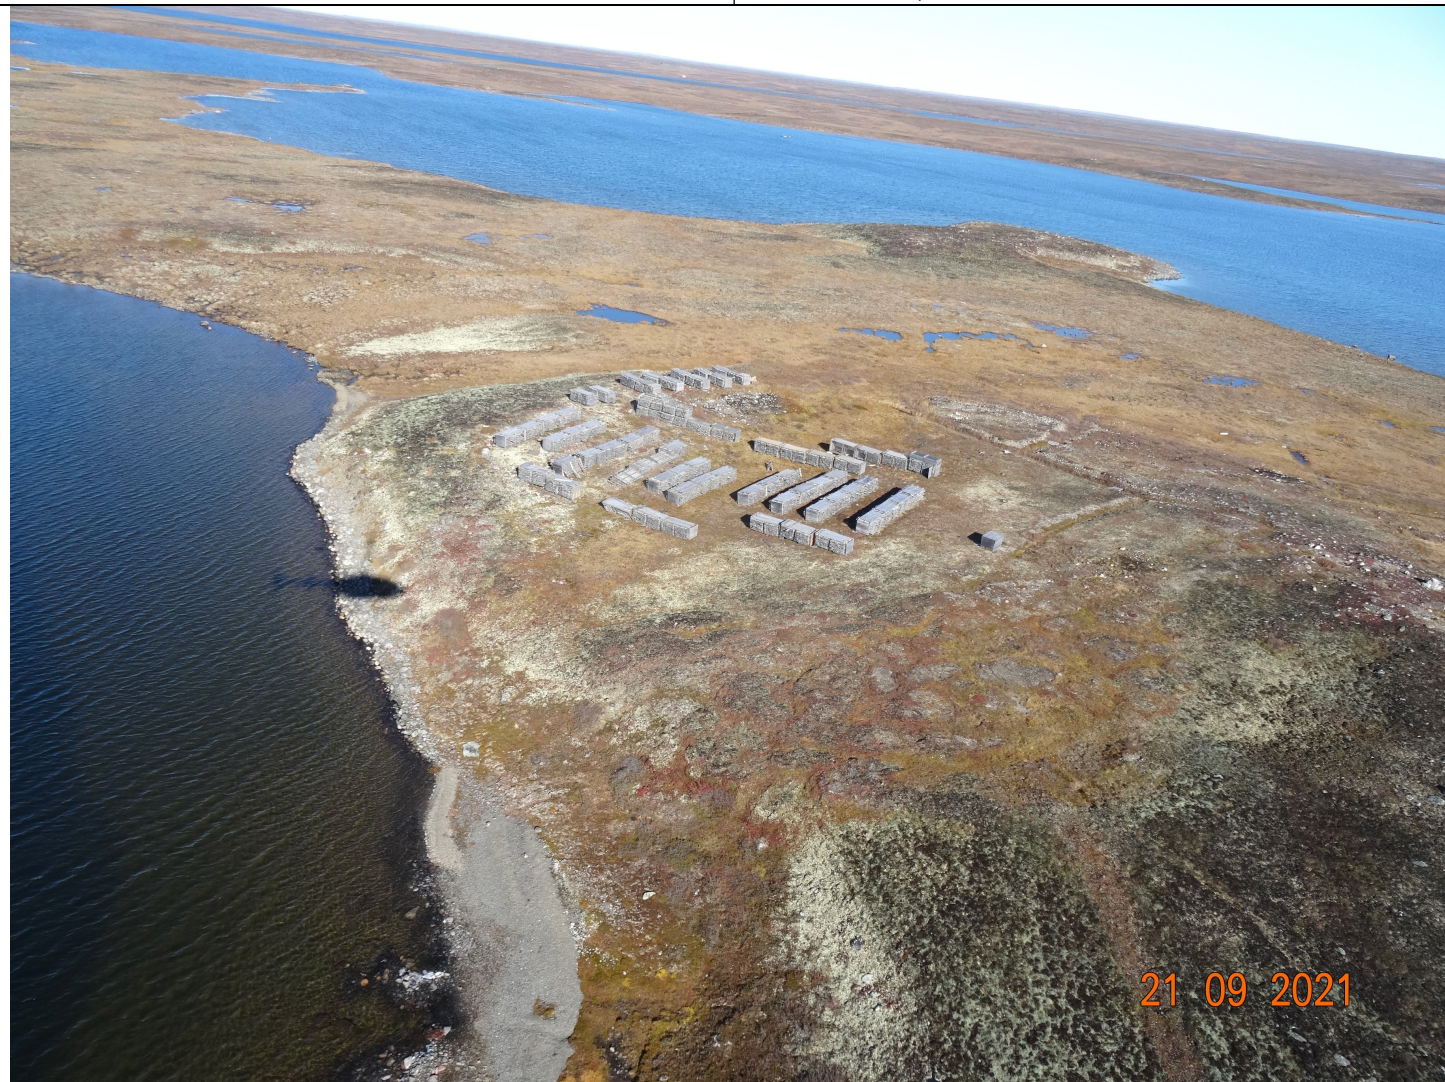
Photo 2

Meladine East, camp reclamation 2

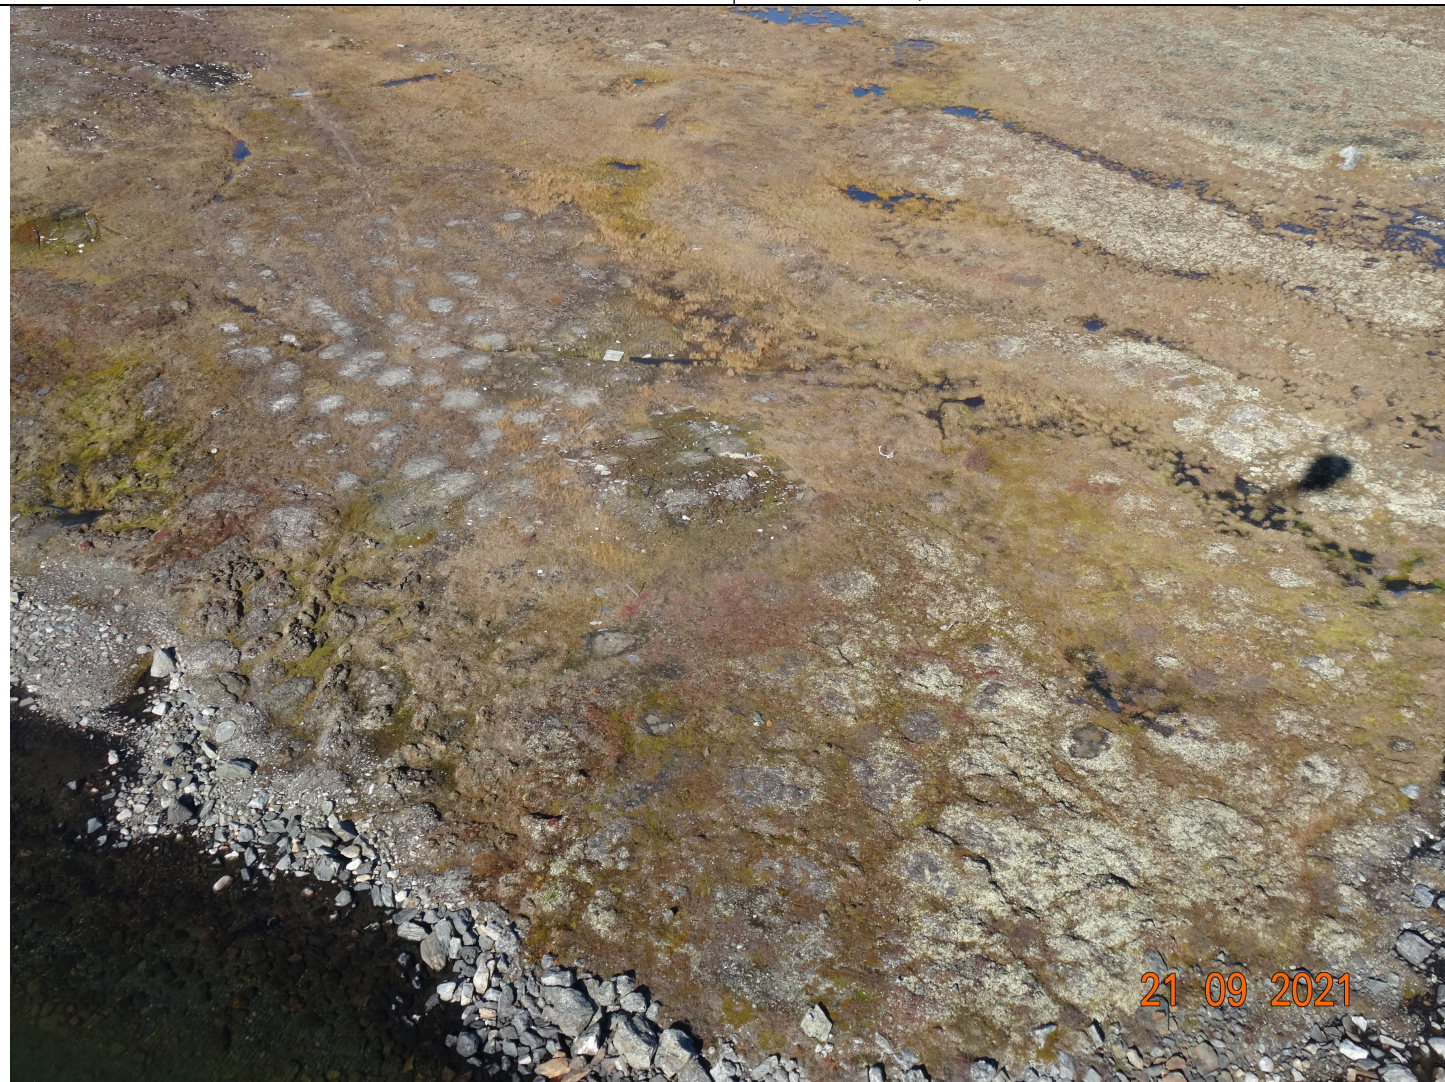
Photo 3

Meliadine East Reclaimed camp 3

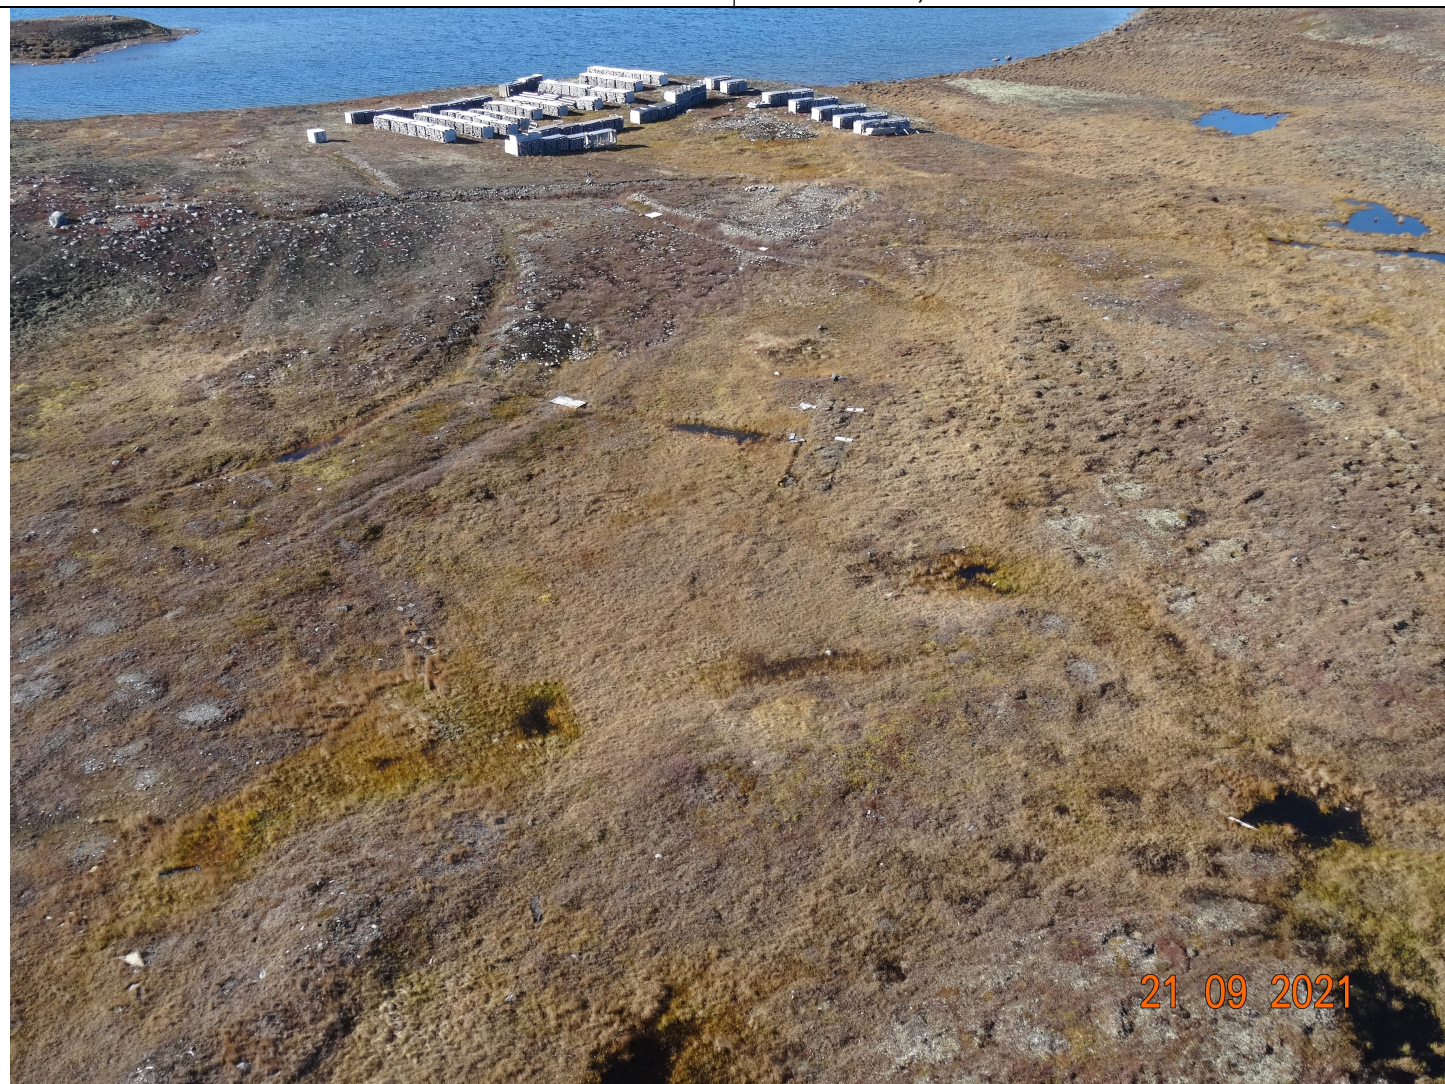
Photo 4

Small amount of clean wood around site.

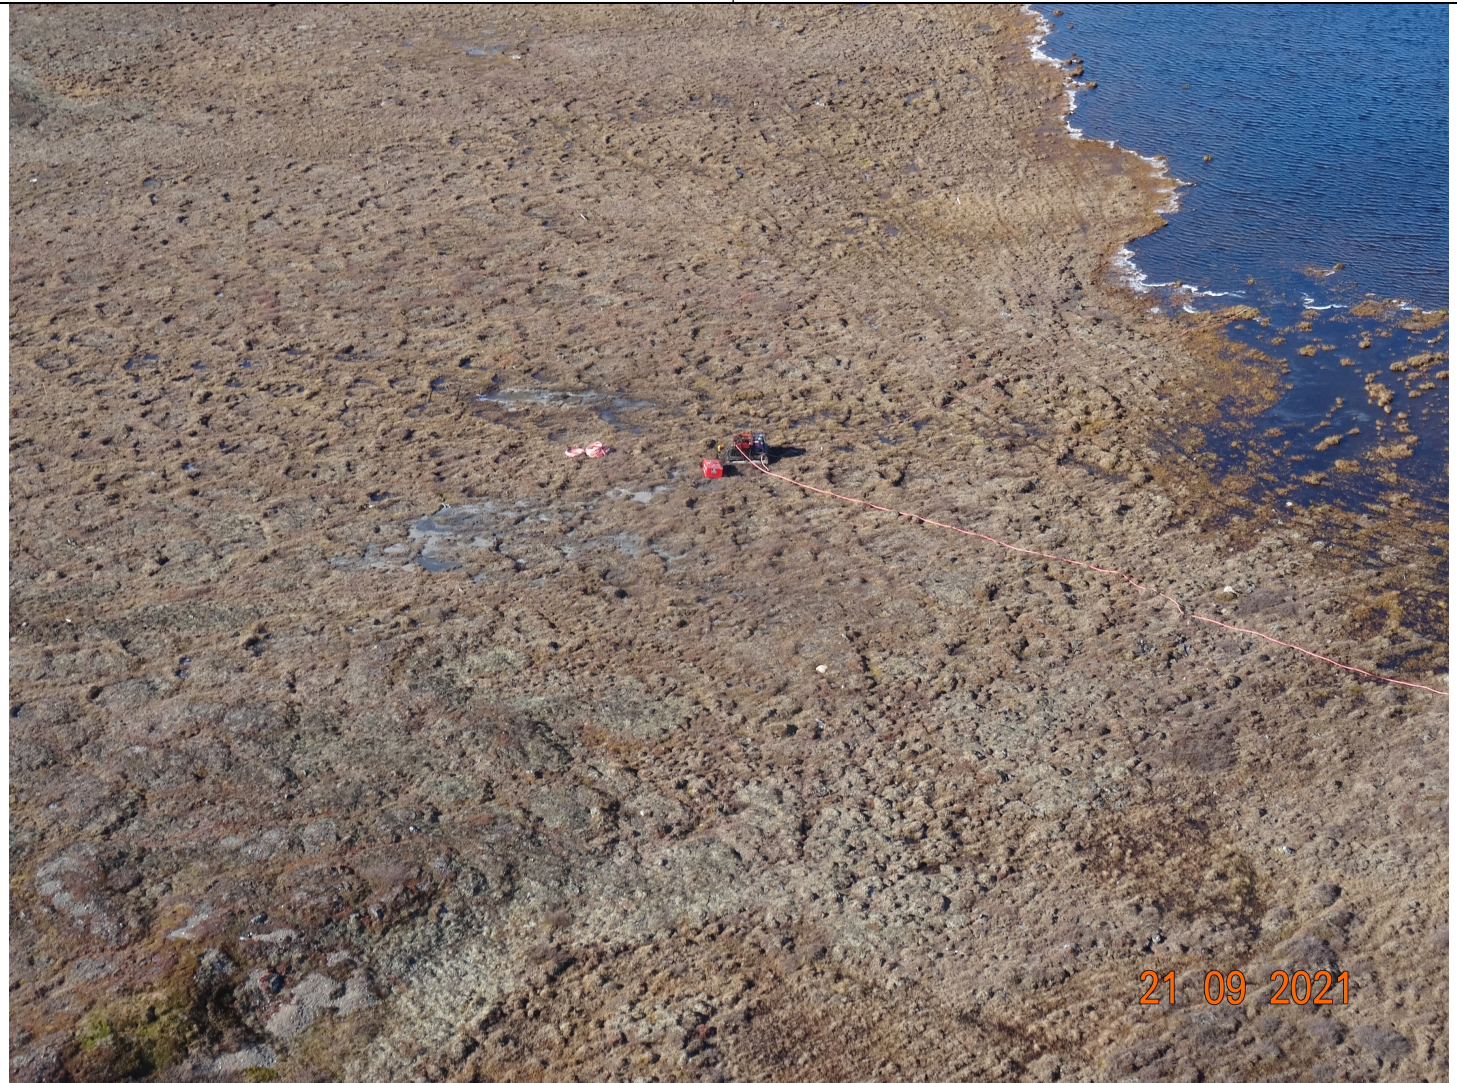
Photo 6

SECTION 1	<input checked="" type="checkbox"/> Comments (s. __)	<input type="checkbox"/> Non-Compliance with Act or Licence (s. __)	<input type="checkbox"/> Action Required (s. __)
<p>An inspection of Agnico Eagle Mines Ltd.'s ('Licensee'), Meliadine East project was completed by Crown-Indigenous Relations and Northern Affairs Canada's, Resource Management Officer, Christine Wilson ('Inspector'). The inspection was conducted to ensure compliance with applicable terms and conditions of water licence ('licence') no. 2BE-MEP1828.</p> <p><b>PRELIMINARY INFORMATION</b></p> <ul style="list-style-type: none"><li>- The Licensee provided information to the Inspector regarding the removal of the old Discovery camp (photo 8) located at N62° 55' 50.0" W91° 54' 58.0".</li><li>- The 2020 annual report is available for review on the Nunavut Water Board FTP website.</li></ul> <p><b>OBSERVATIONS</b></p> <ol style="list-style-type: none"><li>1. The camp has been completely removed in accordance with the plan titled "Updated Reclamation &amp; Closure Plan Nov 2018" (photo 1-5).</li><li>2. Core racks remain at the location and are neatly organized as required by the regulations.</li><li>3. A few pieces of debris are located around the site though they appear to be clean wood. No concerns.</li><li>4. A drill is located at N62° 58' 15.76", W91° 57' 35.77" (photo 5-8). It is unclear if the drill is working under this water licence.</li></ol>

Pump and hose.

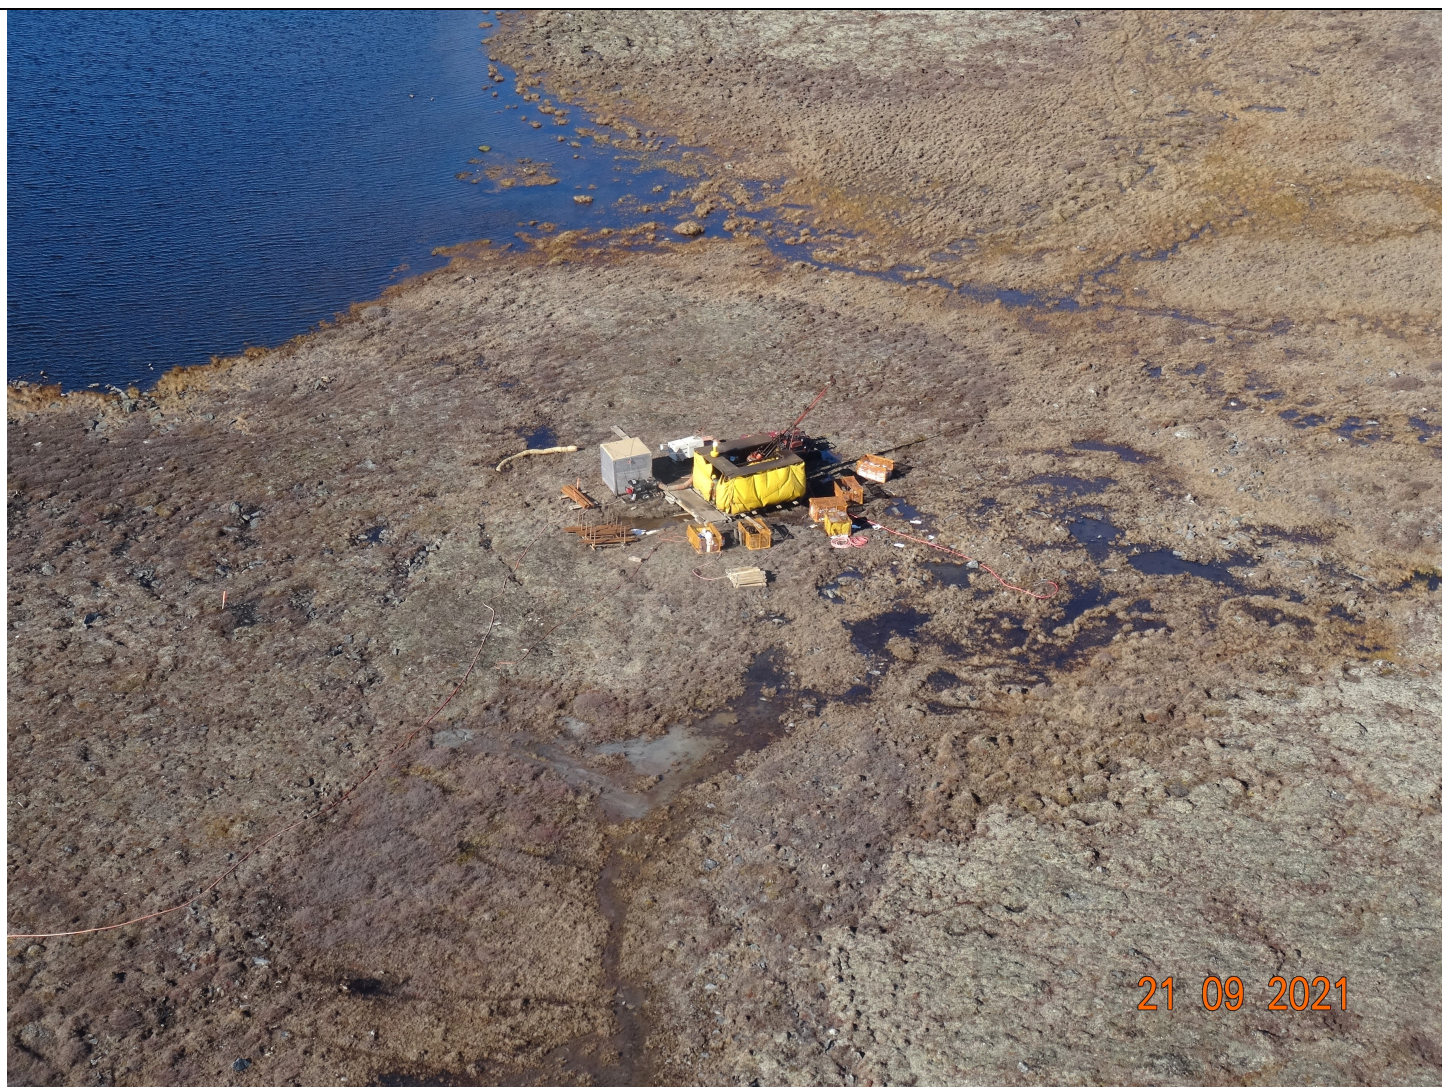
Photo 7

Drill set up.

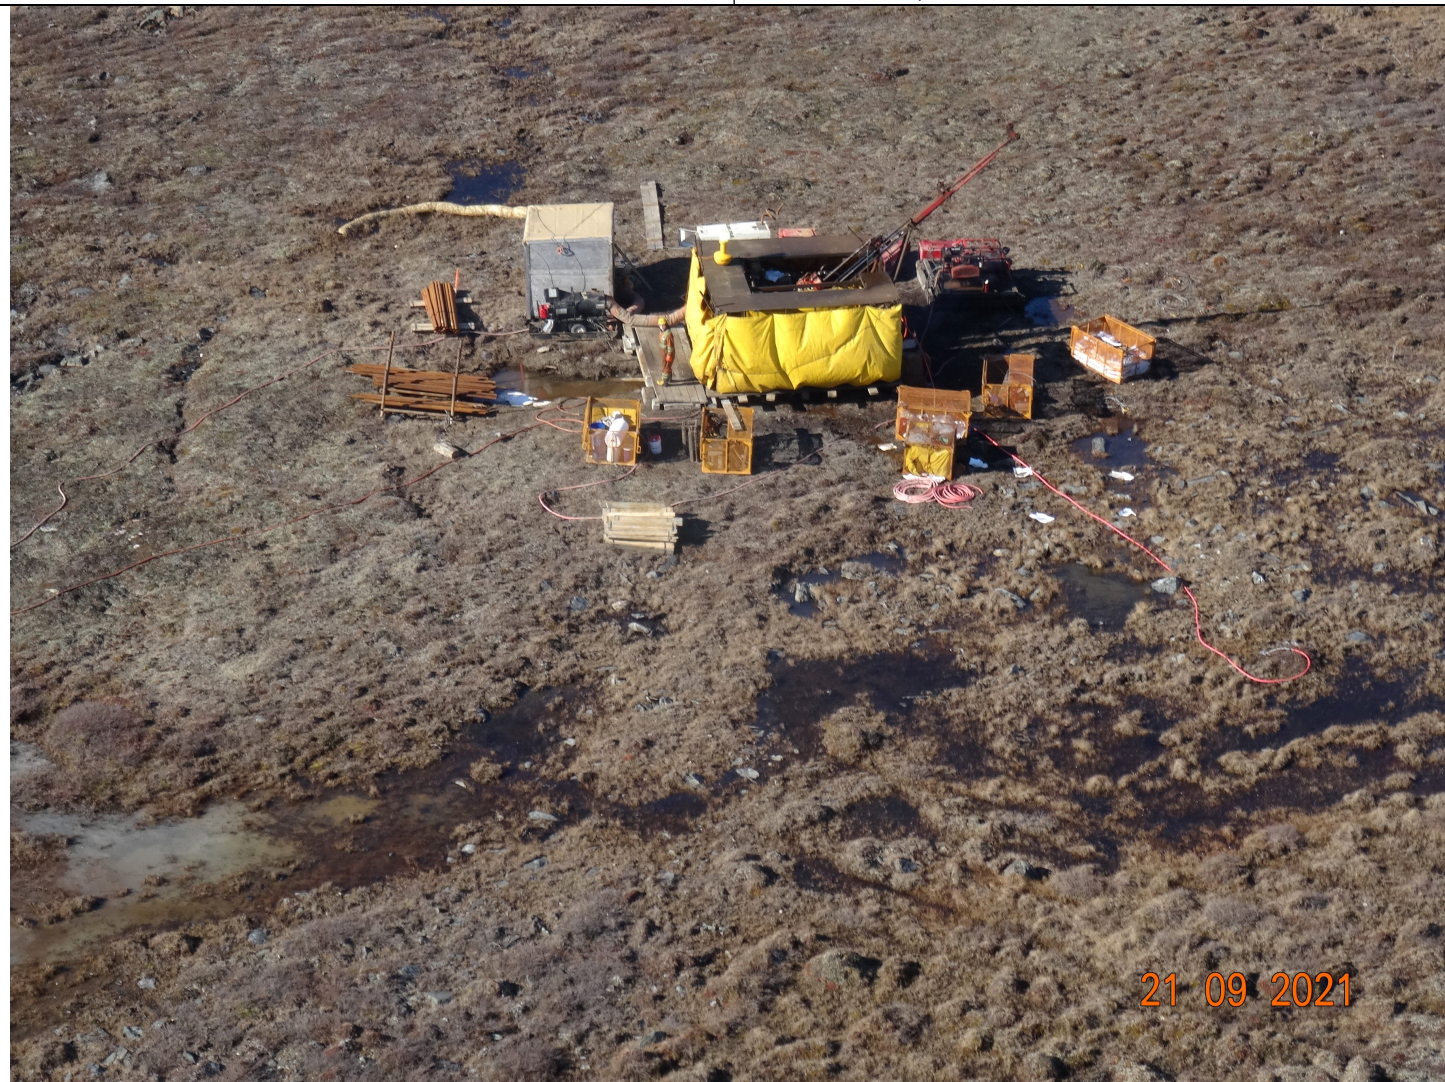
Photo 8

Drill
