Attachment 5:
INAC Land Use Permit Inspection Report
(August, 2016)

LAND USE PERMIT INSPECTION FORM

Permittee	Representative
Sabina Gold & Silver Corp	John Laitin
Permit No. / Expiry	Representative's Title
N2012C0003	Manager – Site Operations
Other Authorizations	Land / Other Authorizations
Date of Inspection	Inspector
9 & 10 August 2016	Baba Pedersen
Activities Inspected	
<input type="checkbox"/> Camp <input checked="" type="checkbox"/> Drilling <input type="checkbox"/> Mining <input type="checkbox"/> Construction <input type="checkbox"/> Reclamation <input checked="" type="checkbox"/> Fuel Storage	
<input type="checkbox"/> Roads/hauling <input type="checkbox"/> :Other <input type="checkbox"/> Other:

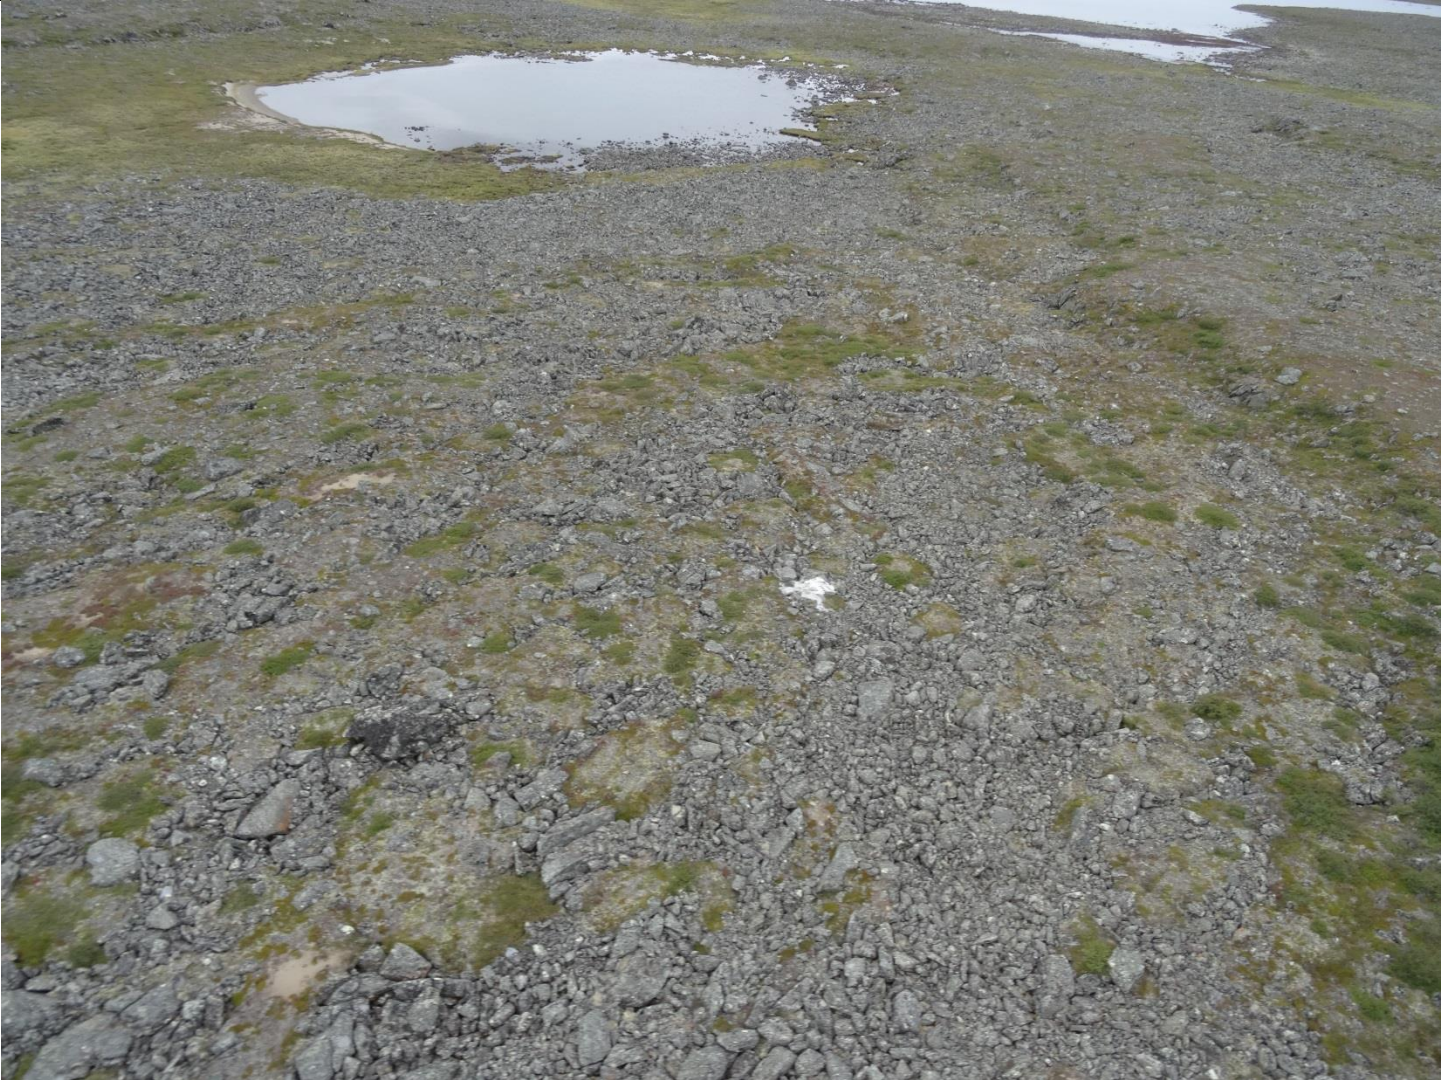
1. I found 1 busted open bag of white powder at the Wishbone 1 Fuel Cache Site, all Fuel has been removed. 2. The Drill Holes were nicely cleaned up with only small Marker Sticks (Photo 3) left behind. The 3 rd Drill Site I checked (Photo 5) had a Wire going into it for what appeared to be a Monitoring Station.			
SECTION 3	<input type="checkbox"/> Comments	<input type="checkbox"/> Non-Compliance with Act or Regulations	<input checked="" type="checkbox"/> Action Required

Date	Camera	Inspector	Authorization
9 & 10 Aug 2016		Baba Pedersen	N2012C0003
Photo Log # 6634		Location N 65° 43' 08.5" W 107° 58' 53.3"	
Photo 1			
Description: Wishbone 1 Fuel Cache Site with 1 Bag of white powder

1. The bag of white powder at the Wishbone 1 Fuel Cache site needs to be cleaned up and removed. 2. Once the Drill Sites are done being used the Marker Sticks and any Monitoring Stations must be removed.			
Licensee or Representative	Inspector's Name		
	Baba Pedersen		
Signature	Signature		
	Original Signature on File		
Date	Date		
	30 November 2016

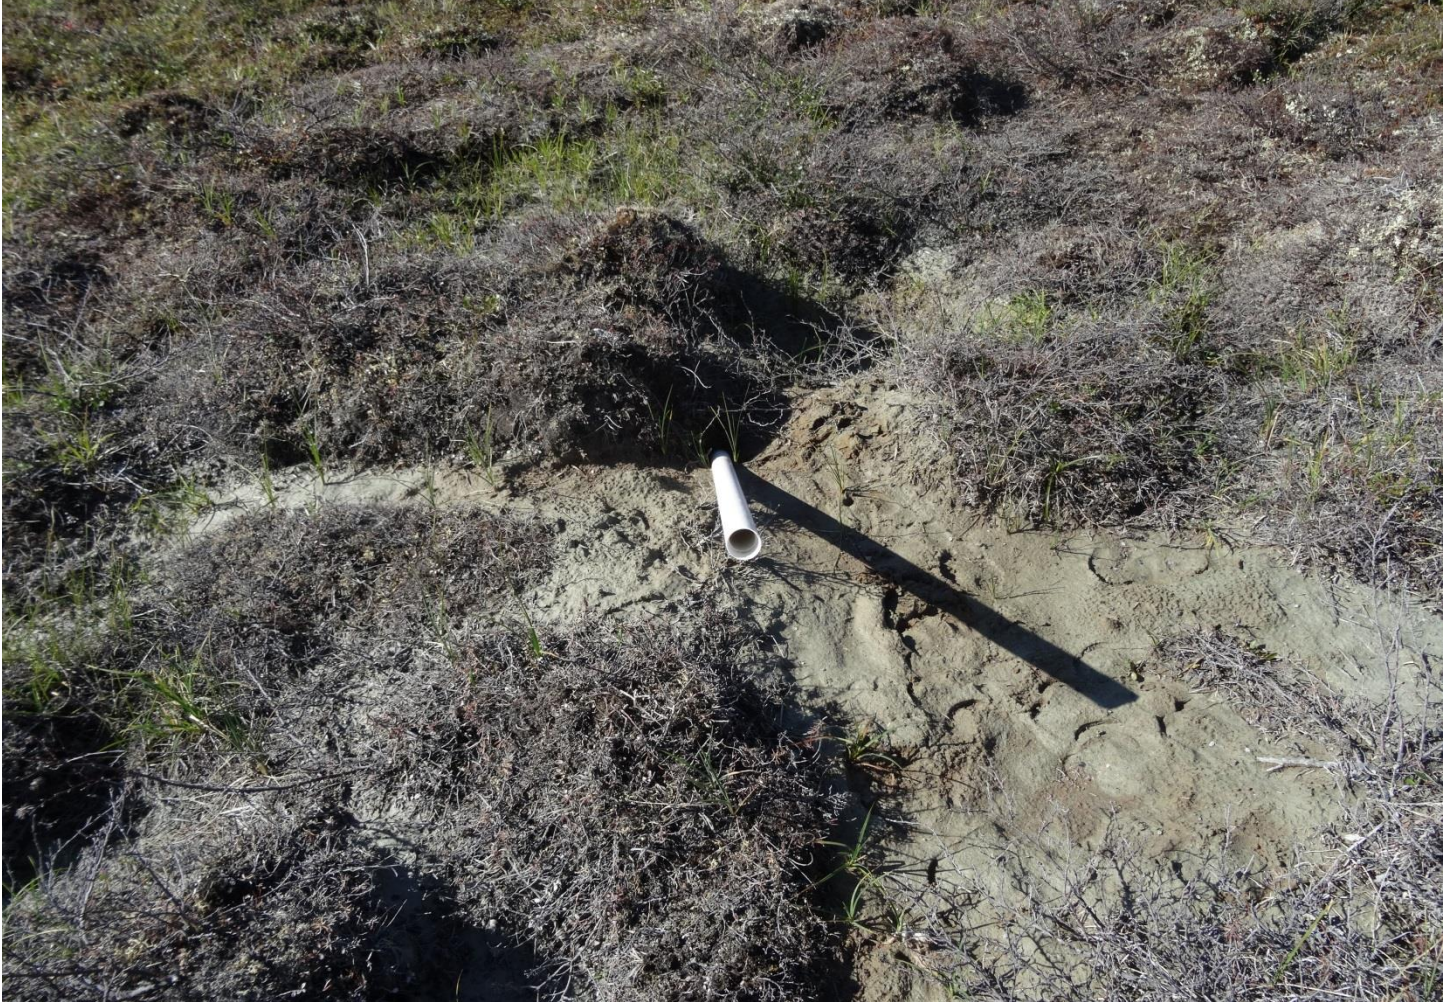
Photo 3

Description: Drill Hole 1 of 3 that I checked

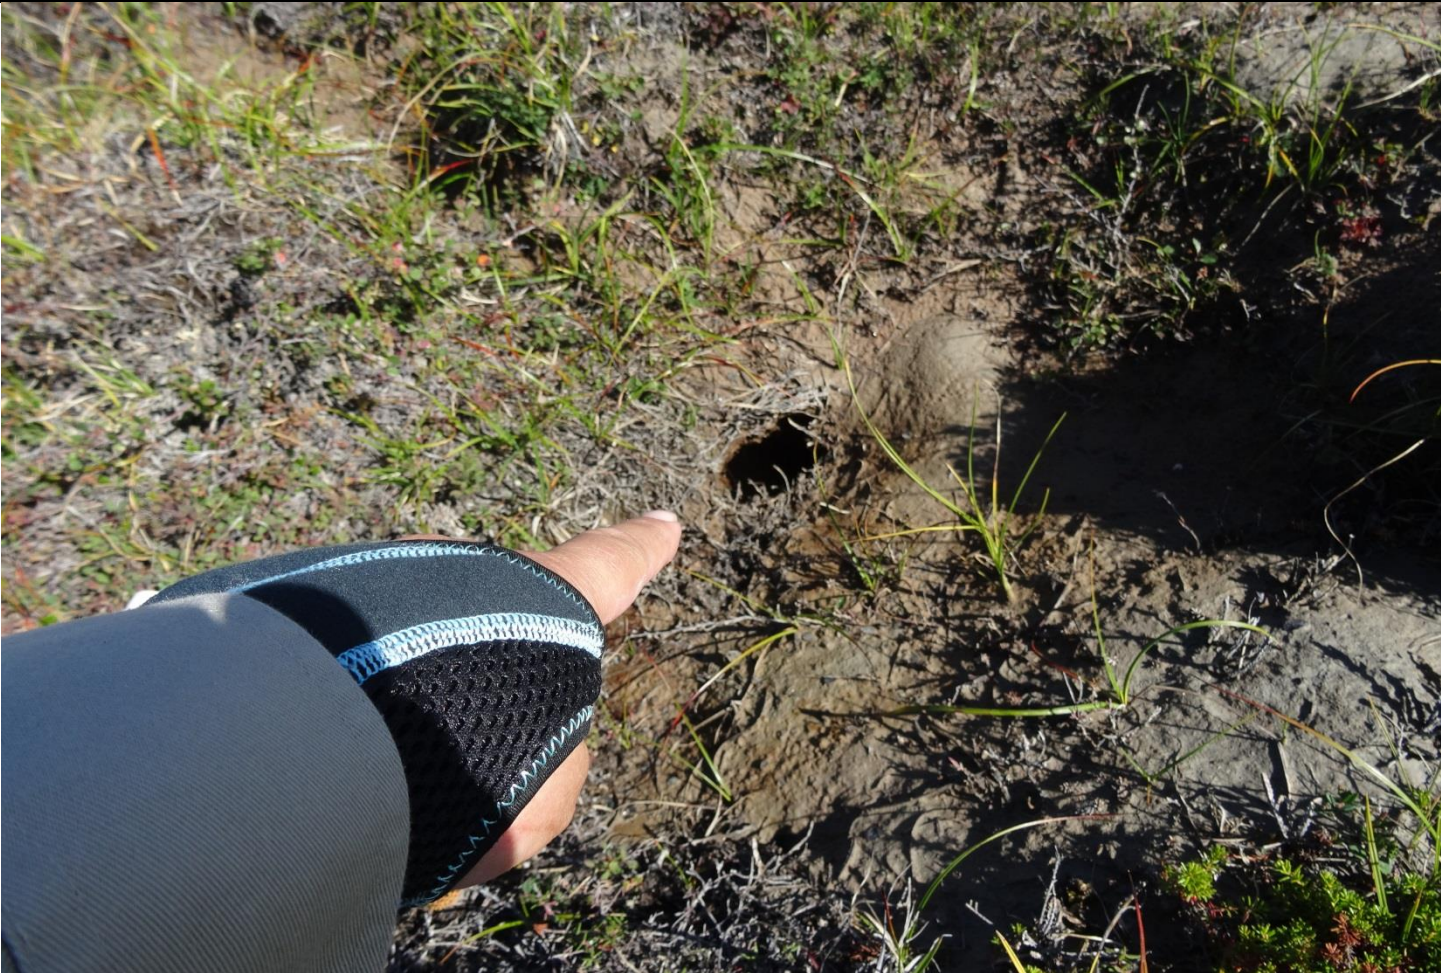
Photo 4

Description: Drill Hole 2 of 3 that I checked

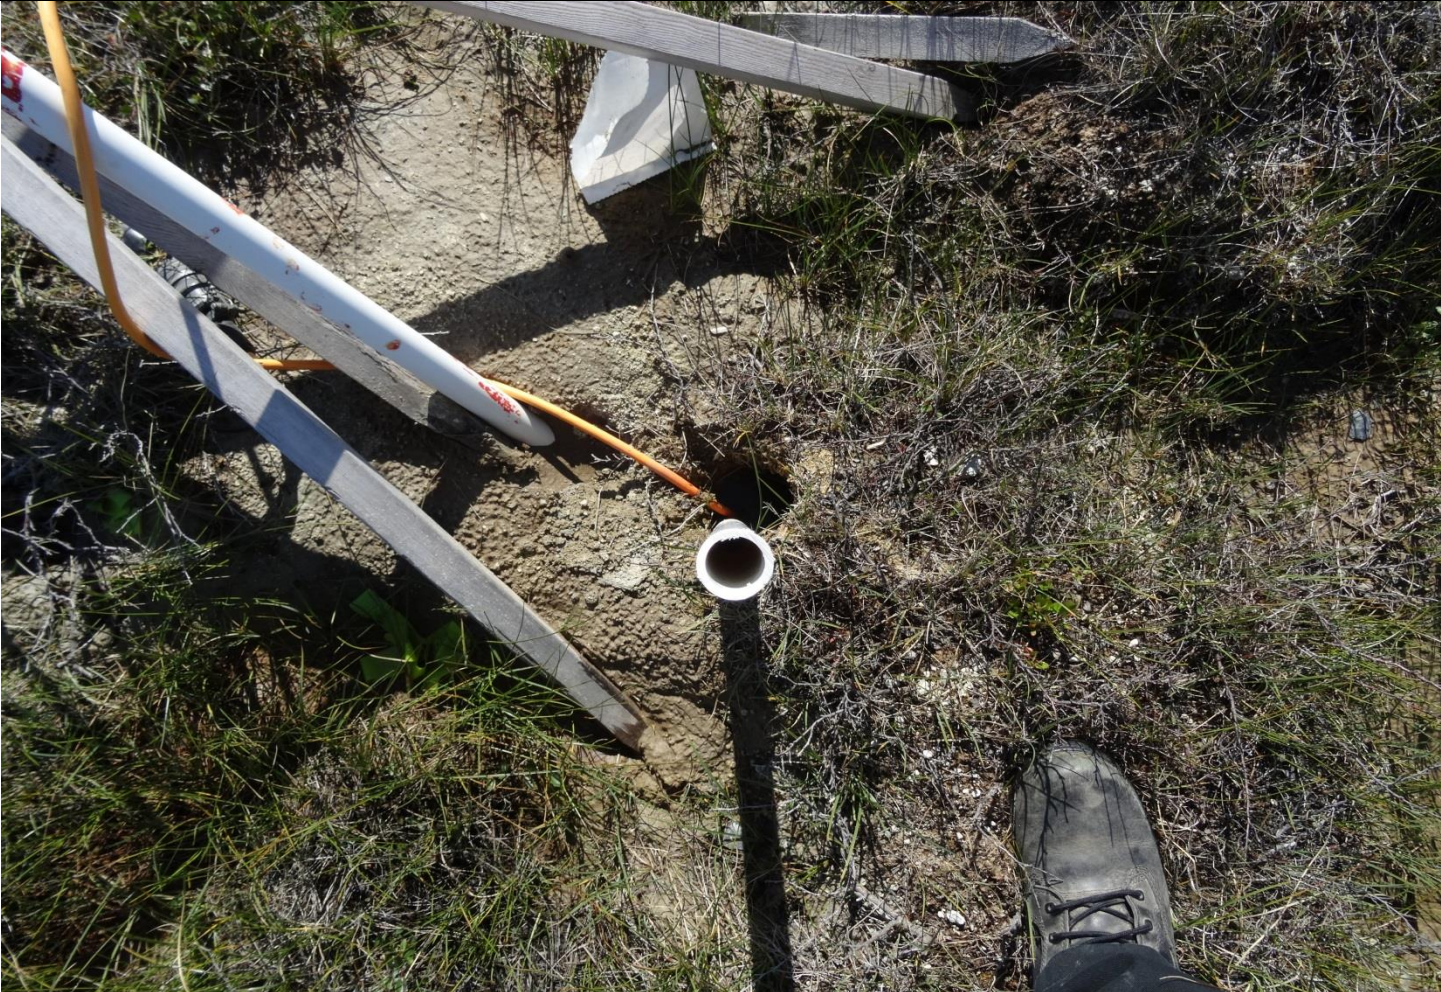
Photo 5

Description: Drill Hole 3 of 3 that I checked
