Photos of July 13 2014 Inspection 2BE-MOU1419

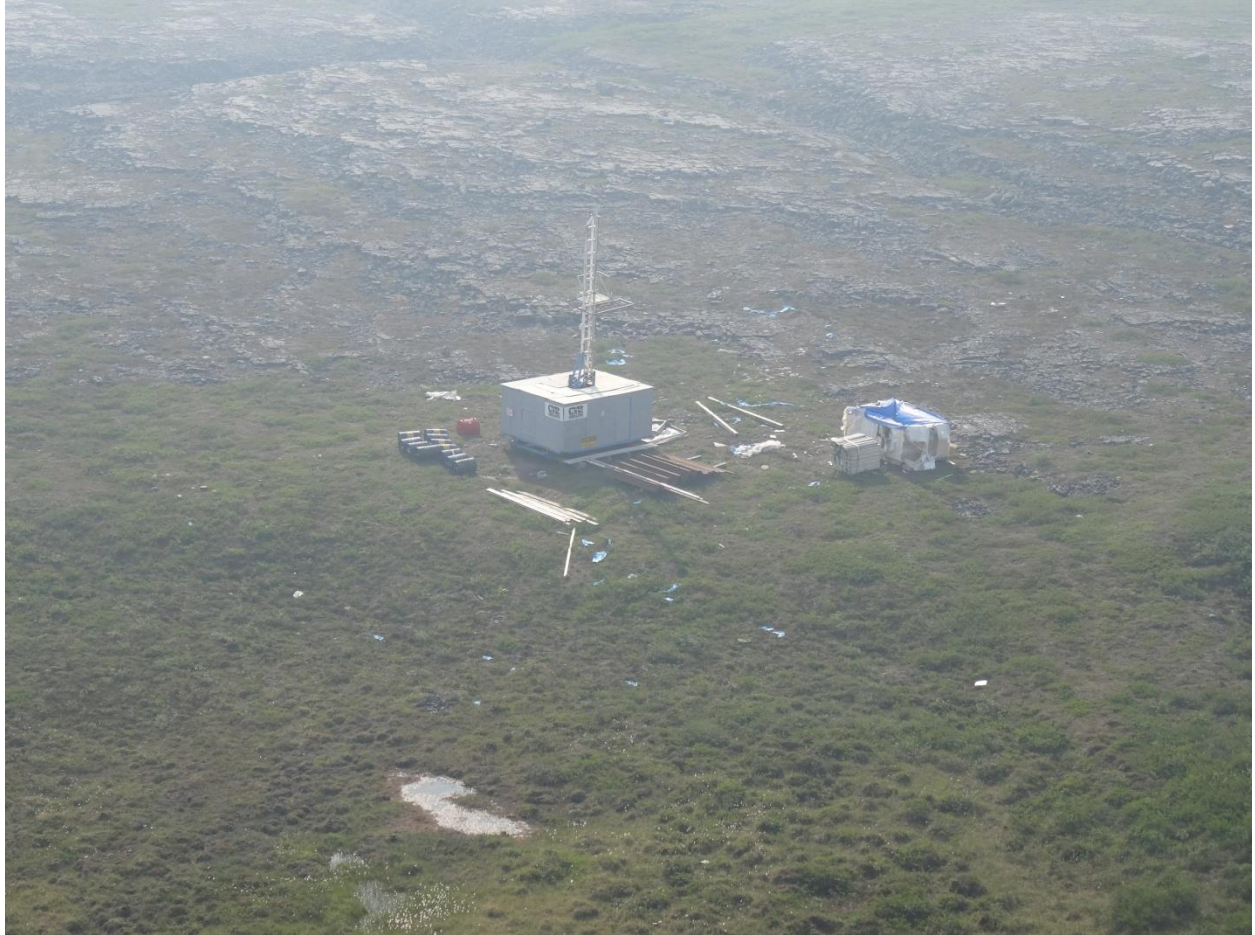
Figure 1. Drill setup at site (B). Note litter strewn around the site from bear damage.

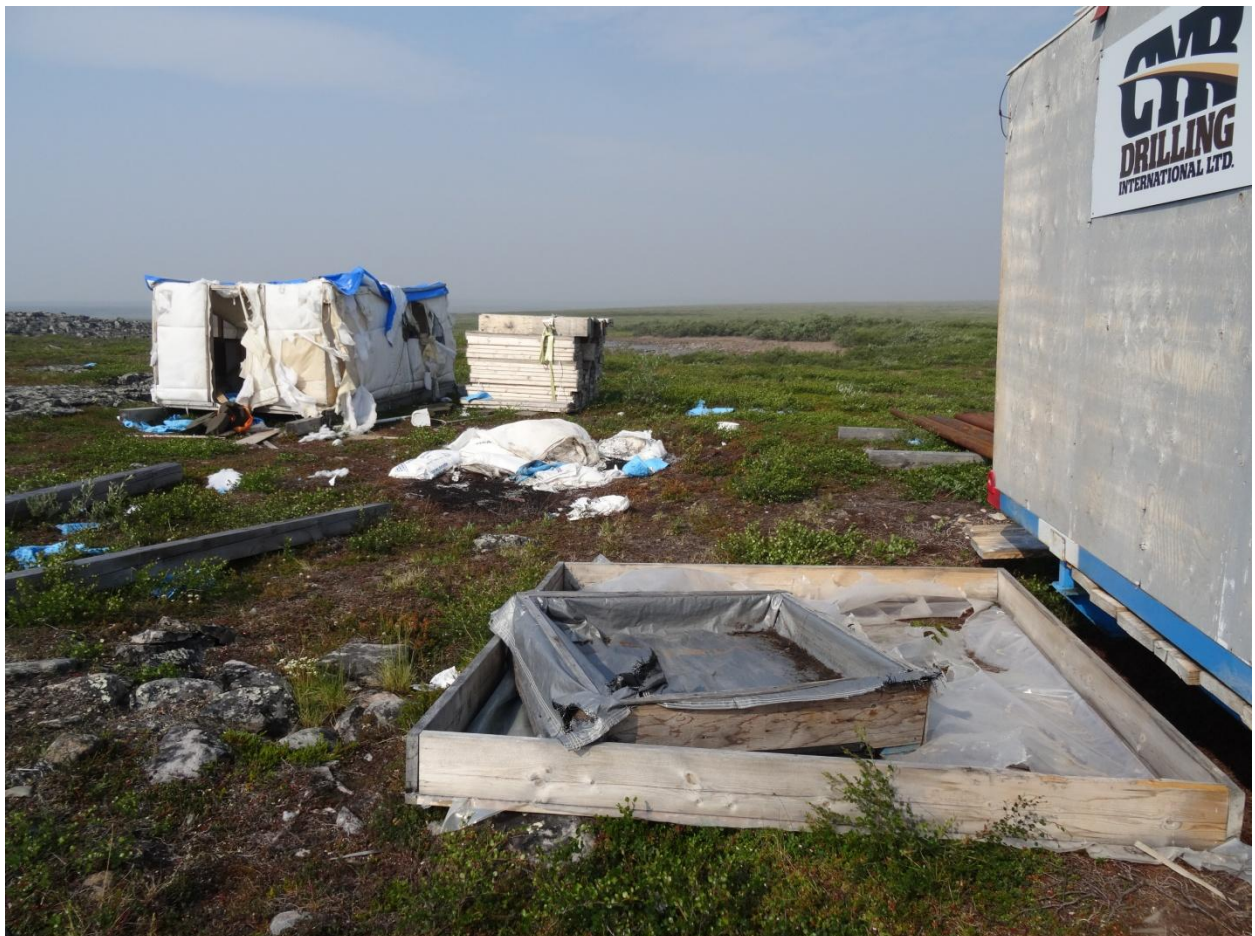
Figure 2. Damaged emergency shelter, salt bags.

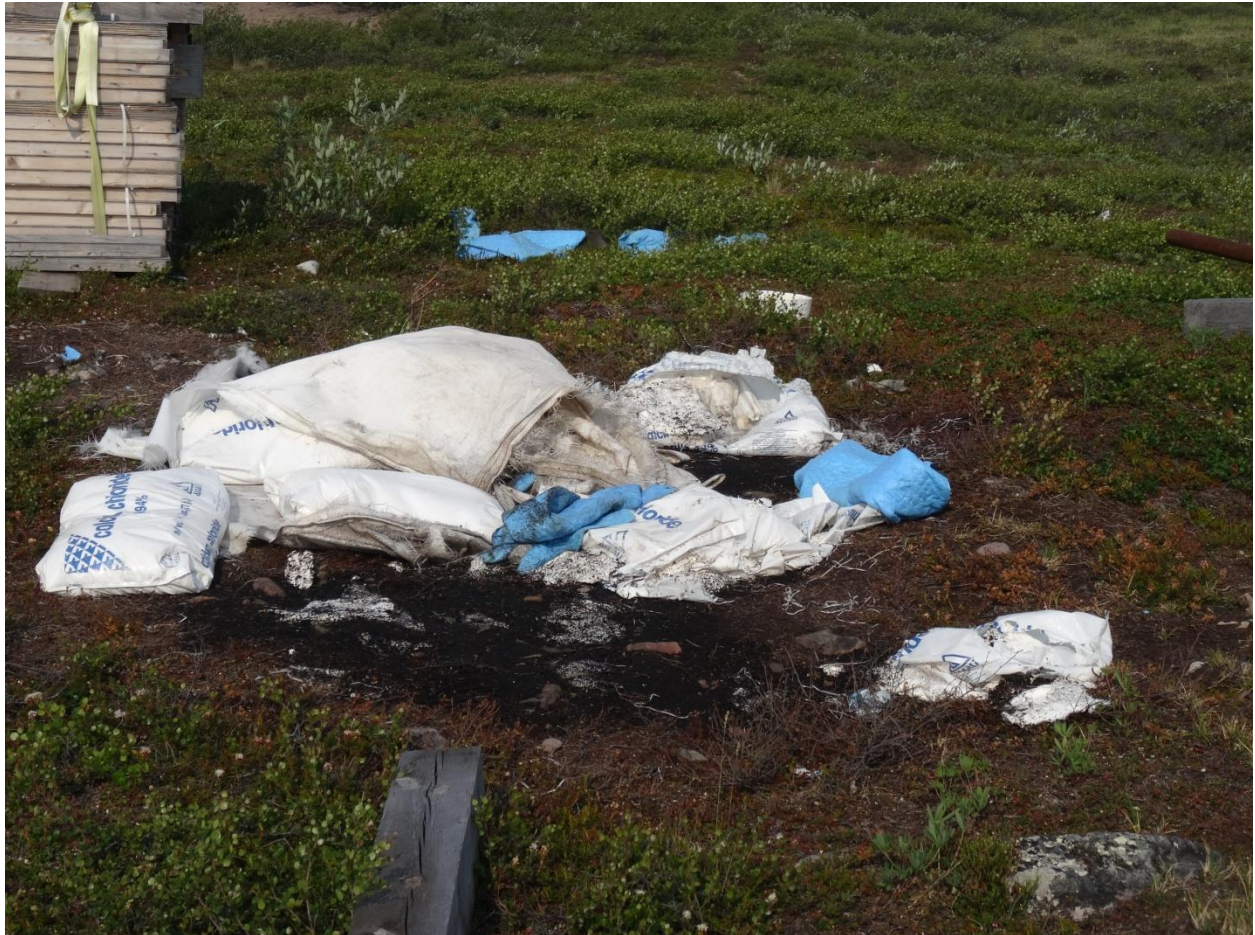
Figure 3. Dissolved salt and resulting dead vegetation. This impact will spread over time until salt is removed.

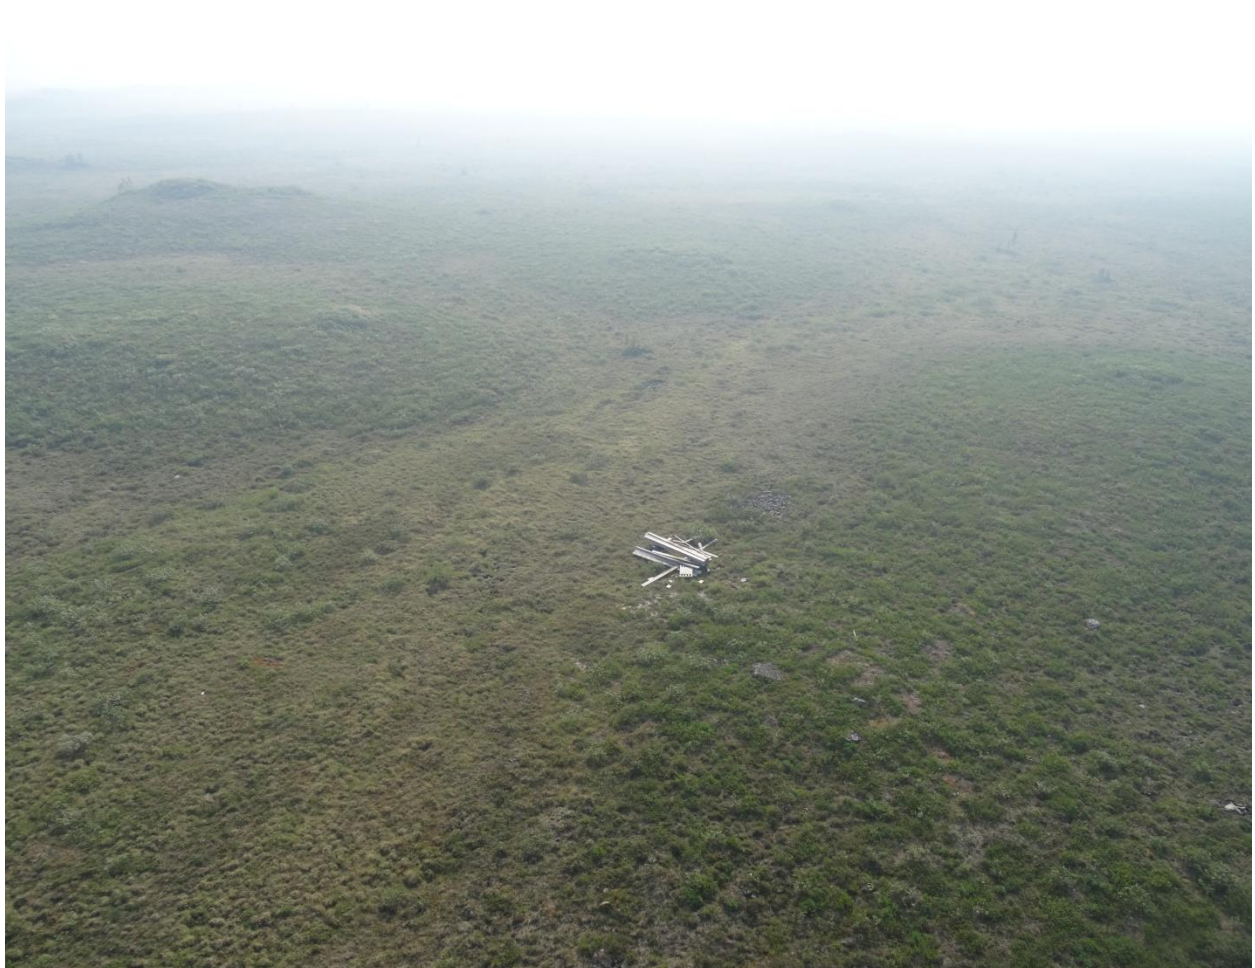
Figure 4. Timbers noted 5 km north of drill setup.

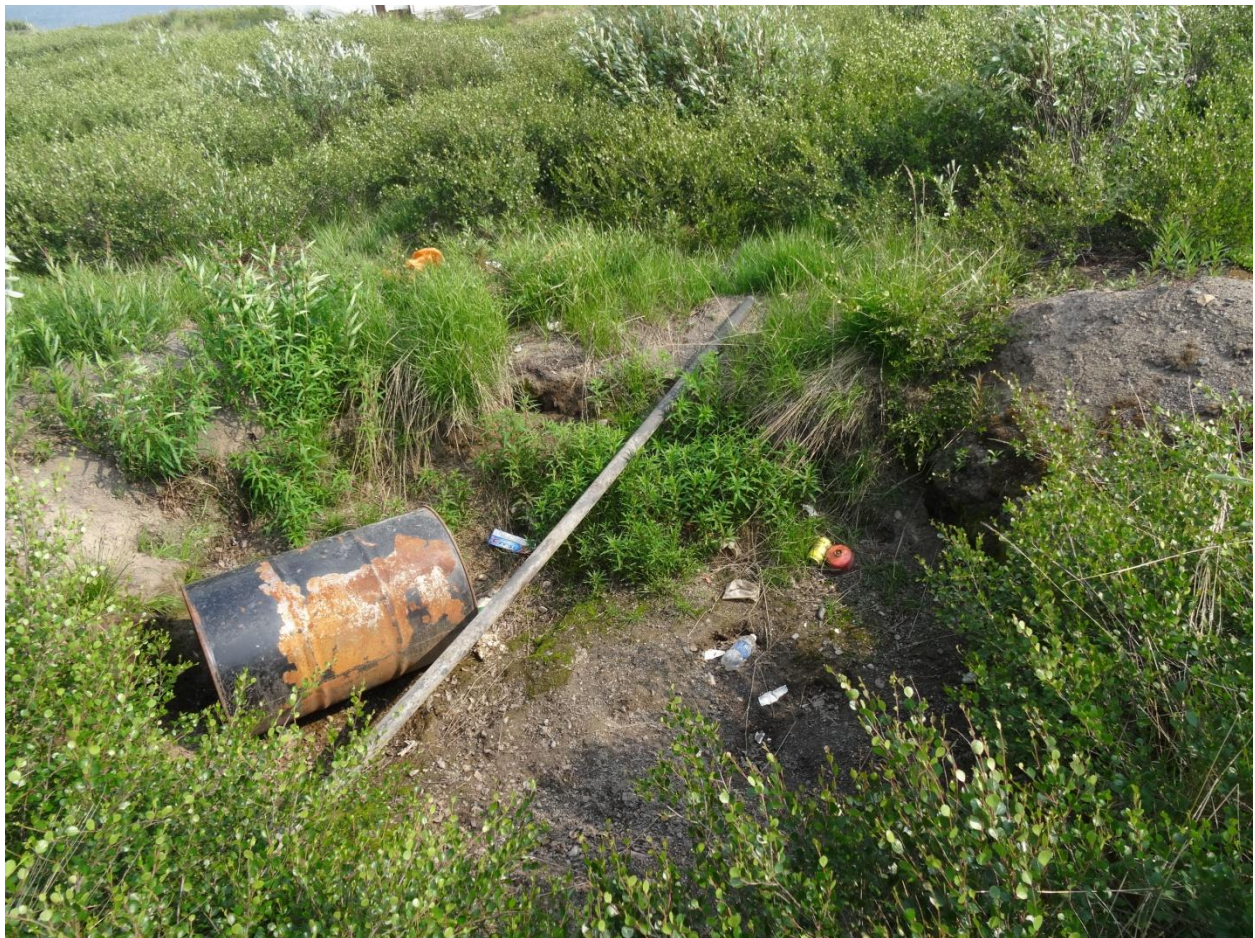
Figure 5. Litter accumulating in kitchen sump.

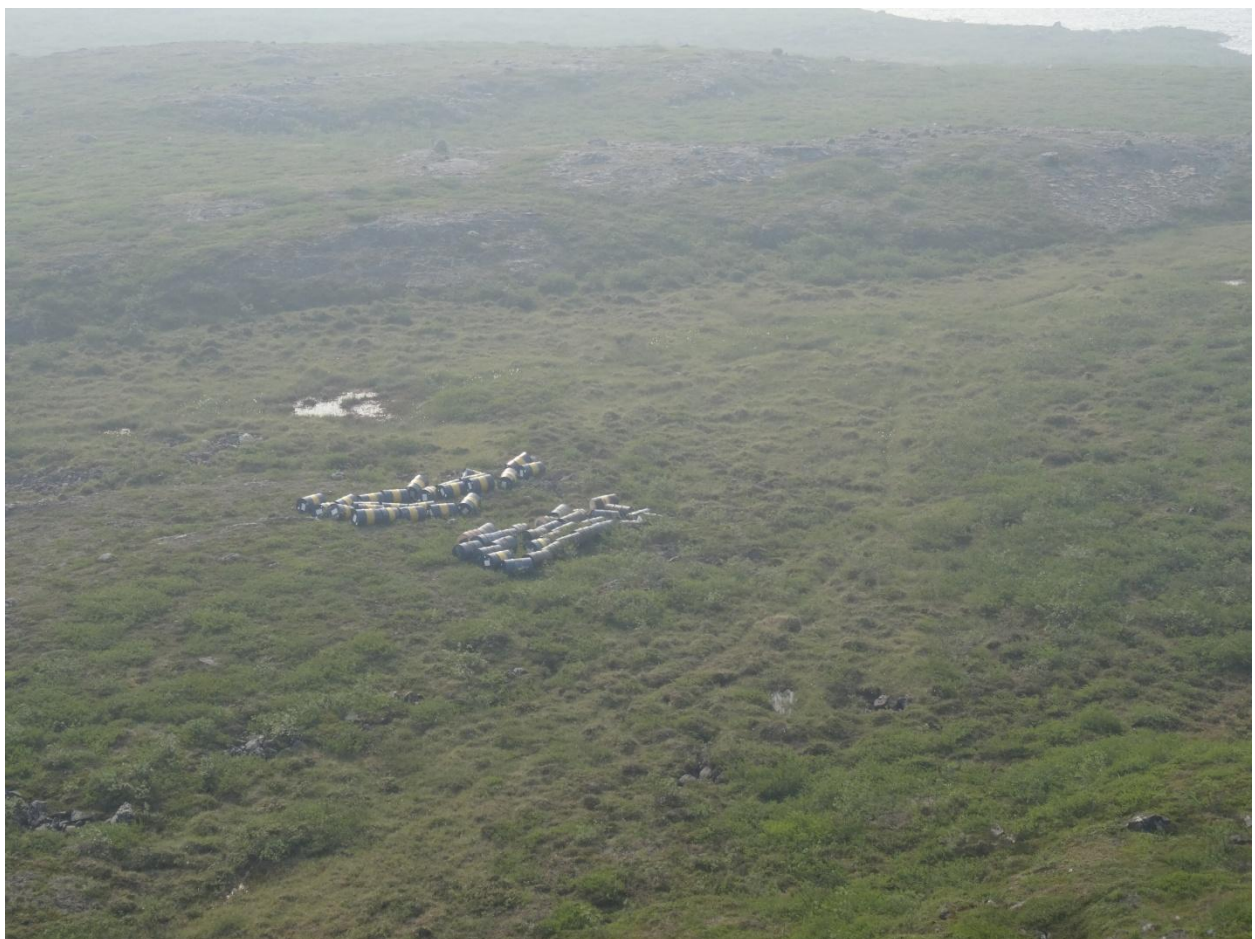
Figure 6. Fuel Cache (A) - barrels at base of hill.

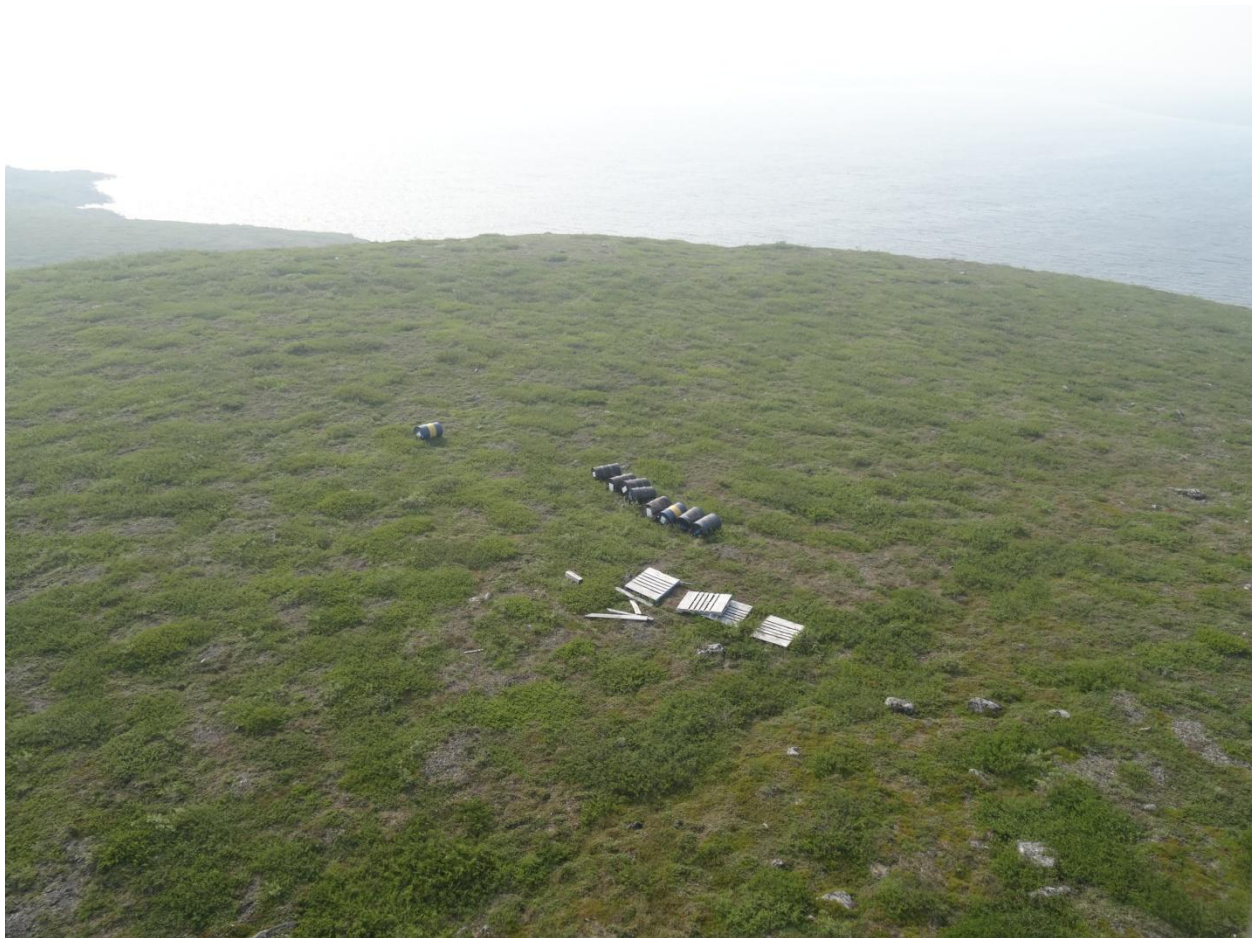
Figure 7. Fuel Cache (A) - barrels and wood on top of hill.

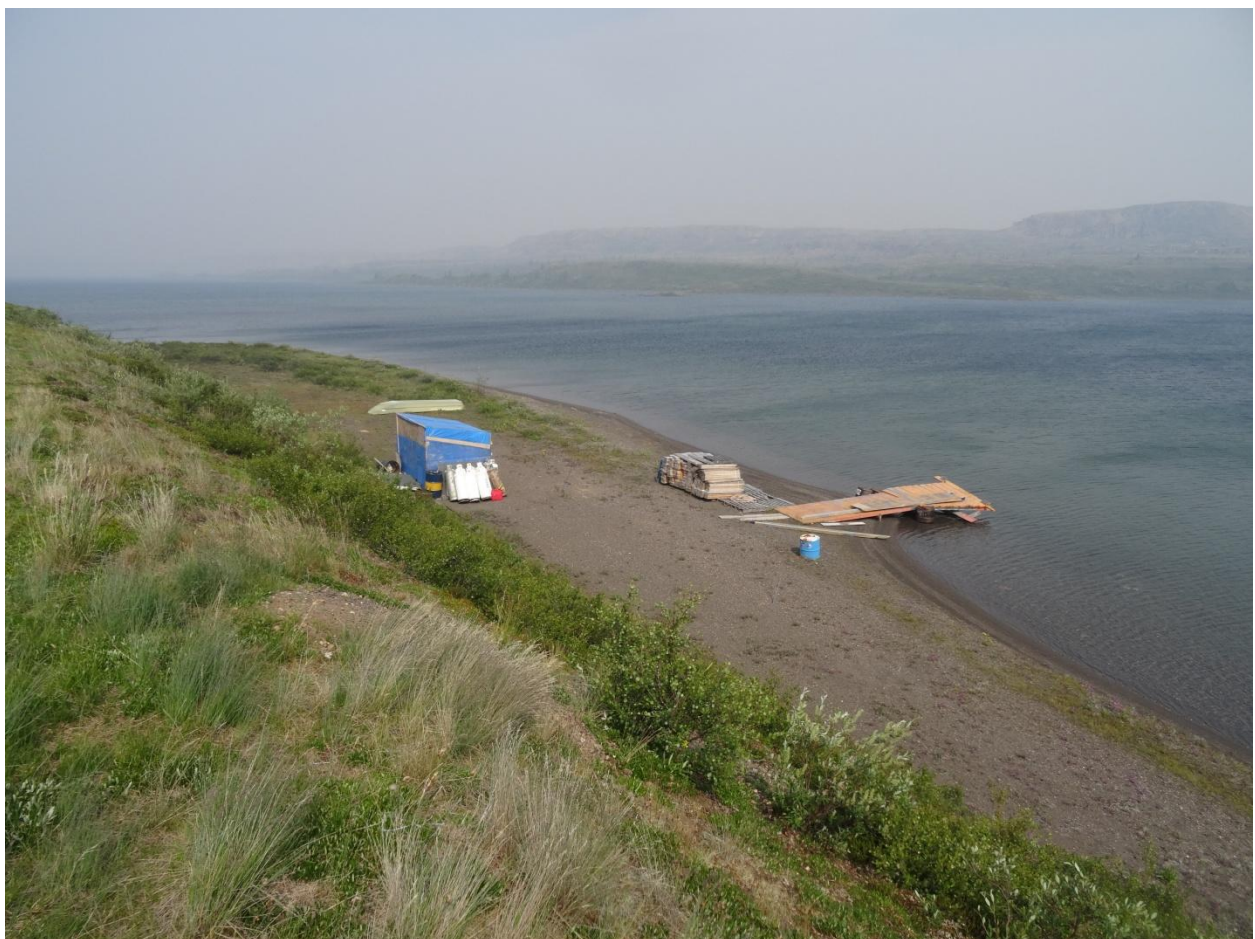
Figure 8. Pallets, core boxes, and propane tanks stored on lake bank.

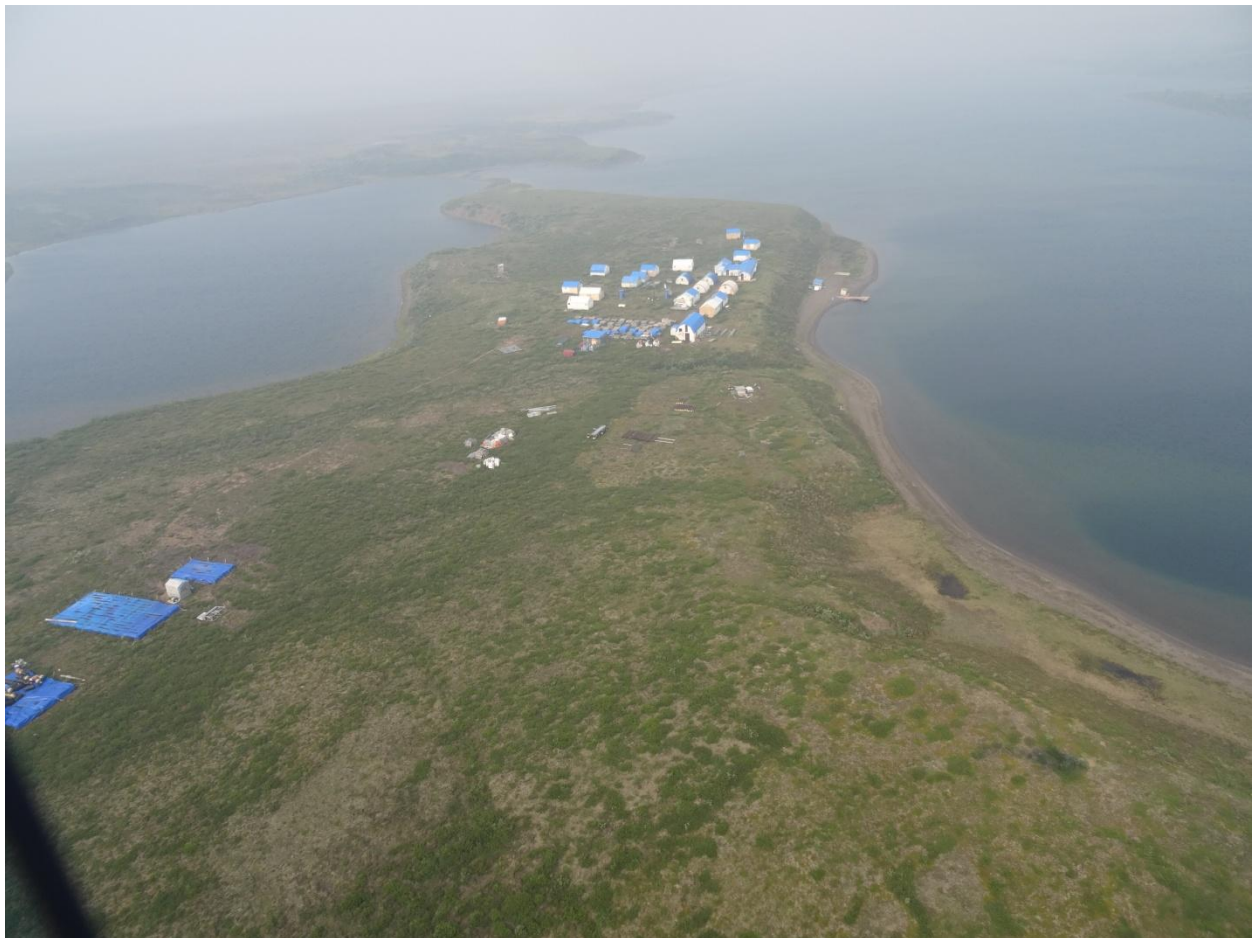
Figure 9. Camp aerial view - 3 berms shown in lower left corner.

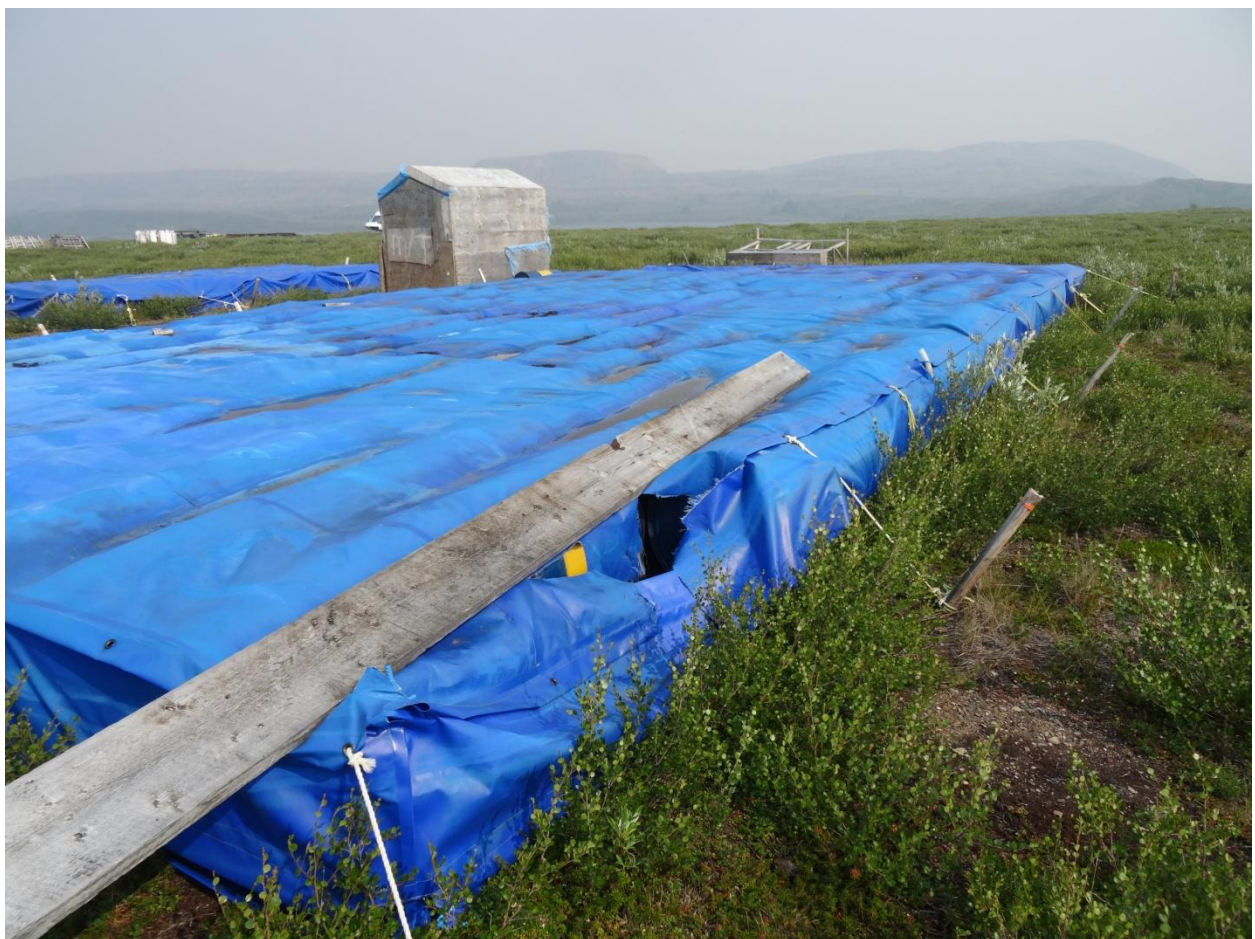
Figure 10. Berm covers are damaged. Cap was left off and (potentially contaminated) water drained out.

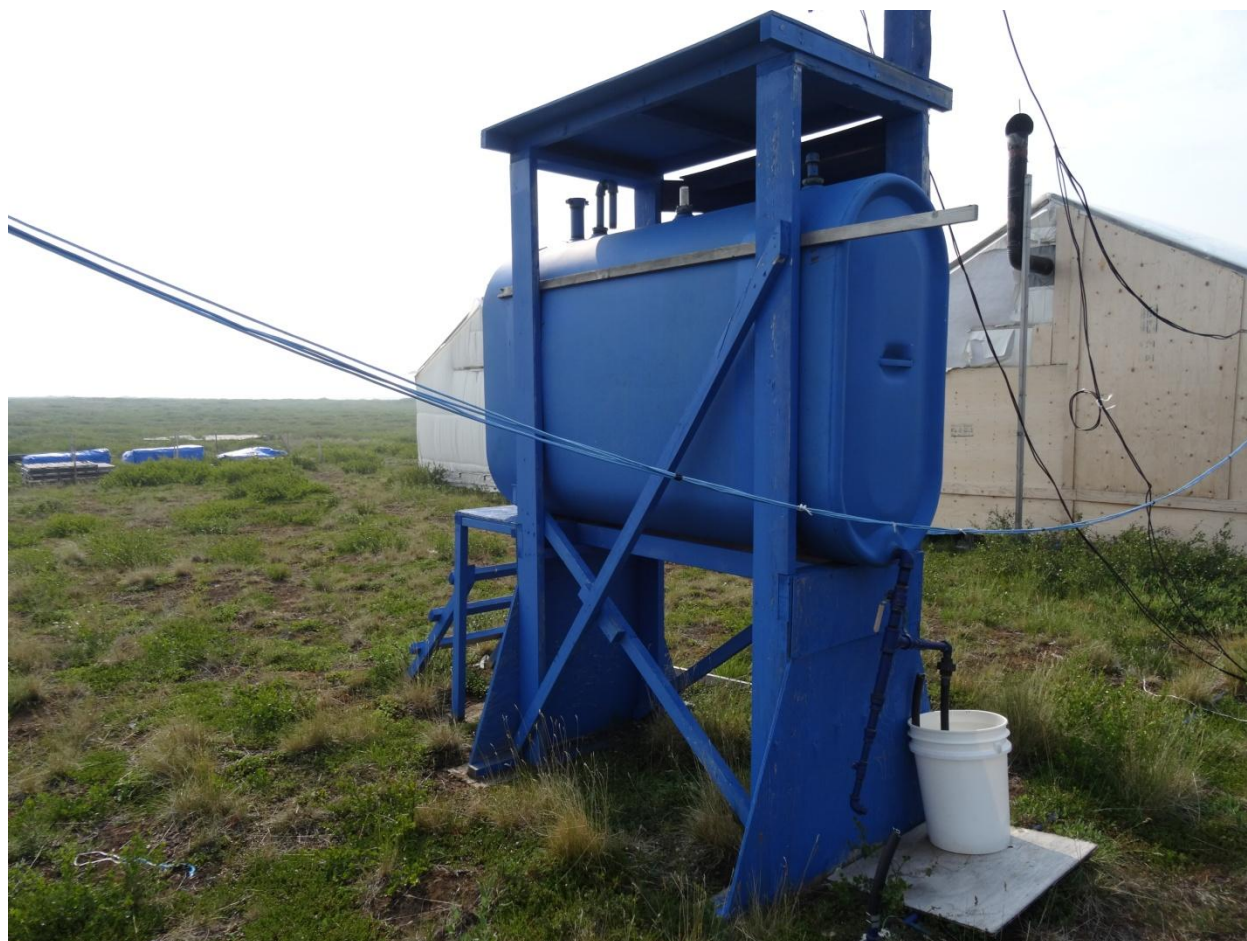
Figure 11. Tall heating fuel setup. No secondary containment for the tank and valves.
