WATER LICENCE INSPECTION FORM

Licensee		Licensee Representative	
Hornby Bay Mineral Exploration Ltd			
Licence No. / Expiry		Representative's Title	
2BE-MOU1419			
Land / Other Authorizations		Land / Other Authorizations	
N2011C0007			
Date of Inspection		Inspector	
24 to 26 August 2017		Baba Pedersen	
Activities Inspected			
<input checked="" type="checkbox"/> Camp	<input checked="" type="checkbox"/> Drilling	<input type="checkbox"/> Mining	<input type="checkbox"/> Construction
<input type="checkbox"/> Roads/Hauling	<input type="checkbox"/> Other:	<input type="checkbox"/> Other:	<input checked="" type="checkbox"/> Reclamation
<input checked="" type="checkbox"/> Fuel Storage

PHOTO LOG

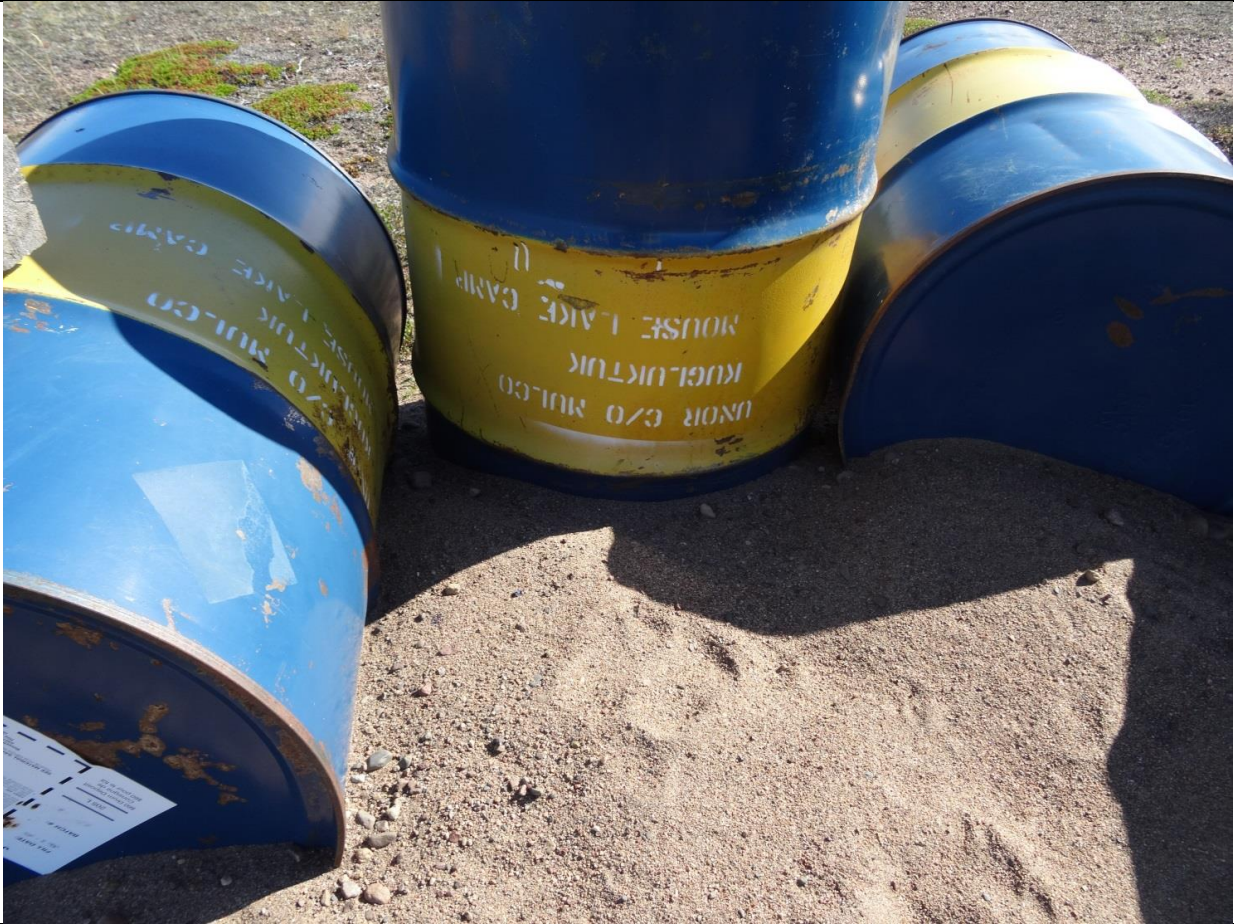
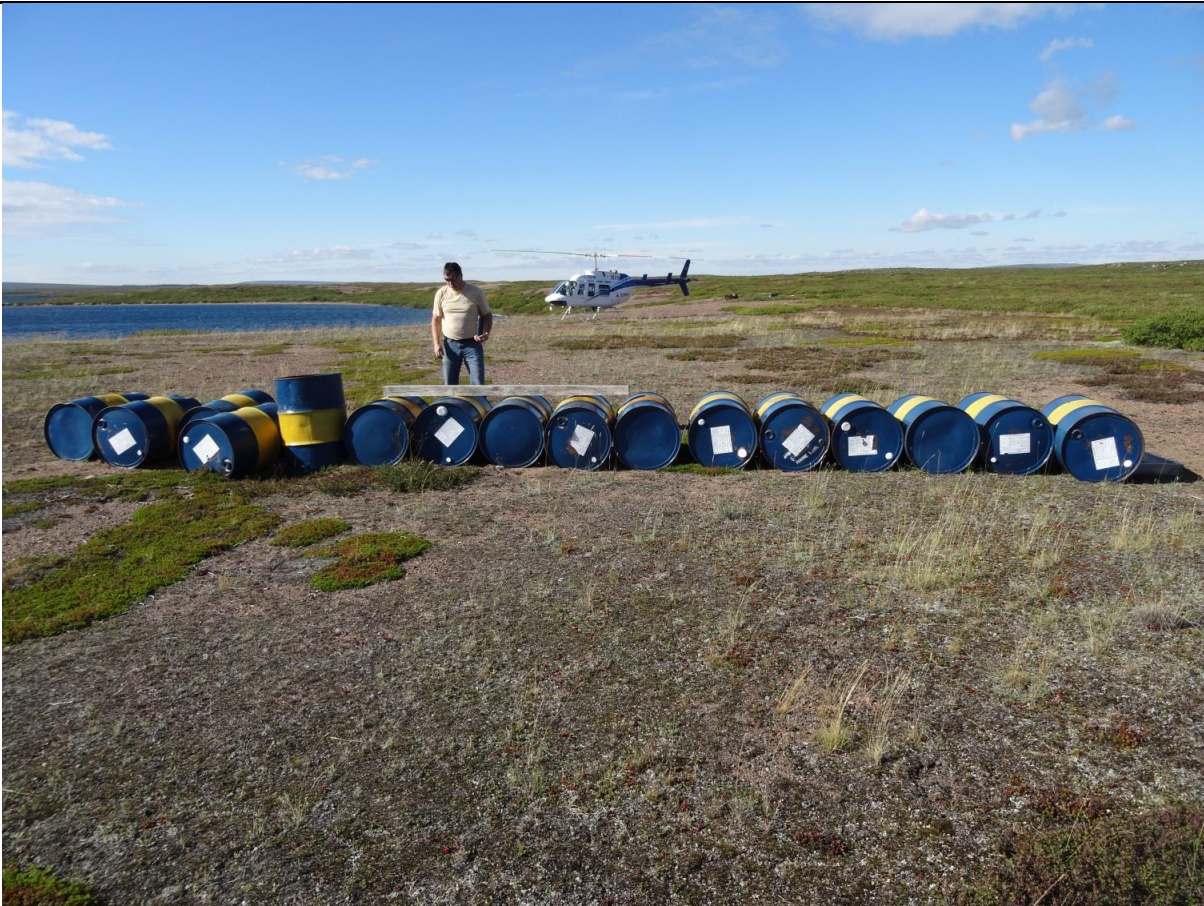
1. At the 2BE-MOU Fuel 1 Site (Photos 1 & 2) I found 16 Drums with no secondary containment. 9 were Full and 7 were Empty. 2. At the Lac Rouviere area Fuel Cache (Photo 3) I found all Drums have been removed. The area is in a Clean and Natural state. 3. At the Mouse Lake Camp (Photos 4 to 16) I found it to be very messy, many buildings were damaged by weather and neglect. 4. At the 2BE-MOU Fuel 3 Drill Site (Photos 17 & 18) I found an abandoned complete Drill Site still standing with 13 Full Drums and a Heli Tank with no secondary containment. 5. At the unknown Fuel Cache site (Photos 19 & 20) I found 5 Full Drums marked "Mouse" within 10 feet of the edge of a lake with no secondary containment. 6. As per the NWB, the 2016 Annual Report has not been submitted yet. Also, there is no Final Clean-up Plan/Schedule on file.			
SECTION 3	<input type="checkbox"/> Comments	<input type="checkbox"/> Non-Compliance with Act or Licence	<input checked="" type="checkbox"/> Action Required

Description: 2BE-MOU Fuel 1, 16 Drums – 9 Full – 7 Empty – No Secondary Containment

1. All Drums at the 2BE-MOU Fuel 1 Site must be removed. 2. The Lac Rouviere area Fuel Cache is acceptable for Closure. 3. The entire Mouse Lake Camp must be Cleaned Up, Removed and Reclaimed. 4. The Drill, Fuel and all associated materials at the 2BE-MOU Fuel 3 Site must all be Cleaned Up, Removed and Reclaimed. 5. All Drums at the unknown Fuel Cache Site must be removed. 6. The 2016 Annual Report and a Final Clean-up Plan/Schedule must be submitted to the NWB without delay . ITEMS 1 TO 5 MUST BE COMPLETED IN THE SPRING/SUMMER OF 2018. I will be conducting a Closure Inspection of All Sites in late July or early August 2018.

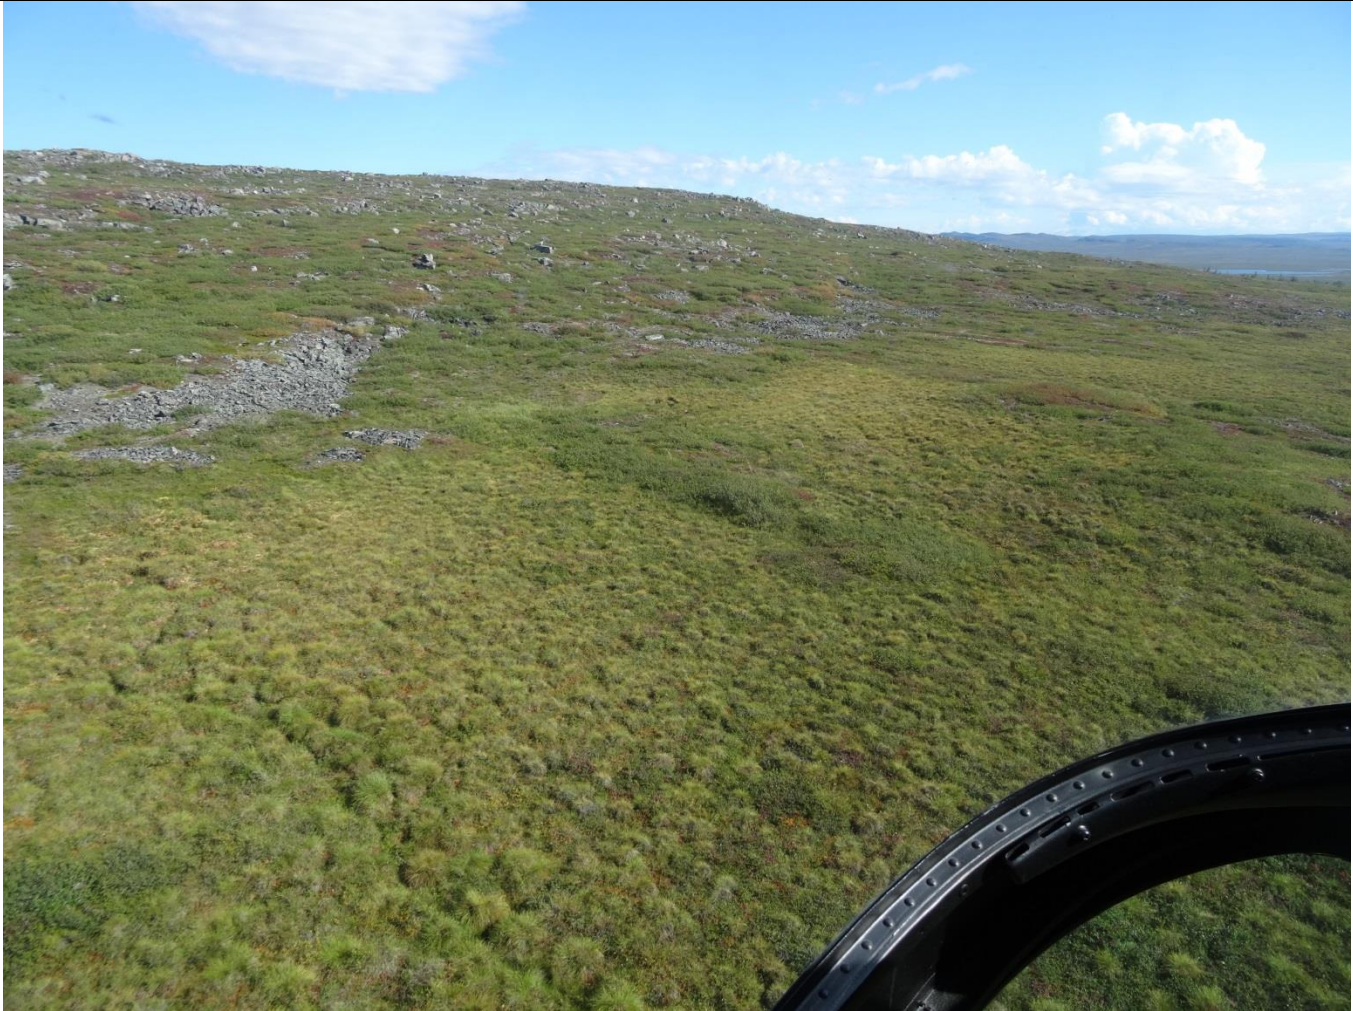
Photo 3

Description: Lac Rouviere area Fuel Cache – All Drums removed – Reclamation Complete

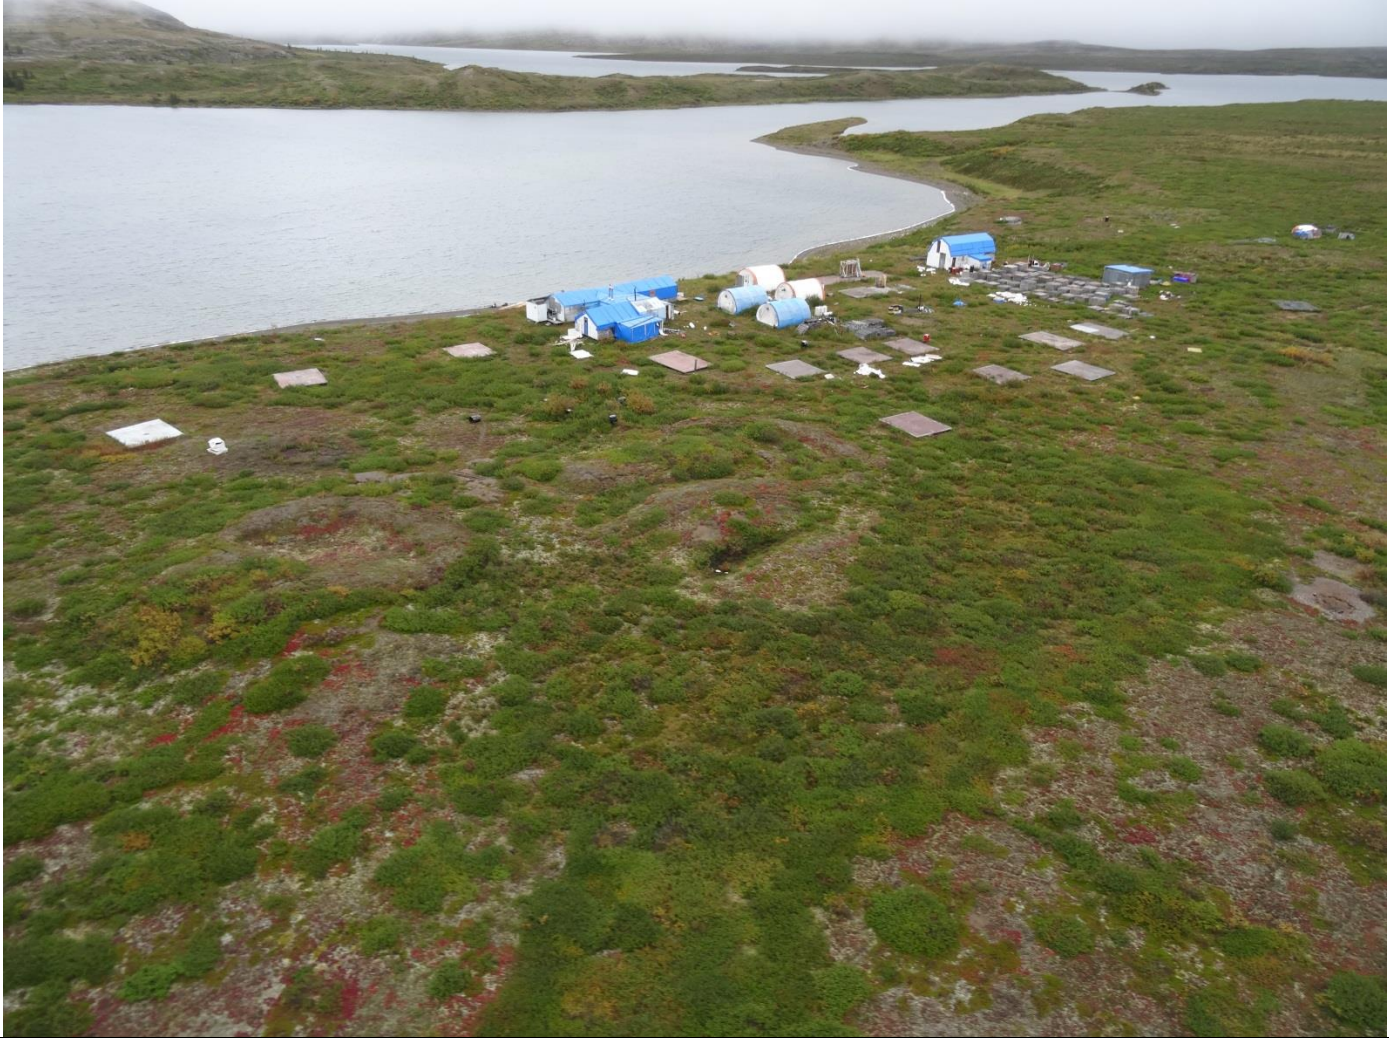
Photo 4

Description: Aerial View of Mouse Lake Camp

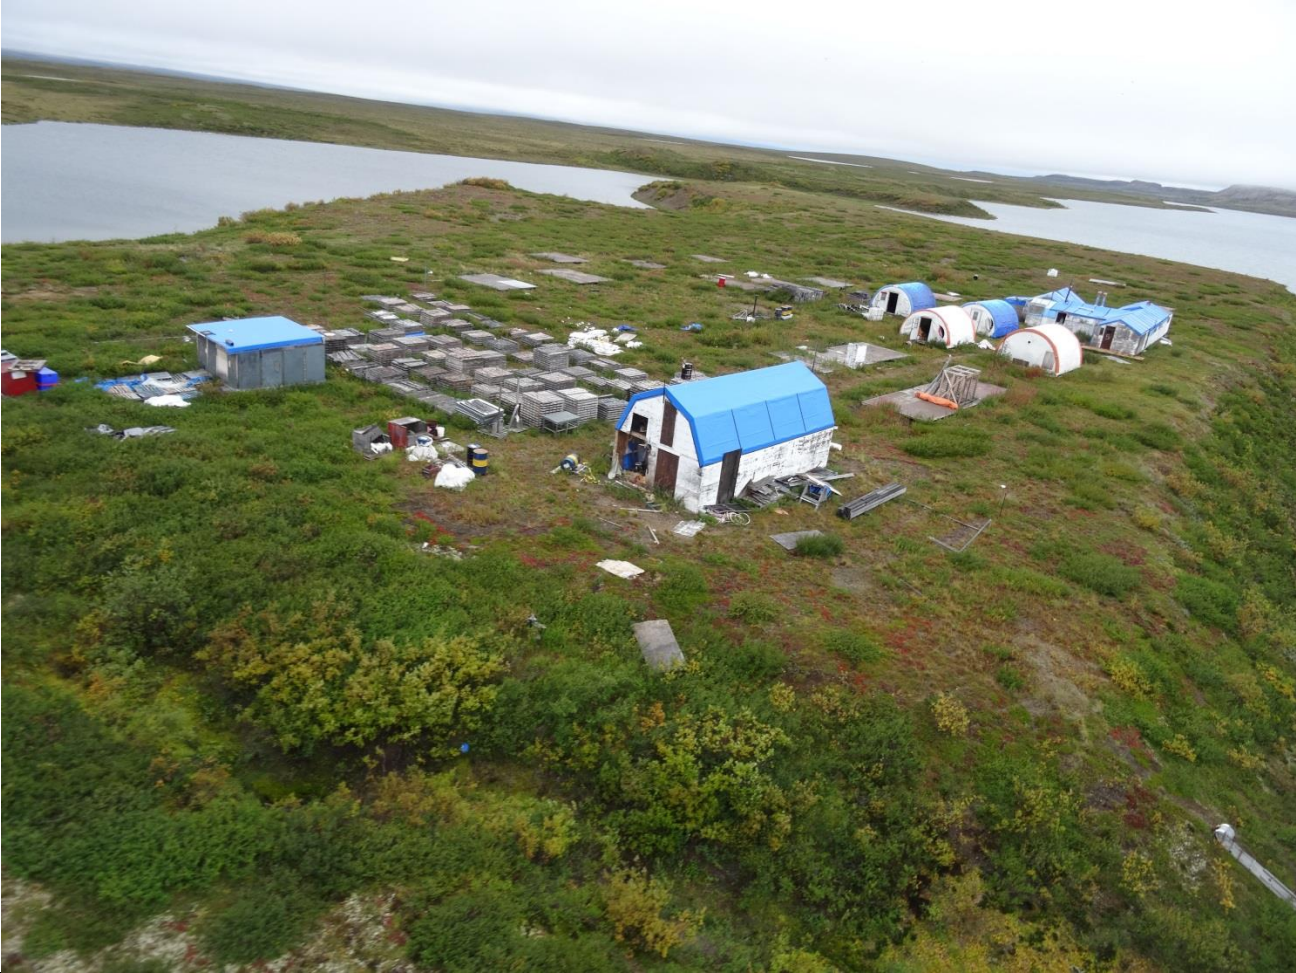
Photo 5

Description: Aerial View of Mouse Lake Camp

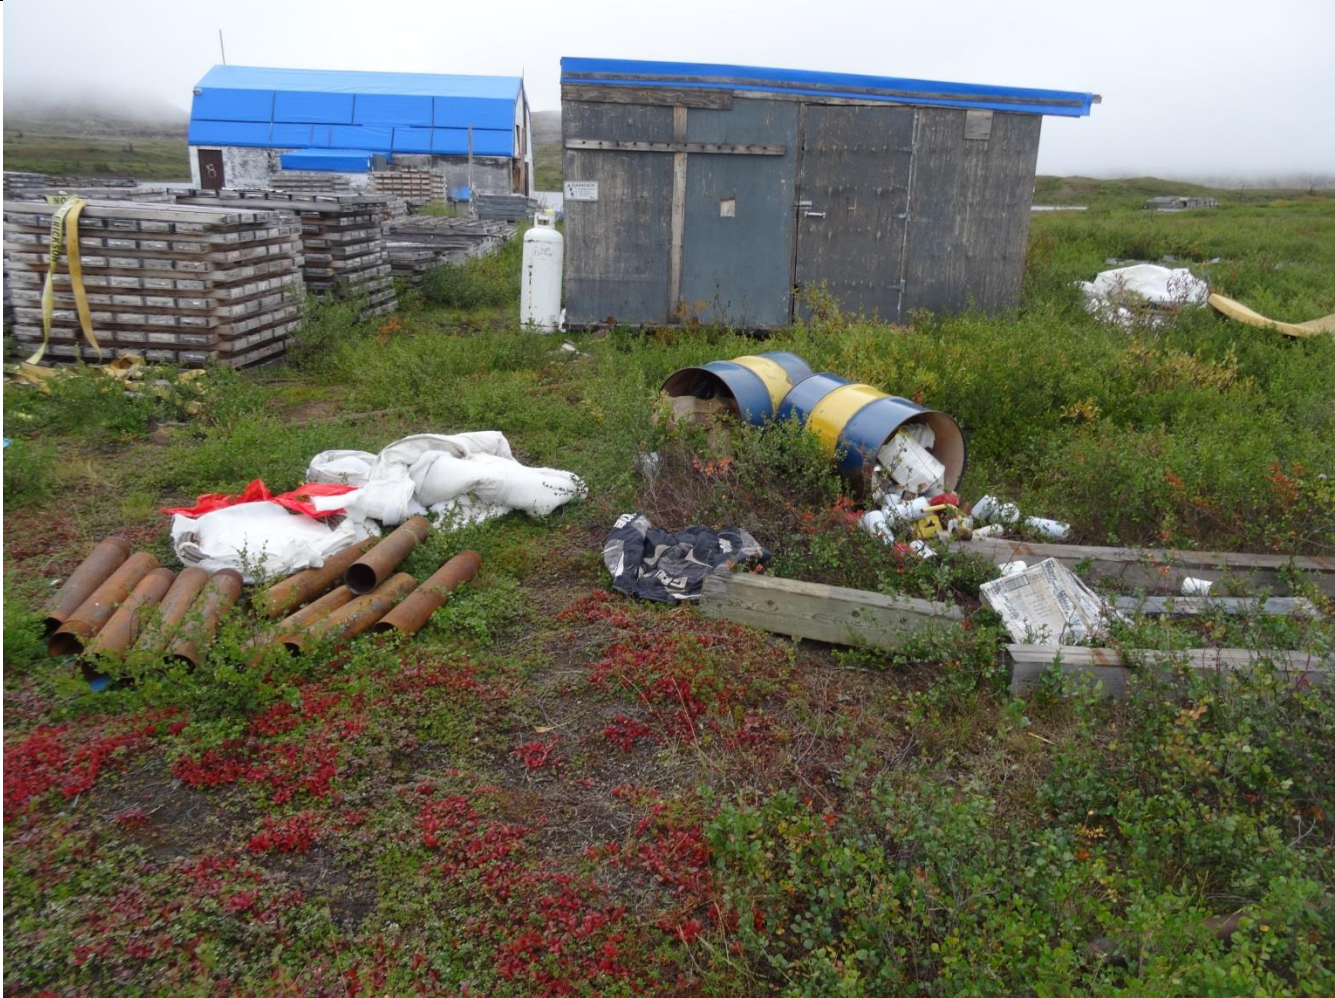
Photo 6

Description: Spilled Garbage Drums with used POL Products on Ground

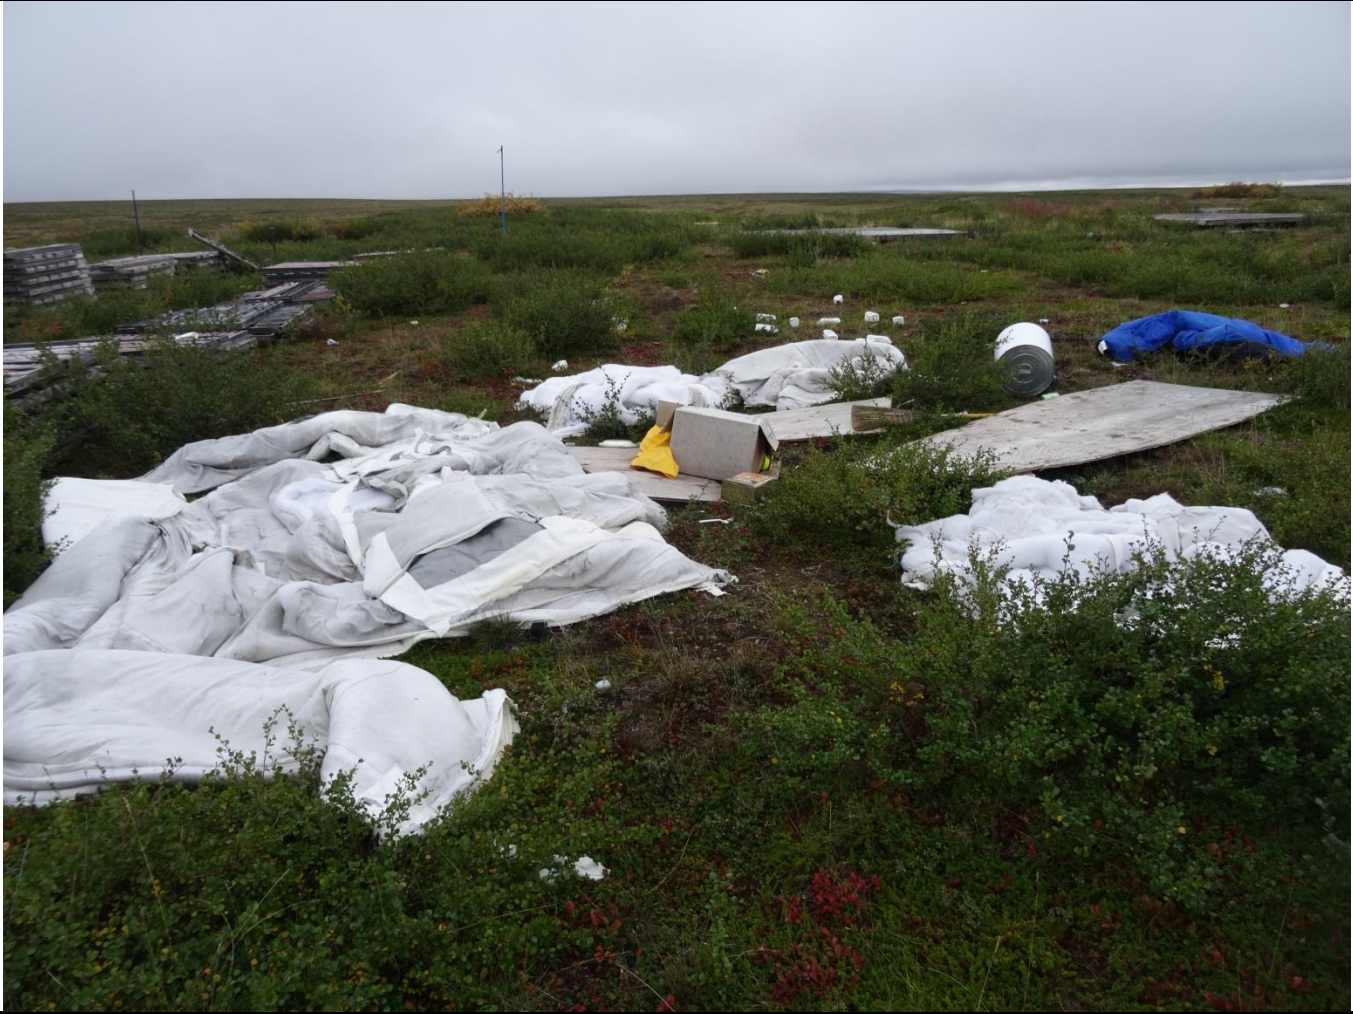
Photo 7

Description: Mess on Ground

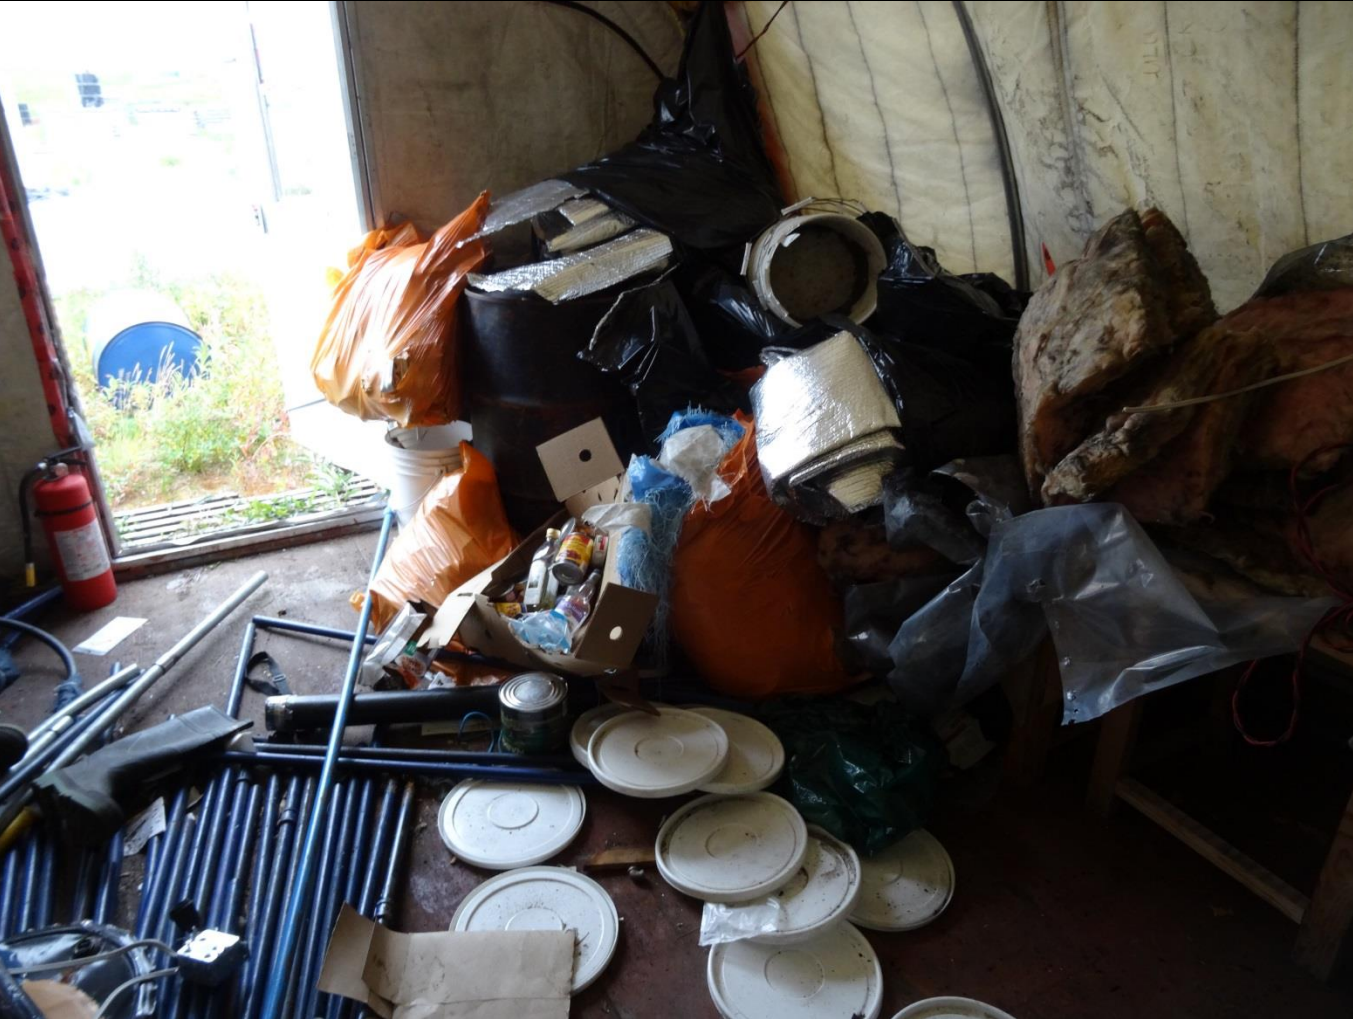
Photo 8

Description: Mess in Damaged Tent

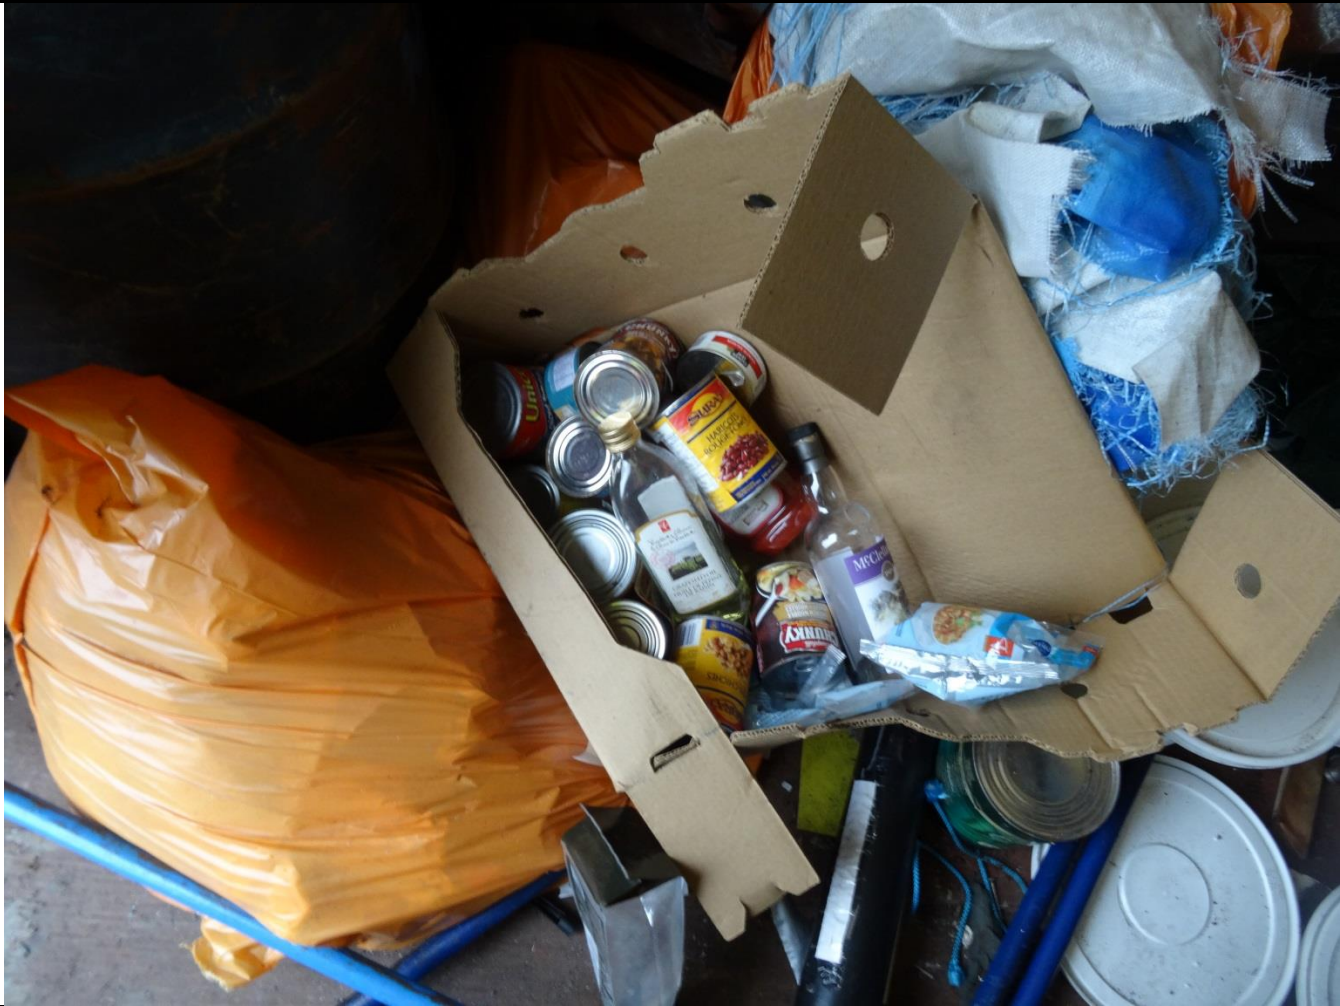
Photo 9

Description: Box of Food in Damaged Tent

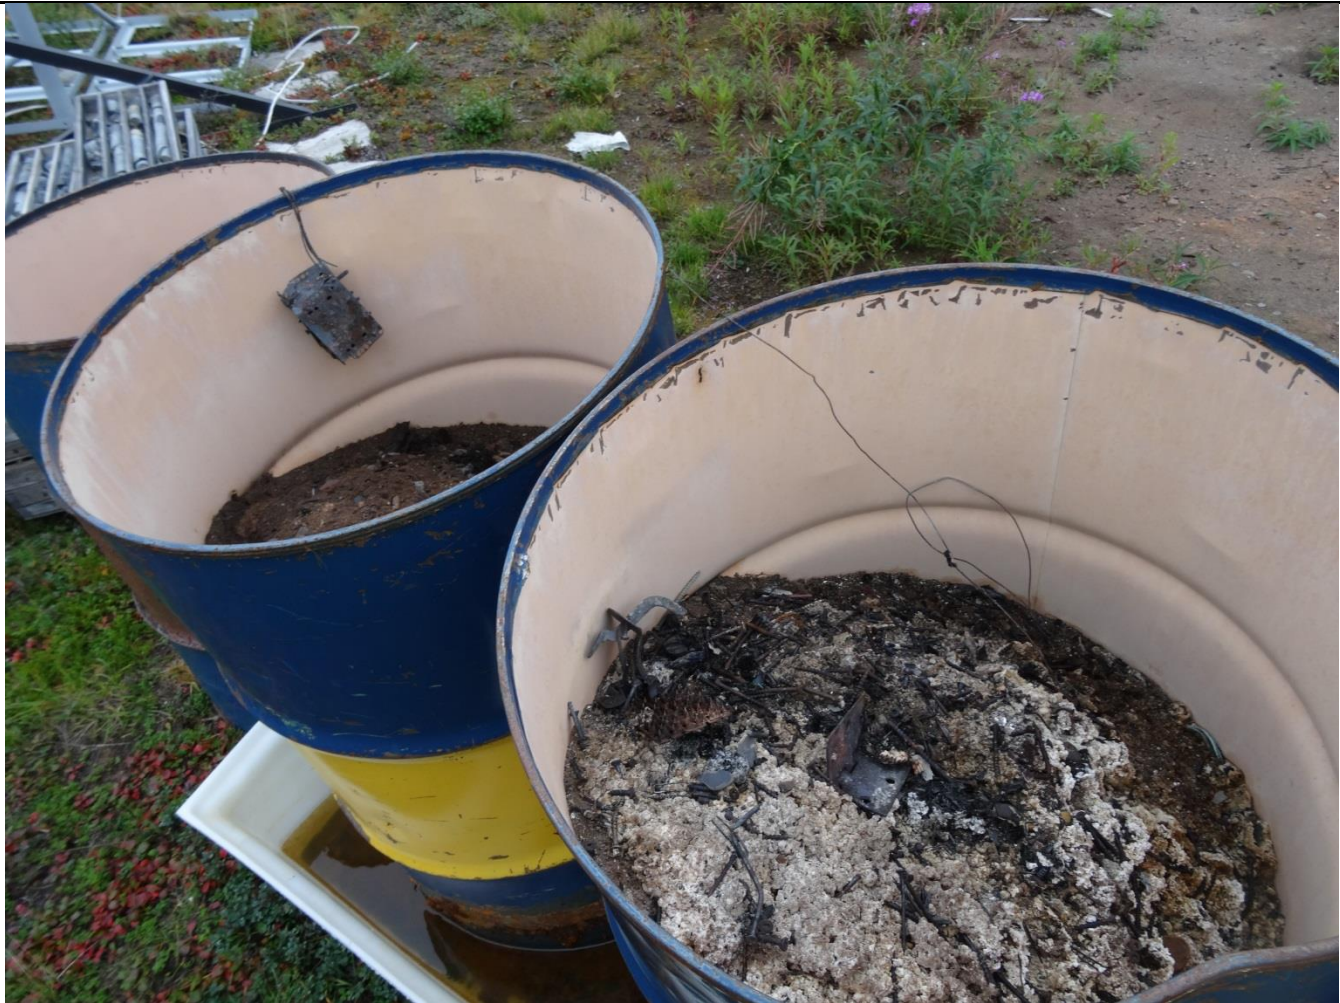
Photo 10

Description: Burnt Ash/Metal in Open Drums

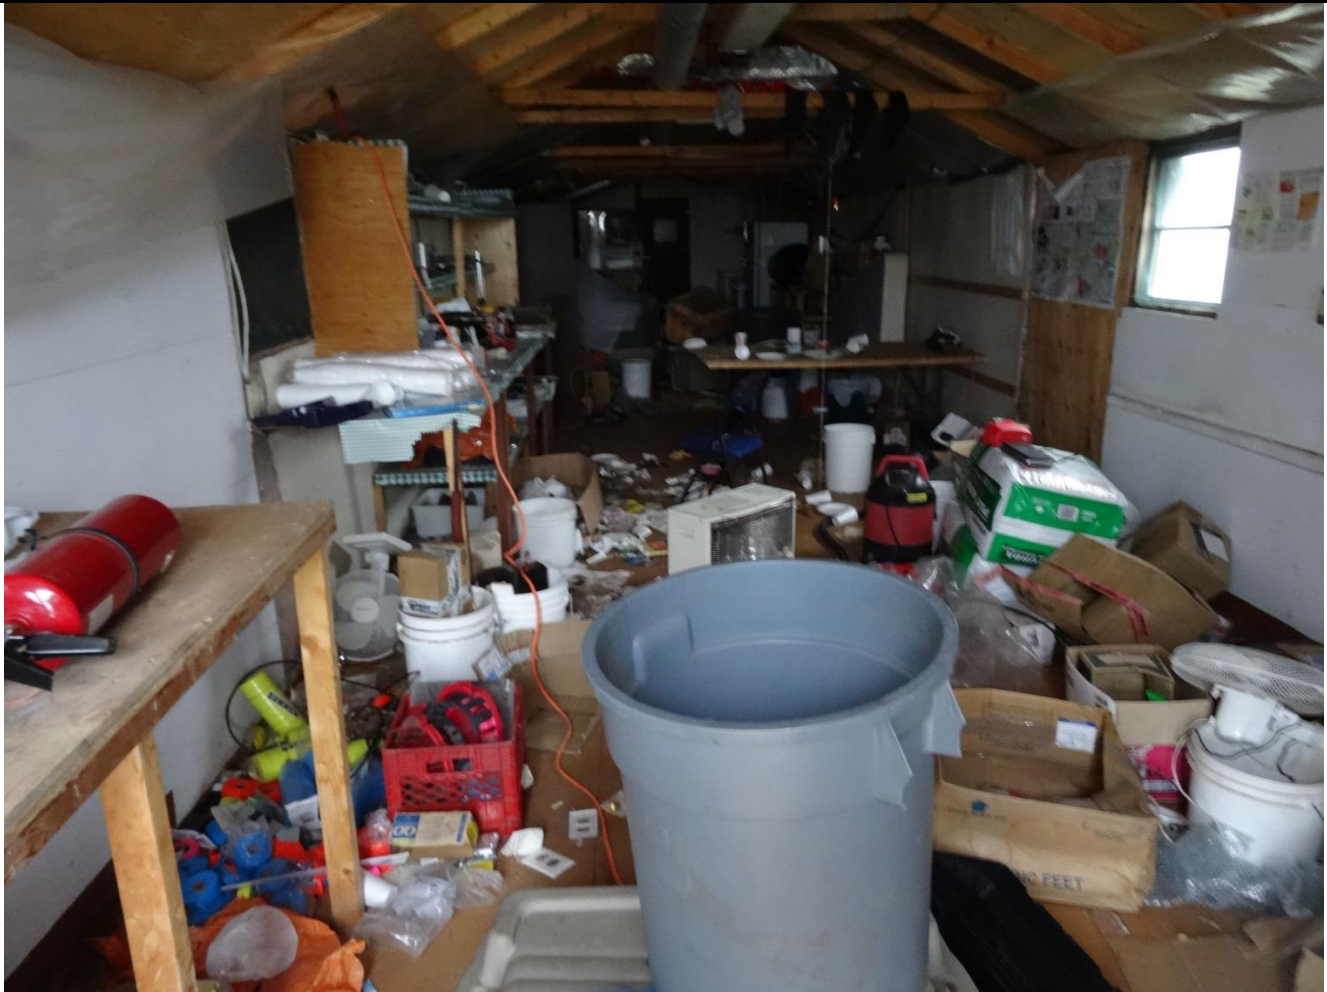
Photo 11

Description: Mess in Damaged Building

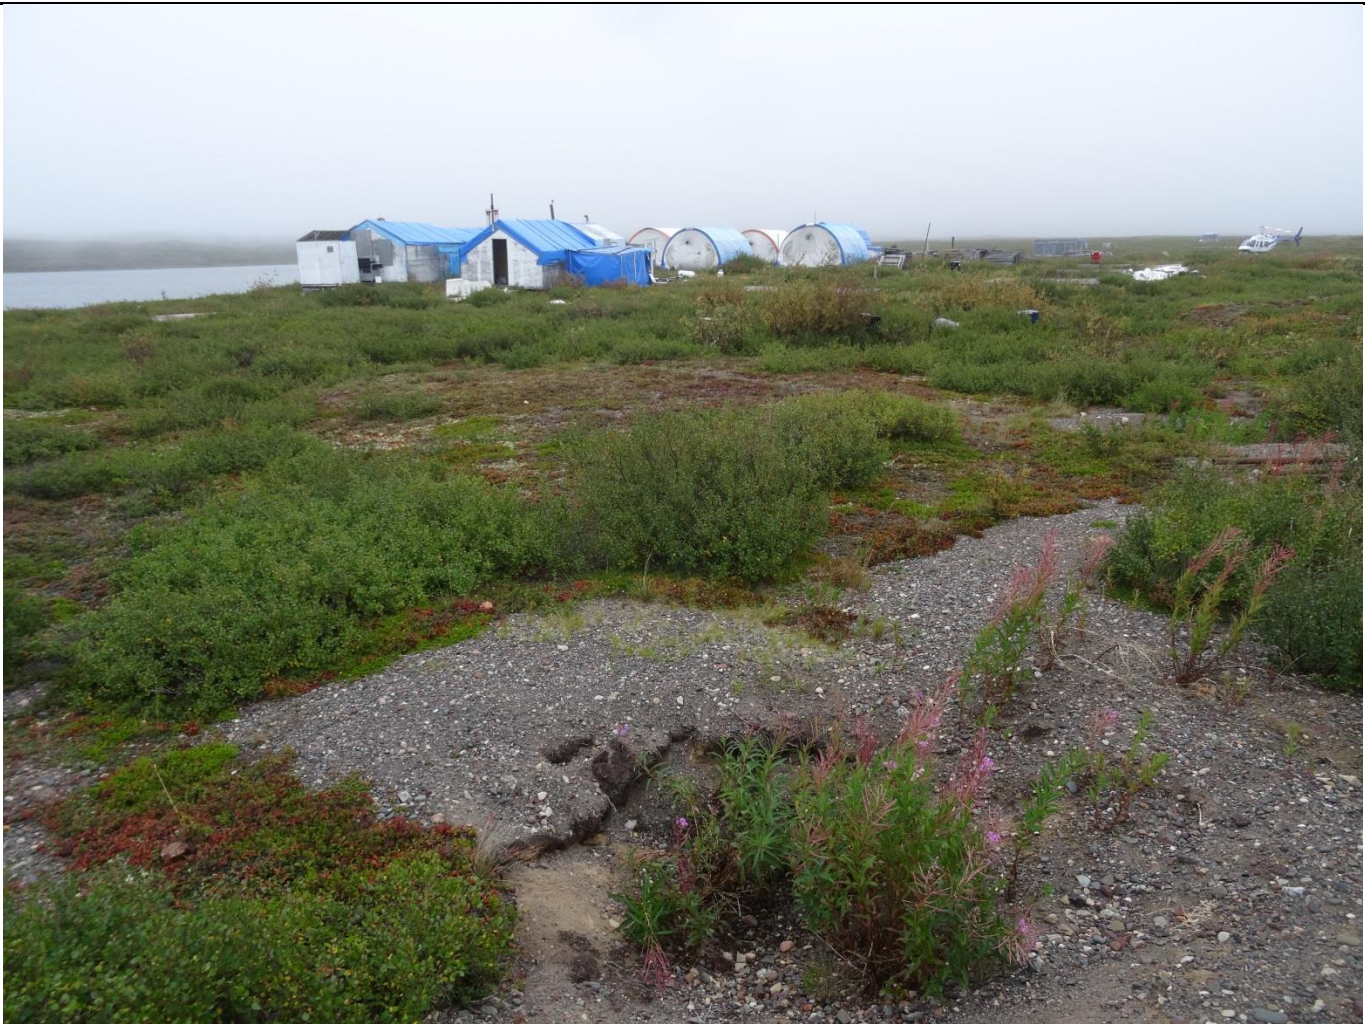
Photo 12

Description: Sump #1 requiring Reclamation

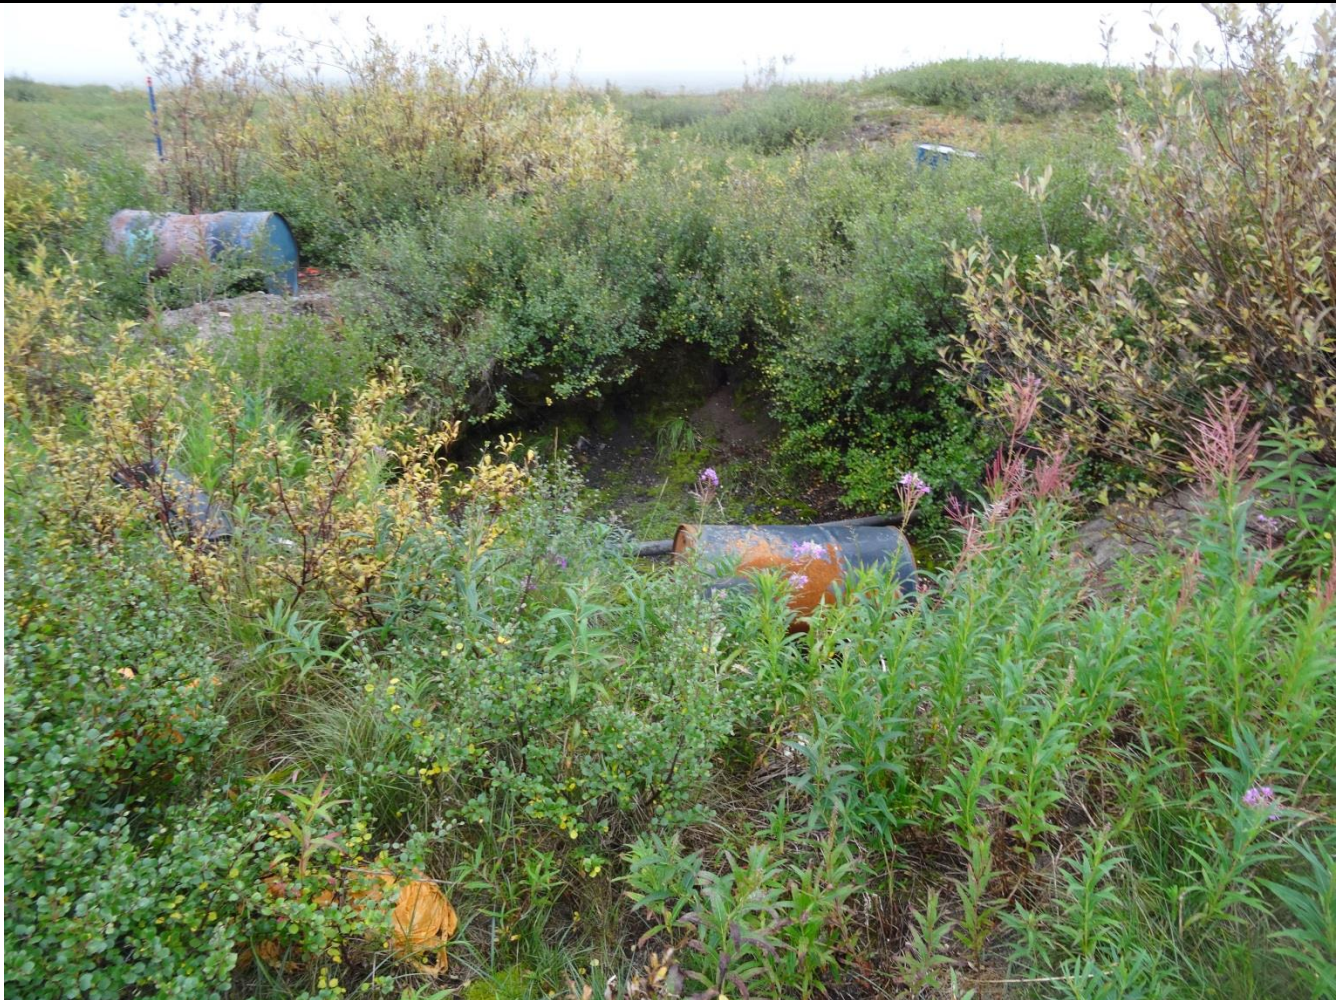
Photo 13

Description: Sump #2 requiring Reclamation

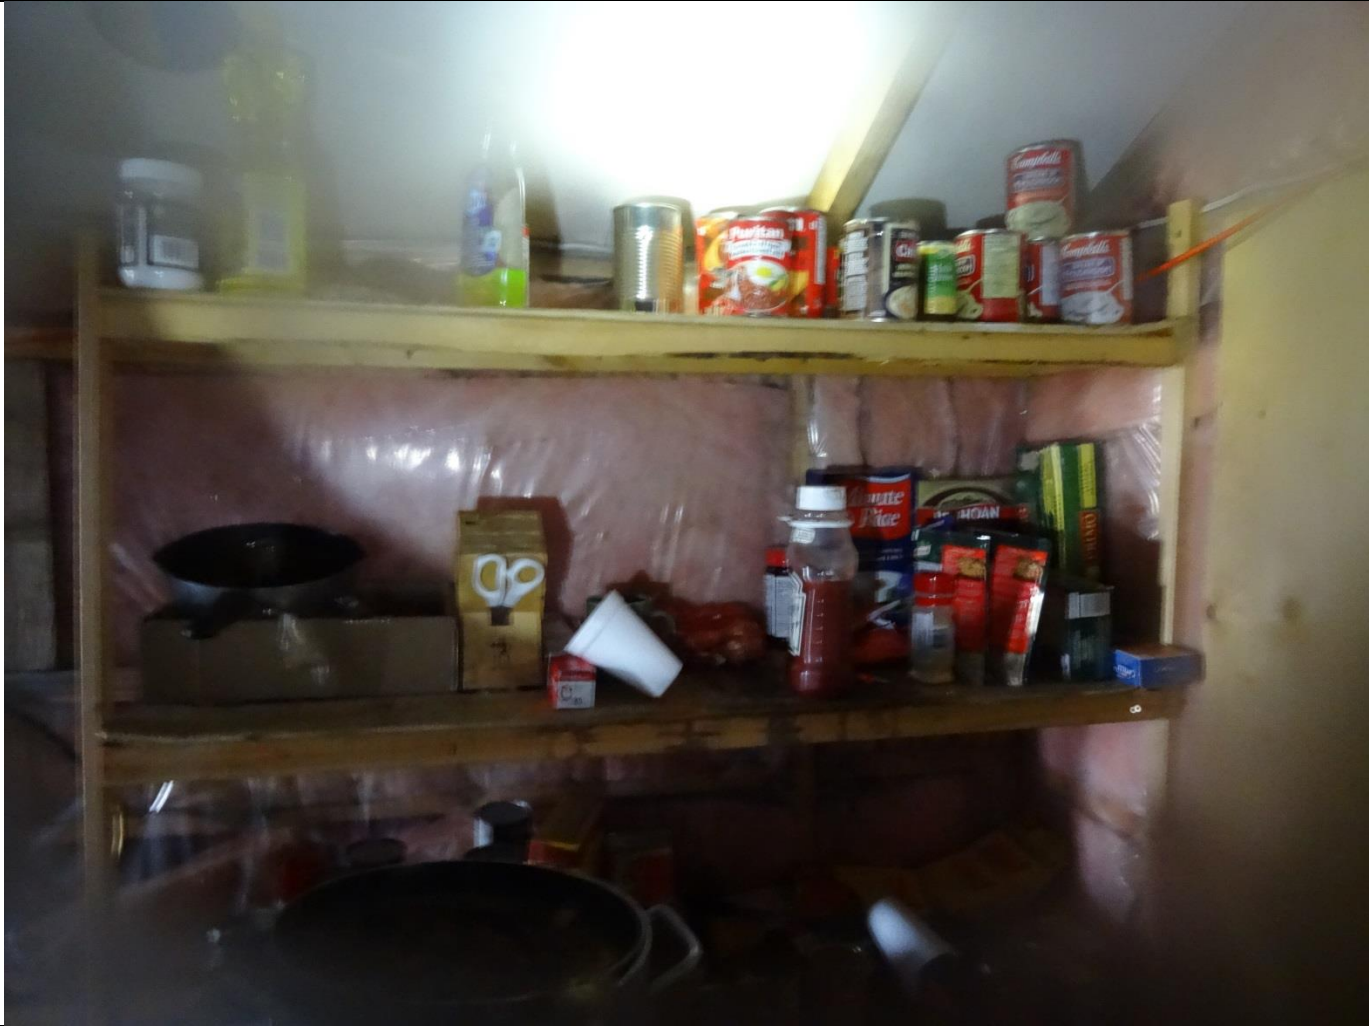
Photo 14

Description: Food left behind in Building

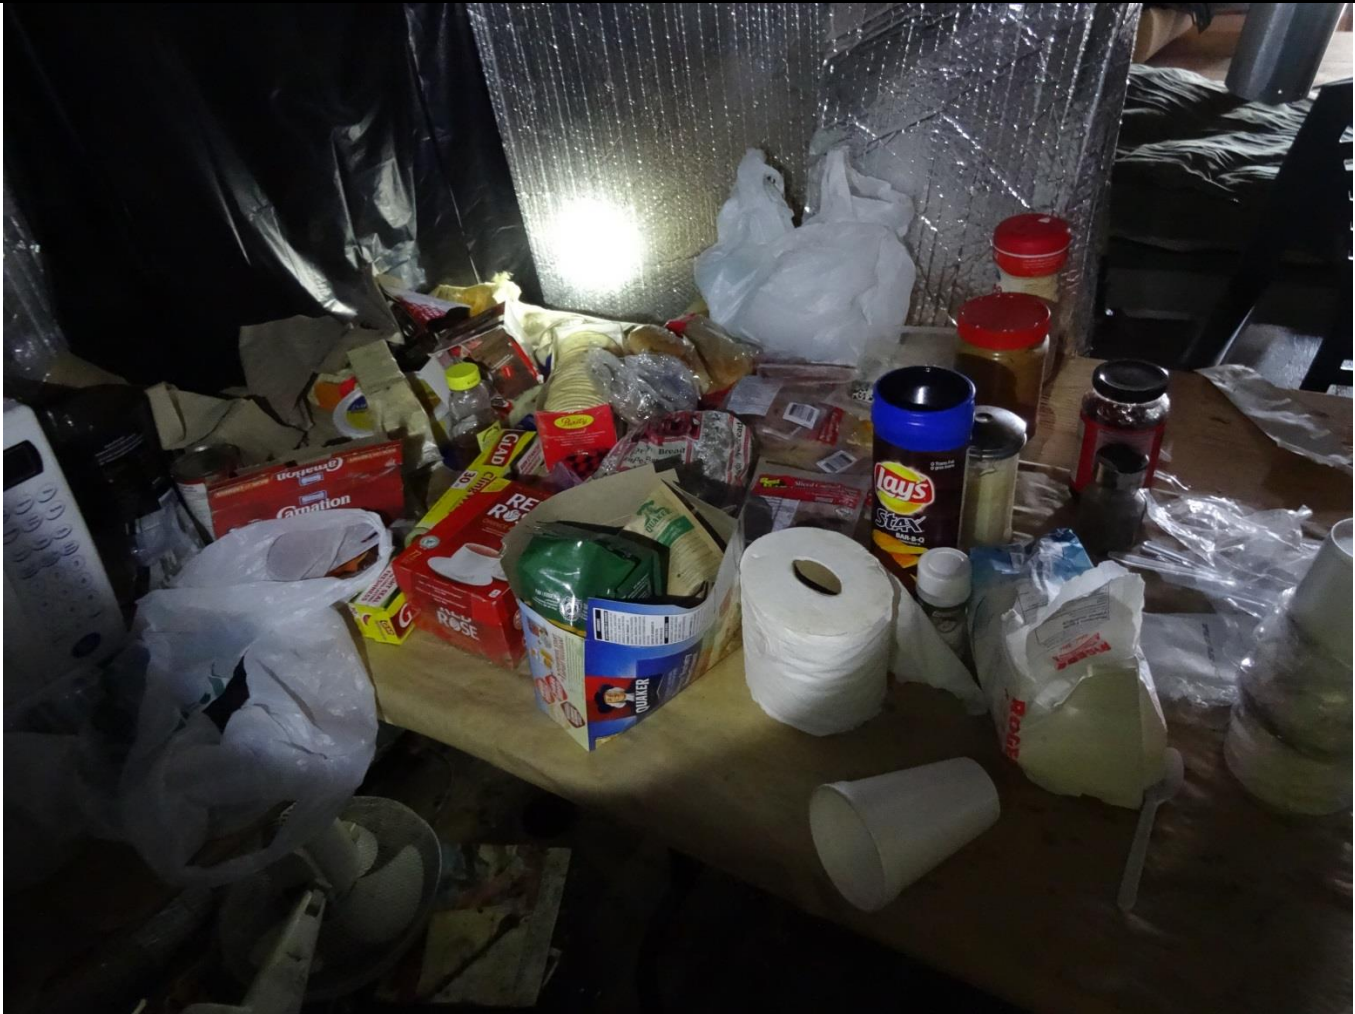
Photo 15

Description: Food left behind in Building

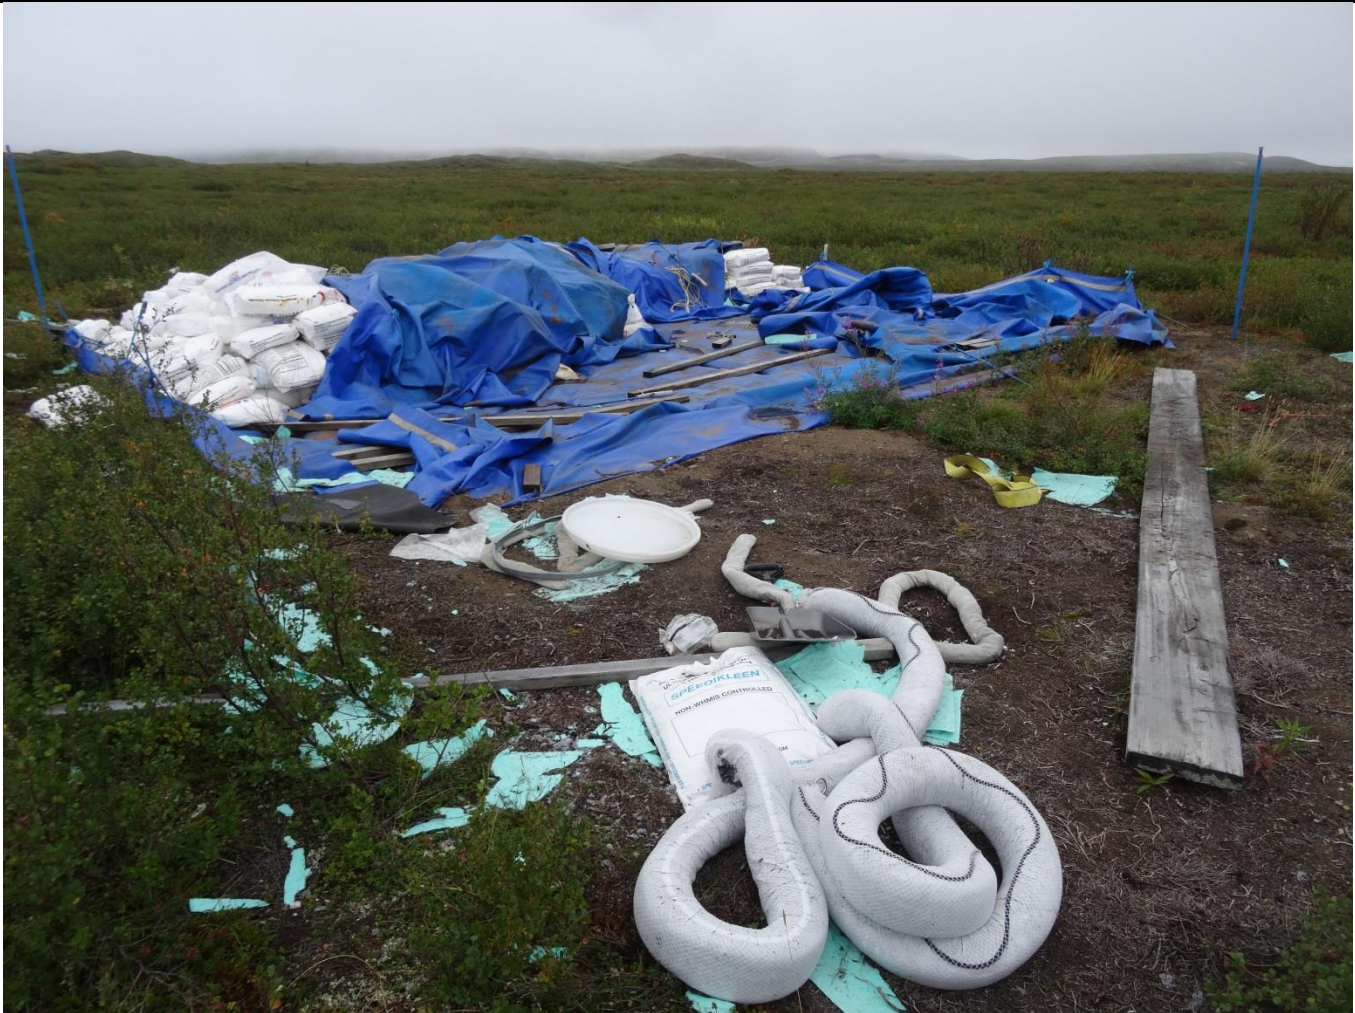
Photo 16

Description: Calcium Chloride Mess in Damaged Secondary Containment
