WATER LICENCE INSPECTION FORM

Licensee		Licensee Representative	
Hornby Bay Mineral Exploration Ltd			
Licence No. / Expiry		Representative's Title	
2BE-MOU1419			
Land / Other Authorizations		Land / Other Authorizations	
N2011C0007			
Date of Inspection		Inspector	
24 to 26 August 2017		Baba Pedersen	
Activities Inspected			
<input checked="" type="checkbox"/> Camp	<input checked="" type="checkbox"/> Drilling	<input type="checkbox"/> Mining	<input type="checkbox"/> Construction
<input type="checkbox"/> Roads/Hauling	<input type="checkbox"/> Other:	<input type="checkbox"/> Other:	<input checked="" type="checkbox"/> Reclamation
<input checked="" type="checkbox"/> Fuel Storage

PHOTO LOG

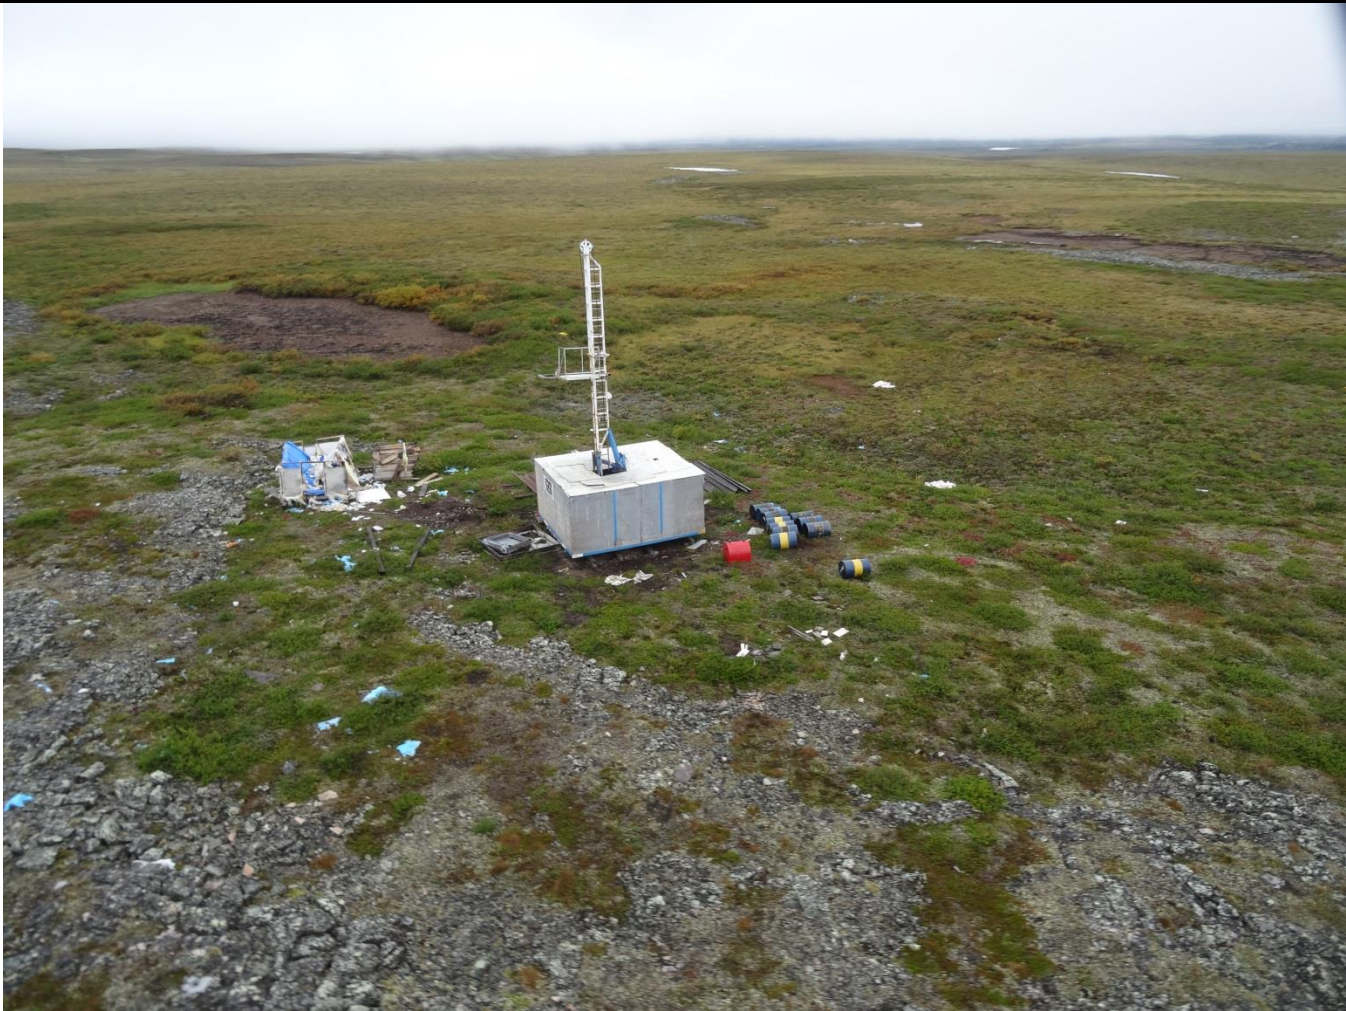
Photo 17

Description: 2BE-MOU Fuel 3 Aerial Photo of abandoned Drill Site

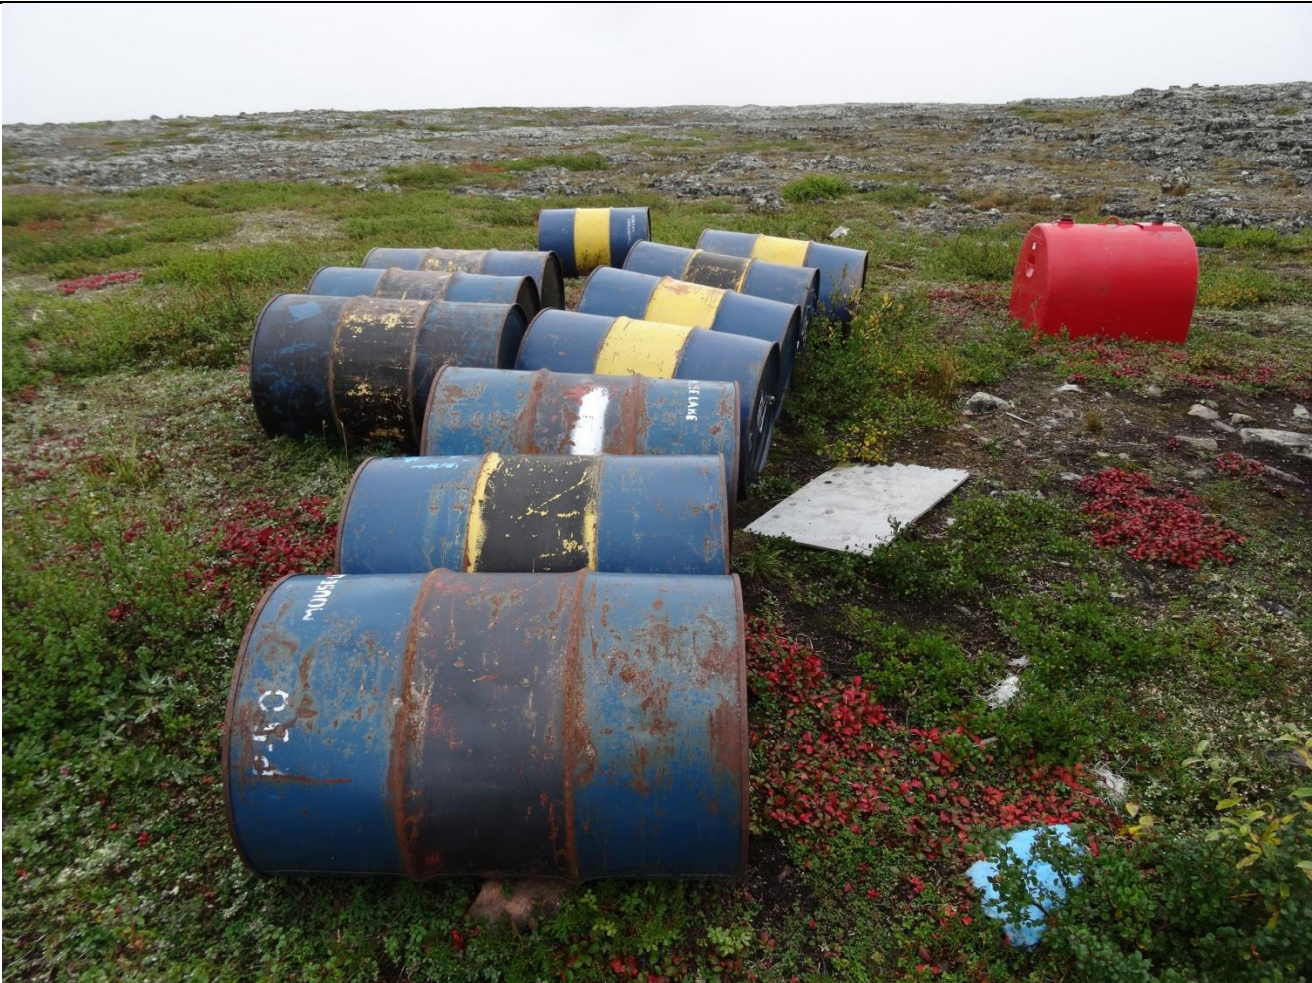
Photo 18

Description: 2BE-MOU Fuel 3, 11 Full Drums and 1 Heli Tank

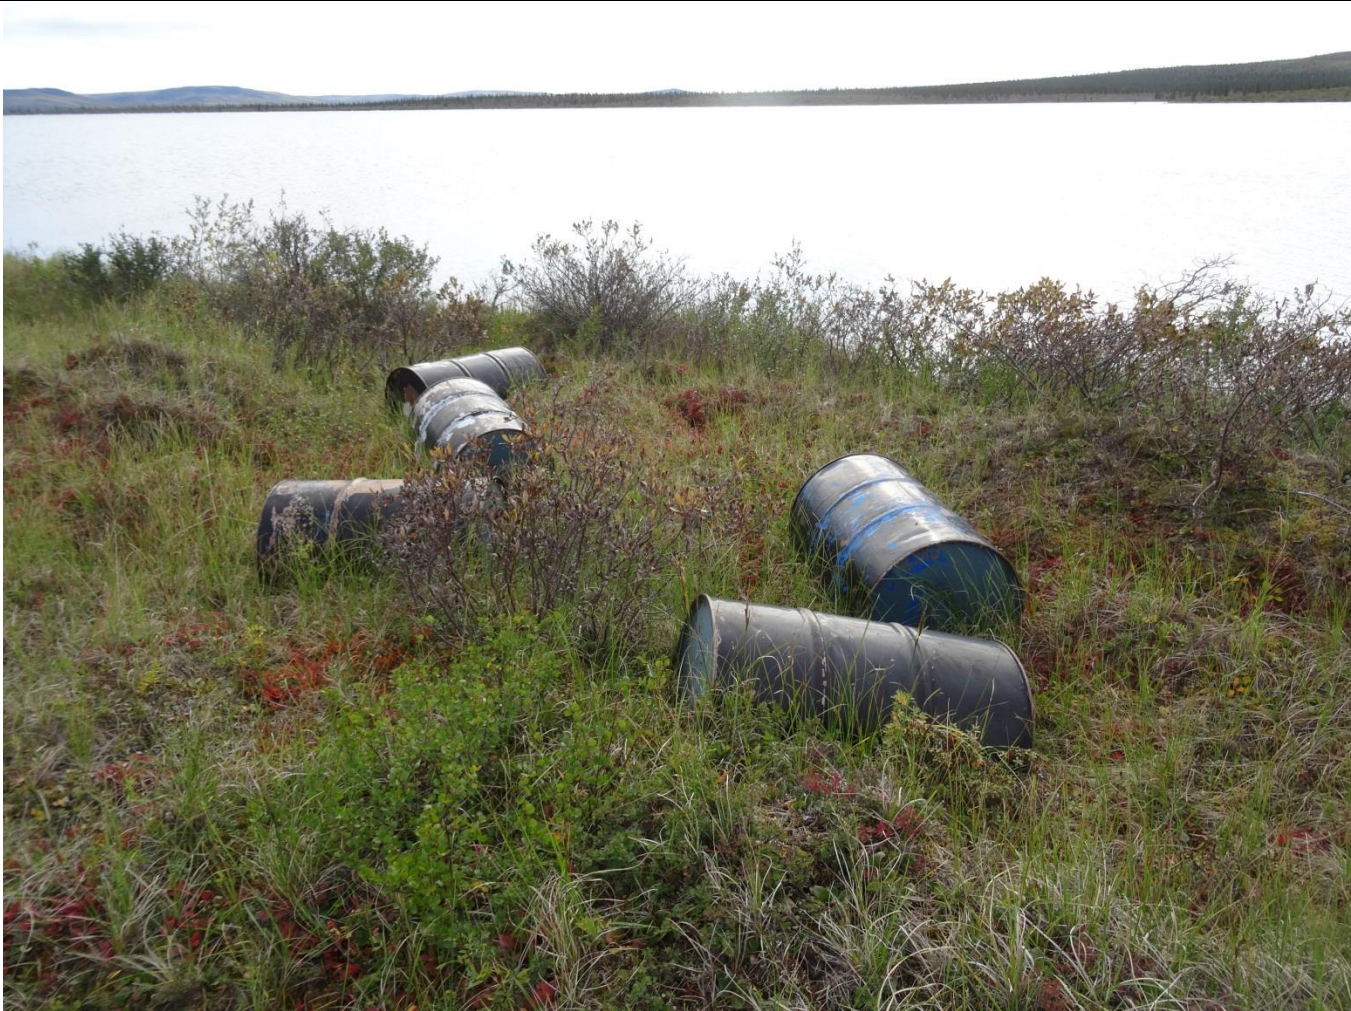
Photo 19

Description: Unknown Fuel Cache with 5 Full Drums within 10 feet of water – marked “Mouse”

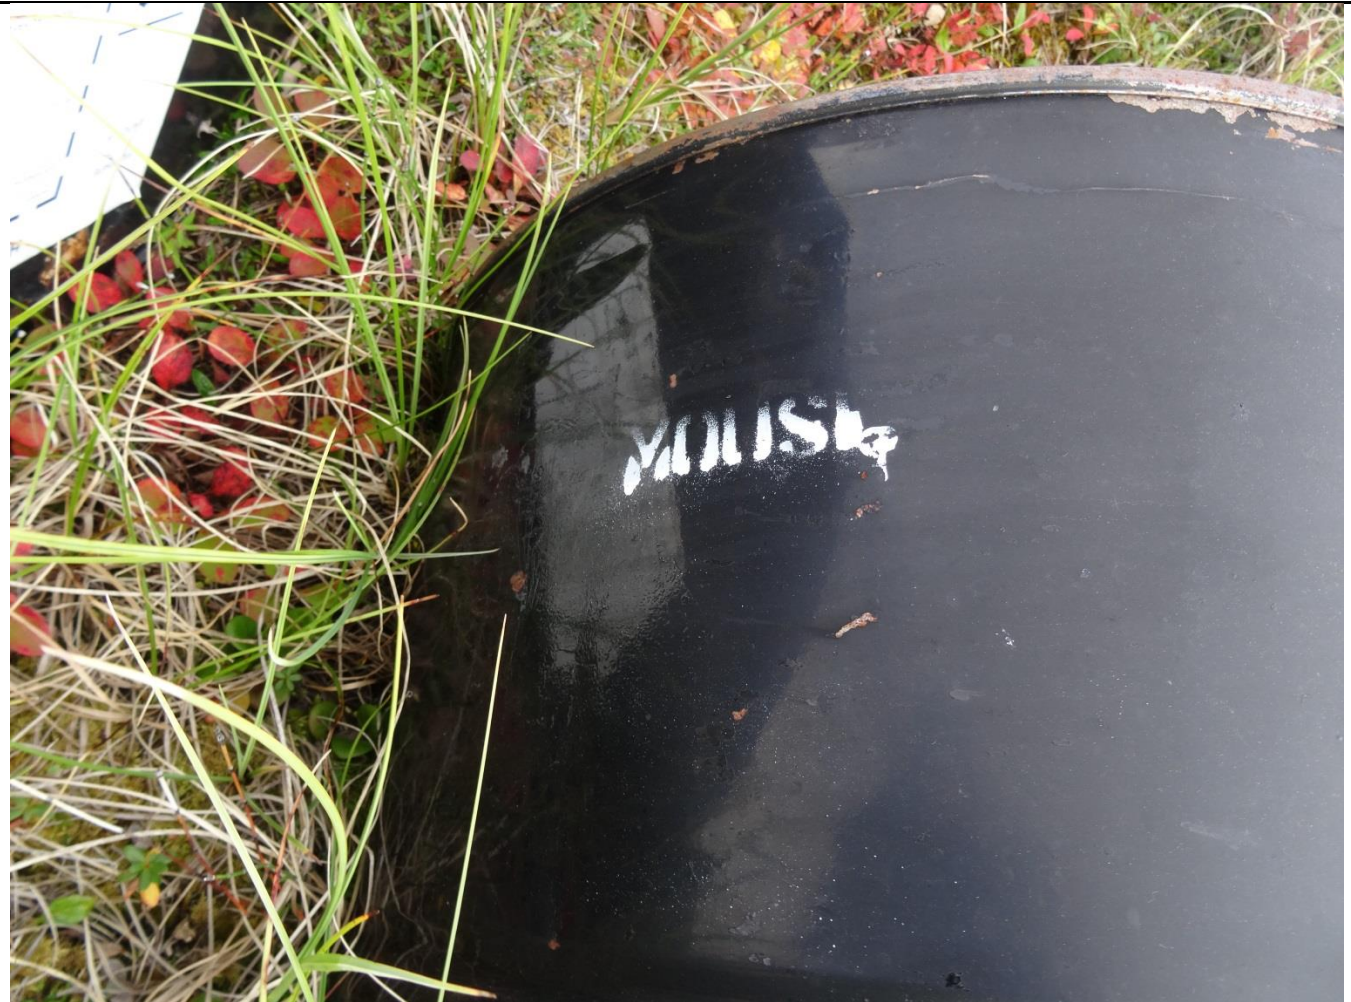
Photo 20

Description: Unknown Fuel Cache with “Mouse” painted on Drums
