Re: Licence 2BE-MOU1419 – Annual Report for 2015

NWB Annual Report

Project Name: Mouse Lake Project

Mouse Lake Camp Demobilization Report:

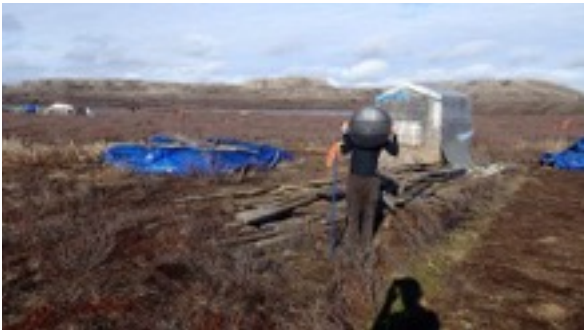
43	67.09 865	-115.7 36	343.31	<p>PIC: from SE. Flag SE corner + NW corner</p> <p>Dimensional lumber. No nails. Good wood.</p> <p>Empty barrels tarped and banded with timber on top.</p>

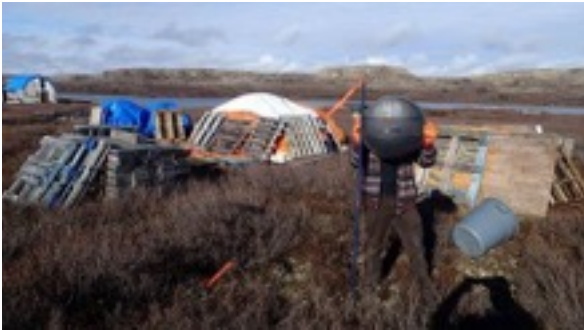
44	67.09 908	-115.7 36	342.35	<p>PIC: from SE. Flag SE corner</p> <p>Organized and contained drilling salts.</p> <p>Pile of empty core boxes.</p> <p>Stacked unused pallets</p>

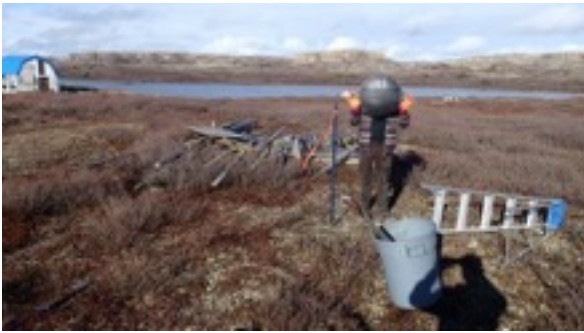
45	67.09 922	-115.7 37	340.19	<p>PIC: from SE. Flag SE corner</p> <p>Timber pile. Good unused no nail dimensional lumber</p>

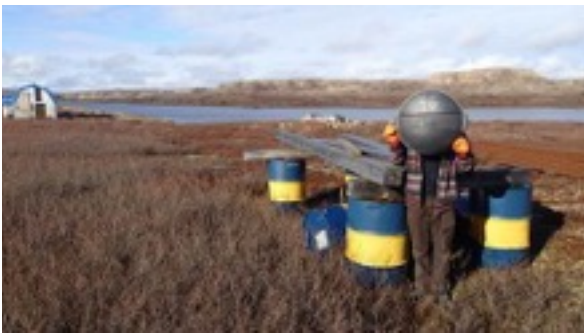
46	67.09 932	-115.7 36	339.23	<p>PIC: from SE. Flag SE corner</p> <p>Empty barrels with beams on top</p>

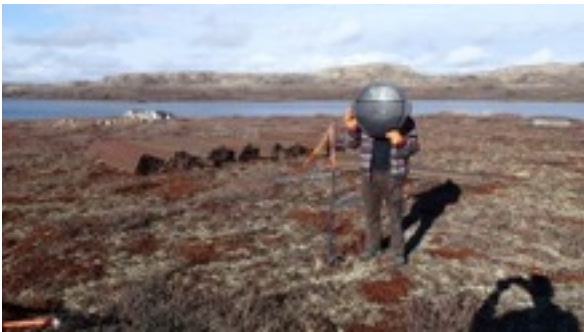
47	67.09 937	-115.7 36	338.51	<p>PIC: from SE. Flag SE corner</p> <p>Stacked drilling pipe</p>

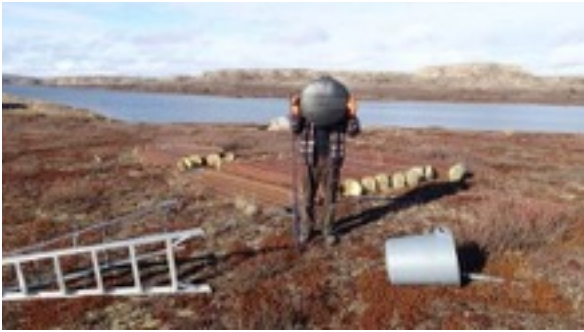
48	67.09 949	-115.7 36	338.51	<p>PIC: from SE. Flag SE corner</p> <p>Stacked drilling pipe</p>

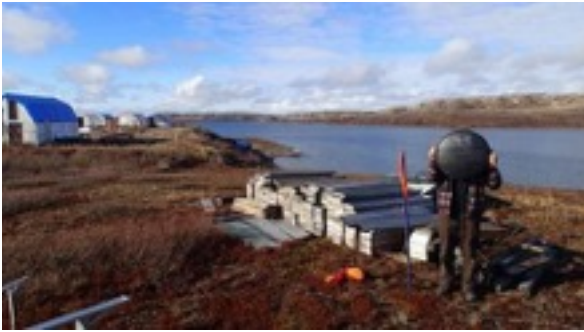
49	67.09 963	-115.7 37	336.1	<p>PIC: from SE. Flag SE corner</p> <p>Empty core boxes</p>

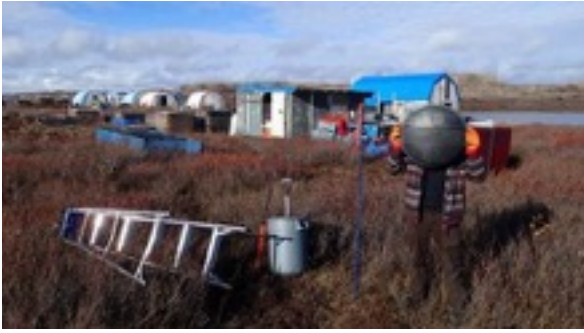
50	67.09 933	-115.7 38	333.7	<p>PIC: from SE. Flag SE corner</p> <p>Corner to drilling equipment area. Drillers shed, drilling rigs, empty steel transport crates</p>

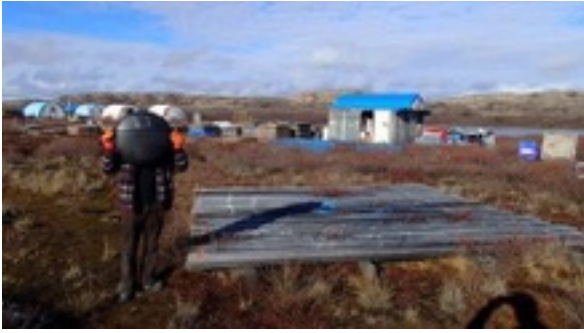
51	67.09 928	-115.7 38	333.46	<p>PIC: from SE. No Flag</p> <p>Helli pad. Good timber</p>

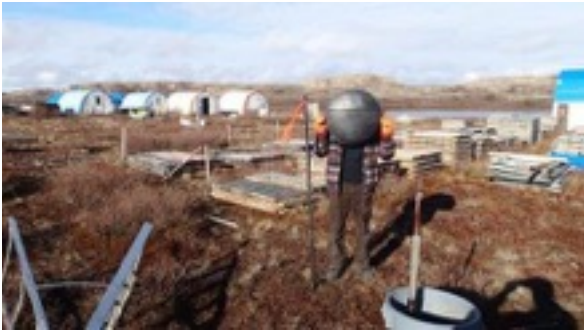
52	67.09 943	-115.7 38	333.7	<p>PIC: from SE. Flag SE corner</p> <p>Core</p>

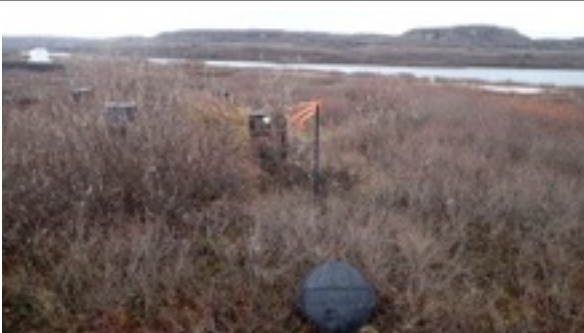
60	67.09 985	-115.7 39	340.91	<p>PIC: from SE. Flag SE corner</p> <p>Empty barrels outlining pit.</p>

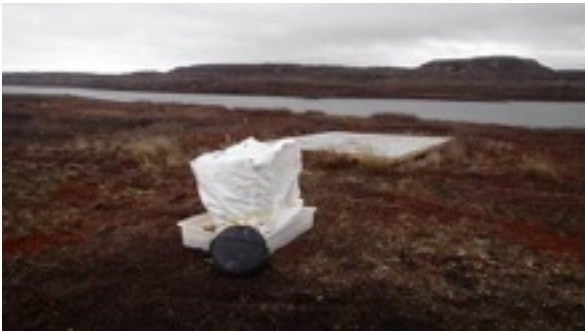
61	67.10 01	-115.7 4	343.31	<p>PIC: from SE. No Flag</p> <p>Non combustible debris at burn site</p>

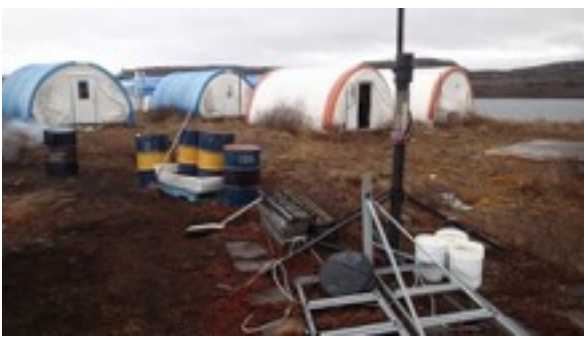
67	67.09 968	-115.7 38	342.59	<p>PIC: from SE. No flag</p> <p>Satellite holders, non combustible debris from burn site</p>

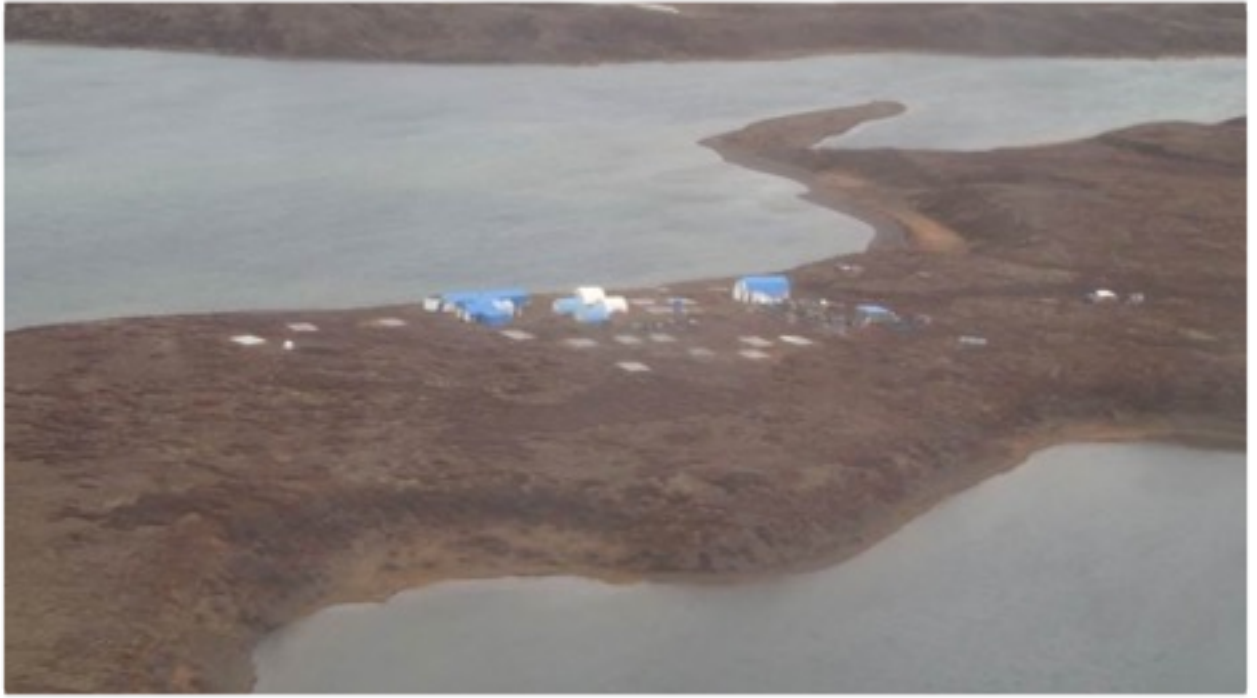
Figure 2: Mouse Lake Camp, Sept 25th, 2015

In addition to the fuel removal from camp, twenty (20) structures were incinerated in 2015. Demobilization tasks completed. The remaining seven structures include four (4) Weatherhaven collapsible tents, the dry shack, generator barn and drillers shed. All contents within the remaining structures have been organized for winter removal. Contents consist of either non-combustible waste or re-usable/salable items. Safe work procedures and environmental best practices were employed during the documented 2015 demobilization effort.

It is recommended that a winter program is conducted. With the use of heavy equipment to facilitate overland removal of Mouse Lake Camp. The detailed program proposal to follow this report. A subsequent summer (2016) rehabilitation effort is recommended successive to the recommended winter camp program for completion activities.
