WATER LICENCE INSPECTION FORM

Licensee	Licensee Representative and title
5530 Nunavut Inc.	Fabio Capponi
Licence No. / Expiry	Project
2BE-MPM2126/ December 31 st , 2026	Meadowbank Precious Metals Property
Land Authorization No. / Expiry	Purpose
N2017C0005/ March 7 th , 2024	Exploration drilling and camp operation
Date of Inspection	Inspector
September 9 th , 2022	WRO Wilson
Activities Inspected	
<input type="checkbox"/> Camp <input checked="" type="checkbox"/> Drilling <input type="checkbox"/> Mining <input type="checkbox"/> Construction <input type="checkbox"/> Reclamation <input type="checkbox"/> Fuel Storage	
<input type="checkbox"/> Roads/Hauling <input type="checkbox"/> Other:	<input type="checkbox"/> Other:

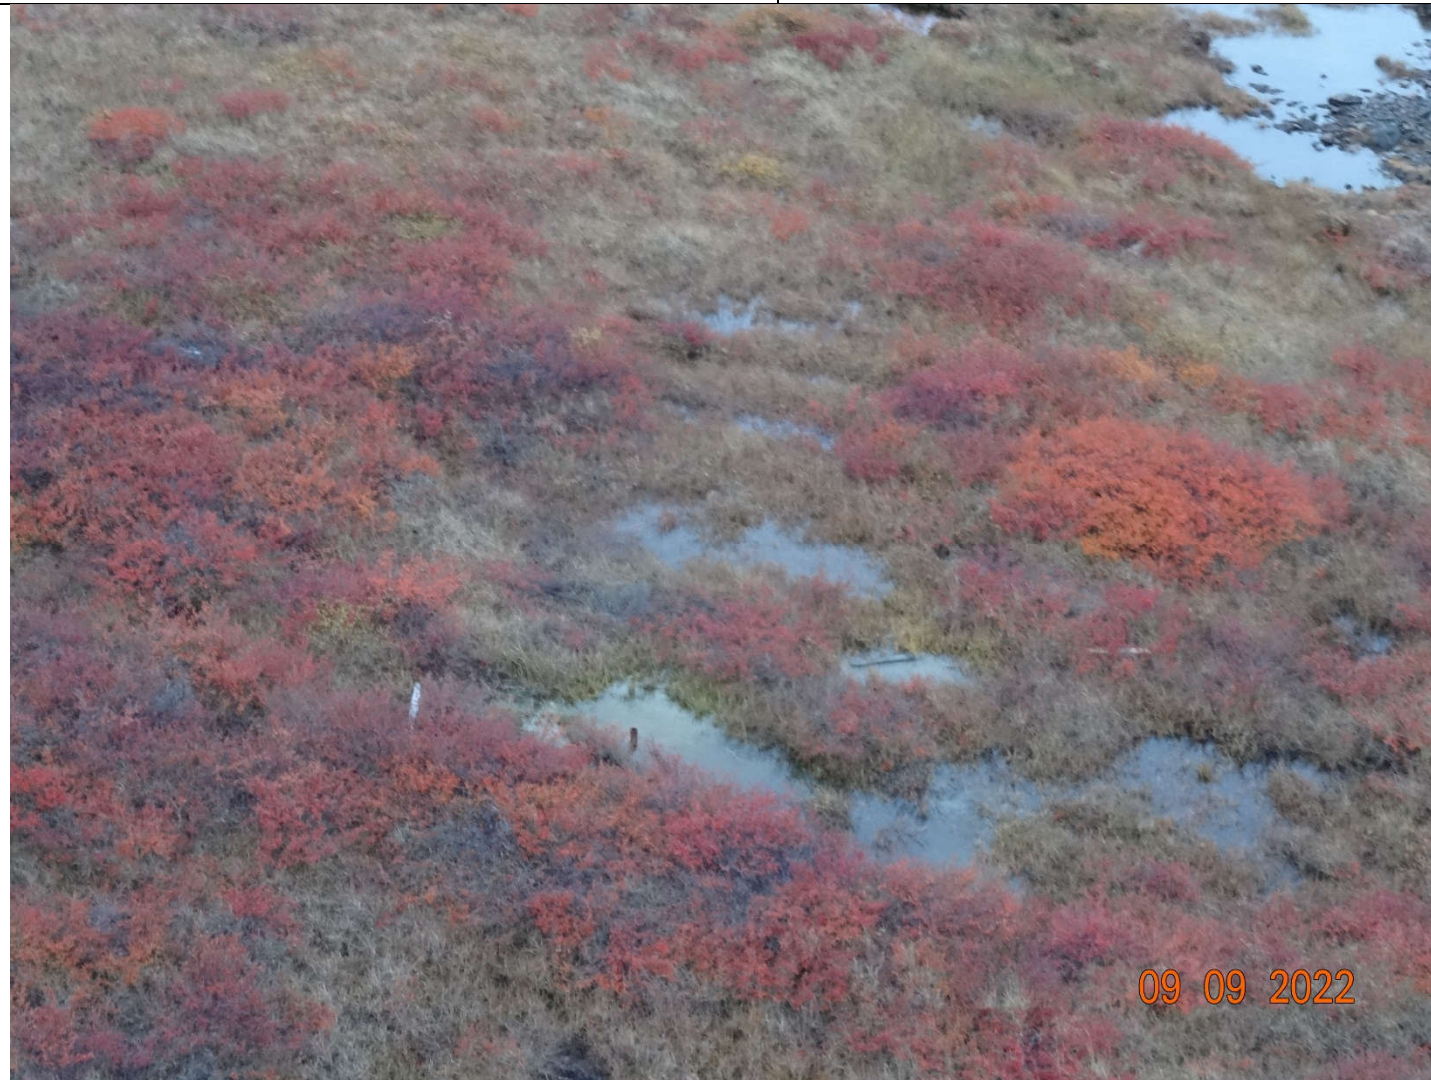
Drill site	Location	Observations
WA1A	N64° 42' 02.0" W96° 01' 50.0"	No concern, cuttings in a isolated location.
WA2	N64° 42' 49.0" W96° 00' 31.0"	Cuttings in a isolated location. Collar still in place.
WA4	N64° 41' 37.0" W96° 06' 36.0"	No concern.
WA5	N64° 41' 56.0" W96° 04' 29.0"	Collar still in place. Site in a low lying area with a lot of water near the drill collar.

2. The collar is still in place at drill sites WA2 and WA5. The collar either needs to be removed or cut off at grade as required by Part I item 10.
3. The placement of the cuttings at drill site WA5 is concerning. The drill site appears to be located in the natural drainage path of nearby lake. Though the drill site is over 31 meters from the natural high water mark of the lake the cuttings could migrate from this location into the lake.

Description:
Drill site WA5. Collar still in place.

The Licensee will complete restoration of the drill hole no. WA2 and WA5 as required by PART I item 10. The Licensee will contact the Inspector to discuss the plan to restore these drill sites by November 23rd, 2022.

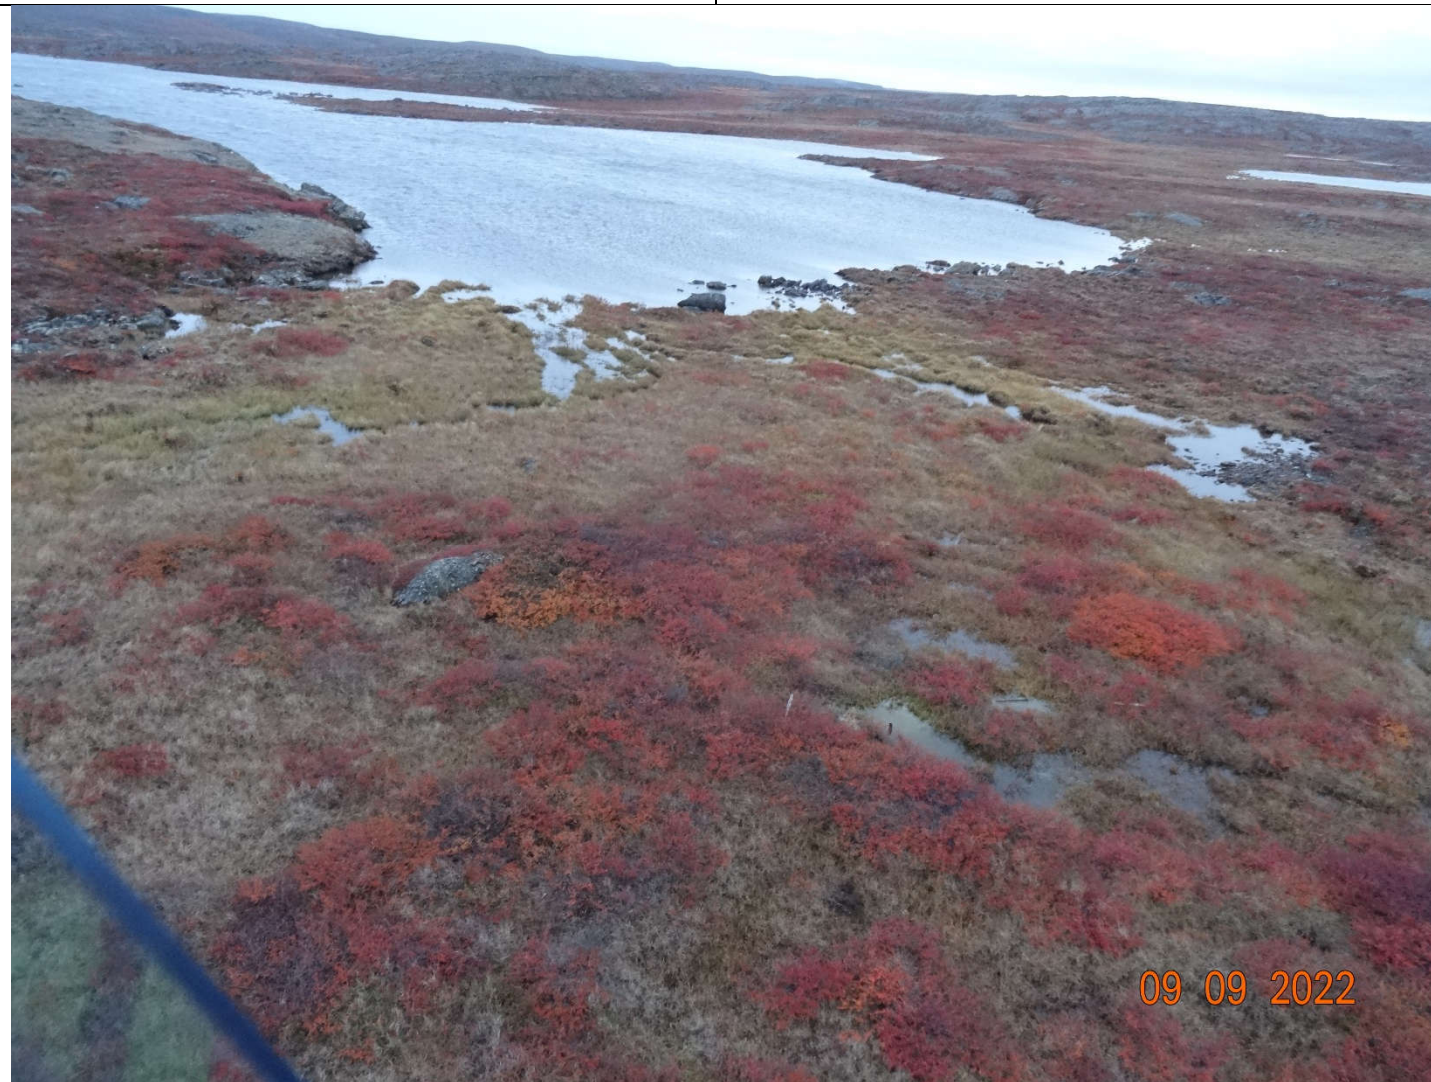
Photo 2

- PART F item 2: concern related to the placement of cutting into a natural depression or properly constructed sump over 31 meters from the ordinary high water mark of the adjacent water body.
- PART H item 3: concern related to deposit of a waste in a place which may enter water.
- PART I item 10: Failure to reclaim drill sites immediately upon completion of drilling.

Drill hole no. WA5 location in relation to nearby water body.

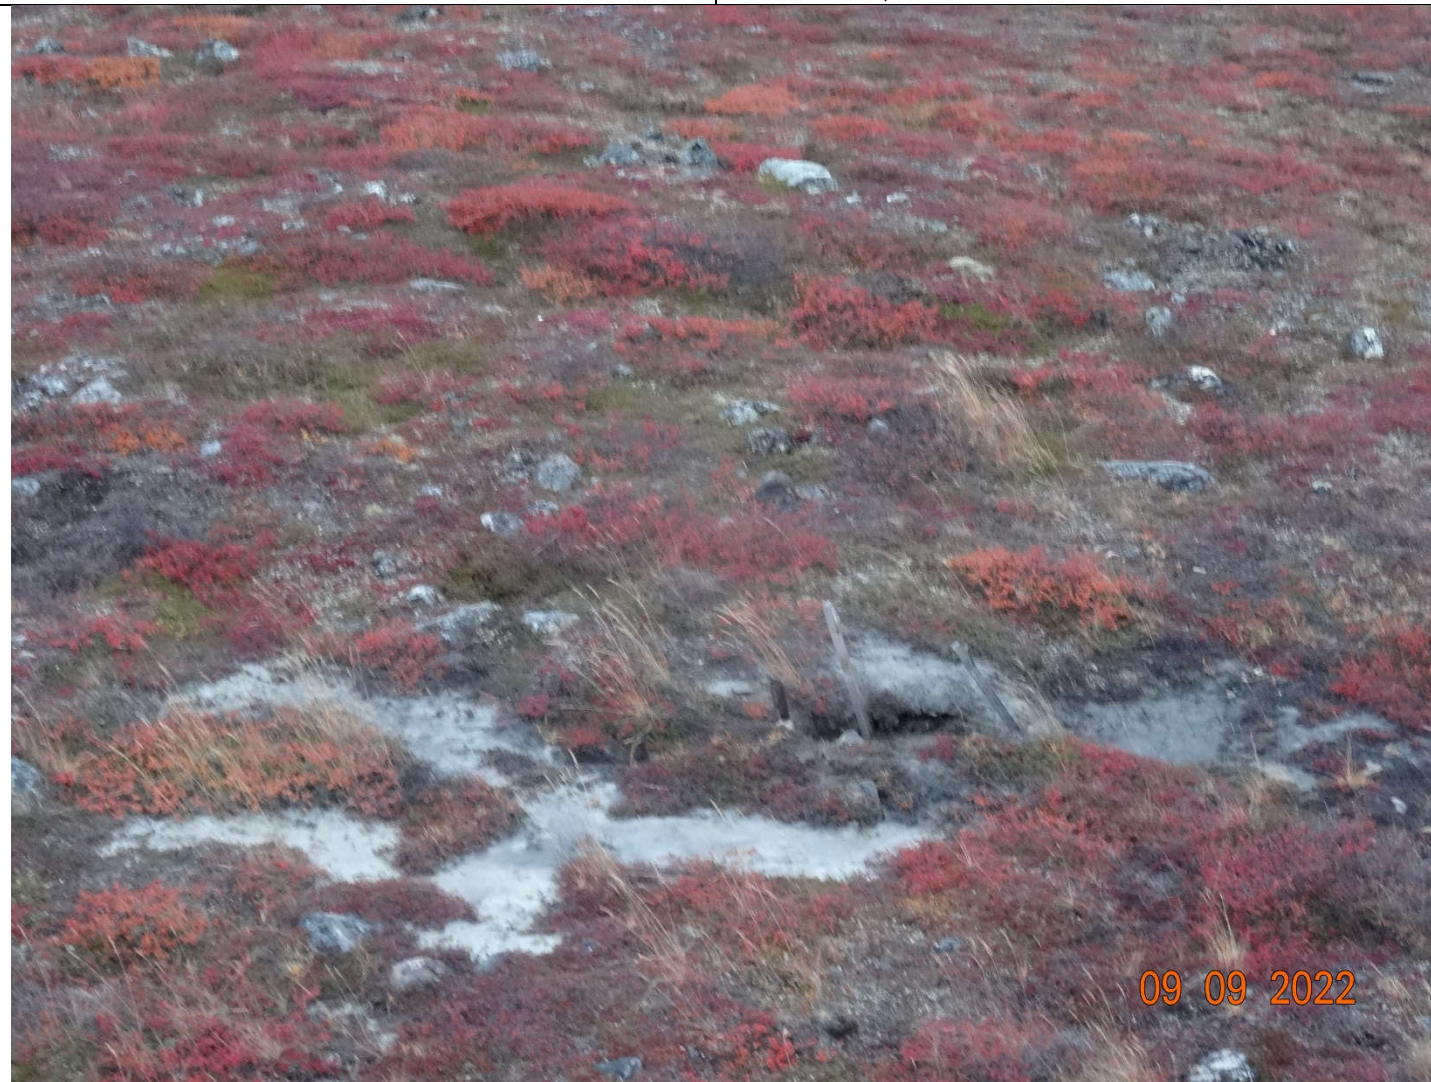
Photo 3

Drill site WA2. Collar is still in place.
