[2022-KIV17-CW] 2BE-MPM2126 Water Licence Inspection Form 11.10.22

Please find attached an inspection report for Meadowbank Precious Metals Property water licence 2BE-MPM2126.

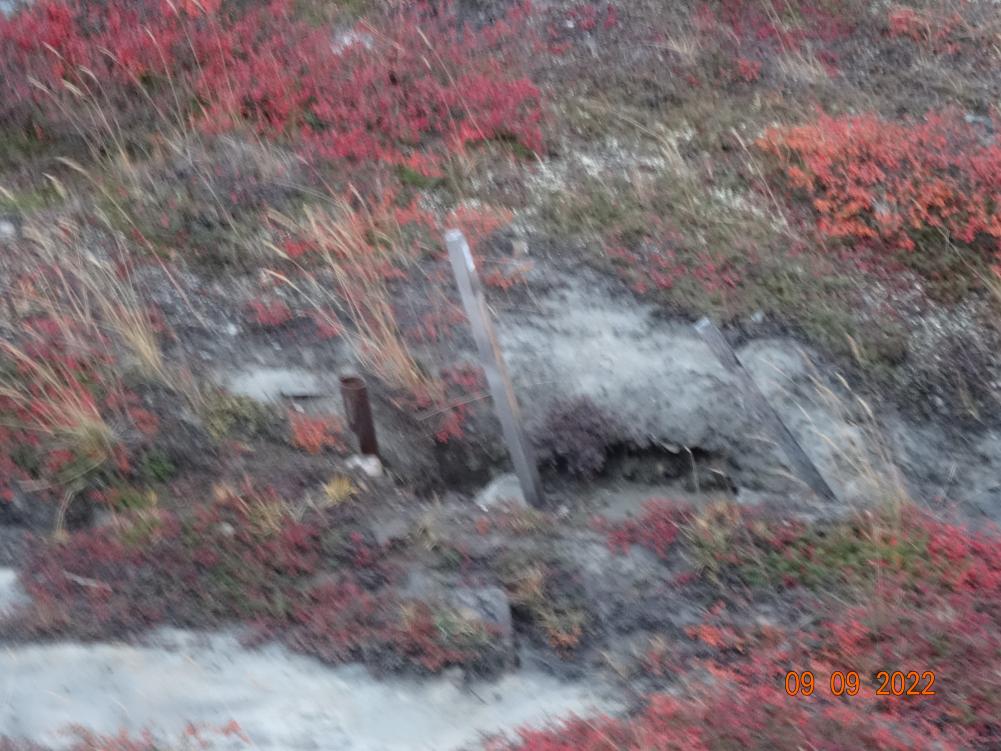
DSC00760.JPG 4481K

Thanks for taking my call today. As discussed, I've attached two pictures that show the metal pipes but were too blurry to include in the report. They do show a metal pipe at both locations, may it be an anchor or a casing. Please have the Permittee confirm this when they are in the field next season.
