WATER LICENCE INSPECTION FORM

Licensee	Licensee Representative
North Arrow Minerals	Michael McMorran
Licence No. / Expiry	Representative's Title
2BE-MPP1924	Geologist
Land / Other Authorizations	Land / Other Authorizations
N2017C0006	
Date of Inspection	Inspector
August 12, 2020	Joseph Monteith
Activities Inspected	
<div><input checked="" type="checkbox"/> Camp<input type="checkbox"/> Drilling<input type="checkbox"/> Mining<input type="checkbox"/> Construction<input type="checkbox"/> Reclamation<input checked="" type="checkbox"/> Fuel Storage</div> <div><input type="checkbox"/> Roads/Hauling<input checked="" type="checkbox"/> Other: seasonal shutdown<input type="checkbox"/> Other:</div>

PHOTO LOG

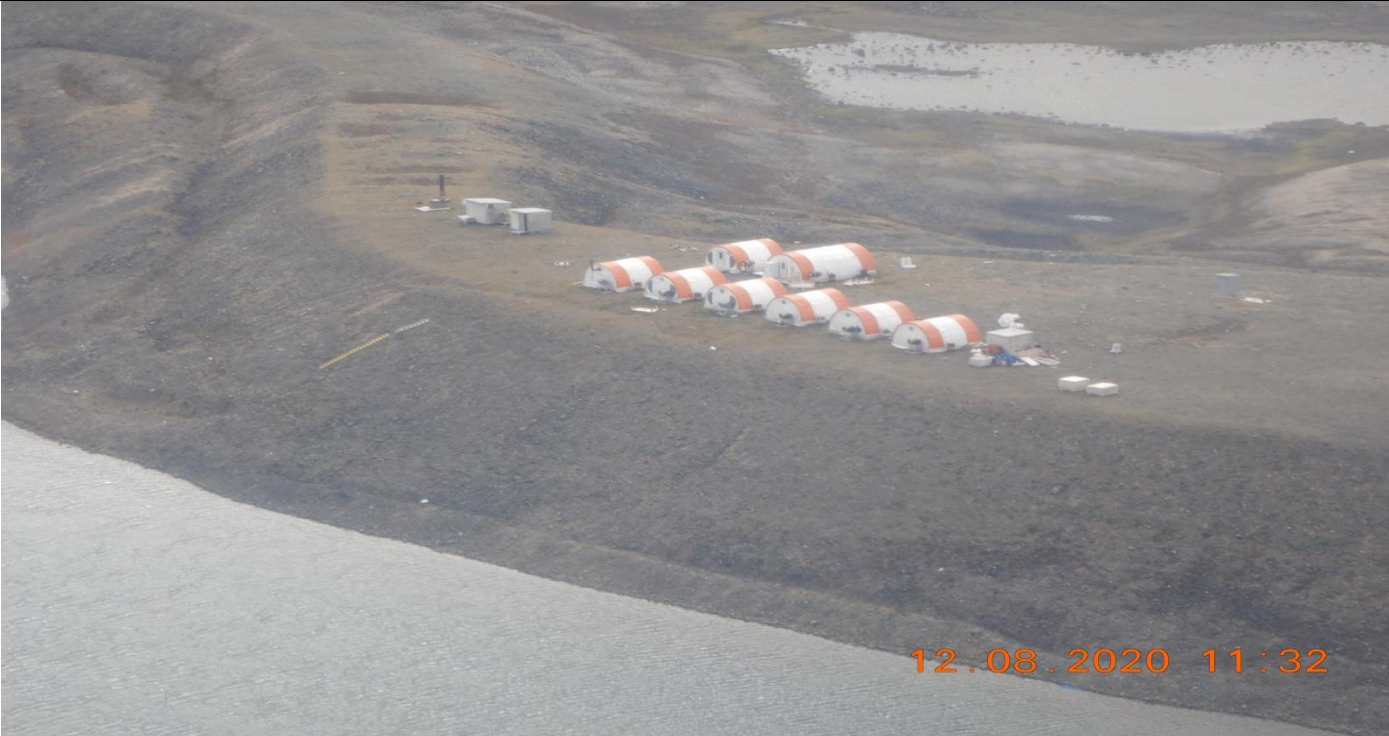
Photo Log #1	Location
Photo 2	Melville Peninsula, Qikiqtani Region, Nunavut

Description: The North Arrow Minerals camp on the Melville Peninsula. The camp is situated on an esker. 8 weather havens, 3 shacks, a latrine shack, and a couple larger boxes make up the footprint of the camp. A drill shack, at other sites is also part of the North Arrow footprint.

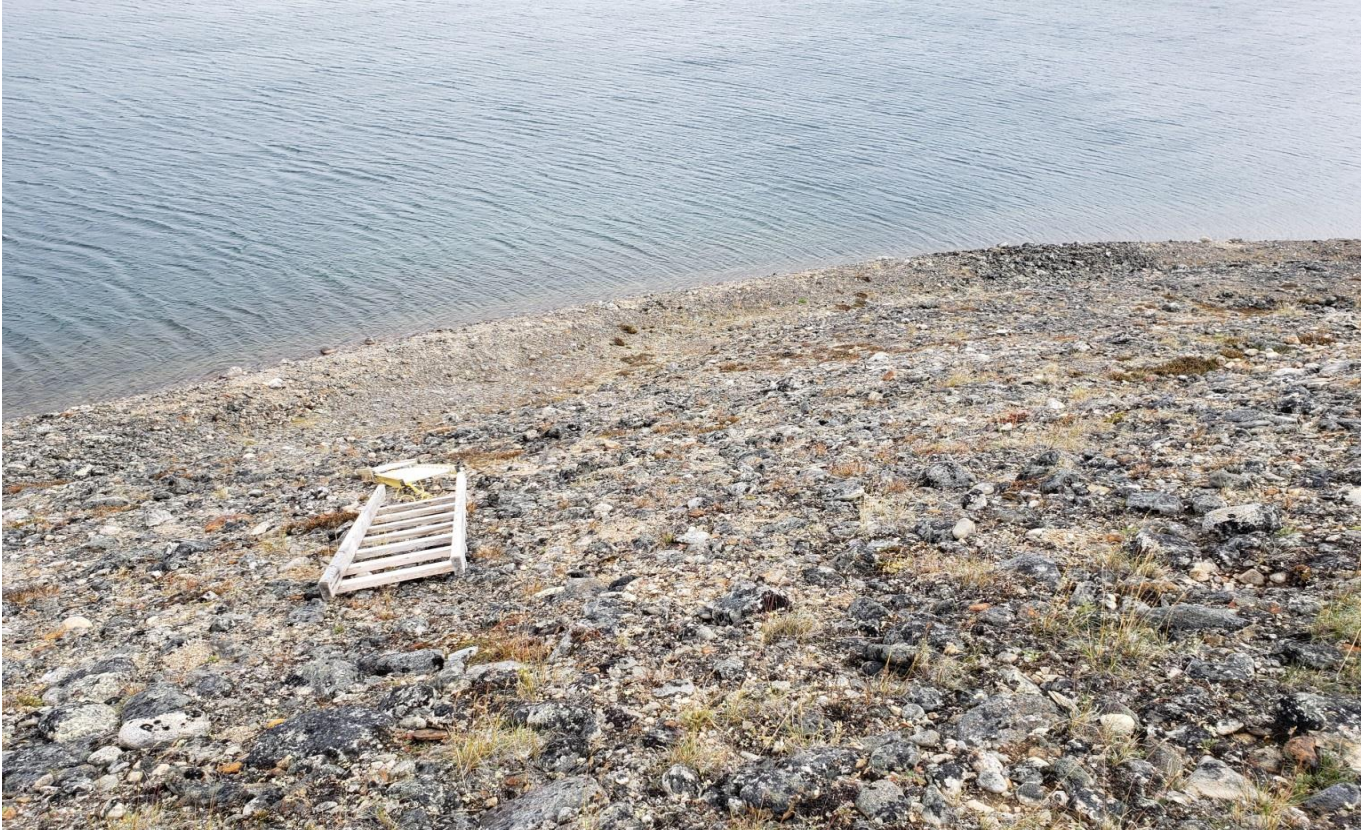
Photo3

Description: ladder used to climb up and down to the water pump. Pump is packed away for the seasonal closure due to COVID-19.

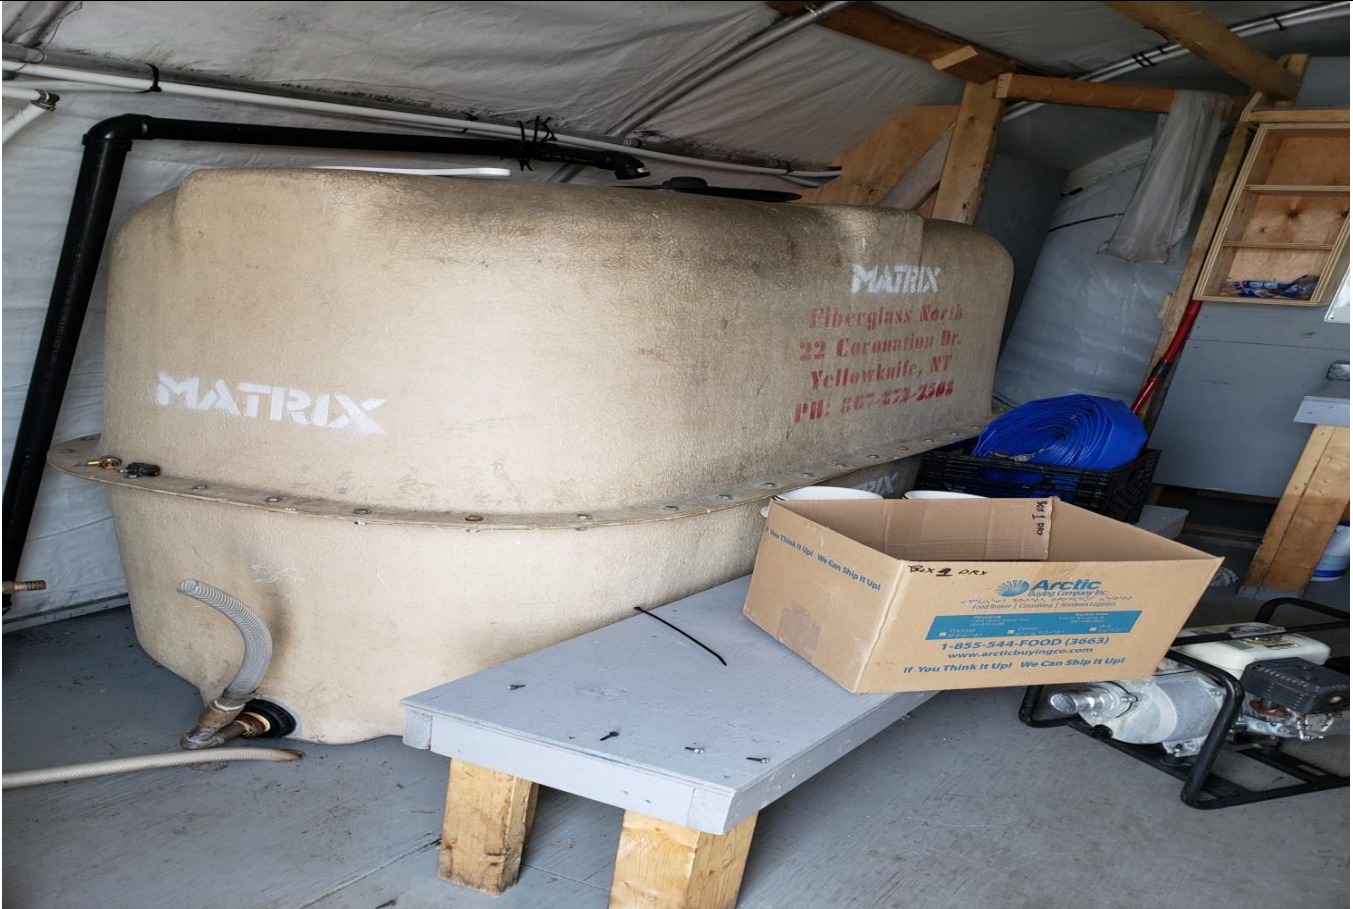
Photo 4

Description: Matrix owned Water Storage Tank - Unknown capacity. Water pump on the ground.

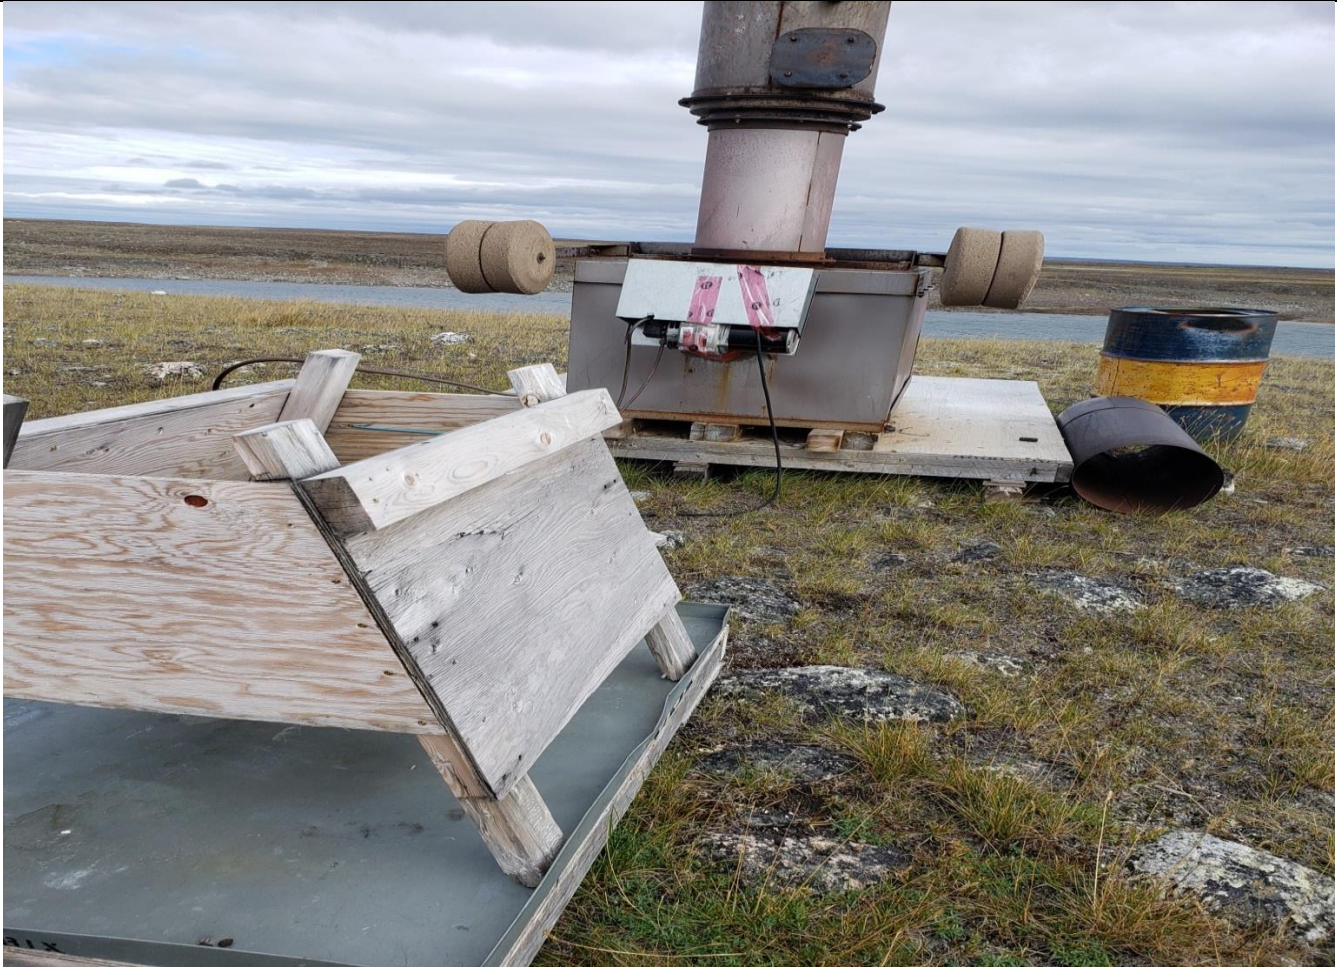
Photo 5

Description: Fish Mesh Screen used at the Withdrawal Point.

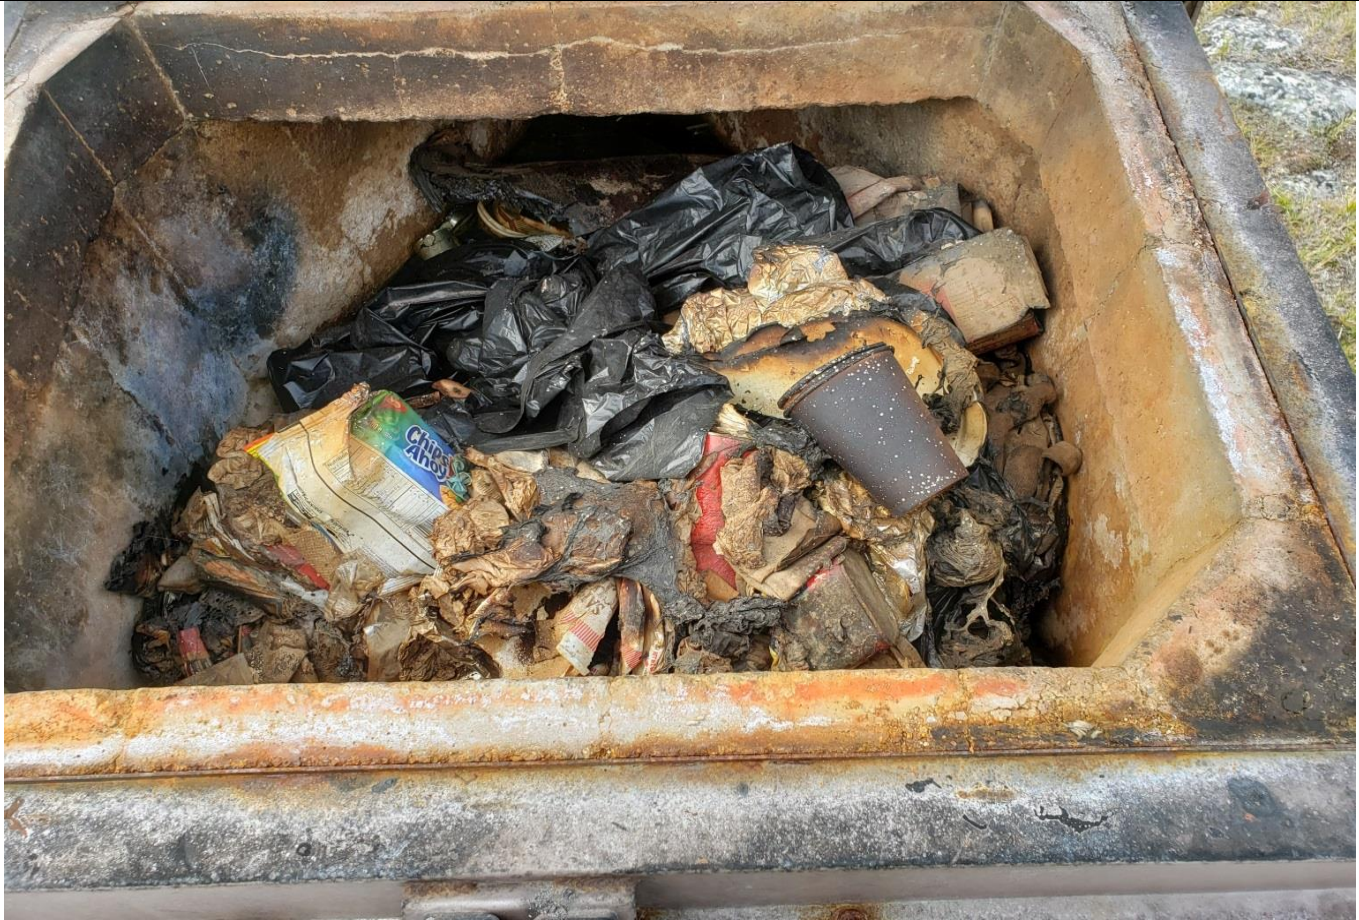
Photo 6

An incinerator was observed on site, with combustible solid waste inside the incinerator, and in drums outside the incinerator (photo).
6.

Description: Waste stored within the incinerator.

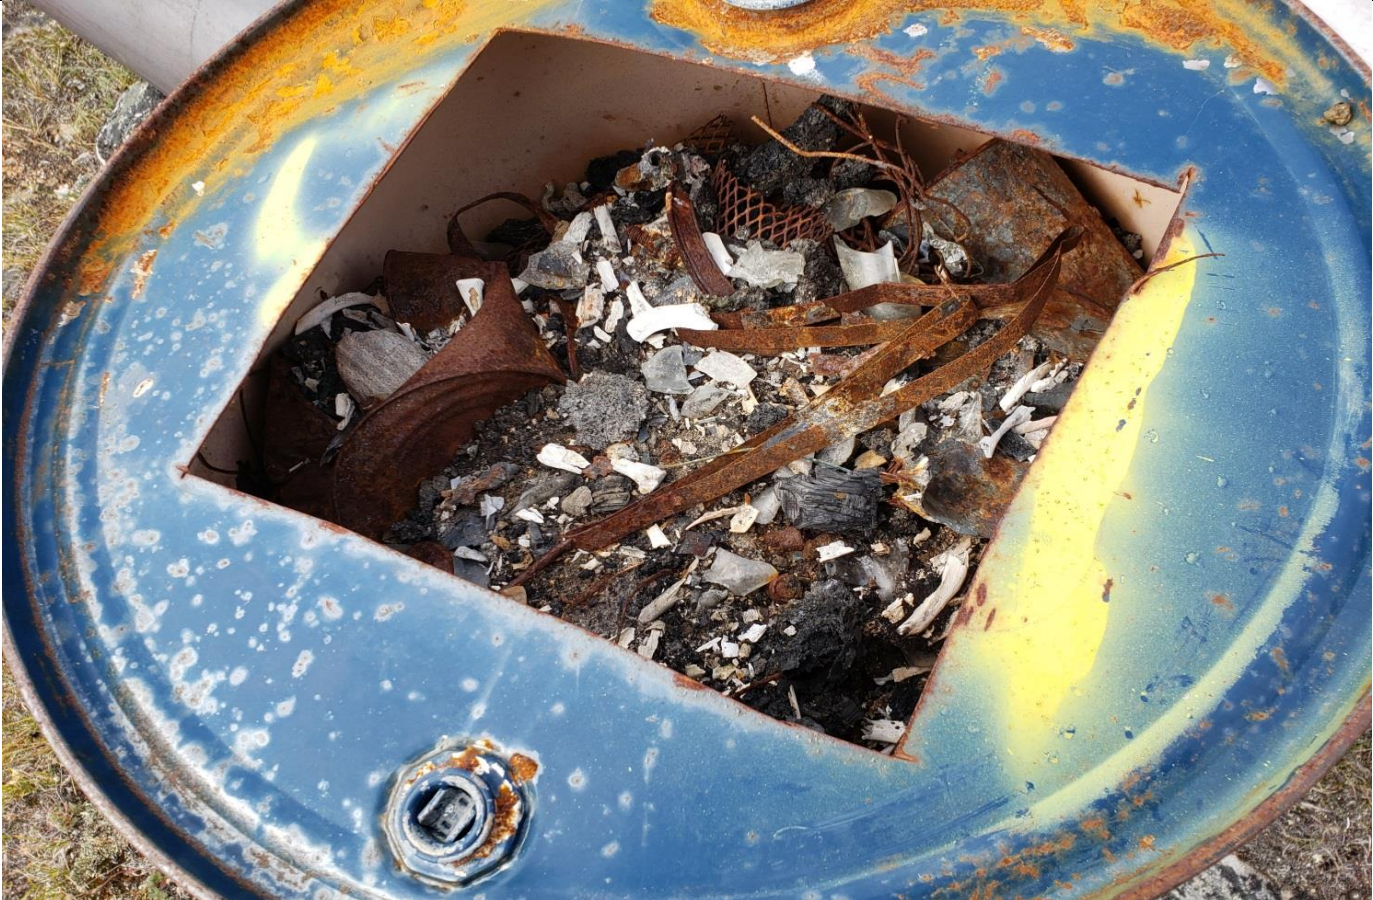
Photo 7

Description: Incinerator waste open, and exposed to the outside elements

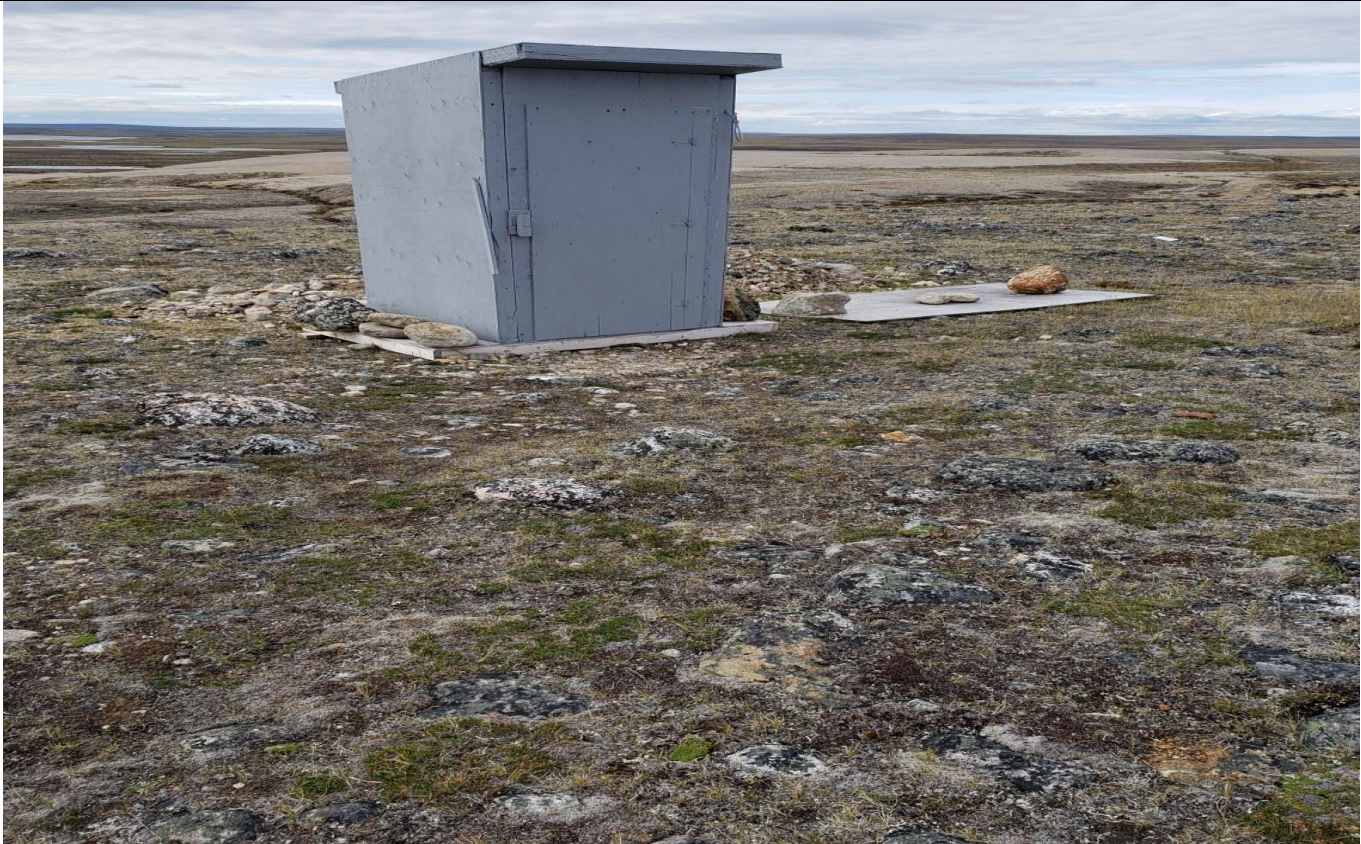
Photo 8

A couple of latrine pits were observed on site, one capped, and the other in use (photo).

Description: latrine, with old latrine pit next to latrine, covered with plywood, and weighed down by a few rocks.

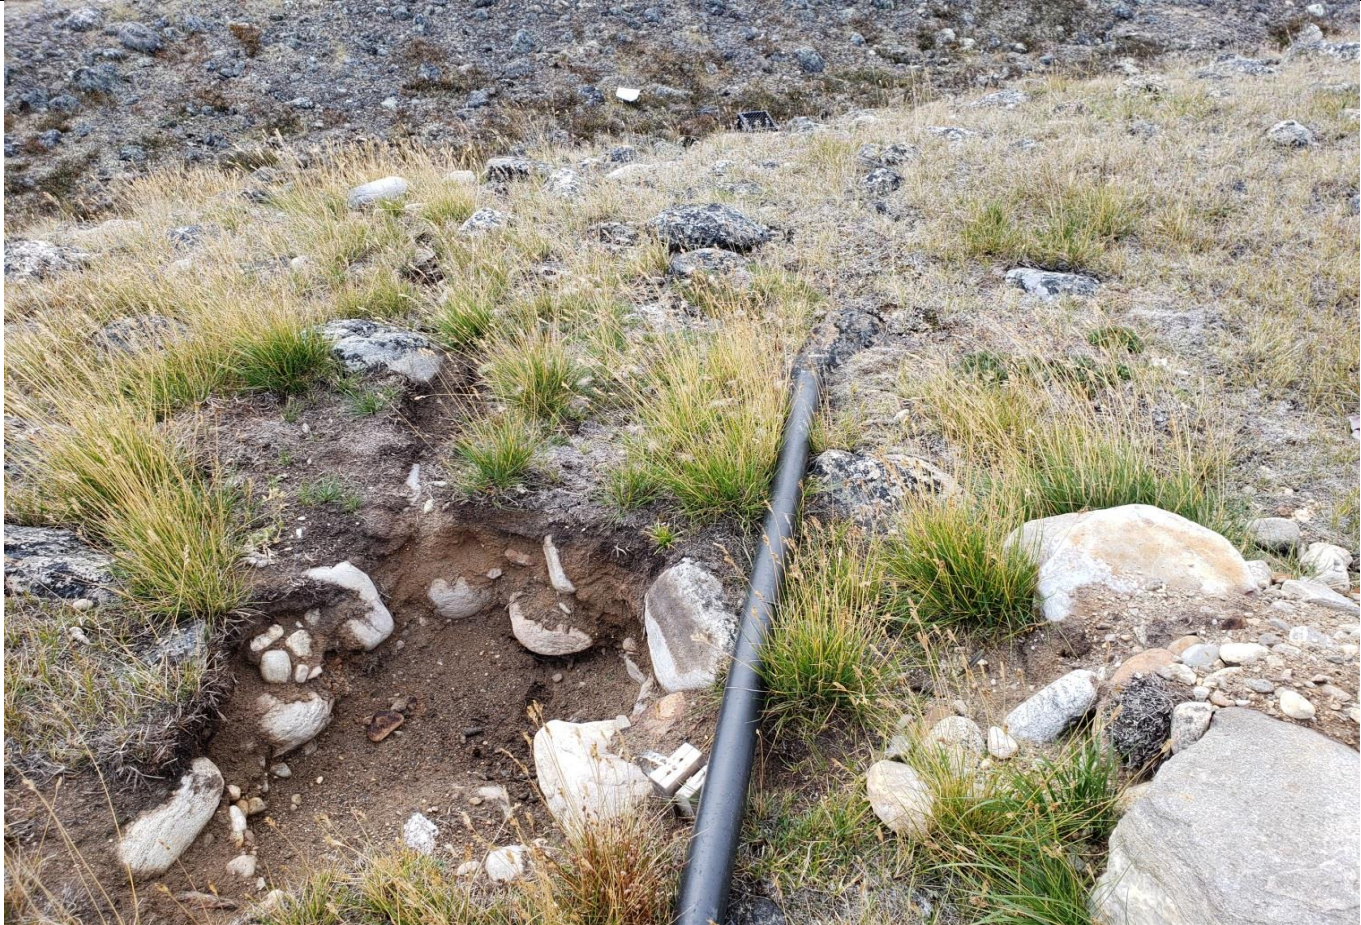
Photo 9

A sump pit was observed on site, disassembled for seasonal closure (photo)
7.

Description: Grey Water Sump Pit. Pipe from building to sump pit disconnected, and migrated a little further downgrade.

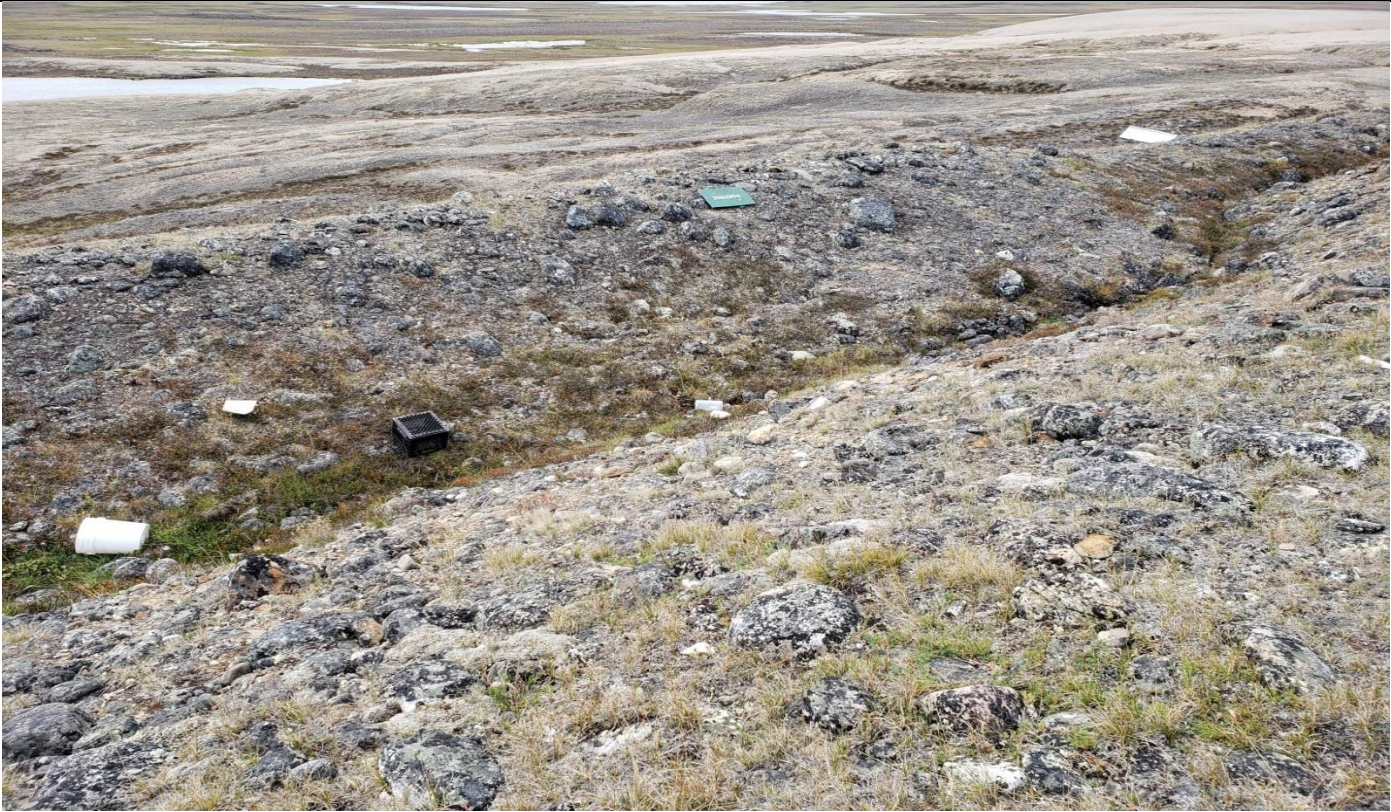
Photo 10

Description: wind-blown debris from camp

SECTION 2	<input checked="" type="checkbox"/> Comments	<input type="checkbox"/> Non-Compliance with Act or Licence	<input checked="" type="checkbox"/> Action Required
The project was in a state of seasonal shutdown due to COVID-19. No major concerns were noted. -Tidy up some of the windblown debris, - fix up secondary containment so the walls are propped up and secured and can contain any product in the event a leak or a spill in secondary containment. - Cover up the drums which contain incinerated material.			
SECTION 3	<input type="checkbox"/> Comments	<input type="checkbox"/> Non-Compliance with Act or Licence	<input type="checkbox"/> Action Required
Click here to enter text.

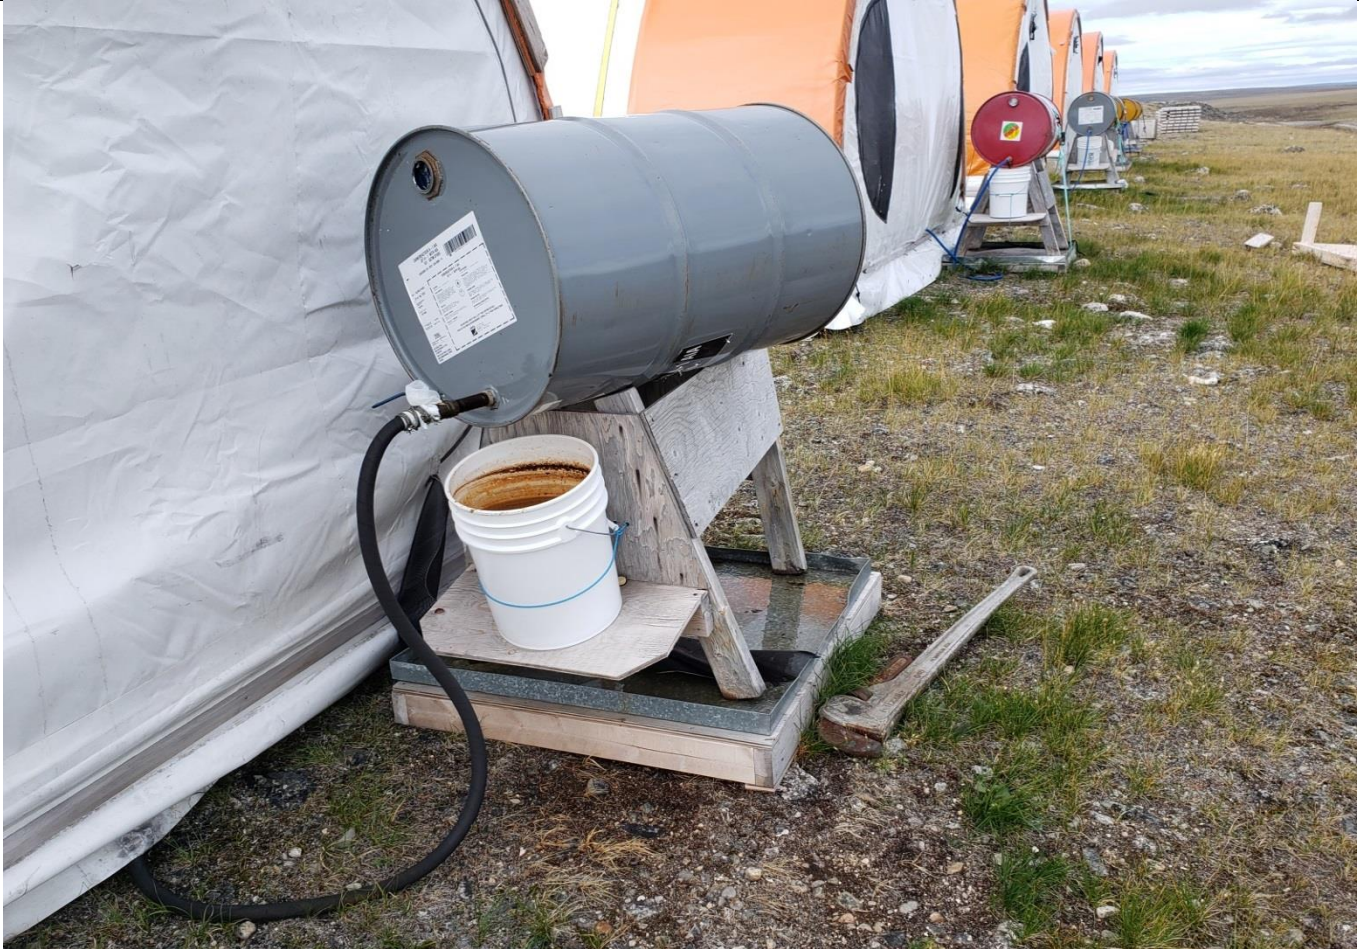
Photo 11

Description: heating fuel drums installed, and secondary buckets, and pans full. Drum not properly fastened

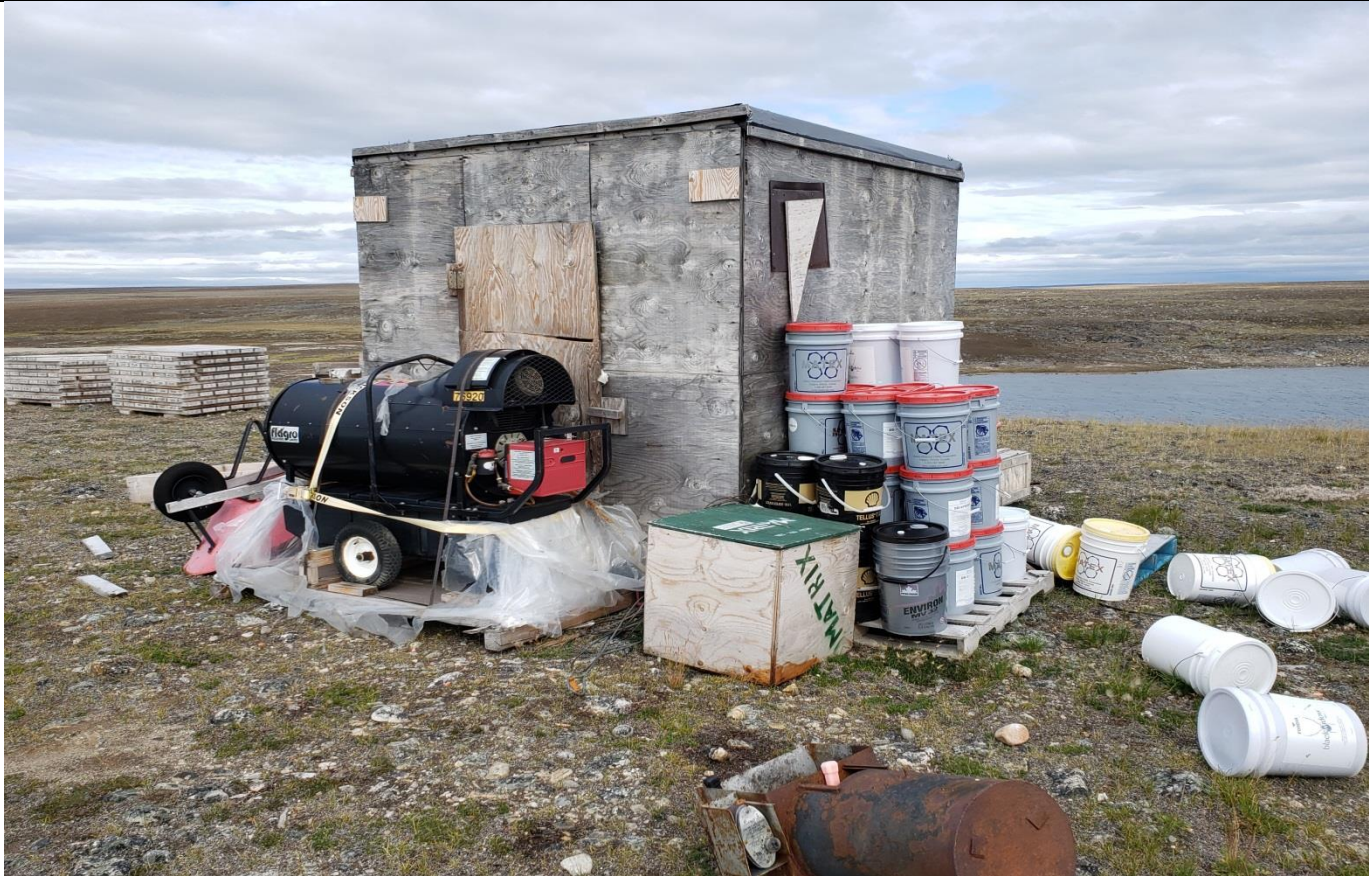
Photo 12

Description: Buckets of product collapsed, and blown across the campsite.

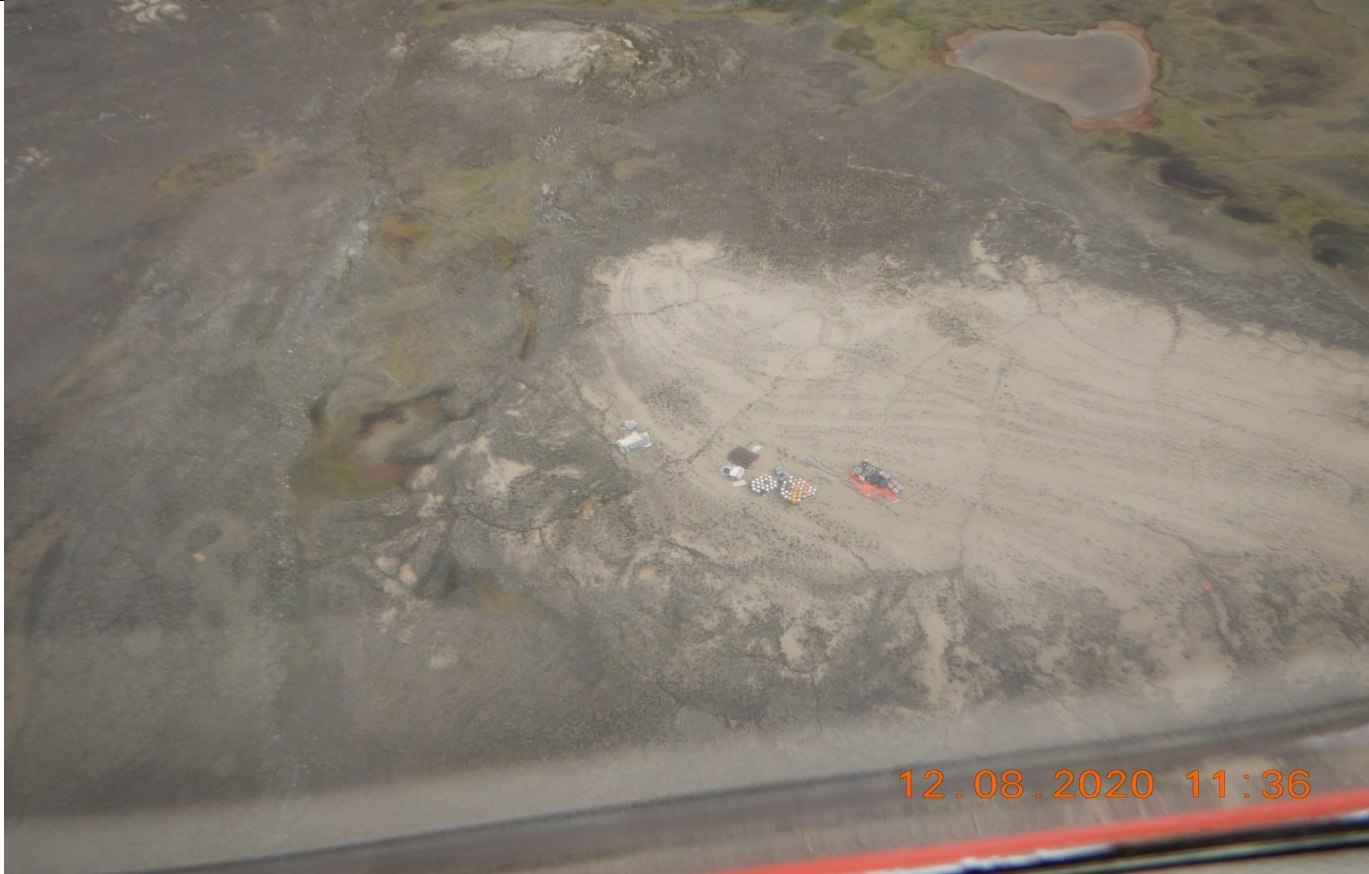
Photo 13

A fuel cache was observed on site. An aerial survey showed that all the empty drums were bound together with a winch strap. 8 x drums in secondary containment. (photo12 & 13).

Description: Fuel cache. 2 x drums bound together using a winch strap. 8 x drums in secondary containment. Drilling equipment.

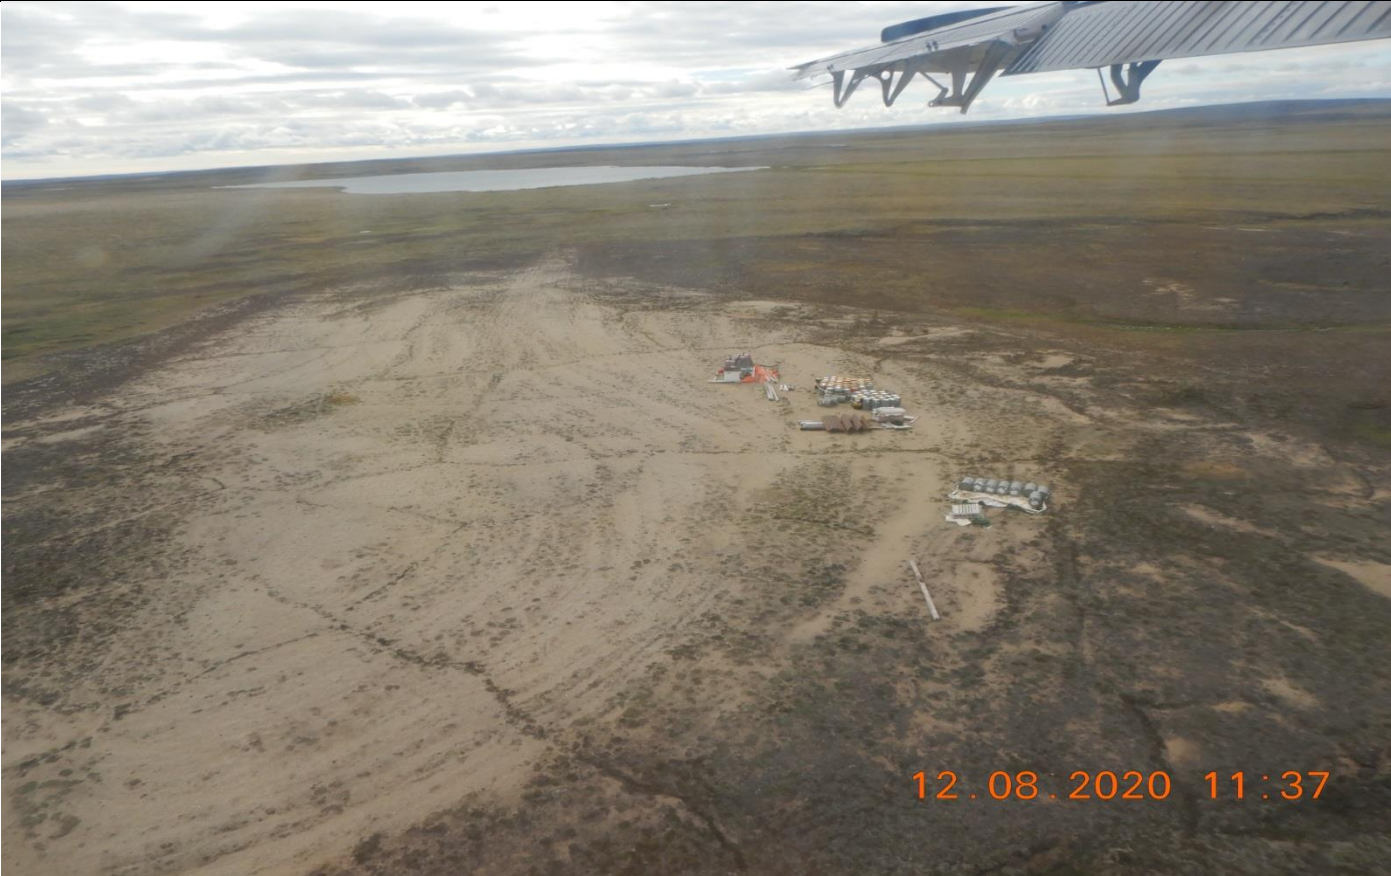
Photo 14

Description: 2 x drums bound together using a winch strap. 8 x drums in secondary containment. Drilling equipment.

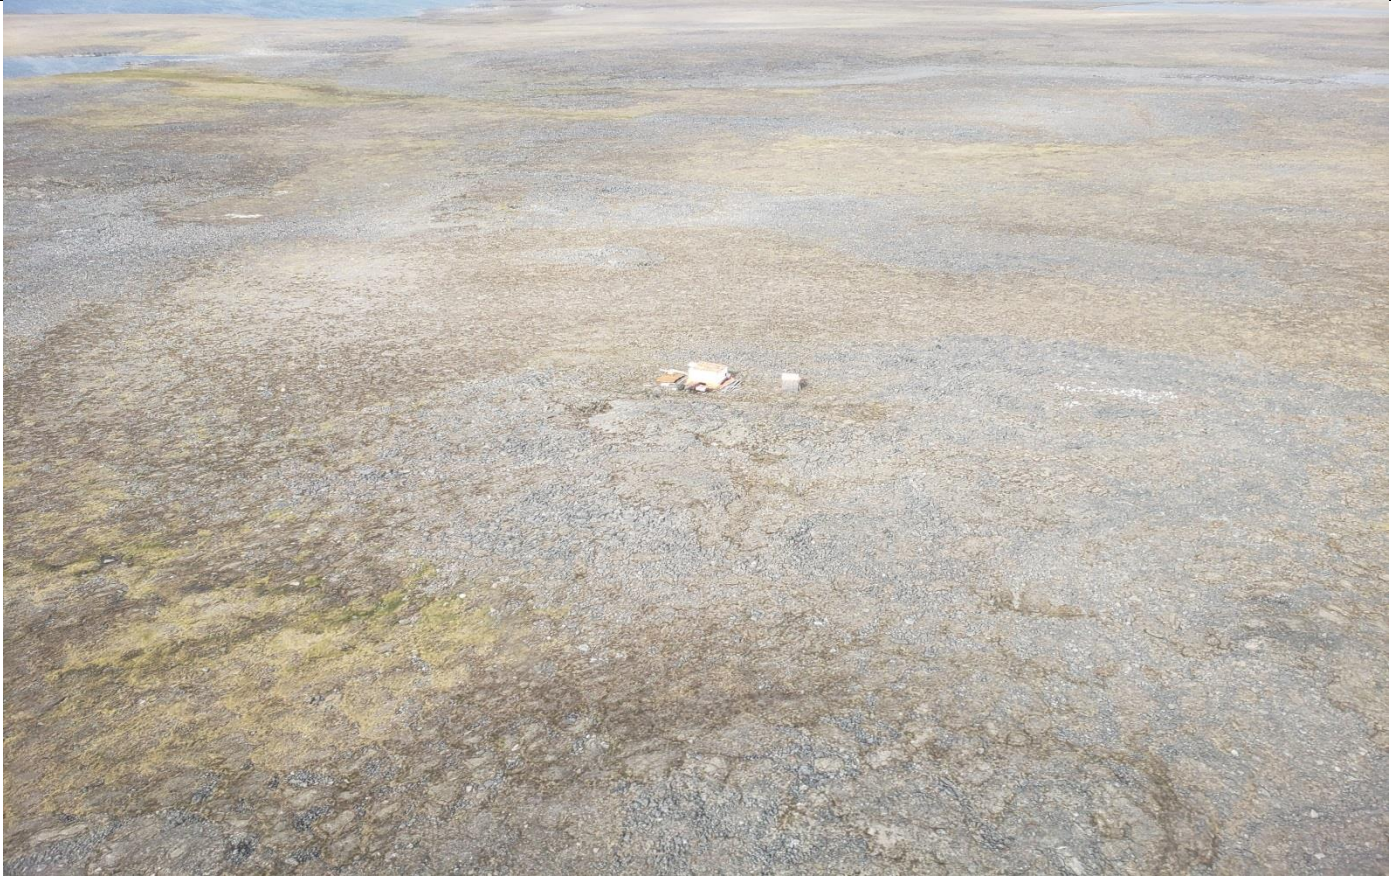
A drill was observed on site. The drill was decommissioned for seasonal shut down due to COVID-19.

Description: Site of drilling. Drill is decommissioned for seasonal shutdown due to COVID-19
