**WATER LICENCE INSPECTION FORM**☒ Original
☐ Follow-Up Report

Licensee	Licensee Representative
Anconia Resources Corporation	Jason Brewster
Licence No. / Expiry	Purpose
2BE-MRC1217/ April 15 th , 2017	Exploration
Land Authorization No. / Expiry	Project Name
N2012C0006/ February 27 th , 2019	Marce Project
Date of Inspection	Inspector
September 16 th , 2021	RMO C. Wilson
Activities Inspected	
<input type="checkbox"/> Camp	<input checked="" type="checkbox"/> Drilling
<input type="checkbox"/> Roads/Hauling	<input type="checkbox"/> Other:
<input type="checkbox"/> Mining	<input type="checkbox"/> Construction
<input type="checkbox"/> Reclamation	<input type="checkbox"/> Fuel Storage

An inspection of Anconia Resources Corporation's ('Anconia'), Marce Project was completed by Crown-Indigenous Relations and Northern Affairs Canada's, Resource Management Officer, Christine Wilson ('Inspector'). The inspection was conducted to ensure compliance with applicable terms and conditions of water licence no. 2BE-MRC1217.

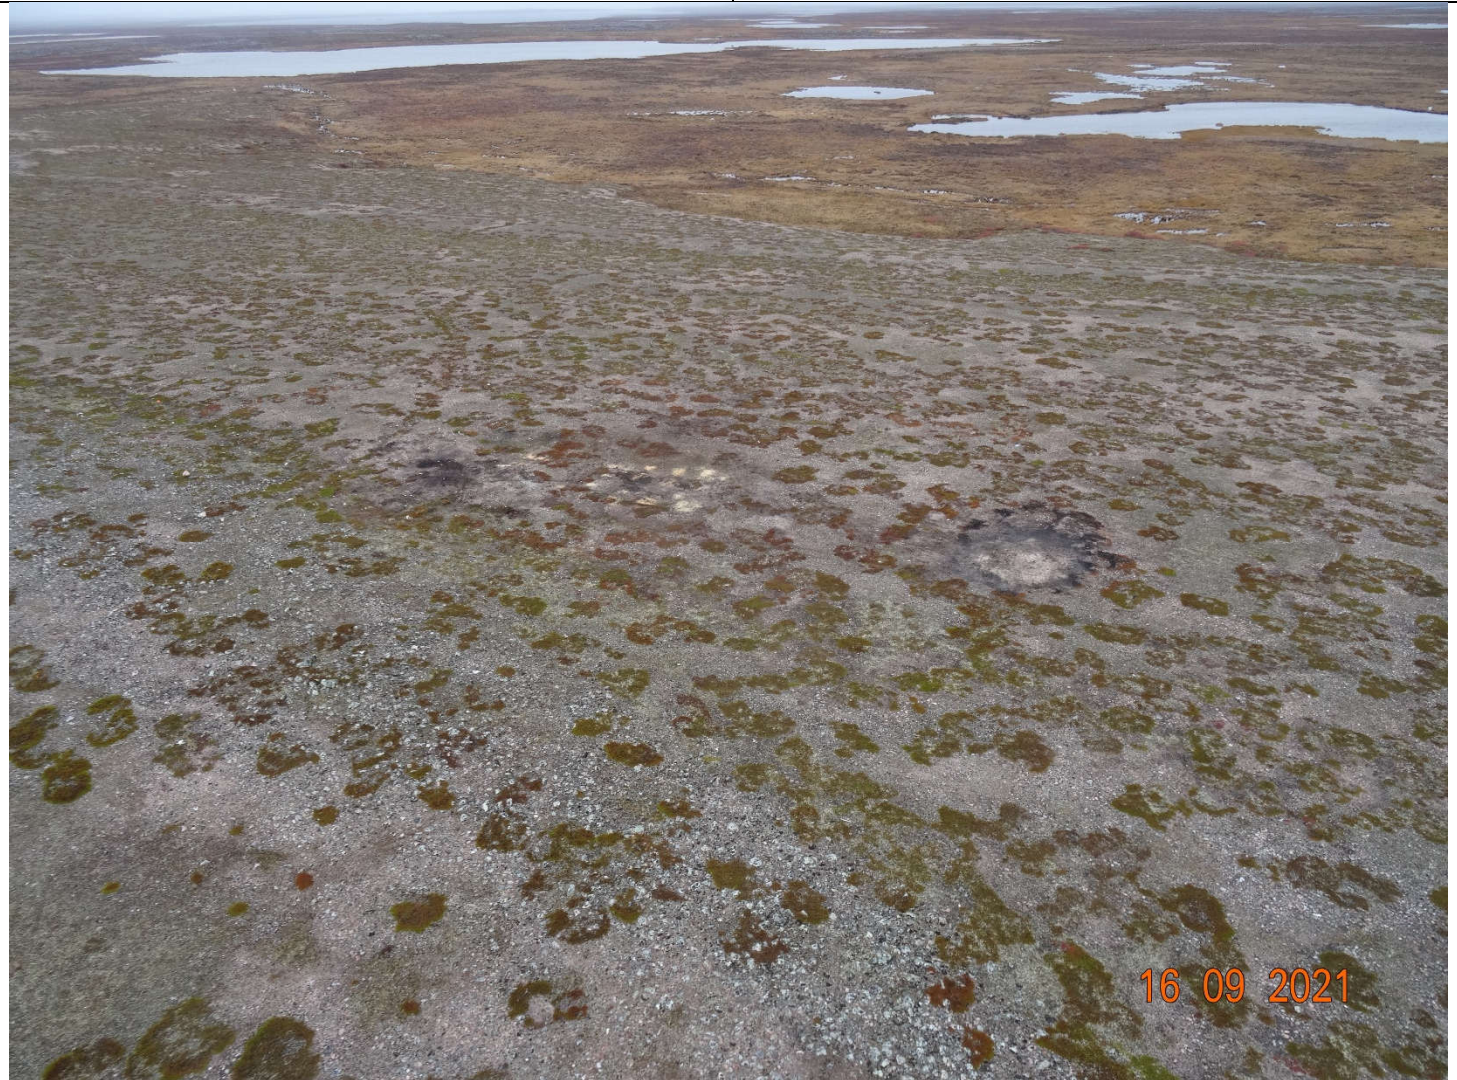
Date:	Authorization Number:	Camera/Model:	Inspector:
September 16 th , 2021	2BE-MRC1217	Sony DSC-HX50V Cyber shot	WRO Wilson
Photo No.:		Lat/Long (DD.MM.SS.SS, NAD83):	
Photo 1		N62° 40' 15.73", W95° 28' 35.33"

1. The materials located at the laydown have been removed; all the clean wood burned and ash backhauled (photo 1 and photo 2).
2. Numerous locations of windblown garbage is noted around the laydown (photo 3- photo 7). Materials as follows; three tarps, an oil jug, metal siding, a small secondary containment berm and insulation.
3. Three empty red and yellow drums (photo 8) are at the end of the airstrip at N62° 40' 9.5", W95° 29' 5.6".
4. Two drill holes at the West end of the air strip require removal or to be cut off at ground level. Locations are listed as follows:
 - drill site 1 approximately located at N62° 40' 6.04", W95° 29' 6.17" (photo 9); and
 - drill site 2 approximately located at N62° 40' 8.40", W95° 29' 7.01" (photo 10).

Description:
Zak Laydown

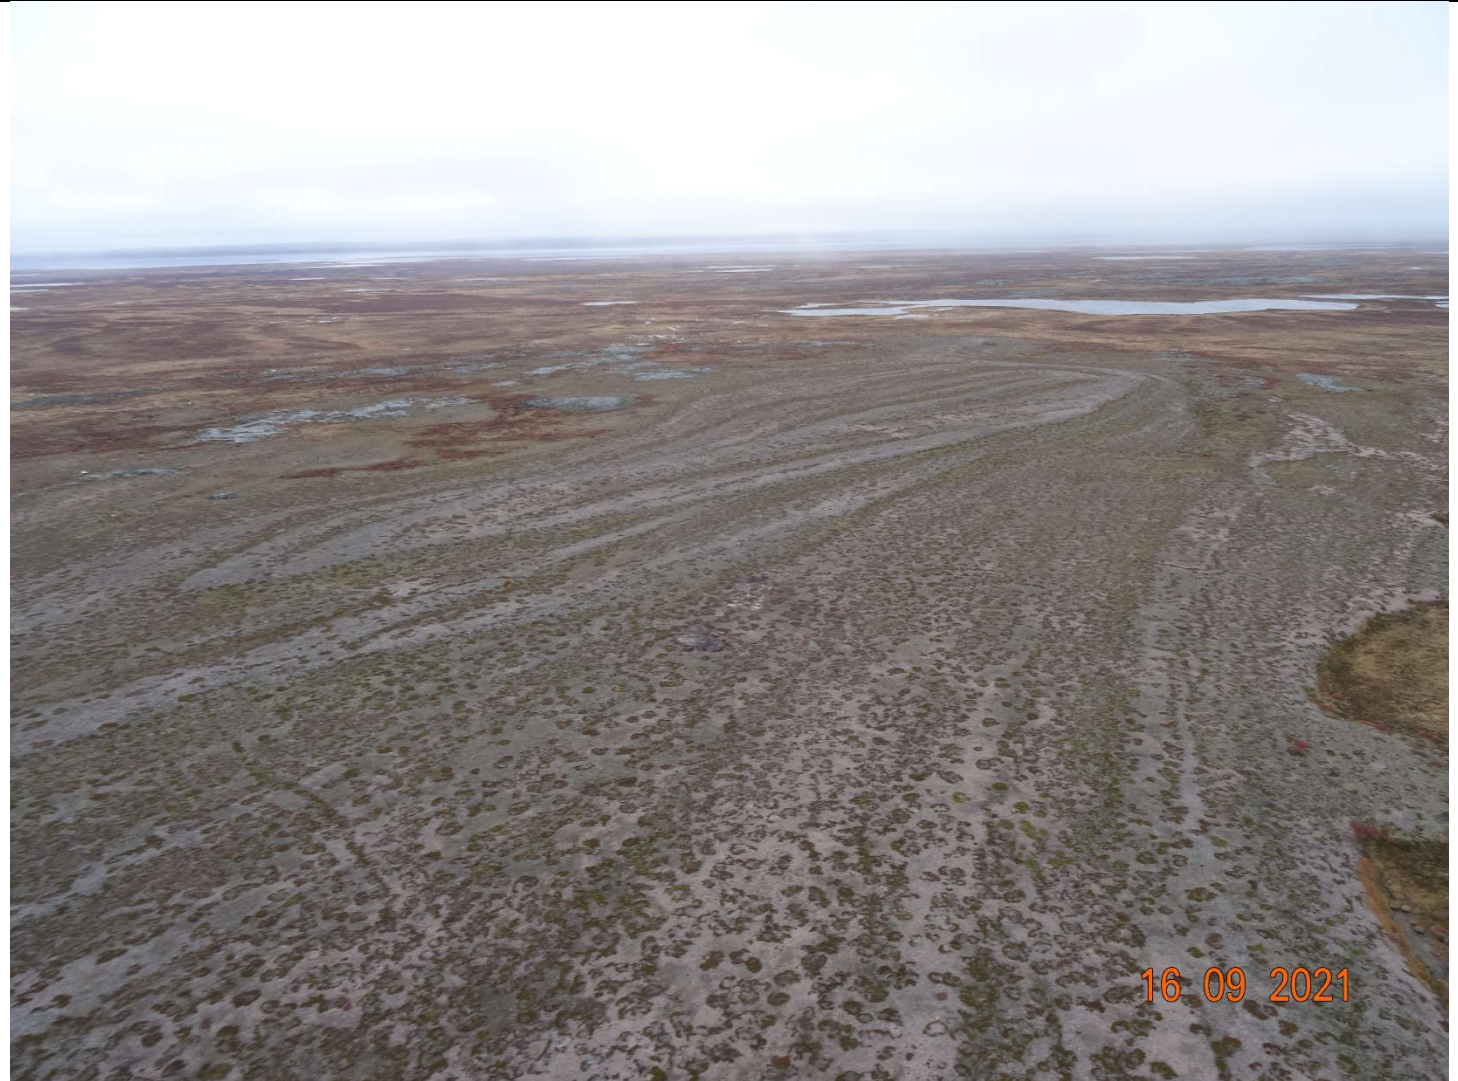
Photo 2

Zak Laydown and adjacent esker airstrip.

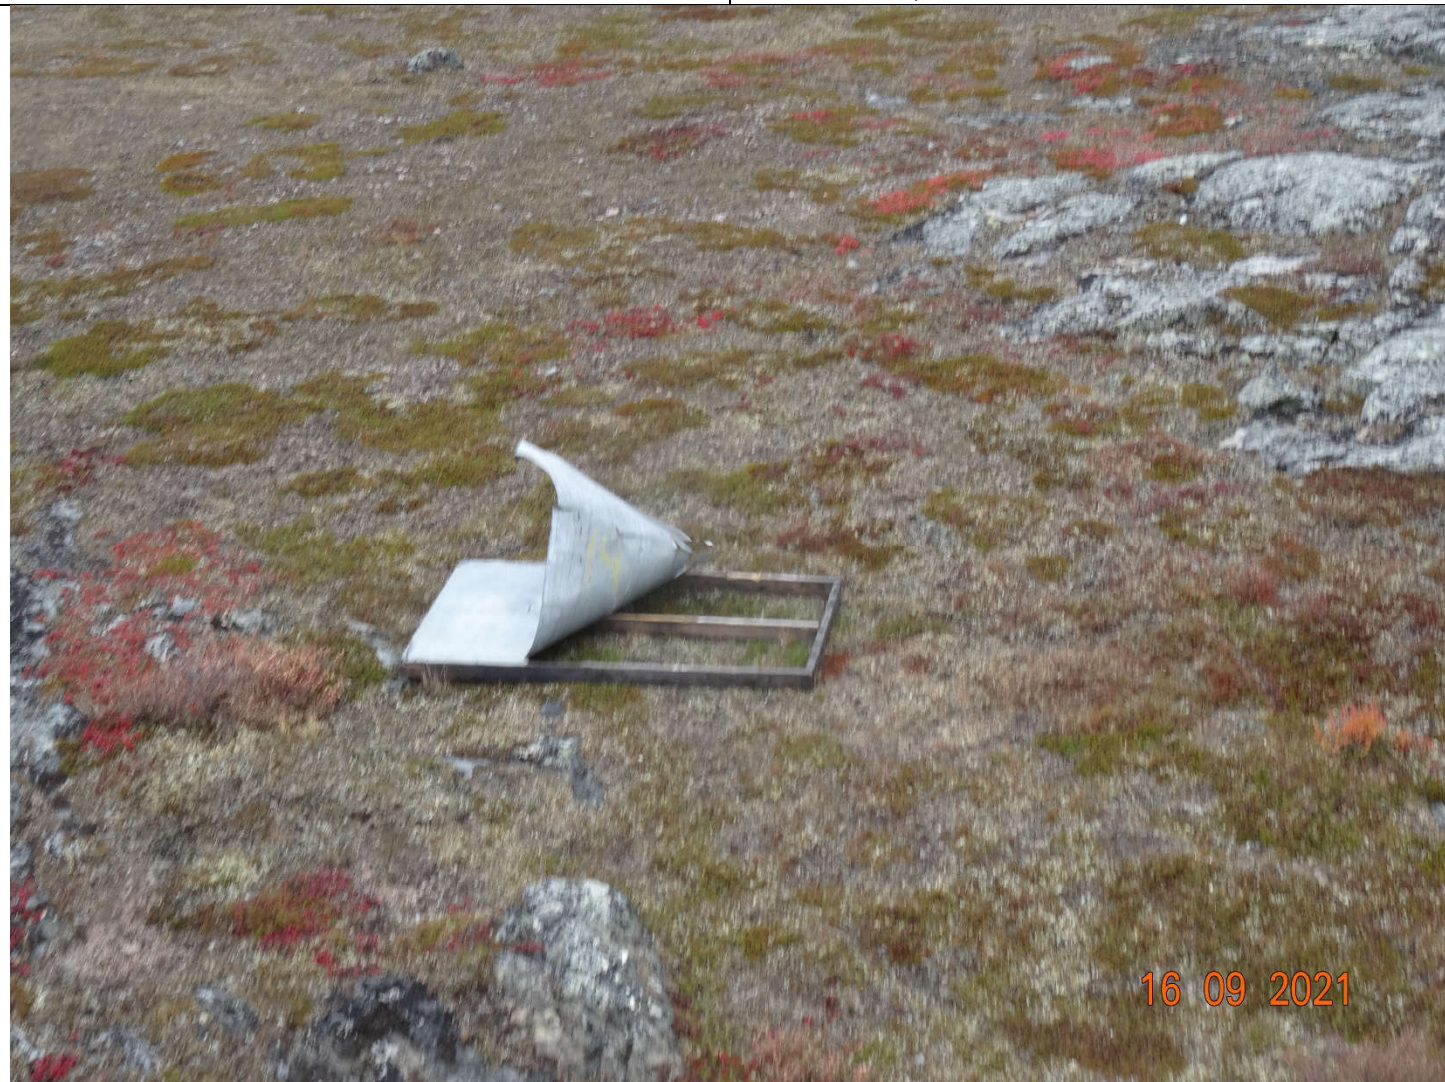
Photo 3

PART I item 4: Failure to remove materials from the land prior to the expiry of this Licence.

Metal siding and wood.

- On September 17th, the Inspector communicated the observation noted in this report to the Permittee's contractor. The Permittee contacted the Inspector and committed to returning to the Zak laydown to complete the work prior to the end of the 2021 field season.
- On October 24th, the Permittee's contractor returned to the Zak laydown and completed an extensive clean-up.

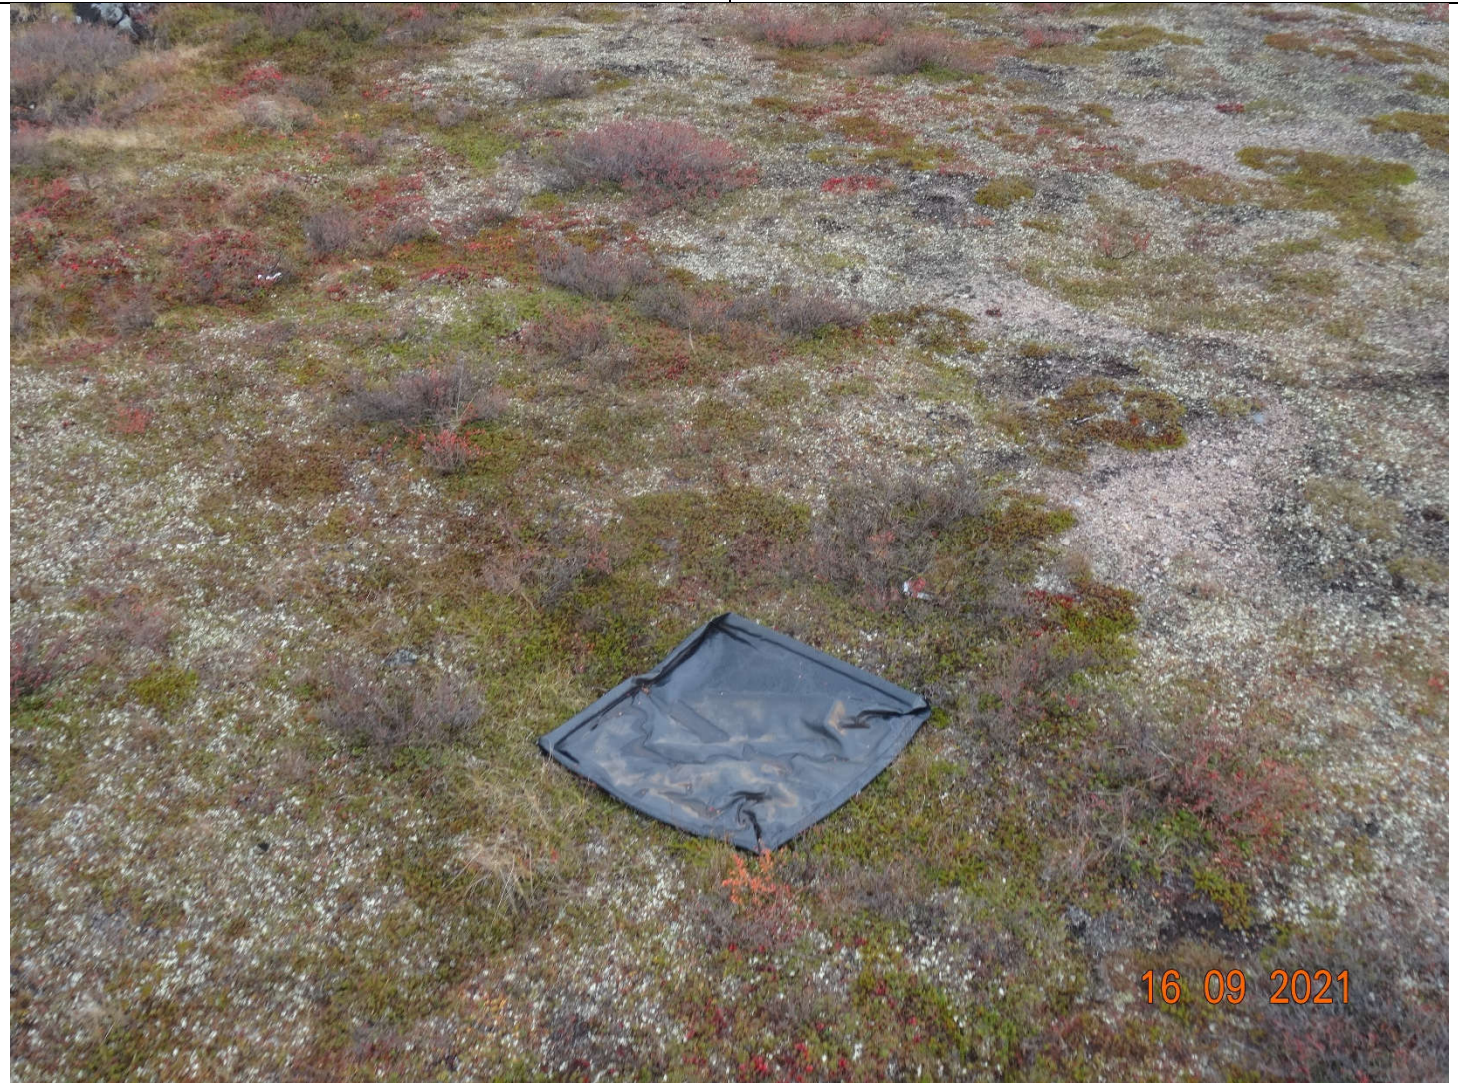
Photo 4

Secondary containment berm.

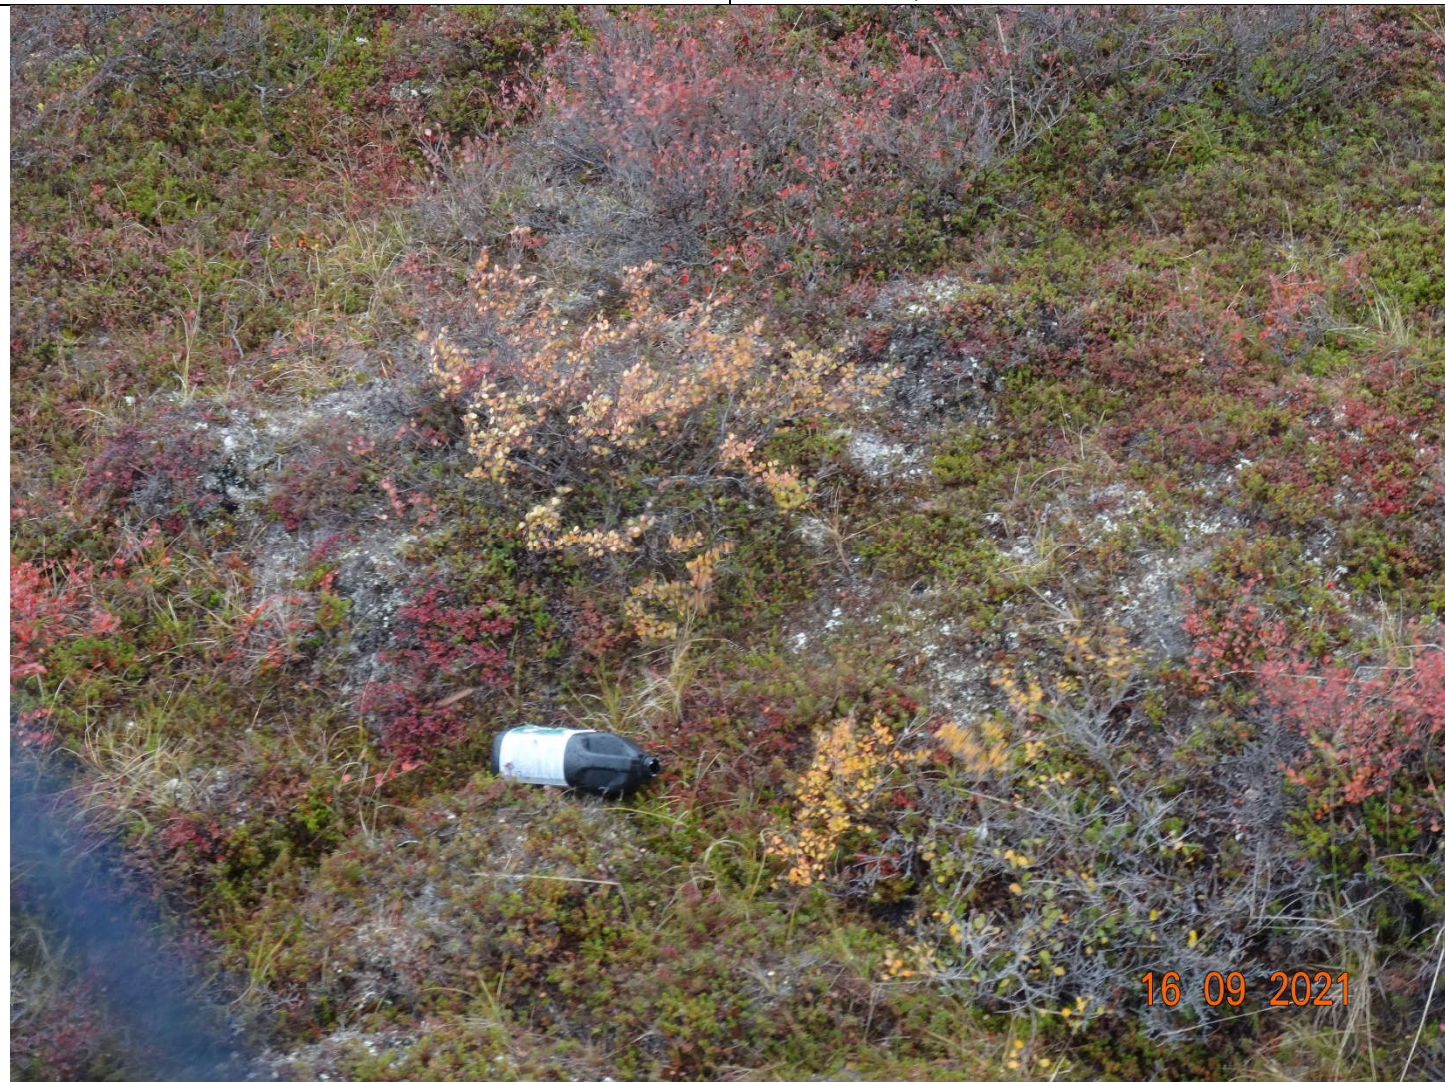
Photo 5

Oil Jug.

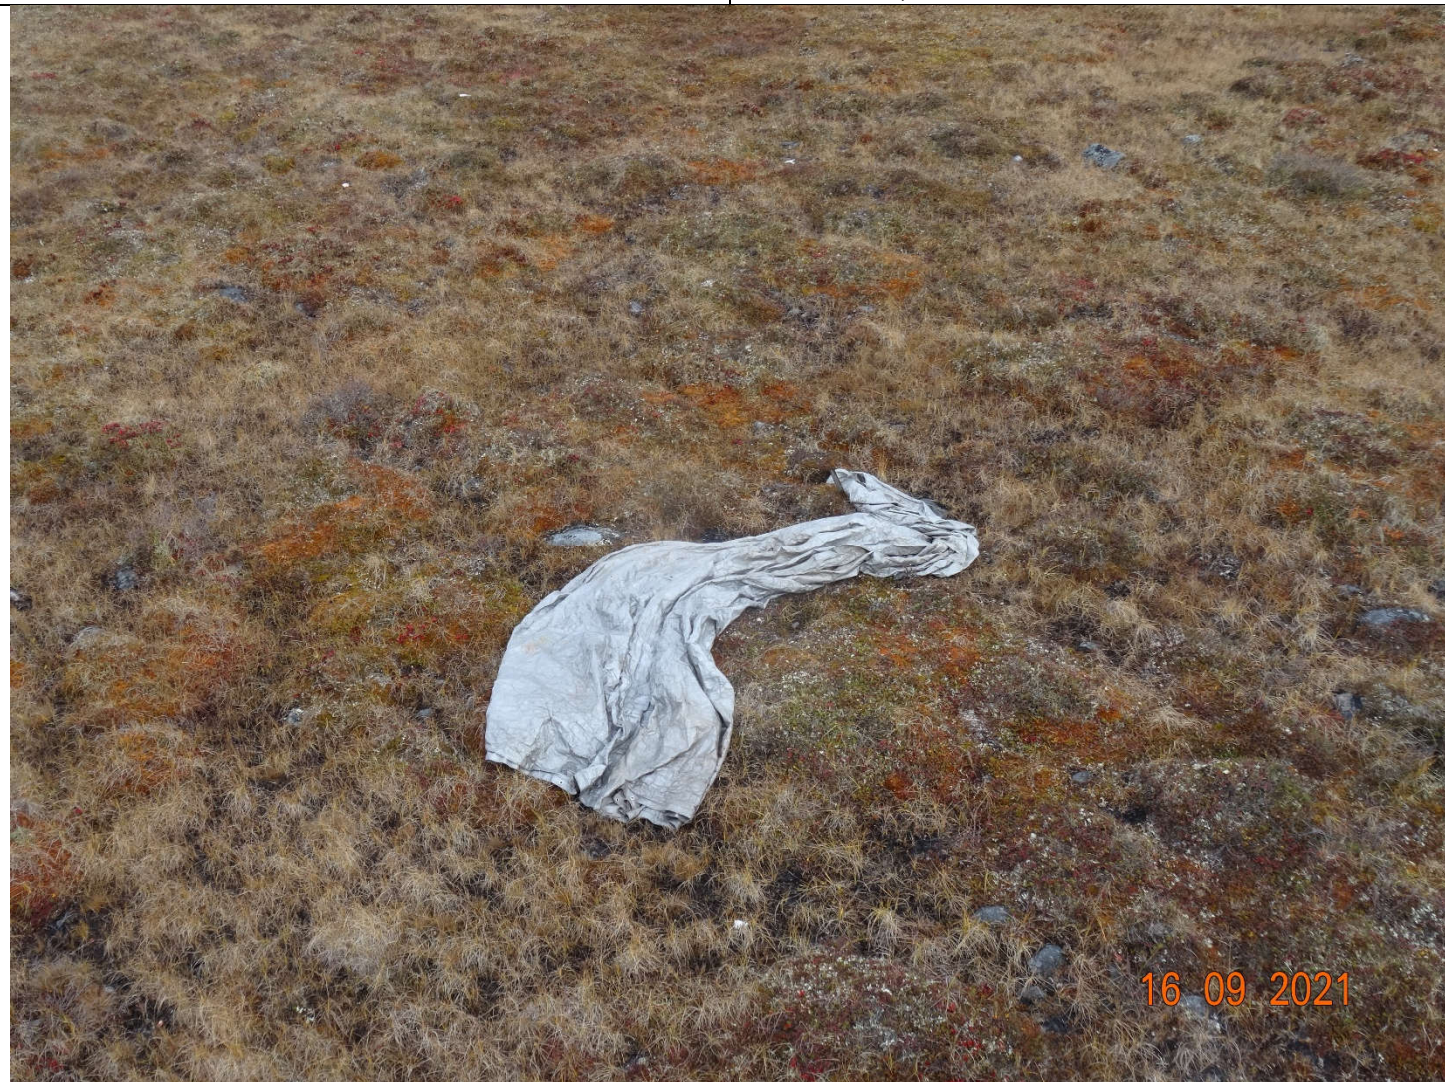
Photo 6

Grey Tarp.

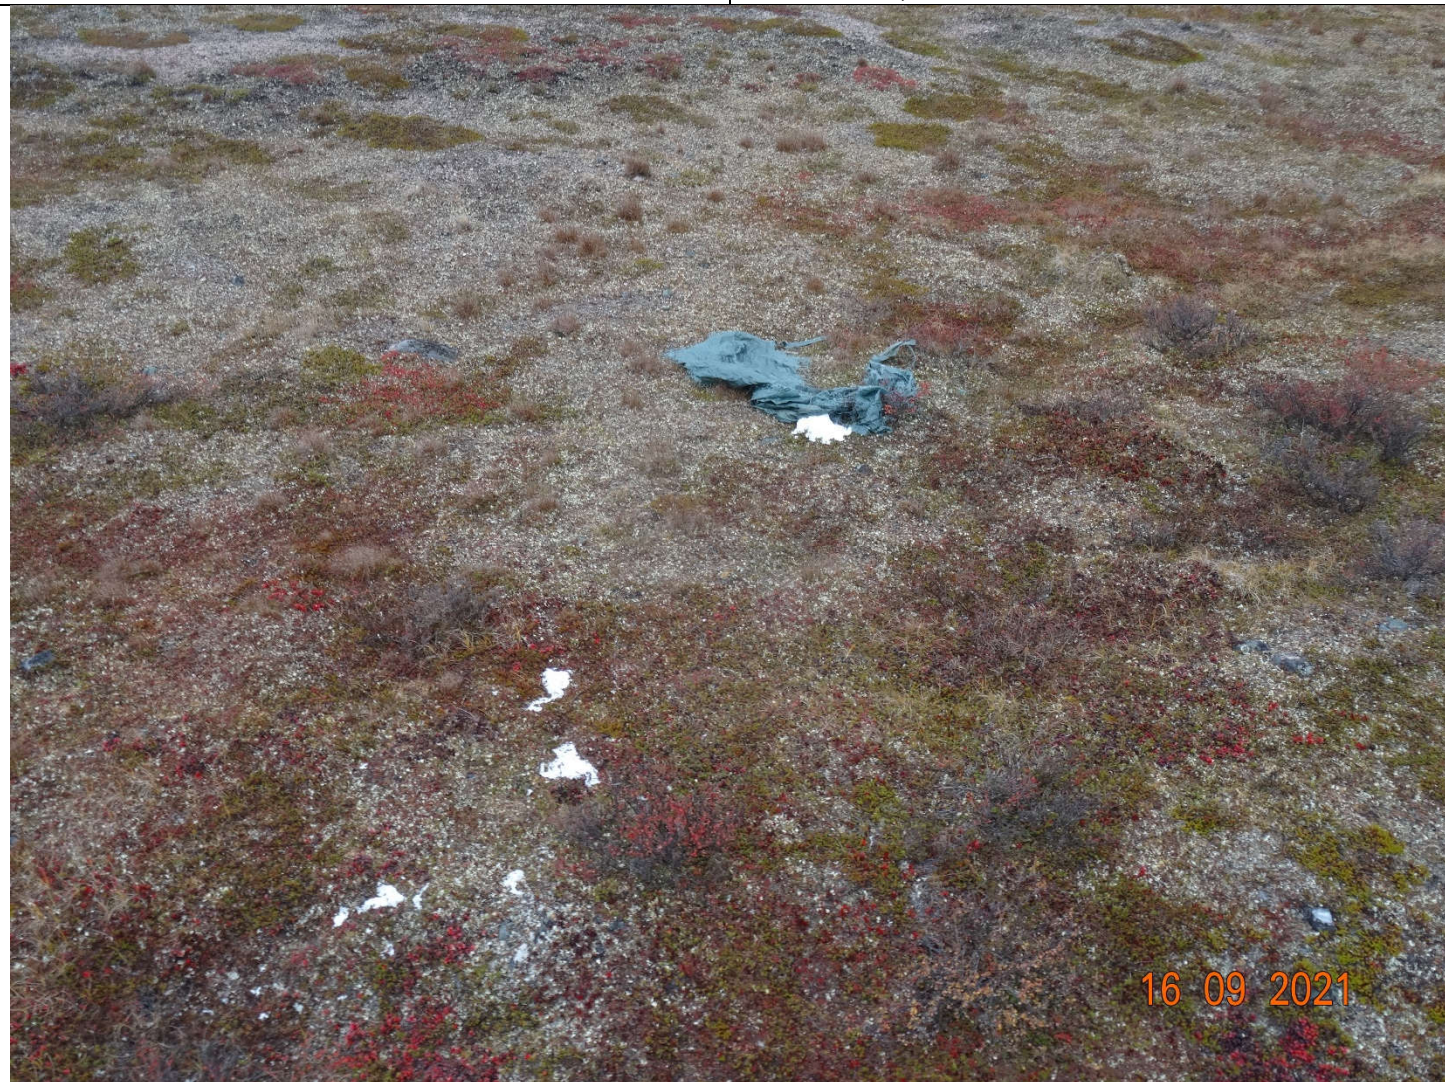
Photo 7

Green Tarp and insulation.

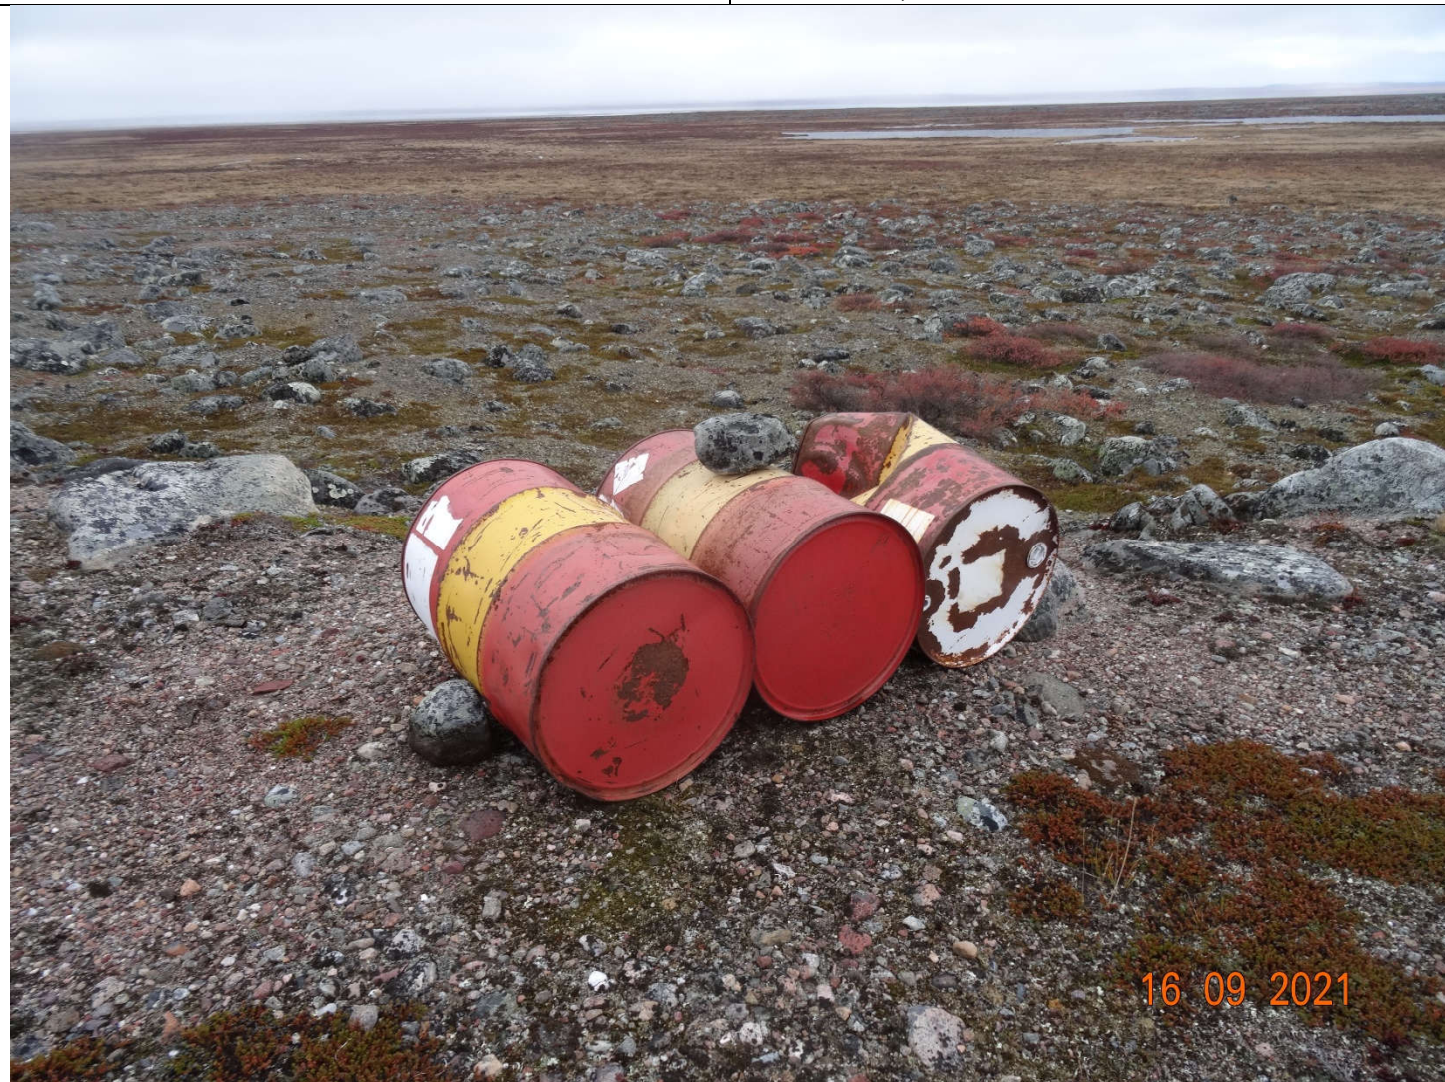
Photo 8

Three empty red and yellow drums.

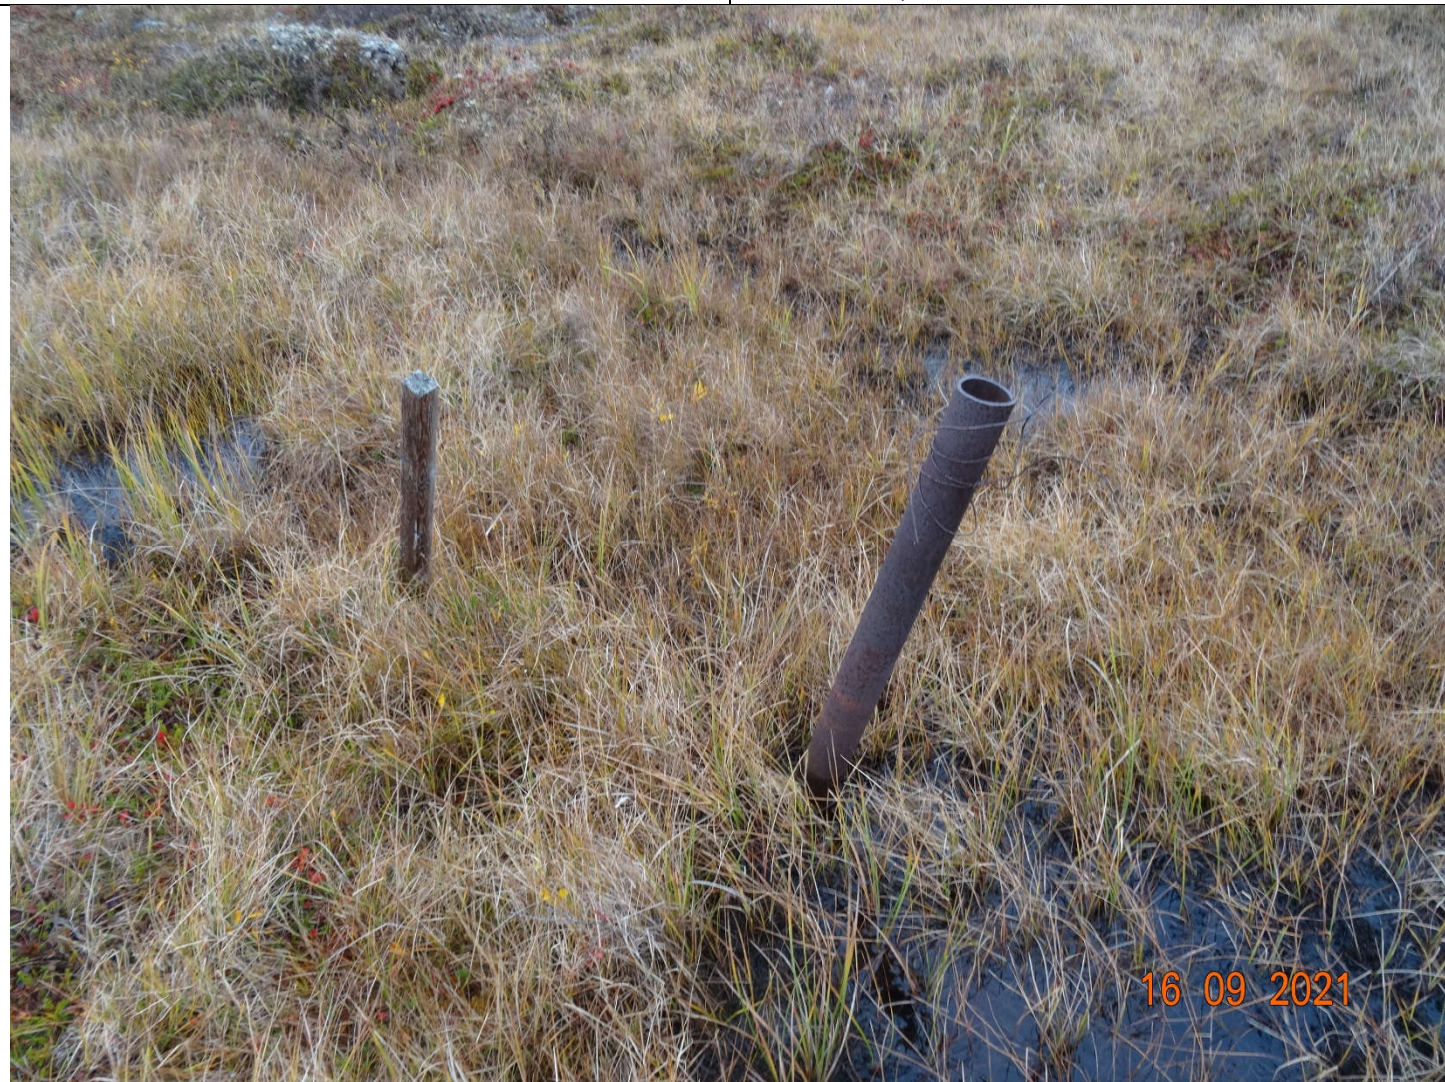
Photo 9

PART I item 8: Failure to reclaim drill holes to the satisfaction of the Inspector.

Drill Site 1

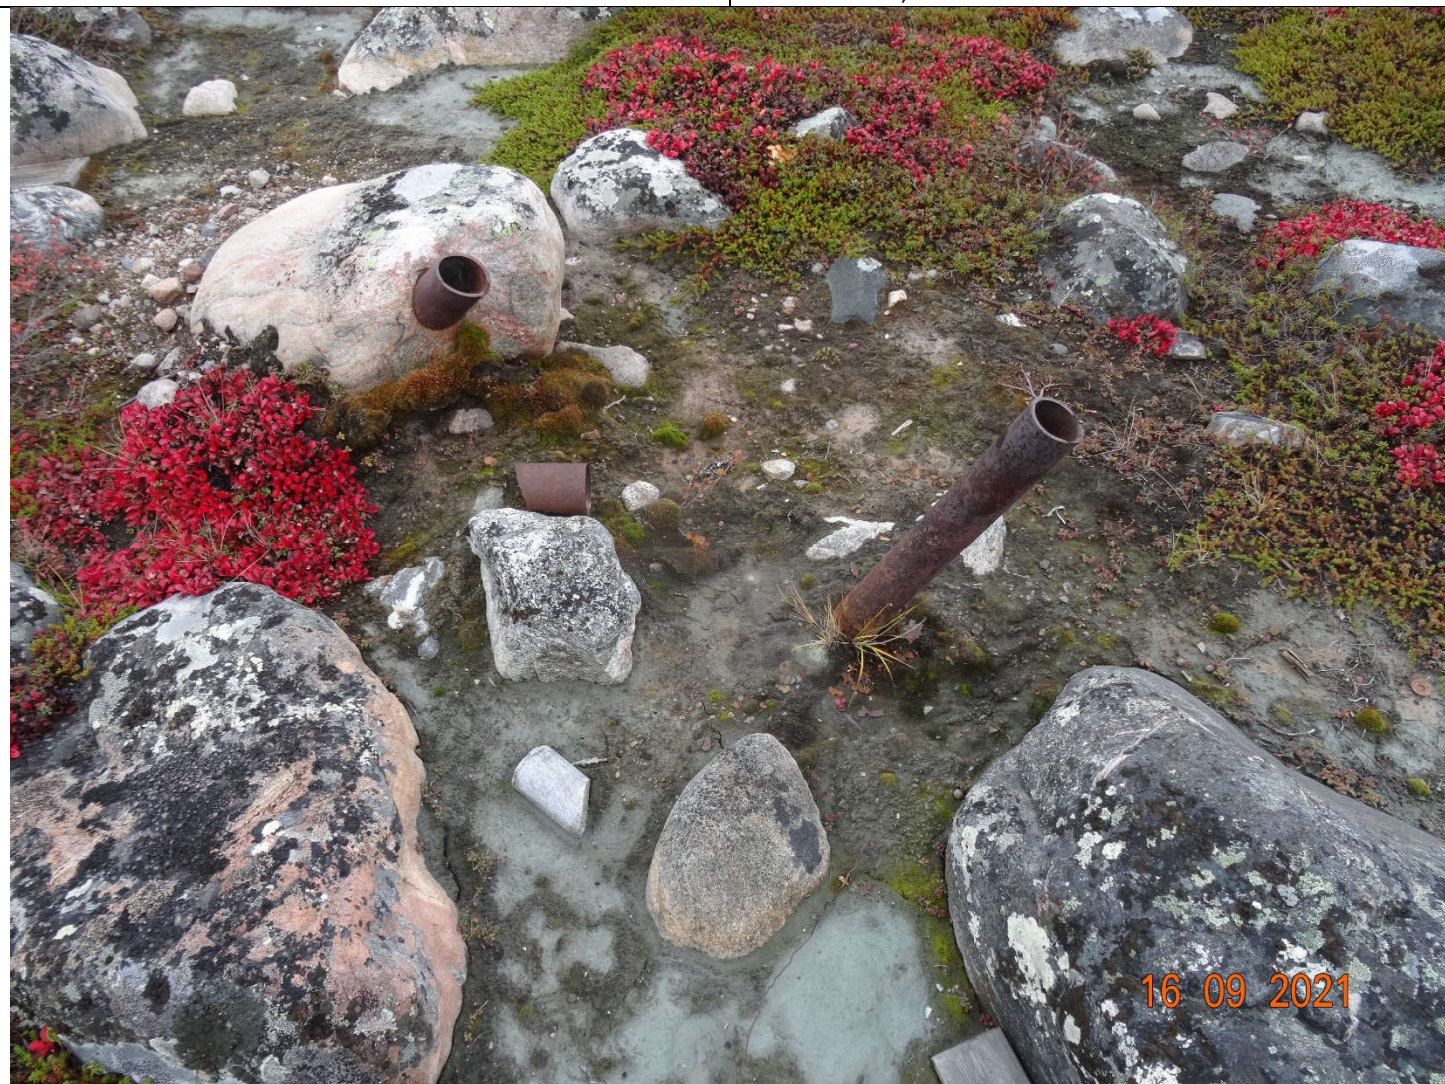
Photo 10

Drill Site 2
