License #: **2BE-MRP1116**

Inspection Date: **July 15, 2013**

| Inspection site location | Maguse River Project, Kivalliq Region, Nunavut | | |

RE: Inspection of Water Licence 2BE-MRP1116, July 15 2013

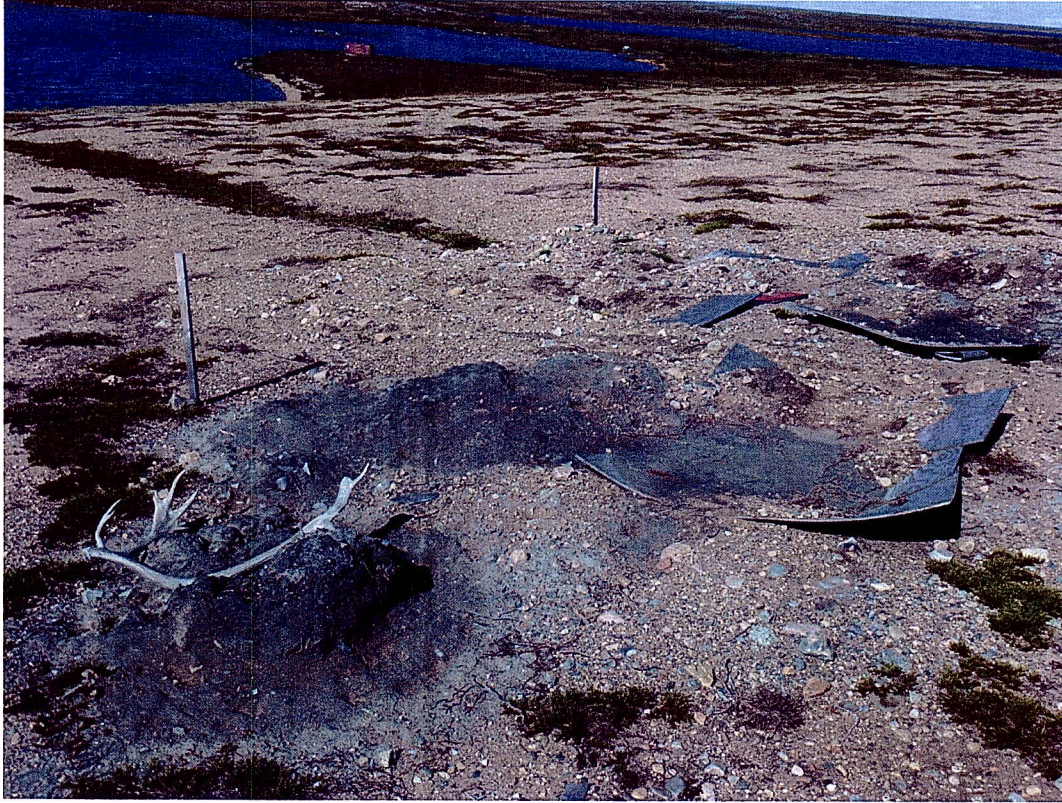
Sump constructed to contain core cutting behind core shack needs modifications and repair. During the time of the inspection the inspector noted that cuttings where not contained in the sump and could possibly run down gradient to the lake.

The overall site was very tidy and clean, Inspector had concerns with sump used for core cuttings that is located behind the core shack/tent frame, and cuttings were place outside the sump and not in it. During the remediation of the site the cuttings should be placed in to the sump that was constructed and back filled.

- Core cutting behind core shack -July 15th 2013

Part F (2) Core cuttings behind Core Shack need to were dumped on ground and need to be placed in to a sump.

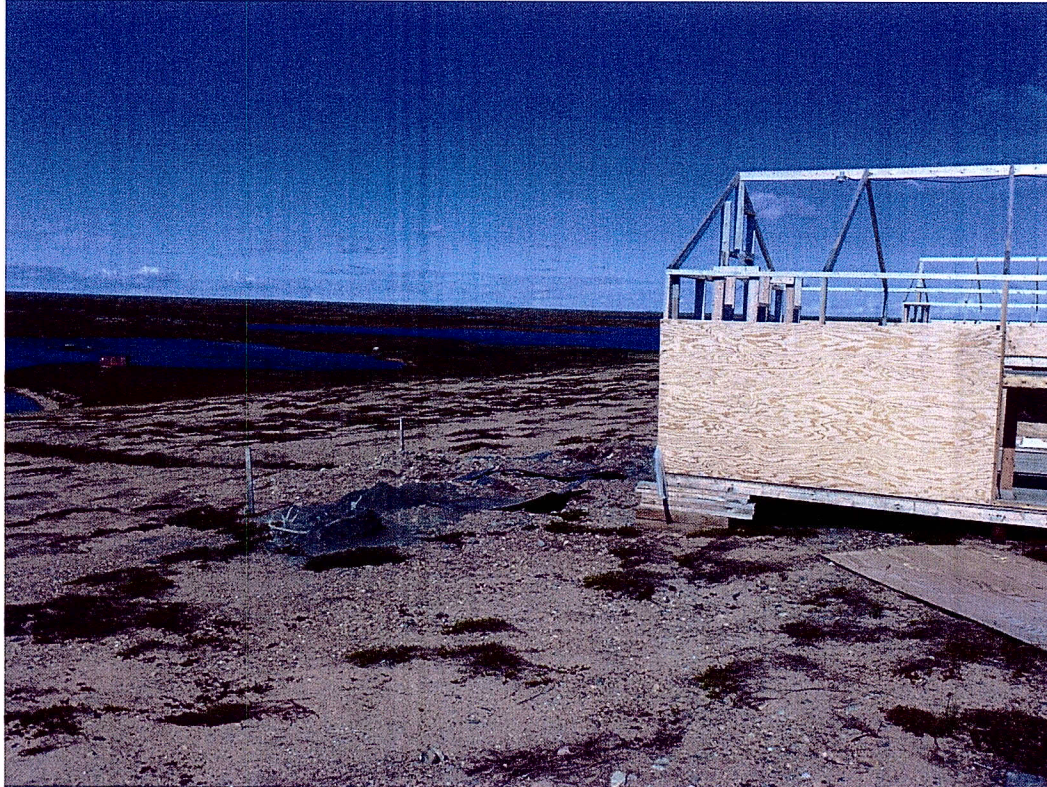
- Core cuttings on slop from core shack -July 15th 2013

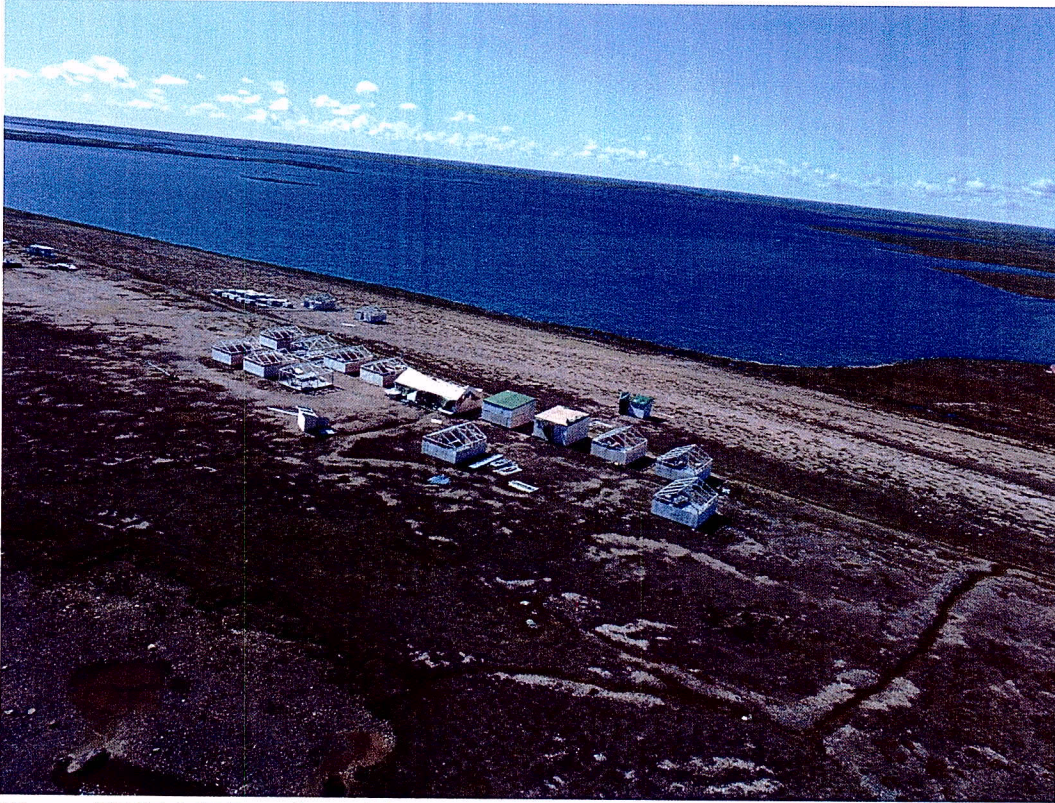
- View of 2BE-MRP project site -July15th 2013
