WATER LICENCE INSPECTION FORM

Licensee	Licensee Representative
Baffinland Iron Mines Corporation (BIMC)	Connor Devereaux
Licence No. / Expiry	Representative's Title
2AM-MRY1325	Environmental Superintendent
Land / Other Authorizations	
8BC-MRY1416, 2BEMRY1421	N2014X0012, N2014Q0016, N2014C0013
Date of Inspection	Inspector
May 16-18 2018	Jonathan Mesher
Activities Inspected	
<input type="checkbox"/> Municipality <input checked="" type="checkbox"/> Roads/Hauling	<input type="checkbox"/> Drilling <input type="checkbox"/> Other: BIMC Main Camp
<input checked="" type="checkbox"/> Mining	<input checked="" type="checkbox"/> Construction <input checked="" type="checkbox"/> Other: Miline Camp Area
<input type="checkbox"/> Reclamation	<input checked="" type="checkbox"/> Fuel Storage

SECTION 1	<input checked="" type="checkbox"/> Comments	<input type="checkbox"/> Non-Compliance with Act or Licence	<input type="checkbox"/> Action Required
Inspectors Statement			
On May 16-18, 2018, a water licence inspection was conducted at the Mary River Project, Qikiqtani Region, Nunavut. Sites inspected included the Mary River Mine Site, the Tote Road and related infrastructure, and the Milne Port area.

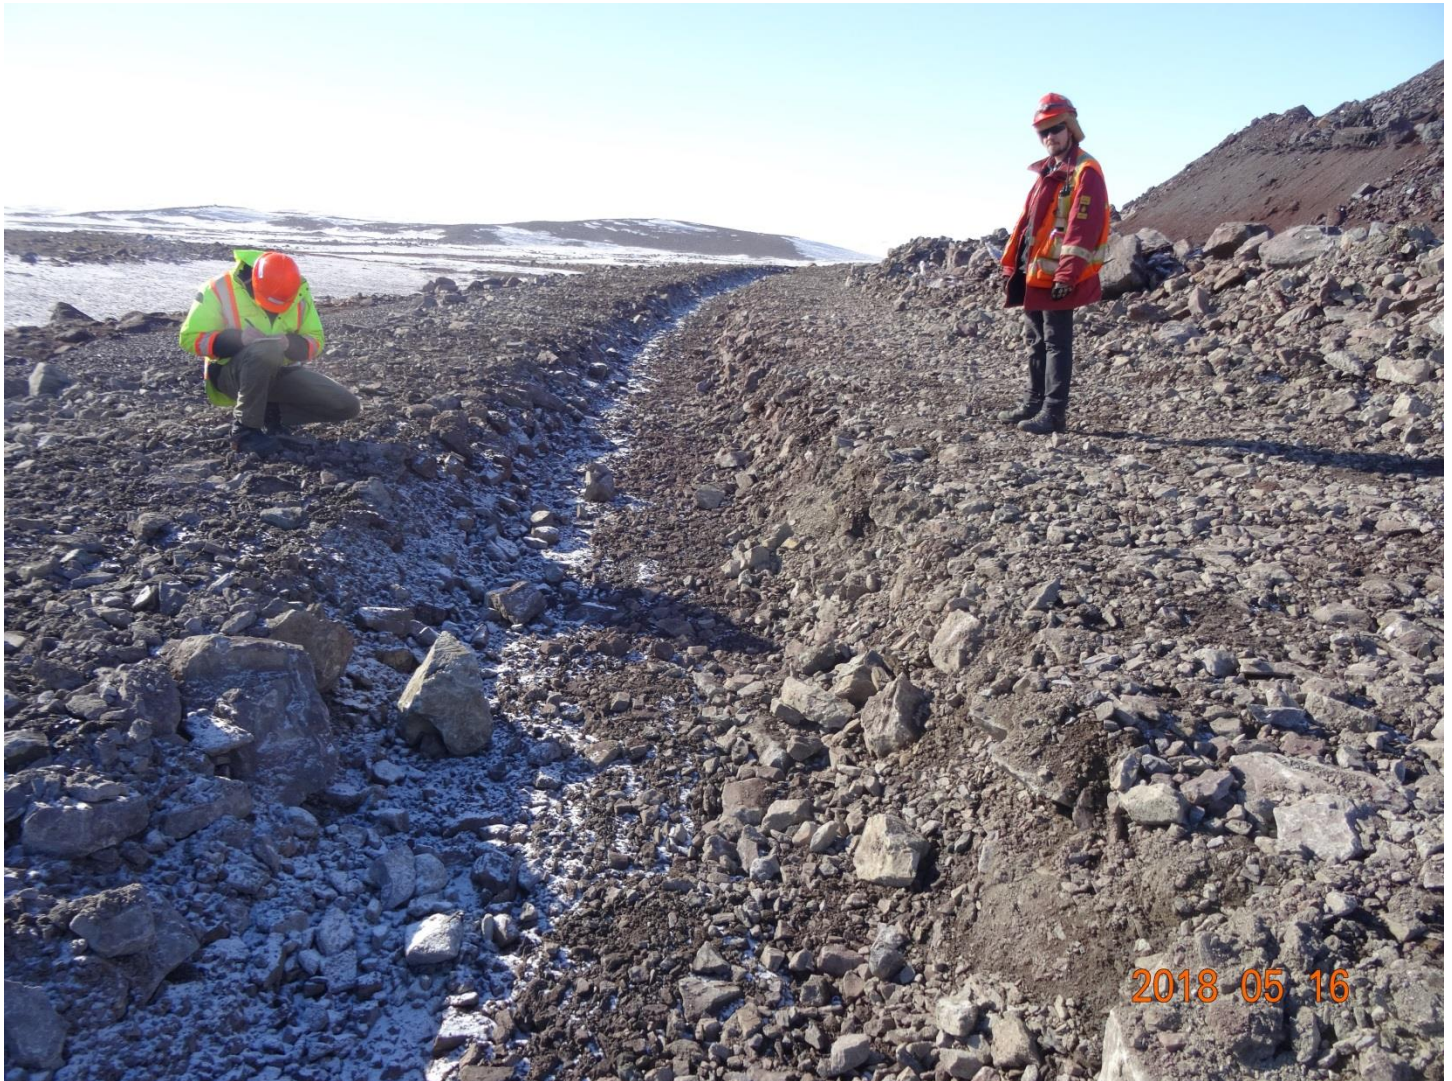
1. Ore Crushing Area and associated water management structures			
a. In the previous inspection report it was noted that the containment ditches surrounding ore stockpile pad were not complete, at the time of this inspections the containment ditches around this facility appeared to be complete. See figure 1

Figure 1: Ditch surrounding Ore Stockpile

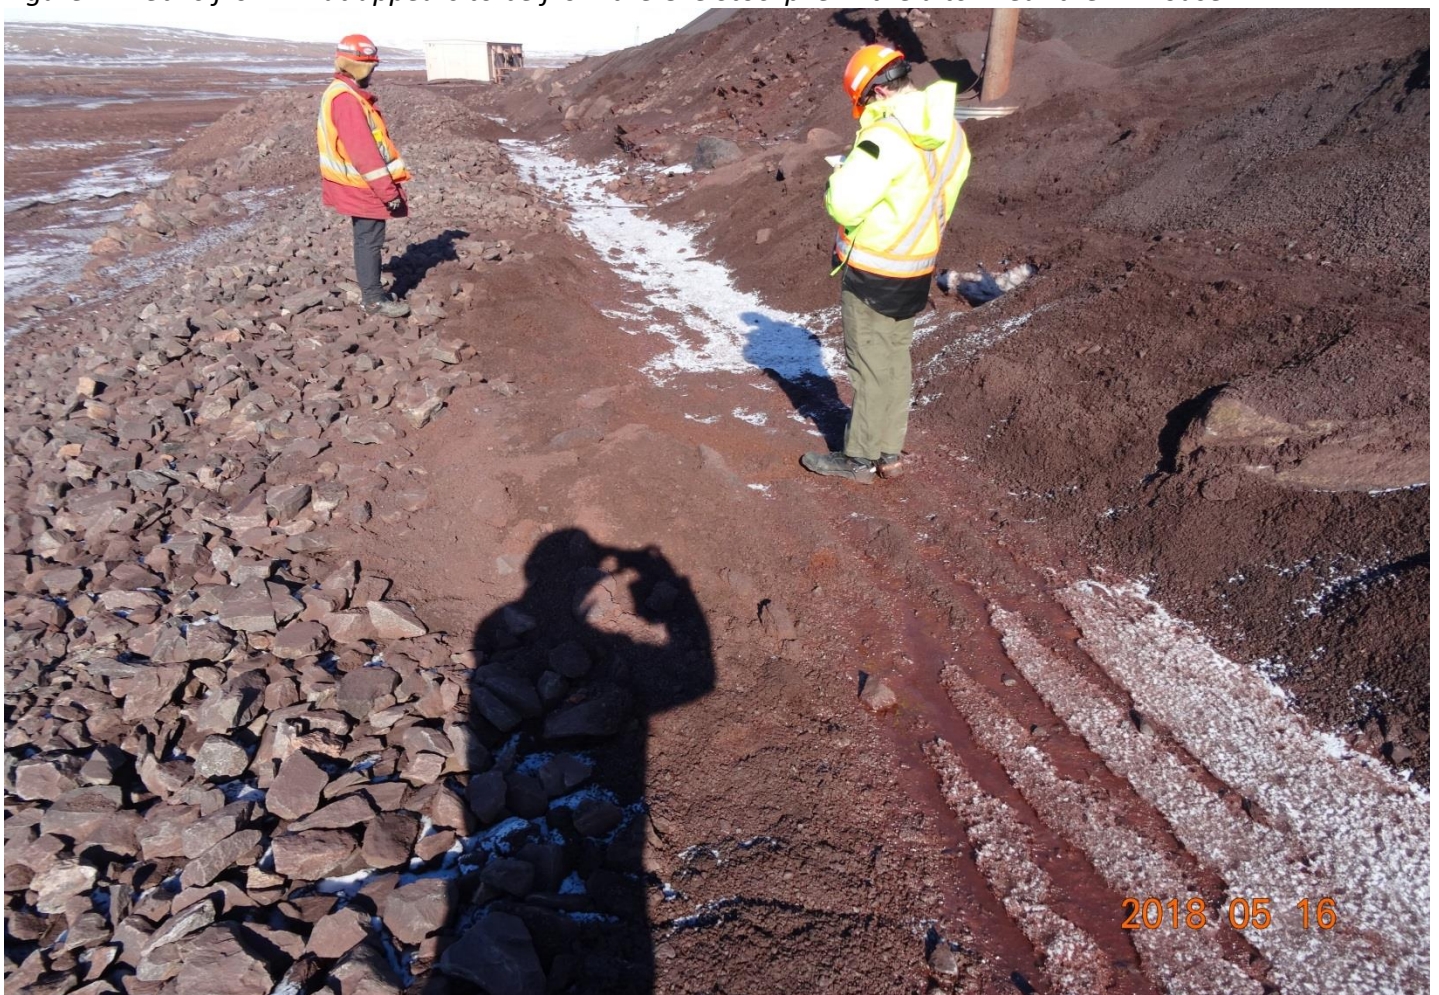
b. It was noted that some debris form what appears to be from the ore stockpile in the ditches (see figure 2) and an outer berm wall was either eroded or is incomplete (see figure 3). This berm wall must be repaired as soon as possible to ensure that contact water does not leach into the environment.

Figure 2: Debris from what appears to be from the Ore Stockpile in the ditch near the “E-house”

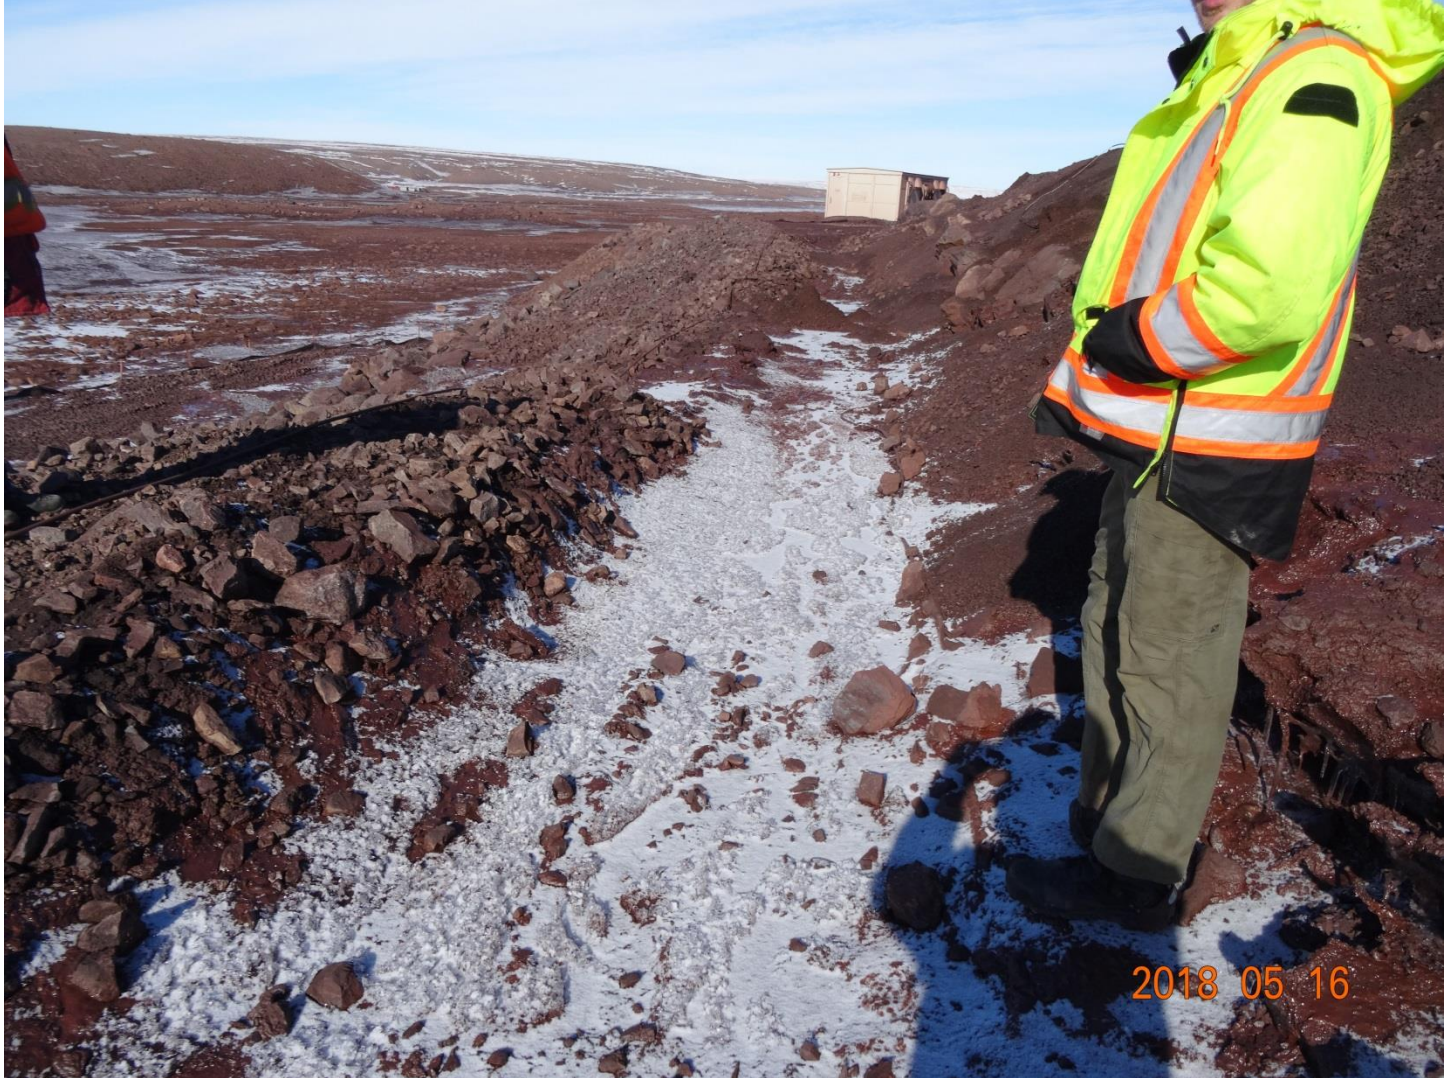
Figure 3: erosion or incompleteness of ditch wall seen in the center of the photograph location near the “Ehouse”

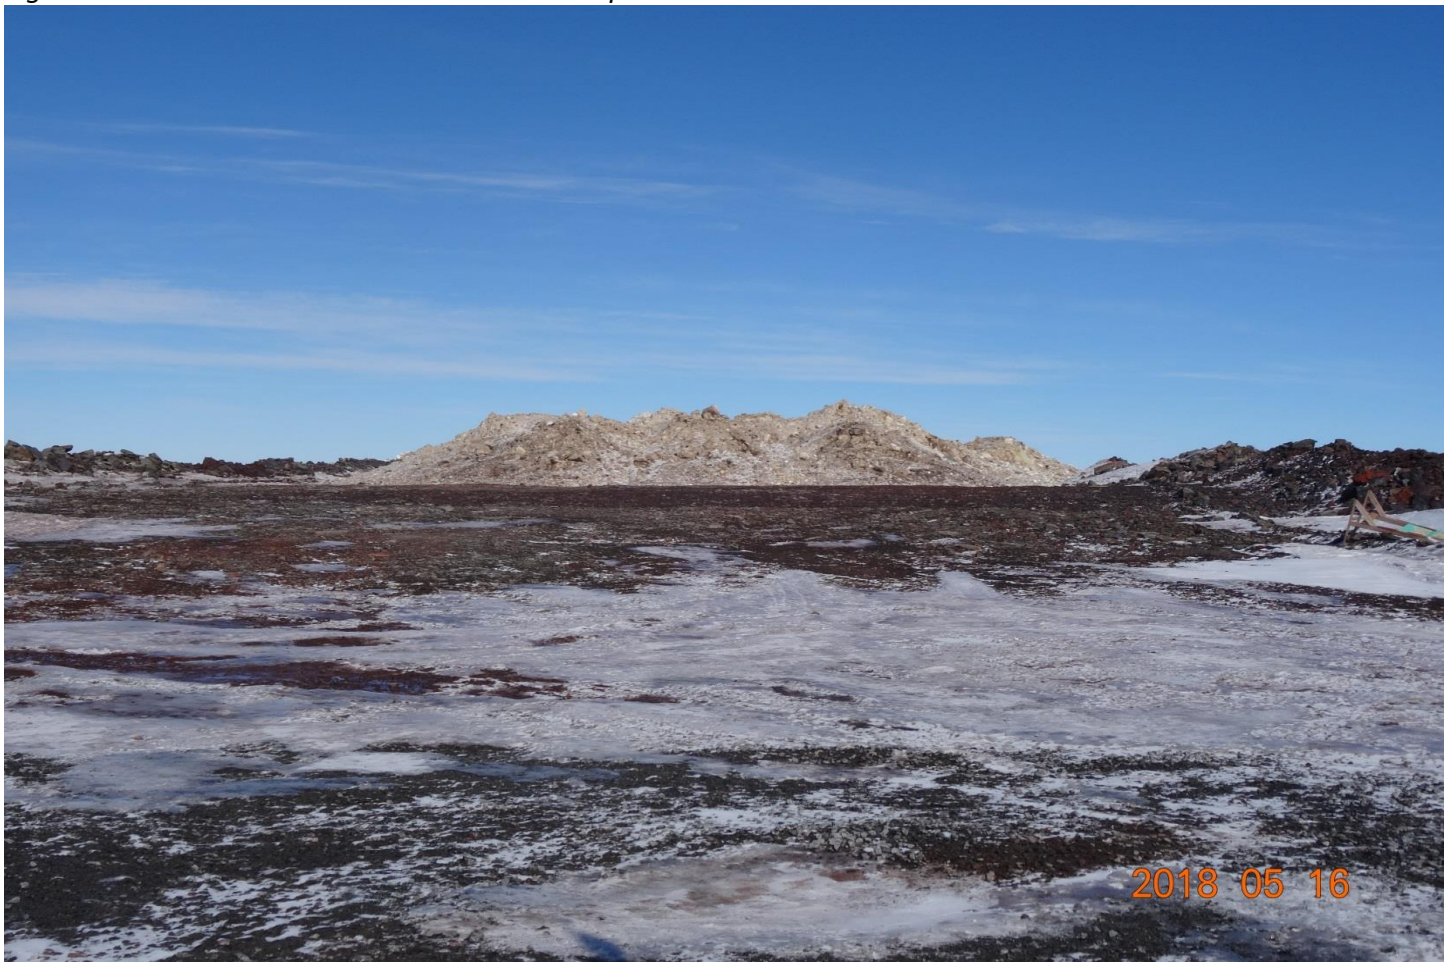
- a. Emergency ditch is cleared and appears to be in good condition; all ice from the emergency ditch has been removed and relocated to the waste rock stockpile (*see figure 4*). However a road was built over top of a diversion ditch on the North East side of the WRSP leading to the waste rock sedimentation pond for containment, this blocks the flow of water to the WRSP sedimentation pond.

Figure 4: ice relocated to the Waste Rock Stockpile

- I. Ditch on the North East side of the WRSP must be marked and cleared annually ensuring proper water management.
- b. Contrary to the comment (4), in the Action required section of the November 2017 inspection report which stated; “To remove all debris from all diversion ditches prior to freshet 2018, so that surface water flows as intended to the sedimentation ponds”. The Licensee has not completed this work, which leads the inspector to believe that an unauthorized deposit of waste may occur.

- II. The access road must be remediated to ensure PAG contact water does not enter the environment and proper diversion of water to the sedimentation pond.

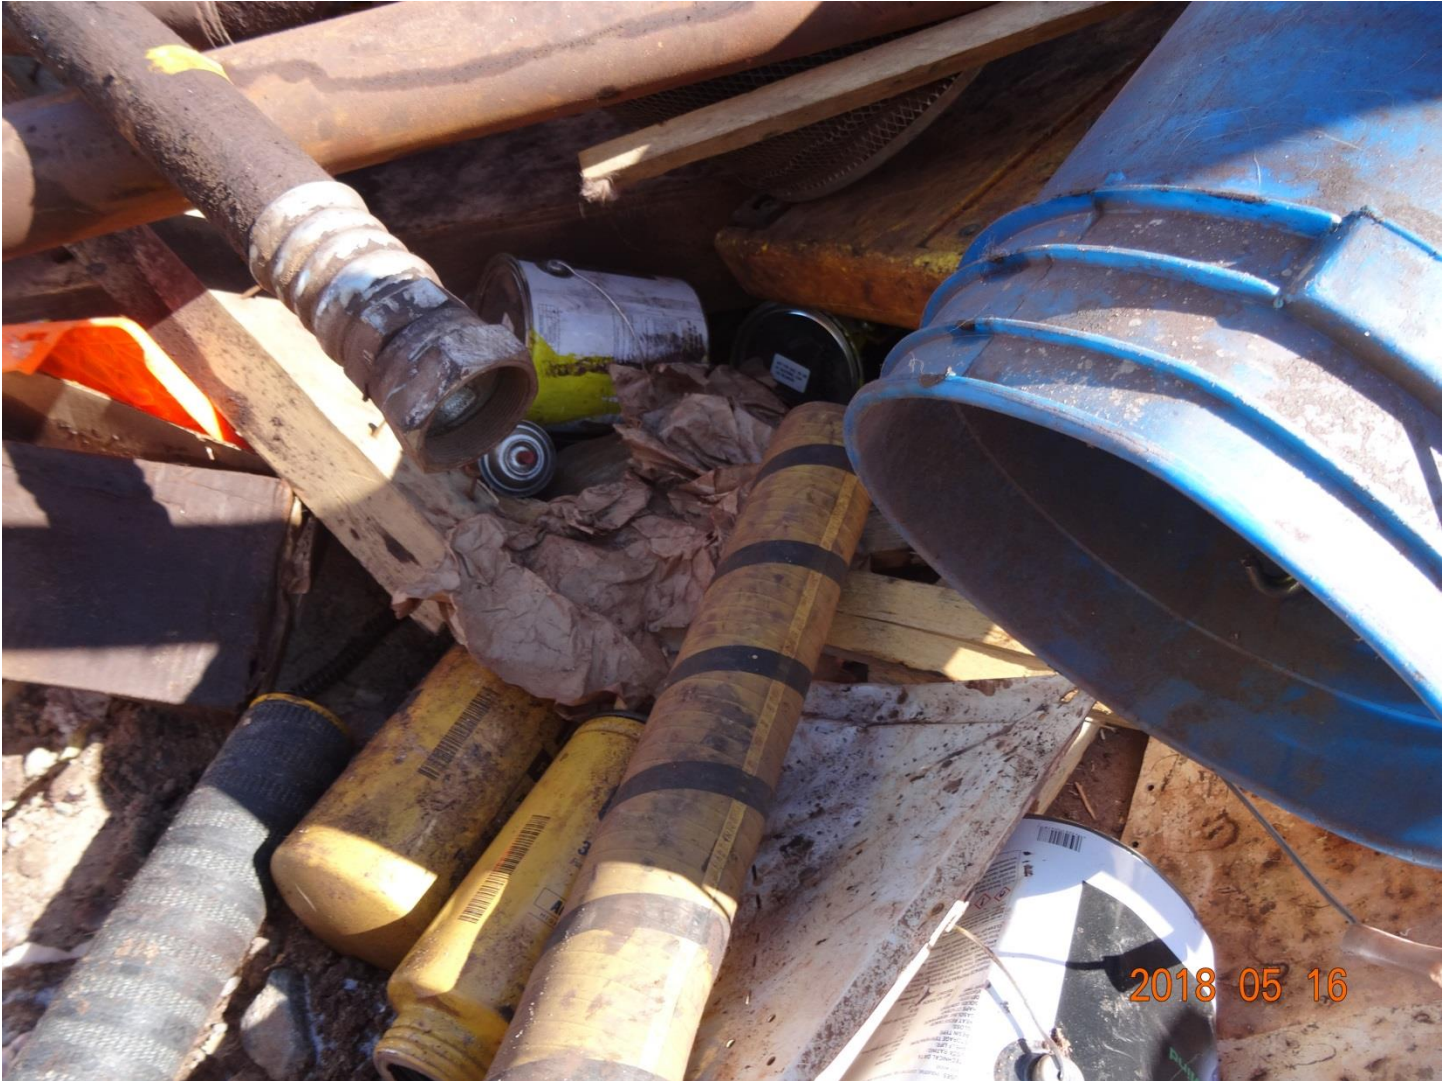
- a. Land fill appears to be properly covered.
- b. Inspector noted that the fence is in poor condition.
- c. The inspector noted that hazardous material was dumped into the land fill. Hazardous waste found in this facility consisted of paint cans, oil filters, and aerosol cans. *See figure 5*.

Figure 5: Hazardous Material found in the Landfill aerosol can, paint cans, used oil filter

- IV. It is BIMC’s obligation to ensure that all BIMC employees understand that this is a non-hazardous landfill.

- V. Hazardous material must be removed from the land fill and stored in an approved lined facility.

5. Hazardous material must be removed from the land fill and deposited into the approved lined facility.

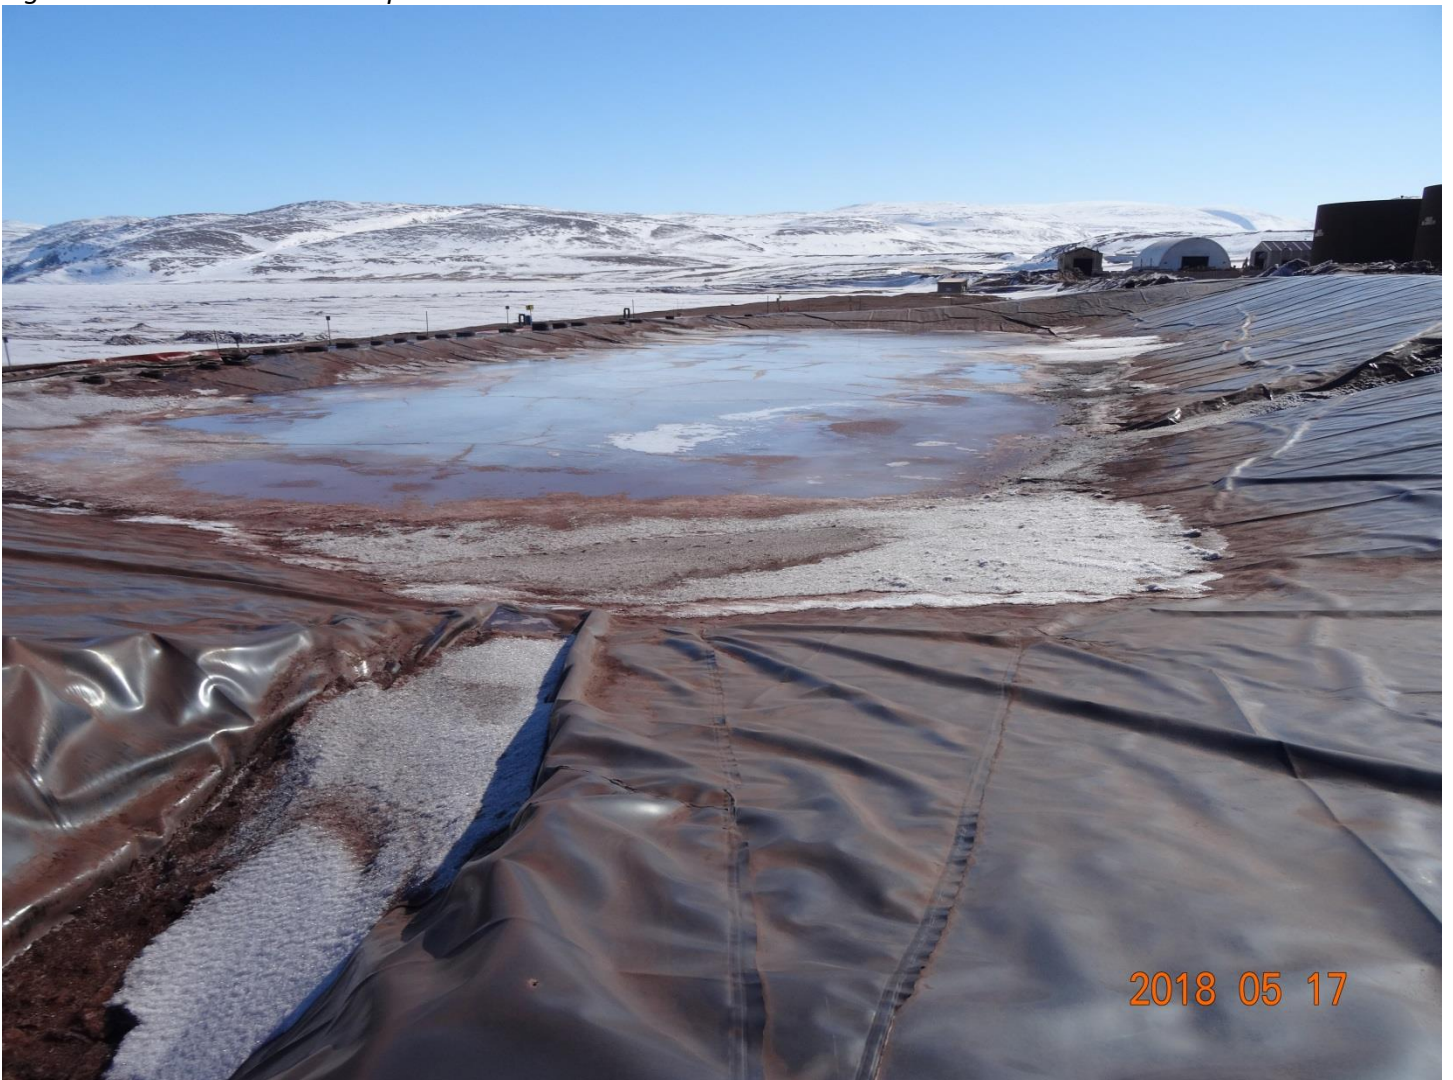
- a. Ore bulk sample remains appear to be removed as requested by the inspector in a previous inspection.
- b. Liners of the East and West sedimentation pond appear to be in good condition.
- c. The culvert on the North East side of the stockpile pad has not been cleared and is allowing water to pool inside of the unlined diversion ditches.
- d. East and west Sedimentation Pond appears to be in good condition. *see figure 6 & 7*.

Figure 6: East Sedimentation pond

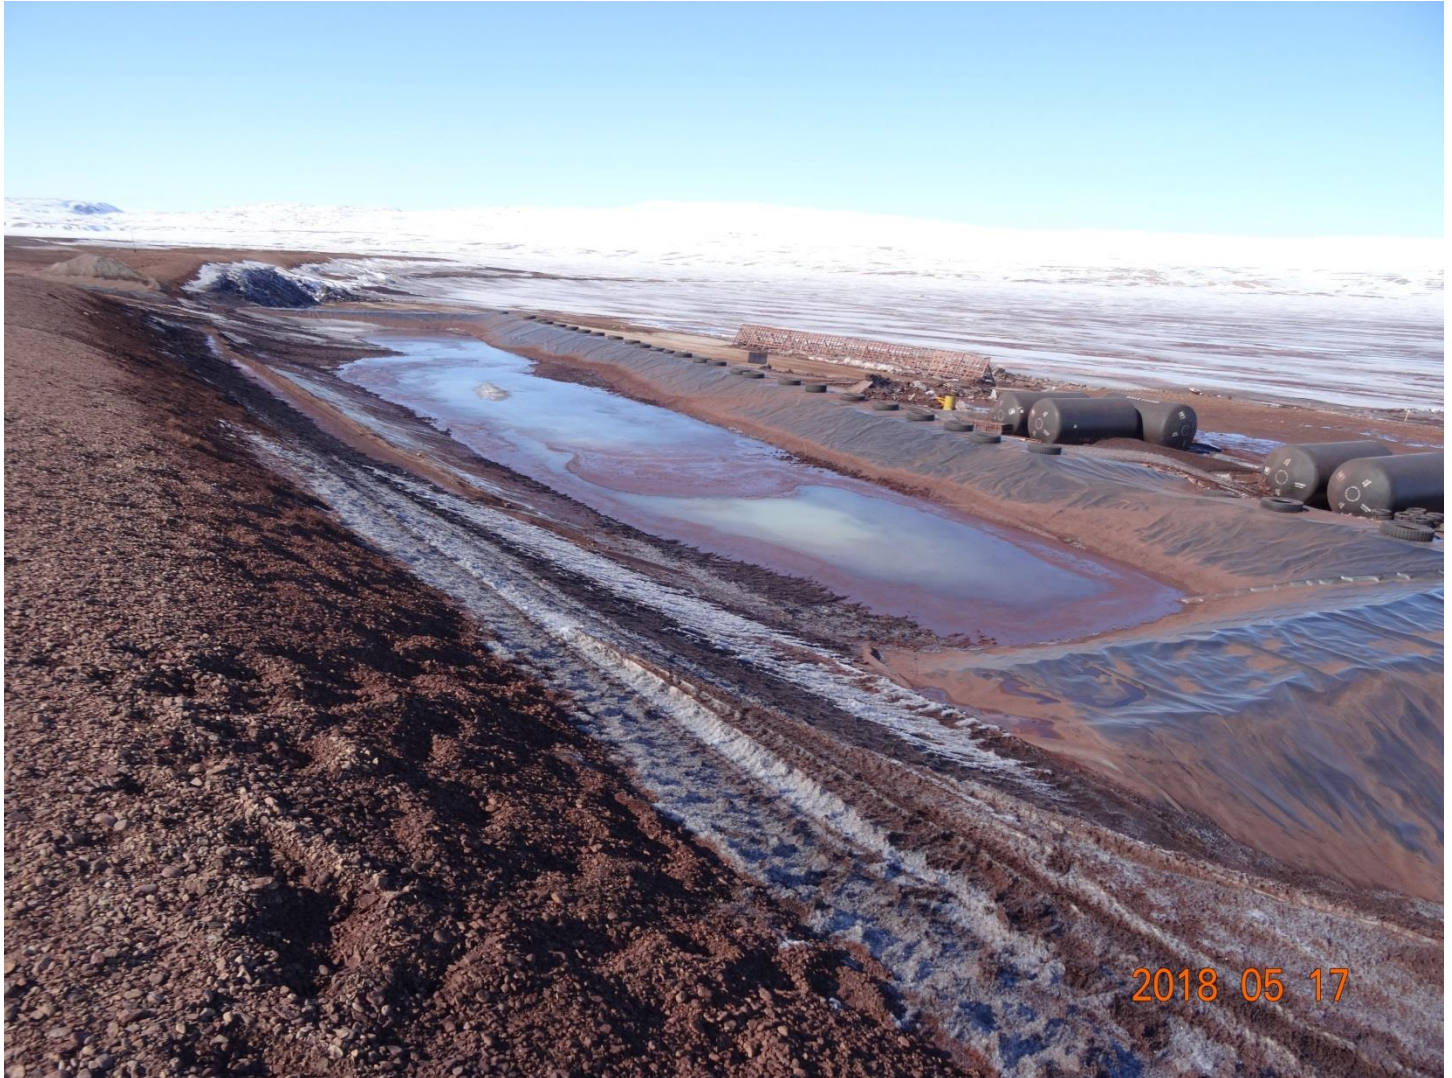
Figure 7: West Sedimentation pond

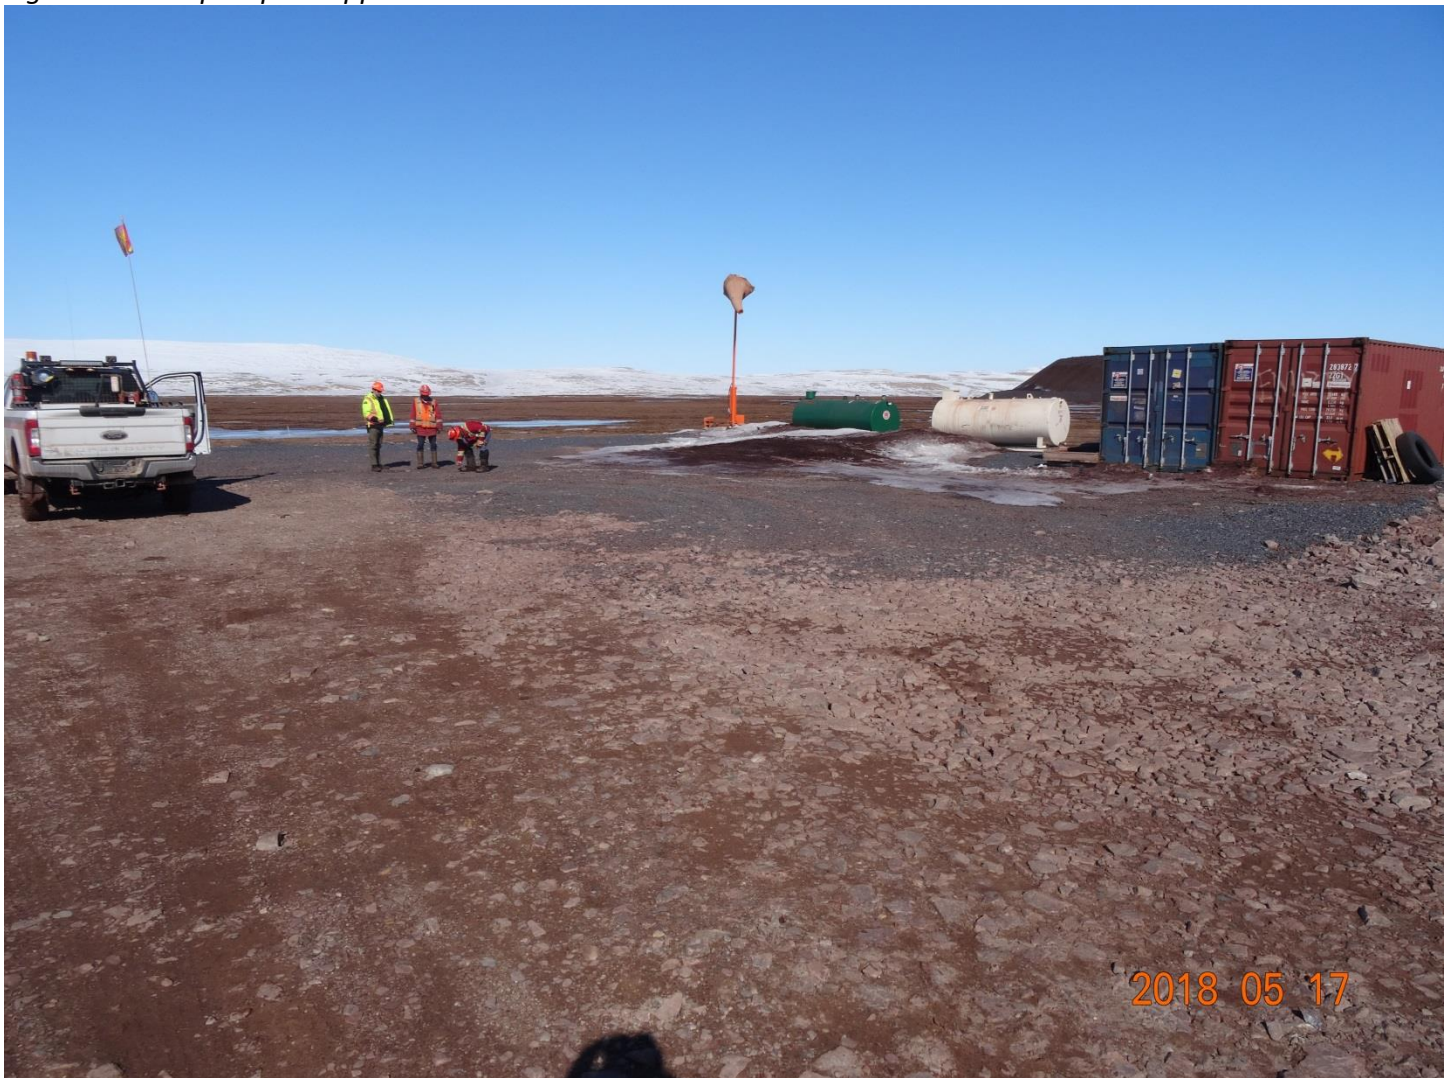
- a. Surface of helicopter pad is topped with Ore, the ore topping the helicopter pad is to be removed or the licensee is provide evidence that this material is approved by the Nunavut Water Board as

construction material. *See Figure 8*

Figure 8: helicopter pad topped with Ore

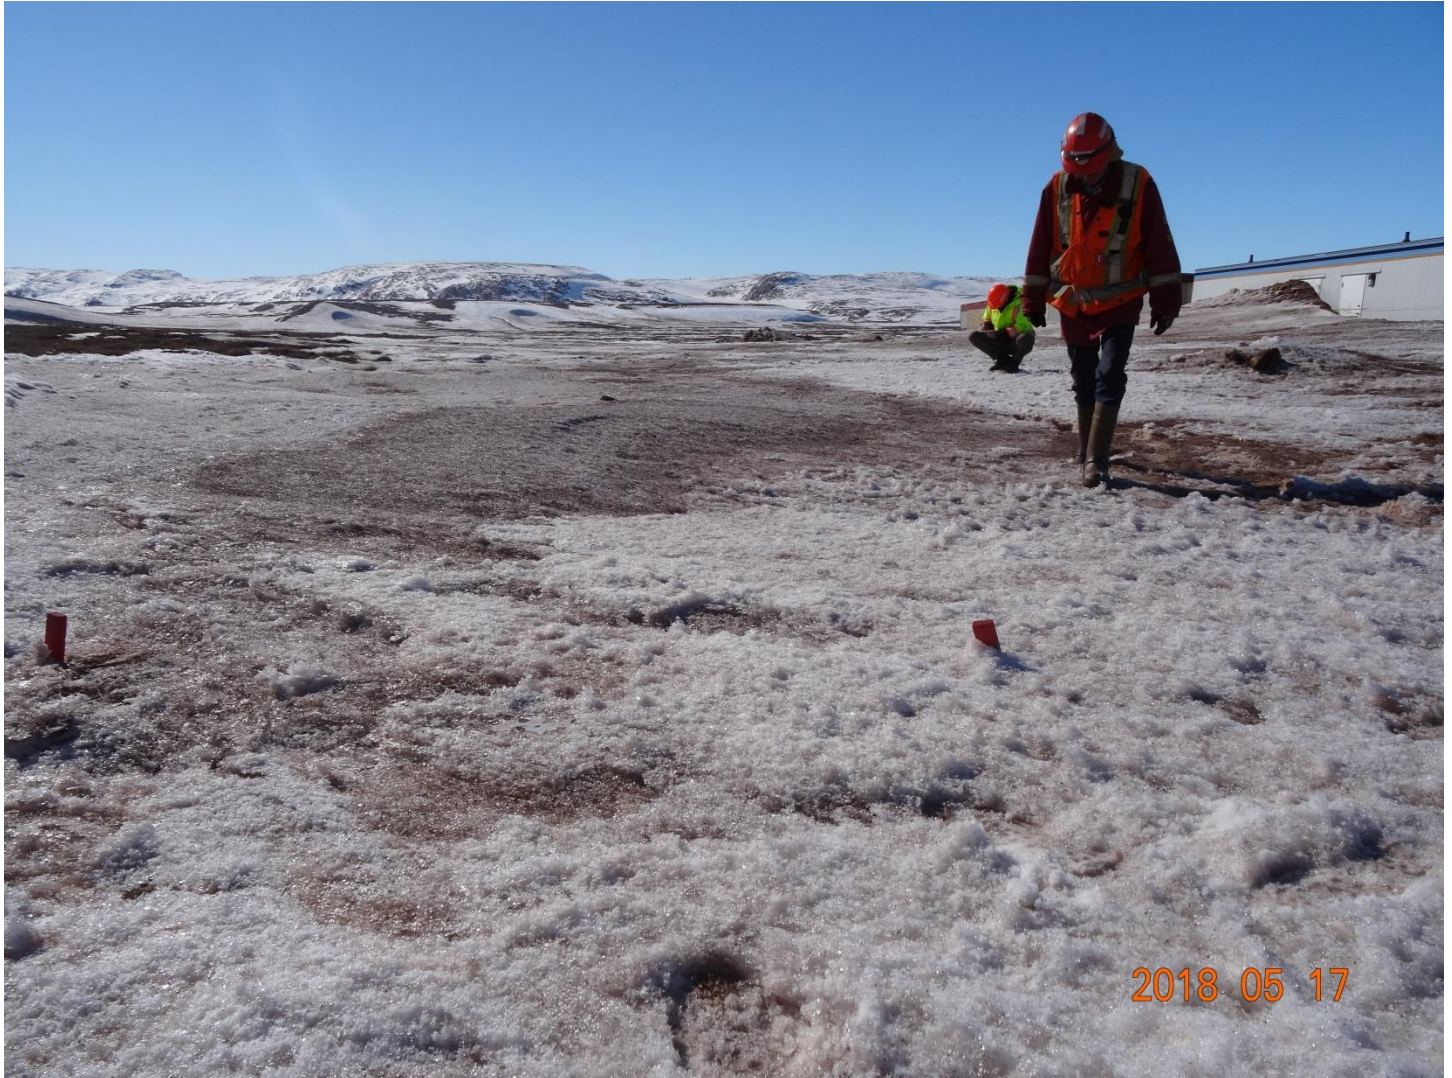
- a. Ditches surrounding new camp pad are unidentifiable due to snow cover
- VI. Ensure that all water management structures are cleared to allow these structures to operate as intended. *See figure 9*
- VII. North of batch plant contaminated soil placed in drums however the drums are not sealed or in containment. *See figure 10 & 11*

Figure 9: Ditch surrounding new camp pad Milne port

6. Ensure that all water management structures are cleared to allow these structures to operate as intended. *See figure 9*

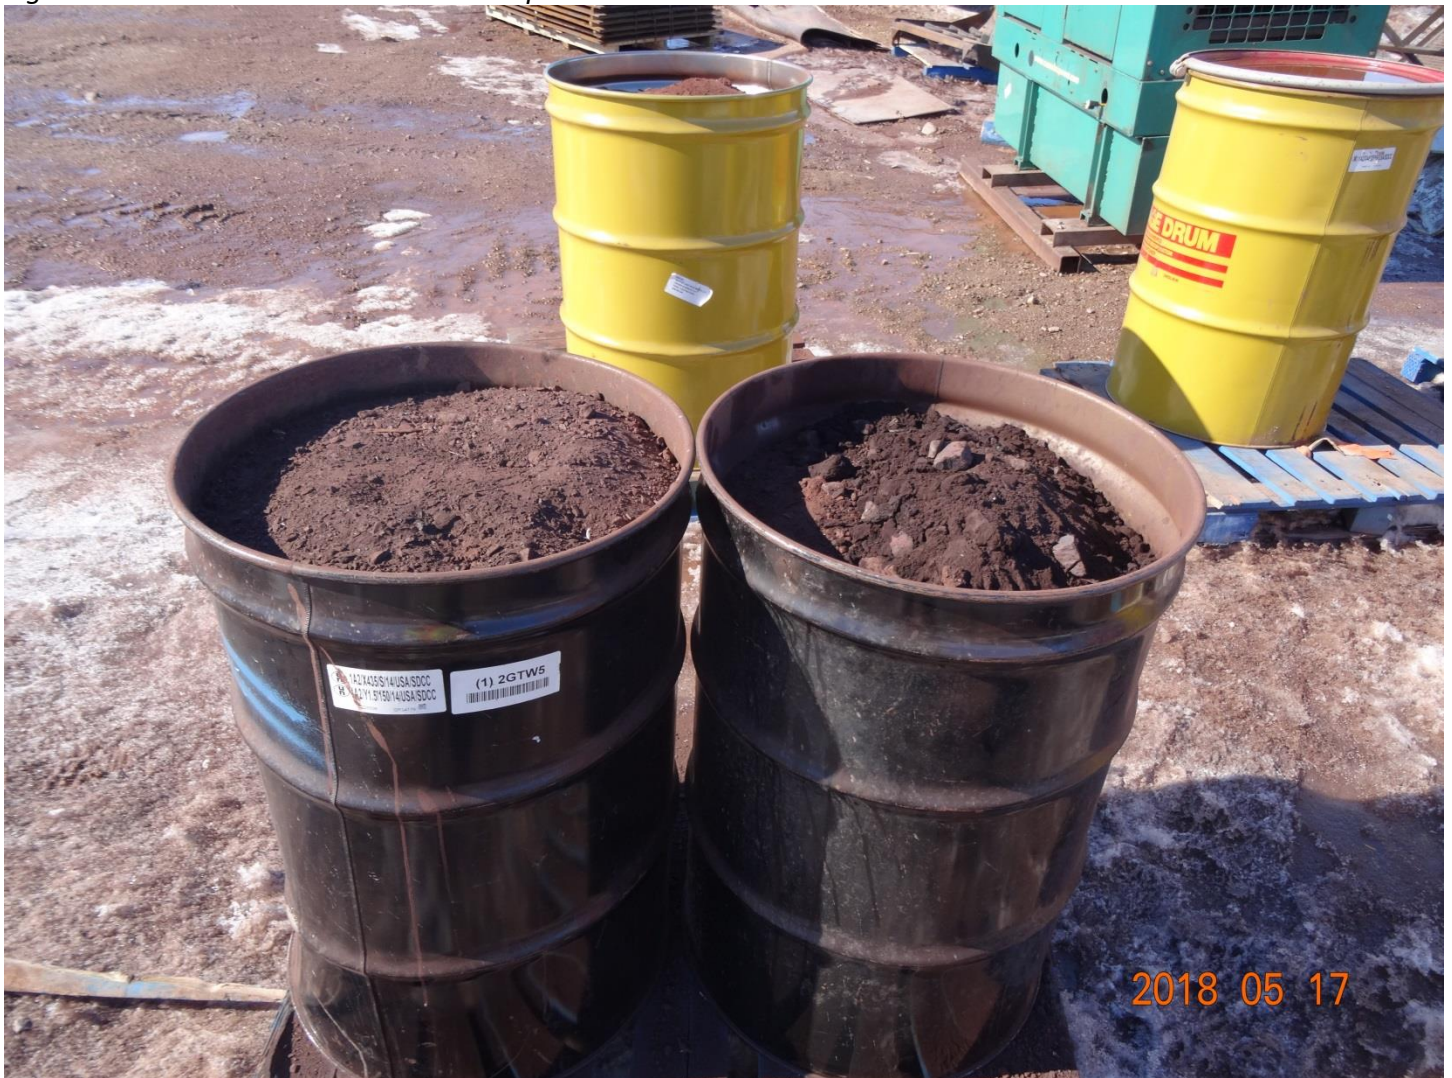
7. North of batch plant contaminated soil placed in drums however the drums are not sealed or in containment. *See figure 10 & 11*

Figure 10: contaminated soil near batch plant

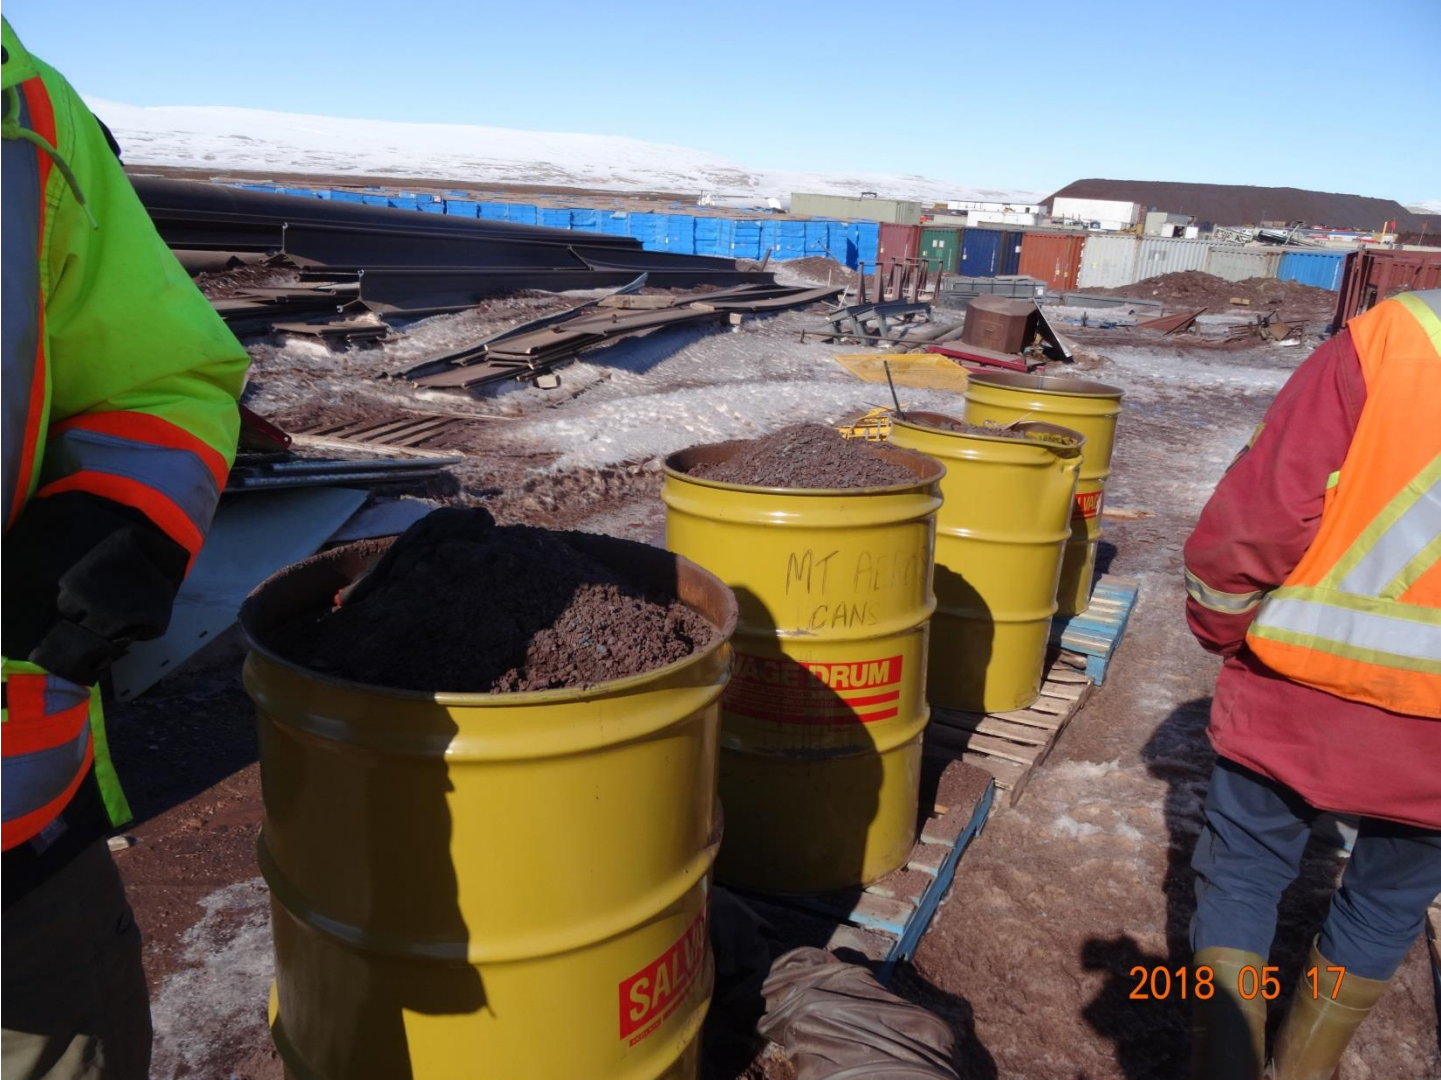
Figure 11: contaminated soil in unsealed containers near batch plant

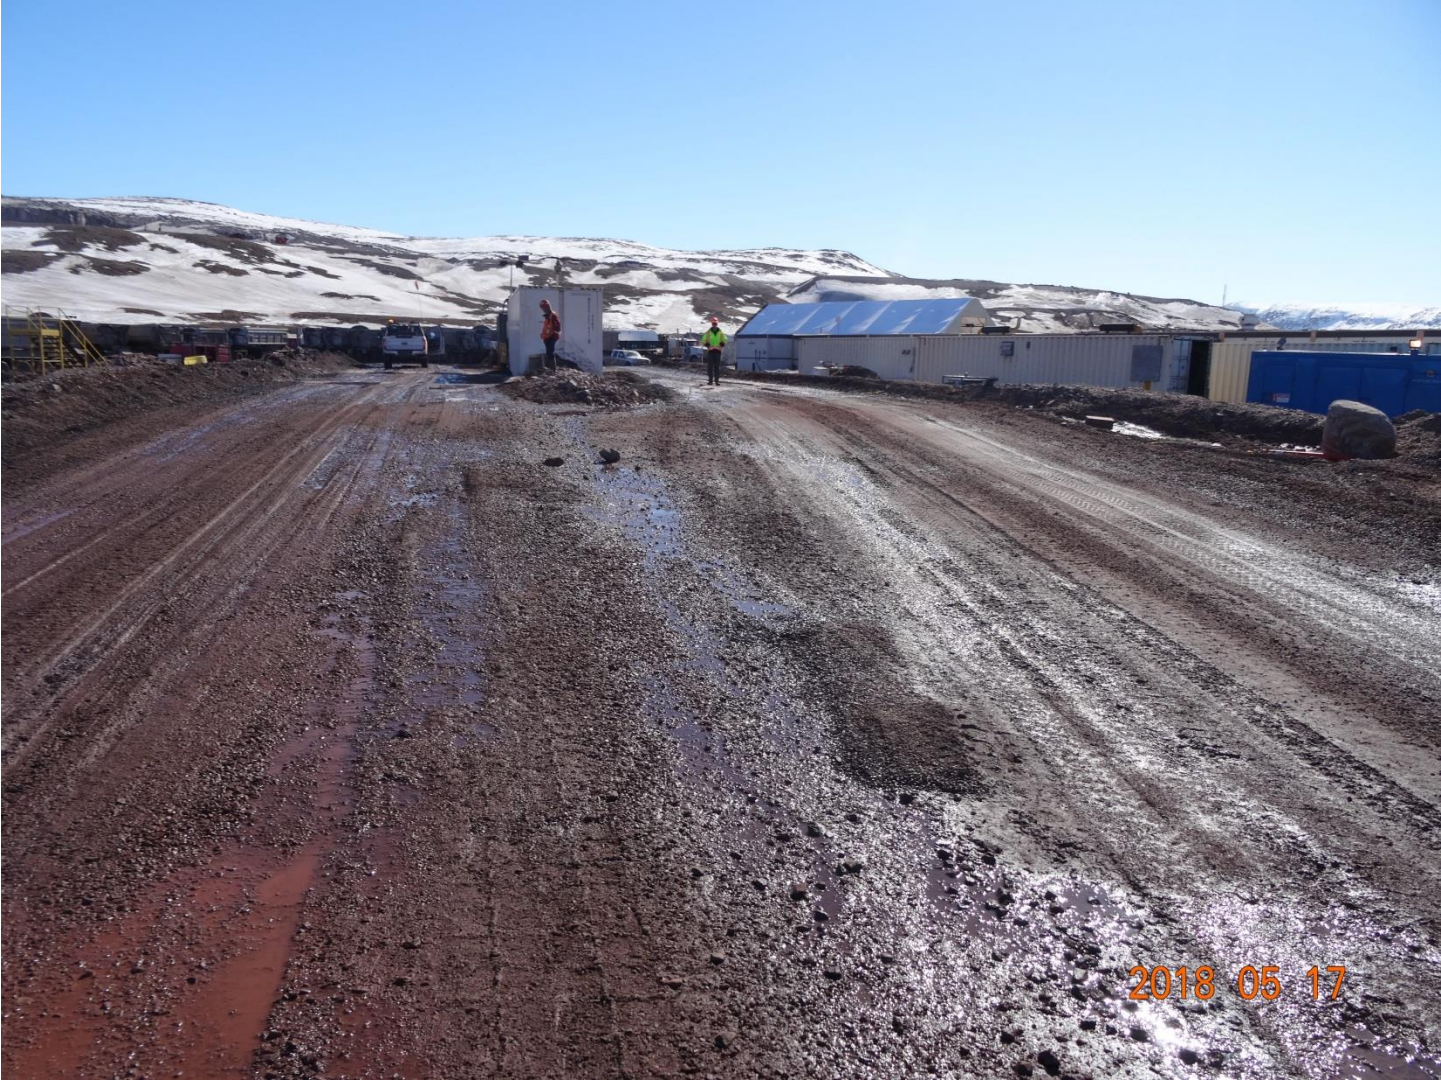
- a. Fuel module does not appear to be properly contained, this facility is lined but, the berms creating the containment area appear to have eroded away or the facility has become full of sediment causing capacity issues. Water from within the facility area appears to be capable of flowing outside of containment area. *See figure 12*
- b. The inspector is requesting for a copy of the as built drawings for this facility.
- c. A grab sample was taken at this location. Waiting for test results for TPH

Figure 12: contact water exiting fuel station module
