WATER LICENCE INSPECTION FORM

Licensee	Licensee Representative
BAFFINLAND IRON MINES CORPORATION	William Bowden
Licence No. / Expiry	Representative's Title
2AM-MRY1325	Environmental Superintendent
Land / Other Authorizations	Land / Other Authorizations
8BC-MRY1416, 2BE-MRY1421	N2014X0012, N2014Q0016, N2014C0013
Date of Inspection	Inspector
August 22-23, 2018	Jonathan Mesher
Activities Inspected	
<input type="checkbox"/> Camp	<input type="checkbox"/> Drilling
<input type="checkbox"/> Roads/Hauling	<input checked="" type="checkbox"/> Mining
	<input type="checkbox"/> Construction
	<input type="checkbox"/> Reclamation
	<input type="checkbox"/> Fuel Storage
	<input type="checkbox"/> Other:

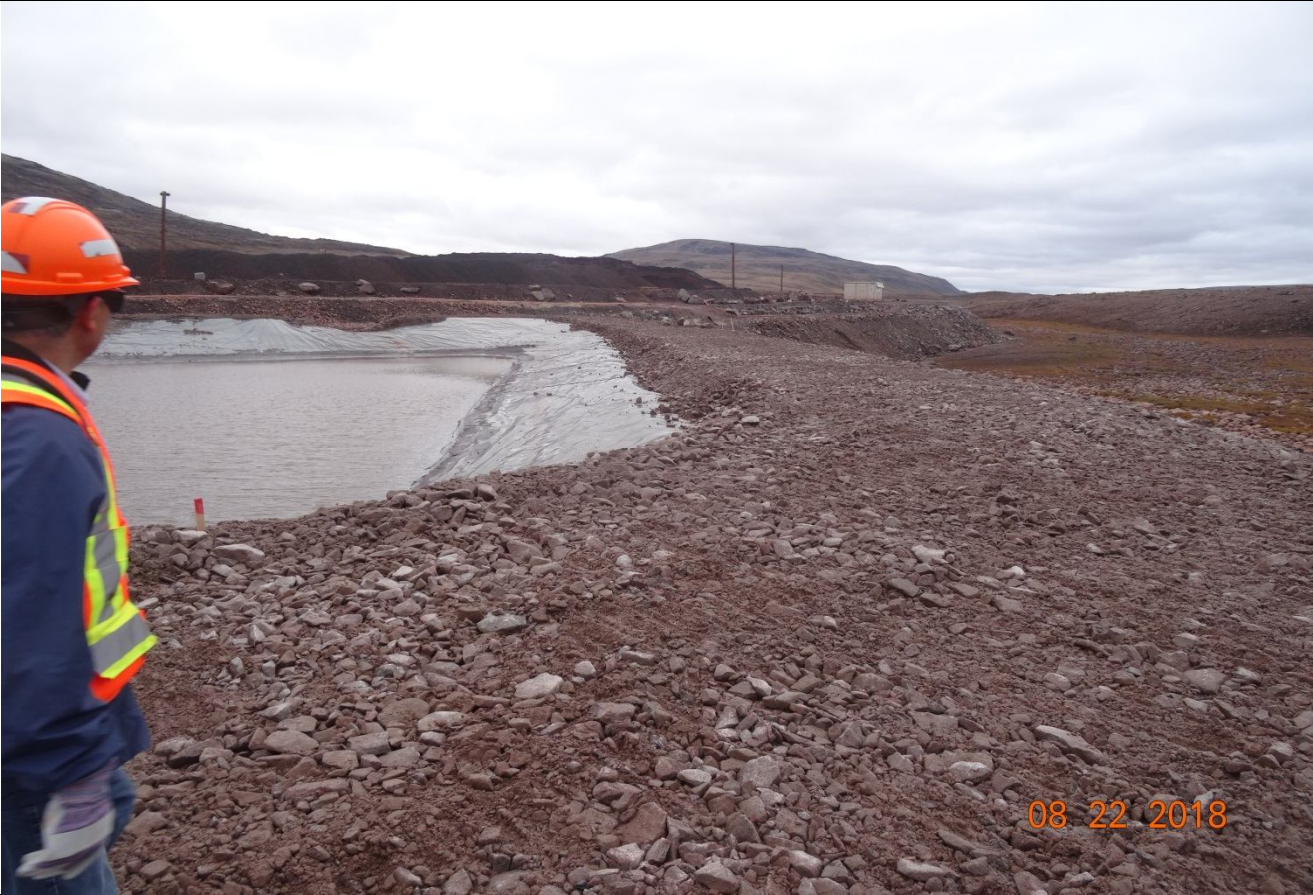
Photo 1

a. At the time of the inspection the licensee was in the process of increasing the capacity of the crusher pad sedimentation pond, there we no concerns noted. See Photo 1.

Description: Crusher sedimentation pond increase

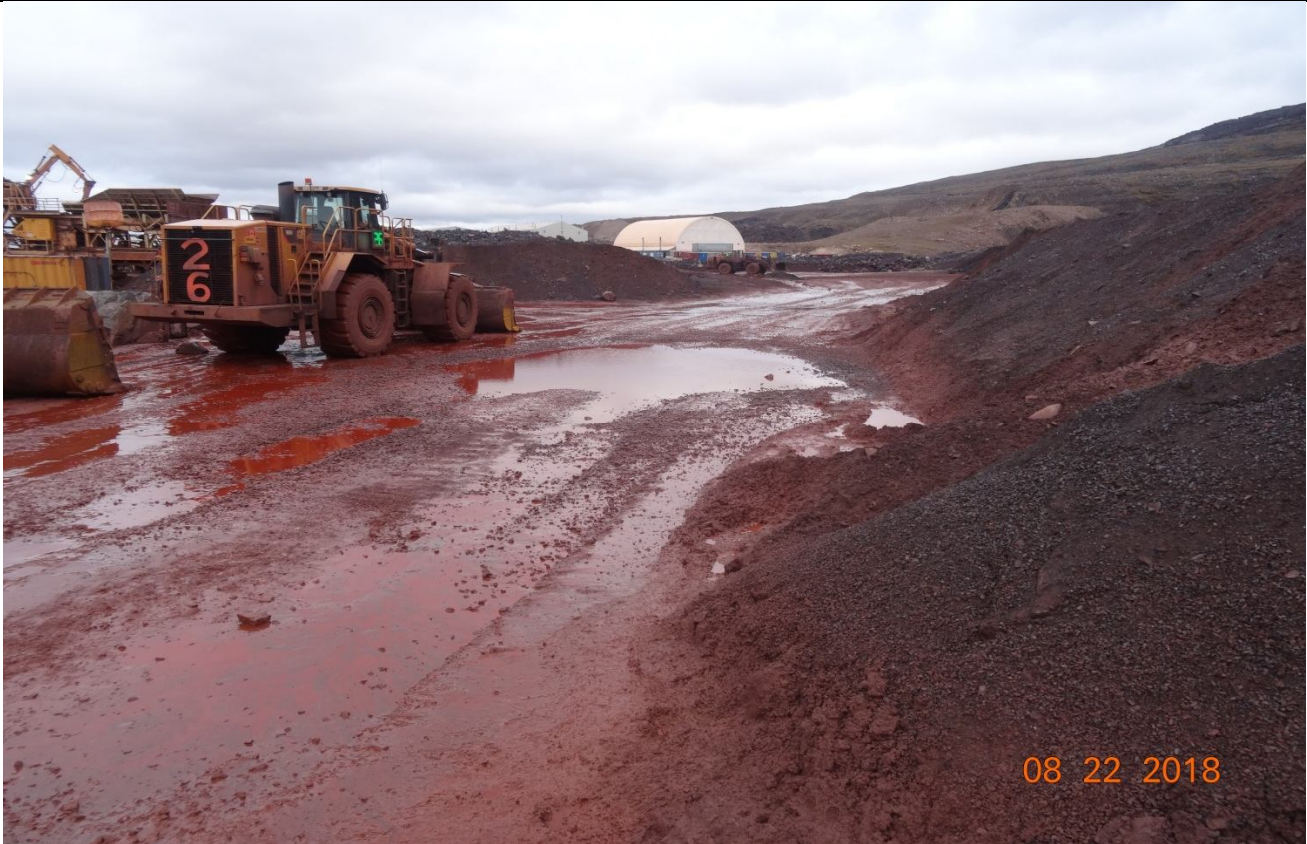
Photo 2

b. As mentioned in previous Inspection Reports from June 22-24 2018, Section 1b, the pooling water inside the crusher pad leads the inspector to believe that the slope of the pad is inconsistent with the approved design drawings. See Photo 2.

Description: Pooling facility

1. The licensee is to ensure that the crusher pad and associated diversion ditches are built to the design drawings prior to the freshet of 2019.		
2. The licensee is to imminently construct the containment ditches surrounding the Waste Rock stockpile as describe in the document "Civil, Design criteria" and install the required ditches to divert non-contact surface water away from this facility.

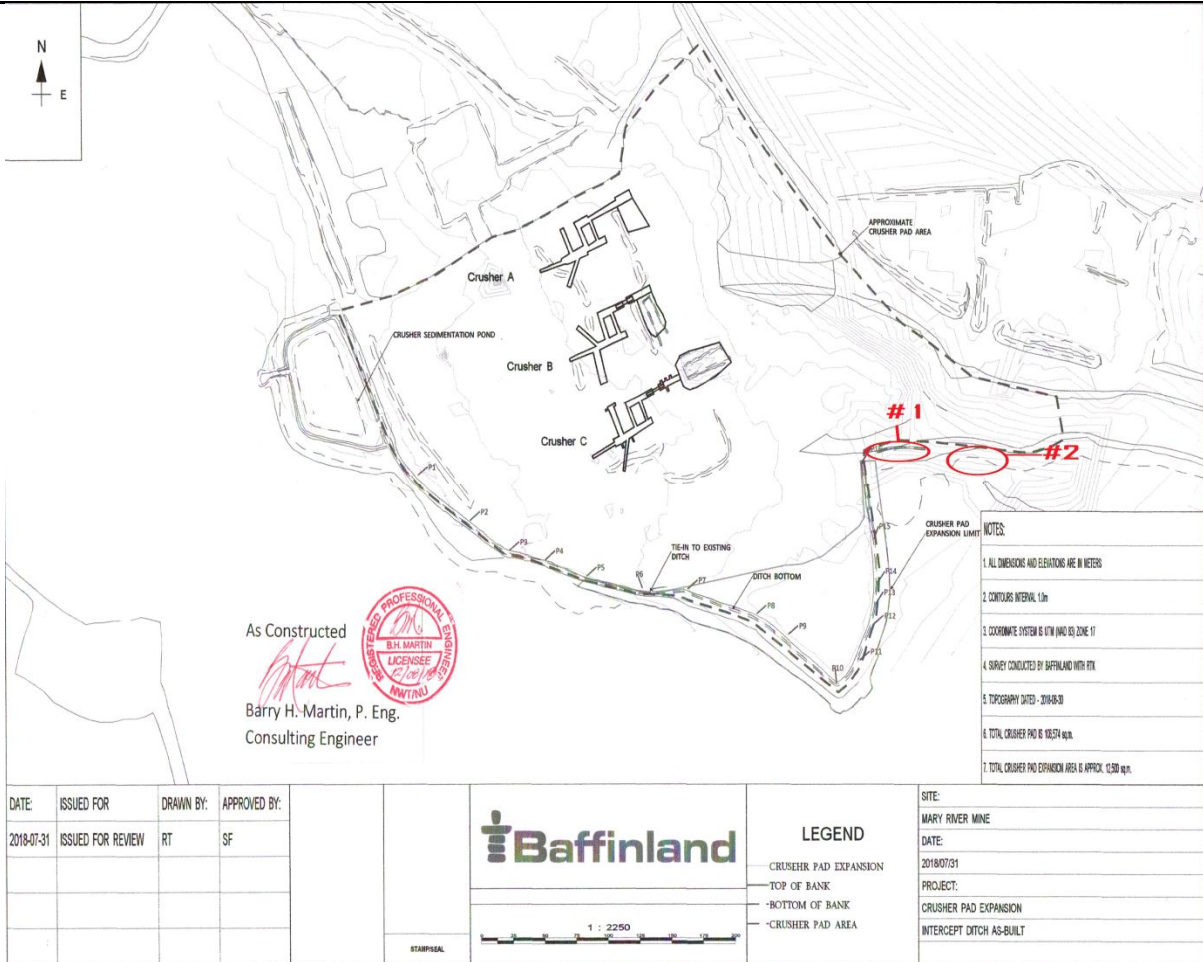
Photo 3

c. During the inspection it was noted that, a pile of iron ore is outside of containment. Please remove the ore from outside containment, see Photo 3. A red circle labeled "#2" identifies the misplaced iron ore's location.

- I. "All drainage ditches should be of trapezoidal cross sections, where possible." This does not appear to be applied at the location identified in photo #3. A red circle labeled "#1" identifies this location.

Description: Ore outside of the ditching system.

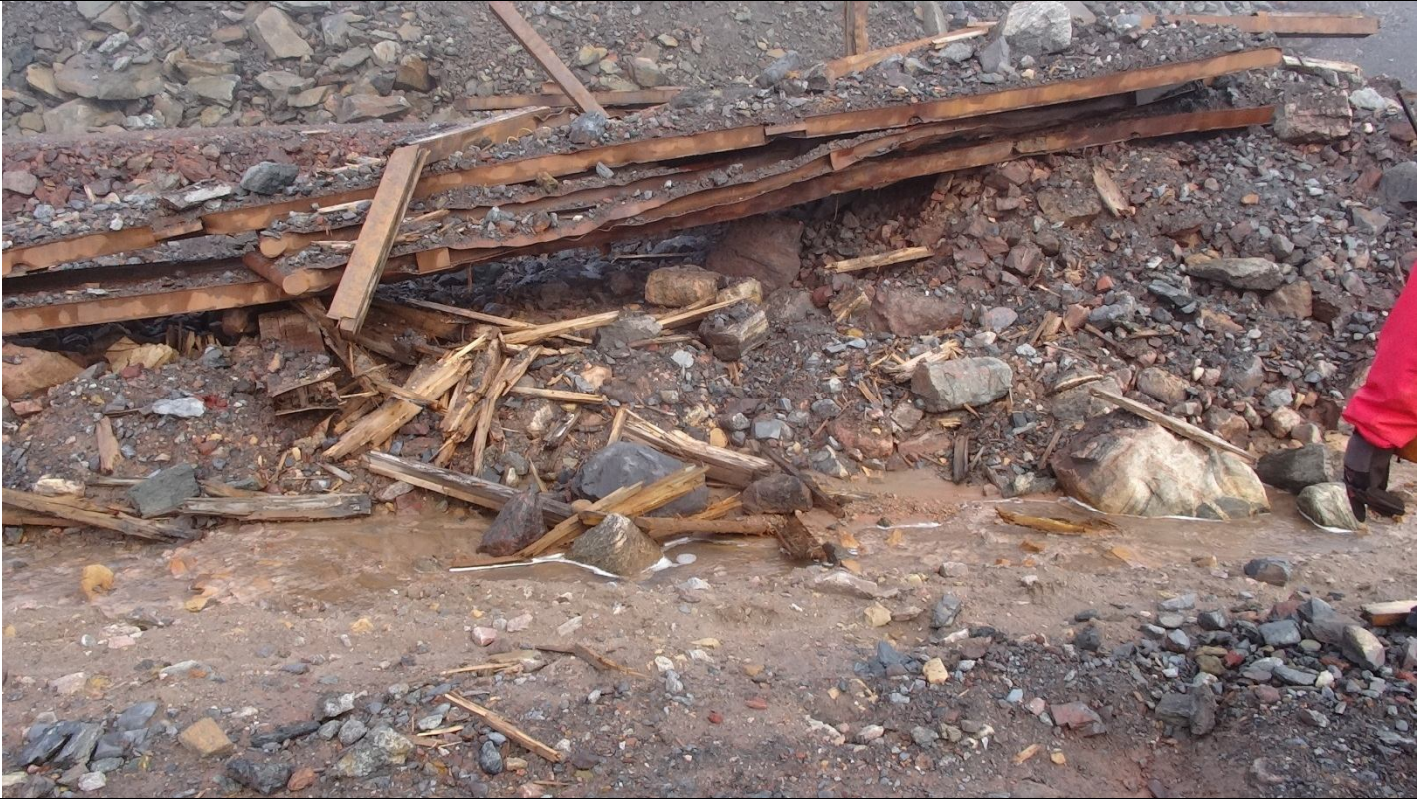
Photo 6

Description: Debris in the WRSP ditches

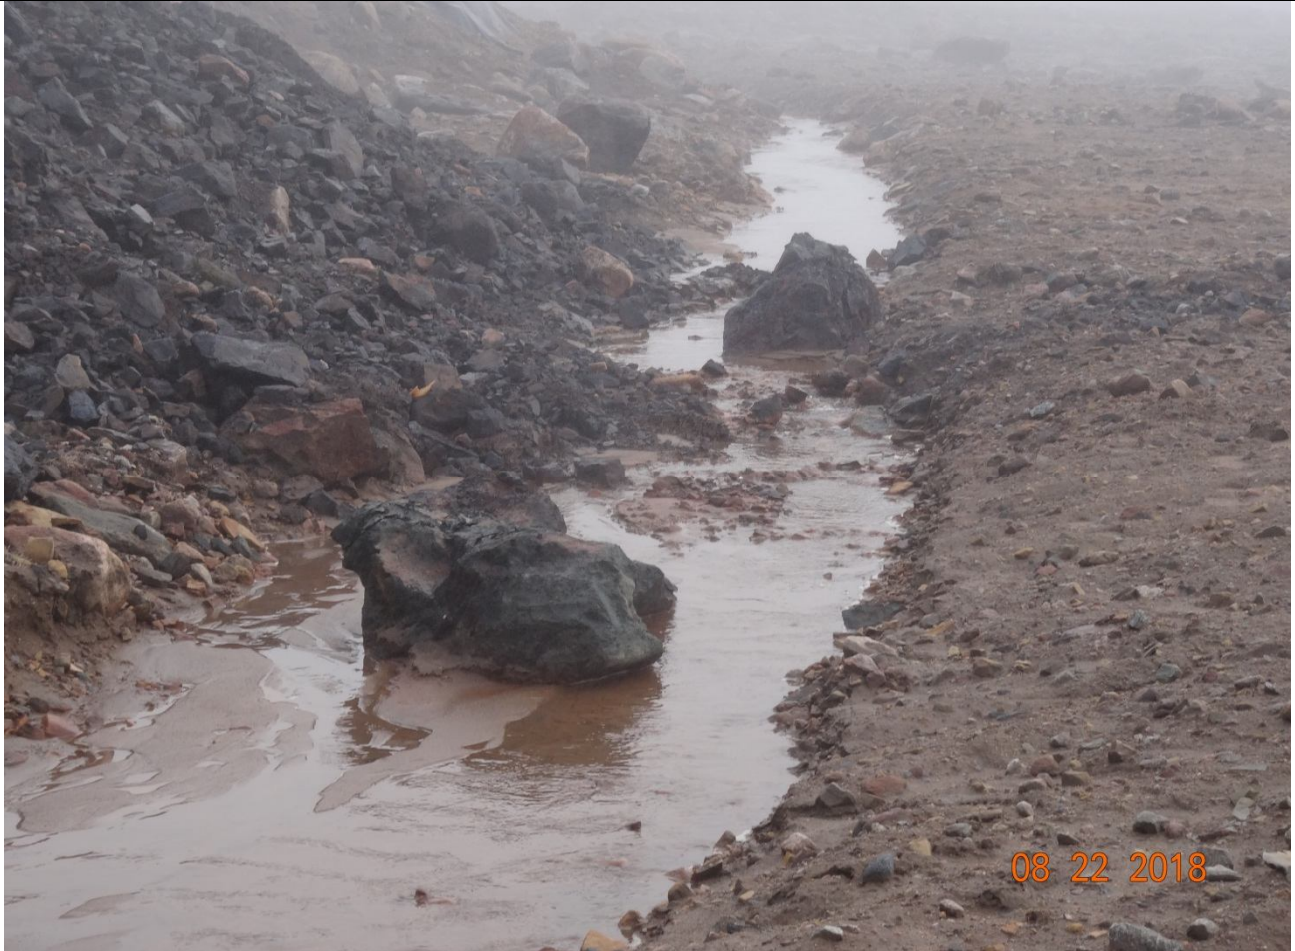
Photo 7

- III. "Ditches shall be designed to convey a 1 in 25 year flood event." The inspector is uncertain if all areas of the ditches are designed due to ditch width and height inconsistencies. See Photo #7.

- IV. "Drainage berms diverting overland flow from the waste rock drainage area to the sedimentation ponds shall be a minimum of 1.0 m high with 1.5H:1V side slopes and 0.5 m top width." Some areas do not appear to have diversion berms to divert overland flow of non-contact water. See Photo #7

Description: Debris in the WRSP ditches, not a trapezoidal shape, appears to be under capacity and no diversion berms to divert non-contact water.

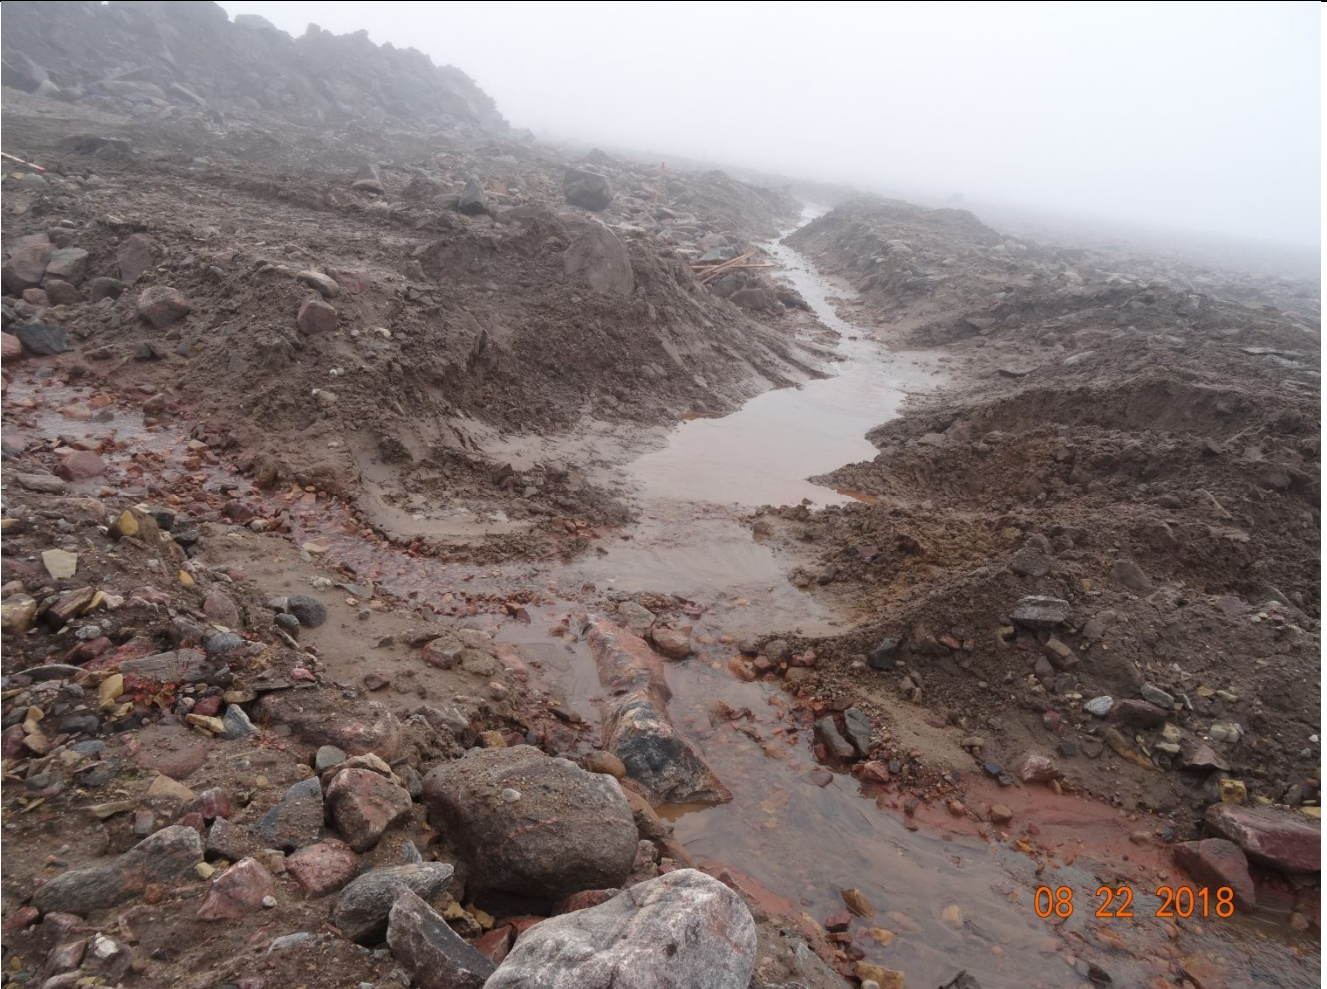
Photo 8

Description; inconsistencies in the ditches, lack of diversion berm and pooling inside ditches.

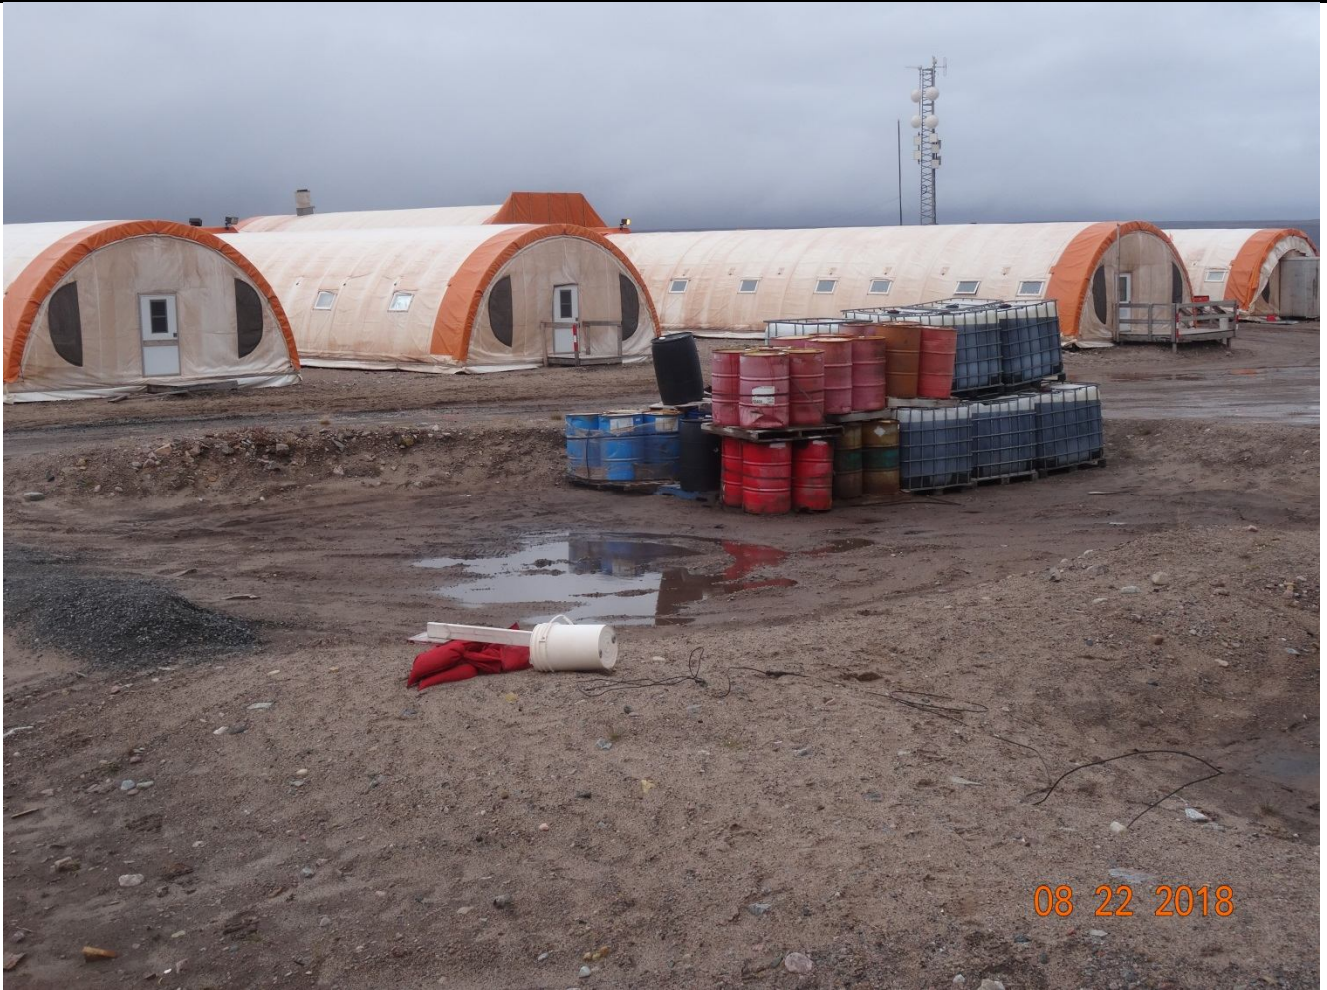
Photo 9

- a. In the past inspection reports, the inspector noted a rip in the liner of Hazardous Waste Berm #7, the licensee has since repaired the liner.
- b. During the inspection all hazardous waste berms were retaining large amounts of potentially contaminated water with the exception of HWB #5; this observation leads the inspector to believe that the liner of this HWB has been jeopardized. Please conduct an internal investigation to determine the condition of this HWB, until this HWB is determined to be operating as intended please discontinue the use of the structure. See Photo #9 for a photo of the concerning HWB.

Description; I Concerning Hazardous Waste Berm

3. The licensee is to ensure that the Hazardous Waste Berm #5 is still capable or retaining water/waste.

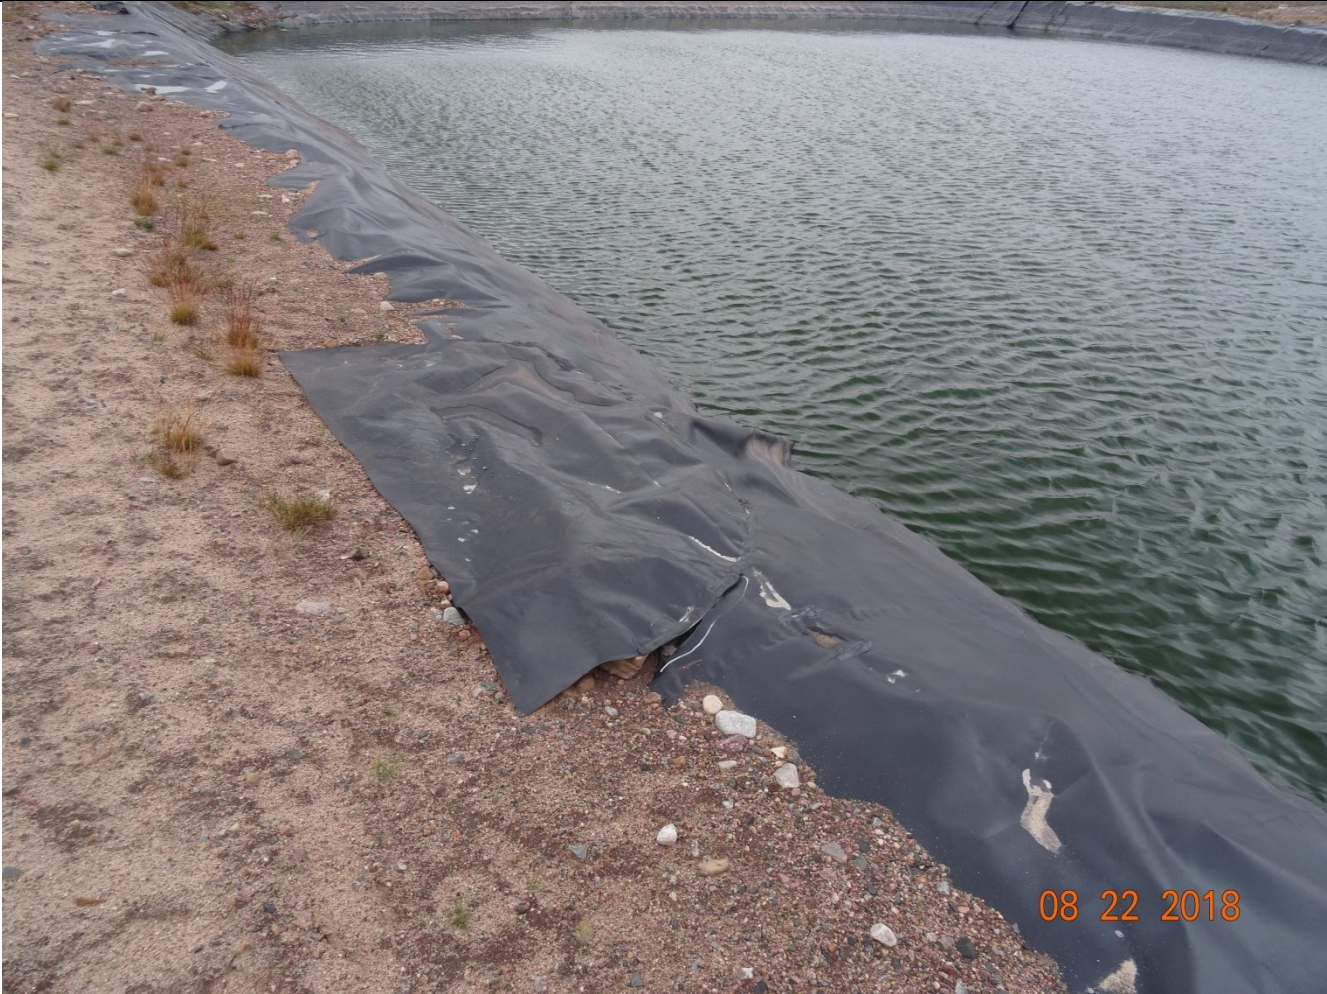
Photo 10

- a. During the time of the inspection there were two areas of the PWSP's at the mine site where the liners were not properly keyed-in. To prevent future damage, it's recommended that the licensee weigh down the areas on the liner that are subject to wind uplift. See Photos 10 and 11 for the areas of concern.

Description; PWSP liner not weighed down.

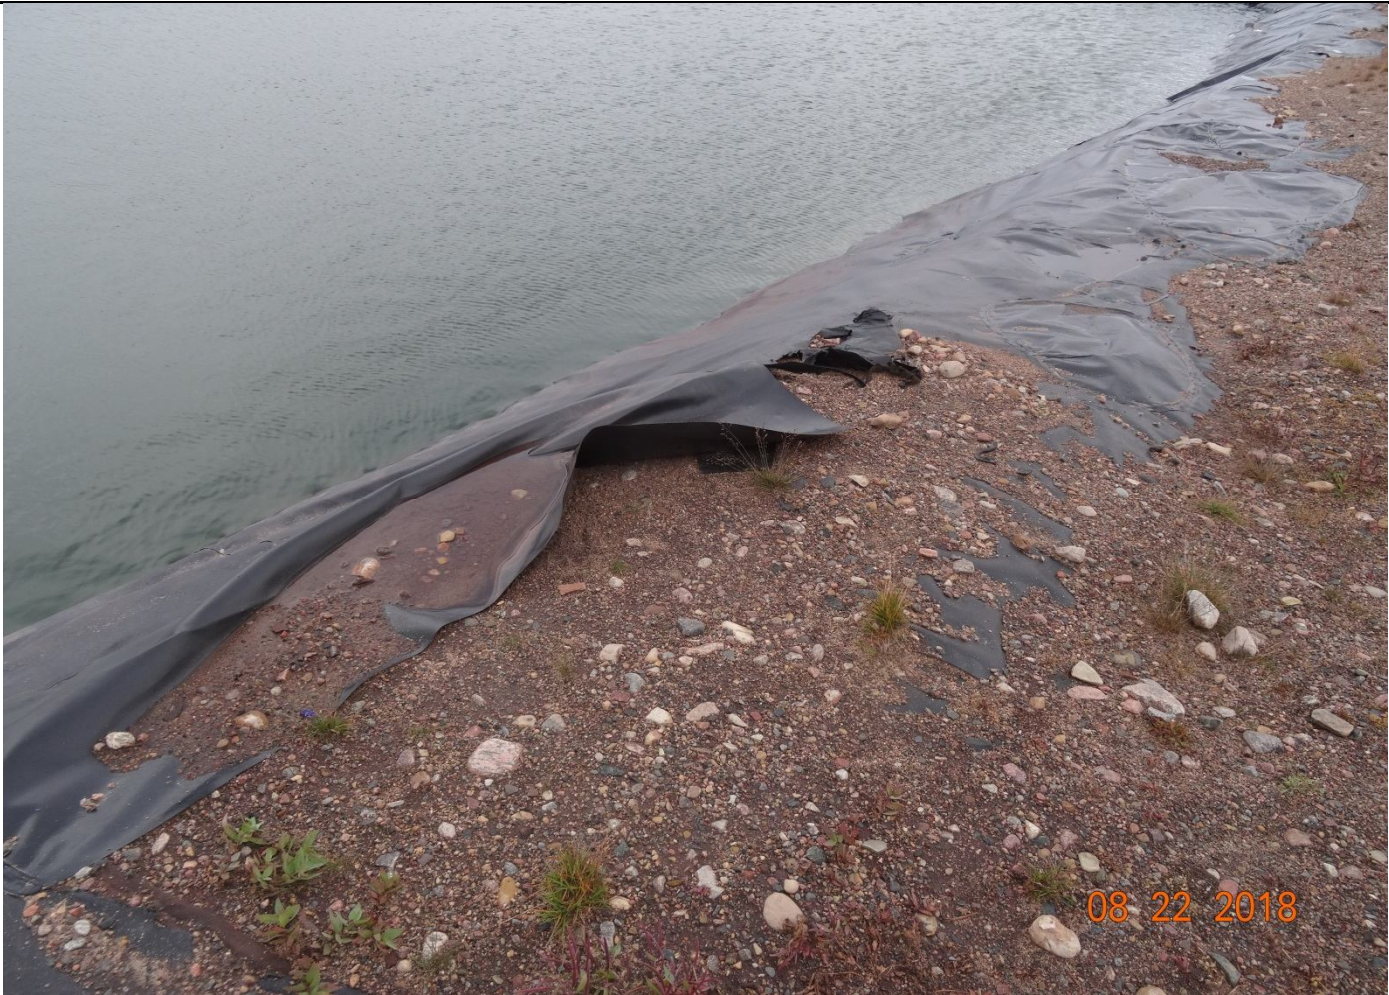
Photo 11

Description; PWSP liner not weighed down.

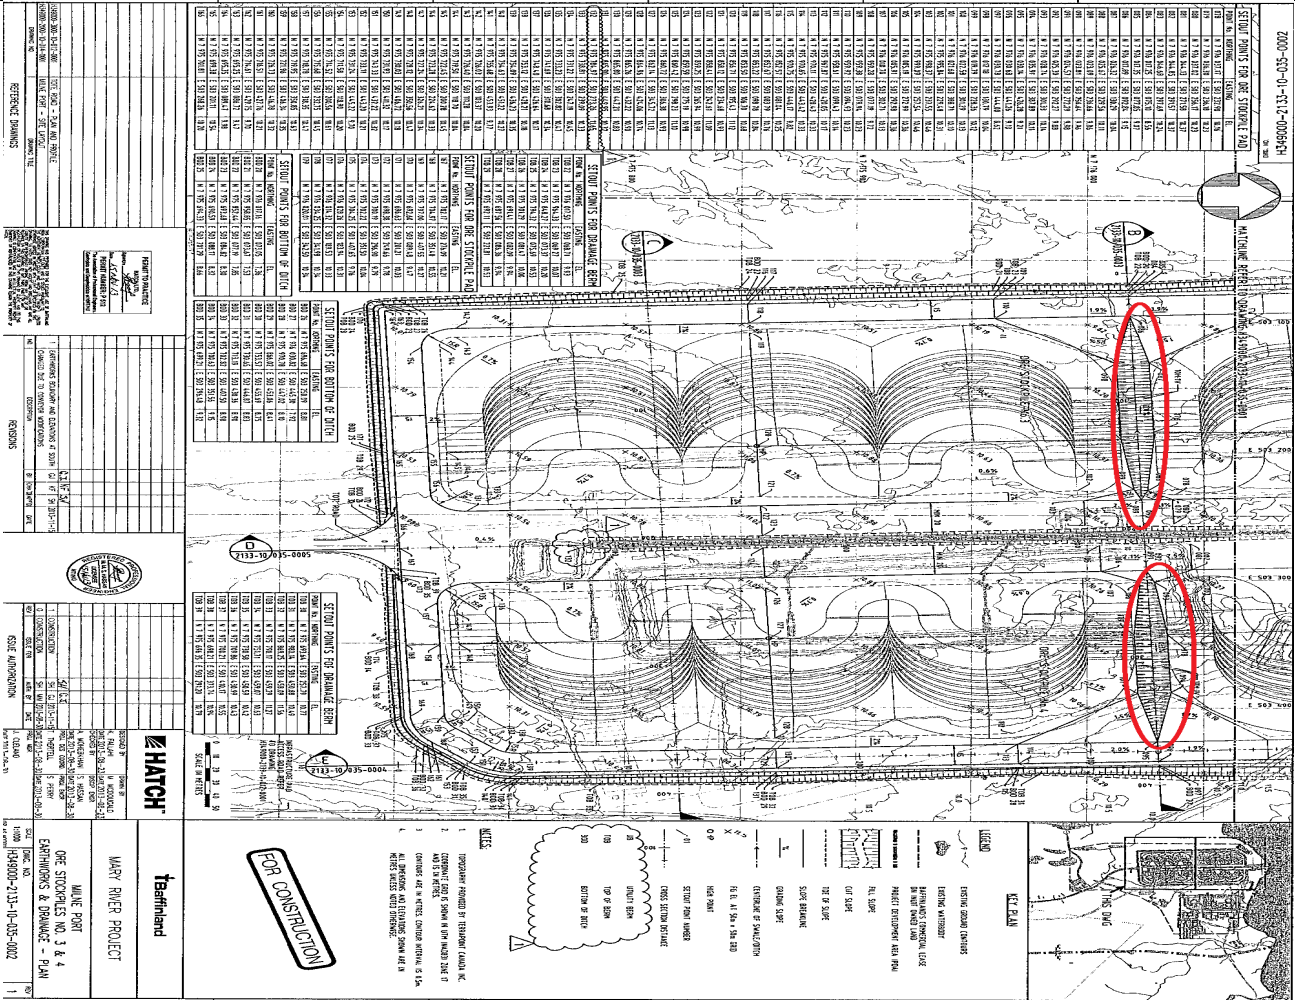
Photo Log #
Photo 12

- a. During the inspection it was noted that the swales highlighted in photo #12 have not been installed/implemented.
- b. There was ore outside containment on the South-West corner of the facility; the licensee is to recover this Ore from outside containment.
- c. The ditch on the East side of the conveyer belt appears to be sloping away from the sedimentation pond.
- d. Remnants of the original bulk sample are still left outside of containment to the east of the west sedimentation pond; Baffinland is to remove the remainder of the bulk sample.

Description; Swales circled in red do not appear implemented.

4. Once the Ore stockpile pad is clear of Ore, the licensee is to clear the swales highlighted in photo #12 and keep them clear of Iron Ore so that the pad operates as intended.
5. The licensee is to ensure that the slope of the ditches surrounding the Ore Stockpile Pad corresponds with the approved design.
6. The licensee is to return the Western Global Fuel module at Milne Inlet to its original approved design.
7. The licensee is to correspond with the NWB and follow the required processes to install the required water management structures to prevent water from flooding the roads identified in Photo's 14 and 15.

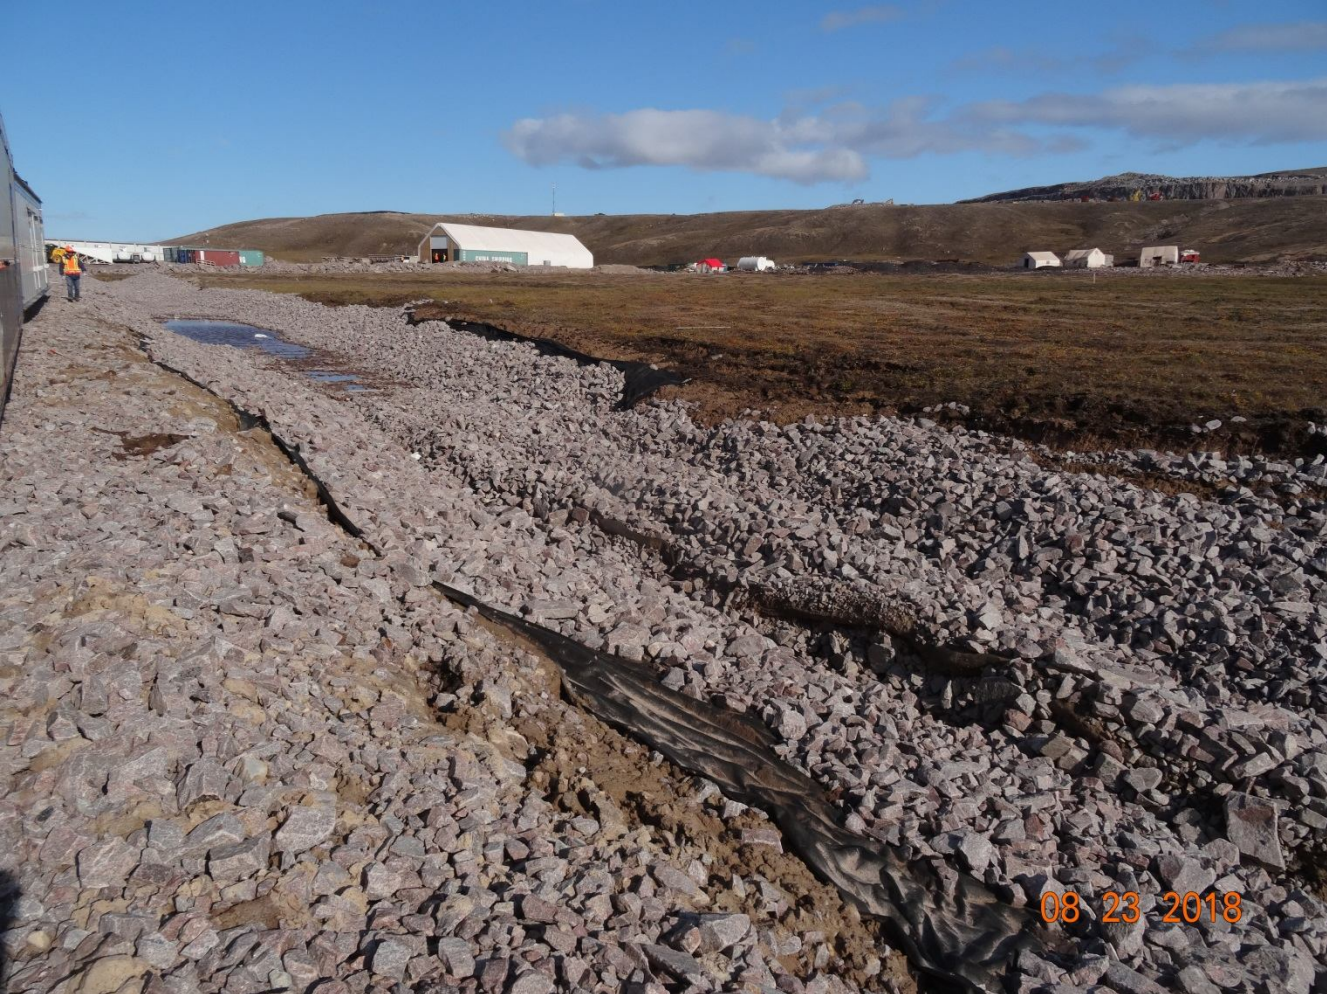
Photo Log #
Photo 13

Description; Ditch not constructed to design.

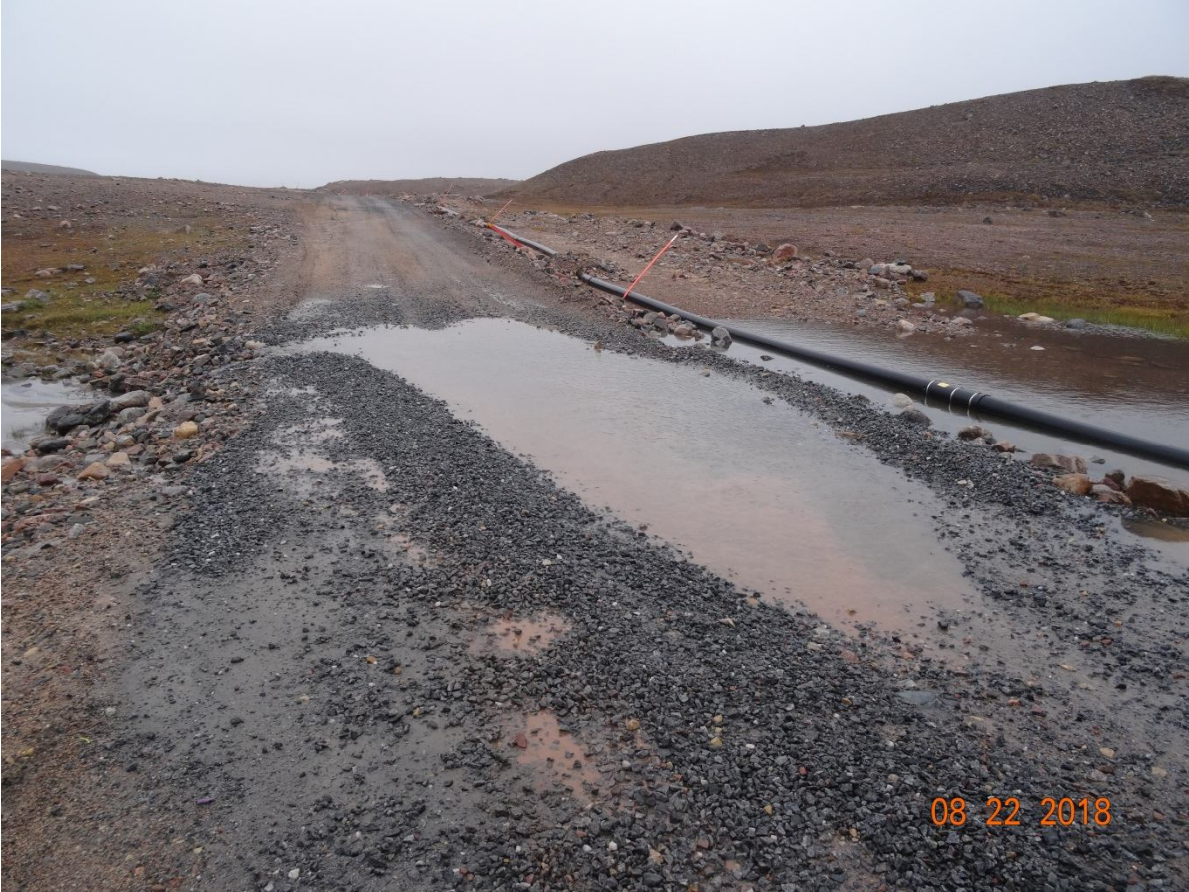
Photo 14

- a. At the time of the inspection there were two areas where surface water has flooded roads; one area is on the road leading to the effluent outfall to Mary River (see Photo #14 for the area of concern), The second area is between the run way and the Polishing Waste Stabilization Ponds(see Photo #15 for the area of concern). In Part E, Item 19 of the license 2AM-MRY1325 it states that, "The Licensee shall undertake appropriate corrective measures to mitigate impacts on surface drainage resulting from the Licensee's operations." And PART D CONDITIONS APPLYING TO CONSTRUCTION AND OPERATIONS, Item 5, of the license 2AM-MRY1325 states "The Licensee shall implement sediment and erosion control measures, as required, prior to and during the Construction and Operations Phases of the Mary River Project to prevent and/or minimize sediment loading into Water."

- b. There does not appear to be any water management in place to prevent the licensee from driving through this surface water or to prevent unnecessary sedimentation and erosion. It is required that the licensee follow the procedures set out in, PART G CONDITIONS APPLYING TO MODIFICATIONS, of the license 2AM-MRY1325 and install the appropriate water management structures.

Description; Flooding of the Mary River outfall access road

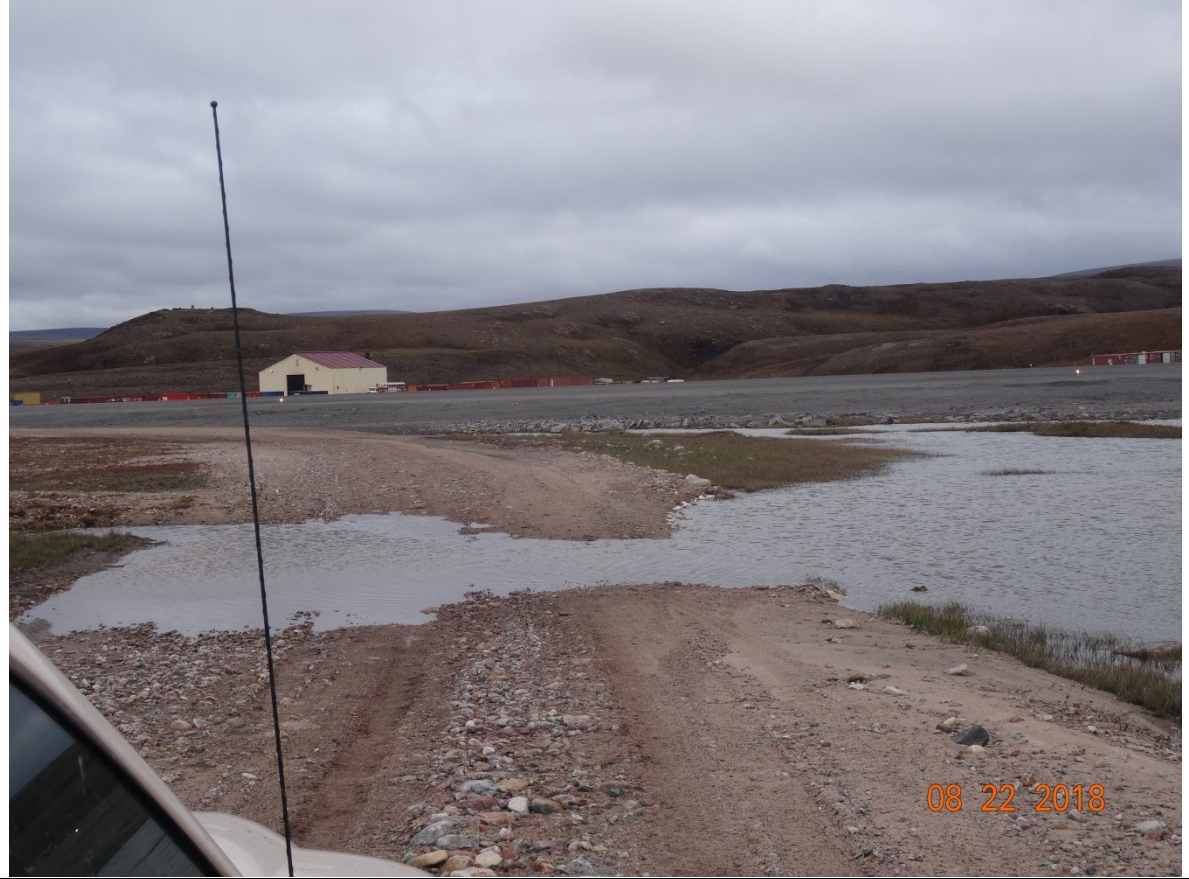
Photo 15

Description; flooding of the road between the polishing waste stabilization ponds and the runway
