INSPECTION FORM

A water licence inspection was conducted at Mary River and Milne Inlet to ensure compliance with the terms and conditions of the Water Licence 2AM-MRY1325. This inspection was conducted by Water Resource Officer JONATHAN MESHER on February 17th through 18th, 2019.

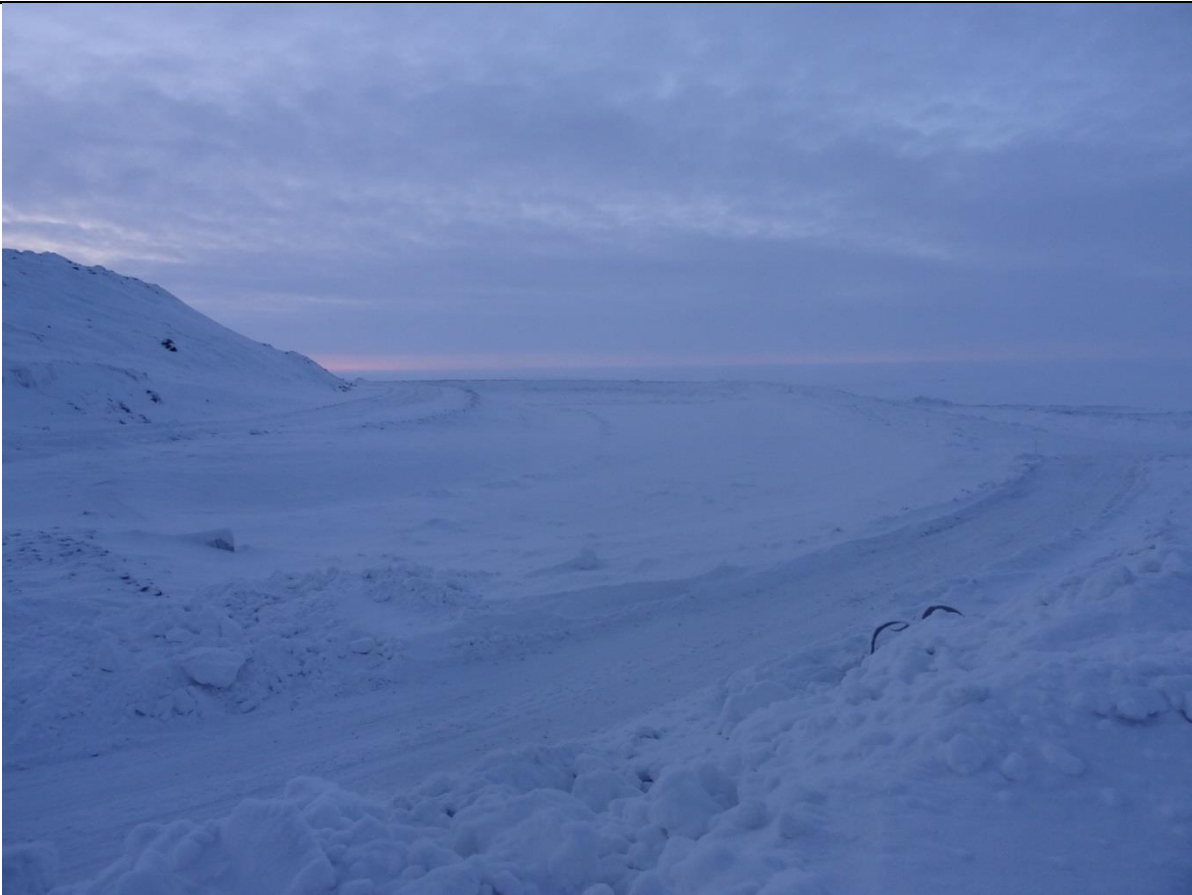
Date	Camera	Inspector	Authorization
	Sony Cyber-shot	J.Mesher	2AM-MRY
Photo Log		Location Iqaluit	
Photo 4

- a) At the time of the inspection, the Waste Rock Stockpile Containment Pond was complete, the construction had completed in January 2020, The inspector is requesting the licensee provide the exact date of completion of this facility and ensure that the plans described in PART G, Item 6 are submitted within the timeframe given. See Photo 4 for the Waste Rock Stockpile containment pond.

Description: waste rock Stockpile Sedimentation Pond.

b) The inspector is requesting the licensee provide the exact date of completion of the Waste Rock Stockpile sedimentation pond and ensure that the plans described in PART G, Item 6 are submitted within the timeframe given.

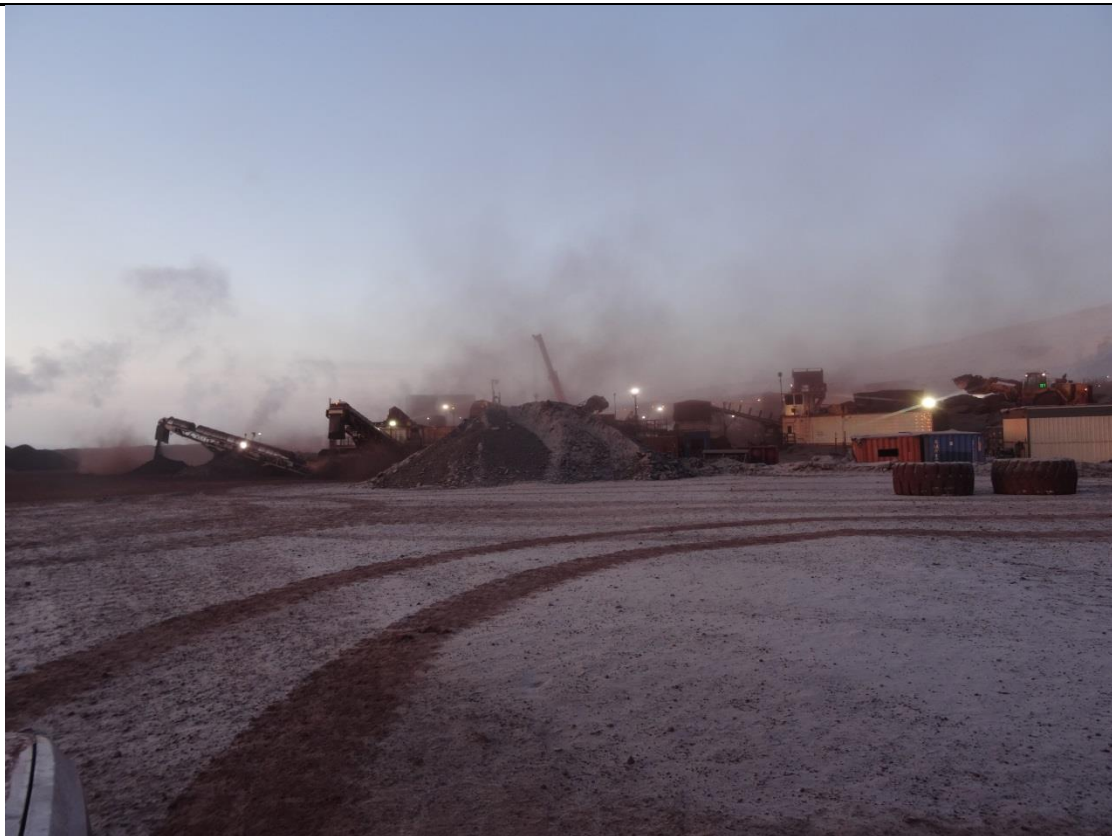
Date	Camera	Inspector	Authorization
	Sony Cyber-shot	J.Mesher	2AM-MRY
Photo Log		Location Iqaluit	
Photo 6

- a) In the previous inspection (September 2019) the Inspector noted the following “the ditch system around the stockpile was not functioning as intended. The licensee is currently pumping water into the ponds from the pooling water on the Pad.” The ditches are still not operational; the licensee is still planning to have them repaired prior to Freshet 2020. This facility will be thoroughly inspected in 2020 to ensure the facility is constructed as described In the approved engineered drawings.

- b) Since May, 2016 CIRNAC has identified pooling water within the crusher pad, the inability of BIMC to effectively manage surface water in the facility is a continual problem on this unlined Pad. This Pad is only approved as described in the As-built and IFC drawings, in the engineered drawings the surface water should flow to the ditches without the need for human intervention such as pumps, due to the slope of the pad. The licensee is to develop a plan to ensure this facility is appropriately maintained, the inspector is requesting that this plan include schedules for grading of the facility to ensure that this pooling discontinues, grade is maintained throughout the seasons and the ditches surrounding the facility are operating as intended. See photos 5 and 6 for the ore crushing pad.

Description: Crushing area looking Northeast.

c) The licensee is to develop a plan to ensure that the ore stockpile pad is appropriately maintained, the inspector is requesting that this plan include schedules for grading of the facility to ensure that this pooling discontinues, grade is maintained throughout the seasons and the ditches surrounding the facility are operating as intended.

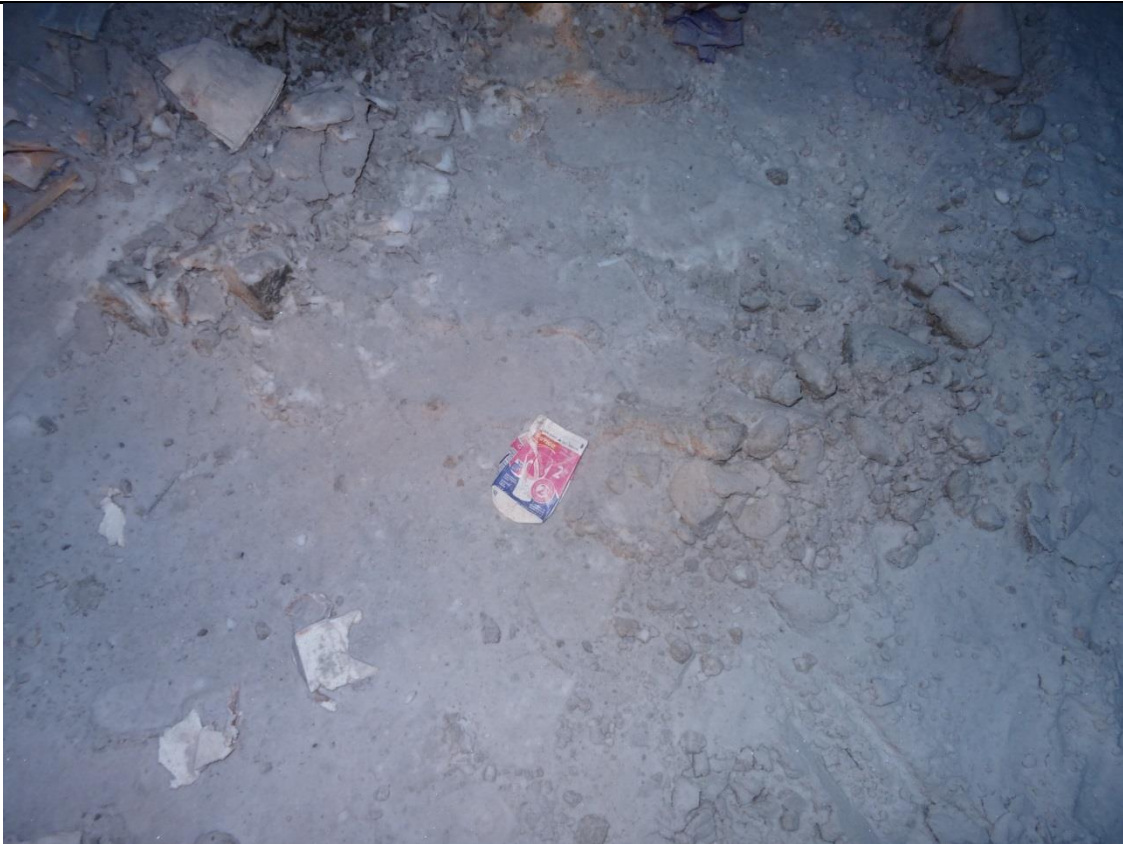
Date	Camera	Inspector	Authorization
	Sony Cyber-shot	J.Mesher	2AM-MRY
Photo Log		Location Iqaluit	
Photo 7

- a) At the time of the inspection the new fence surrounding the landfill was completed, the landfill was left unlocked and unmanned.
- b) The inspector noted small amounts food waste within the Landfill, see photo 7 for the food waste identified. In section 3.7 of BIMC’s Waste Management Plan (BAF-PH1-830-P16-0028) Baffinland states that: “Disposal of all domestic (food) waste, hazardous and biomedical materials at the Landfill Facility is prohibited.” BIMC is encouraged to continue to educate its employees in order to prevent further unapproved deposits of food waste into this facility.
- c) There was also a large pile of cigarette butts found in the landfill, I am not certain if the cigarette is intended to be deposited of within this land fill. The inspector will correspond with the NWB to determine if this is an appropriate activity. See photo 8 for the cigarette butts.

Description: Food waste within landfill.

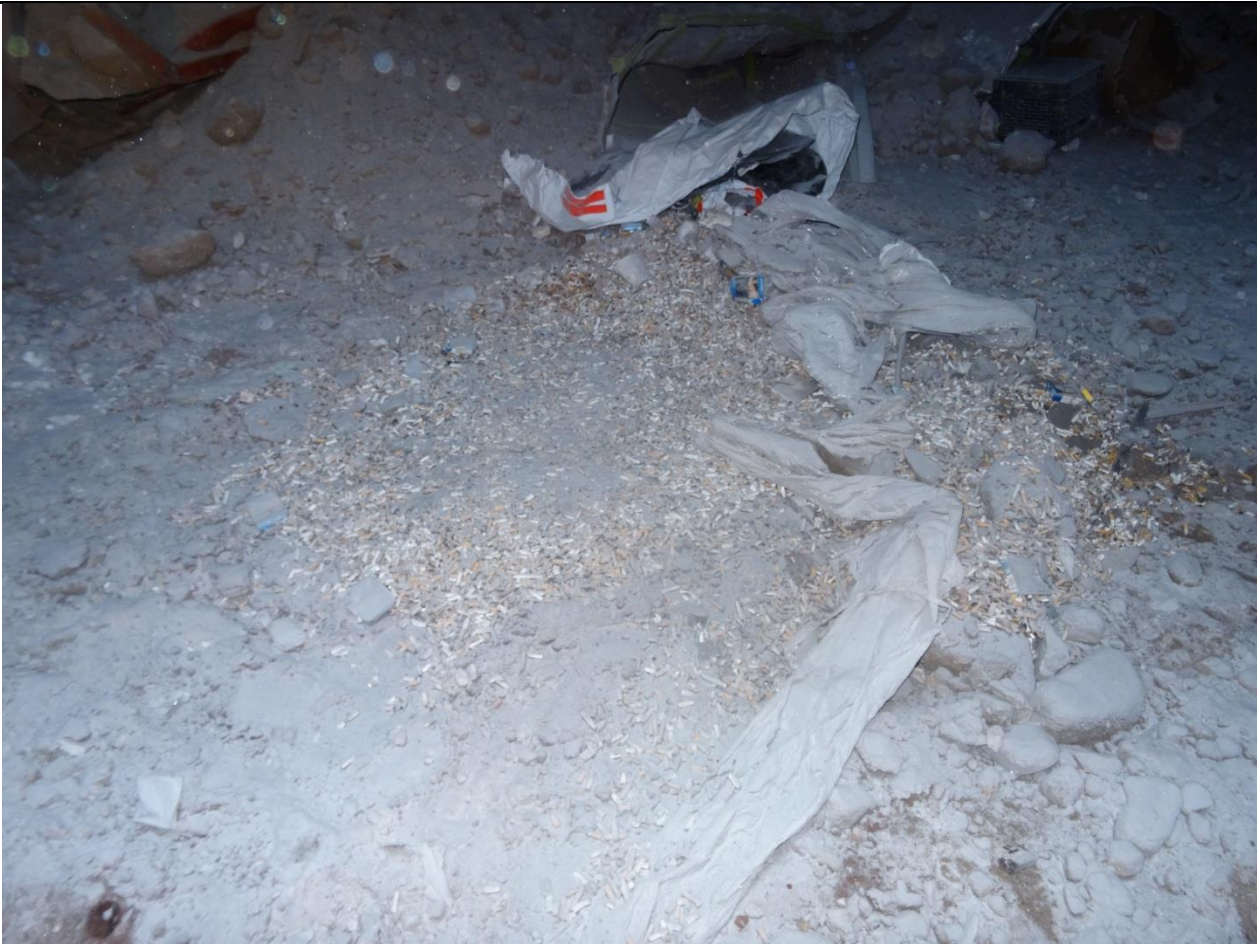
Photo 8

Description: Cigarette butts within the lanfdill.

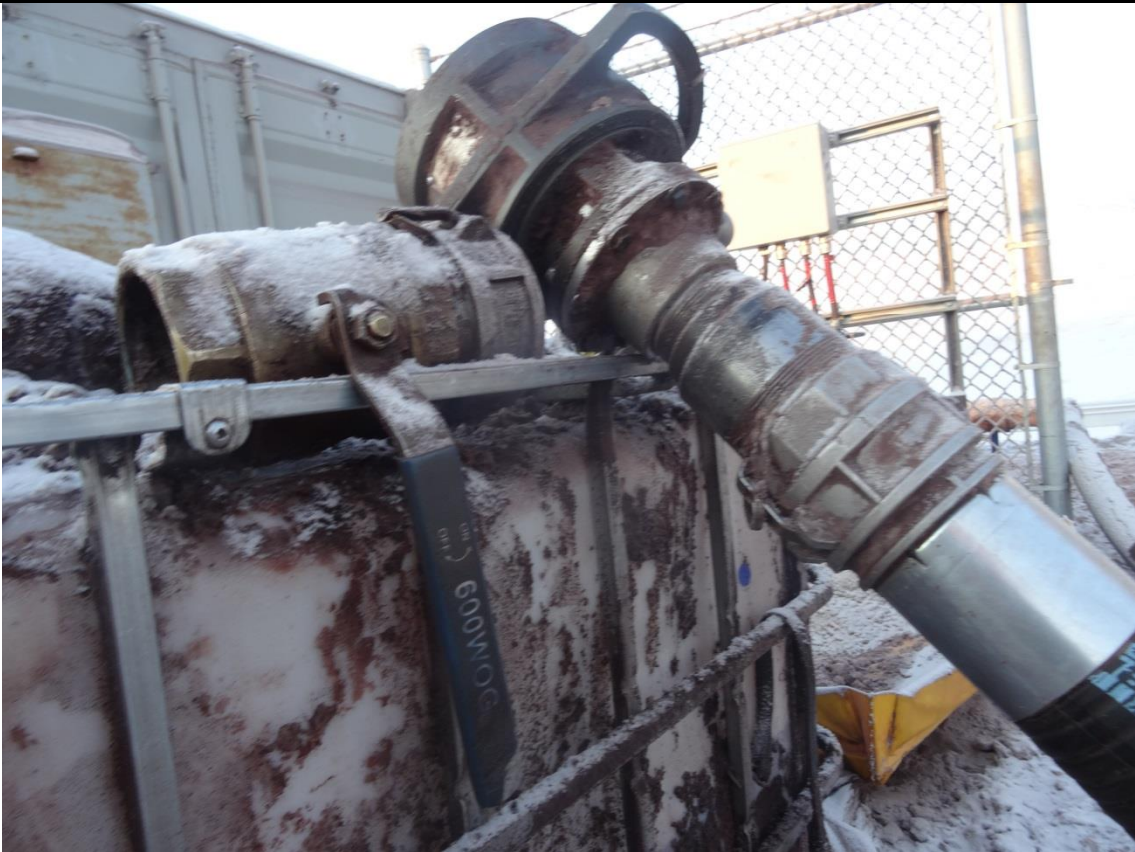
- a) At the time of the inspection the hose used for fuel transfer was actively leaking, the snow within the containment berm had a strong smell of Diesel Fuel. The licensee explained that this leak was from a gasket on the coupling. See Photo 9 for the leaking coupling and 10 for the hose sitting outside the drip tray.

Description: leaking coupling.

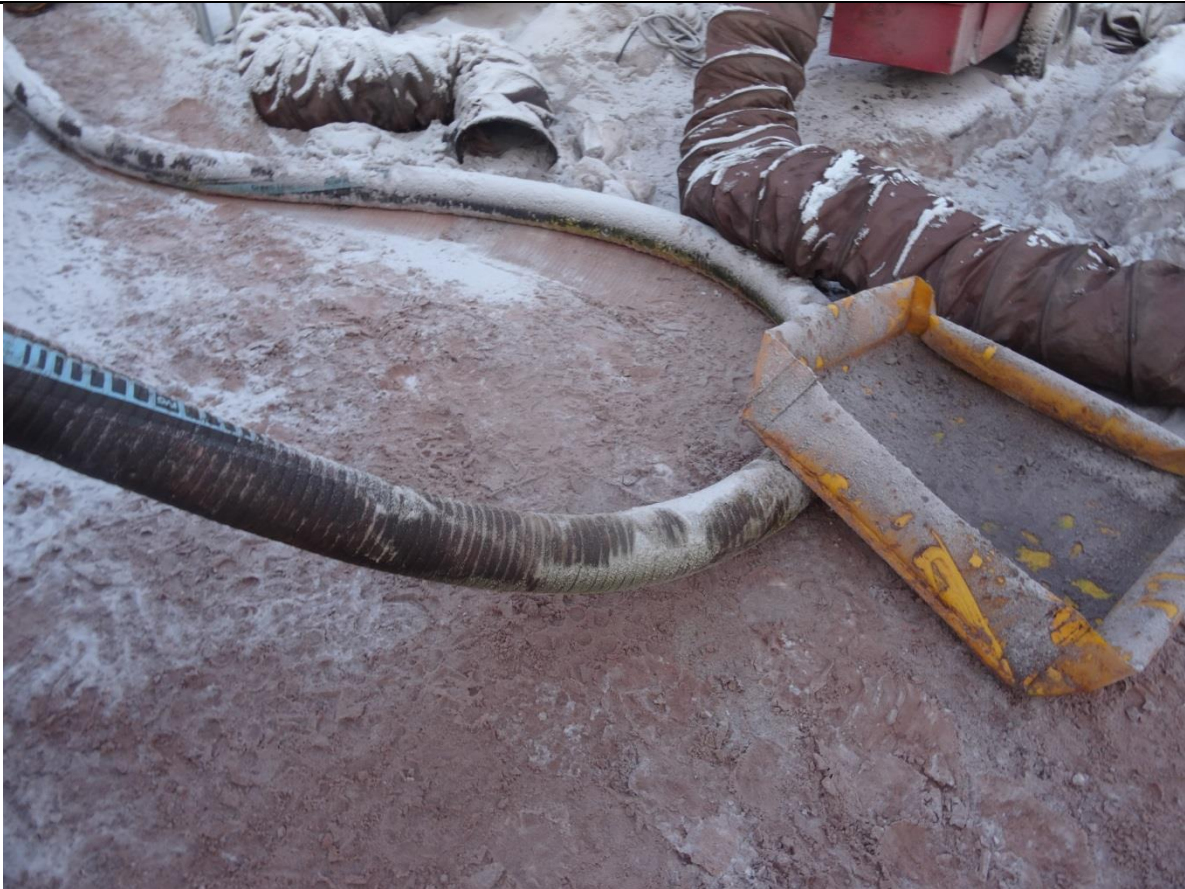
Date	Camera	Inspector	Authorization
	Sony Cyber-shot	J.Mesher	2AM-MRY
Photo Log		Location Iqaluit	
Photo 10

Description: hose from leaking coupling.
