## **APPENDIX E.7.1**

### **AANDC INSPECTION REPORTS AND BAFFINLAND RESPONSE**

WATER LICENCE INSPECTION FORM

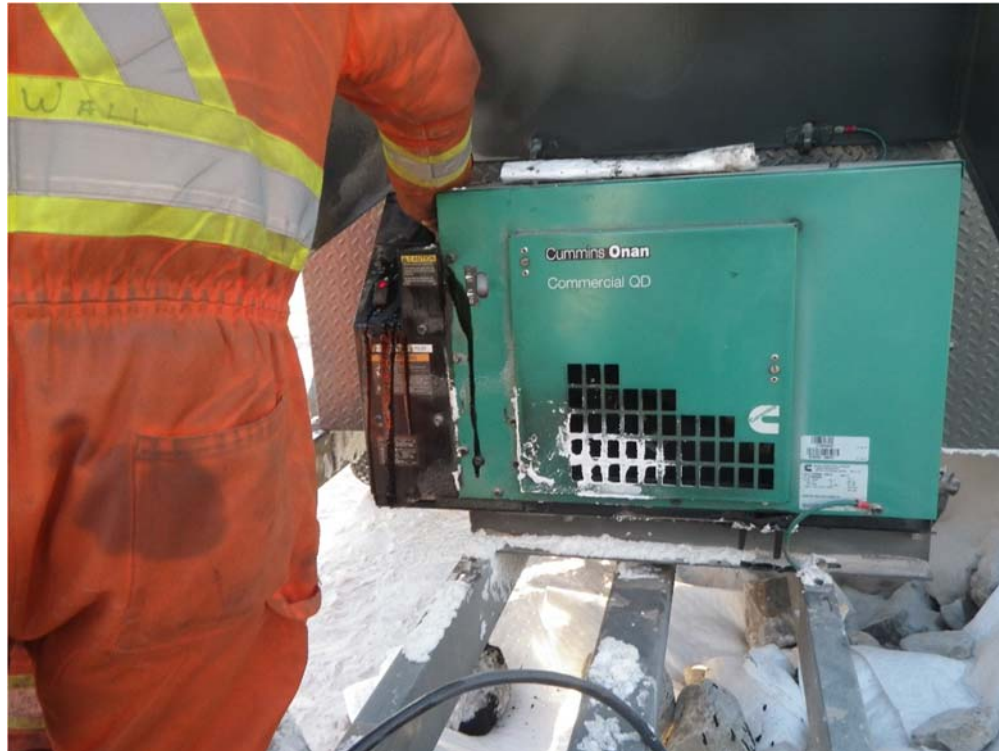
On March 11, 2015 at 17:00, a leak was observed under a ground thawing unit located at Km 38 of the Tote Road. The unit was positioned on the frozen stream at crossing CV099. Approximately 1L of engine oil escaped from an improperly positioned dip stick and was released onto the frozen stream ice surface. There was no spill tray in place to prevent the oil from leaking directly onto the stream bed.

**Photo 1** - Spill location- Oil dripping from the unit (left)

Upon discovery, a spill tray and absorbent material was put underneath the leak to prevent further release to the receiving environment. Repairs were then made to the unit to stop the leak. Approximately 0.2 m<sup>3</sup> of impacted snow and gravel was recovered and transported/disposed of in the landfarm facility at Milne Port. The ground thawing unit was subsequently inspected, found to be in good working order with no further leaks, and put back into service by the maintenance department. A large spill tray was installed to protect the ground / stream bed under the unit. The Operations Group, who are responsible for the operation of the ground thaw unit, were reminded that ongoing utilization of spill trays and monitoring of same are key requirements of our environmental permits.

The Ground Thaw Unit is back in service. Regular inspections are conducted on the ground thawing unit and other equipment to check for leakage and to ensure spill tray use.

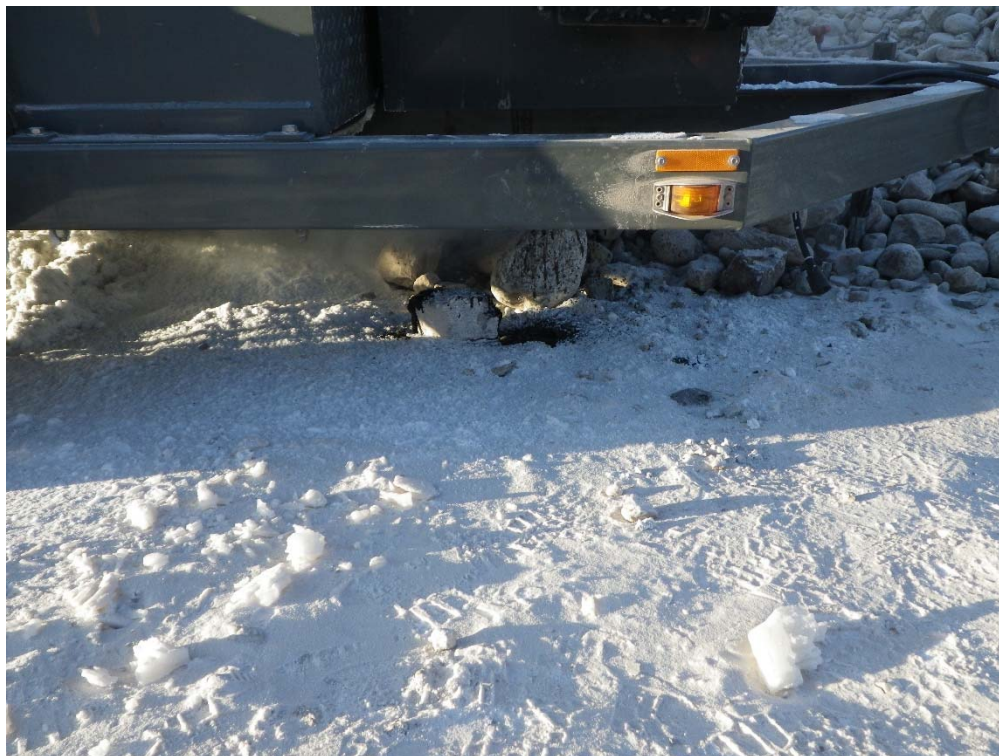
**Photo 2** – Engine oil onto ground – less than 1L

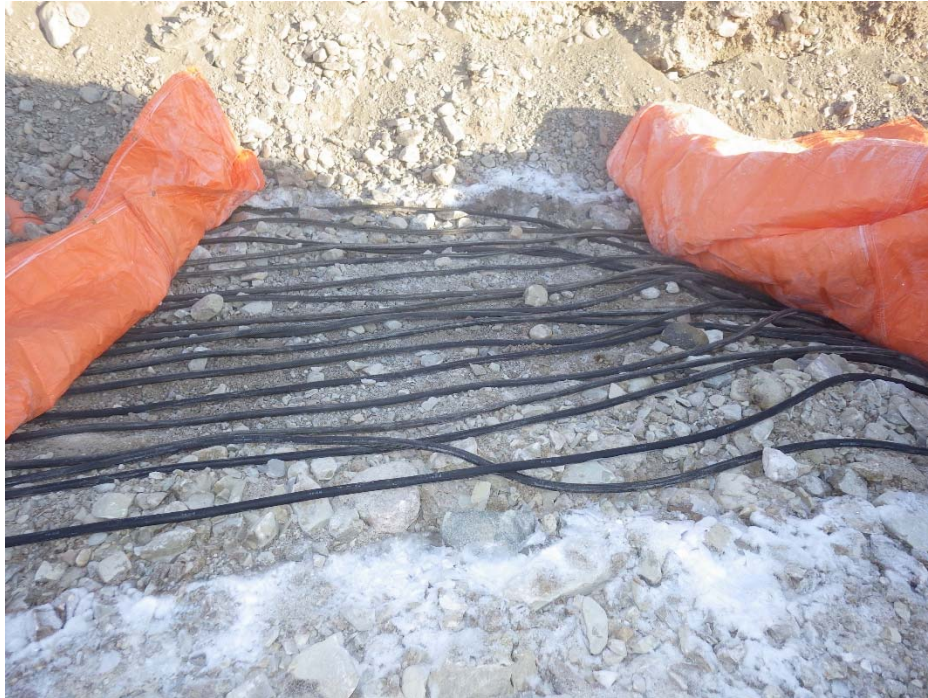
**Photo 3 – Spill location post clean up**

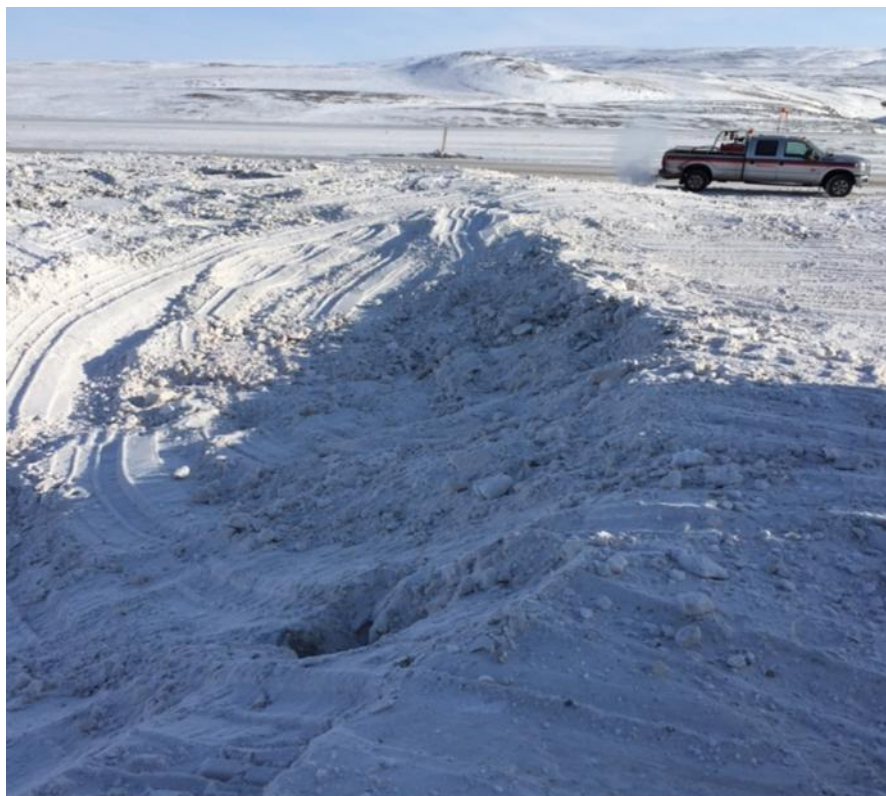
April 8, Drainage to Camp Lake, looking east and upstream toward airstrip.

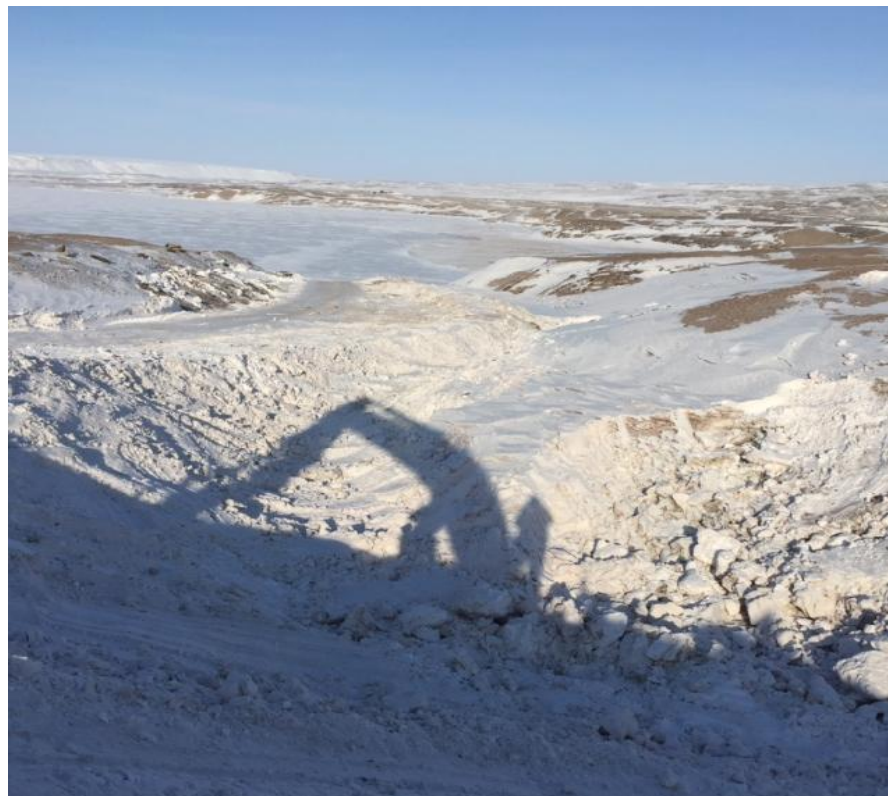
April 8, Drainage to Camp Lake, looking west and downstream toward Camp Lake.
