APPENDIX E.7.3

WSCC INSPECTION REPORTS AND BAFFINLAND RESPONSE

REPORT OF AN INSPECTOR OF MINES

Mine:	Milne Inlet
Operator:	BAFFINLAND IRON MINES CORPORATION
Mine Manager:	Michael Anderson
Date of Inspection:	January 20, 2015
Address:	300 - 2275 Upper Middle Road East Attn: Annu Sira Oakville, Ontario, L6H-0C3
Reference Number:	PR 2015-LL-00009

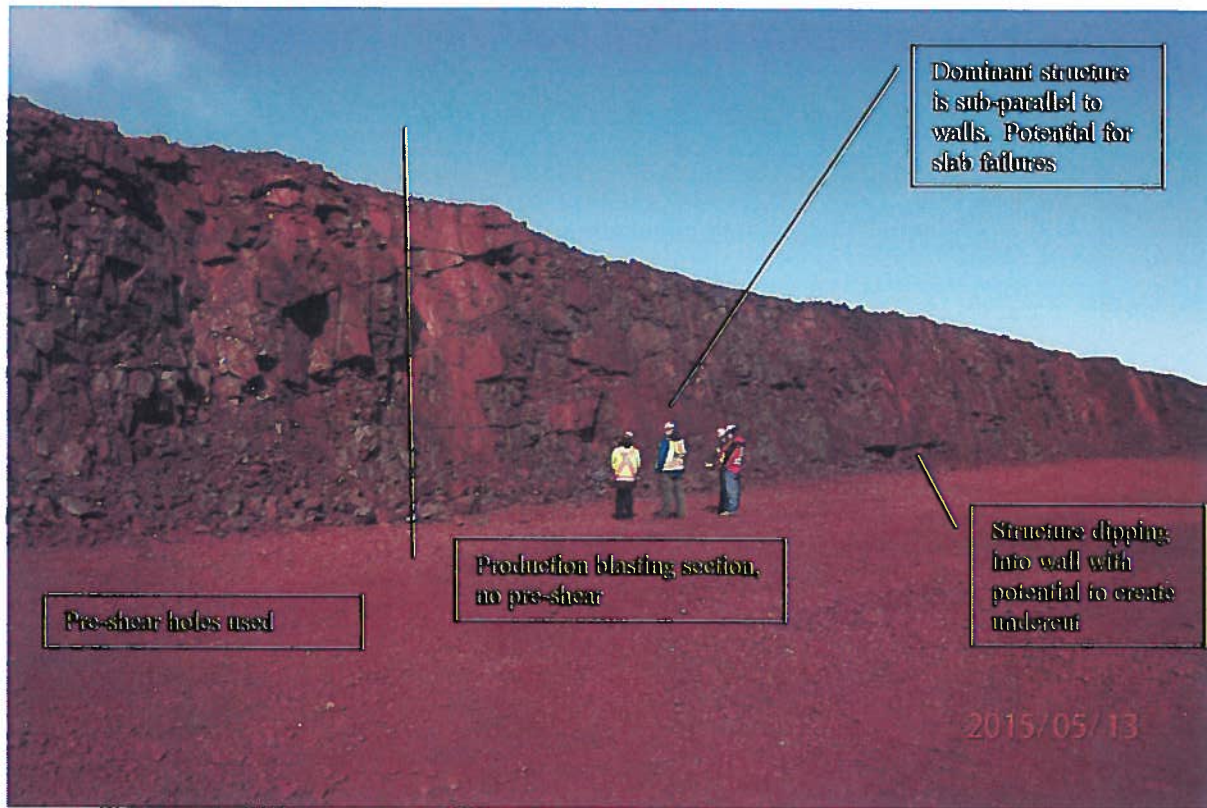
Only the first 7.5m bench has been developed on the top of the mountain, see Photo 1. Rock conditions exposed in the bench face range from fair to poor. Based on experience in other northern mines conditions should improve once out of the frost damaged cap rock zone which is typically 10 to 30m thick. Face stability appears to be controlled by geologic structure; we noted the following:

- The dominant geologic structure is sub-parallel to the bench face. This structure has the potential to result in slabbing type failures. The presence of other structure perpendicular to the bench face has the potential to create the side release surfaces for the slabs. We note that where the perpendicular structures are closely spaced a columnar type failure scenario may develop.
- A shallow structure dips into the face. This structure has the potential to result in undercutting, see Photo 1.
- Several structures cross cut the bench face and appear to have potential to create wedges with kinematic potential for failure.

Photo 1: First 7.5m highwall exposed on top of mountain. Rock conditions are expected to improve once away from the surficial cap rock zone. It is understood that pre-shear holes were used on the left side of the photo but not on the right.

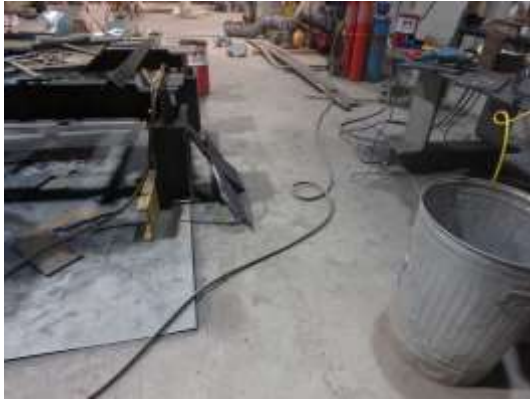
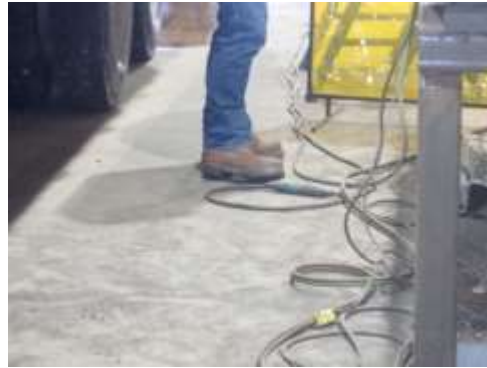
This is a repeat infraction see inspection reports 21 March 2015 and 29 March 2014. Please ensure no supervisor allows electrical cords, hoses and other items to lie indiscriminately and without protection over the ground or across a floor where they are a potential trip hazard and or other hazard if un-intentionally cut

or damaged.

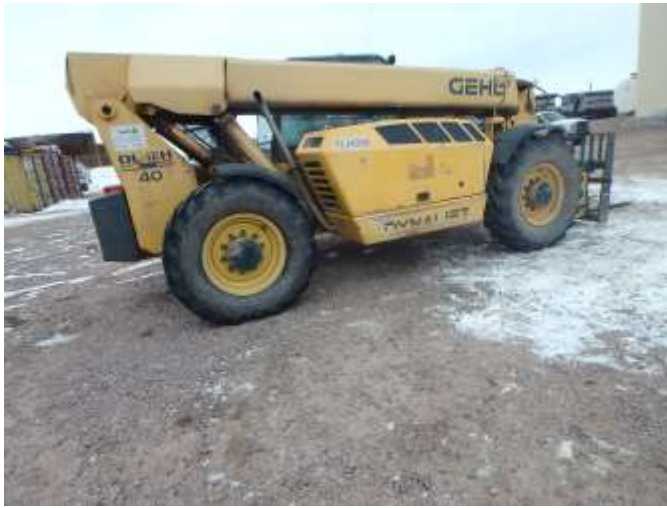
Telehandler 001 and 006 parked but the operator had not blocked a wheel on the equipment, to prevent its unintended movement. This is a repeat infraction see inspection report 26 July 2014.

Please ensure each equipment operator before leaving their equipment in a parked position, blocks one of the unit's wheels with wheel chocks, to prevent unintended movement.

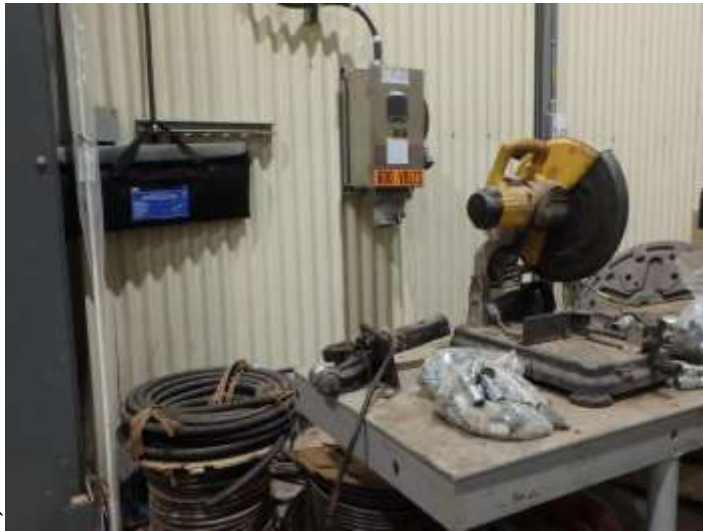
Noticed in the mobile maintenance shop at Milne, a hydraulic hose assembly blocking access to a wall mounted electrical disconnect switch.

This is a repeat infraction see inspection reports 21 March 2015, 31 October 2014, 26 July 2014. Please ensure all supervisors in their area of responsibility, enforce the requirement for at least one Meter of clear access to electrical equipment in their area. This is required to service the equipment and enable unobstructed access in case of an emergency.

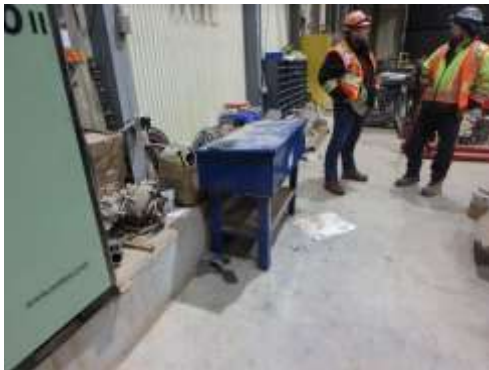
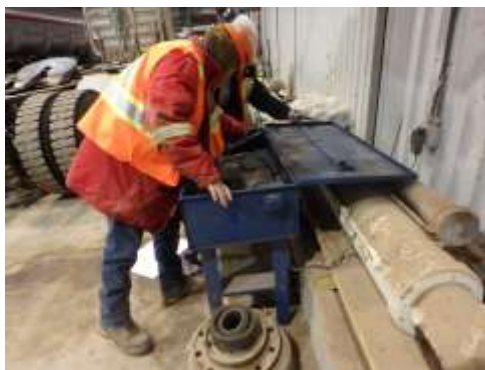
Noticed the lid on the 40-gallon solvent cleaning tank, in the mobile maintenance shop at Milne Inlet and the maintenance shop at Mary River did not have its restraining device connected to prevent the lid from opening 90 degrees or more.

Please install the lid restraining device in the solvent tanks as per the manufacturer's instructions to ensure the lid will automatically fall closed, in case of a fire in the solvent tank.

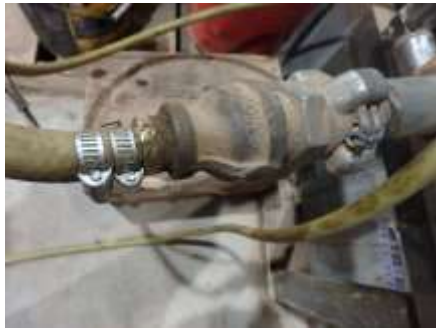
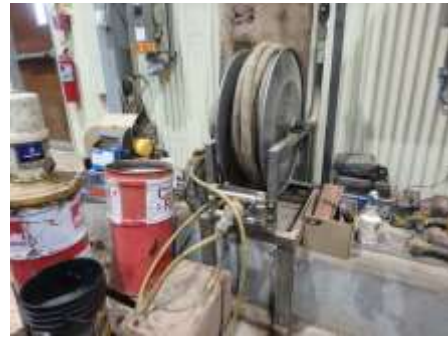
Noticed a screw type hose clamp used on a high-pressure air hose in the mobile maintenance shop. This type of clamp must not be used on high-pressure air service.

Please check all high-pressure air hoses and replace any gear or screw type hose clamp with a crimping device.
