APPENDIX E.7.4
FOLLOW-UP SPILL REPORTS

Re: Follow-up to Spill 15-003 Reported on January 2nd, 2015
Mary River Project - Water Licence No. 2AM-MRY1325

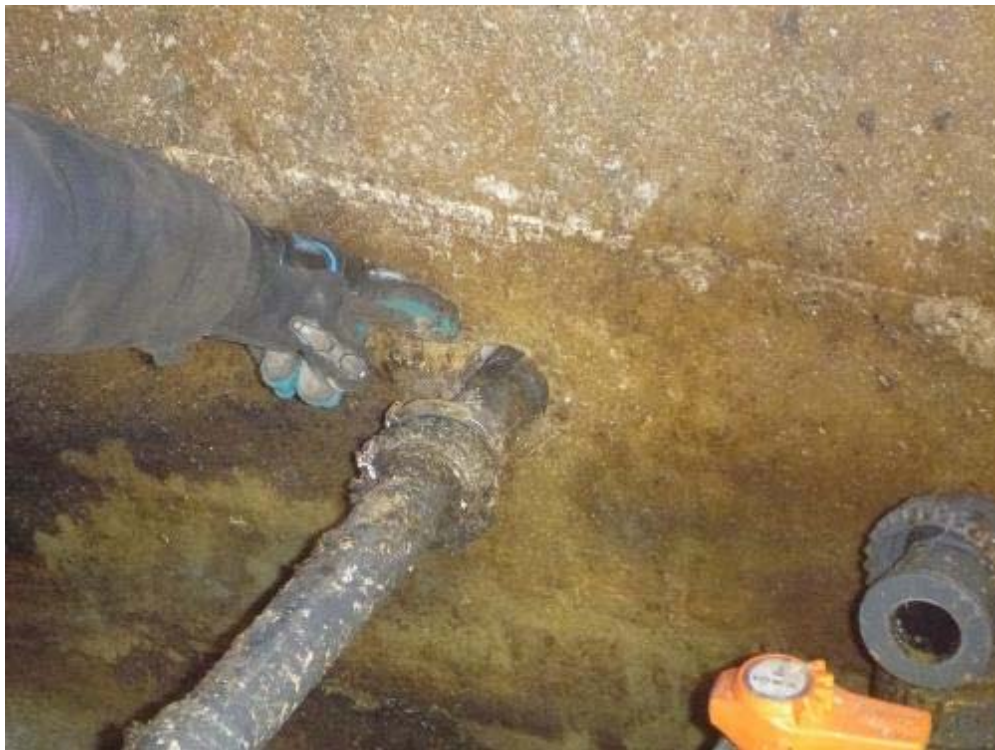
On January 30 2015 at 12:30 PM, a worker detected a leak at the Port Site Complex accommodations BD wing North Lift Station. Environment and Site Services investigated the report. On investigation, a significant amount of sewage had been released from the lift station. The 1.5" discharge pipe's O-ring rubber seal, that seals the piping to the containment tank, had unglued and separated from the fitting. This caused sewage to release underneath the tank and freeze, lifting the containment tank. This resulted in the 4" mechanical joint clamp on the gravity influent line separating from the tank, causing the spill. It was conservatively estimated that the volume of the spill was 2 m³, based on an area of contamination of approximately 50m². The sewage froze in place and did not migrate further. The closest water body, Milne Inlet, is more than 350 m away and is presently frozen.

Photo 1 - Spill location- BD North Wing Lift Station

A vacuum truck was mobilized to pump out any remaining sewage in the lift station and containment tank. The water was shut off to that side of the BD wing. The influent and discharge line connectors and fittings were replaced and reattached to the lift station. The contaminated material was removed and disposed of in the polishing waste stabilizing pond, a slight amount of contaminated material still remains under the wing.

Extreme temperature changes which cause the piping and fittings to expand and contract promotes leaks and pipe failures. Ongoing routine inspection of the piping systems are required to inspect for leaks and potential locations of failure. A longer term plan to solve this issue is in development.

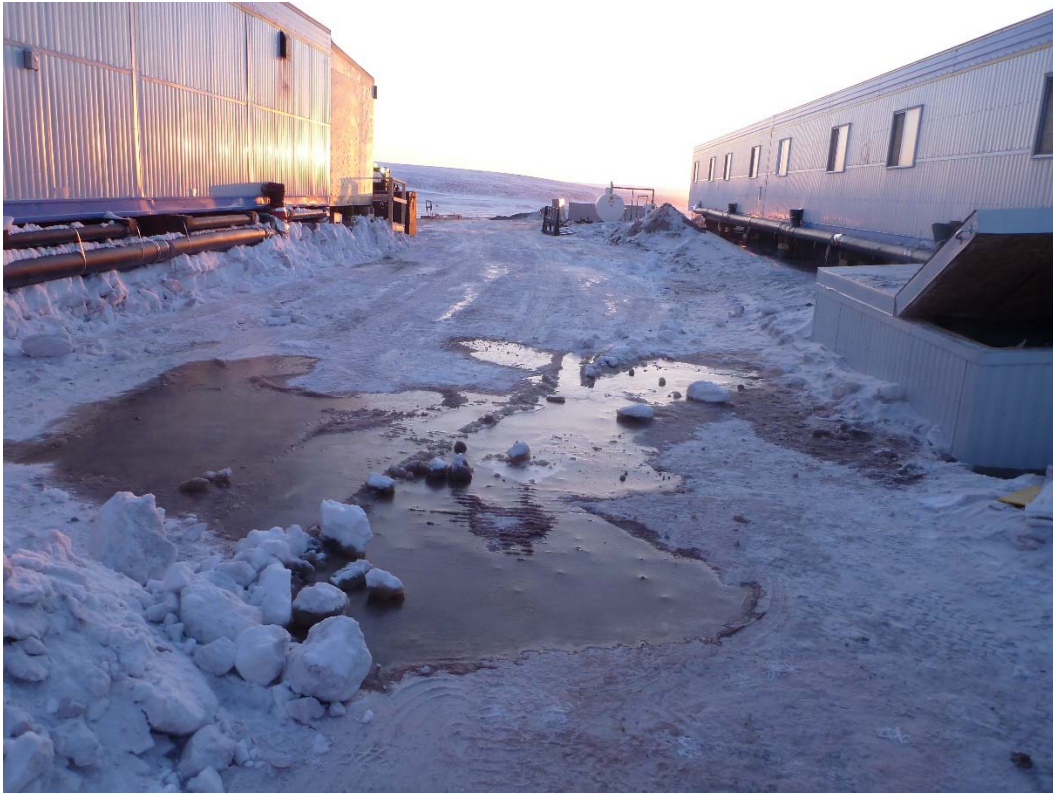
Photo 1 - Spill location- AG South Wing Lift Station Discharge Pipe

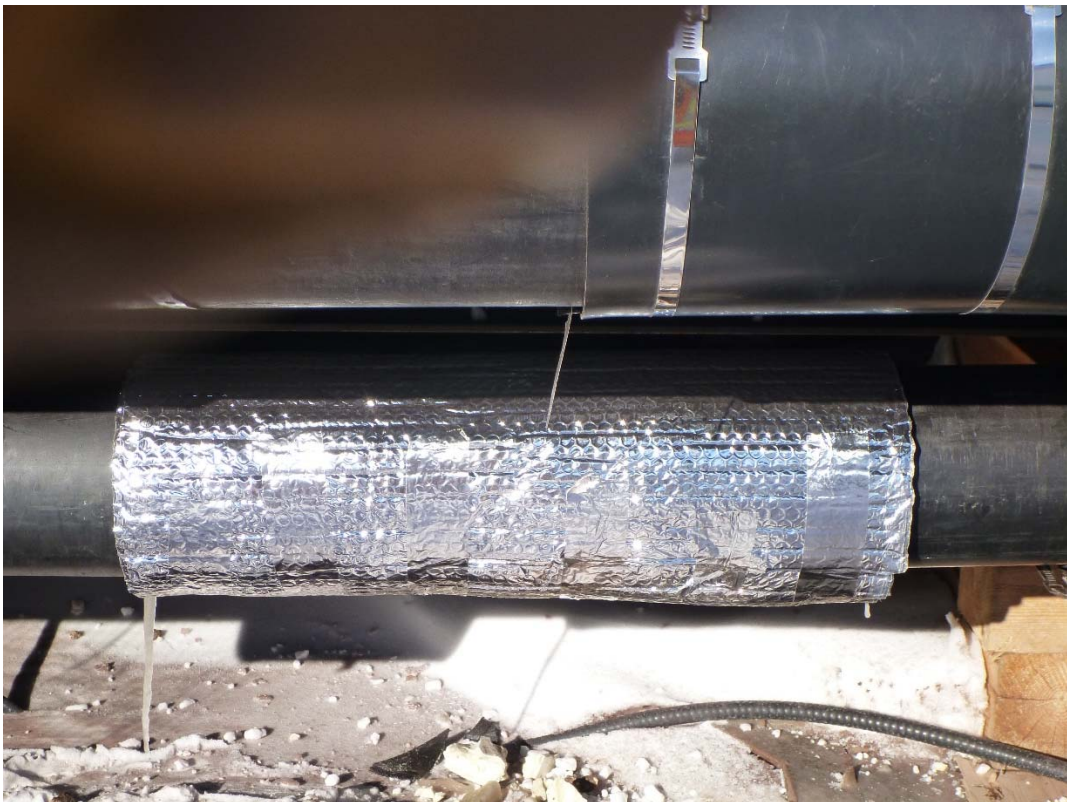
Photo 2 – Repair made on discharge pipe

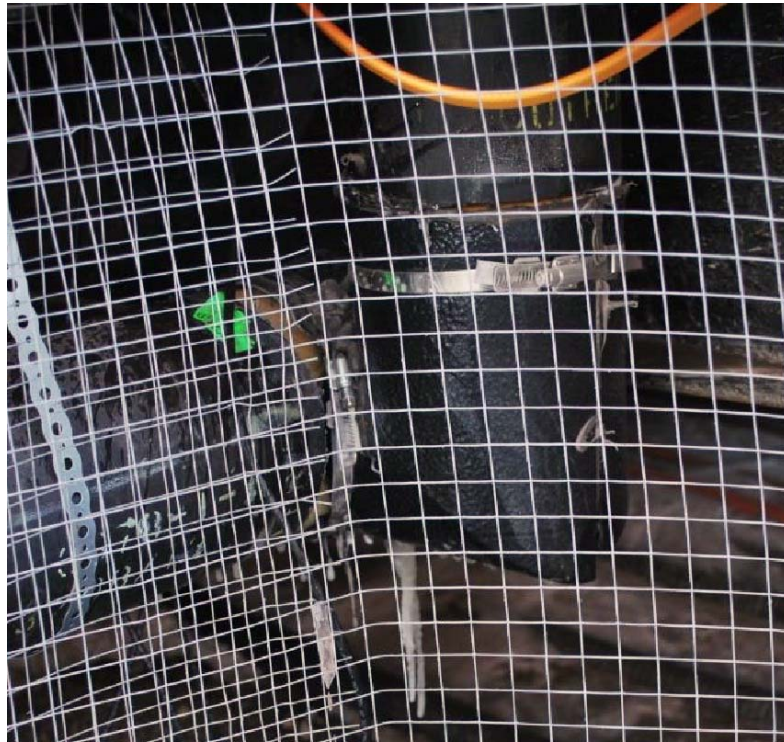
Photo 1 – Failed Joint

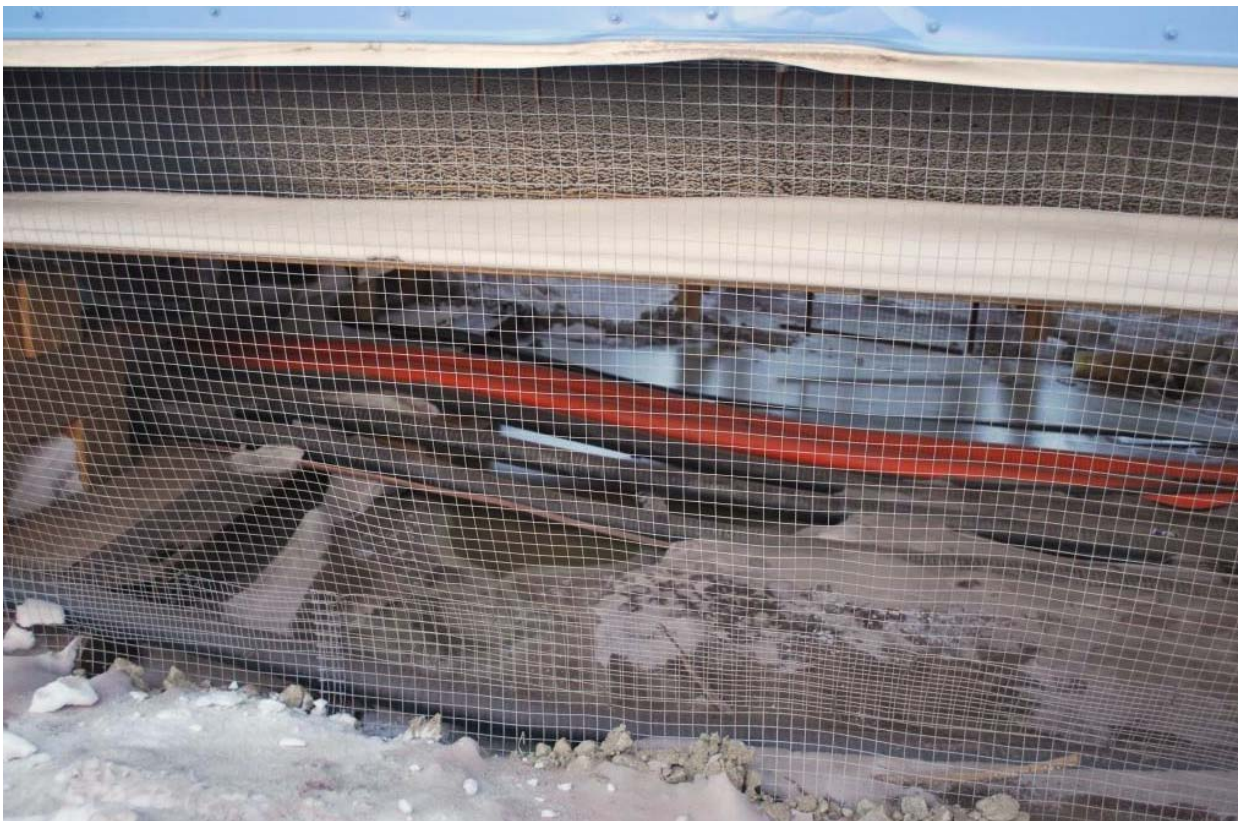
Photo 2 – Sewage Spill underneath MSC Arctic Corridor

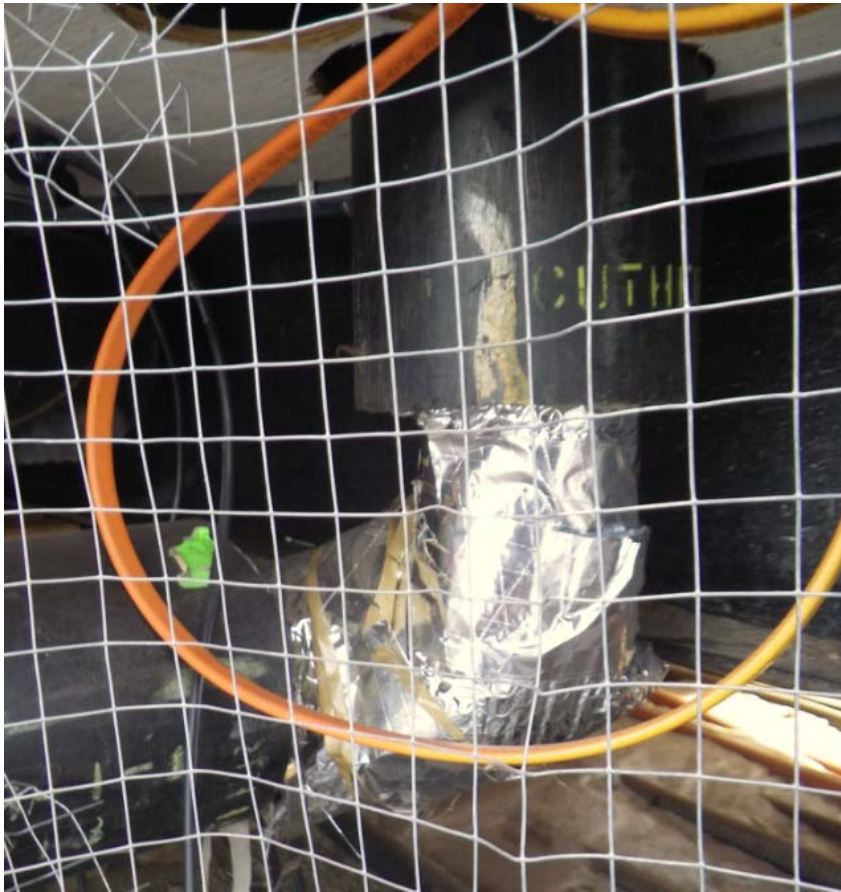
Photo 3 – Repaired Joint

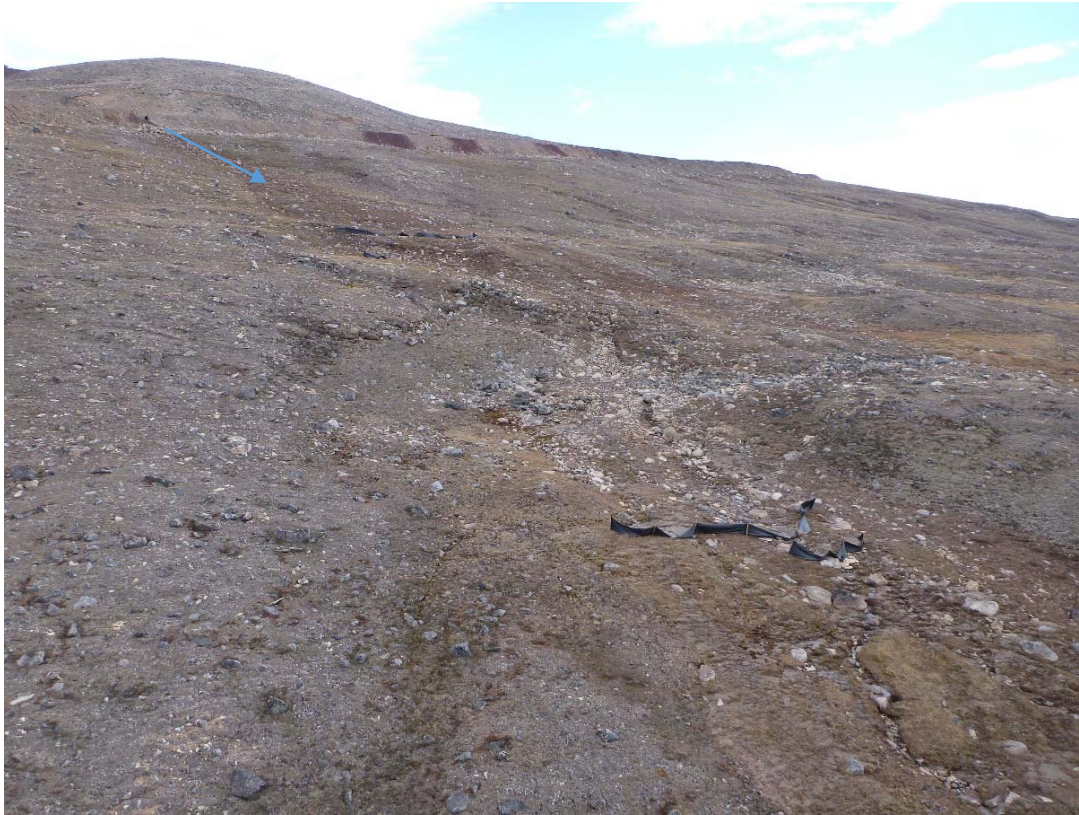
Photo 3 – view upstream toward culvert at Km 107 Mine Haul Road. Note steep gradient and silt fences erected June 27.

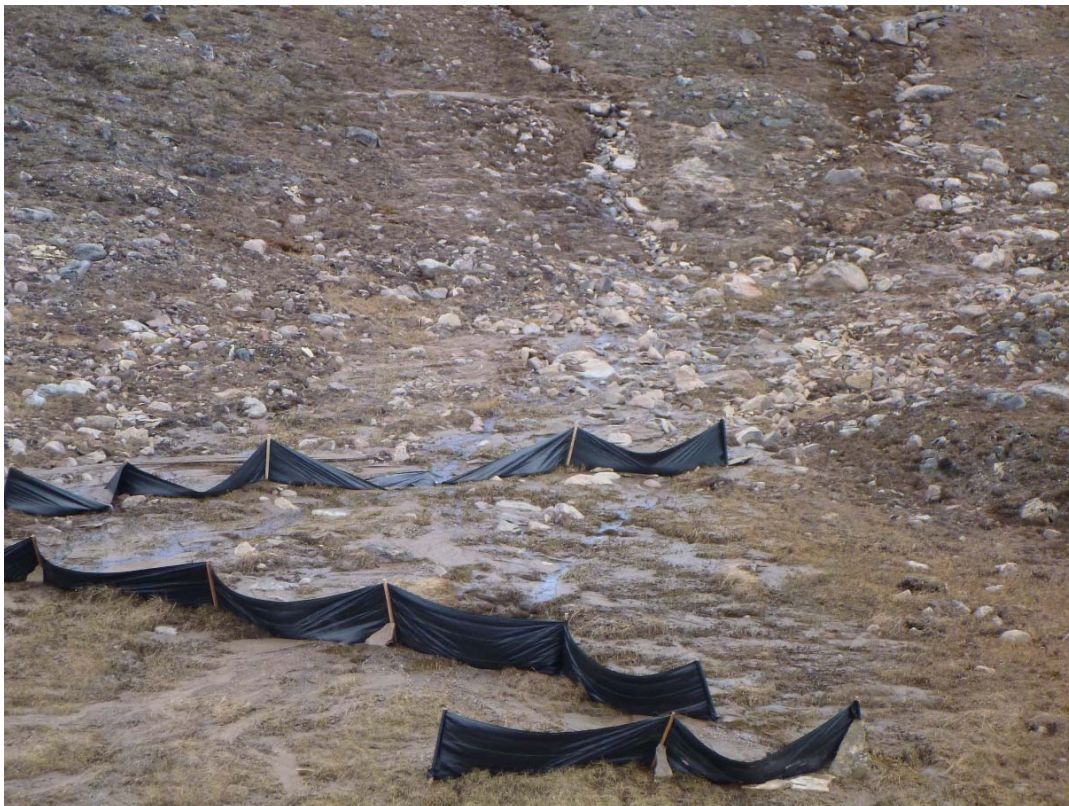
Photo 4: Silt fences effectively trapping sediment release downstream of Culvert at Km 107 on June 27.

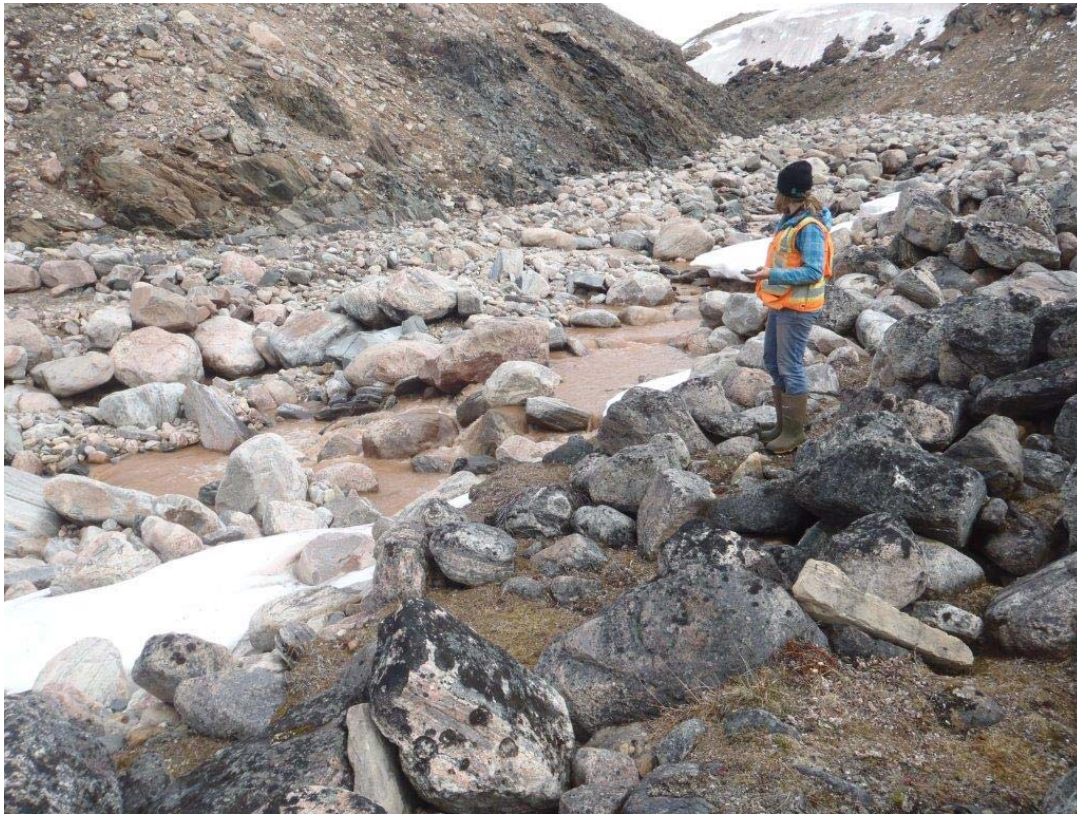
Photo 5: View upstream of sample location FO-01, near confluence of Mary River at time of discovery of sediment release on June 26. Prior to implementing mitigative actions.

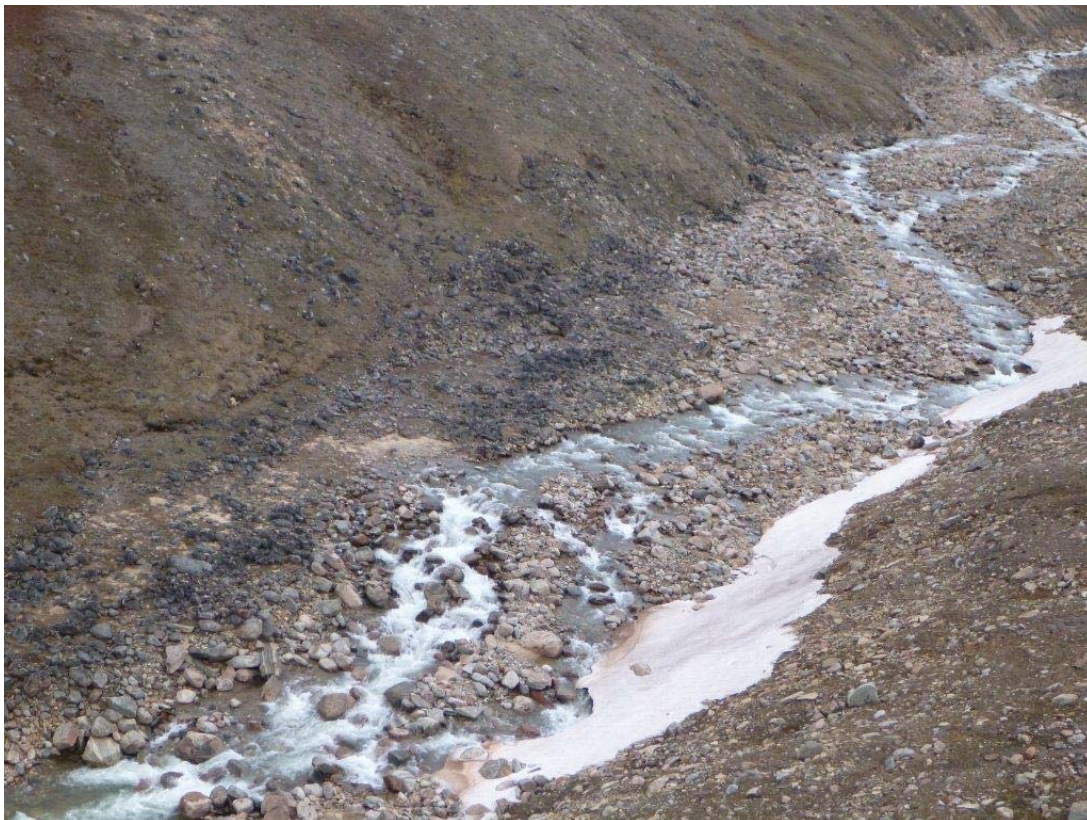
Photo 6: Just upstream of Photo 4, on June 28 after implementation of mitigative actions on June 27. Stream is running clear.

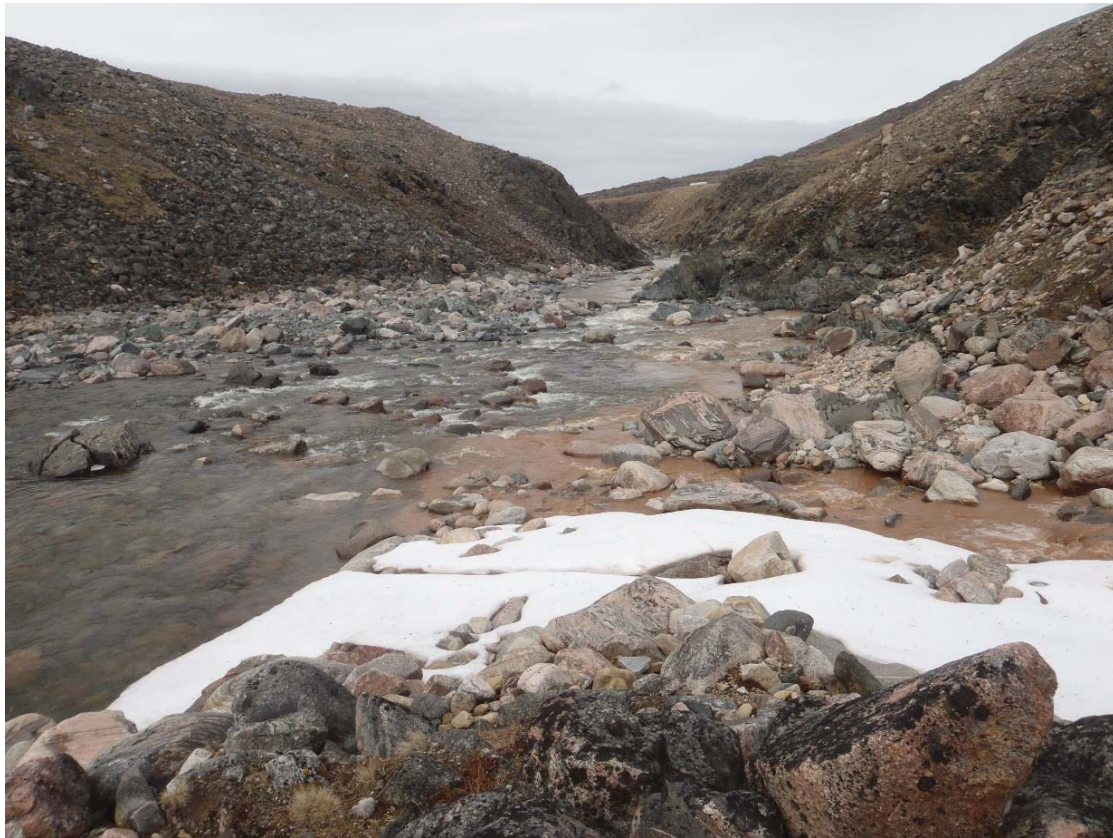
Photo 7: View downstream Mary River at confluence of tributary, just downstream from sampling location FO-01 at time of discovery of sediment release on June 26, prior to implementing mitigative actions.

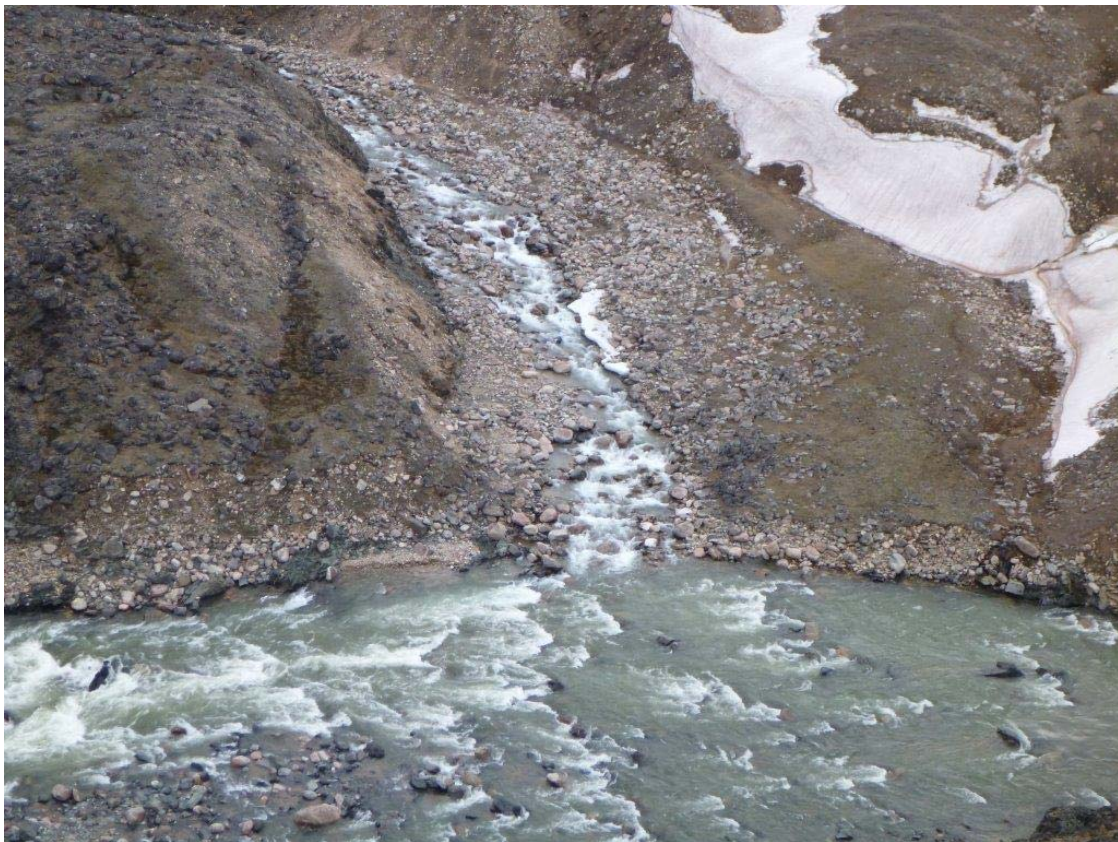
Photo 8: View of confluence of tributary with Mary River on June 28 after implementing Action Plan on June 27. Stream is running clear. Note increased flow in Mary River.

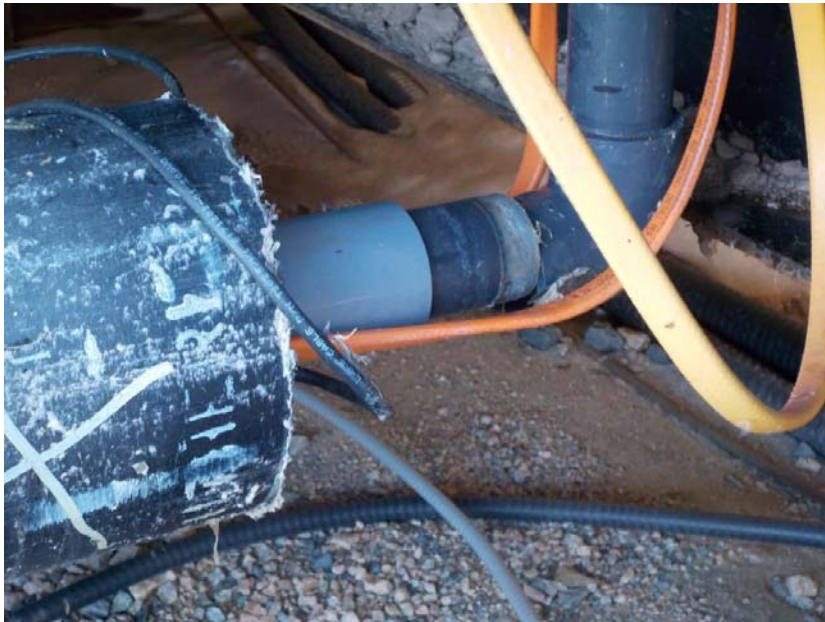
Photo 1 – Failed Joint

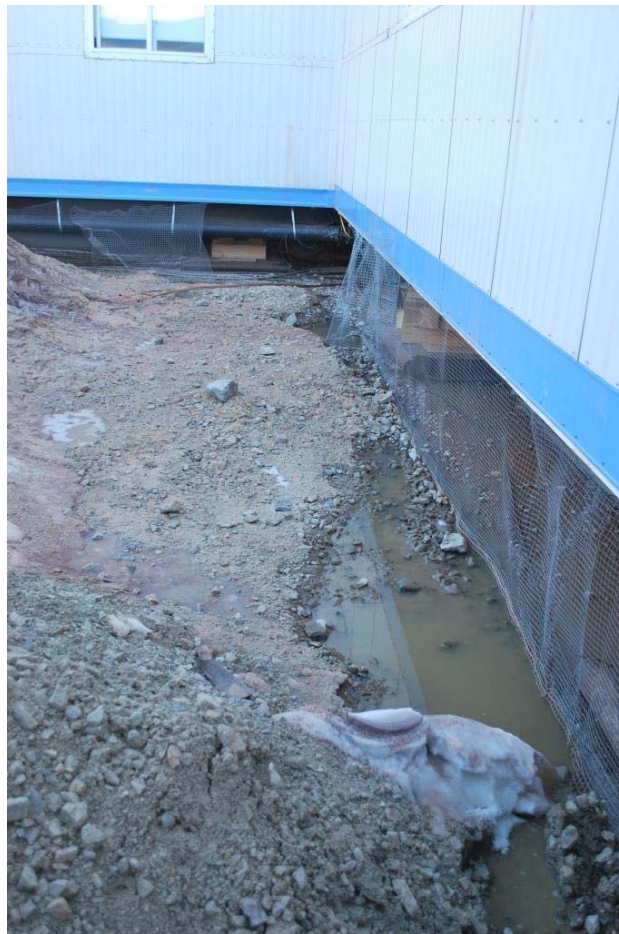
Photo 2 – Sewage Spill underneath MSC Arctic Corridor

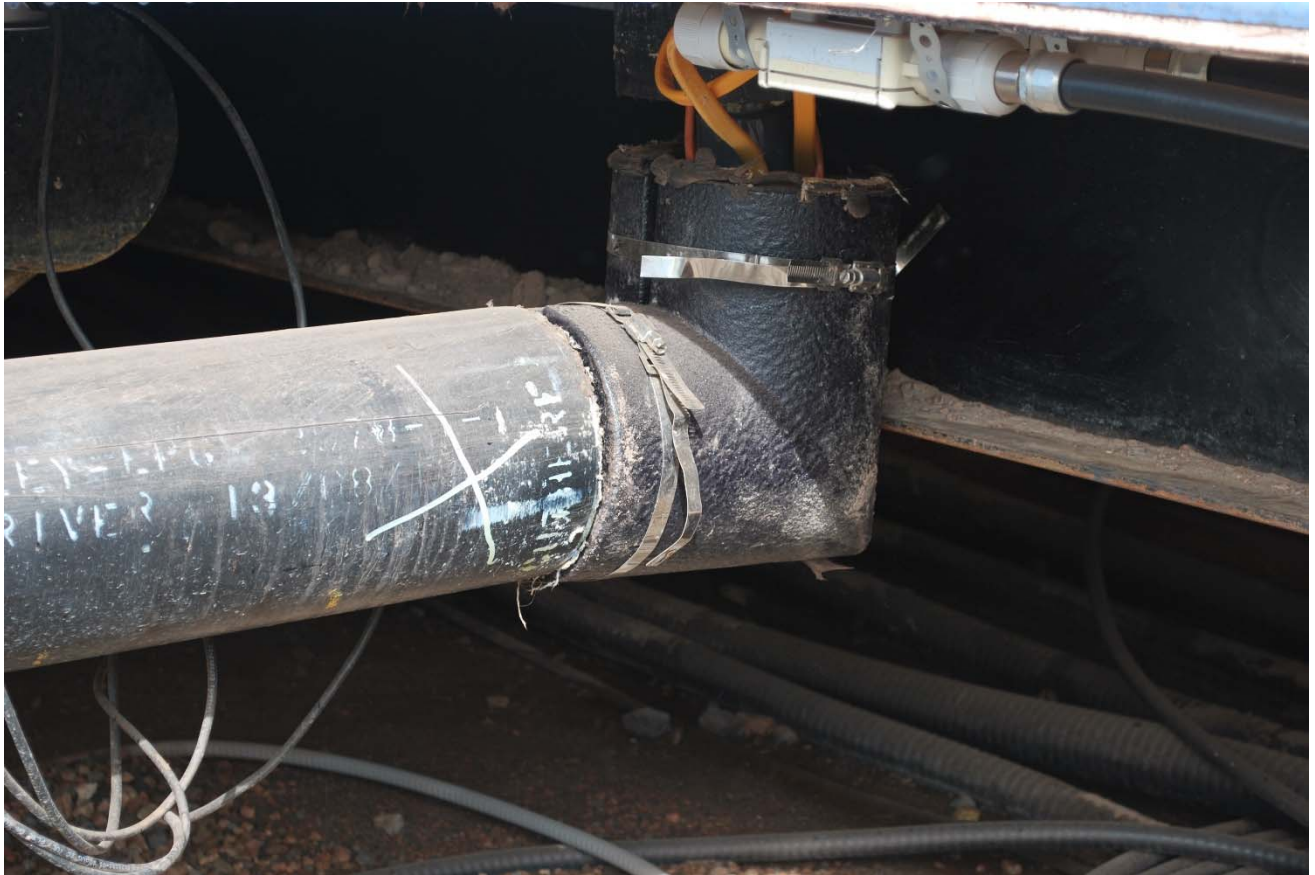
Photo 3 – Repaired Joint

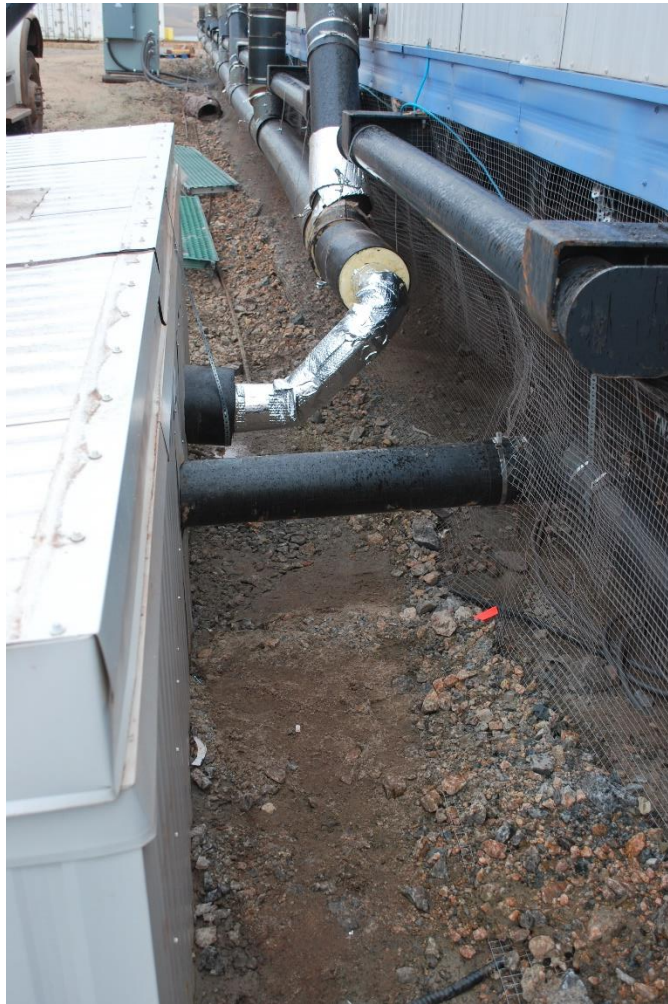
Photo 3 – Repaired Joint

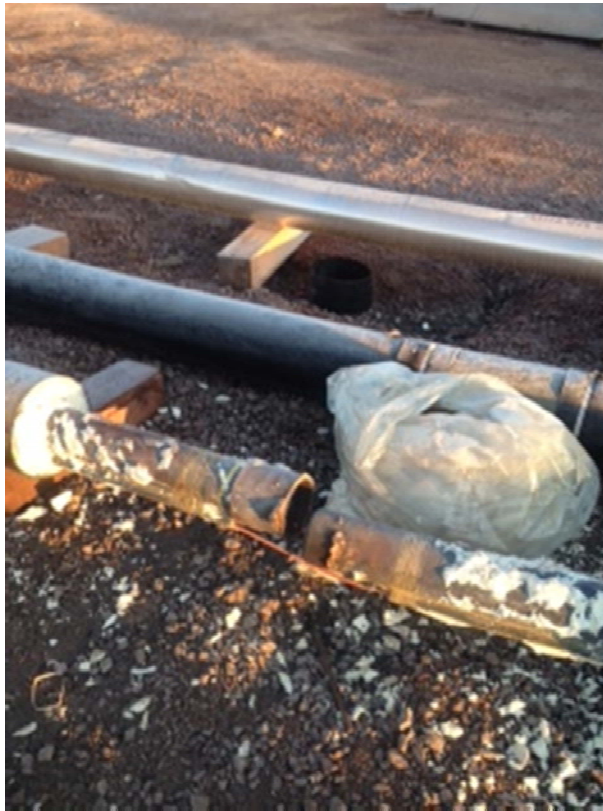
Photo 1 – Failed Joint (Insulation Removed)

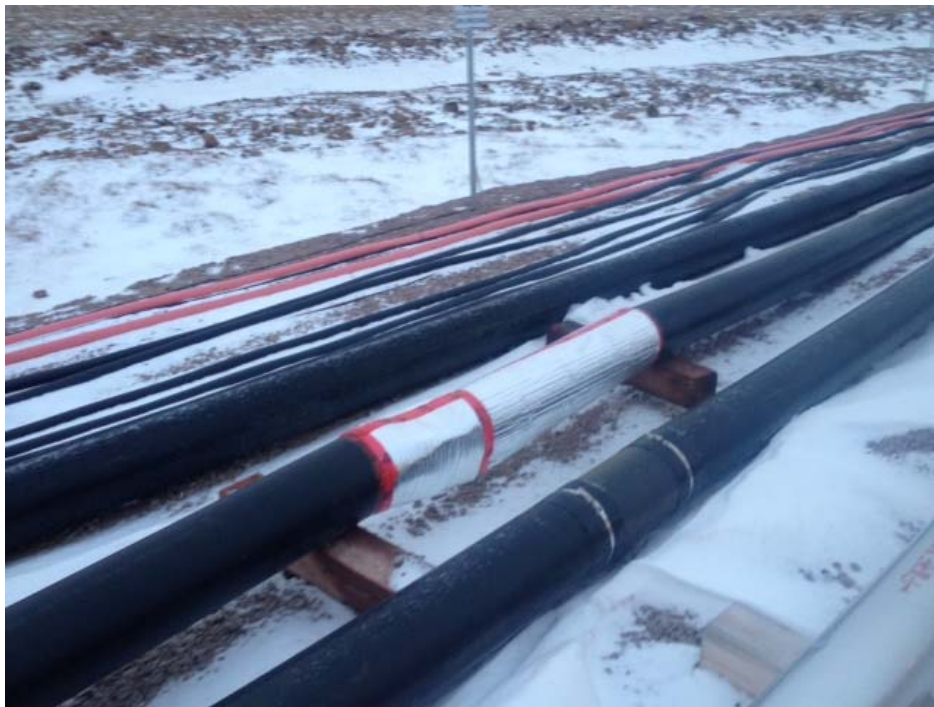
Photo 2 – Repaired Joint

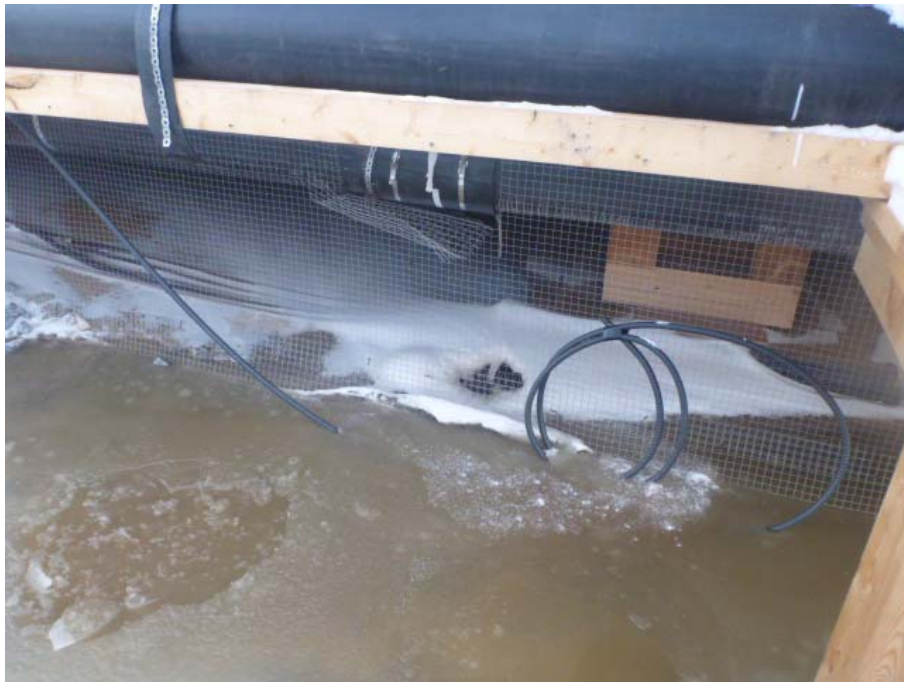
Photo 1 – Failed Joint

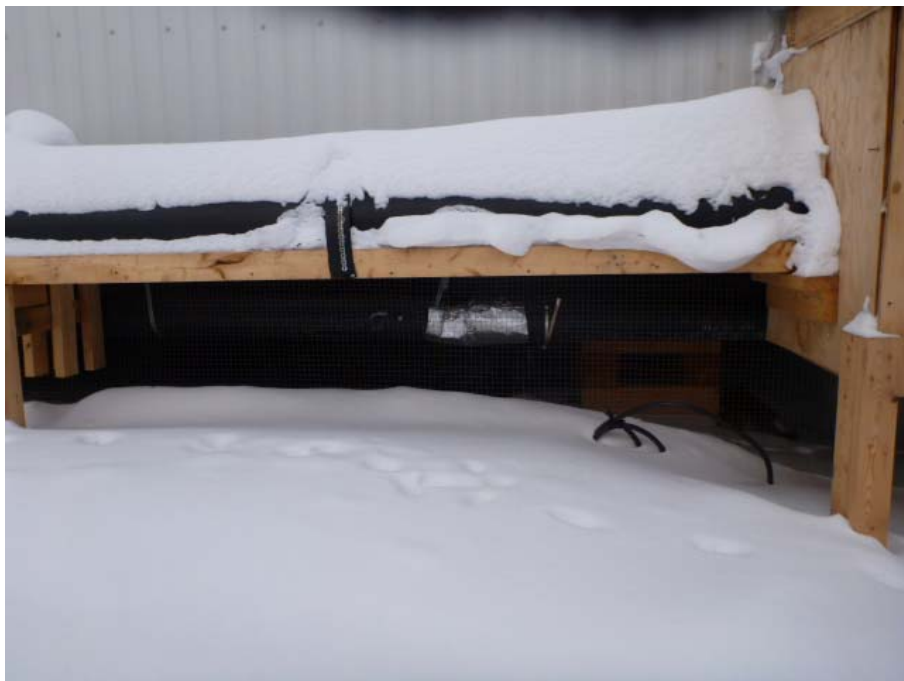
Photo 2 – Repaired Joint

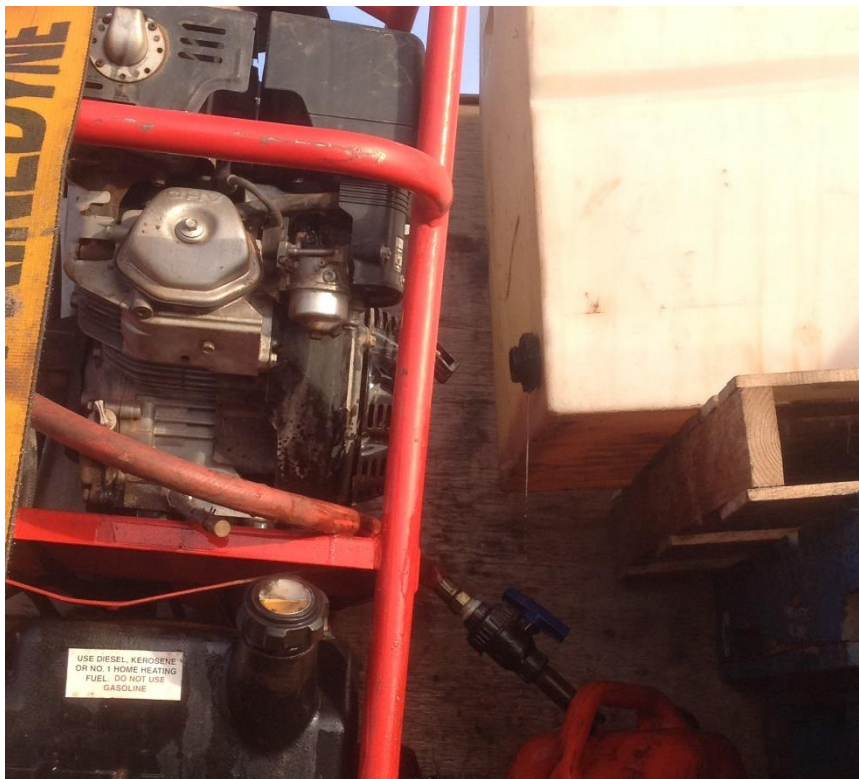
Photo 2 – Broken Fitting

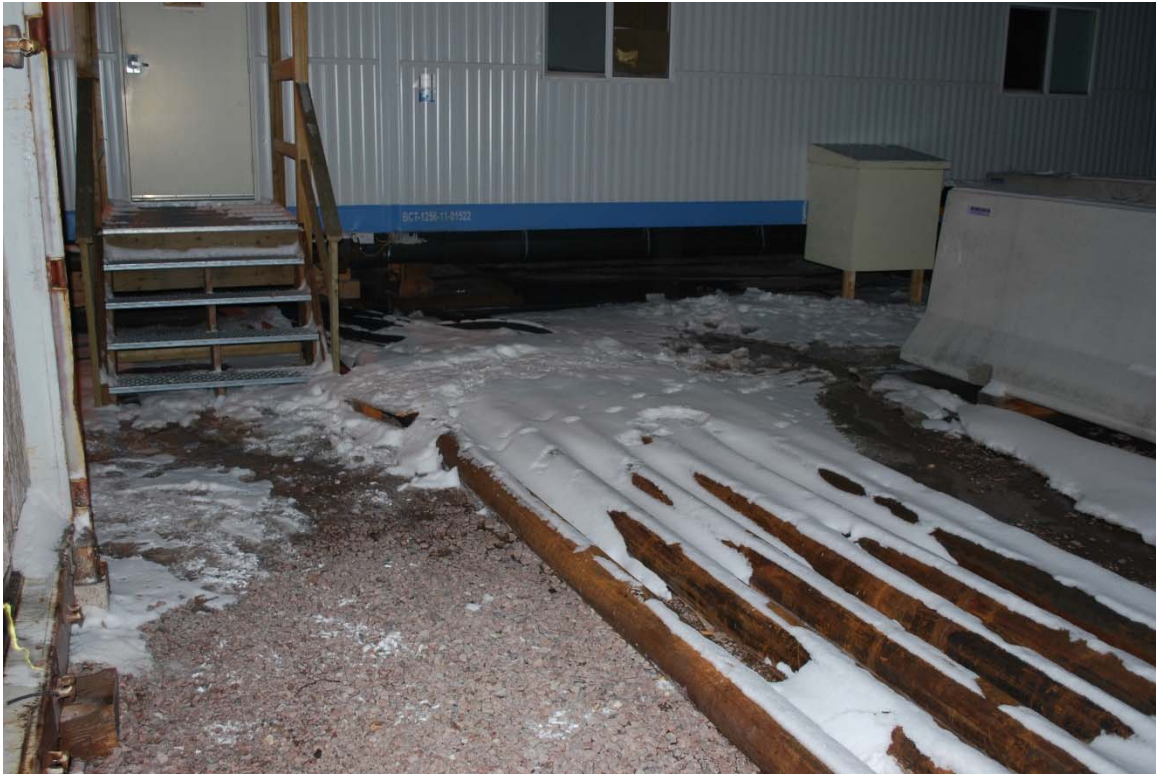
Photo 1 – Sewage Spill Outside Main Lift Station

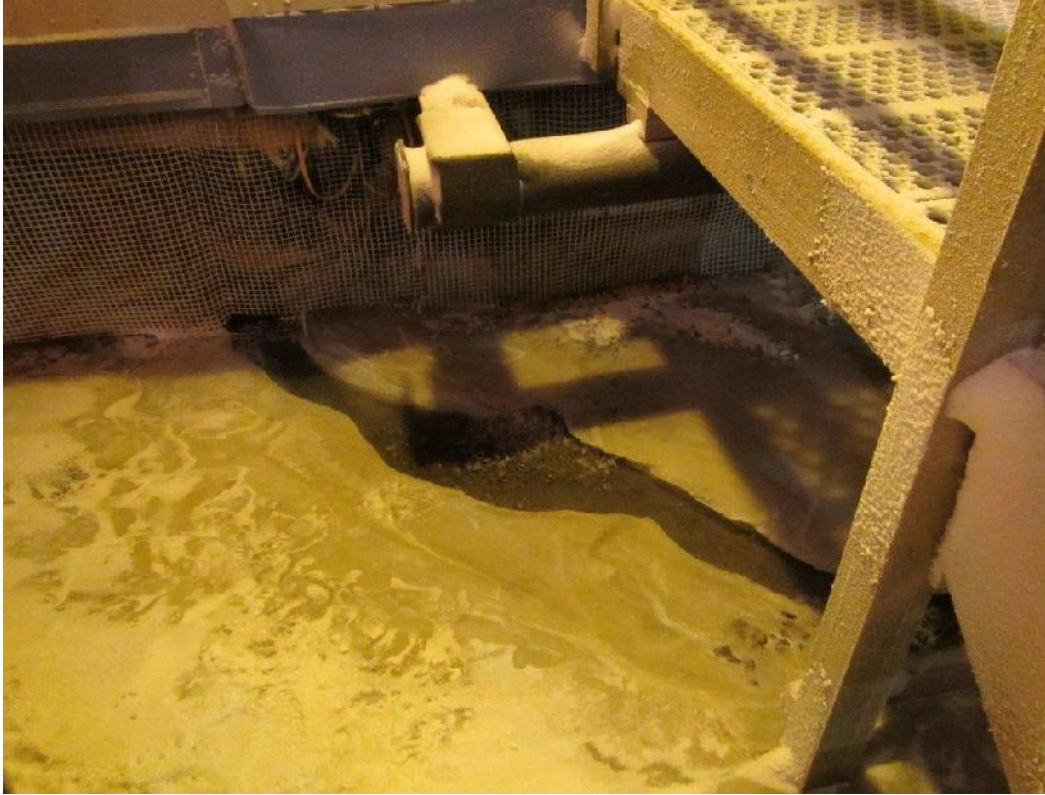
Photo 1 – Sewage Spill

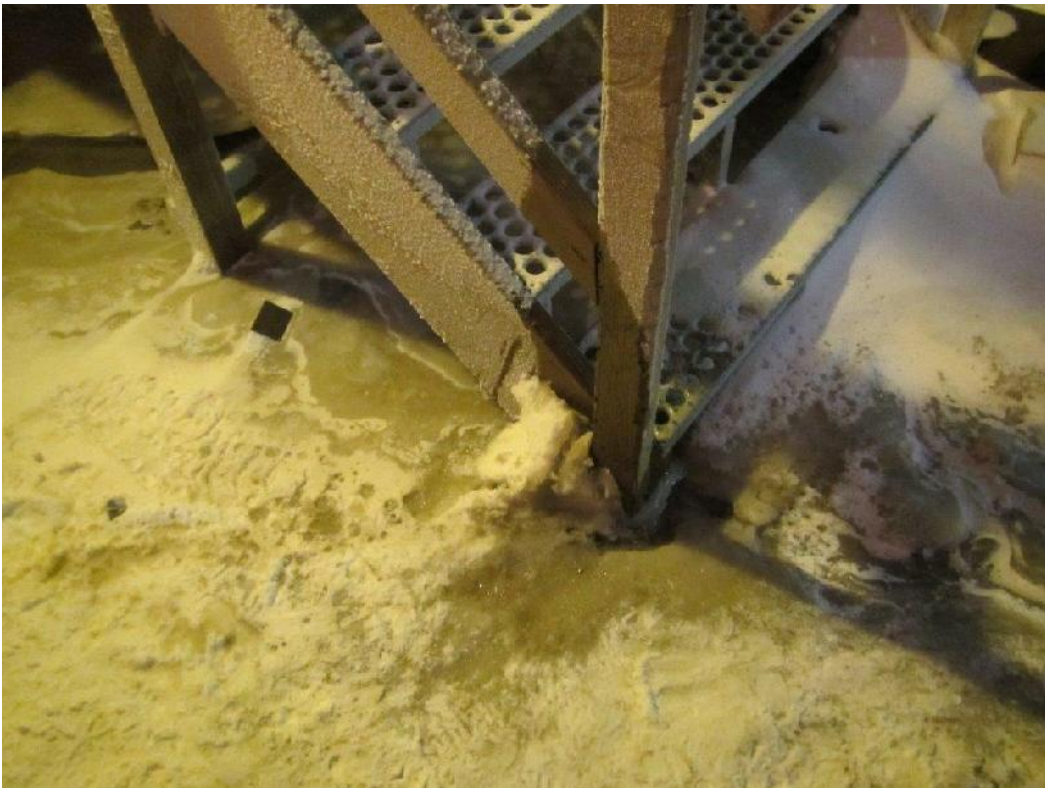
Photo 2 – Sewage Spill
