Photos of August 16th 2014 Inspection – 2BE-MSX0712

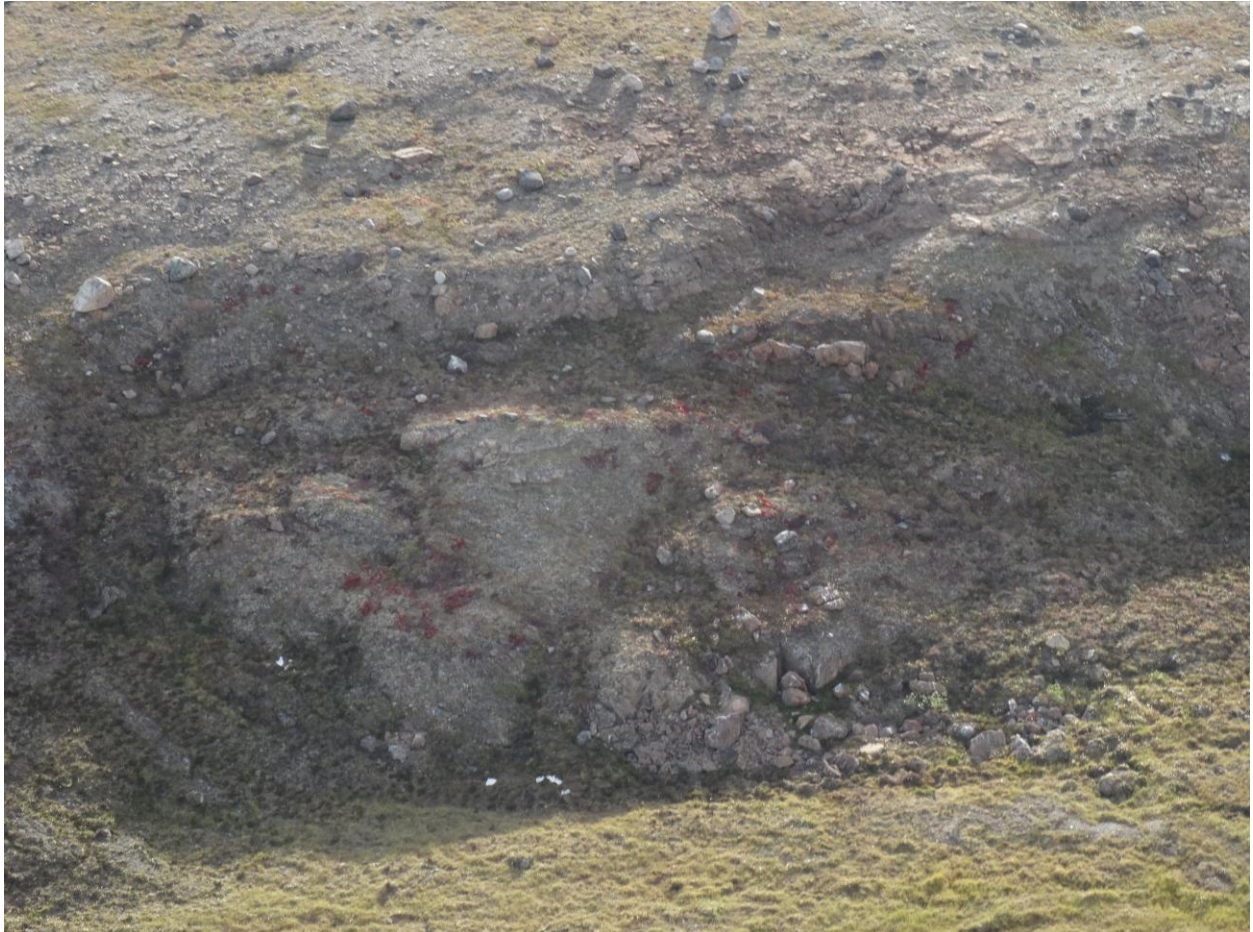
Figure 1. Waste noted on back of hill upslope from historic camp location (a).

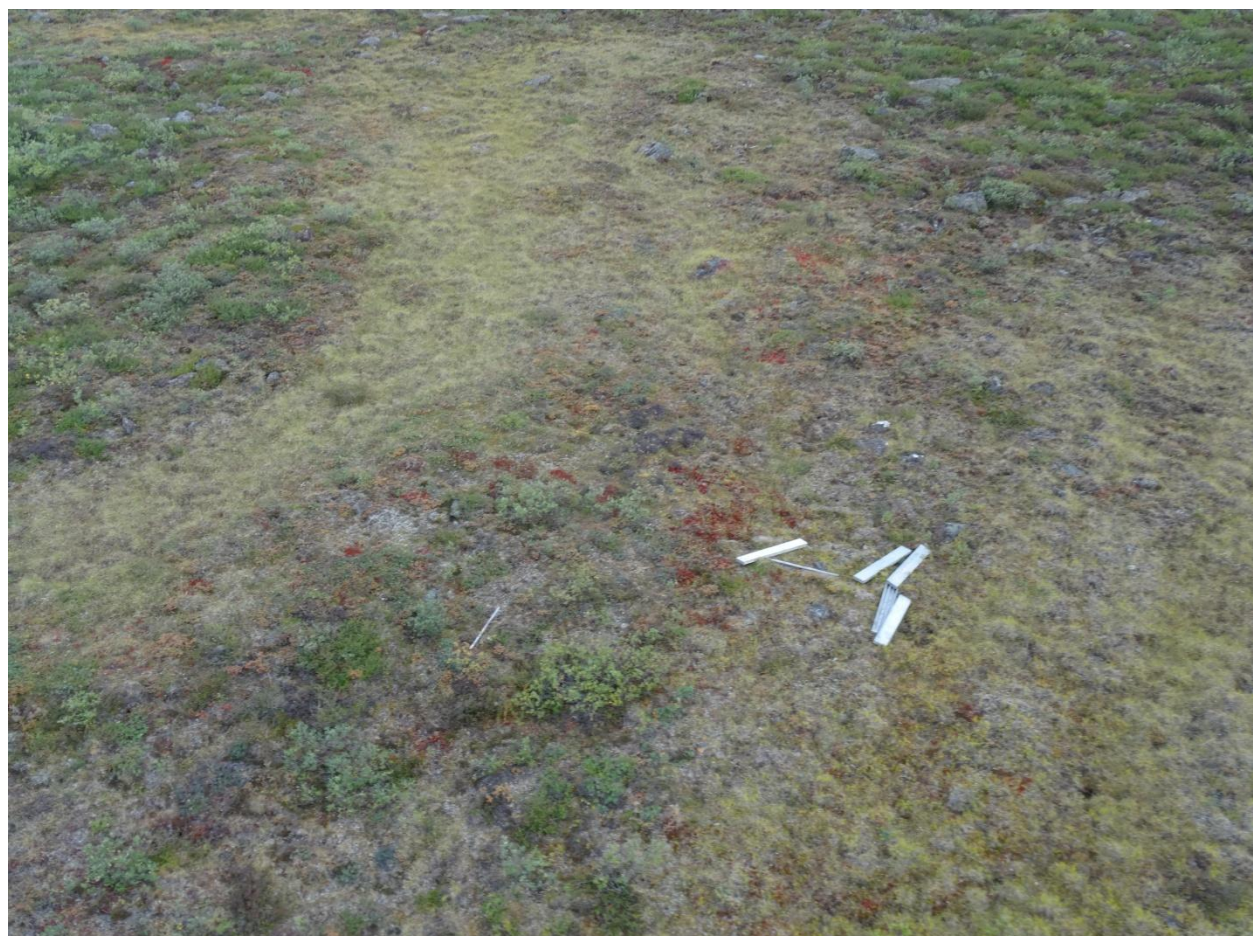
Figure 2. Drill location c). Smaller debris was noted at other drill sites.

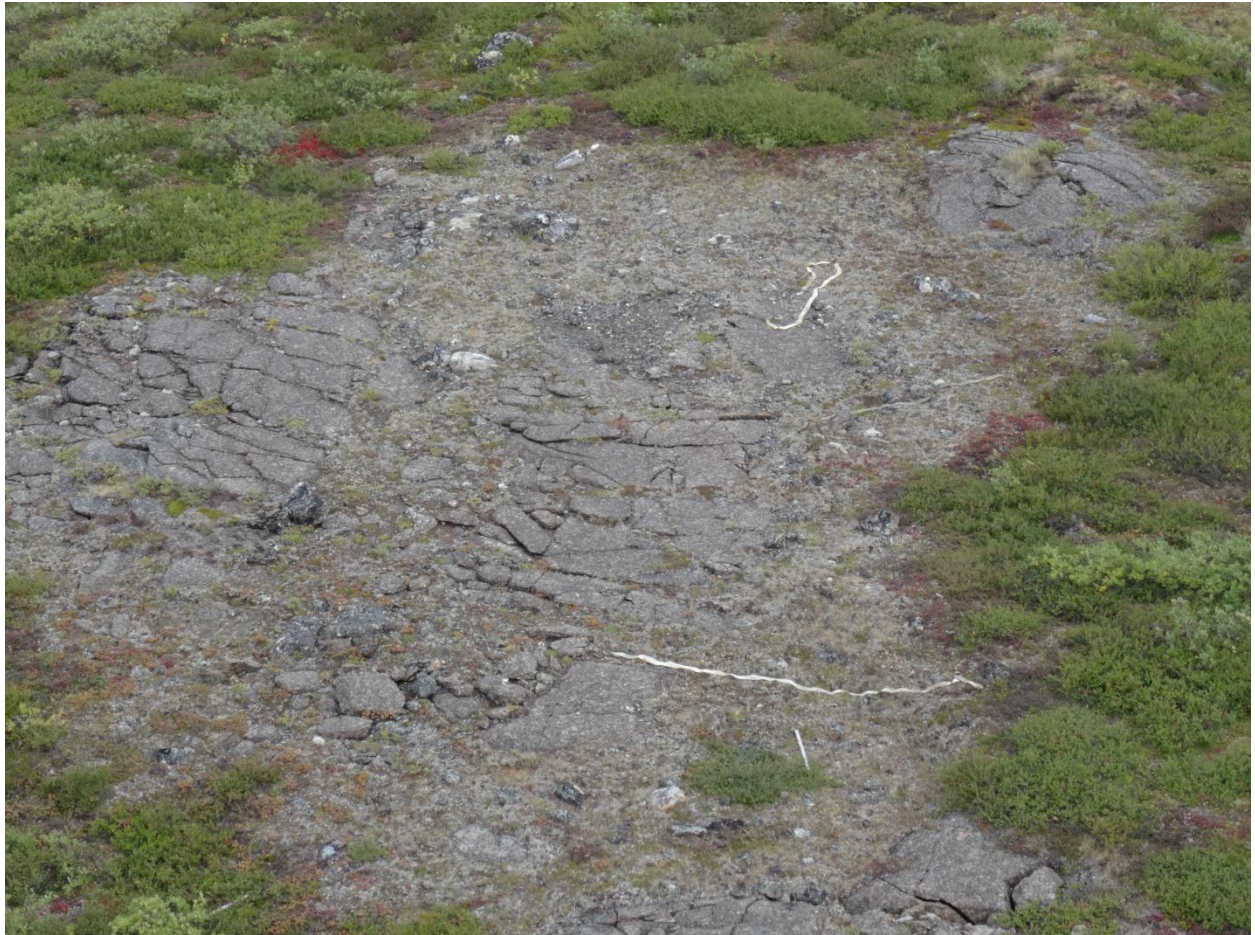
Figure 3. Cargo straps on bare patch to the north of location c).

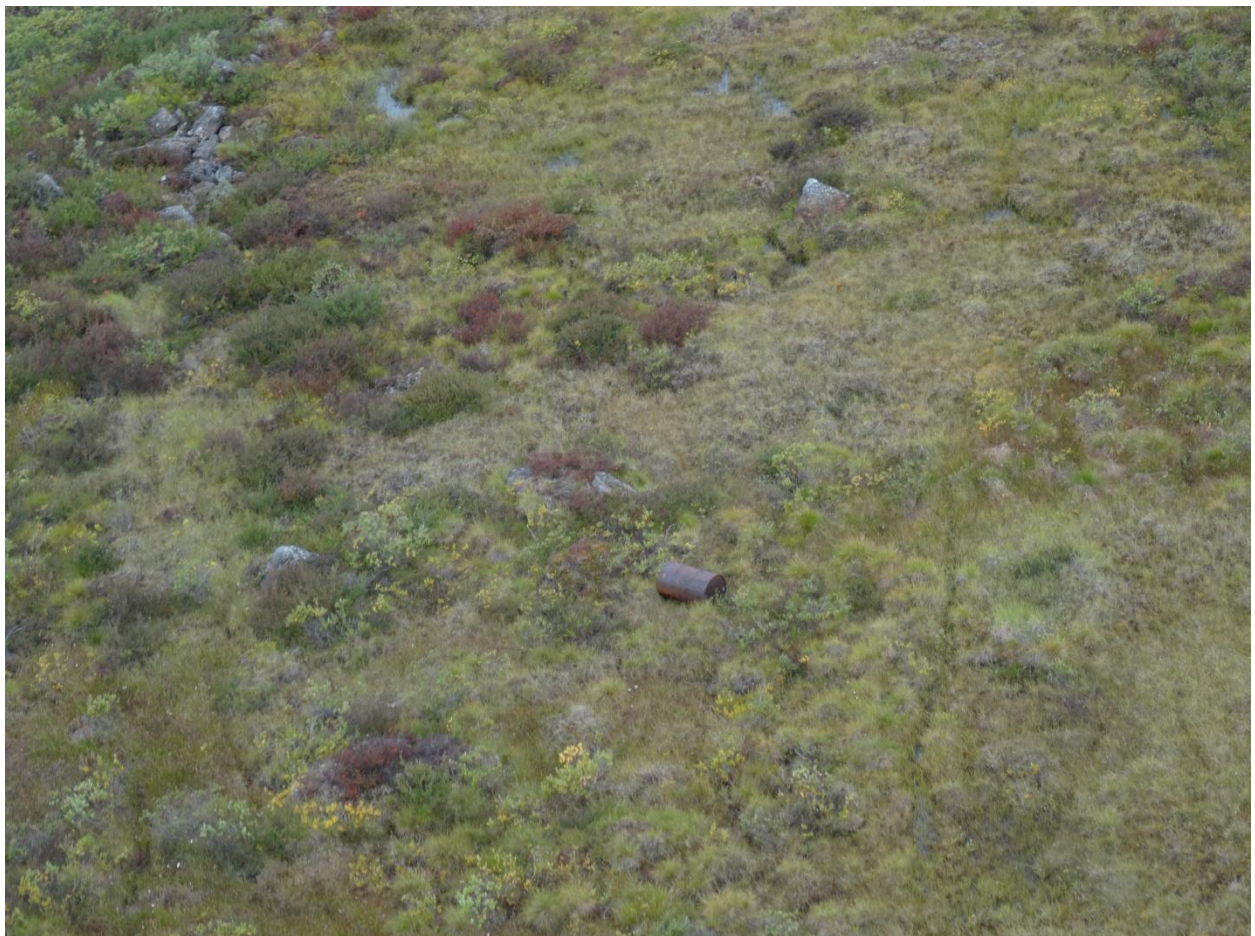
Figure 4. Barrel noted downslope from drill location c).

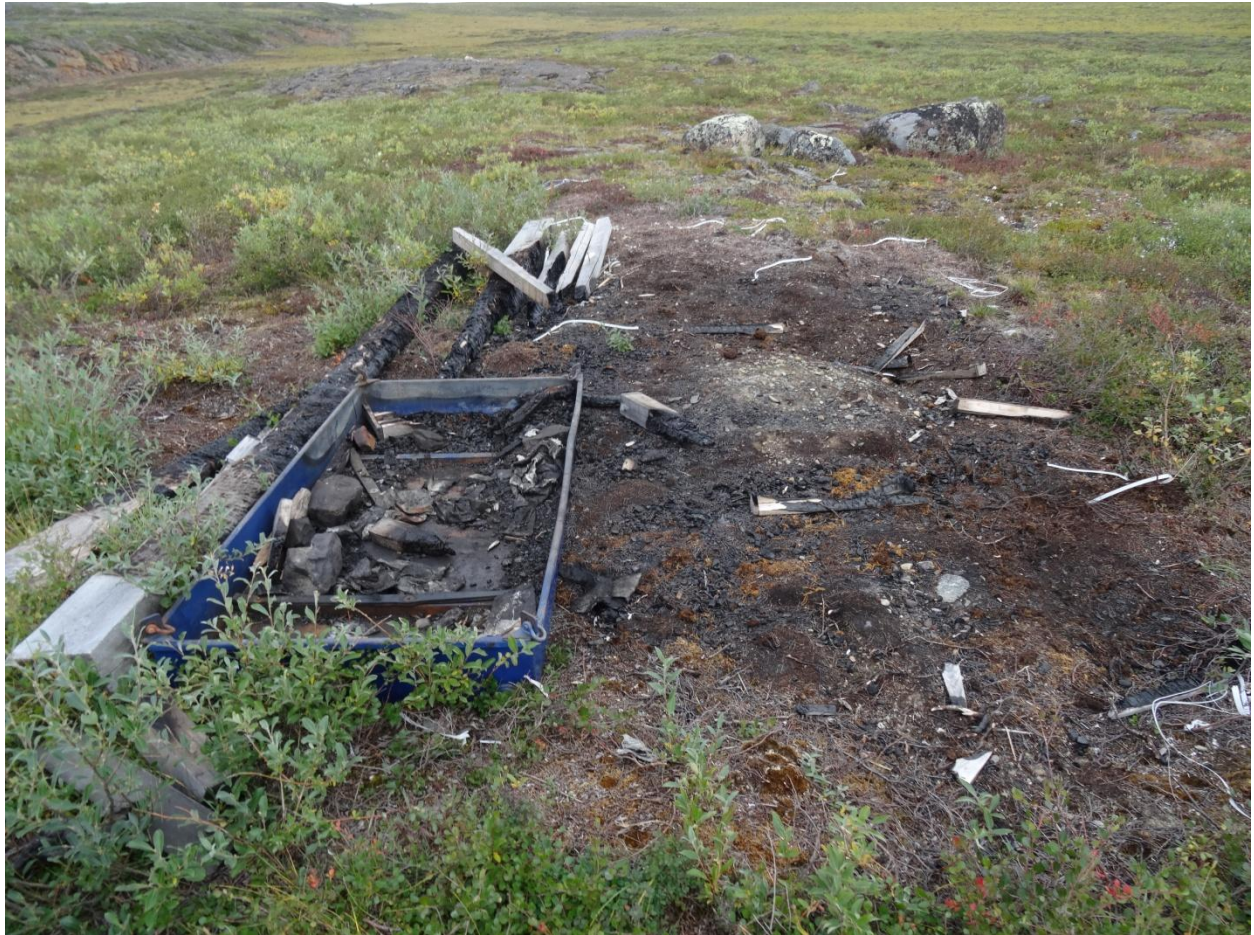
Figure 5. Partially burned debris left at location e).

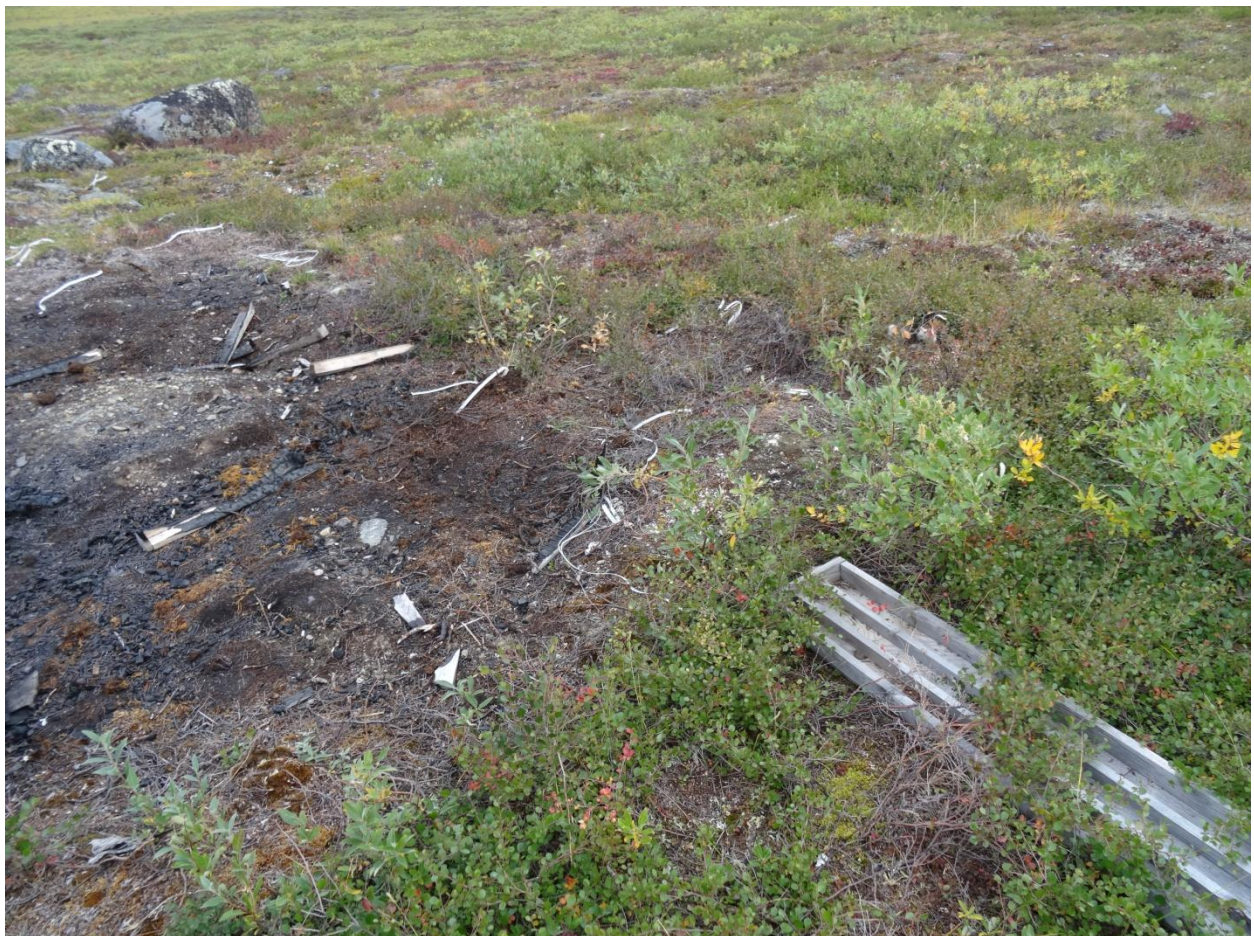
Figure 6. More debris at location e).

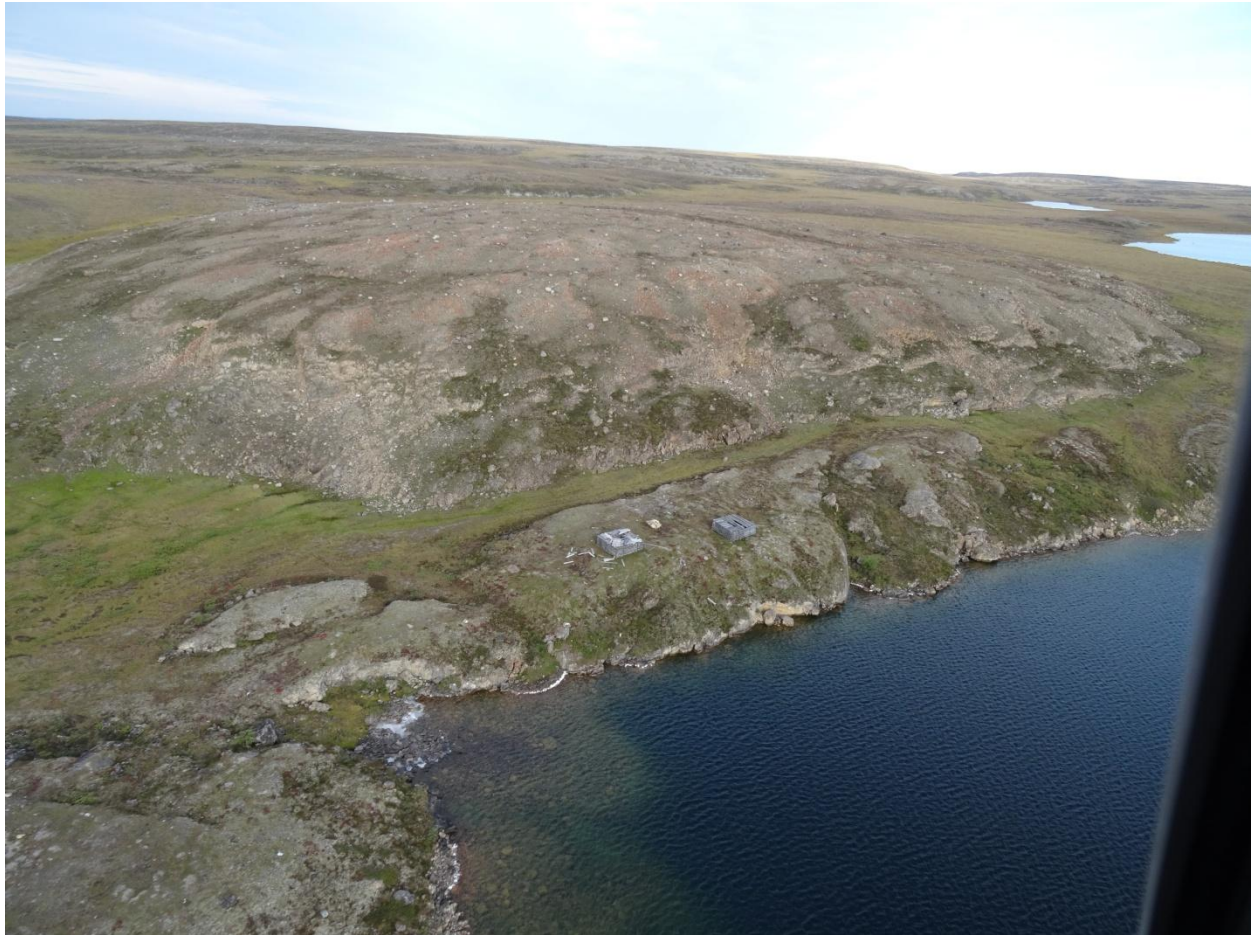
Figure 7. Core racks poised on the side of the hill, close to the camp location a).

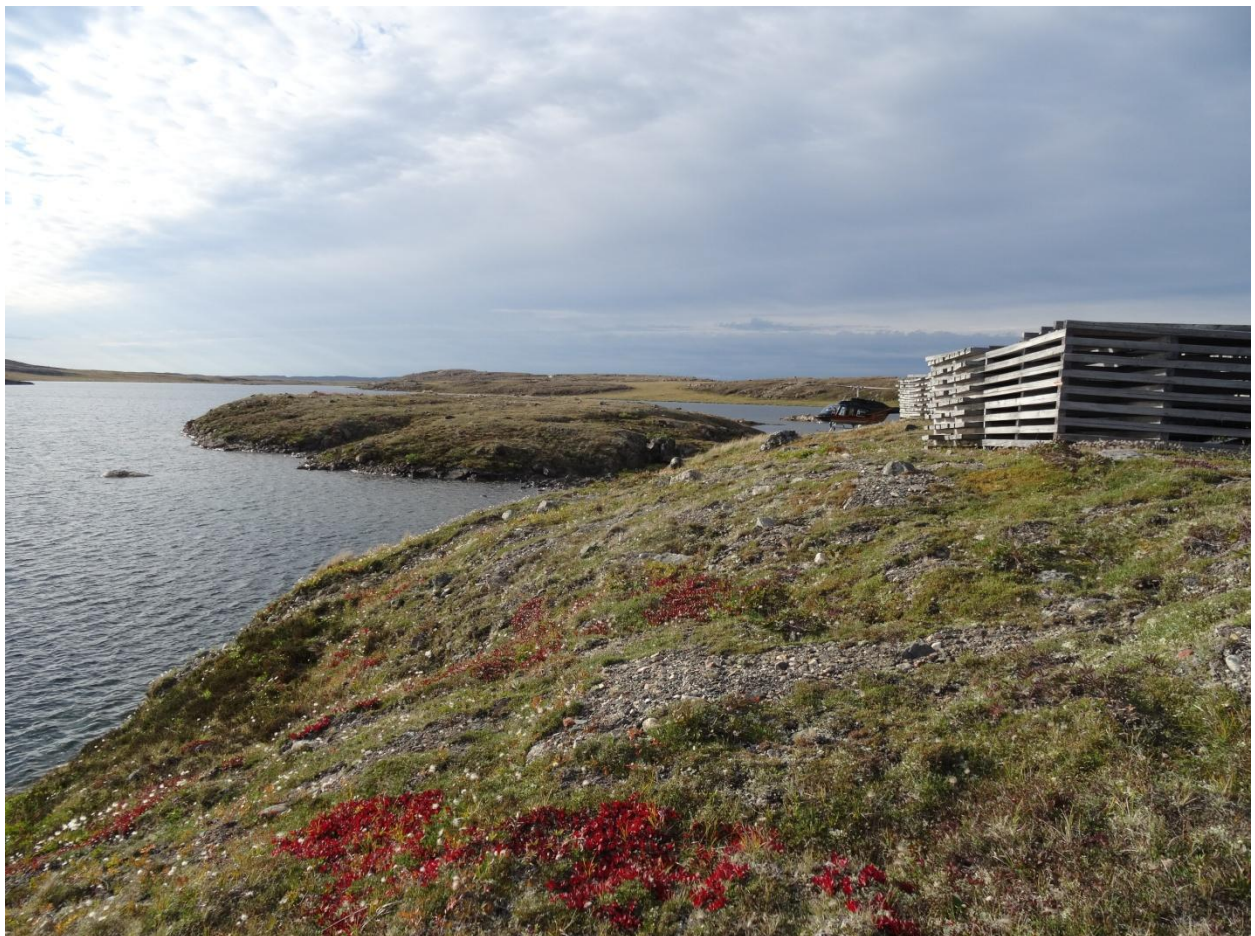
Figure 8. Steep slope from the core racks to the lake. Racks are also within 30m of the water.

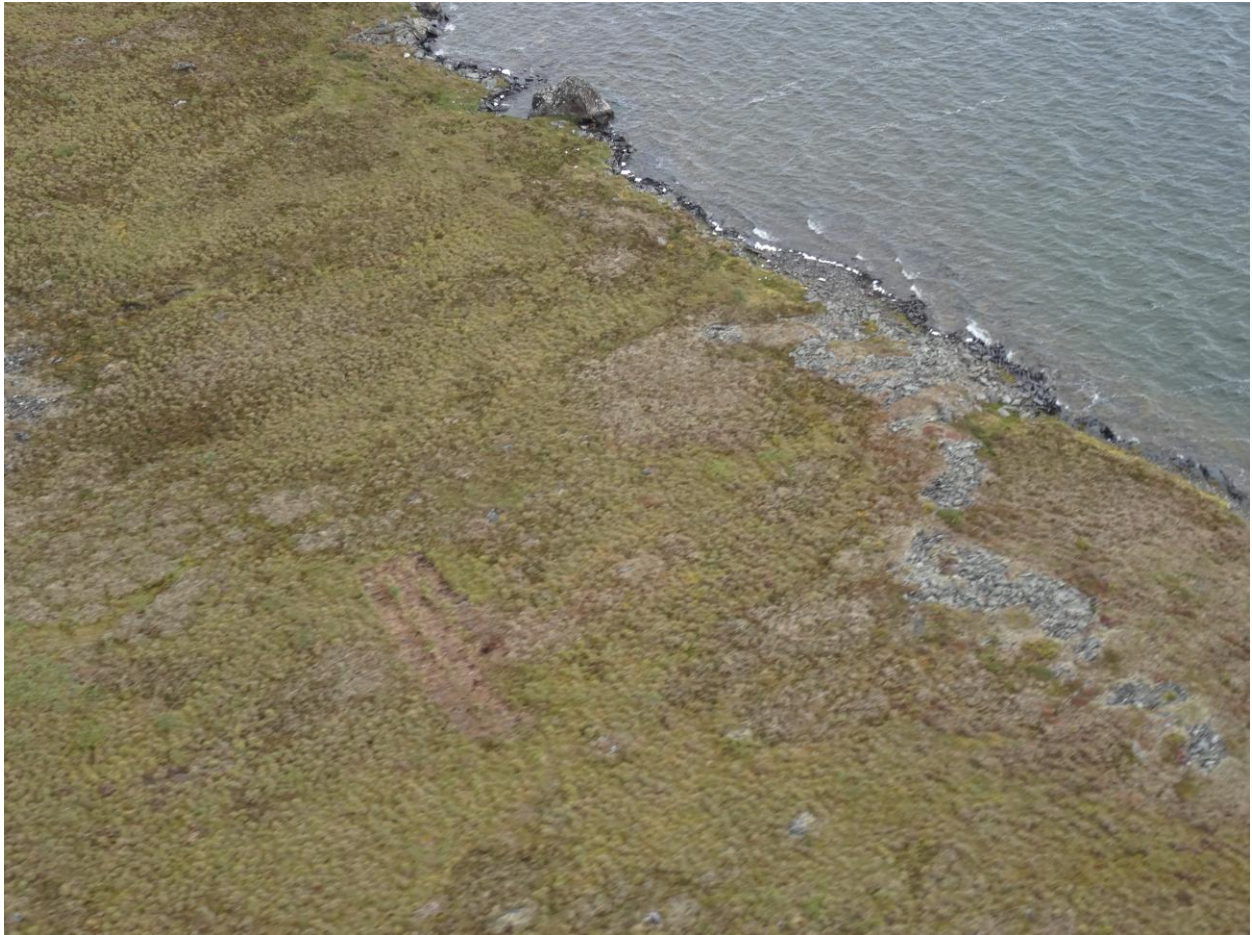
Figure 9. Fuel cache at location b). Dark spot is a hydrocarbon stain.

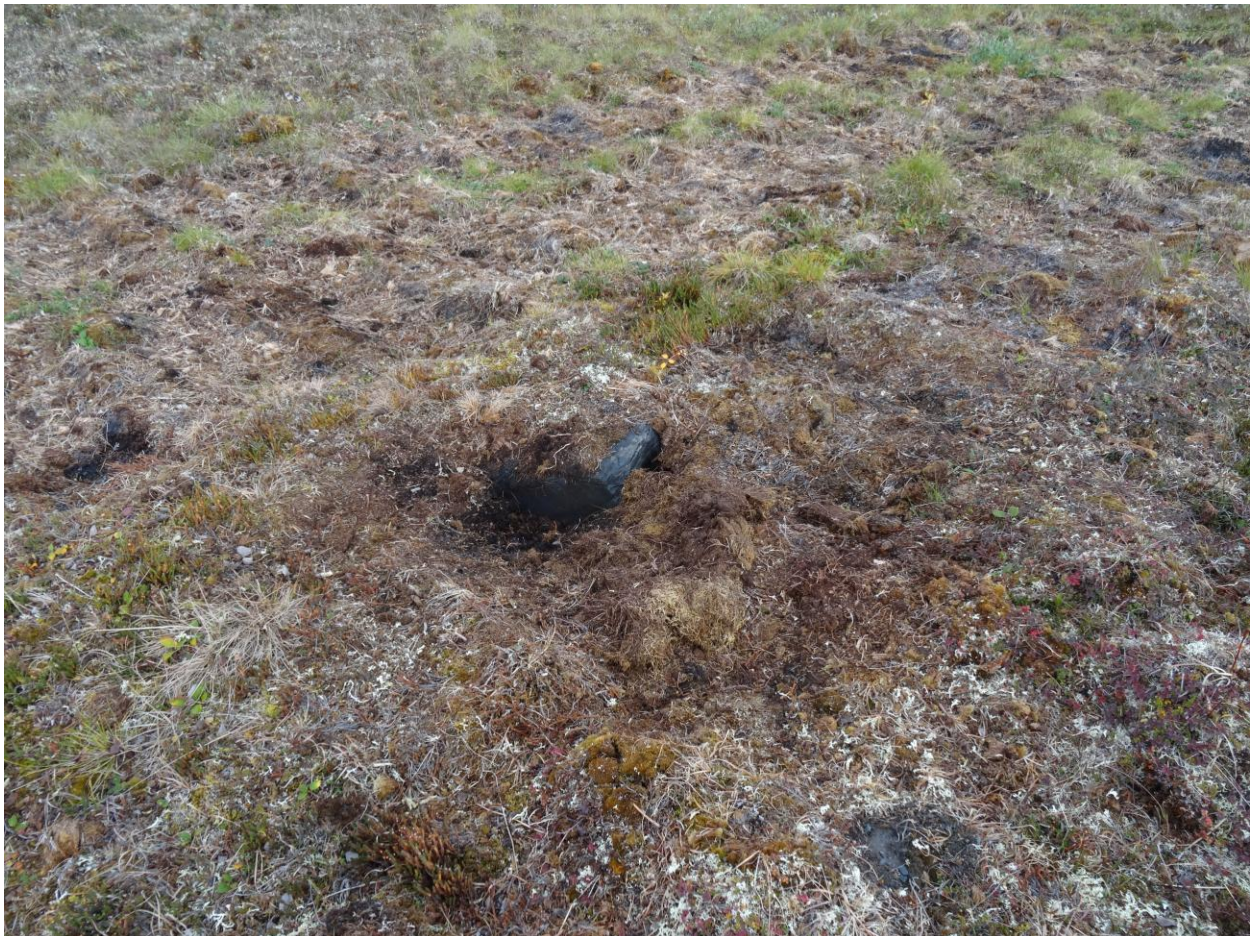
Figure 10. Closer view of hydrocarbon stain at b). Strong hydrocarbon smell remains in the humic (organic) layer.
