Date: August 12, 2015

2BE-MSX0712 SITE RESTORATION

Silvermet has noted the deficiencies that were reported after your inspections of Silvermet locations dated August 16, 2014 and July 15, 2013.

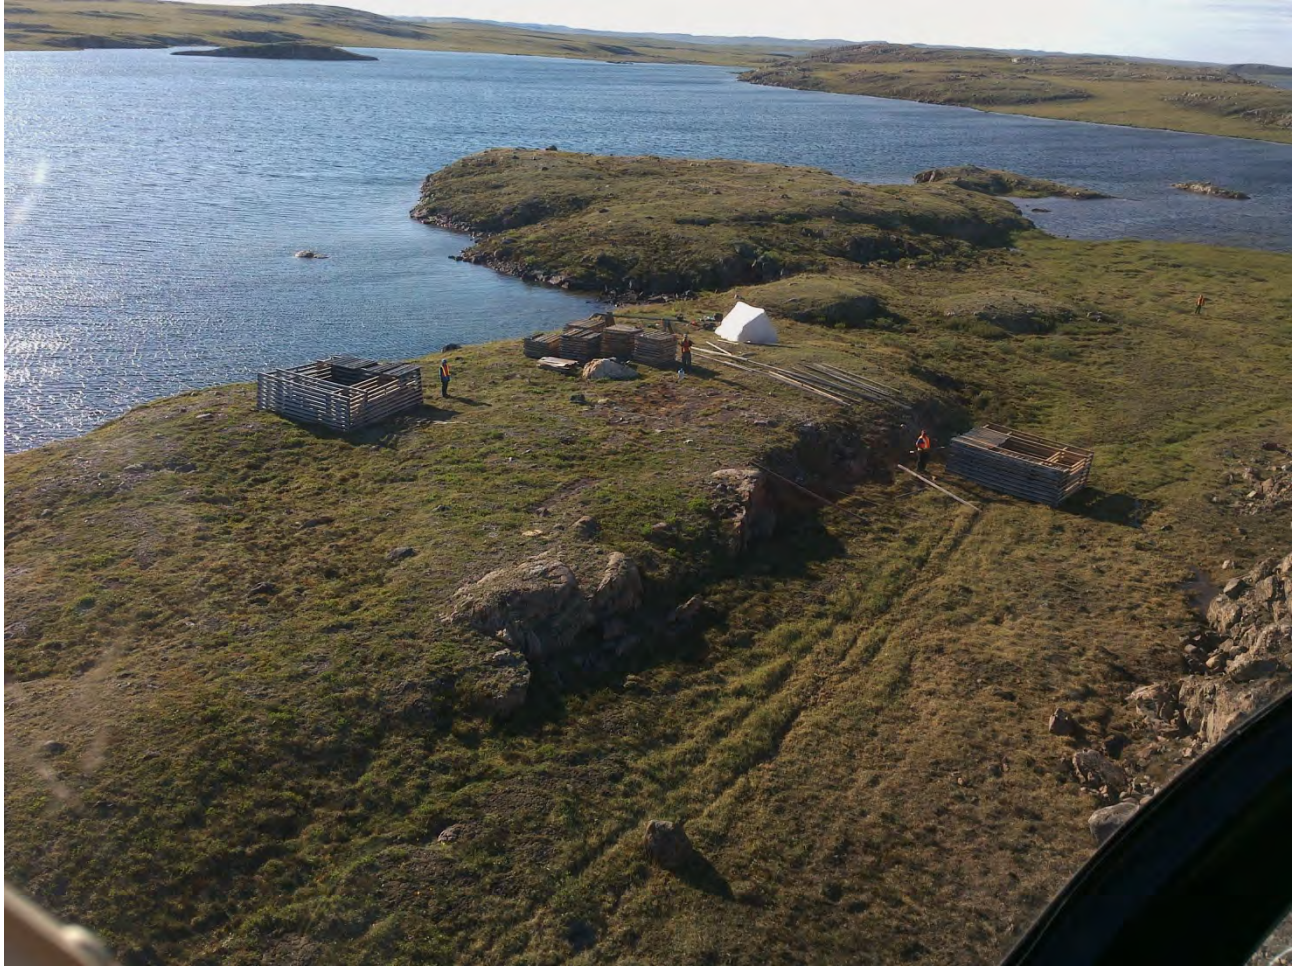
All debris on the back of the hill upslope from the camp location has been cleaned and backhauled. Two 16' by 16' core racks containing approximately 4,000 meters of core samples have been moved at least 20 meters away from the edge of water.

Figure 1: Two 16' by 16' core racks being moved. Left: One third of core boxes still on the first rack. Middle: core boxes. Right: One of the core racks moved into new location.

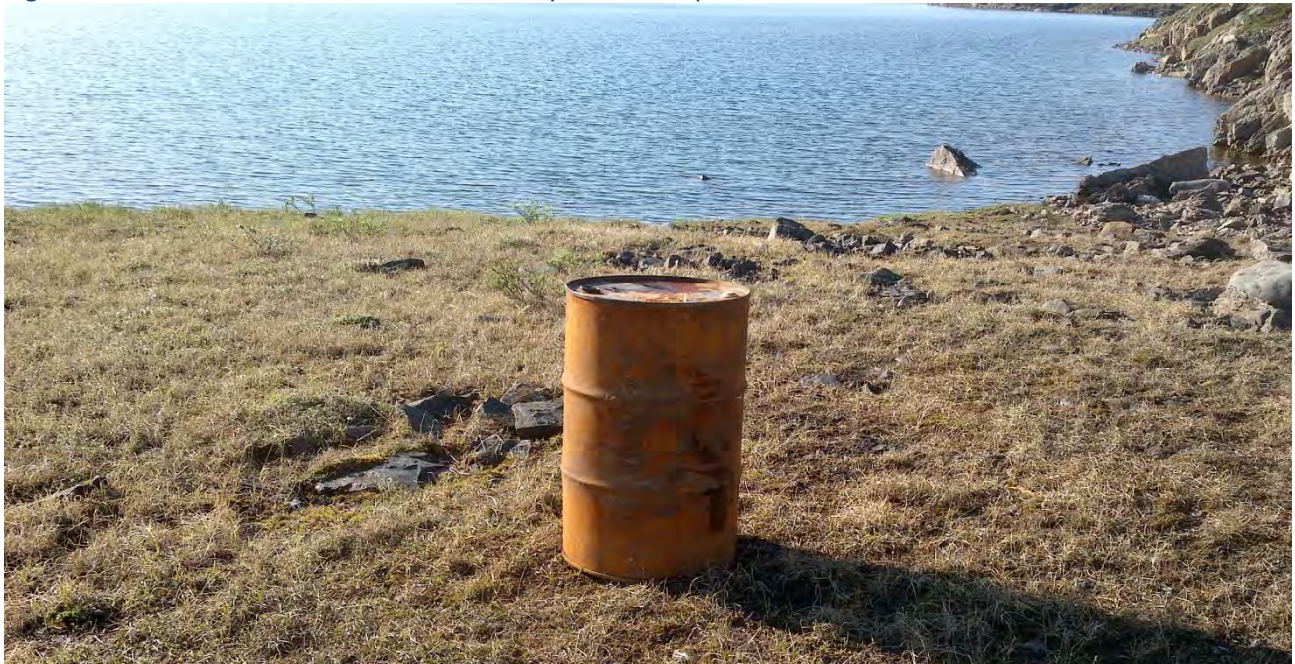
Figure 2: Barrel taken out of lake in the vicinity of the camp site

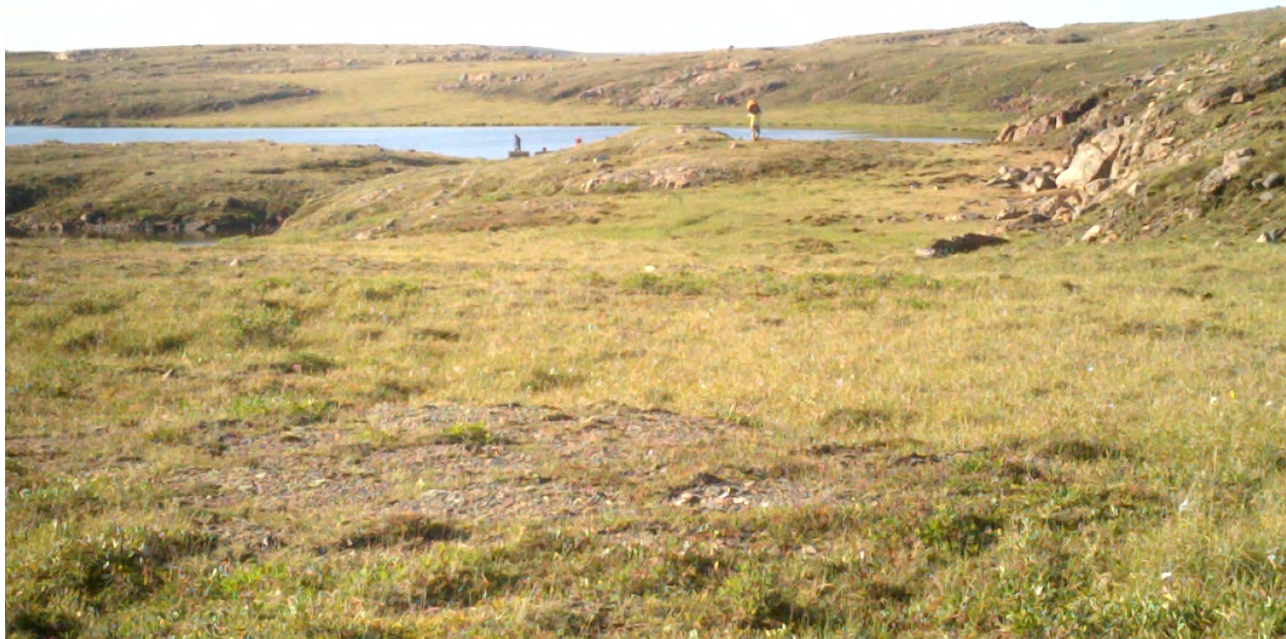
Figure 3: In the distance: Barrel being carried away. Foreground: Cleaned up camp site

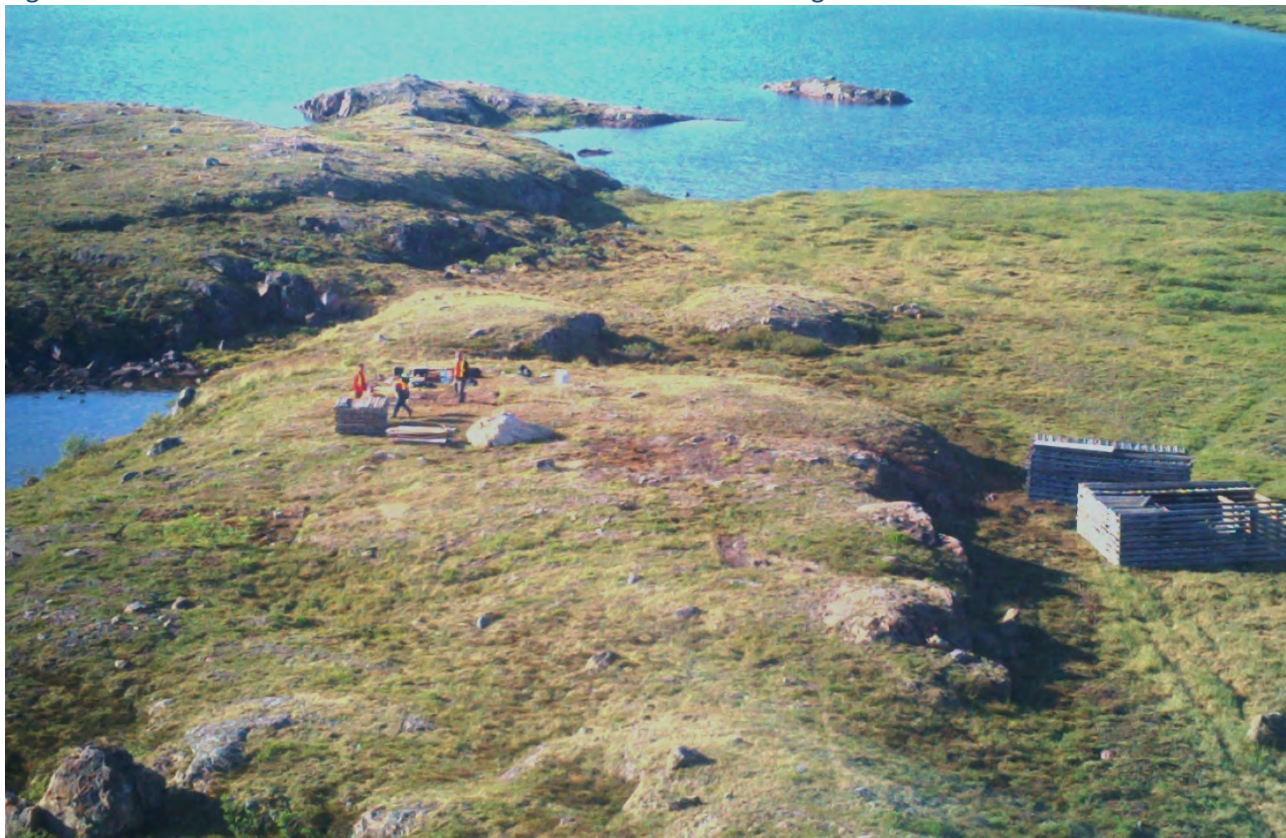
Figure 4: Core racks in new location. Left: some core boxes still being moved.

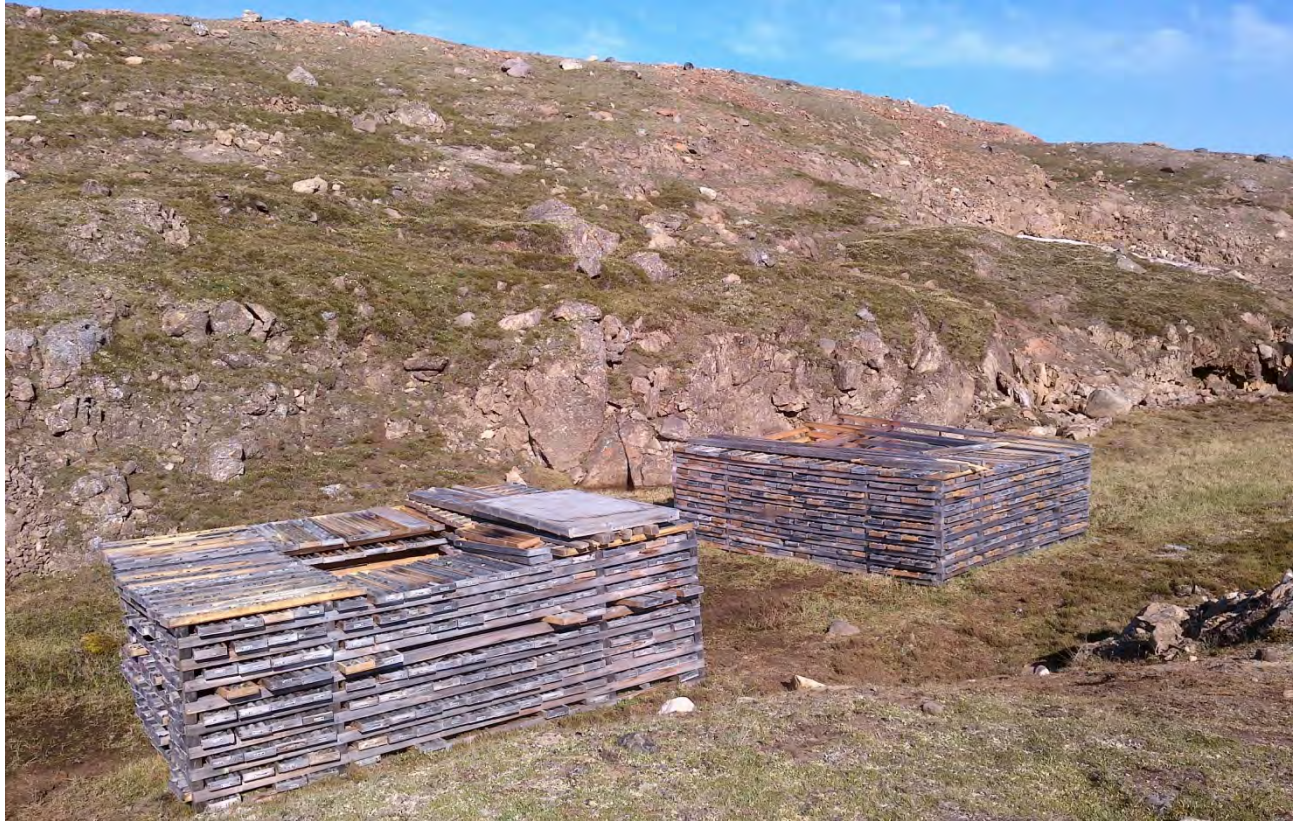
Figure 5: Core racks after completion of move

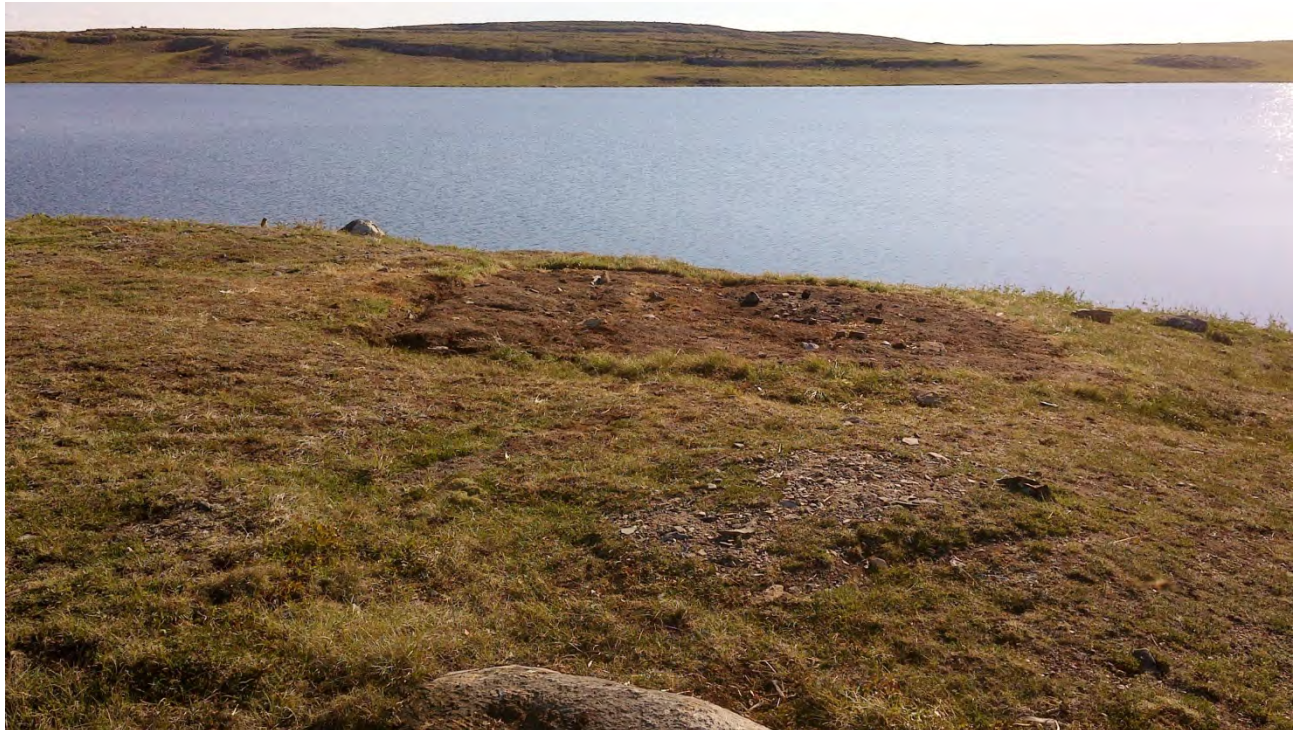
Figure 6: Camp site after clean up – Location of first core rack

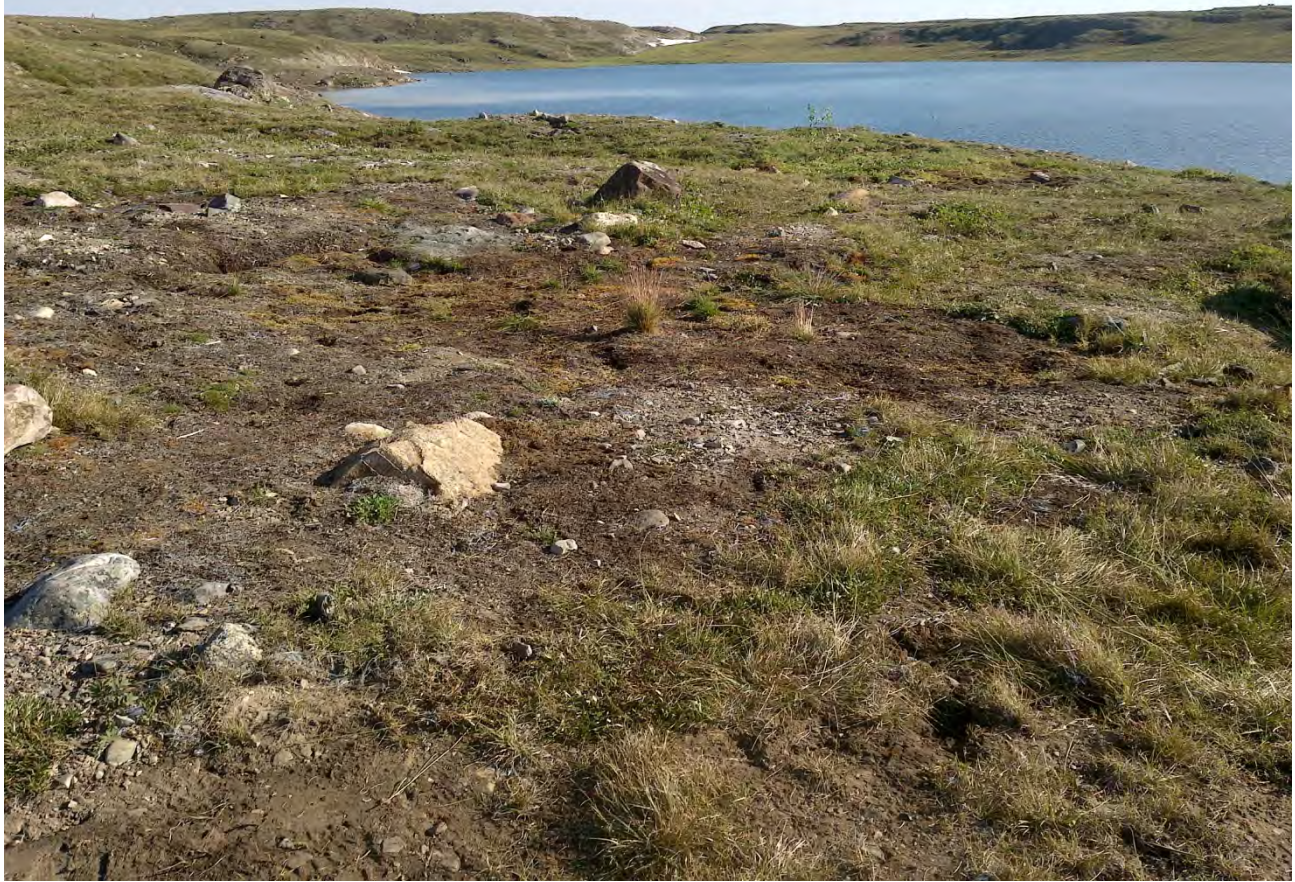
Figure 7: Camp site after clean up – Location of second core rack

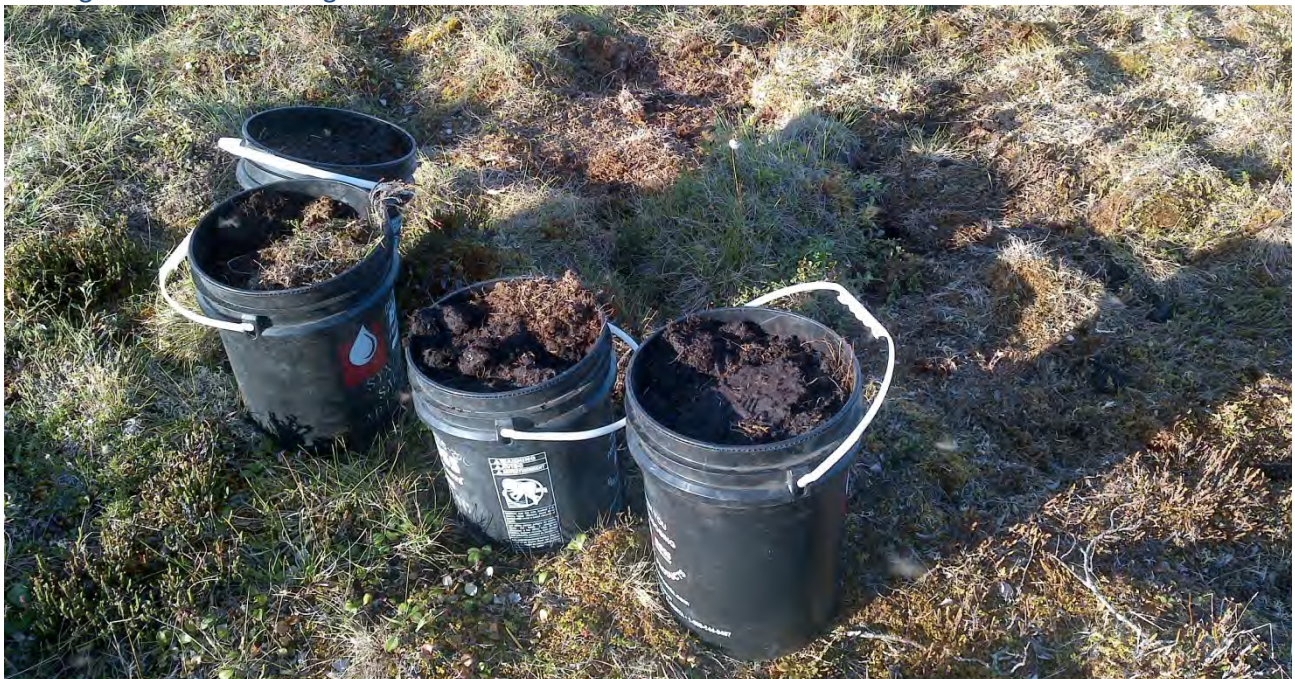
Hydrocarbon impacted soil was located at the fuel cache location with faint hydrocarbon smell. A total of six pales of impacted humic layer were removed and hole was back filled with clean material.

Figure 8: Site of hydrocarbon stain after clean up. Foreground: Four of the six pales with impacted soil. Back and Right: Hole after having been backfilled with clean material.

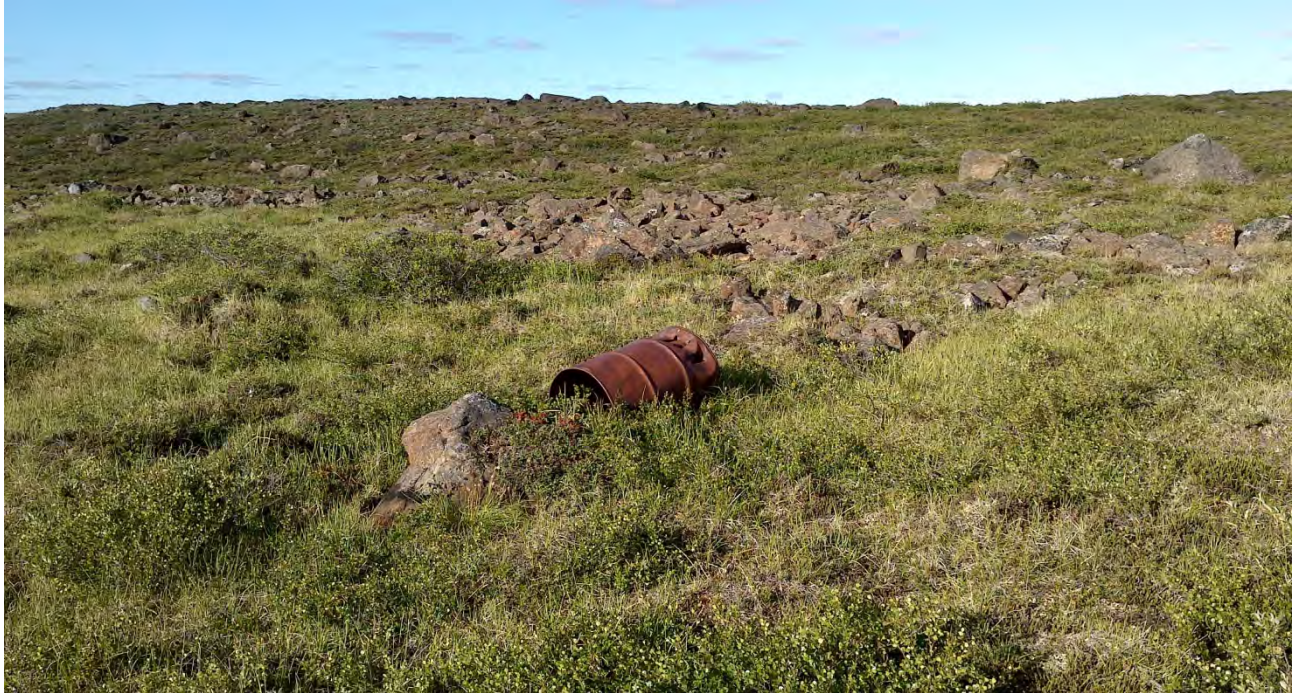
At and in between locations C and D, extensive debris was found. It was noted that while some debris looked relatively new, others were clearly from 1970's and earlier periods. All new material and most of the old material were collected and hauled away.

Figure 9: Barrel down slope before removal

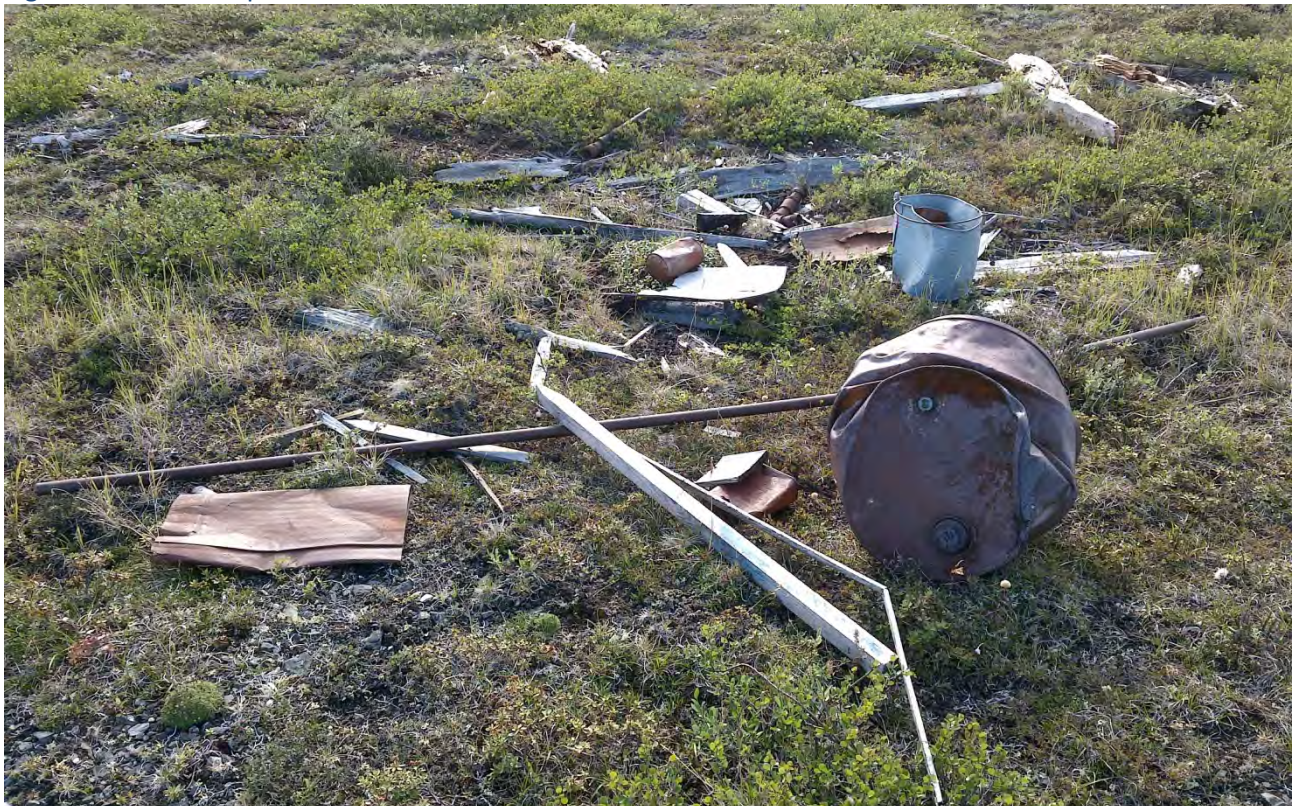
Figure 10: Debris dispersed around locations C & D before removal

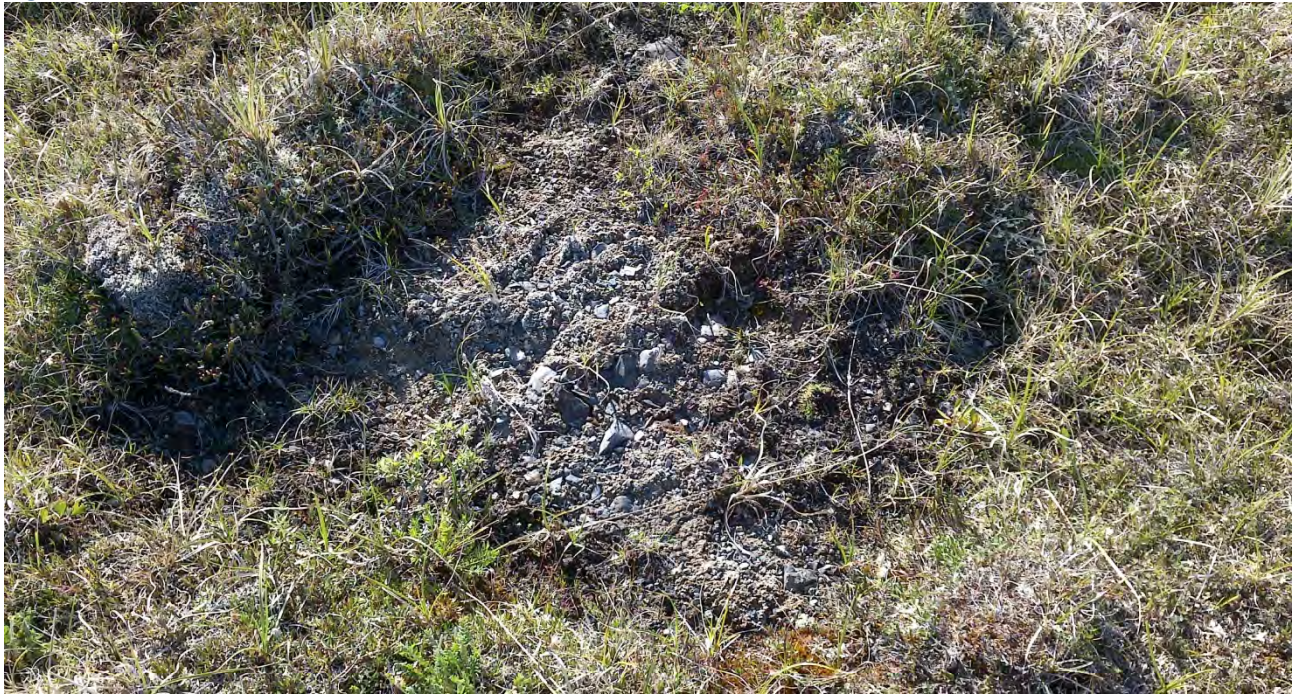
Figure 11: Location C after removal of debris

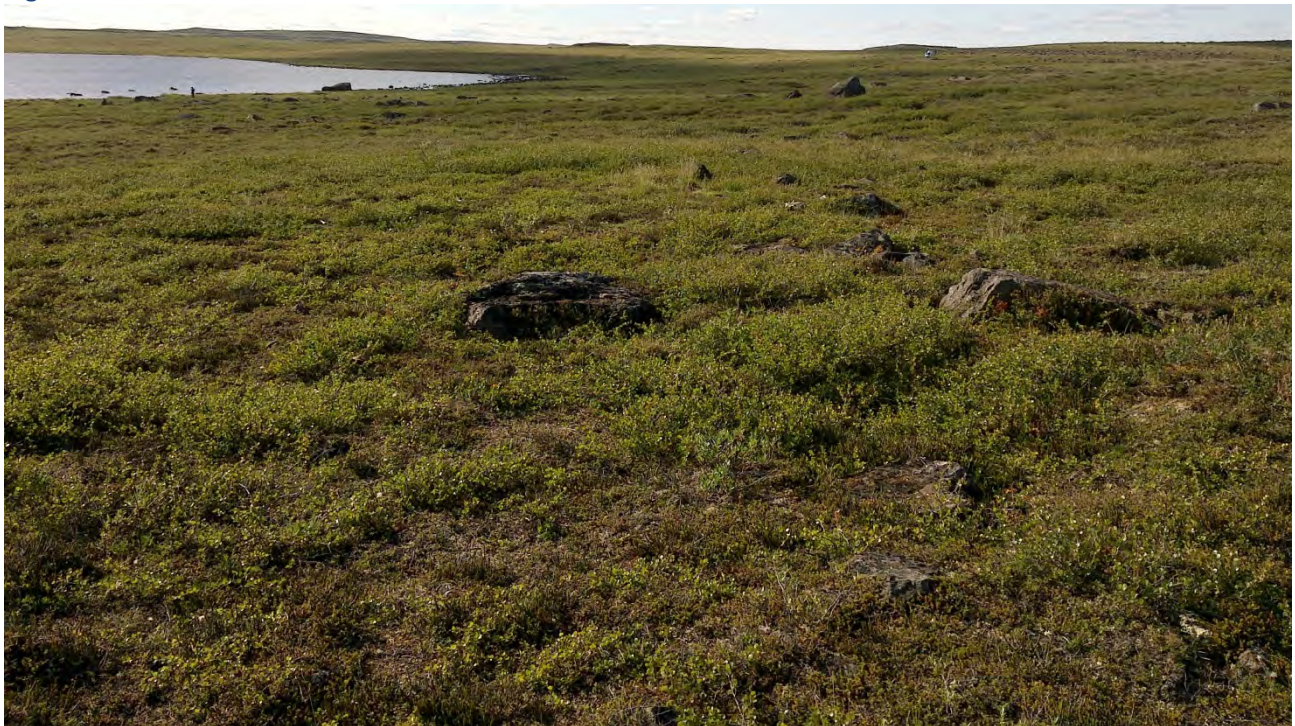
Figure 12: Location D after removal of debris

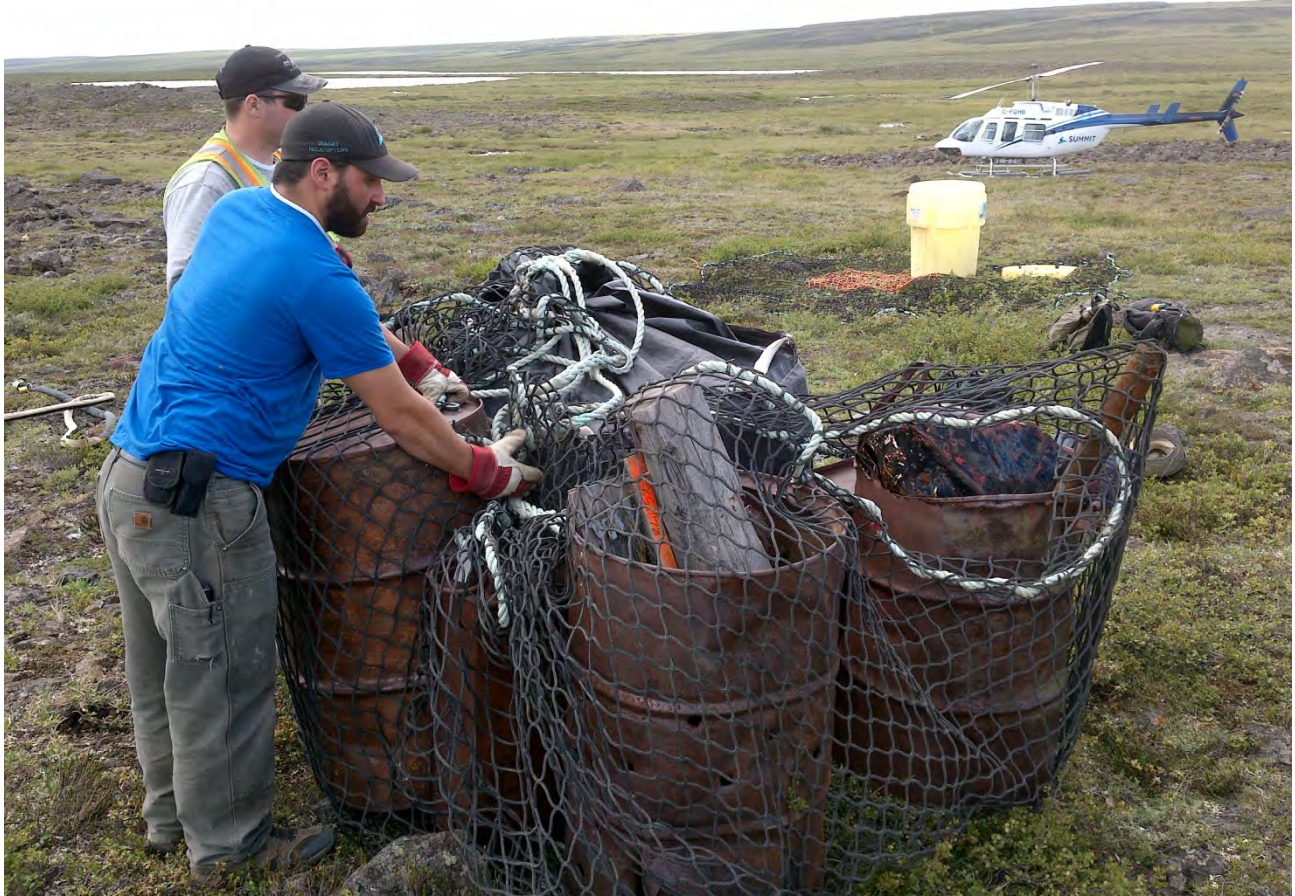
Figure 13: Barrels and small debris before being hauled away from drill sites MX-02 and MX-10. Note black container at the back has equivalent capacity of three barrels.

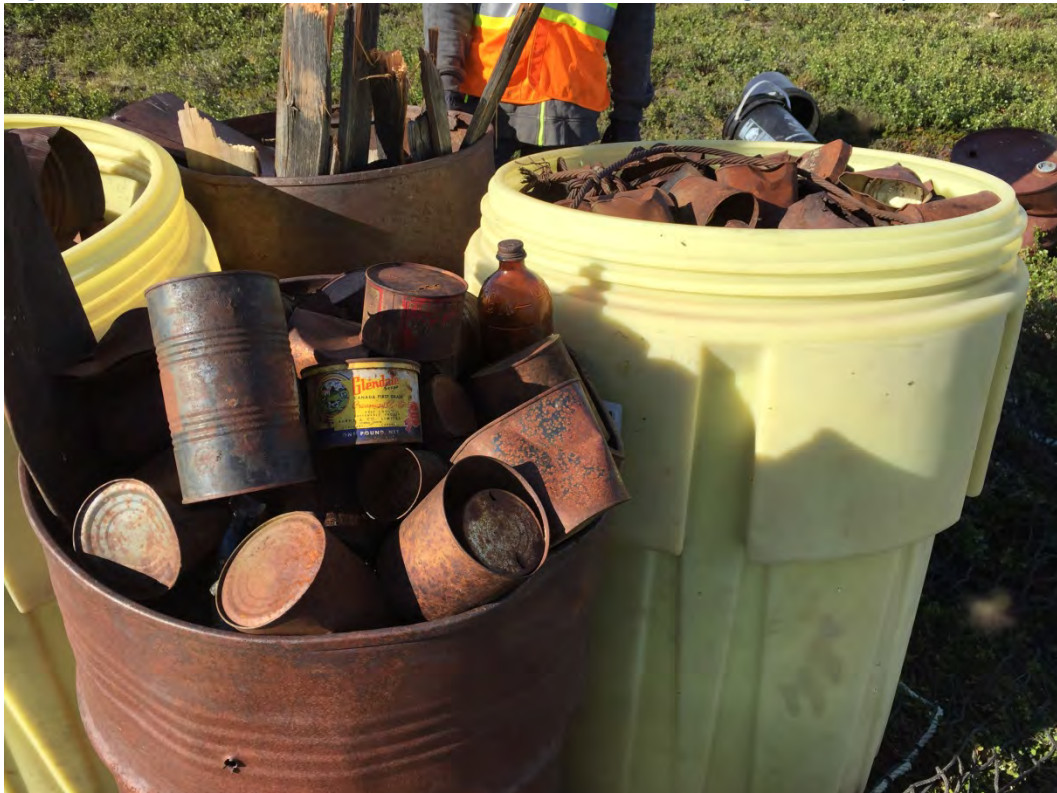
Figure 14: Second load of barrels and small debris before being hauled away from drill sites MX-02 and MX-10.

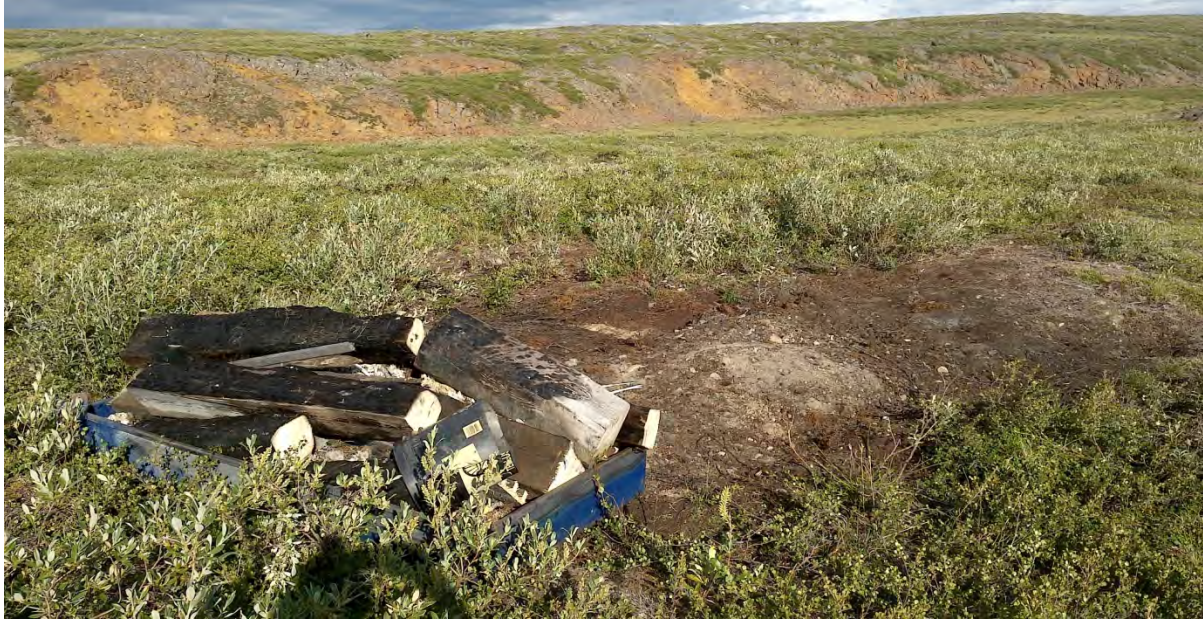
At the fuel cache, all debris including a metal sling basket, partially burnt timbers, plastic garbage, nails, staples and ash were cleaned up and hauled away.

Figure 15: Metal sling basket filled with partially burnt timbers, other debris and ash. Ready to be hauled...

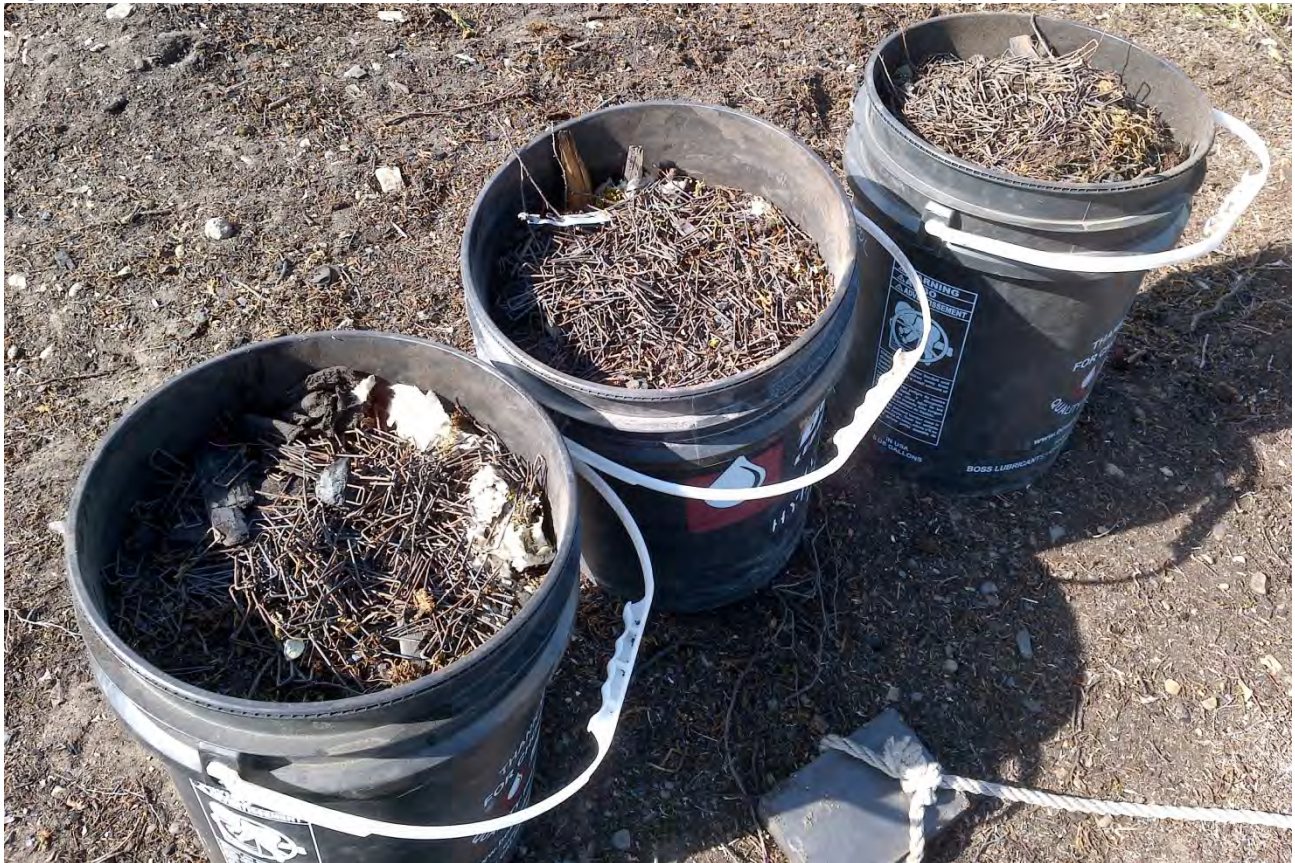
Figure 16: Three pails were filled up with nails and staples collected with the help of magnets.
