## **Melville Project**

# **Annual Report & Final Closure and Restoration Plan**

Water Licence 2BE-MVP1217

December 9<sup>th</sup>, 2013

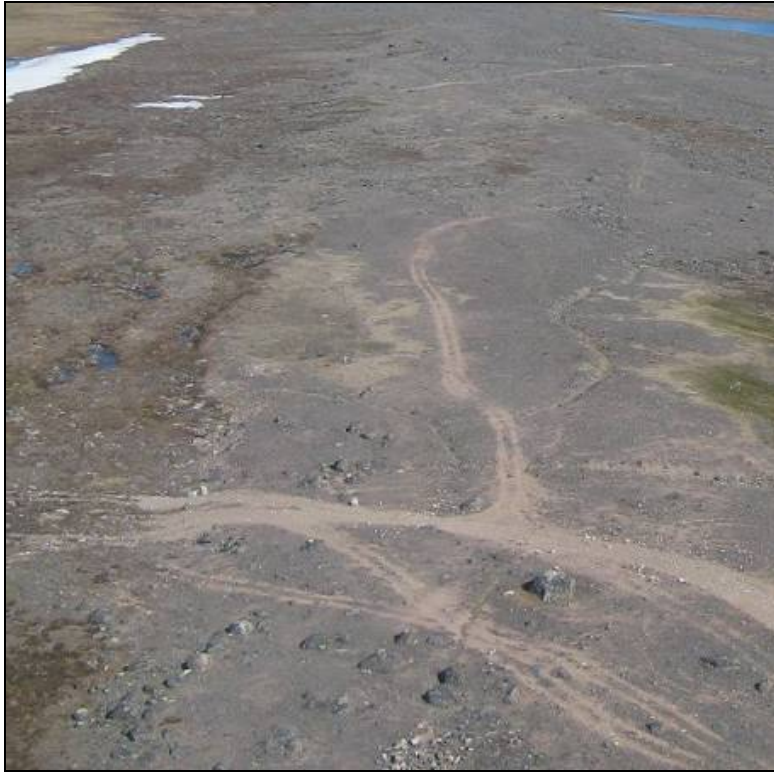
**Figure 3** Location of camp prior to mobilization and construction

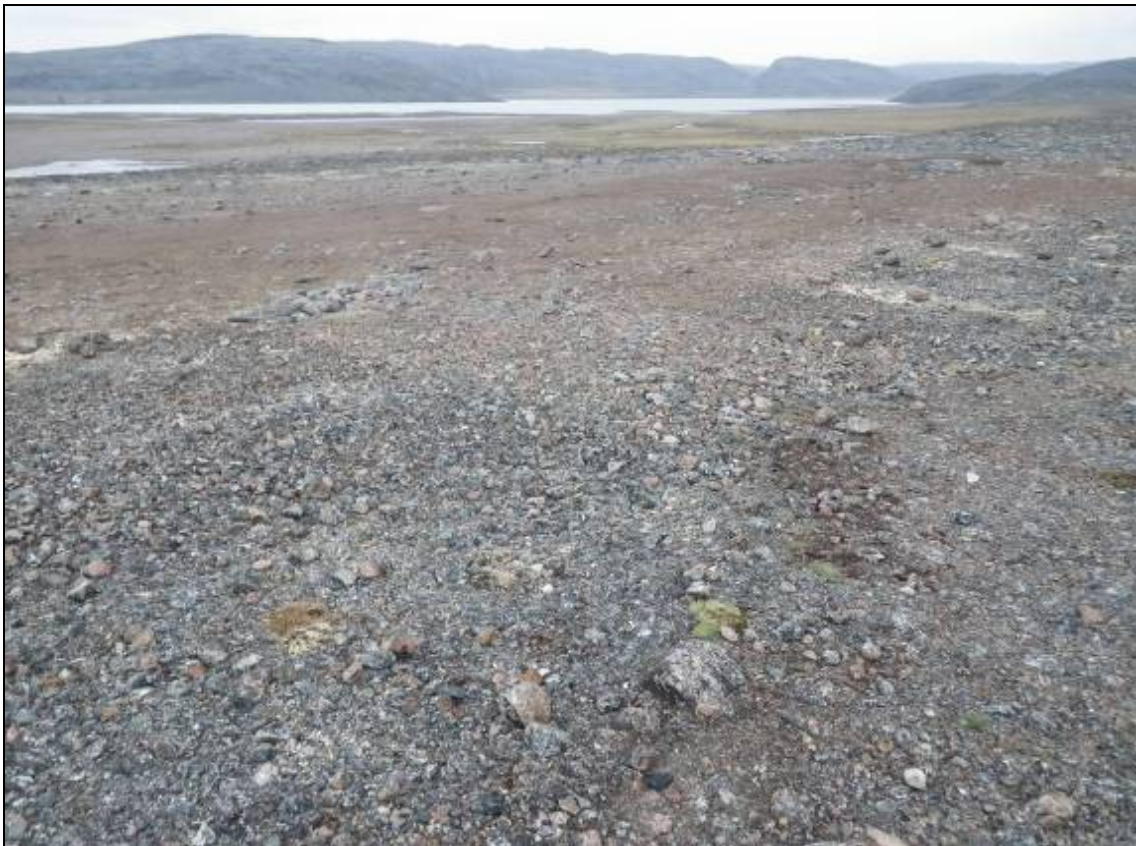
**Figure 4** Location of camp after final closure and restoration

The camp covered an area of approximately 0.25 ha and consisted of Weatherhaven tents and a small plywood generator building. All reusable equipment such as tents, tent frames, stoves, beds, showers, etc. were dismantled and removed from site by airplane to Hall Beach from where they were shipped on the sealift to Valleyfield, QC and onwards. All consumables associated with camp construction and operations, such as nails, screws, anchors, etc. were recovered as much as possible, packaged and flown out with other non-hazardous solid waste for disposal in Iqaluit.

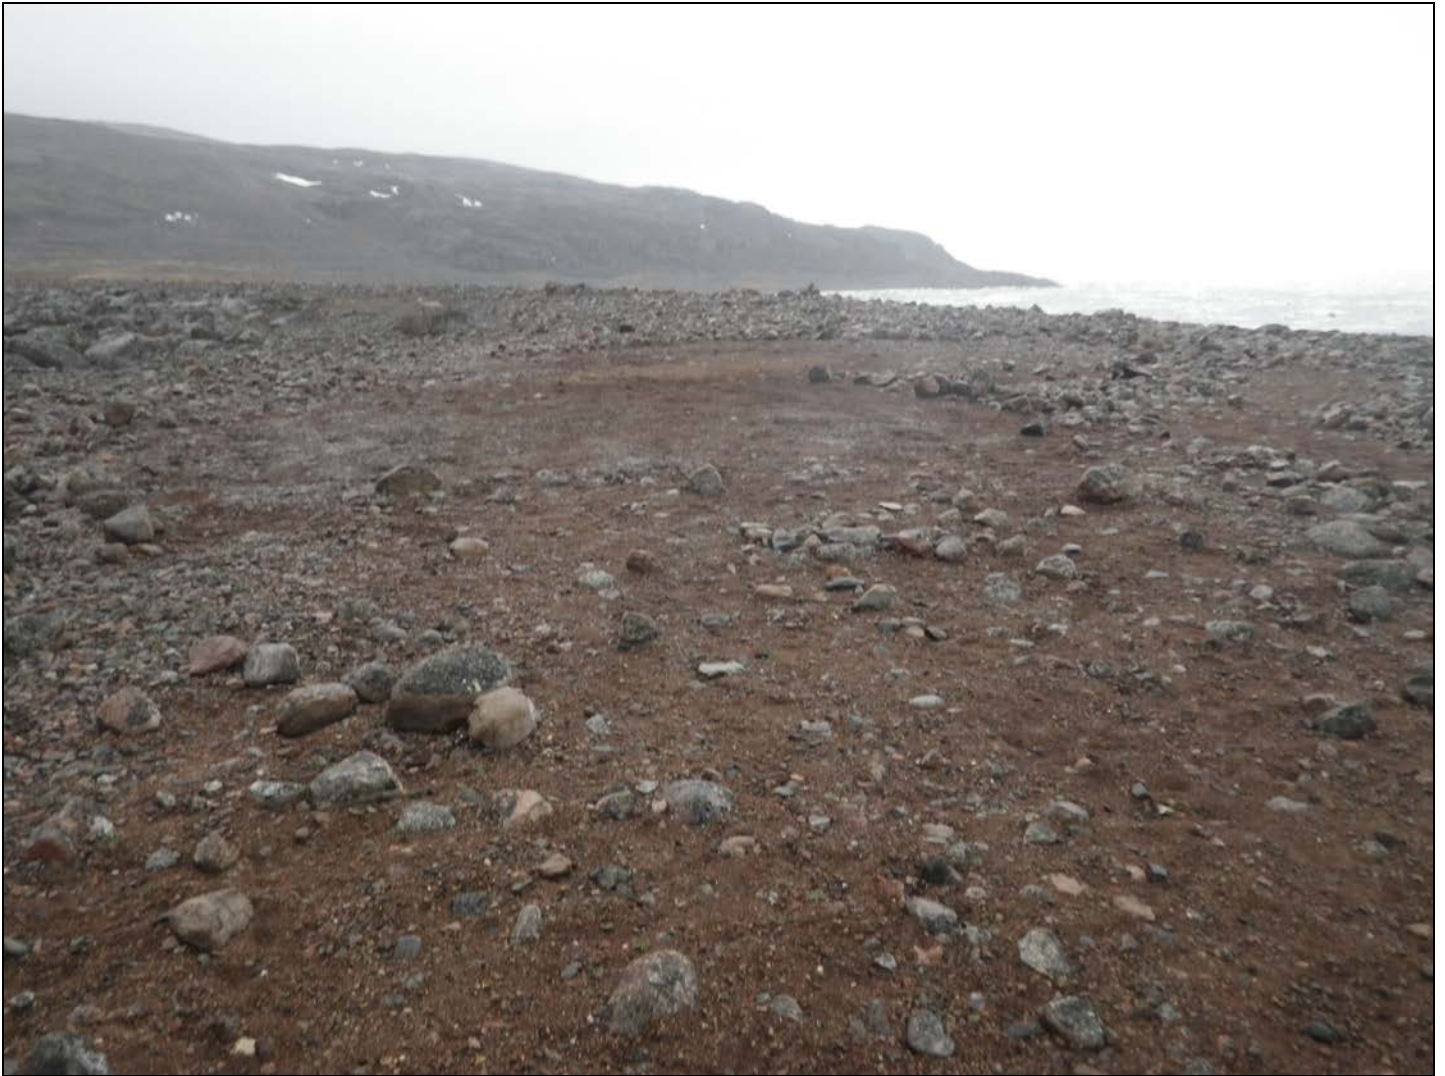
**Figure 5** Location of larger, most westernmost fuel cache after final closure and restoration

All remaining fuel drums and empty drums have been removed from site. The soil under the surrounding fuel caches was thoroughly inspected for any contamination and photographs have been taken.

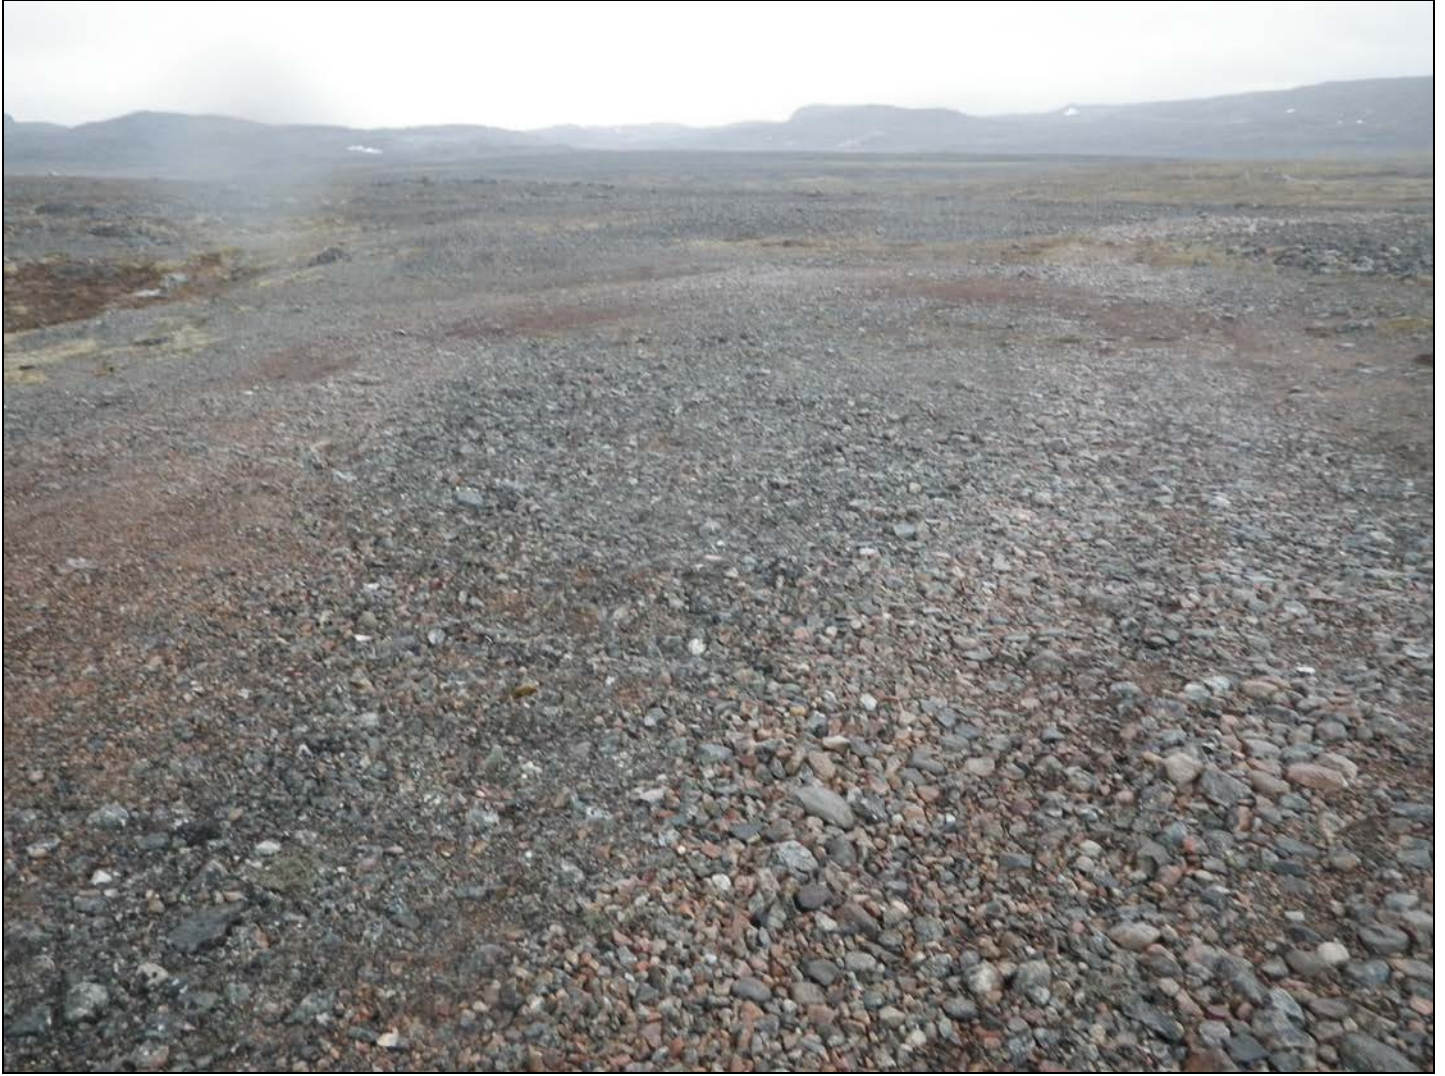
**Figure 6** Location of smaller, easternmost fuel cache after final closure and restoration

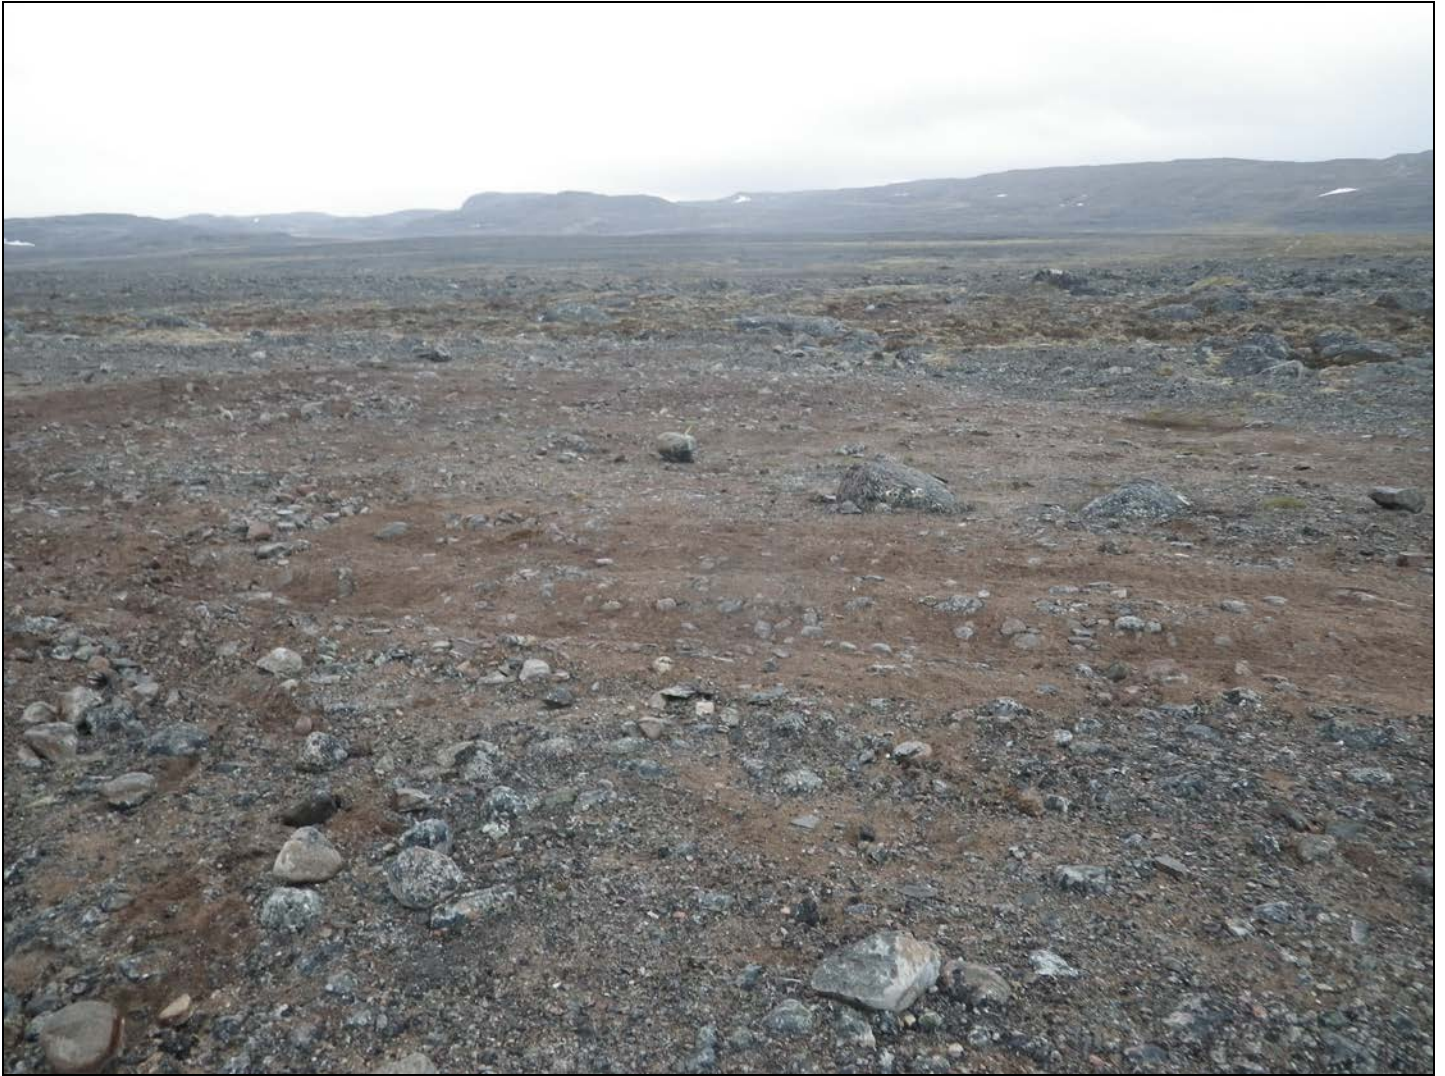
**Figure 8** Area of incinerator after final closure and restoration

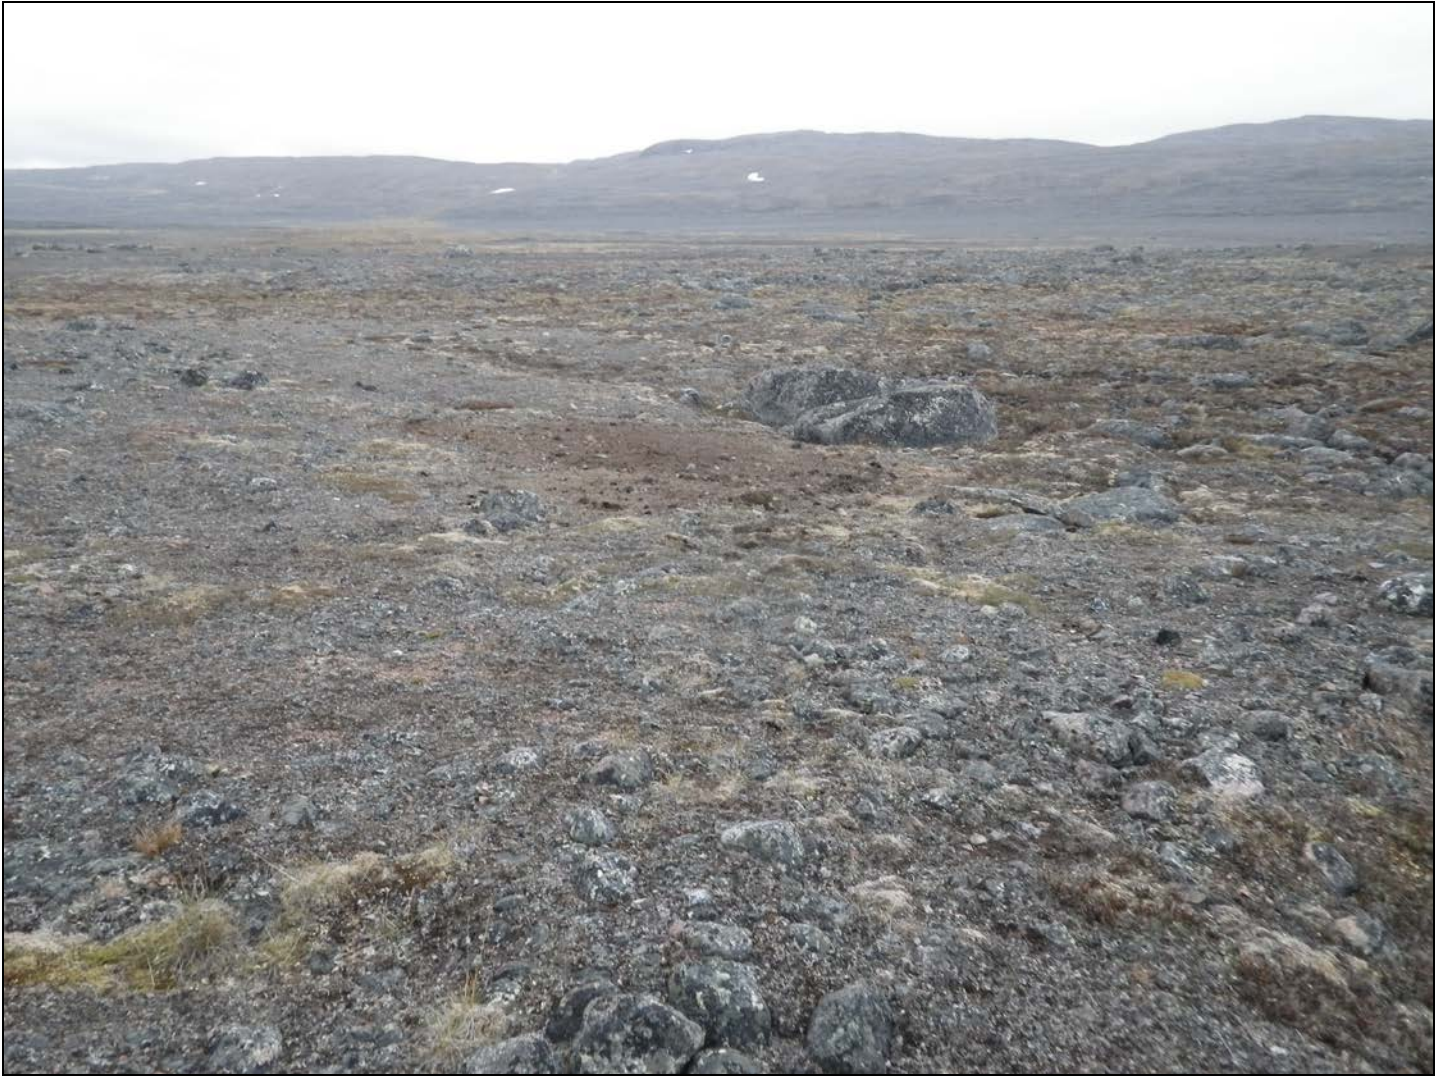
**Figure 9** Location of greywater sumps after final closure and restoration

All paper products, paperboard packaging, untreated wood, food wastes, and food packaging were incinerated in a high efficiency incinerator in accordance with the procedure describe in the Government of Nunavut's *Guideline for the Burning and Incineration of Solid Waste* (GN 2013). All other non-hazardous wastes were also incinerated in the two stage incinerator. Sewage was contained using Pacto toilets and then incinerated. During final camp closure, all ash was removed from the incinerator, packaged and backhauled to Iqaluit, Nunavut. The soil under and surrounding the incinerator was inspected for contamination. Greywater from the camp was directed to a sump over 30 m away from any water body and the sump filled during final closure.

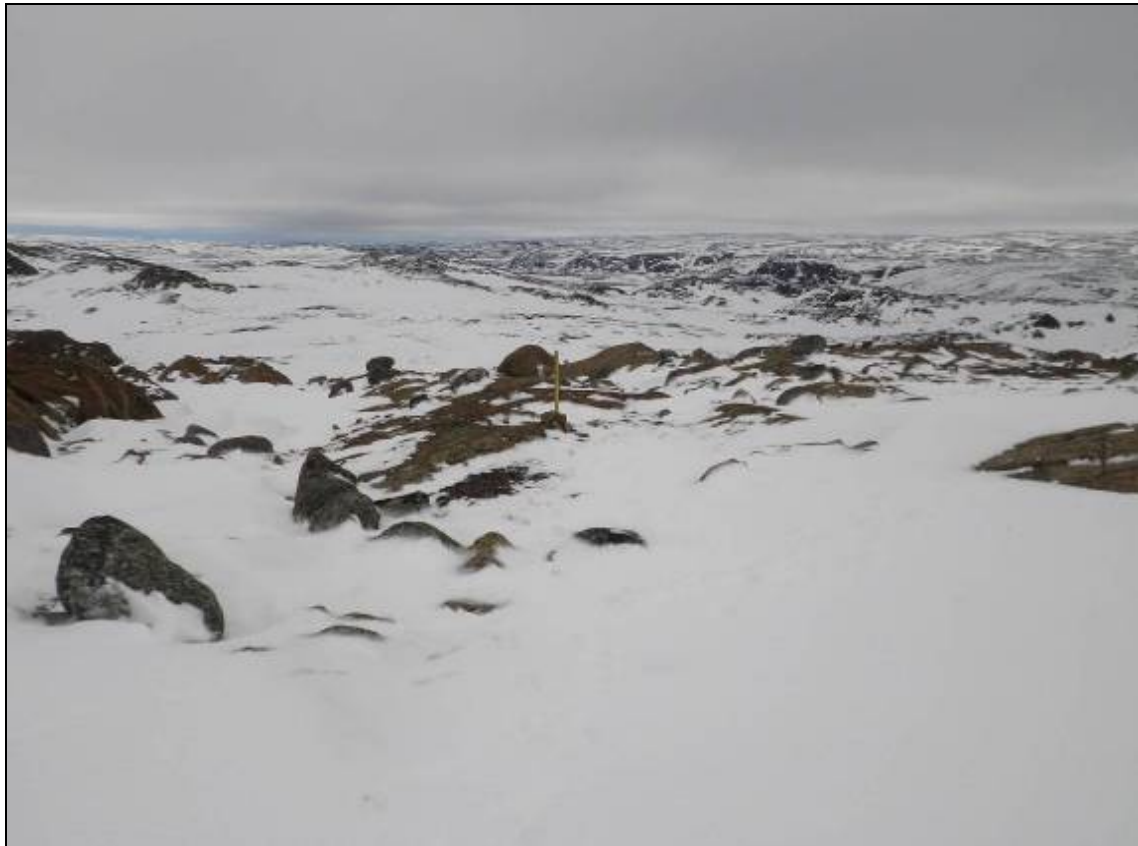
**Figure 10** Location of diamond drill hole MLVL-13-001 prior to drilling

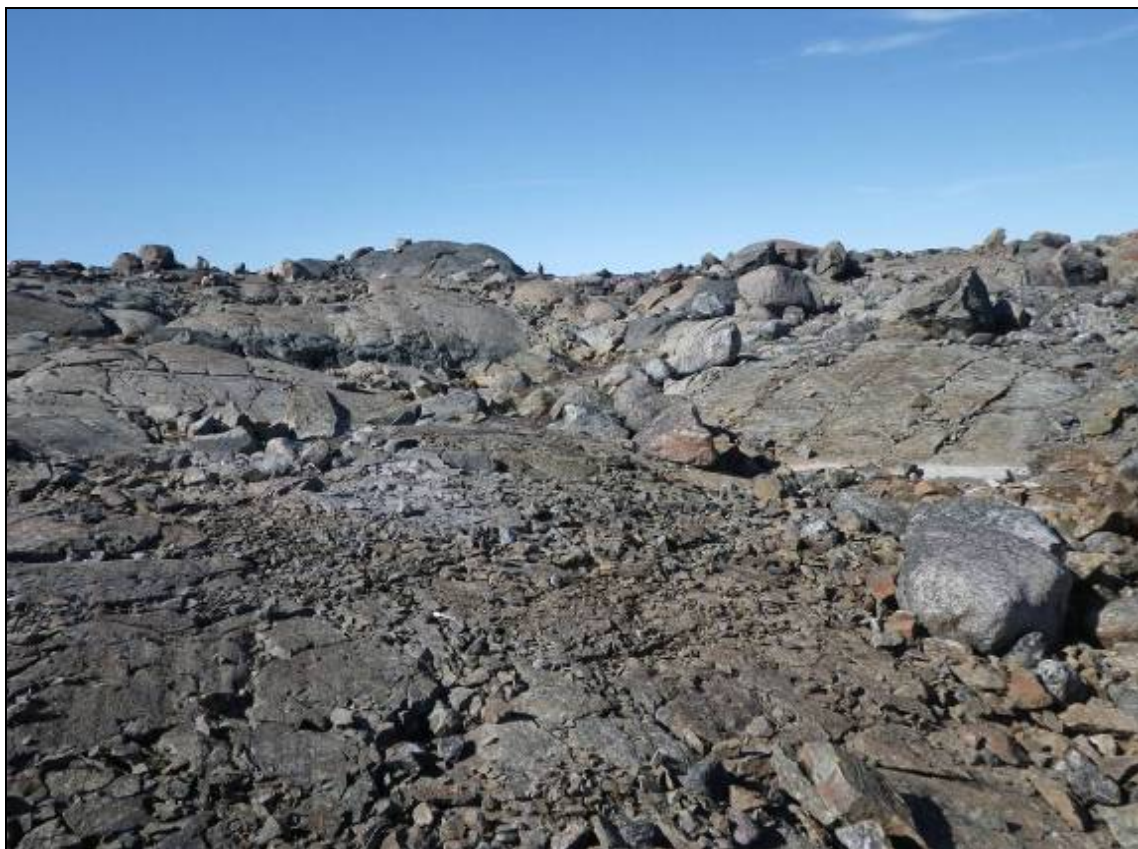
**Figure 11** Location of diamond drill hole MLVL-13-001 after drilling and reclamation

All drill locations were inspected and photographed immediately after completion of the drill holes. All waste was collected and returned to the camp for incineration or removed to an approved disposal facility in Iqaluit. No sumps were dug as all drill cuttings were directed to natural depressions capable of containing their volume. A diligent inspection was conducted of the soil surrounding all drill sites with particular attention paid to any possible contamination.

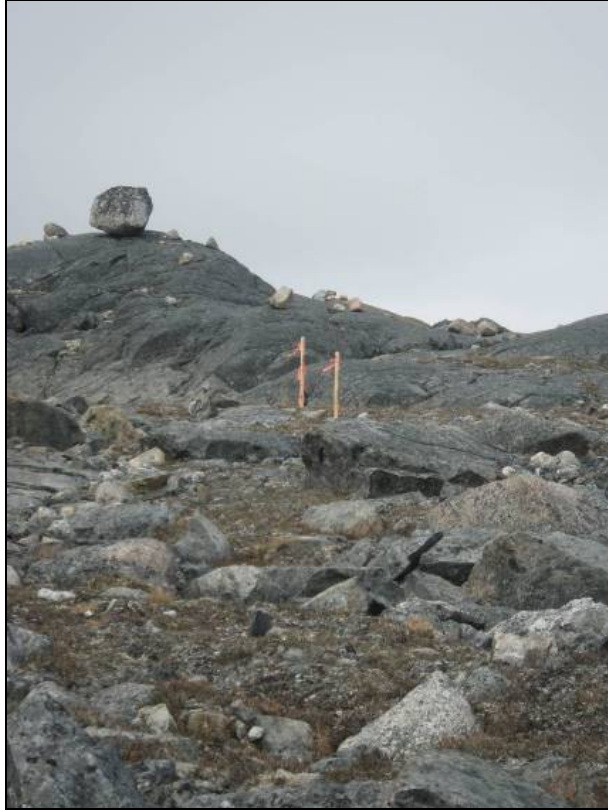
**Figure 12** Location of diamond drill hole MLVL-13-002 prior to drilling

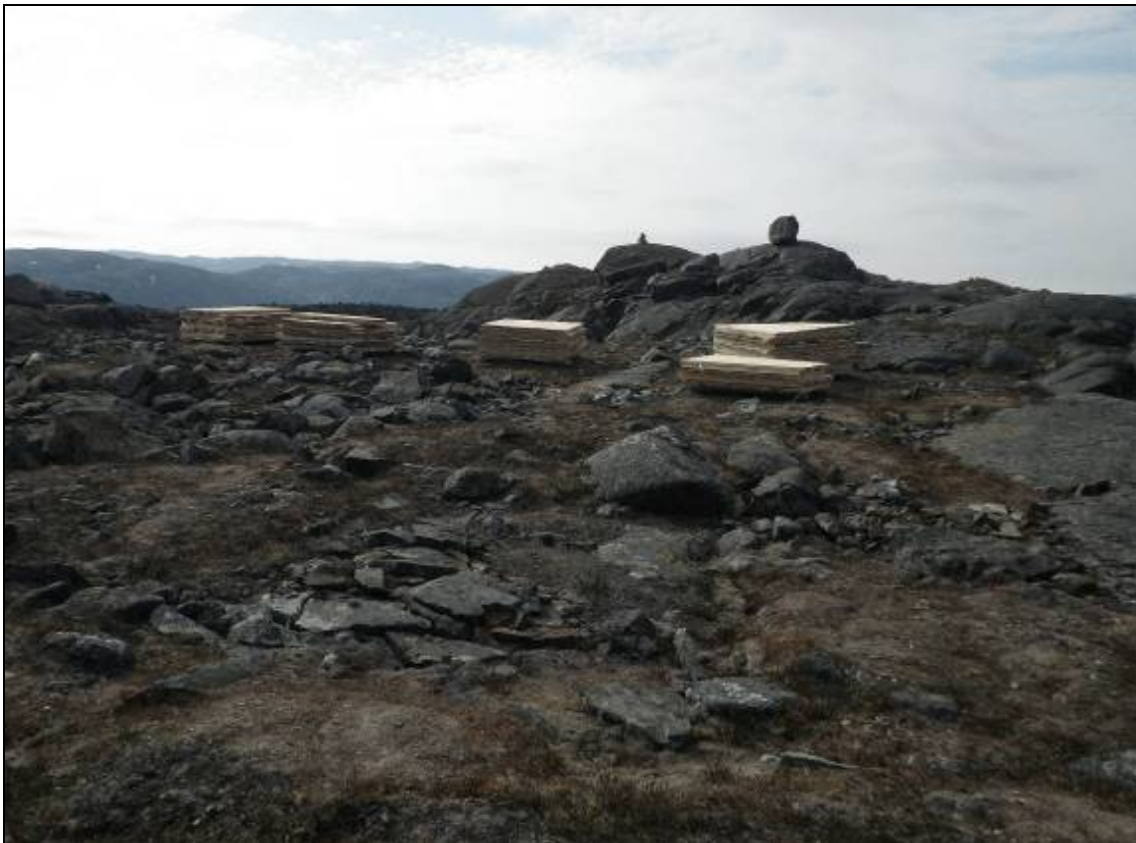
**Figure 13** Location of diamond drill hole MLVL-13-002 and final core storage after drilling and reclamation

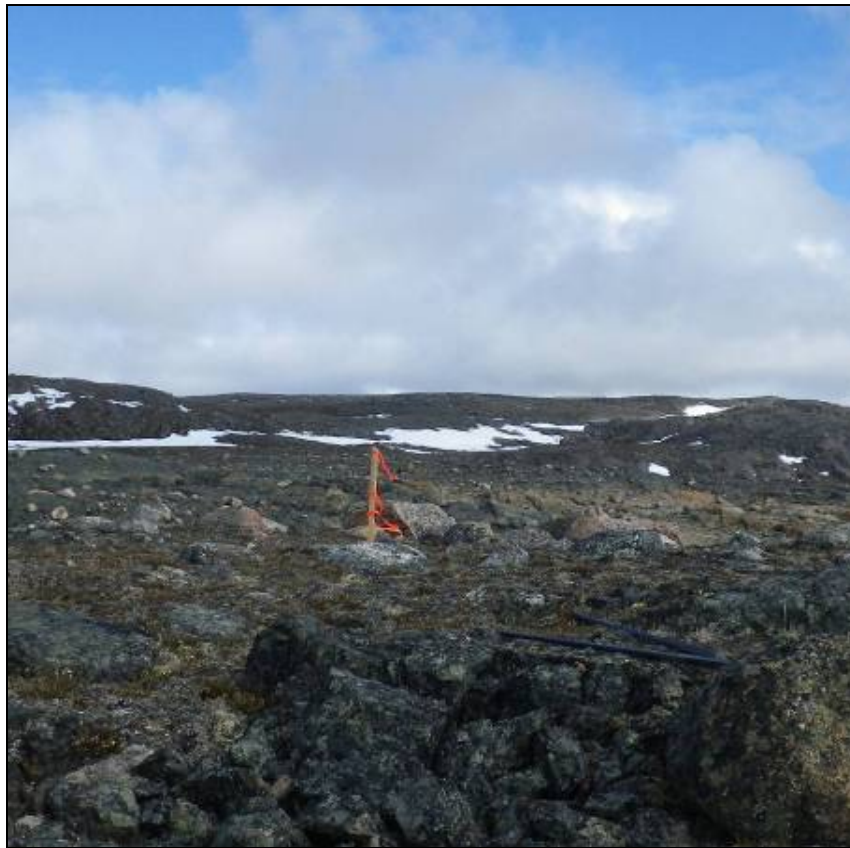
**Figure 14** Location of diamond drill hole MLVL-13-003 prior to drilling

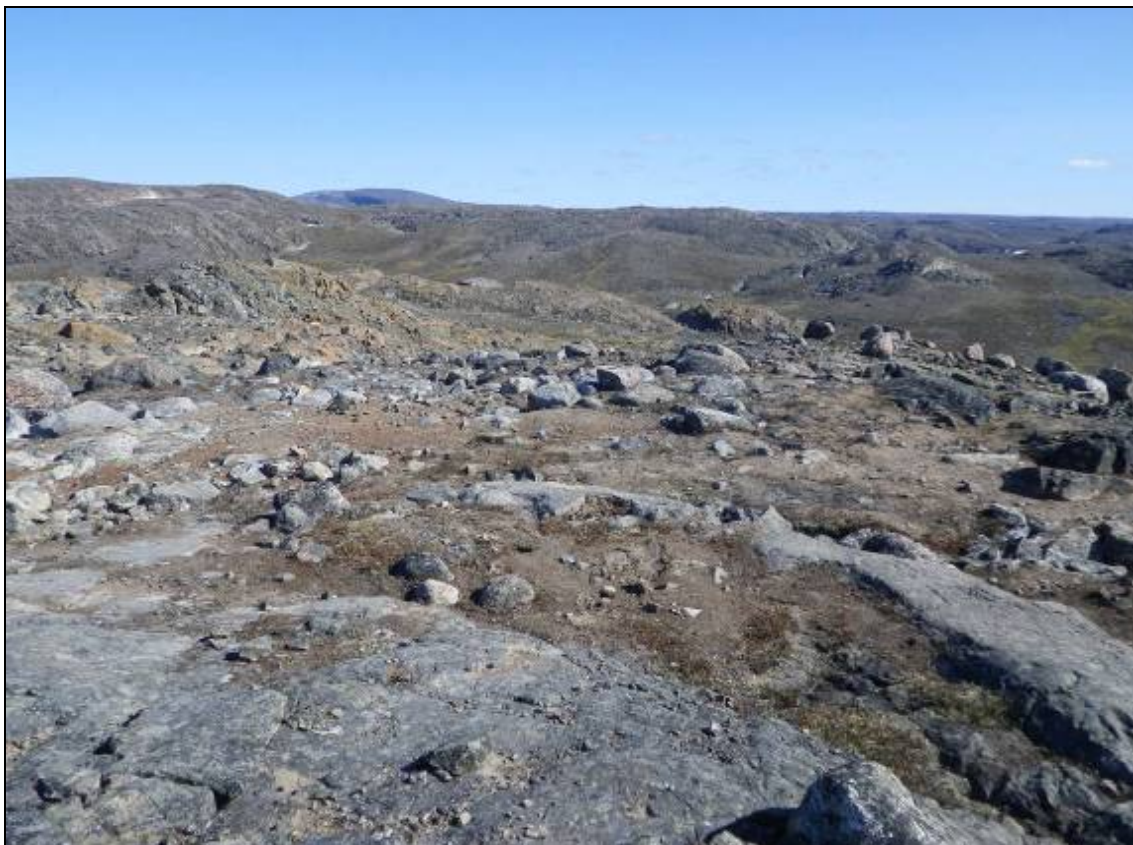
**Figure 15** Location of diamond drill hole MLVL-13-003 after drilling and reclamation

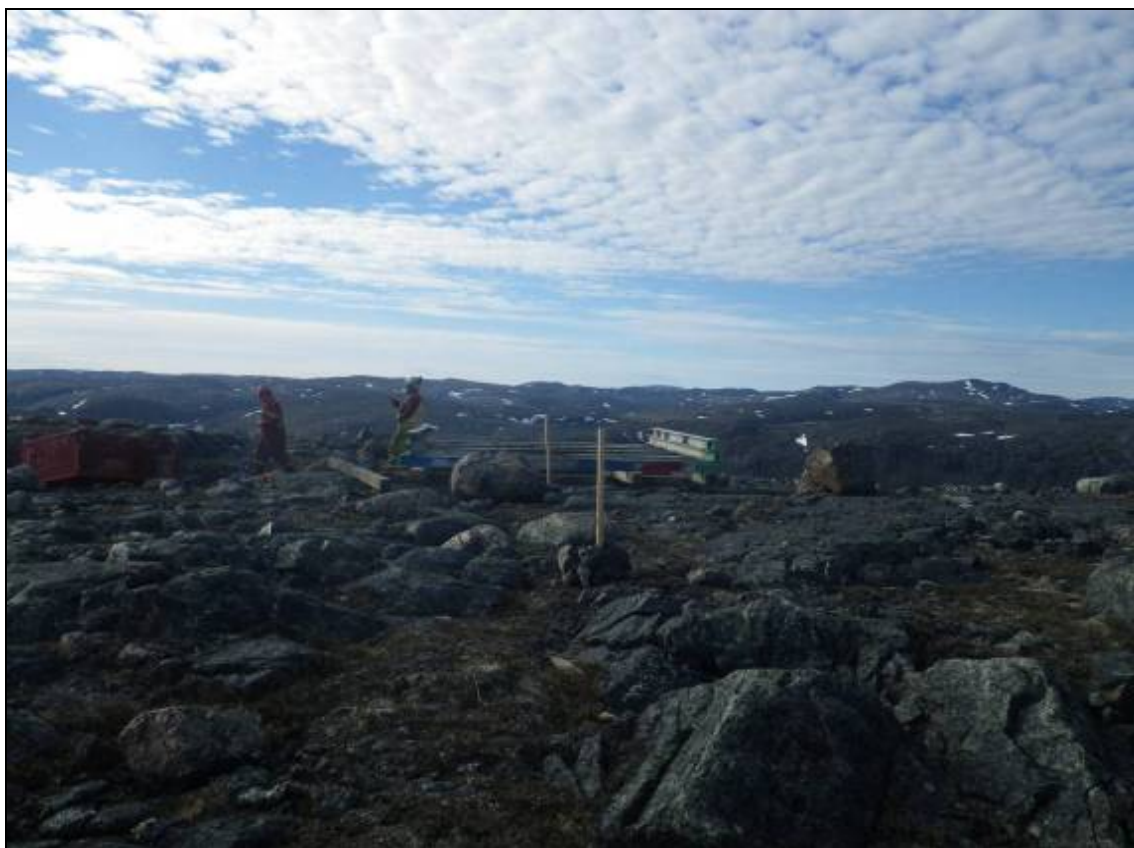
**Figure 16** Location of diamond drill hole MLVL-13-004 prior to drilling

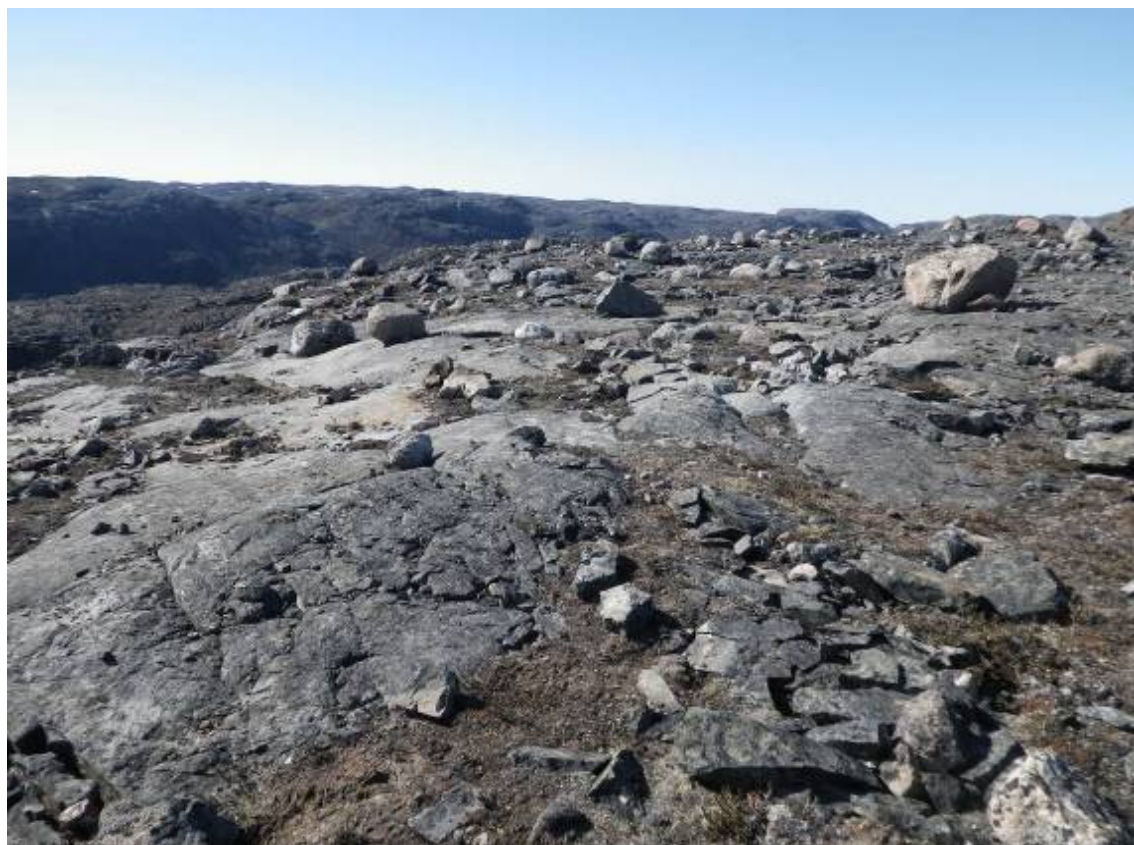
**Figure 17** Location of diamond drill hole MLVL-13-004 after drilling and reclamation

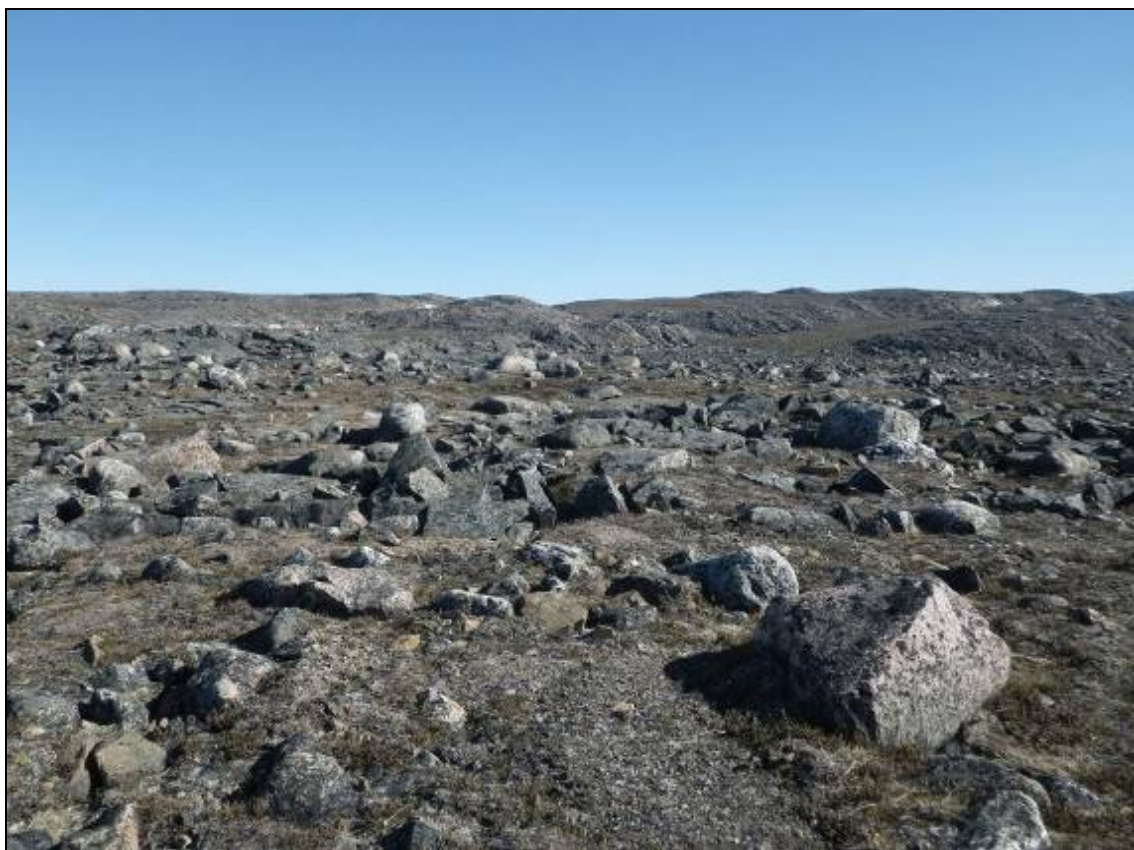
**Figure 18** Location of diamond drill hole MLVL-13-005 prior to drilling

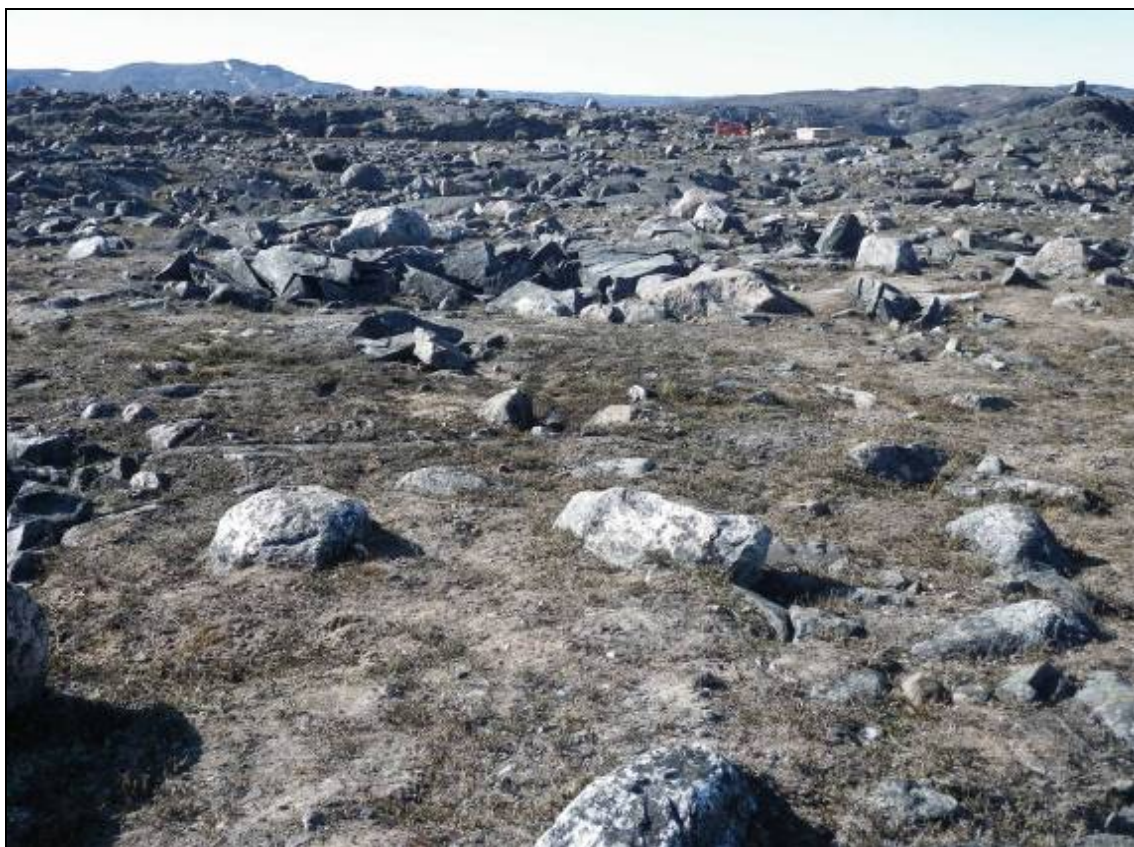
**Figure 19** Location of diamond drill hole MLVL-13-005 after drilling and reclamation
