October 16, 2013

**Commander Resources Ltd**  
11<sup>th</sup> Floor, 1111 Melville Street  
Vancouver, BC V6E 3V6

**Subject: Securing of Camp Site at FOX-3 Dewar Lakes, Nunavut – Final Report**  
**(O/Ref.: CO 3666)**

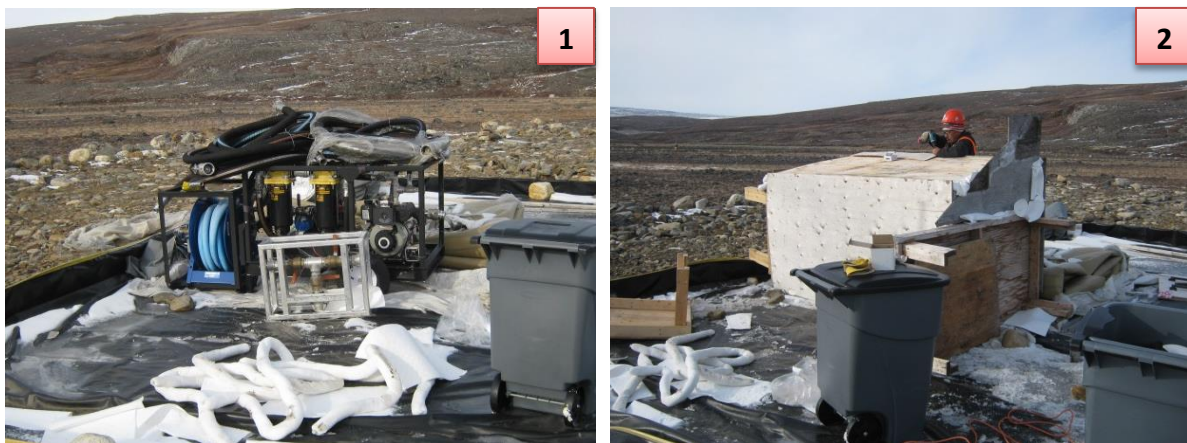
Figures (1) and (2) – Barricading the pumping system

As it was not possible to move the pumps from their current location, the pumping system was boarded up with bed frame plywood pieces and insulation.

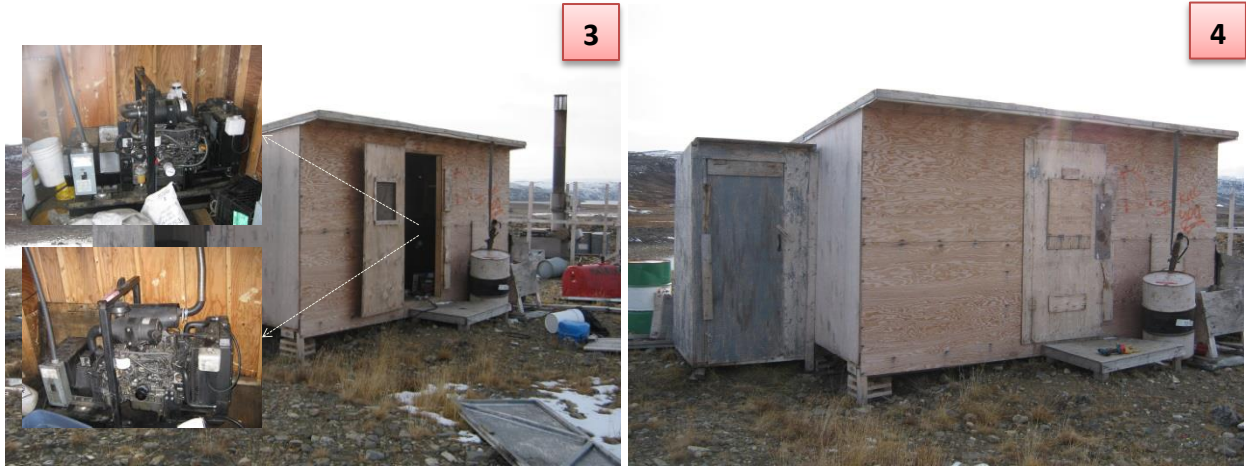
Figures (3) and (4) – Securing the shack housing the generators

The two generators found on-site were secured by fixing the shed that is used to house them. The doors to the shack and attachment were reinstalled and properly closed, while all structure holes were covered.

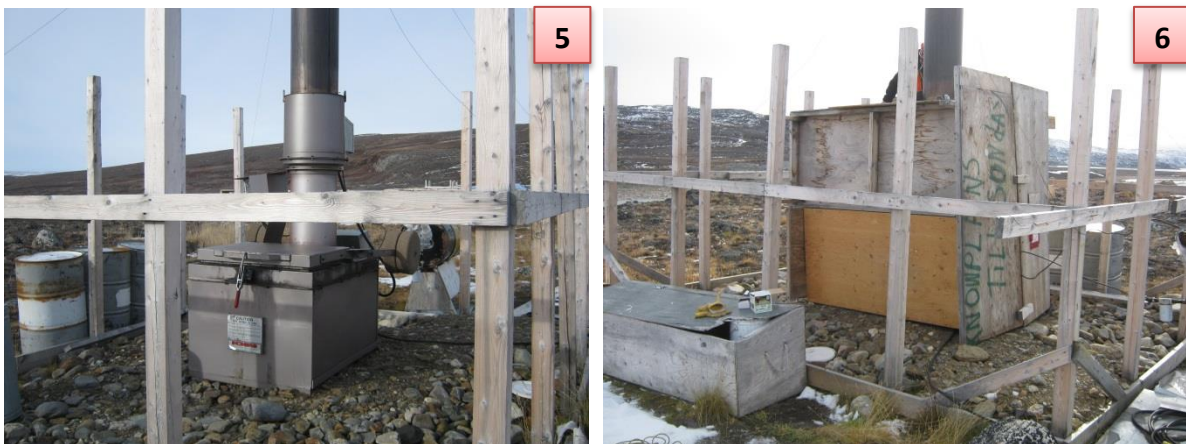
Figures (5) and (6) – Protection box around the incinerator

A box was made around the incinerator to protect it (Figures 5 and 6).

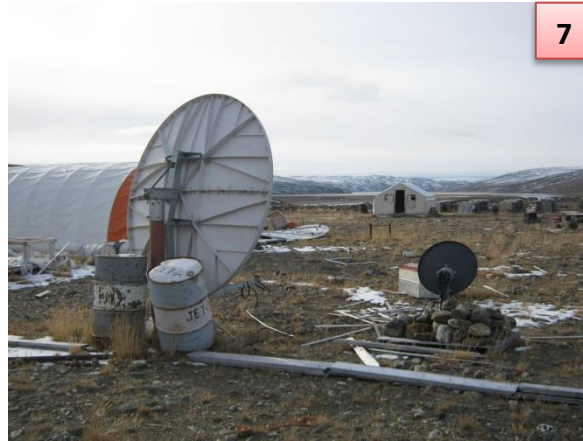
Of the two satellite dishes found on-site, the antennas and electronic boxes were missing. The smaller dish was detached from its tripod and the two pieces were brought back. It was not possible to disassemble the second dish with the tools available on-site; the assembly was too large to fit the plane and the dish was left at the site. Other pieces of communication systems found were two printers, however both were broken.

Figure (7) – Satellite dishes

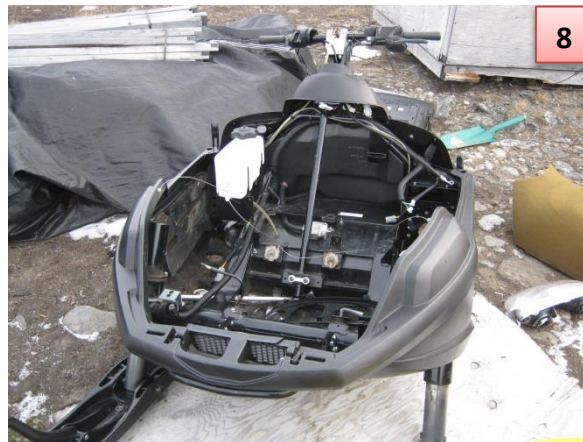
The skidoo was found in poor condition, with only the frame and one ski remaining. It was left as is.

Figure (8) – Skidoo frame, with 1 ski

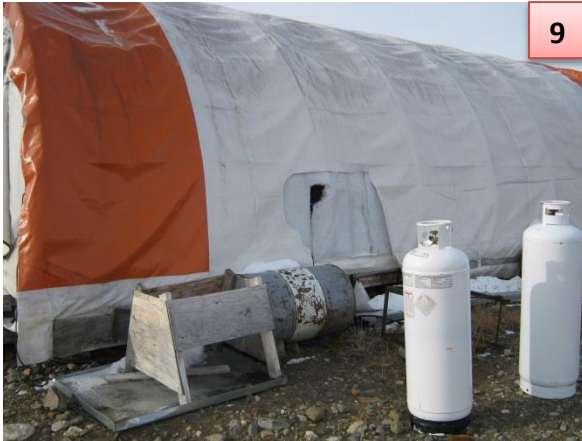
9

Figures (9) and (10) – Boarding up kitchen/dining hut torn tent sections (side)

The kitchen/ dining hut tent was repaired with cords and pieces of wood salvaged on-site. Kitchen related items and other material were moved to be stored in the kitchen.

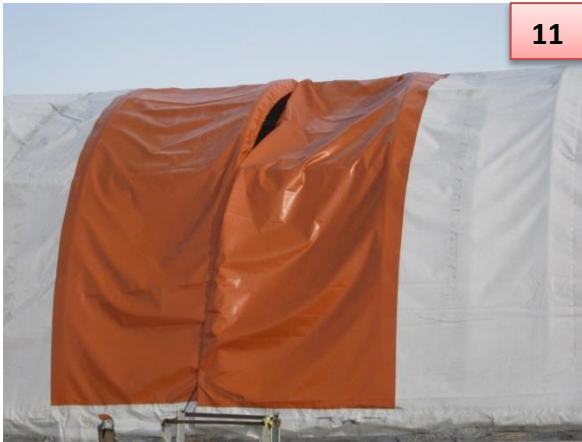
11

Figures (11) and (12) – Restoring kitchen/dining hut tent (top)

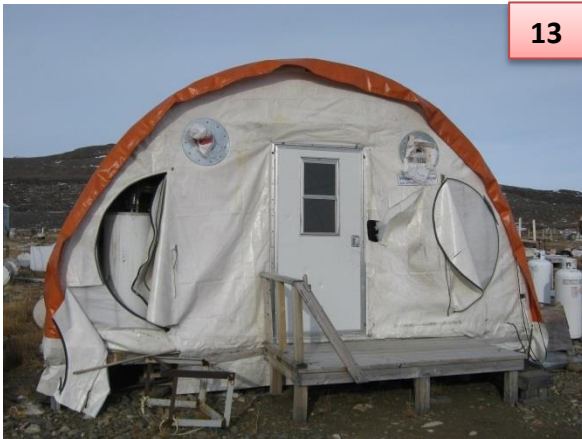
13

Figures (13) and (14) – Boarding up kitchen/dining hut torn tent sections (front)

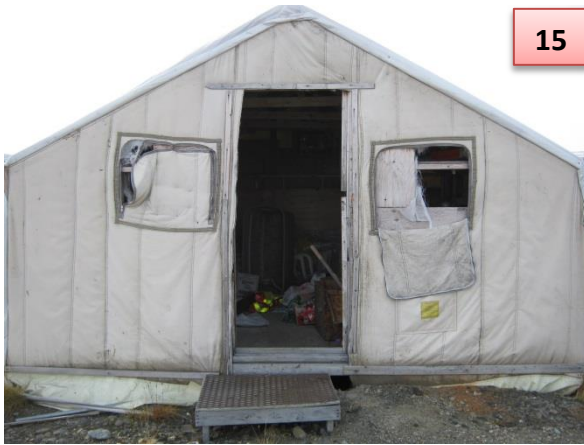
15

Figures (15) and (16) – Boarding up door and window openings

Structures that were partially damaged were secured by having their doors reinstalled, wall

openings (i.e. where windows used to be mounted) boarded up, and any tent rips covered with tarps and ropes. The silo door and roof hatch were repaired and properly closed.

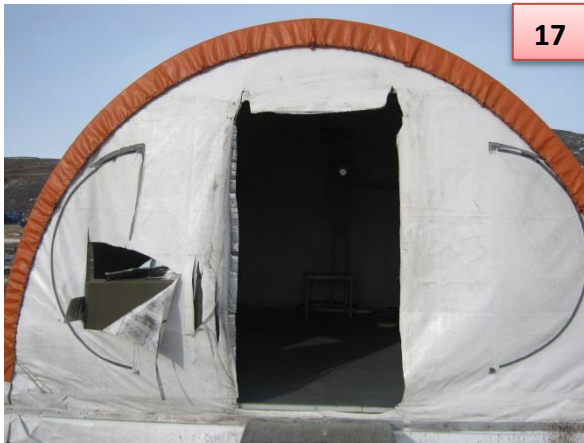
17

Figures (17) and (18) – Boarding up openings and tears on tent

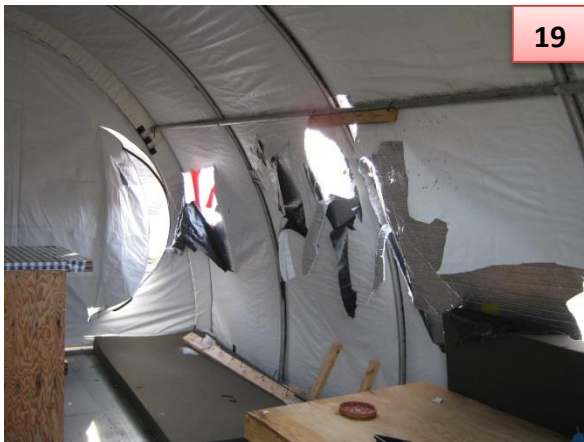
19

Figures (19) and (20) – Covering tears on tent (view from interior/ exterior)

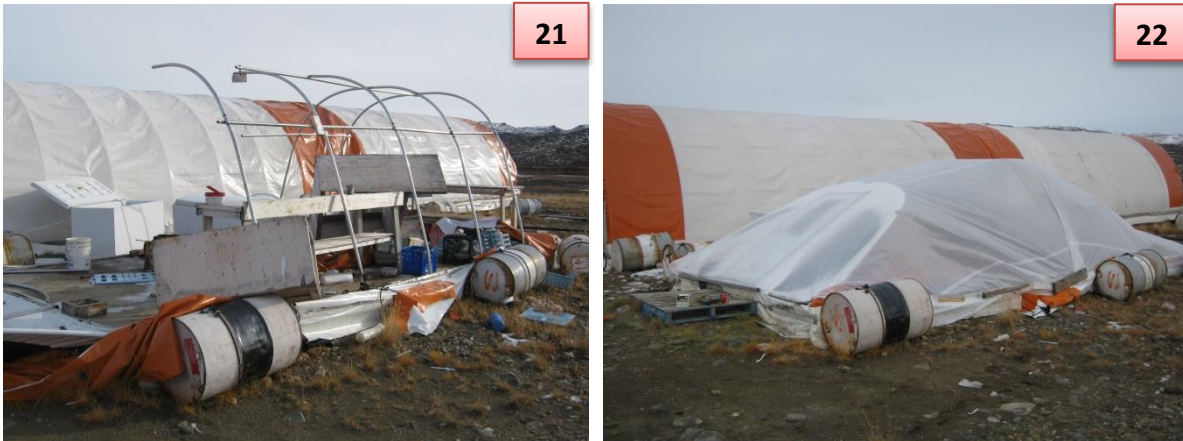
Figures (21) and (22) – Securing damaged hut

Items formerly contained in huts that were irreversibly damaged were removed and placed in protected spaces (huts or sheds). In one case, the damaged hut structure was covered with tarps and secured with wood boards.

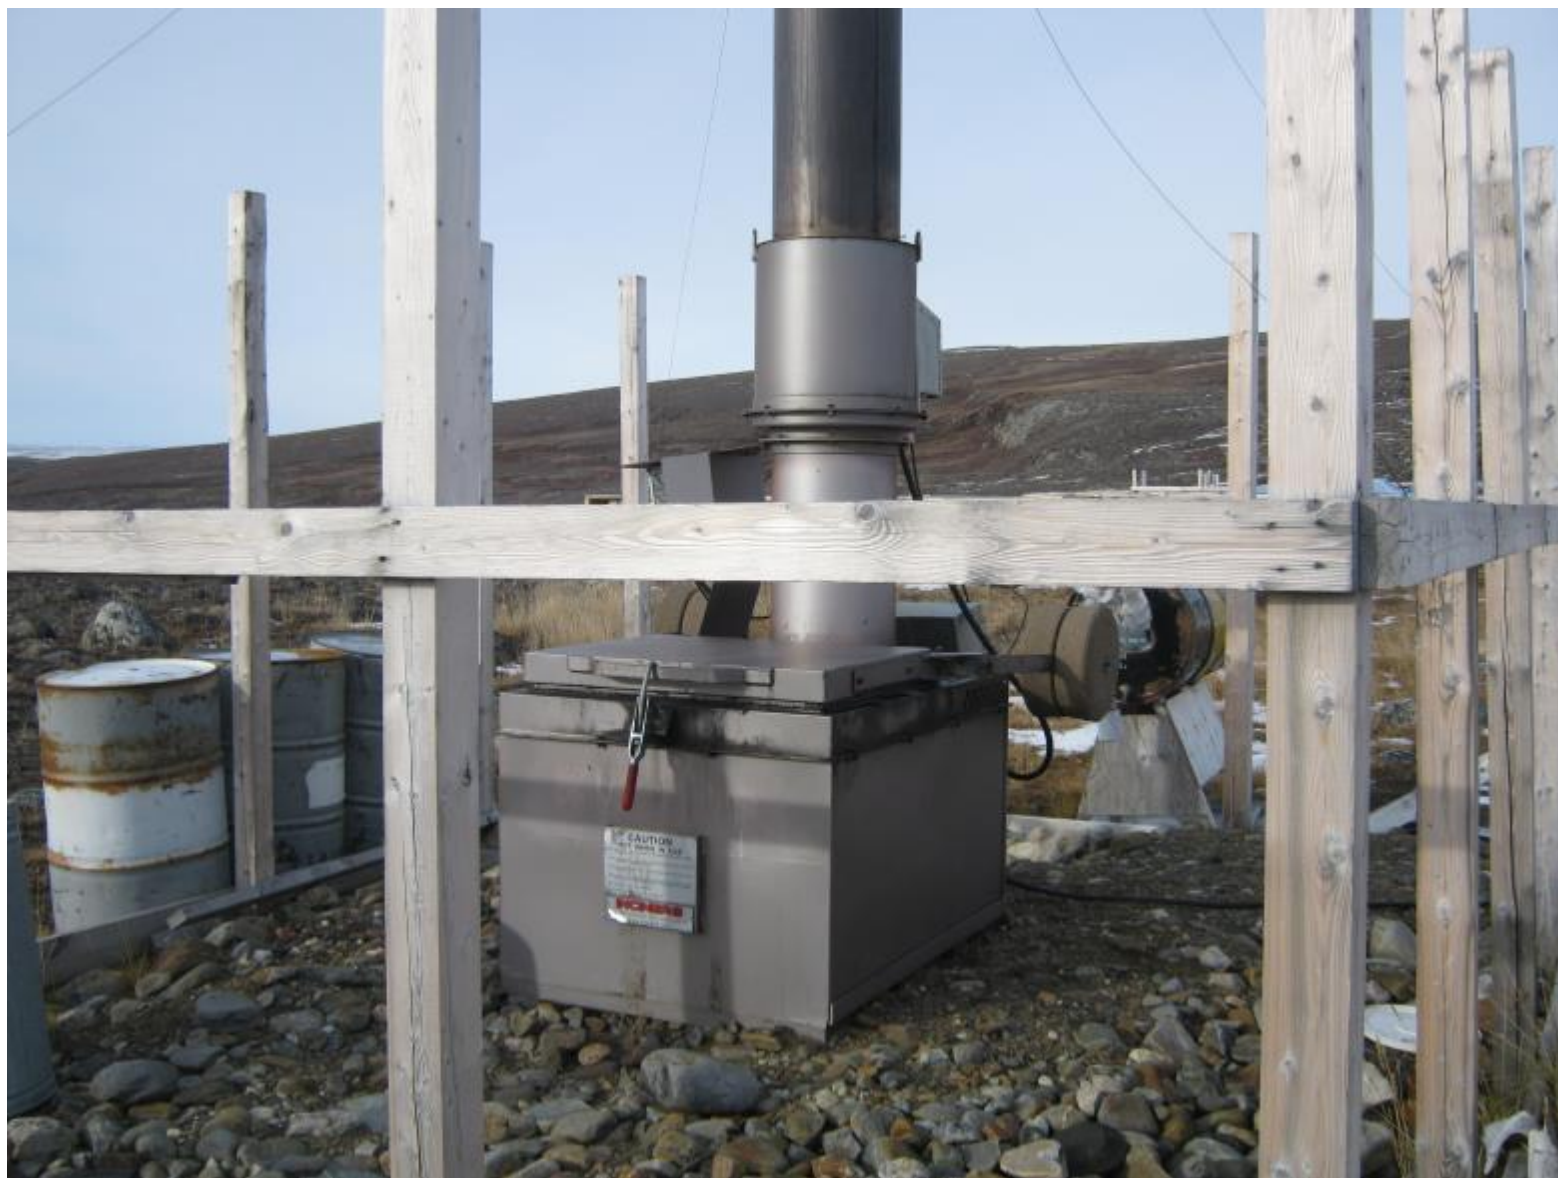
Figure 1 – Exposed incinerator

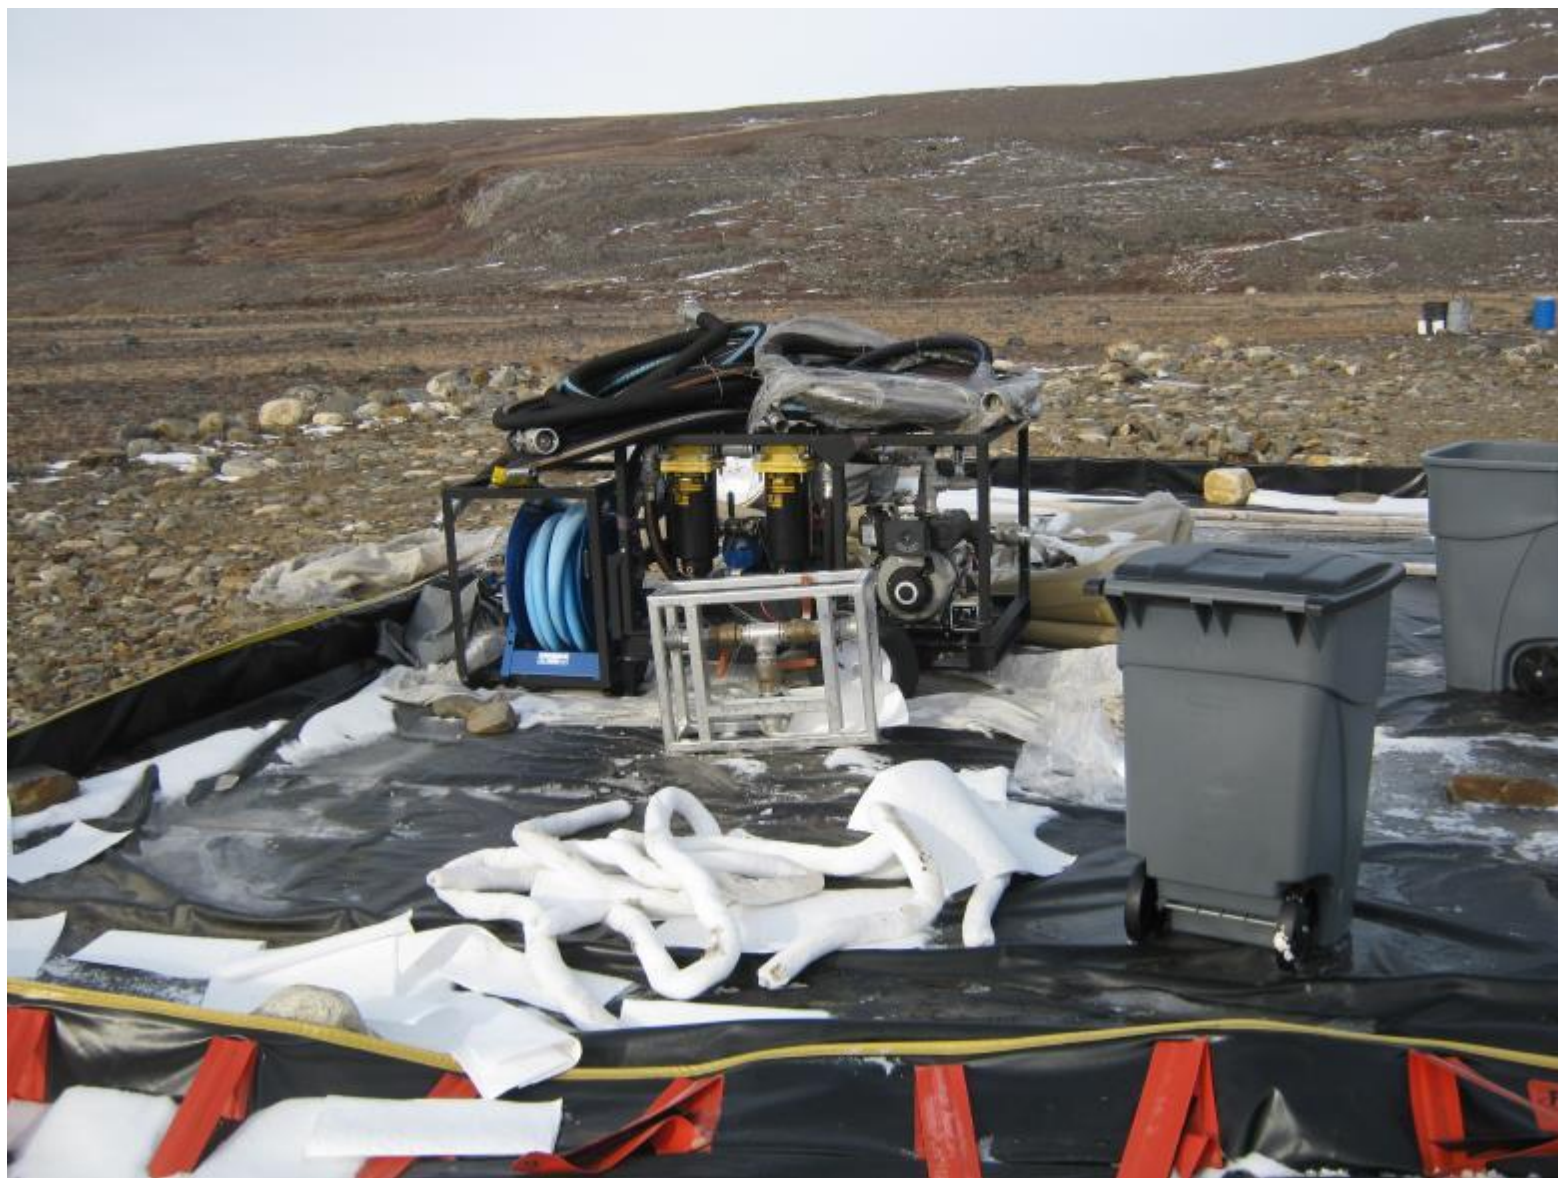
Figure 2 – Exposed water and fuel pumps

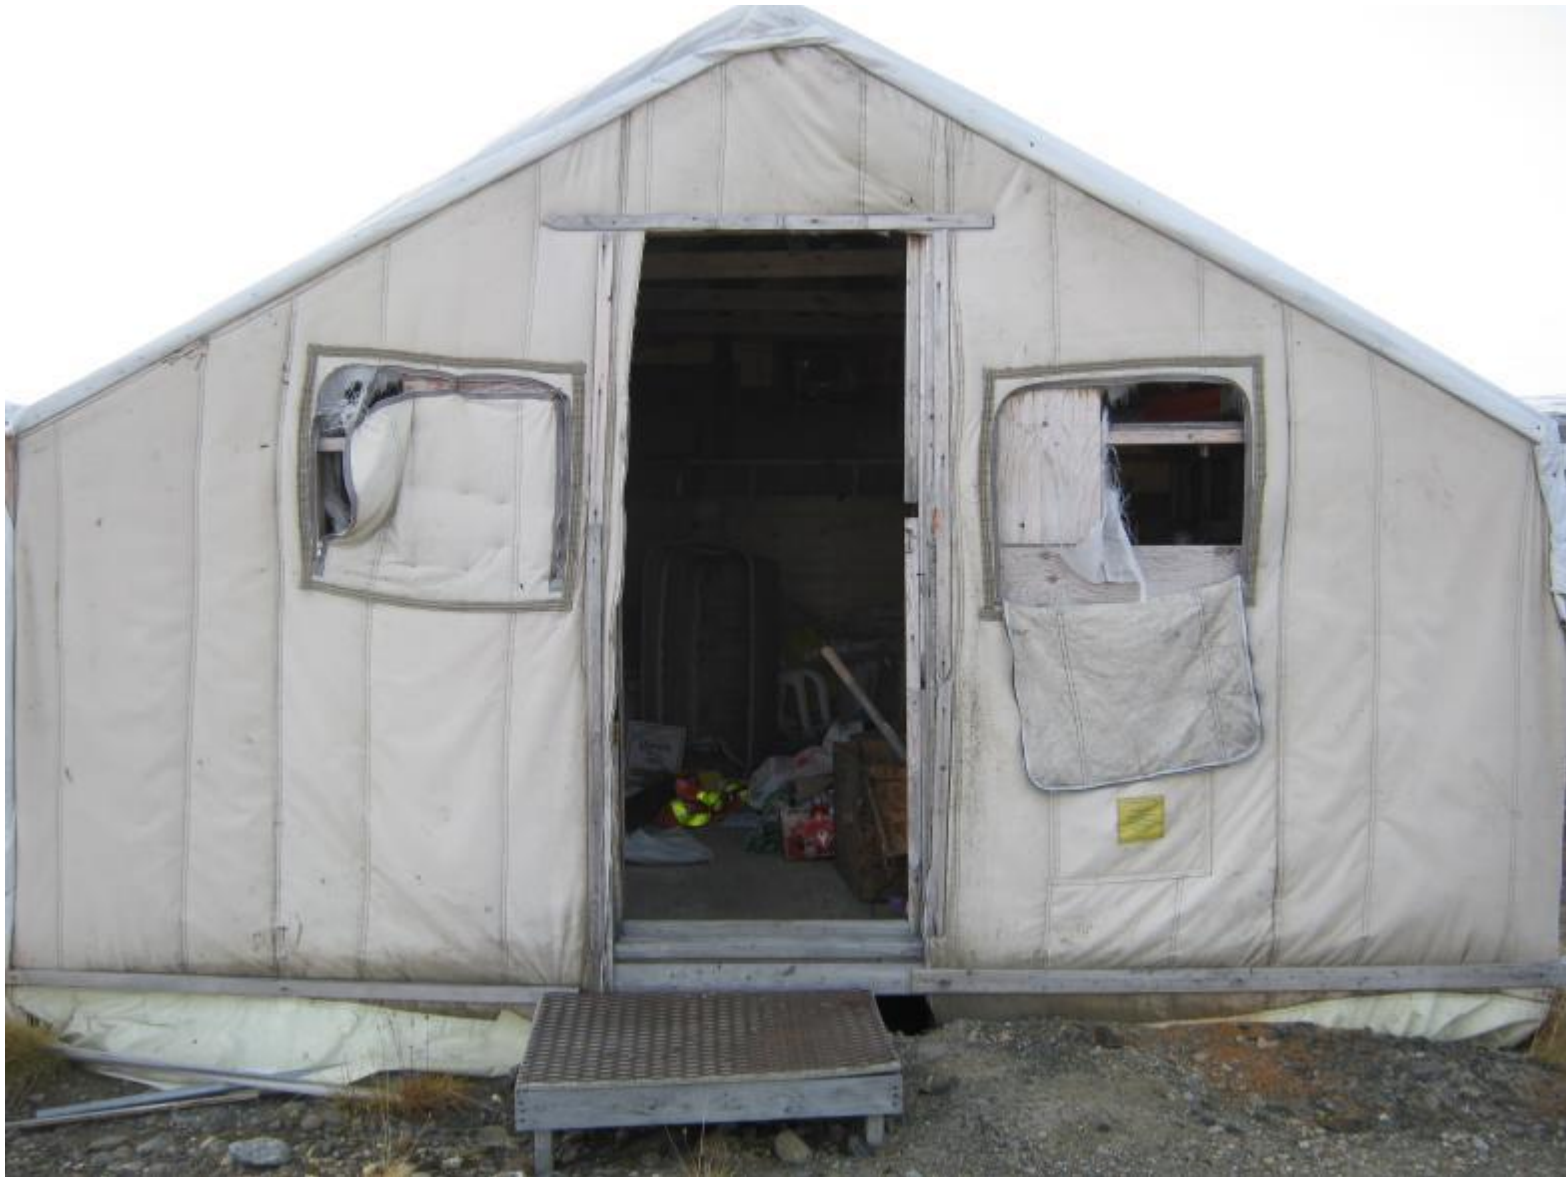
Figure 3 – Partially damaged hut

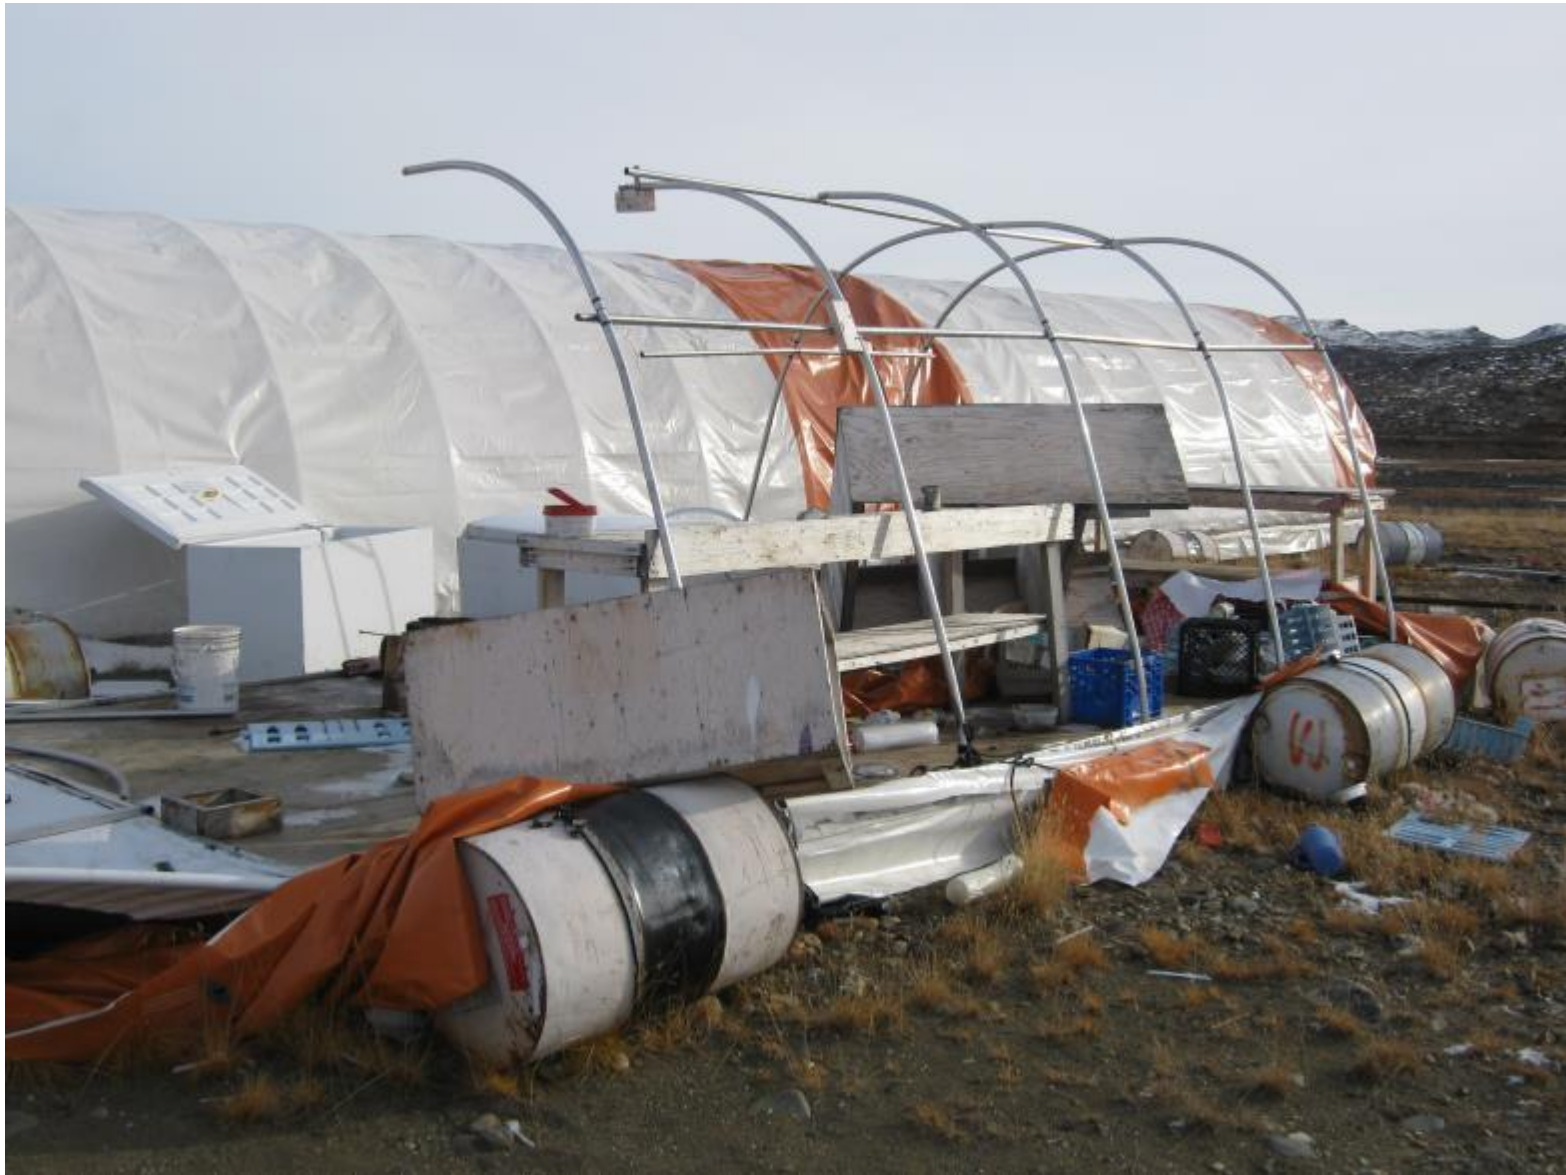
Figure 4 –Damaged hut and exposed interior

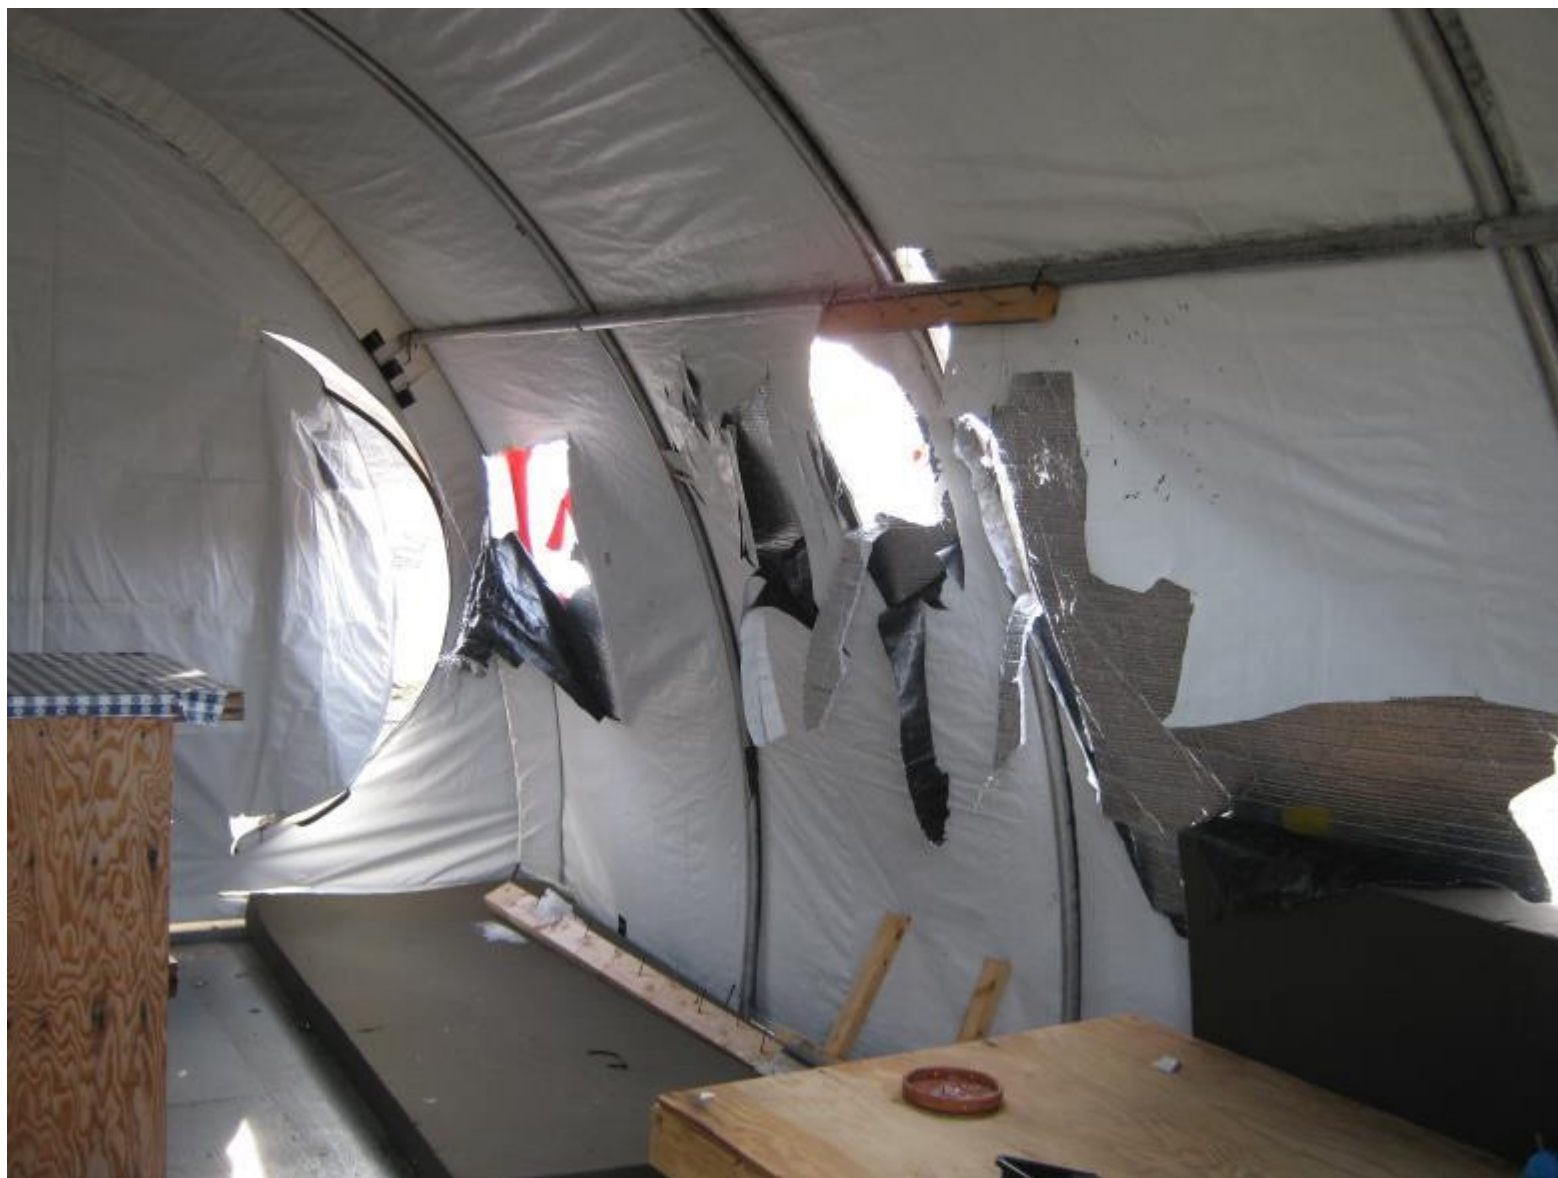
Figure 5 – Ripped tent

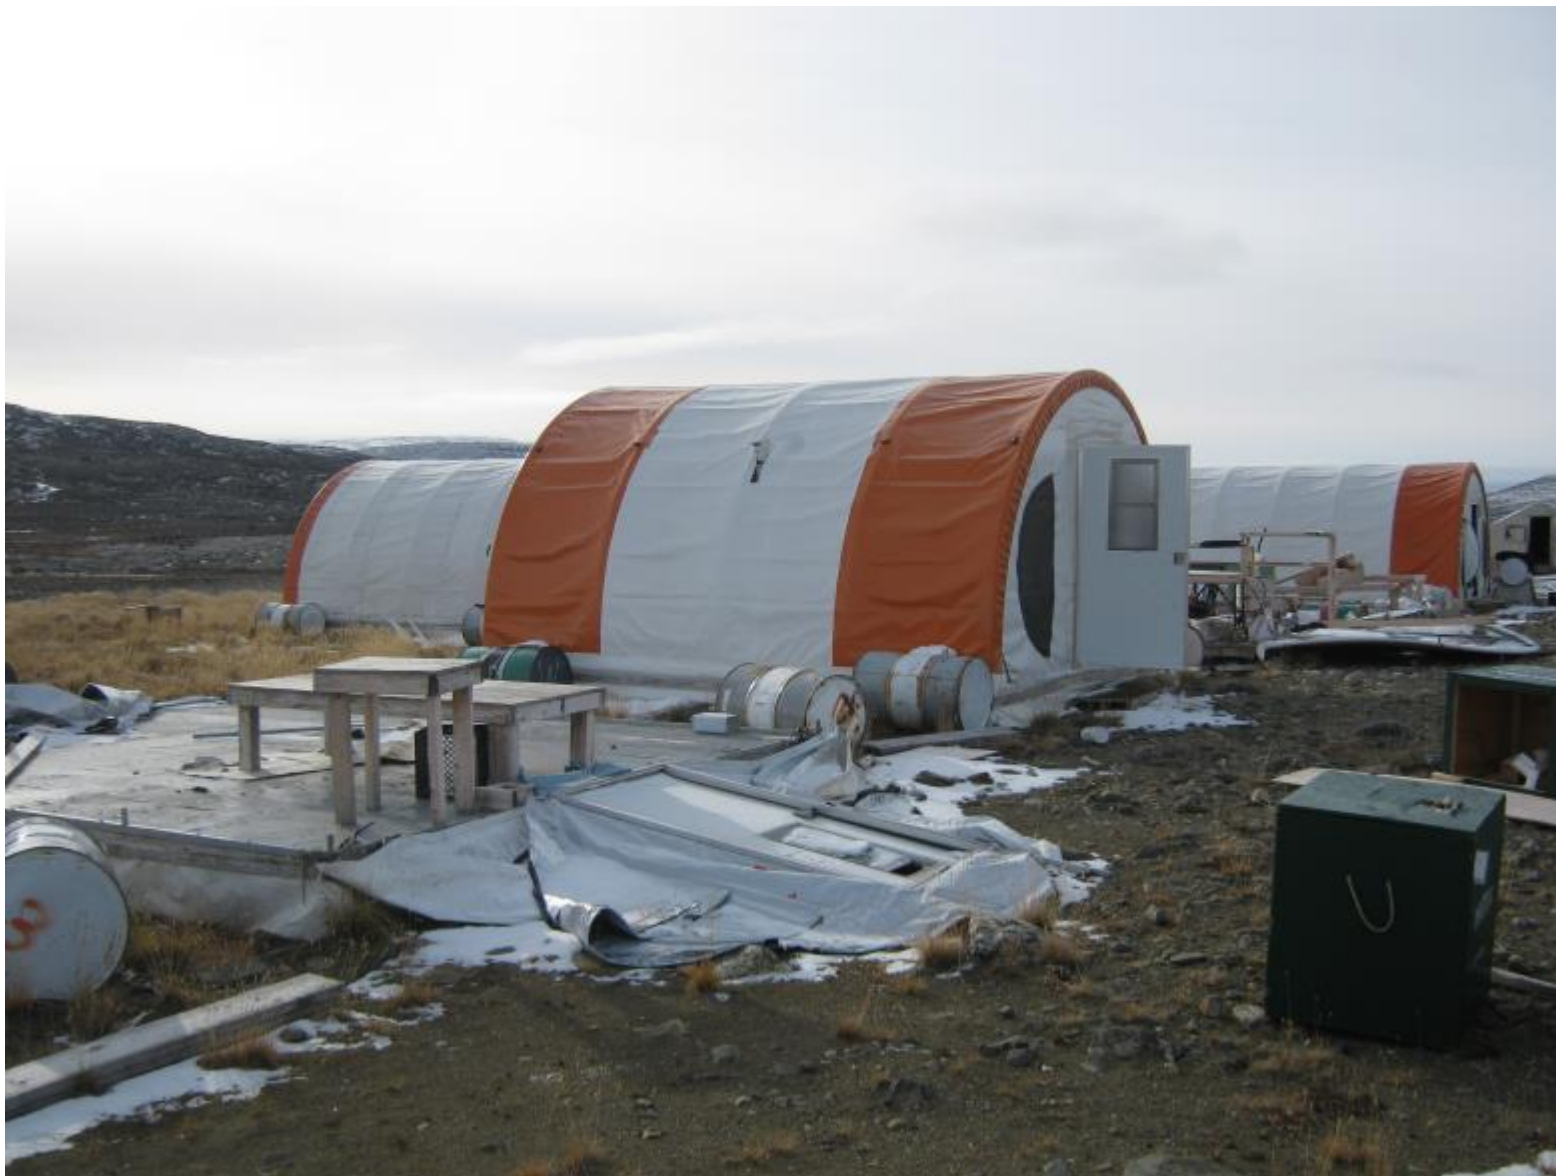
Figure 6 – Damaged huts; general site view

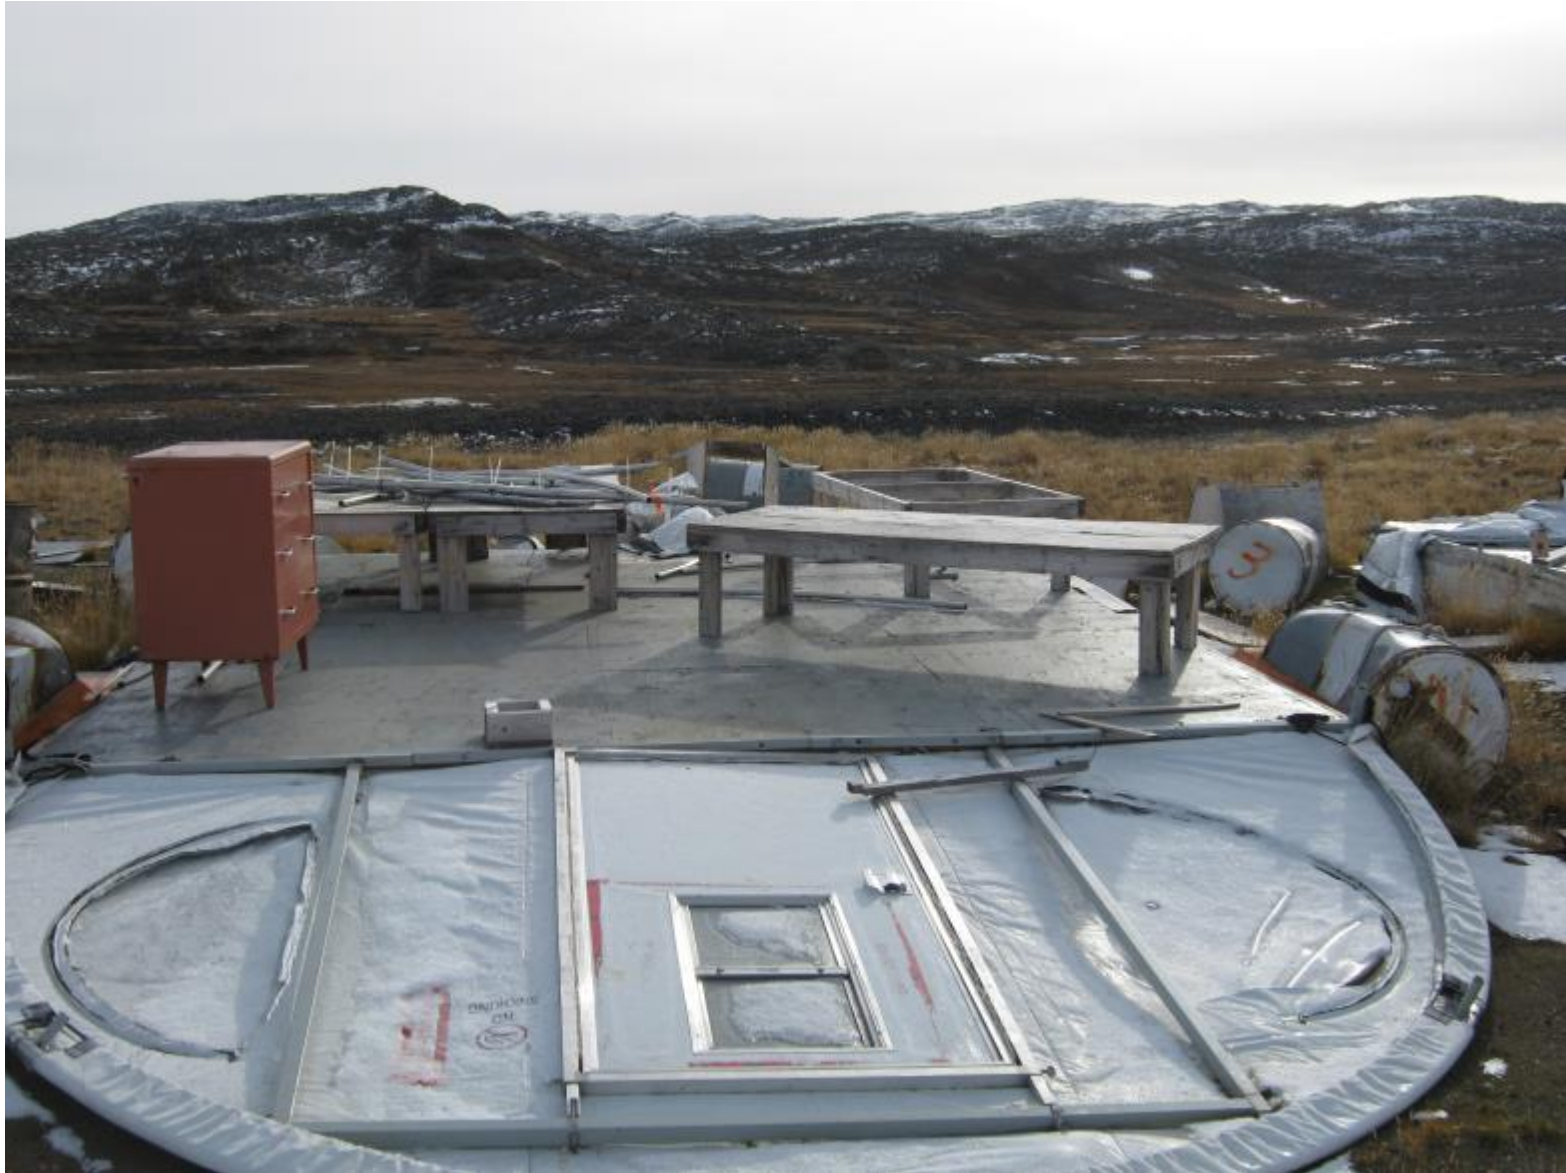
Figure 7 – Damaged hut and exposed interior

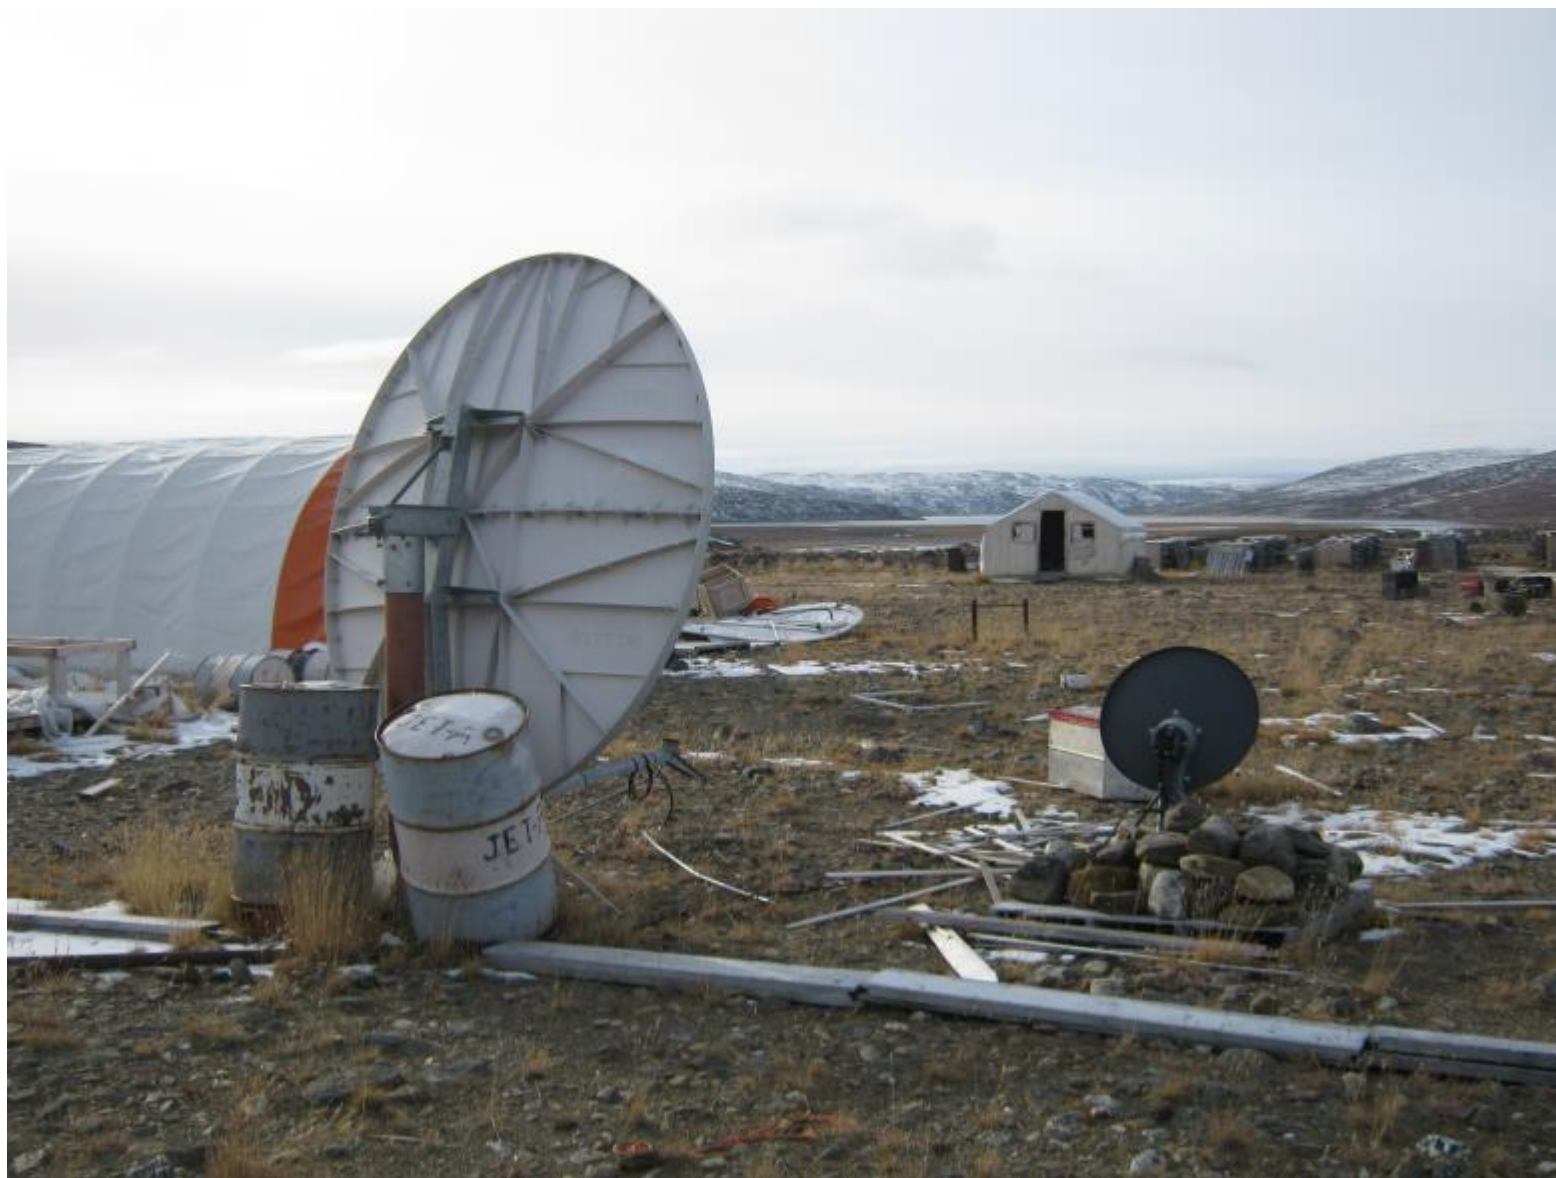
Figure 9 – Satellite dishes; general site view

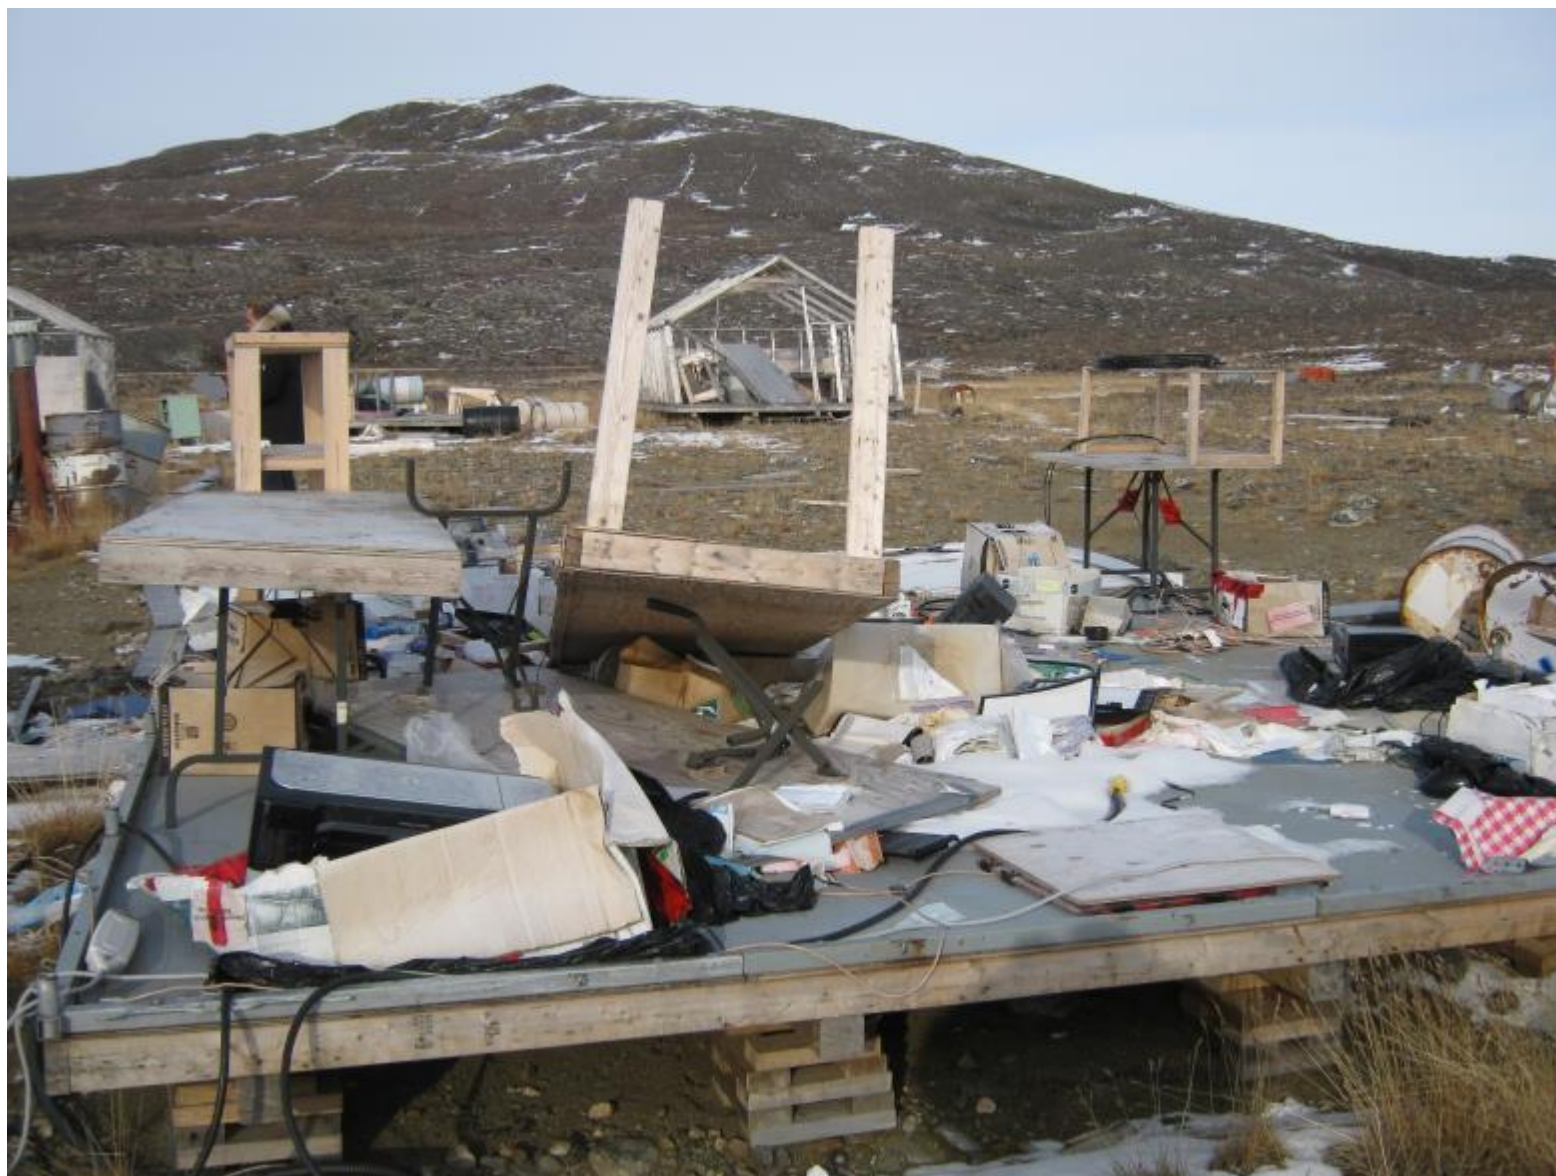
Figure 10 – Damaged hut and exposed items; general site view

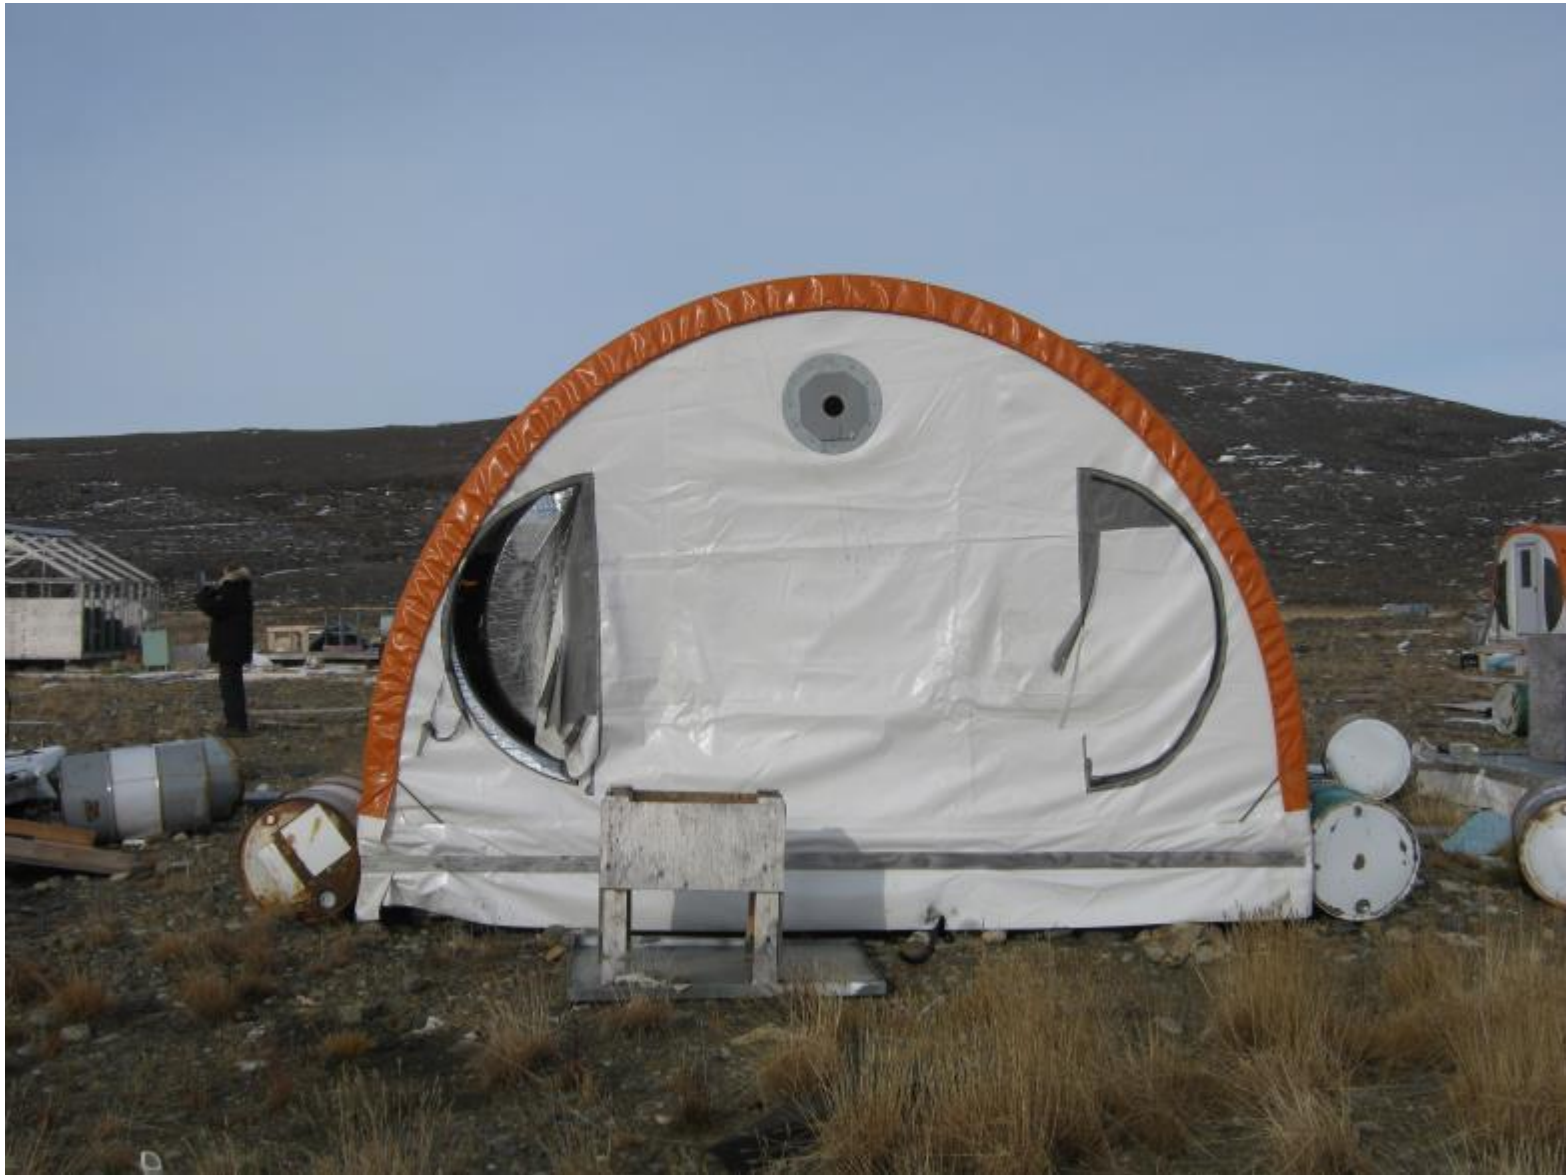
Figure 12 – Ripped tent opening on hut
