October 16, 2013

**Commander Resources Ltd**  
11<sup>th</sup> Floor, 1111 Melville Street  
Vancouver, BC V6E 3V6

**Subject: Securing of Camp Site at FOX-3 Dewar Lakes, Nunavut – Final Report**  
**(O/Ref.: CO 3666)**

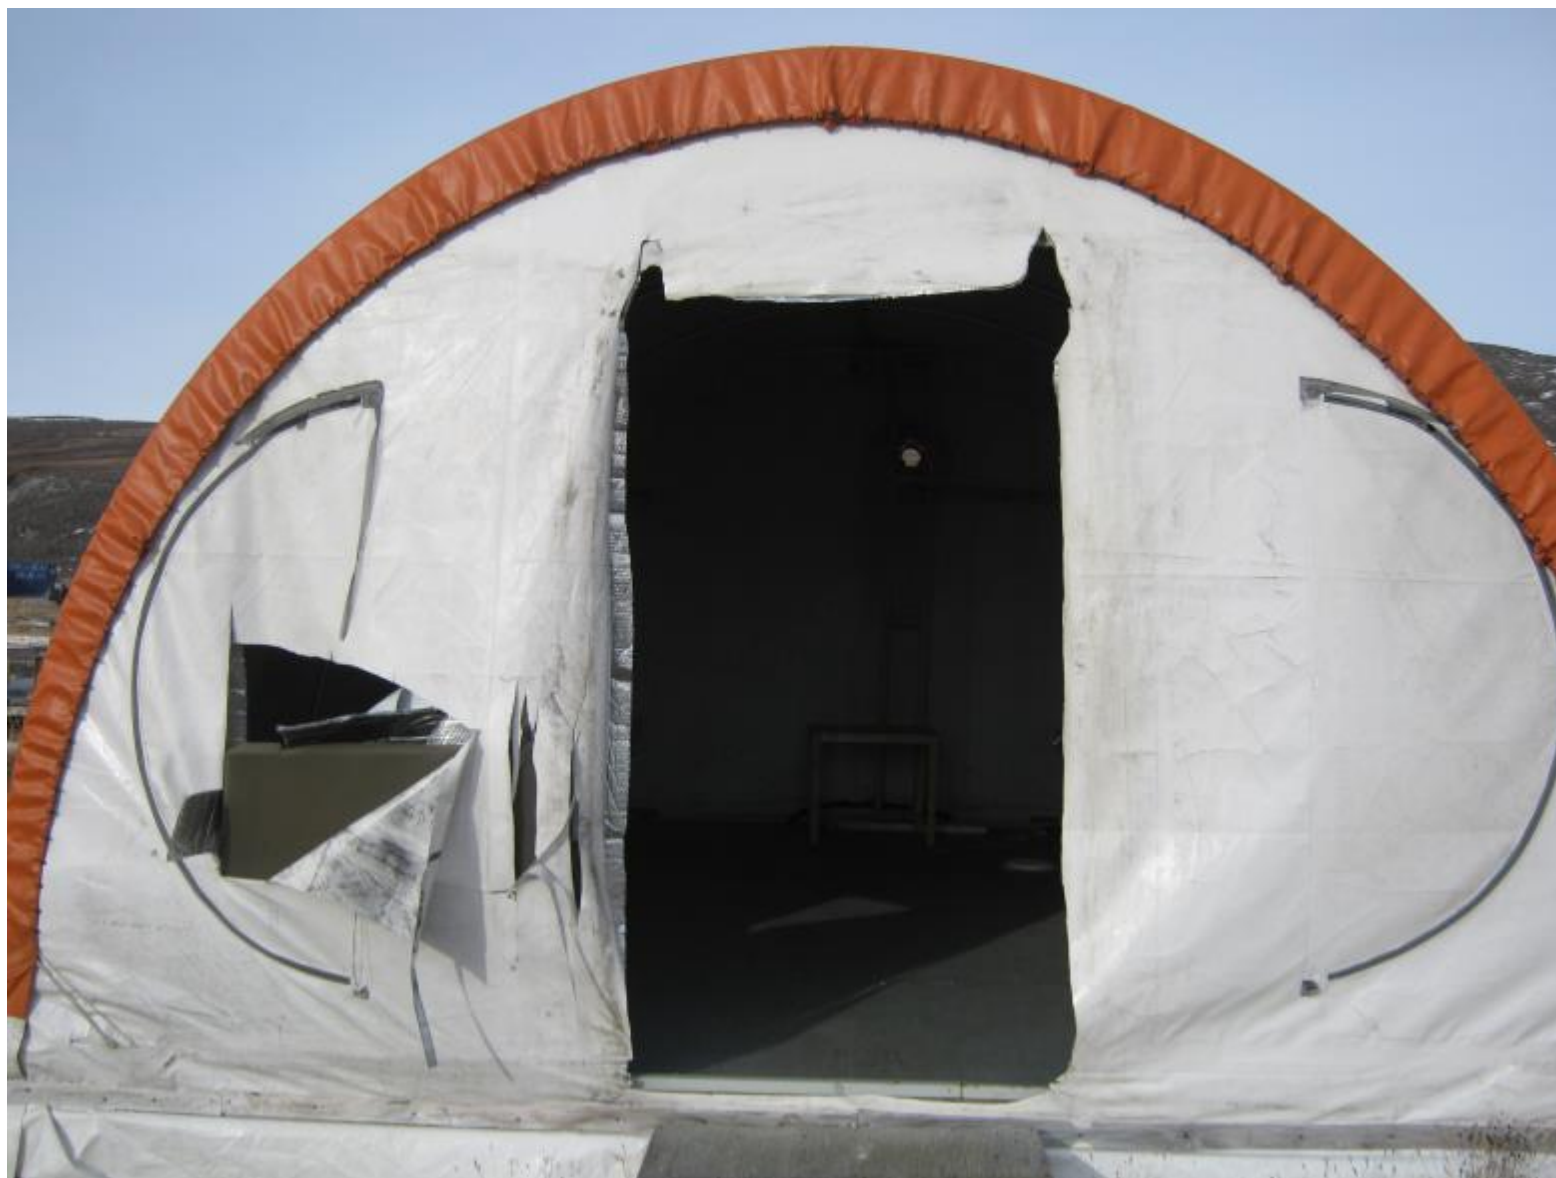
Figure 13 Torn tent and detached door on hut

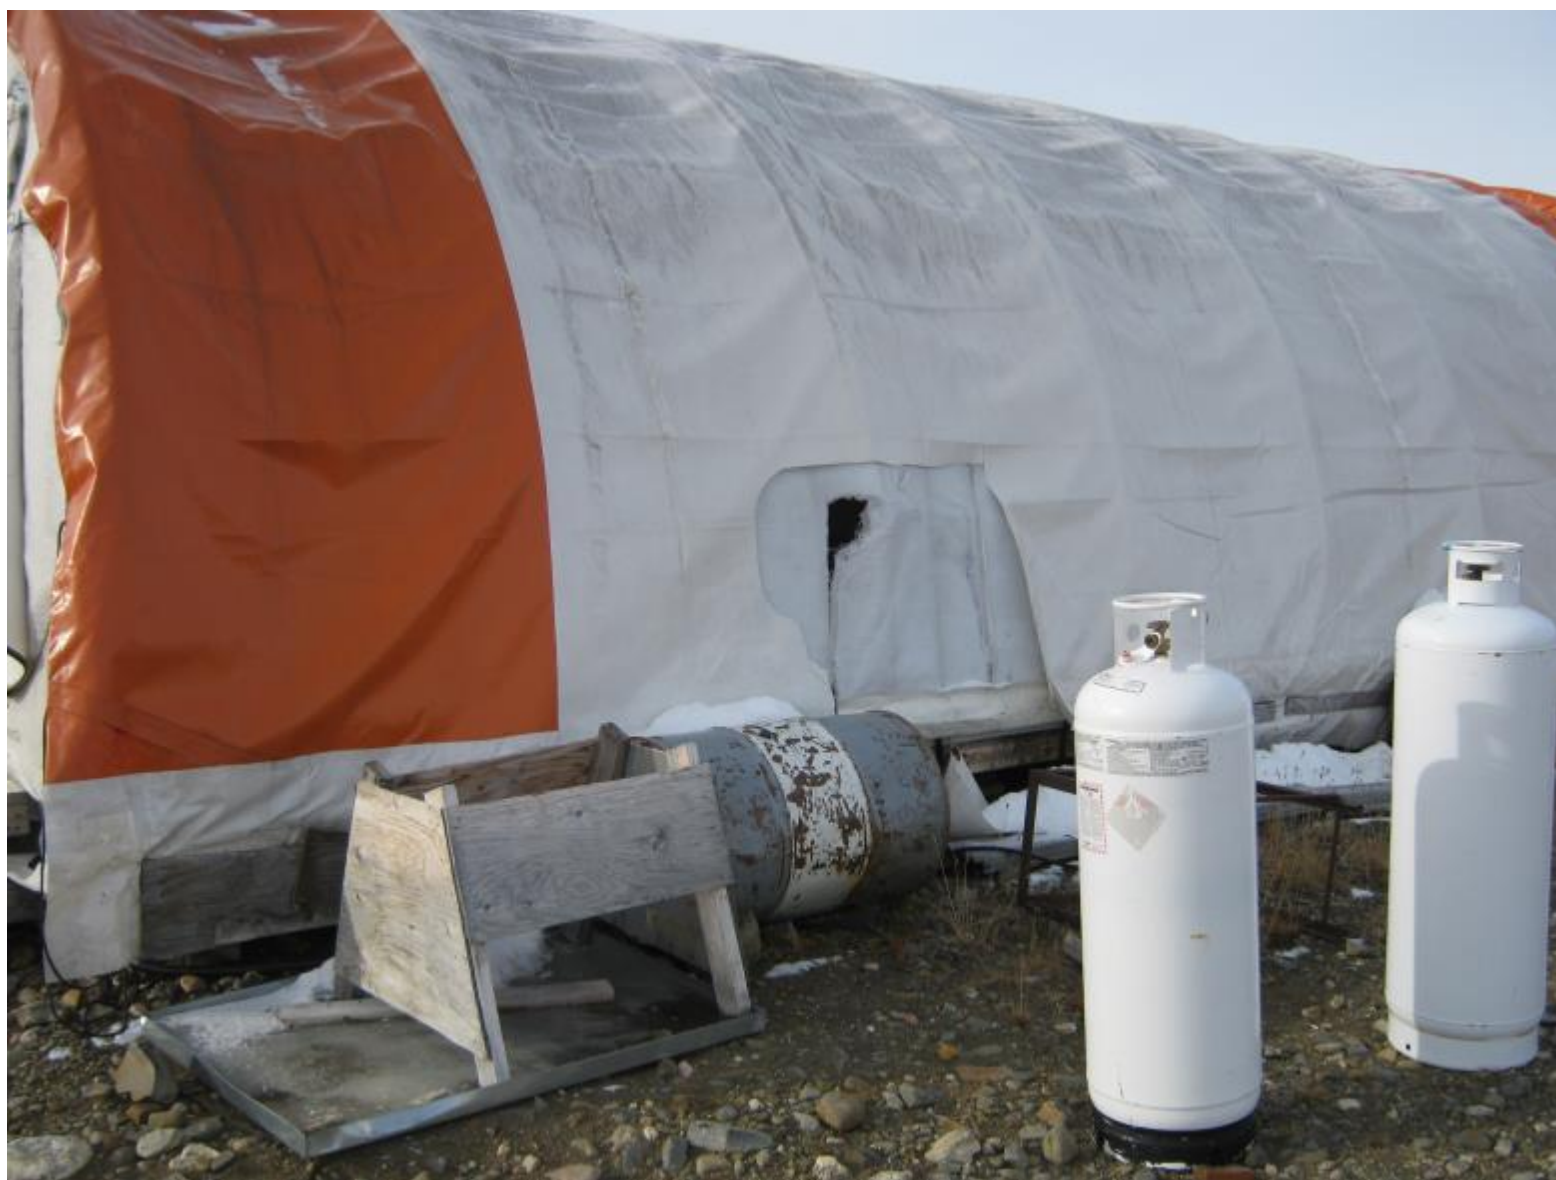
Figure 14 – Torn tent on hut

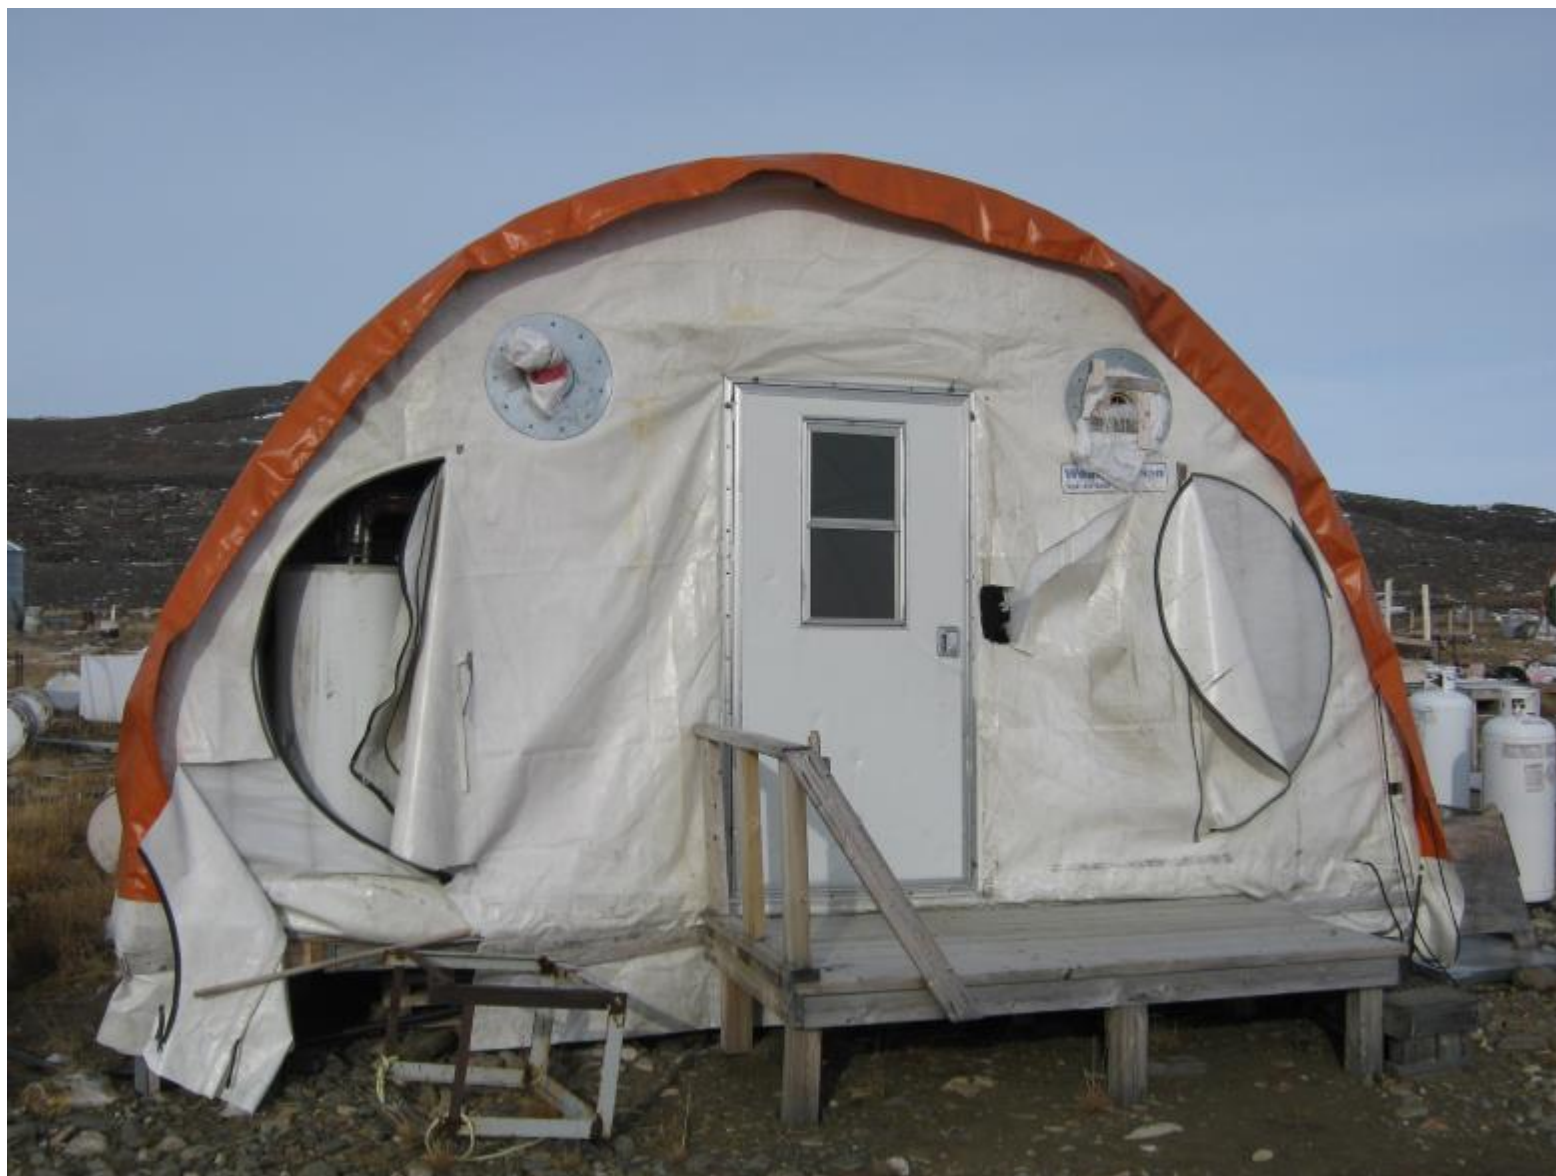
Figure 15 – Torn tent sections on hut

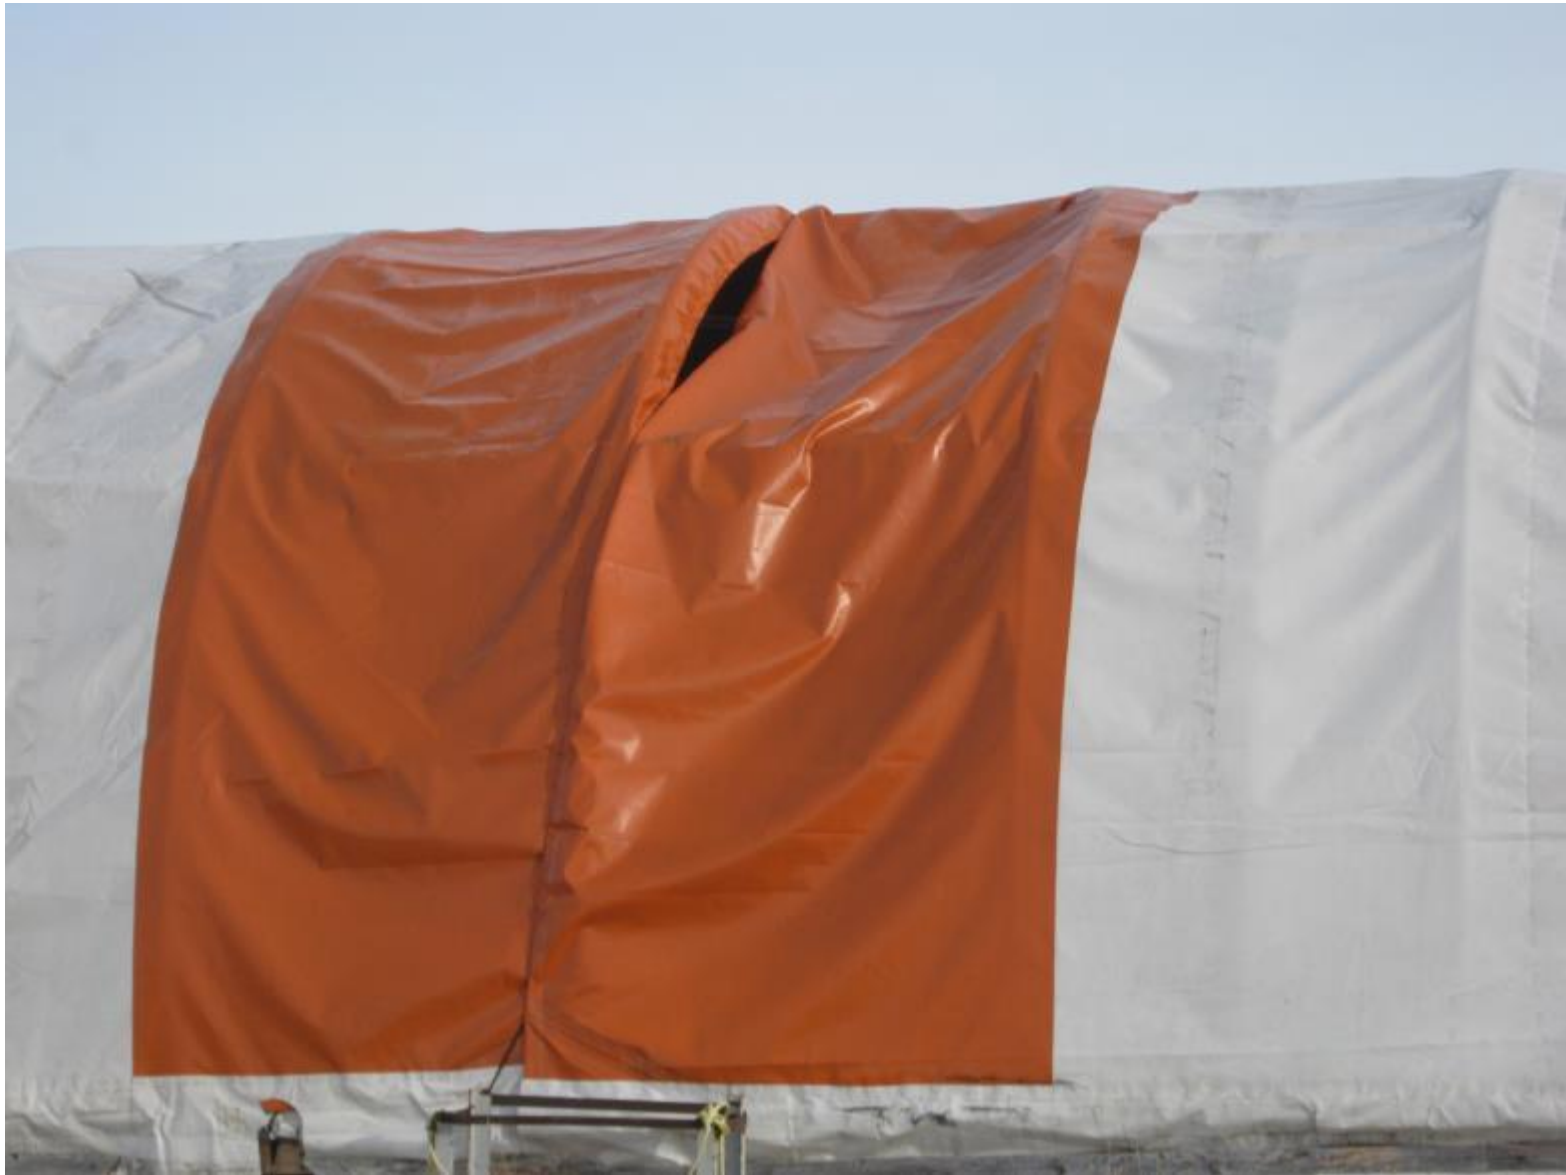
Figure 16 – Loose kitchen/ dining hut tent

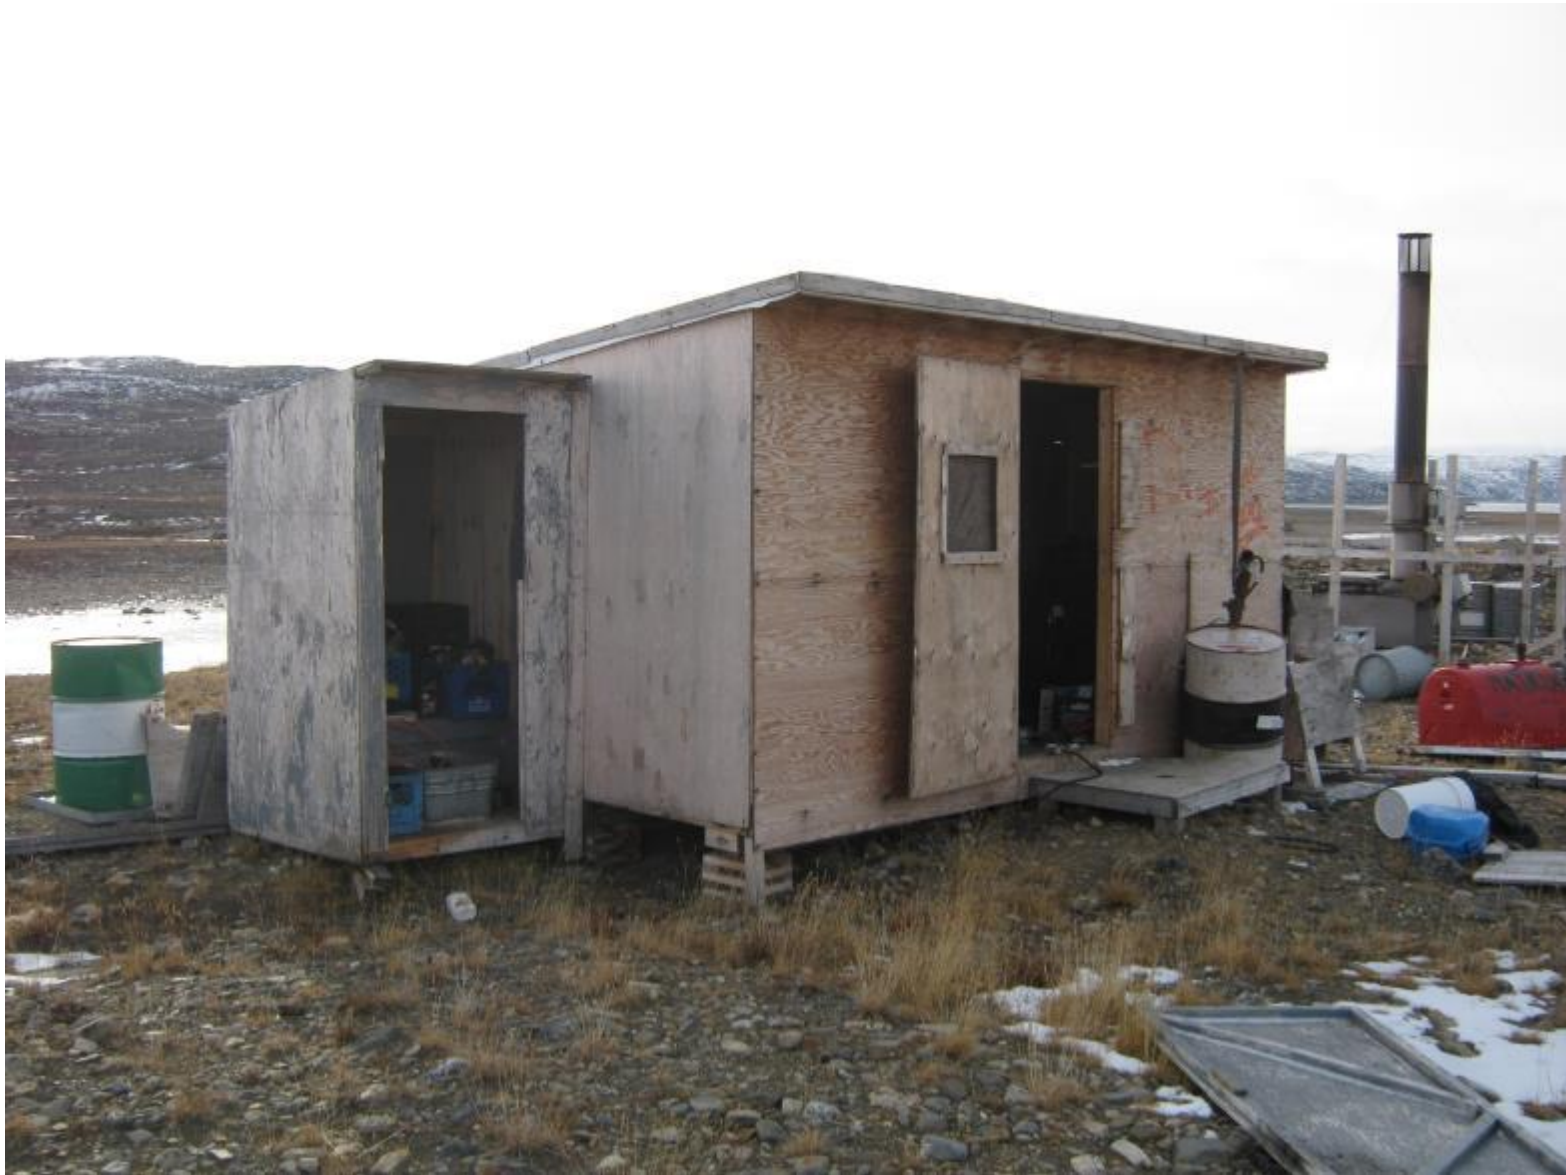
Figure 17 – Shed and attachment with open/ missing doors

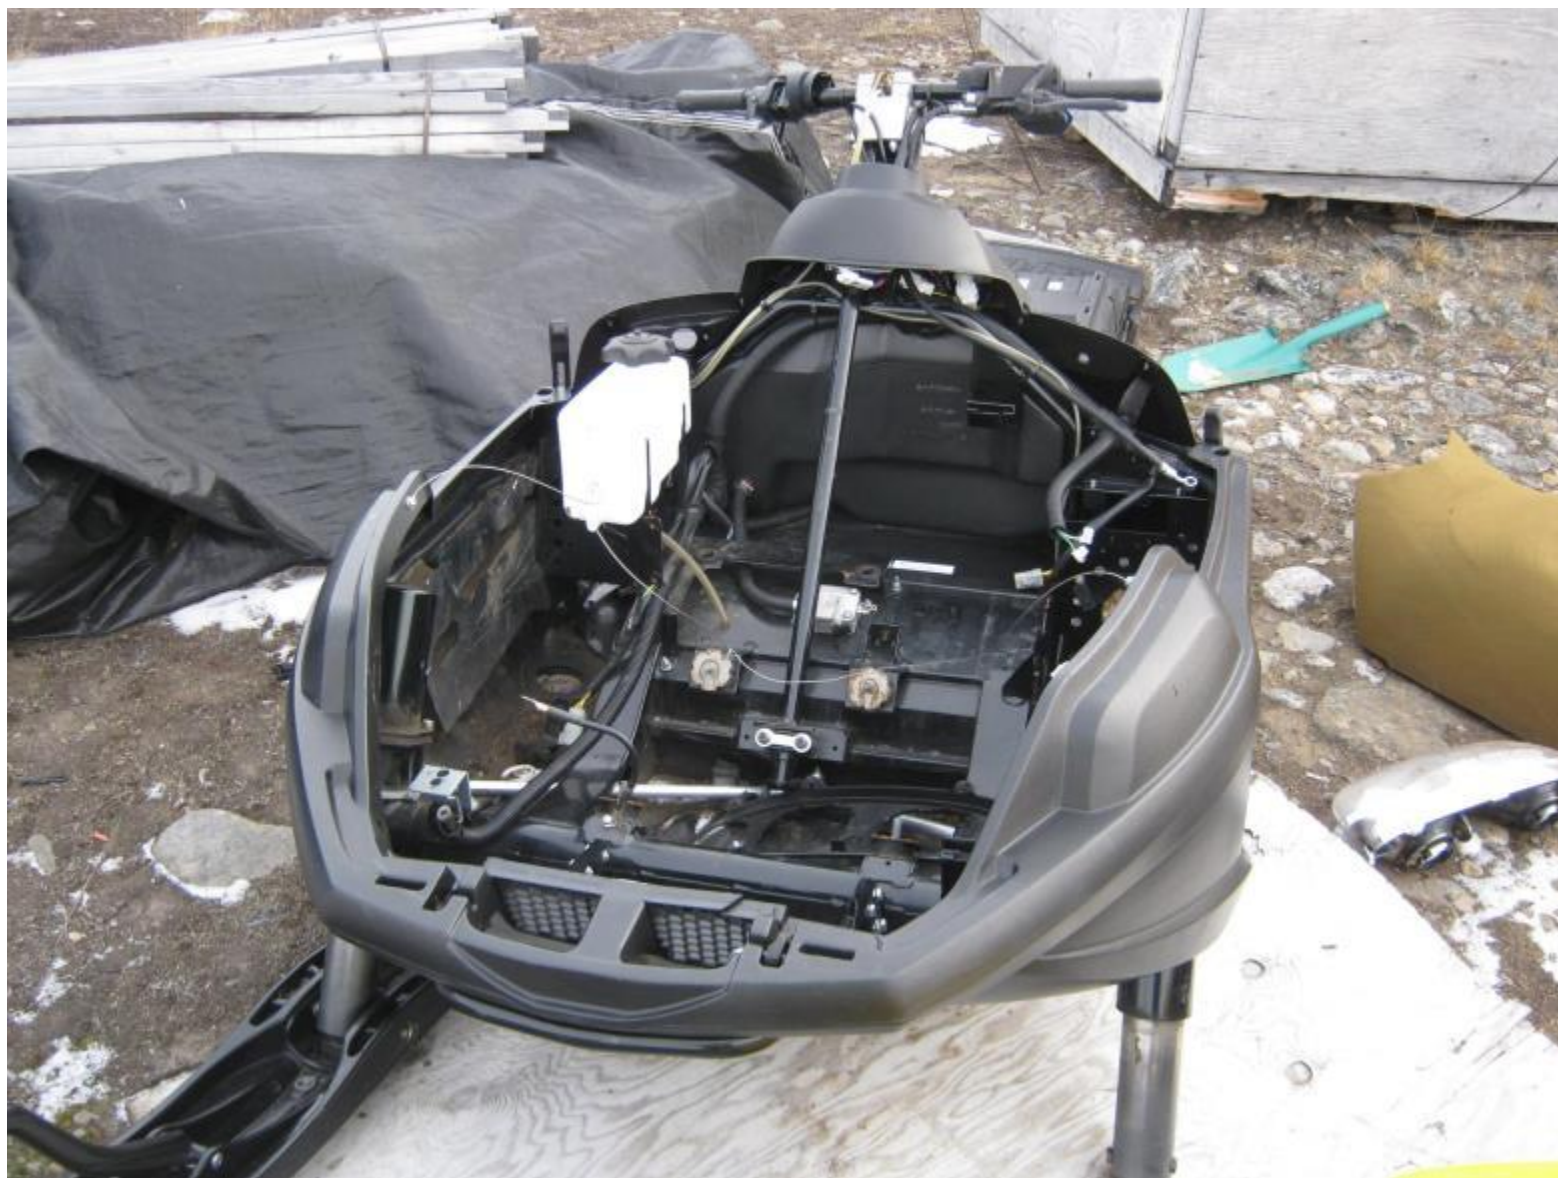
Figure 28 – Skidoo frame and 1 ski
