PEREGRINE
DIAMONDS LTD.

09 July 2009

REPORT ON A SPILL INCIDENT AT NANUQ CAMP, KIVALLIQ, NU: DISCOVERED AND CLEANED UP 07 JULY 2009

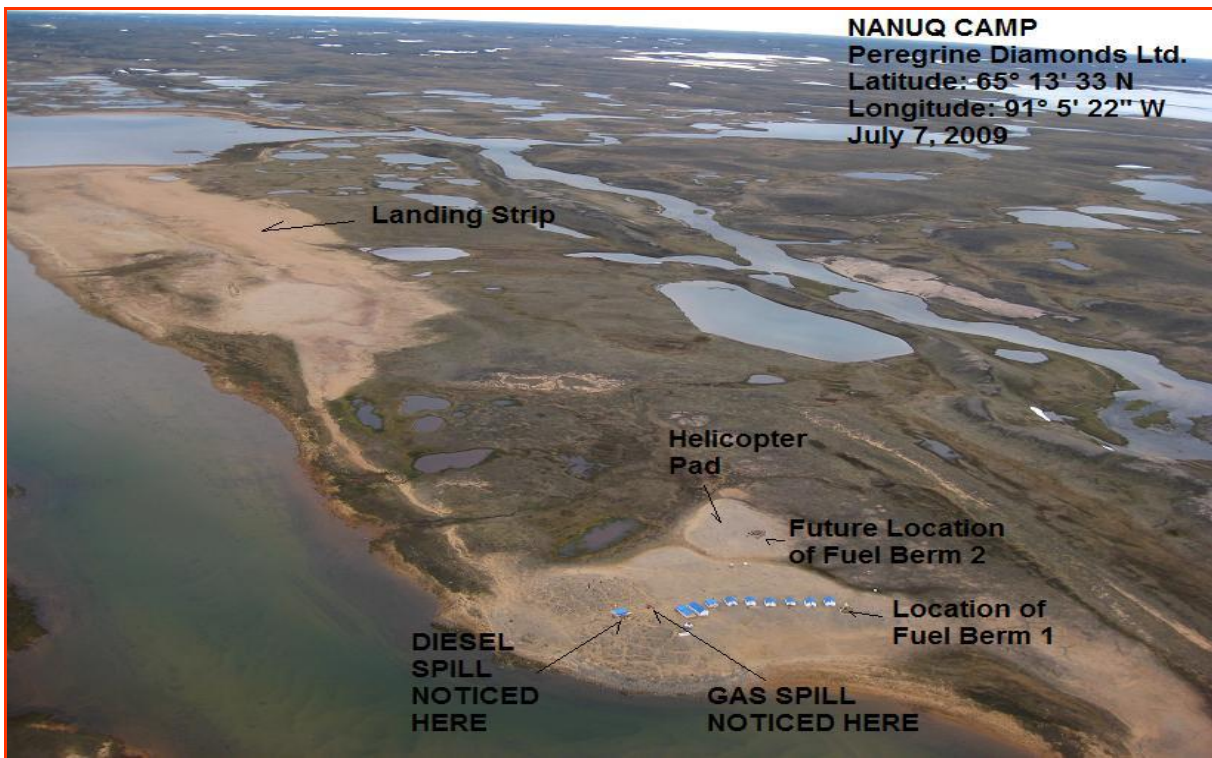
PHOTO 1: AERIAL VIEW WITH SPILL SITES, NANUQ CAMP, NU

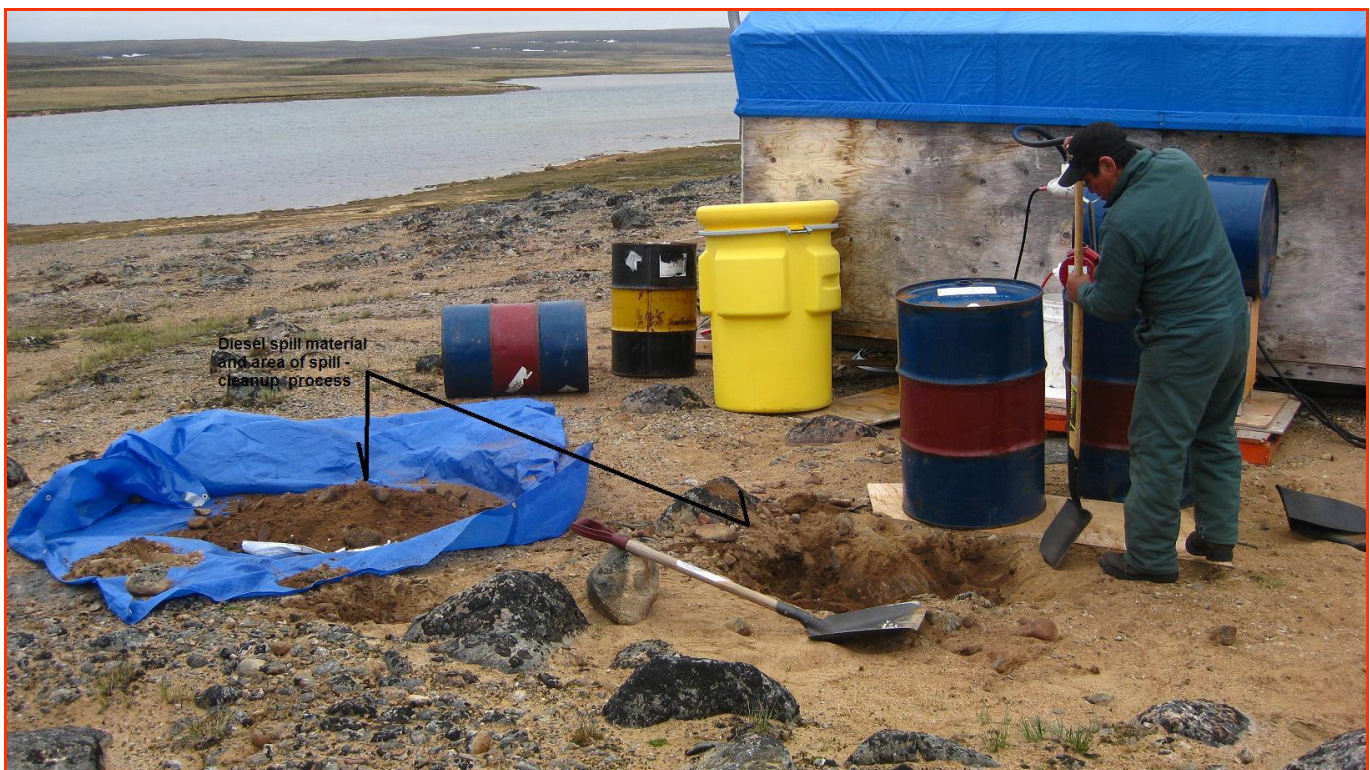
PHOTO 2: CLEANUP IN PROGRESS: DIGGING OUT DIESEL SPILL, NANUQ CAMP, NU

After the leaks were stopped by repositioning the drums, the crew accessed a spill kit near the shed and dug out the contaminated sandy material and placed it in waste-management bags from the kit. The contaminated soil was then transferred onto tarps, where it will be shovel-turned through the summer whilst the camp is open.

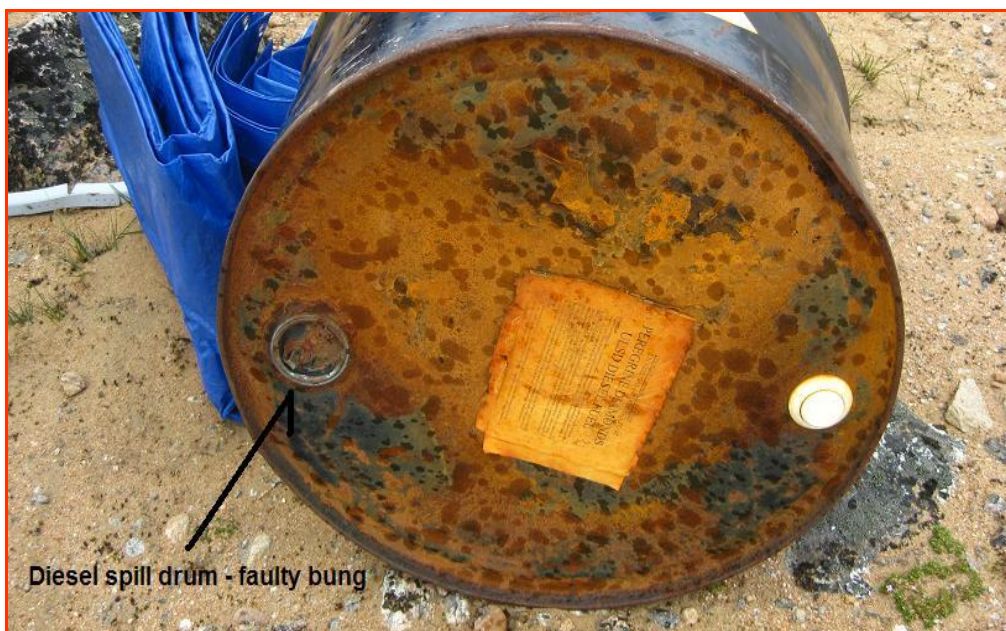
Upon occupying the site, the Nanuq crew discovered that two refilled drums already on site had leaked fuel onto the underlying sand in the vicinity of the generator shed. One leak emanated from a faulty bung on a P50 diesel drum, and Mr. Sell calculated a loss of 80L. The other leak emanated from a puncture or pressure rupture in a petrol (gasoline) drum, and Mr. Sell calculated a loss of 15L.

PHOTO 3: CLOSEUP OF FAULTY BUNG ON REFILLED DIESEL DRUM, NANUQ CAMP, NU

A protocol ("Quality-Control Checklist") has been developed by Peregrine for checking refilled drums, which have proven to be the source of leaks and spills in Nunavut. Peregrine will work with its expeditors who ship fuel to site to ensure that drums are properly checked before being transported to site and also with site personnel, so that damaged drums are not offloaded at site.

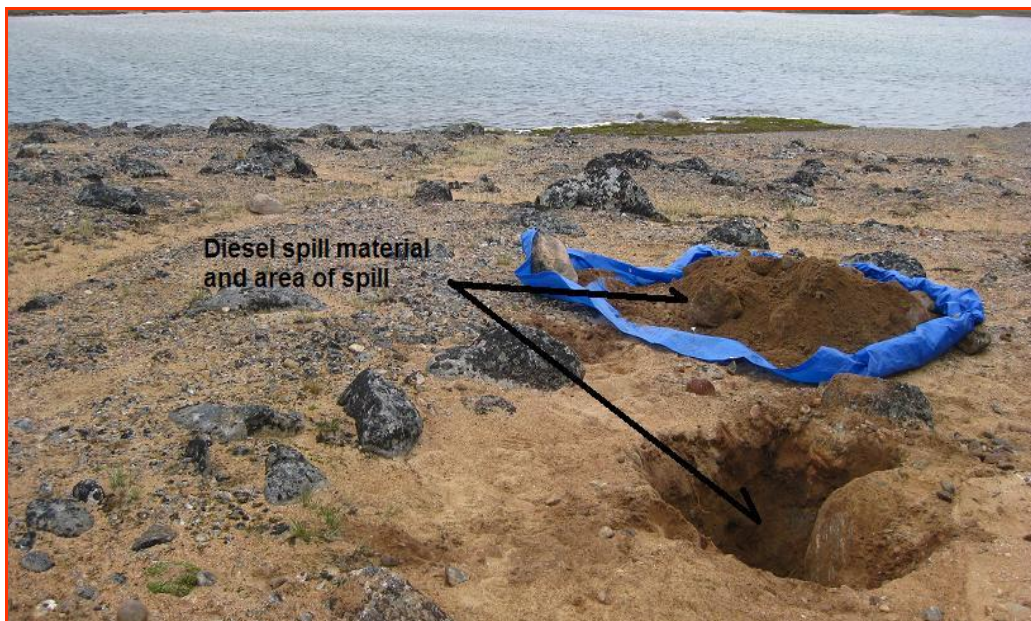
PHOTO 4: DIESEL SPILL MATERIAL TRANSFERRED ONTO TARP, NANUQ CAMP, NU

Additional tarps will be placed at the site of the excavated sand from the P50 spill, so that the material is thinly spread across the overlapped tarps in order to achieve a thin lift of material and thus encourage aeration. It is further planned to use rocks along the sides of the groundsheet to create a barrier wall on the N-NE side closest to the river. (Neither site is closer than 48M from the OHWM.) Similar action is being taken with regard to the excavated sand from the petrol spill.

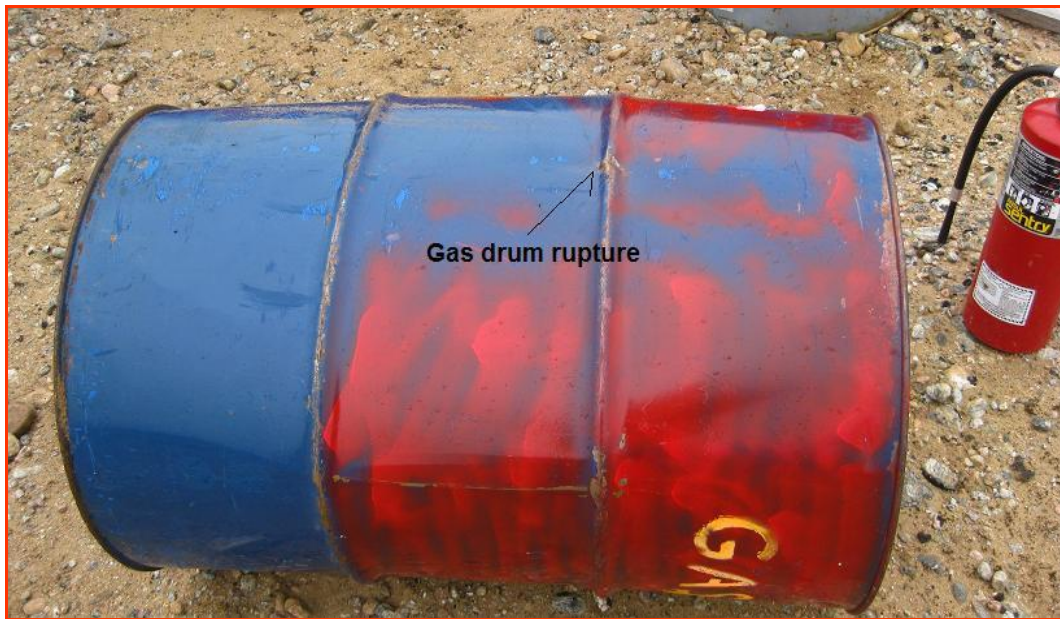
PHOTO 5: REFILLED PETROL DRUM WITH RUPTURE, NANUQ CAMP, NU

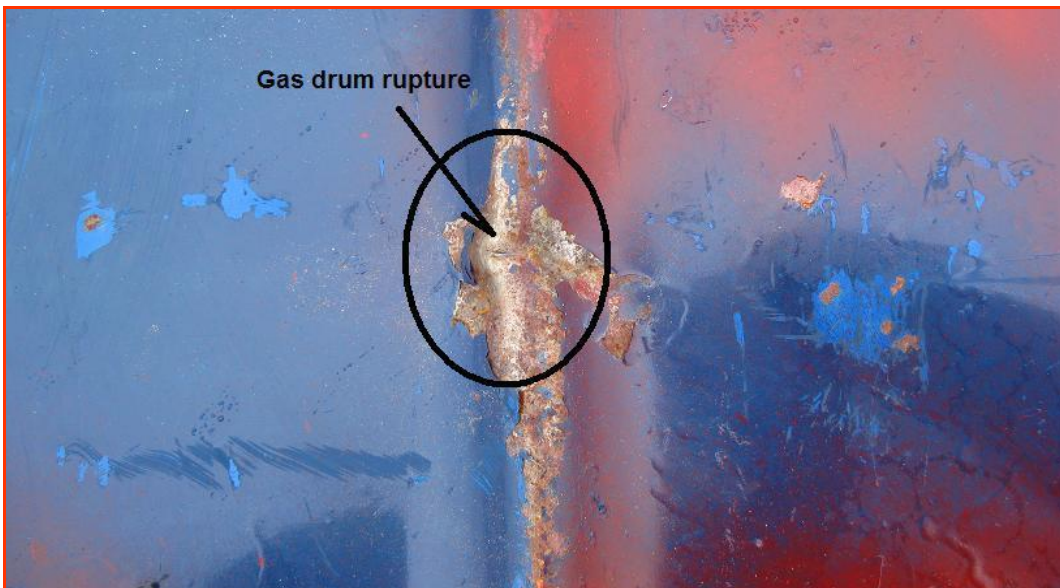
PHOTO 6: CLOSEUP OF PETROL DRUM RUPTURE, NANUQ CAMP, NU

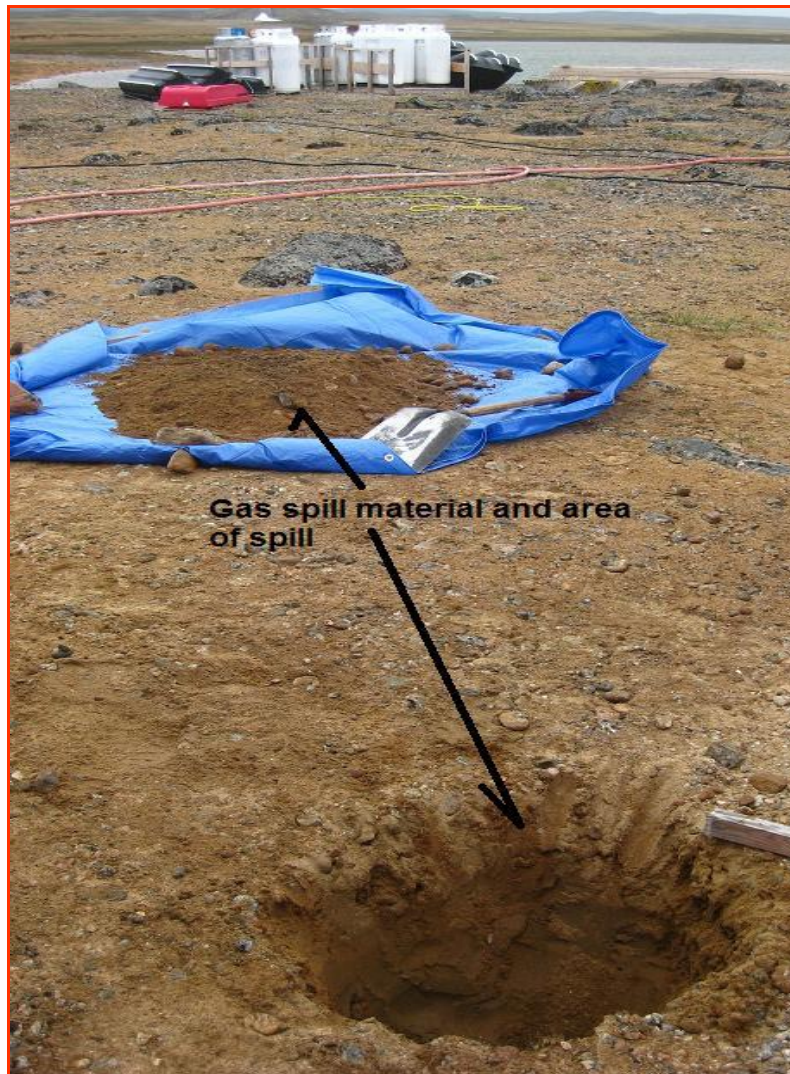
PHOTO 7: PETROL SPILL MATERIAL TRANSFERRED ONTO TARP, NANUQ CAMP, NU
