WATER LICENCE INSPECTION FORM

Licensee				Licensee Representative					
Strongbow Exploration Inc. N				N/A					
Licence No. / Expiry			Representa	tive's Title					
2BE-NTI0507 -									
Land / Other Authorizations			Land / Othe	er Authoriz	ations				
IOL: CO-20									
Date of Inspection			Inspector						
12/07/2014			Eva Pa	ul					
Activities Inspected	7					□			
		☐ Mining ☐ Construction ☐ Other:		Reclamation	☐ Fuel Storage	9			
	<u></u>								
	ceptable		- Unaccept	table	NA –	Not Applicable	NI – Not Ins	pected	
Water Use	Condition Comment	Site Conditions		Condition	Comment	Haz/Mat Manage	ement Condition	Comment	
Intake/Screen	NA	Water Management S	tructures	NA		Storage	NA		
Flow Measure. Device	NA	Culverts / Bridges		NA		Spills	NA		
Source:	NA	Drainage		NA		Spill Plan	NA		
Water Use:	NA	Erosion / Sediment NA		NA					
Recirculation (y /n)	NA	Mitigation Measure	s	NA		Administrative			
		Reclamation Activit	ies	U	1	Records	А		
		Materials Storage		NA		Reports	Α

Photos of July 12, 2014 Inspection

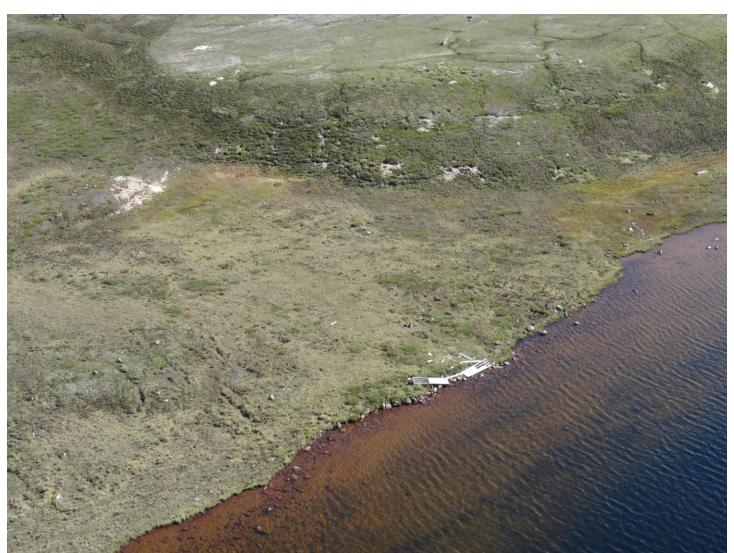
D. Camp - N66°31'01.2" W110°40'37.2" – debris noted all around the lake									
E. Licence location - N66°50′00.0" W110°57′00.0" – nothing but core boxes just north of the licence location

Figure 1. Debris at the lake indicated as a camp location (coordinate 'D' above).

SECTION 3	Comments	Non-Compliance with Act or Licence Action Required					
1. All debris left at the lake/camp location is to be removed.							
2. Drill casings for nearby drill sites are to be cut to the ground and capped (if feasible), however, it is understood that the drill							
collars pre-	collars pre-existed Strongbow's tenure on this property.						
Cancellation of	Cancellation of this licence is not recommended until location D (the 2005 fly camp) is restored to a re-disturbed state.						
Licensee or Repres	sentative		Inspector's Name				
-			Eva Paul				
Signature			Signature				
_			Sent electronically				
Date			Date				
-			28/11/2014				
APPENDICES:	Inspection Photos	Sample Resu	lts Other:				
Office Use Only:	Follow-up report to be issued by Inspecto	r	☐ Yes ☐ N	lo			
CC:	Phyllis Beaulieu, Manager of Licens	ing, NWB

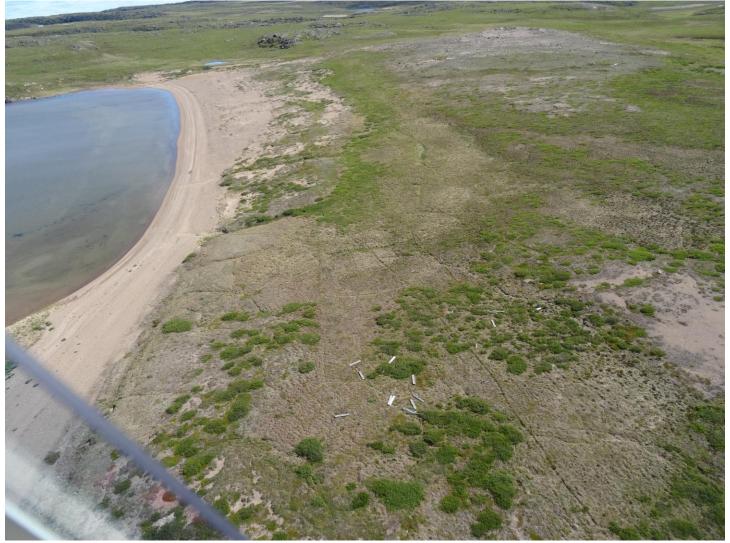
Figure 2. Further debris noted at the lake indicated as a camp location (coordinate 'D' above)
