WATER LICENCE INSPECTION FORM

| 2BE-NUP2227/October 12, 2027 | Project Geologist/Camp Manager |
| July 14, 2024 | RMO Kyle Amsel |

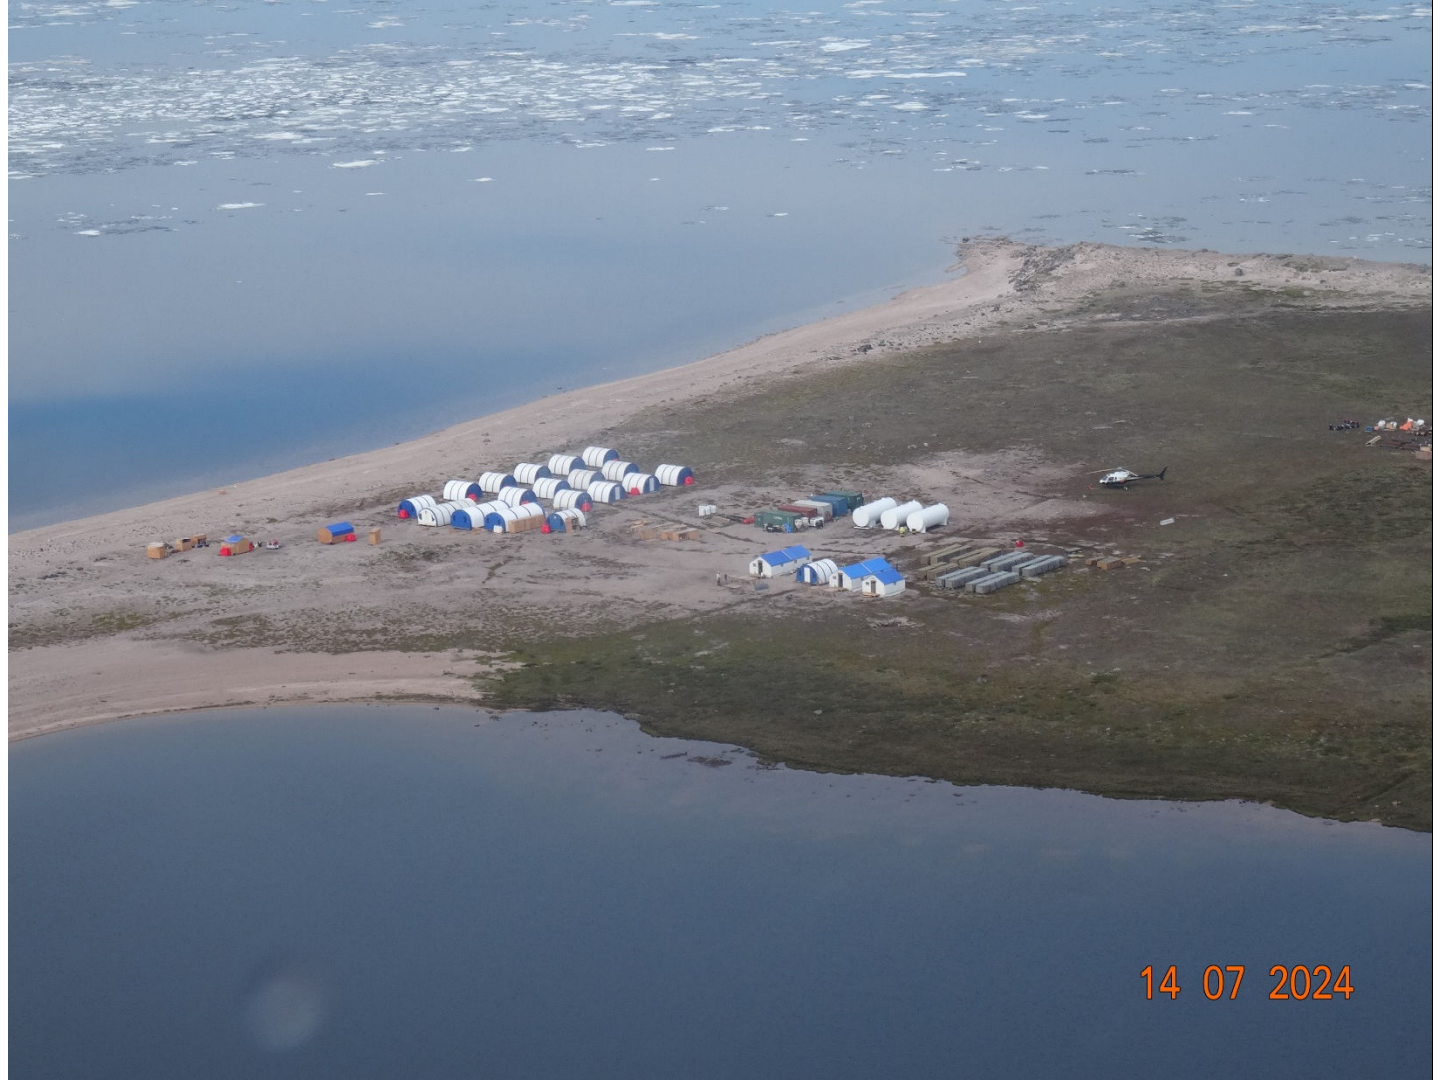
| Photo No. | Lat/Long (DD.MM.SS.SS, NAD83) |
|---|---|
| Photo 2 | N64° 23' 35.0" W98° 27' 4.4" |

**Description:**  
As above, Forum Camp. Weather haven tents on left side are for kitchen and accomodation, while blue roof tents on right are core shacks. Three white fuel tanks behind core shacks. Heli pads are co-located to fuel tanks on far side of tanks. Top right of photo with small red items are drilling equipment staged for slinging. One left of photo, generator shacks and incinerator.

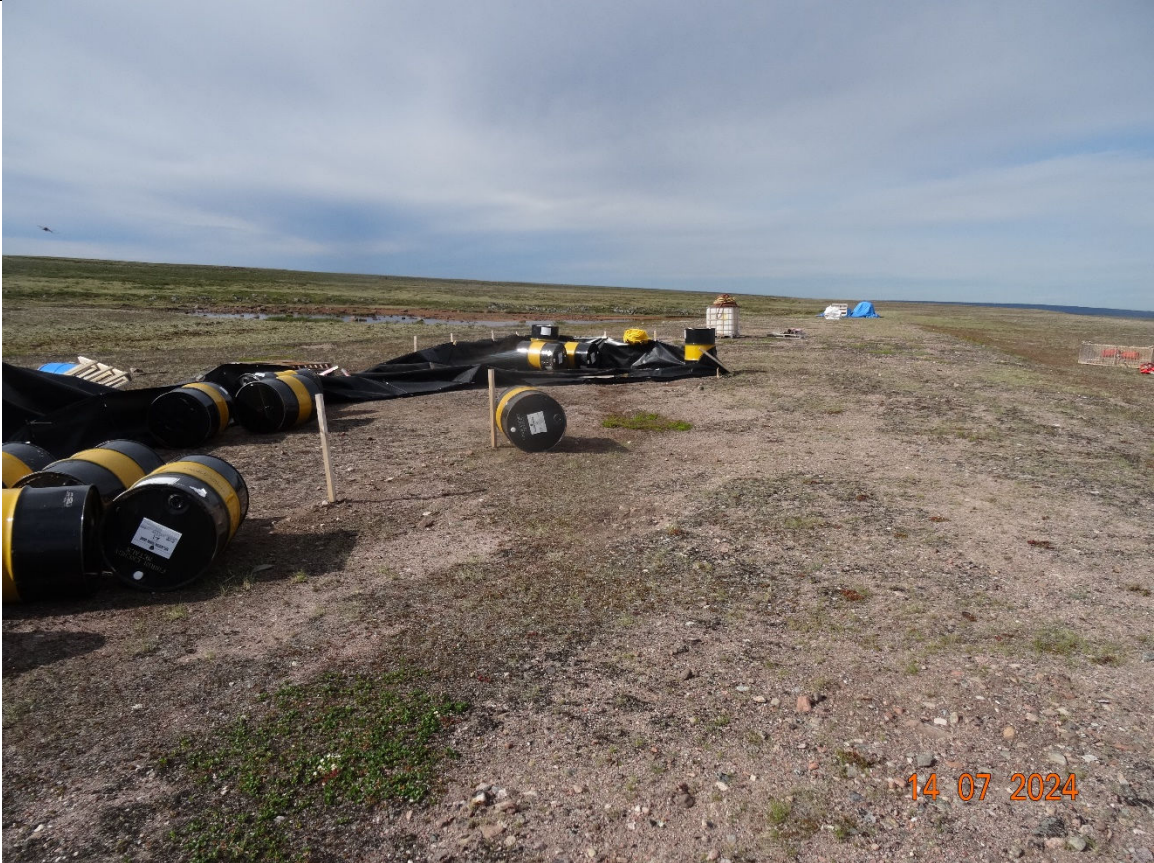
| Photo No. | Lat/Long (DD.MM.SS.SS, NAD83) |
|---|---|
| Photo 3 | N64° 22' 25.4" W98° 11' 31.4" |

**Description:**  
Loki Laydown. Note that drums are not within the berm as they were actively being used.

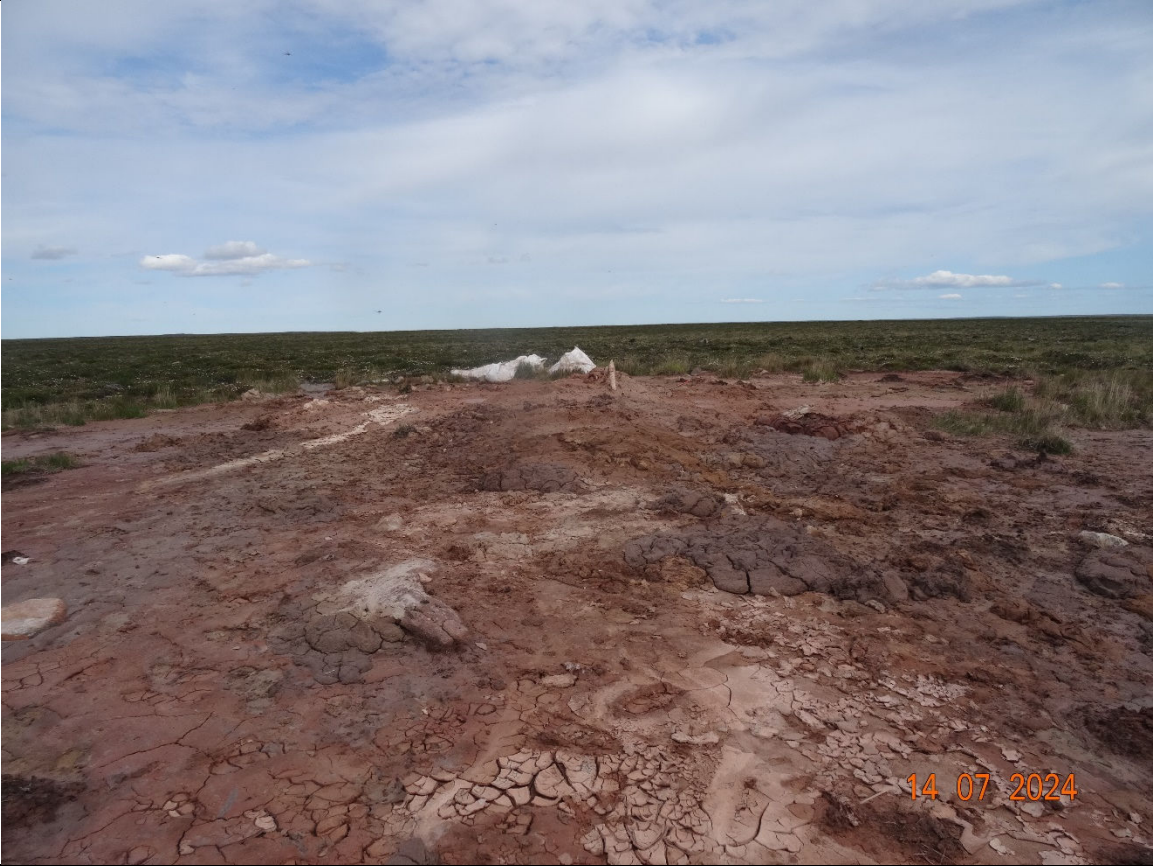
| Photo No. | Lat/Long (DD.MM.SS.SS, NAD83) |
|---|---|
| Photo 4 | NA |

| Failure to comply with Licence <ul style="list-style-type: none"><li>- Part F Item 3, failure to contain cuttings in appropriate sump or natural depression</li><li>- Part B Item 1, failure to pay water use fees</li></ul> | | | |

| Photo No. | Lat/Long (DD.MM.SS.SS, NAD83) |
|---|---|
| <b>Description:</b><br>Cuttings sump. Note cuttings are not contained and spreading to surrounding lands. | |

| The Licensee shall: <ul style="list-style-type: none"><li>- Use appropriate sumps or natural depressions to dispose of cuttings</li><li>- Ensure appropriate records are maintained of backhauled waste and their final disposal</li><li>- Contact the Nunavut Water Board to pay for any outstanding fees associated with the Licence</li></ul> | | | |

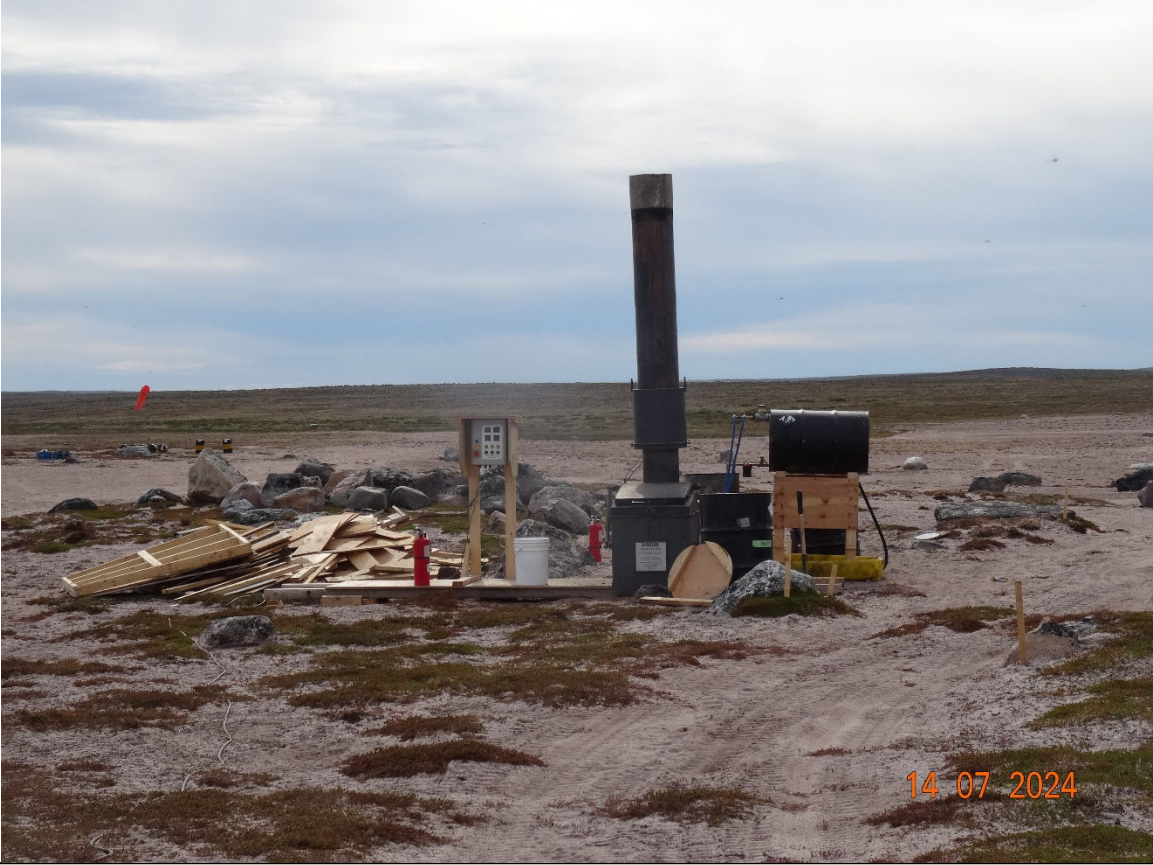
| Photo No. | Lat/Long (DD.MM.SS.SS, NAD83) |
|---|---|
| Photo 5 | N64° 23' 29.5" W98° 27' 51.9" |

| Photo No. | Lat/Long (DD.MM.SS.SS, NAD83) |
|---|---|
| <b>Description:</b><br>Incinerator. | |

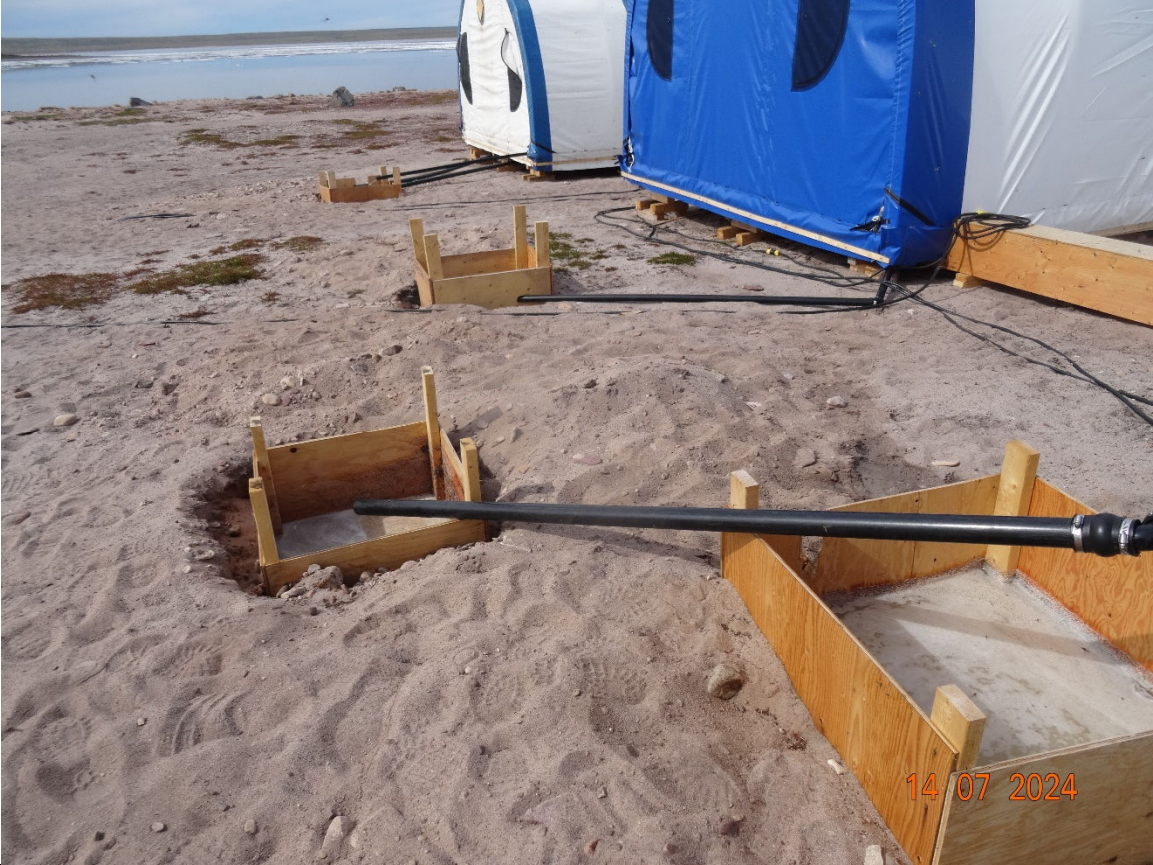
| Photo No. | Lat/Long (DD.MM.SS.SS, NAD83) |
|---|---|
| Photo 6 | N64° 23' 32.1" W98° 27' 56.9" |

**Description:**  
Grey water sumps.

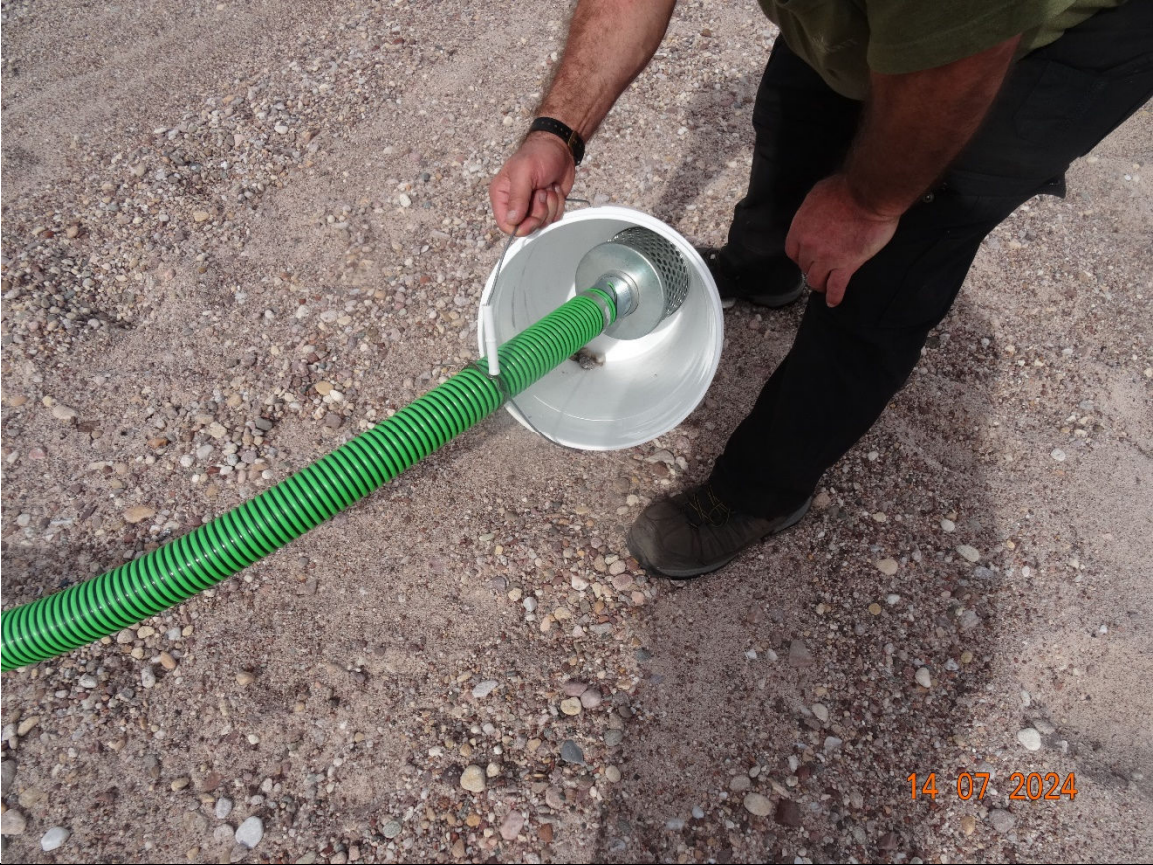
| Photo No. | Lat/Long (DD.MM.SS.SS, NAD83) |
|---|---|
| Photo 7 | NA |

**Description:**  
Screen on water intake.
