WATER LICENCE INSPECTION FORM

Licensee		Licensee Representative	
Adamera Minerals Corp		-	
Licence No. / Expiry		Representative's Title	
2BE-PEL0813 (expired)		-	
Land / Other Authorizations		Land / Other Authorizations	
N20012C0009		-	
Date of Inspection		Inspector	
22/07/2015		Eva Paul	
Activities Inspected			
<input checked="" type="checkbox"/> Camp	<input checked="" type="checkbox"/> Drilling	<input type="checkbox"/> Mining	<input type="checkbox"/> Construction
<input type="checkbox"/> Roads/Hauling	<input type="checkbox"/> Other:		<input checked="" type="checkbox"/> Reclamation
			<input type="checkbox"/> Fuel Storage

Attachment 1: PHOTO LOG

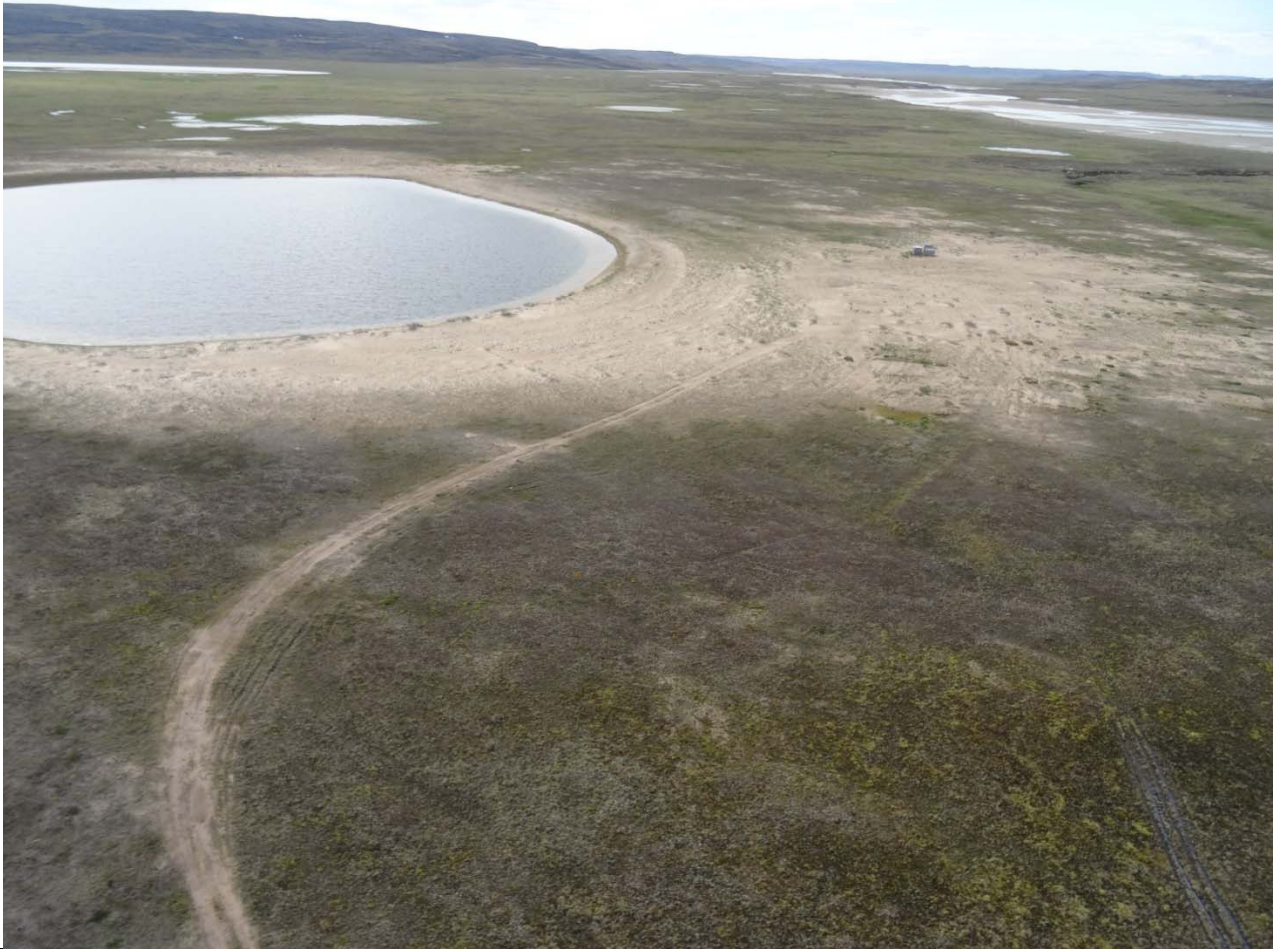
Date	Camera	Inspector	Authorization
22/07/2015	SONY DSC-HX50V	Eva Paul	2BE-PEL0813
Photo Log # 1		Location (NAD 83 DD MM SS.SS)	
Photo DSC04570		N68 07 42.11	W90 04 10.03 (approximate; taken while flying)

Description: Site of previous Amaruk Camp; only core racks remain, as permitted.

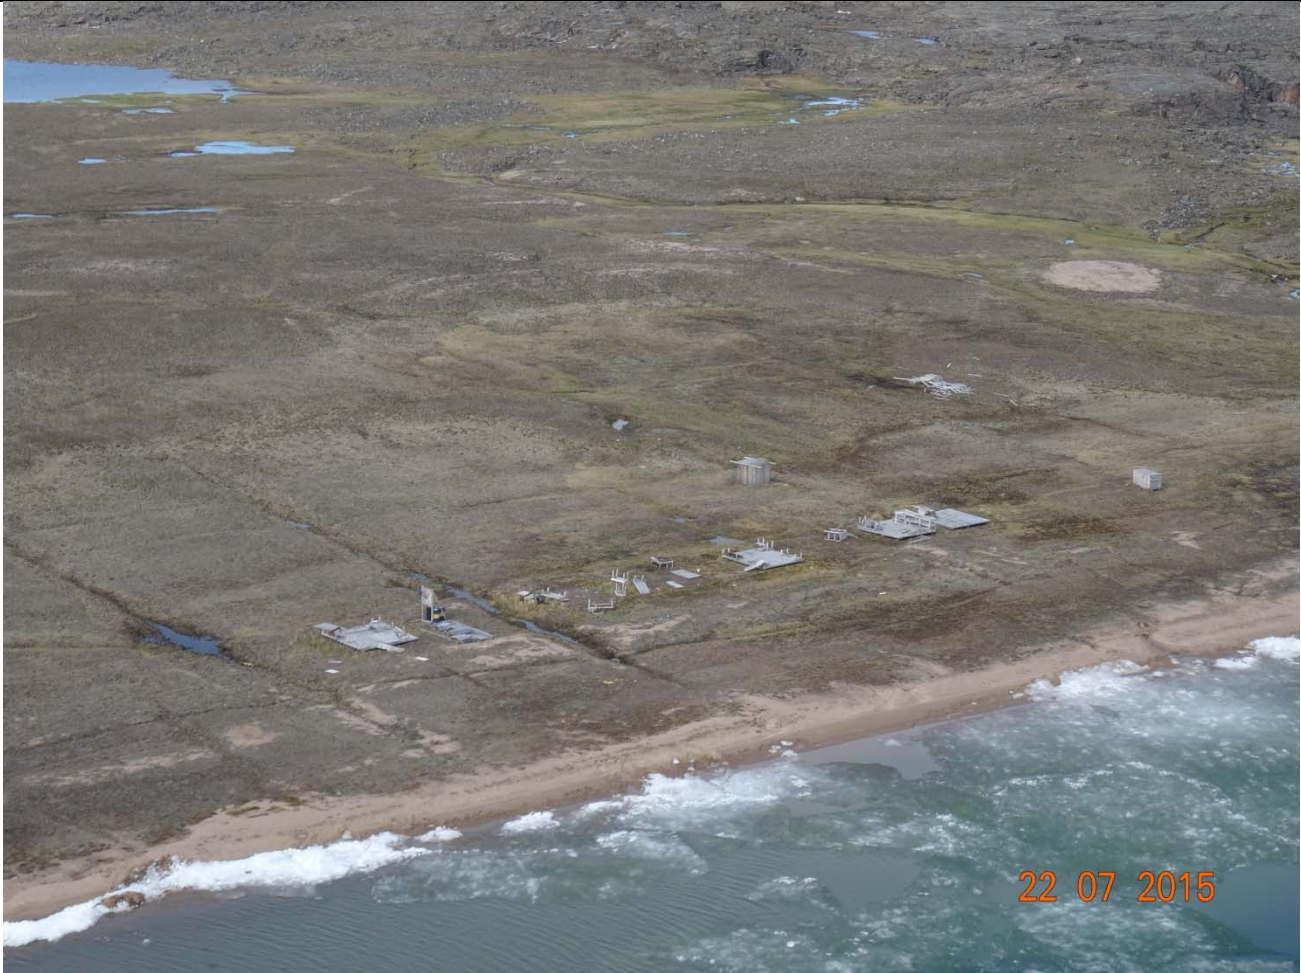
Photo Log # 2	Location (NAD 83 DD MM SS.SS)		
Photo DSC04540	N68 07 39.69	W91 30 24.47 (approximate; taken while flying)

Description: Tunerq Camp; camp has not been removed.

The Licensee is to undertake reclamation of **all sites** associated with this project, including a review of all drill holes to ensure compliance with the Licence conditions. The work is to be undertaken during the snow-free season in 2015 or 2016.

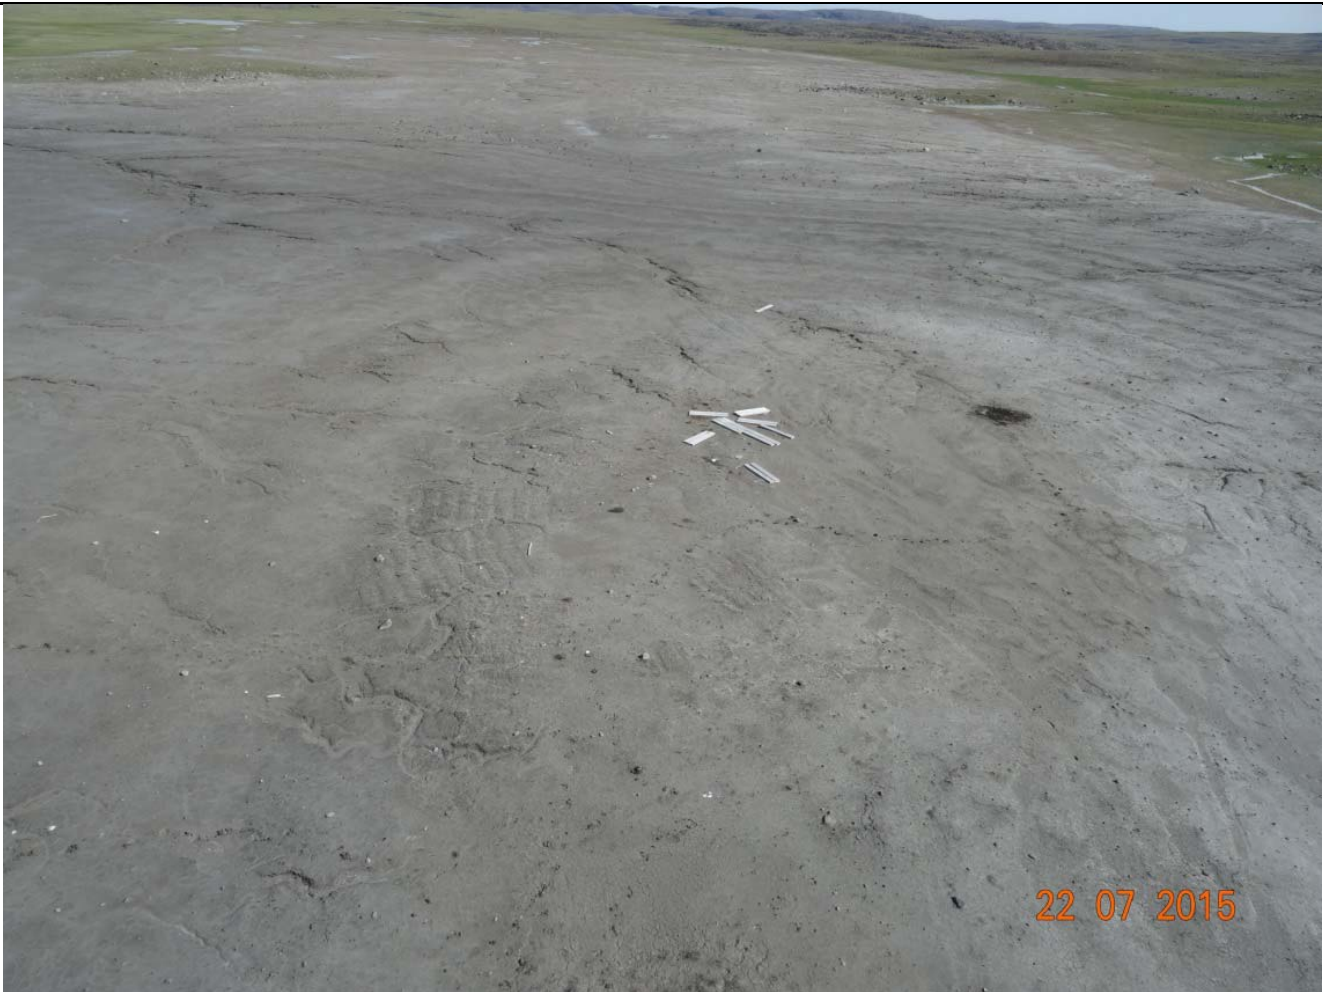
Photo Log #5

Description: Debris at New Tuktu cache, as noted in 2012.

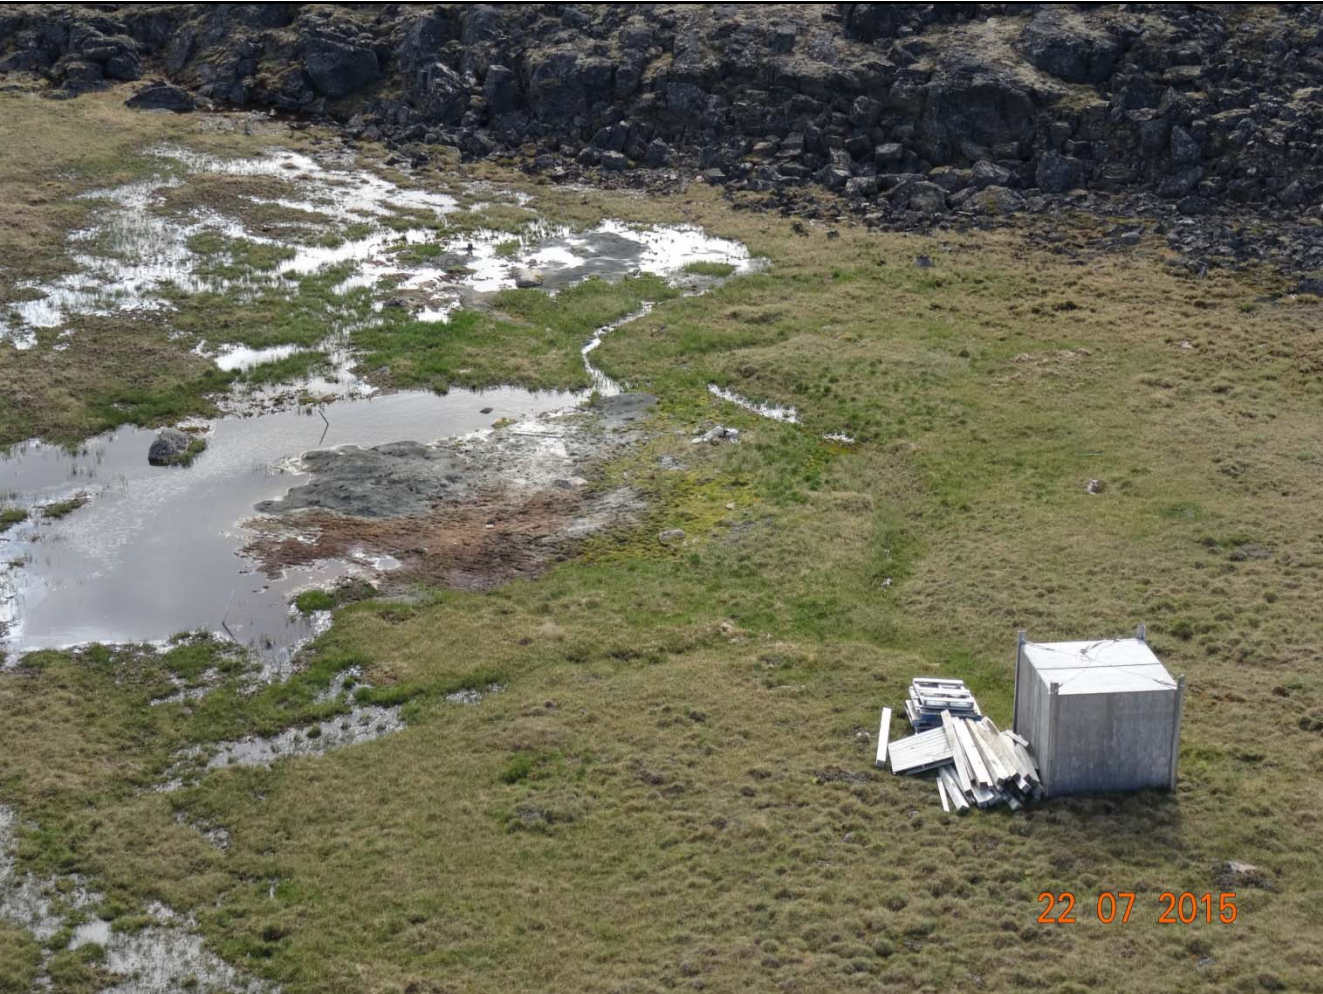
Photo Log #6

Description: Emergency shack, pallets and drill cuttings as seen at Beluga 3C.

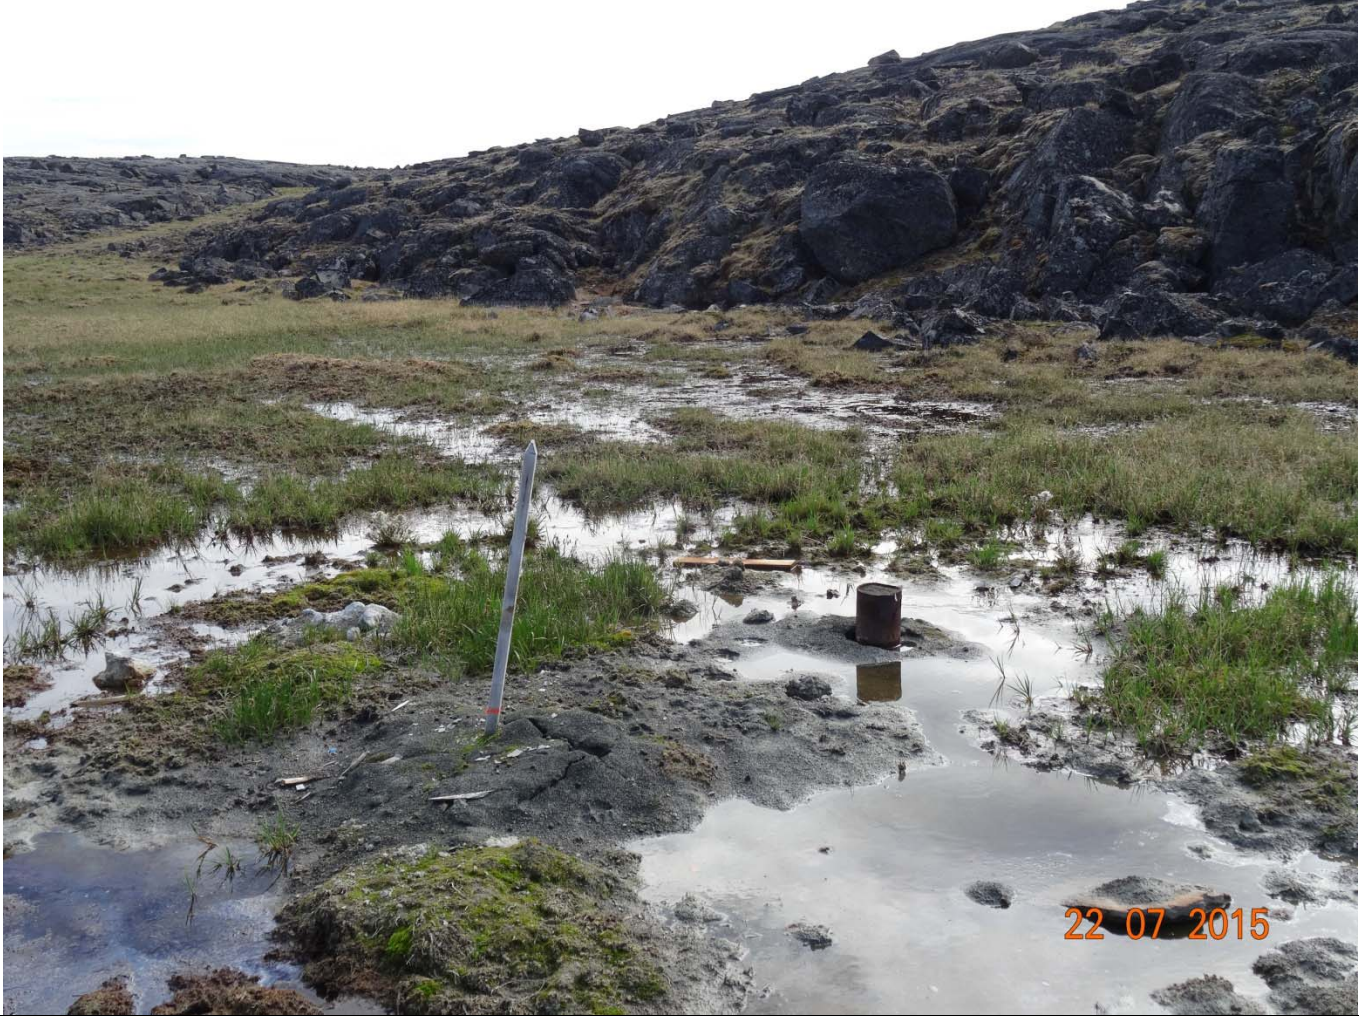
Photo Log #9	Location (NAD 83 DD MM SS.SS)	
Photo DSC04559	N68 09 47.6	W90 27 20.6

Description: Another collar, cuttings, and debris visible in the same Beluga drill area.
