WATER LICENCE INSPECTION FORM

Licensee	Licensee Representative
Meliadine Gold Corp.	Glen Dickson
Licence No. / Expiry	Representative's Title
2BE-PET1114	President
Land Authorization No. / Purpose / Expiry	Land Authorization Expiry
IOL	---
Date of Inspection	Inspector
July 29 th , 2016	WRO Wilson
Activities Inspected	
<input type="checkbox"/> Camp <input checked="" type="checkbox"/> Drilling <input type="checkbox"/> Mining <input type="checkbox"/> Construction <input checked="" type="checkbox"/> Reclamation <input checked="" type="checkbox"/> Fuel Storage	
<input type="checkbox"/> Roads/Hauling <input type="checkbox"/> Other: Water Discharge <input type="checkbox"/> Other:

PHOTO LOG

Date: July 29 th , 2016	Authorization Number: 2BE-PET1114	Camera/Model: Sony DSC-HX50V Cyber shot	Inspector WRO Wilson
Photo No. Photo 1	Lat/Long (DD.MM.SS.SS, NAD83) N/A

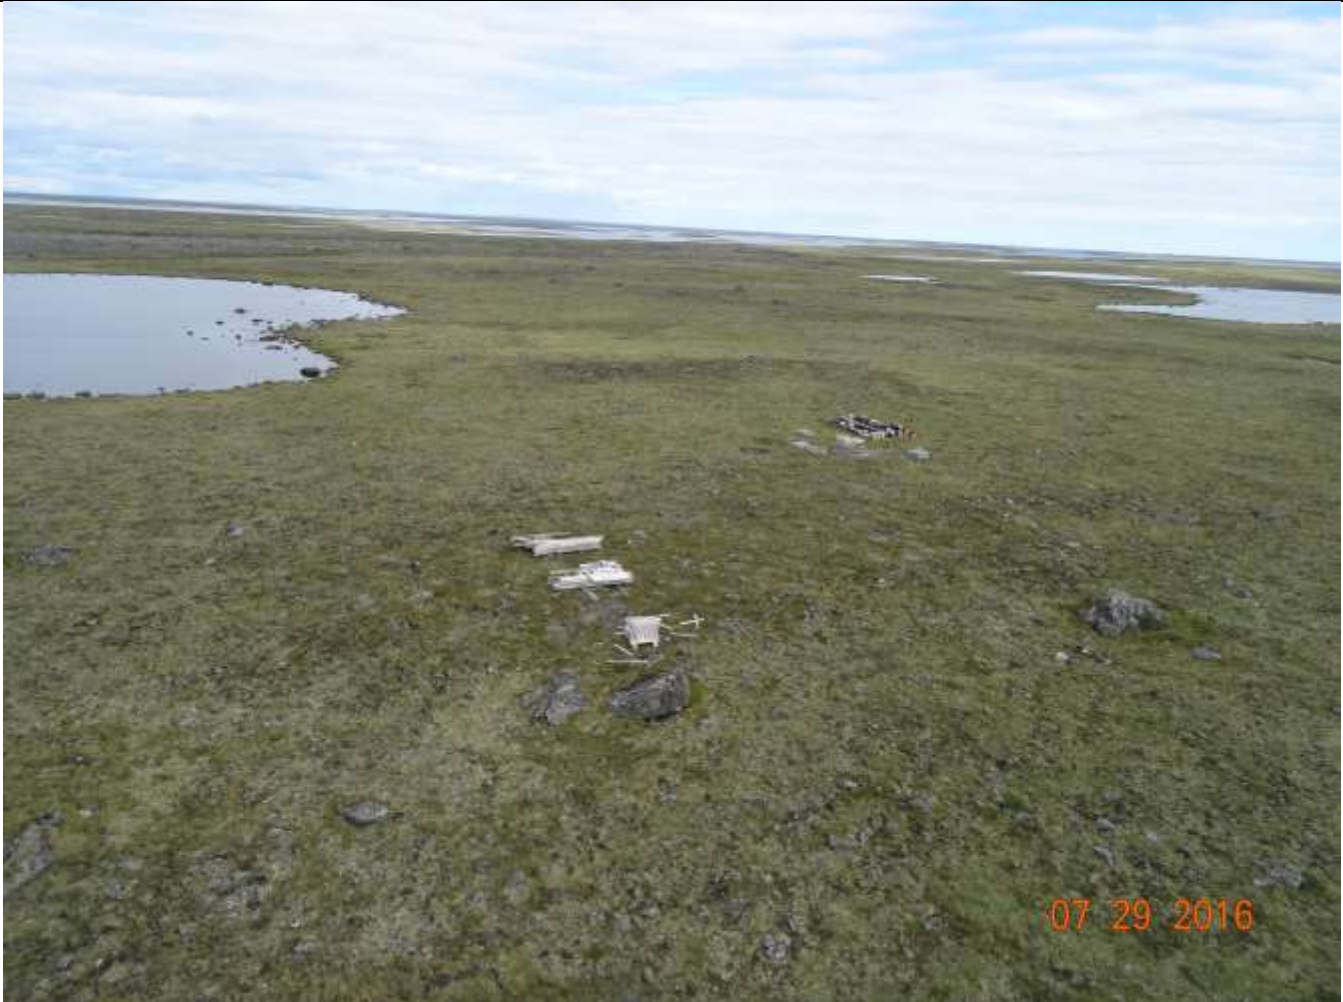
Description:
Peter Lake Project, Laydown area

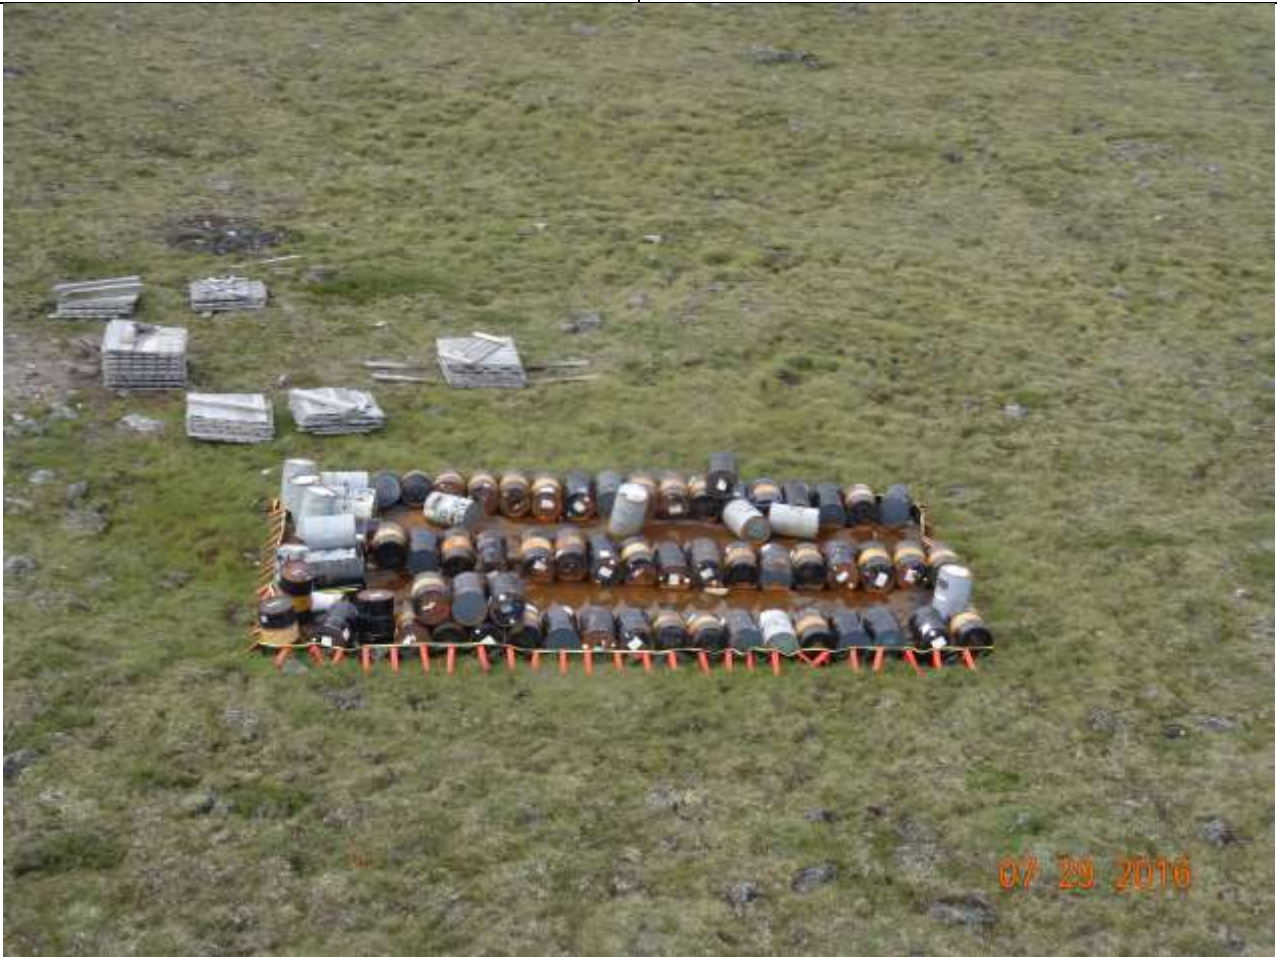
Photo No. Photo 2	Lat/Long (DD.MM.SS.SS, NAD83) N63° 6' 43.12" W 92° 31' 10.99"
----------------------	--

Description:
Peter Lake Fuel Cache

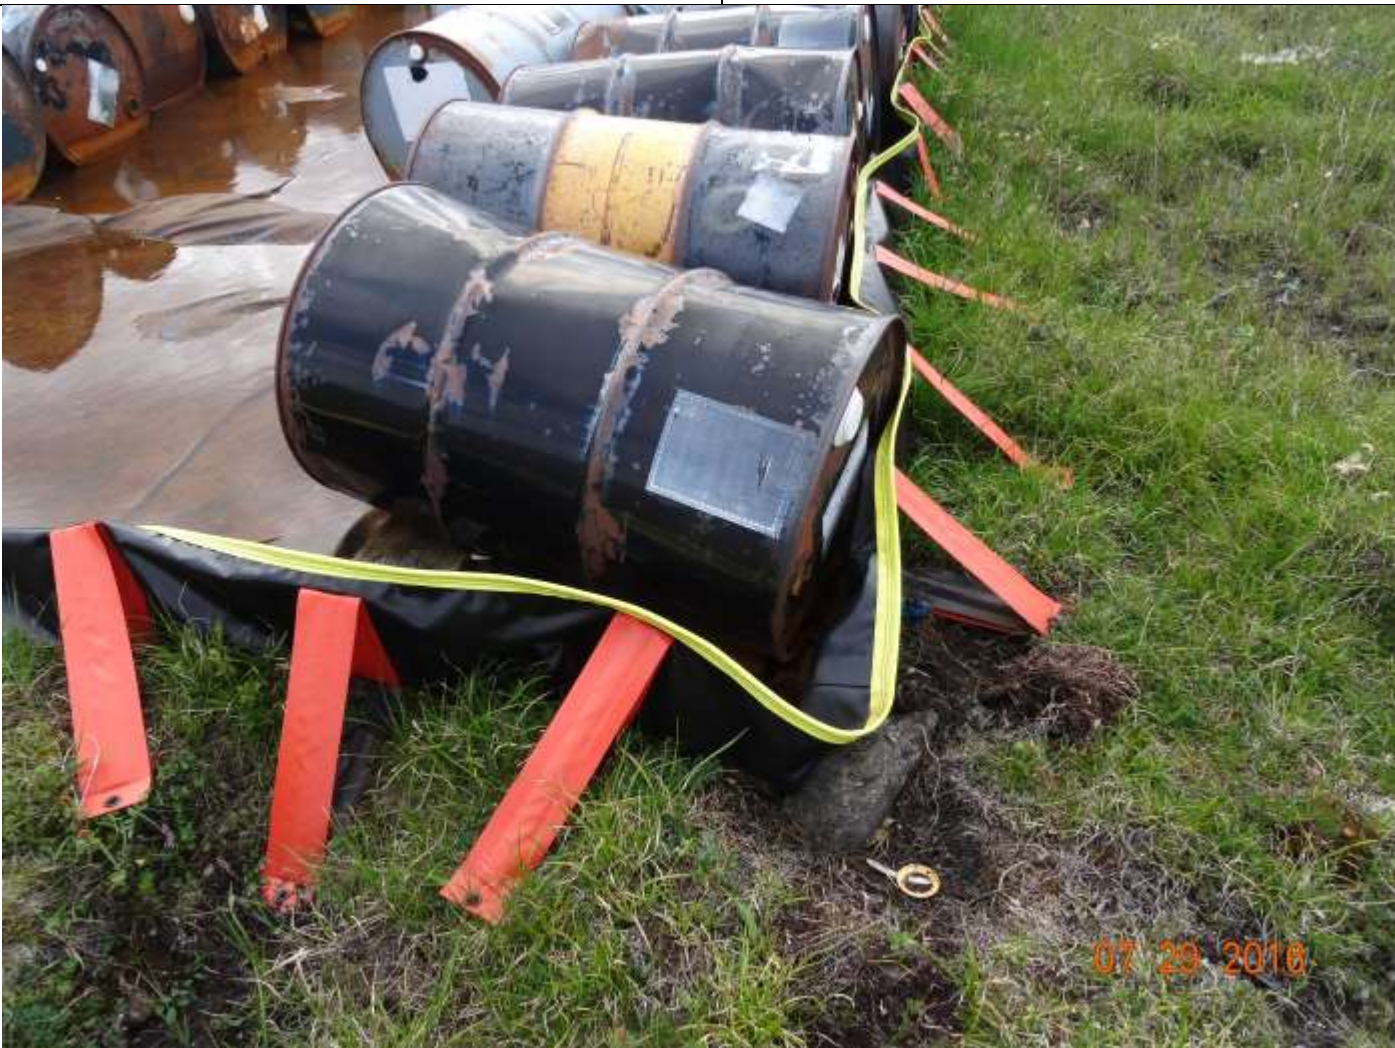
Photo 3

Secondary containment berm, hydrocarbon staining, contaminated water, rusted drums, poor condition of drums

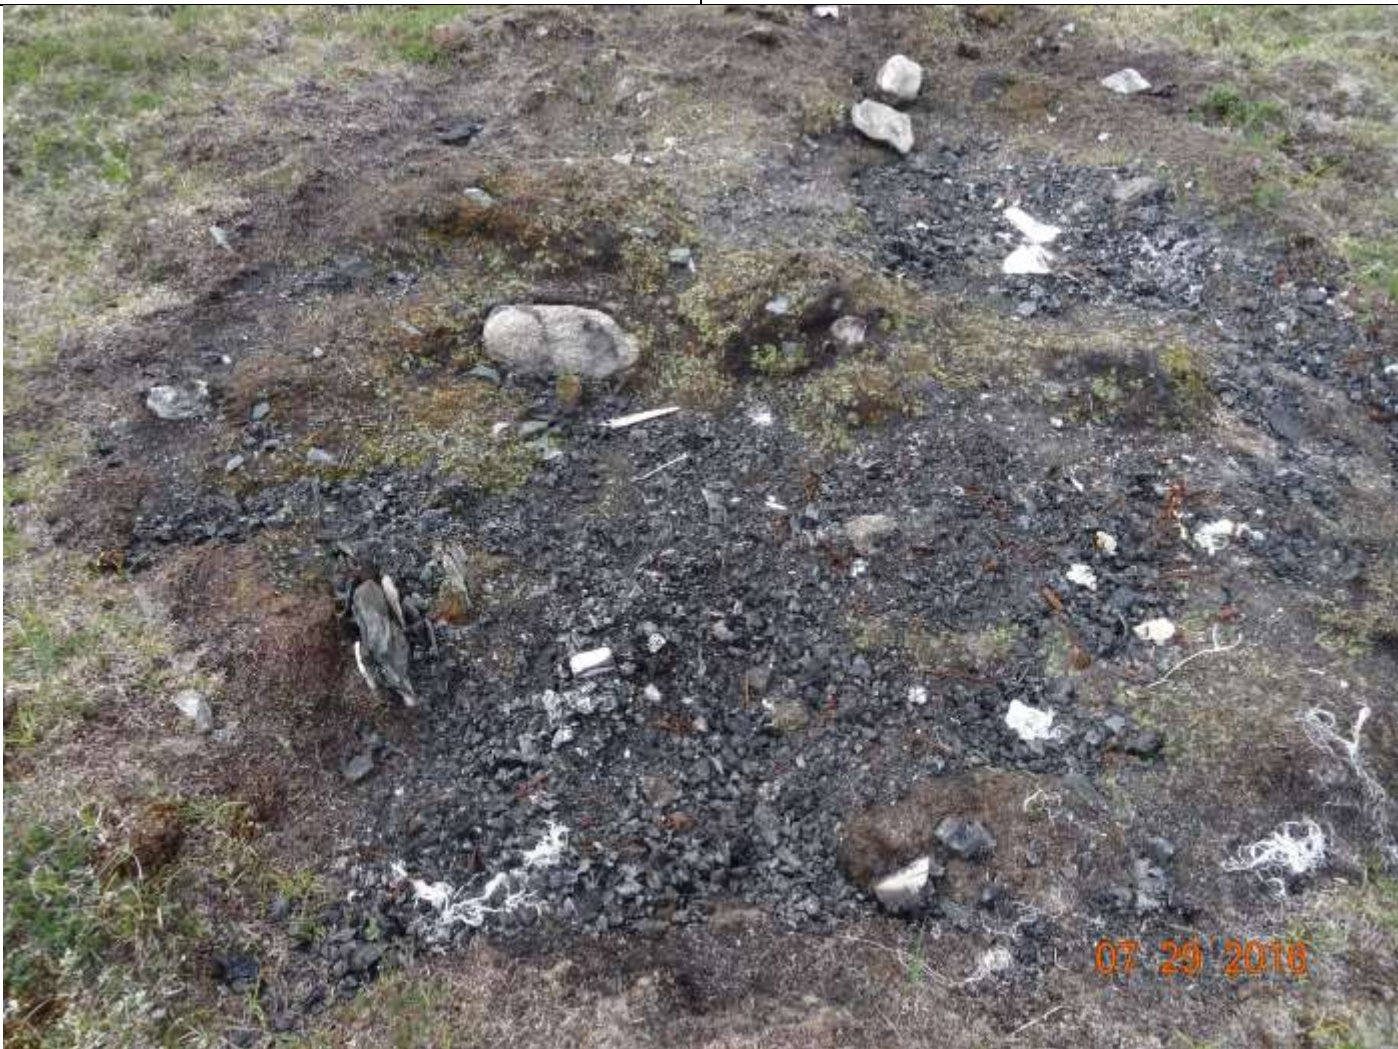
Photo 4

Open burning pit, some remiaing metal waste
