**WATER LICENCE INSPECTION FORM**☒ Original
☐ Follow-Up Report

Licensee	Licensee Representative
Agnico Eagle Gold Mines	David Frenette, Environmental Coordinator
Licence No. / Expiry	Representative's Title
2BE-PKR2126 / October 30 th , 2026	Parker and Cone Hill Project
Land Authorization No.	Land Authorization Expiry
N2016C0002 (Drilling and winter trail)	Camp is located on IOL
Date of Inspection	Inspector
September 11 th , 2022	WRO C. Wilson
Activities Inspected	
<input checked="" type="checkbox"/> Camp <input type="checkbox"/> Drilling <input type="checkbox"/> Mining <input type="checkbox"/> Construction <input type="checkbox"/> Reclamation <input type="checkbox"/> Fuel Storage <input type="checkbox"/> Roads/Hauling <input type="checkbox"/> Other: <input type="checkbox"/> Other:

PHOTO LOG

Parker Lake Exploration Project

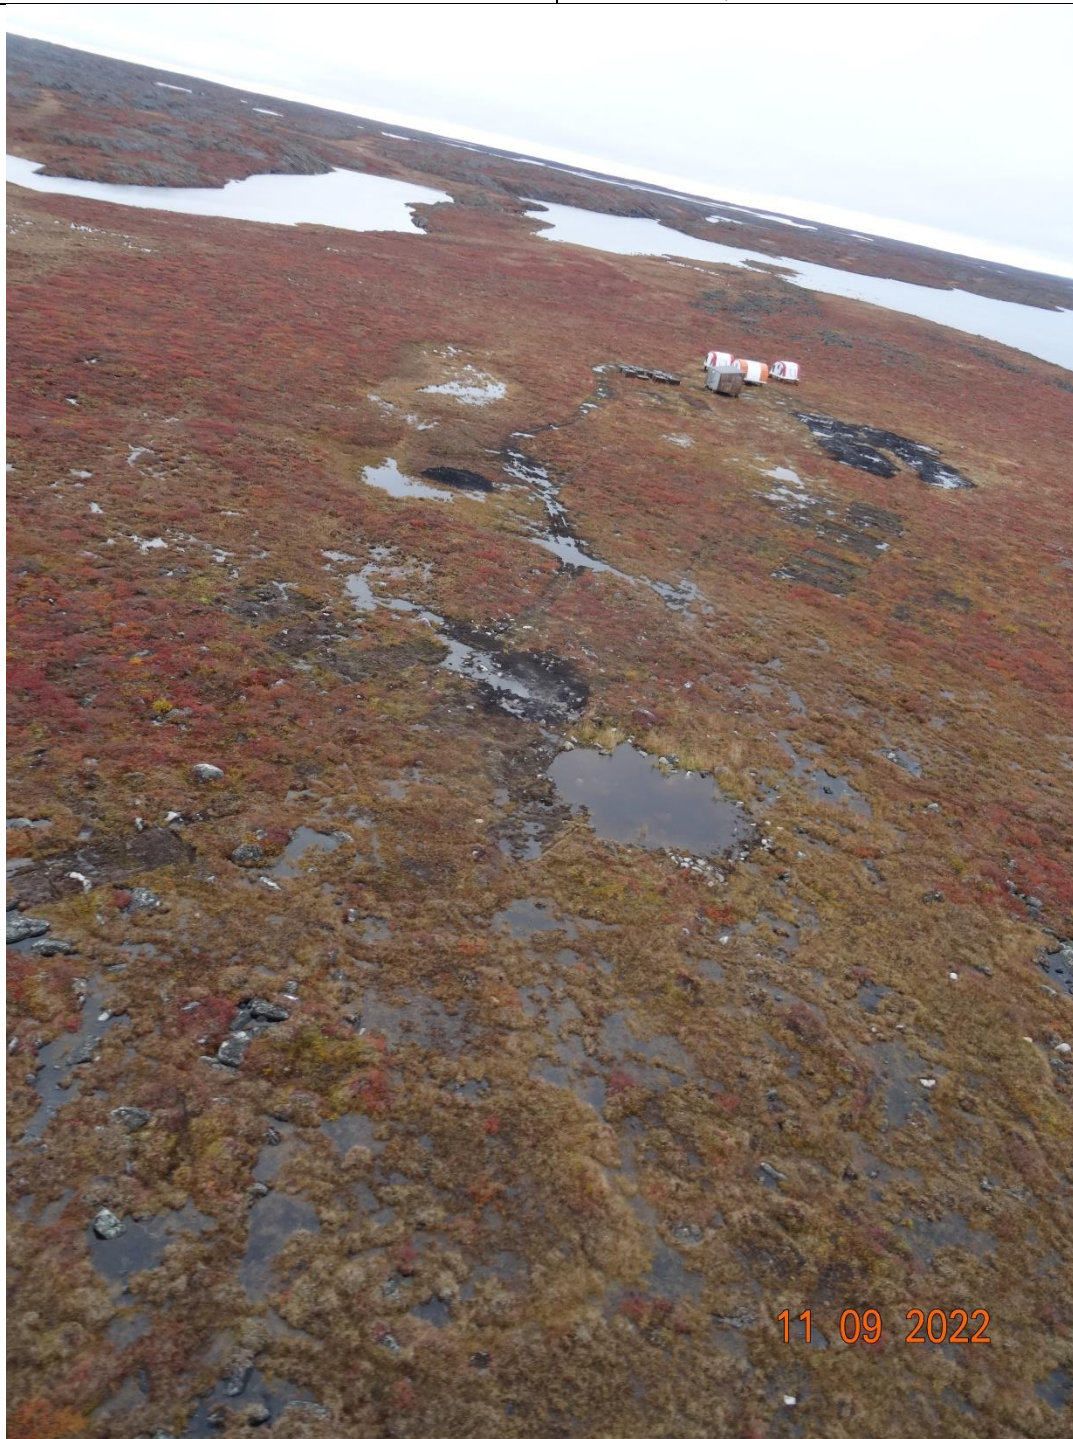
Date:	Authorization Number:	Camera/Model:	Inspector
September 11th, 2022	2BE-PRK2126	Sony DSC-HX50V Cyber shot	WRO Wilson
Photo No.	Lat/Long (DD.MM.SS.SS, NAD83)		
Photo 1	N63° 35' 11.93", W94° 6' 43.79"

Description:
Parker Lake Exploration Camp, Agnico Eagle Mines

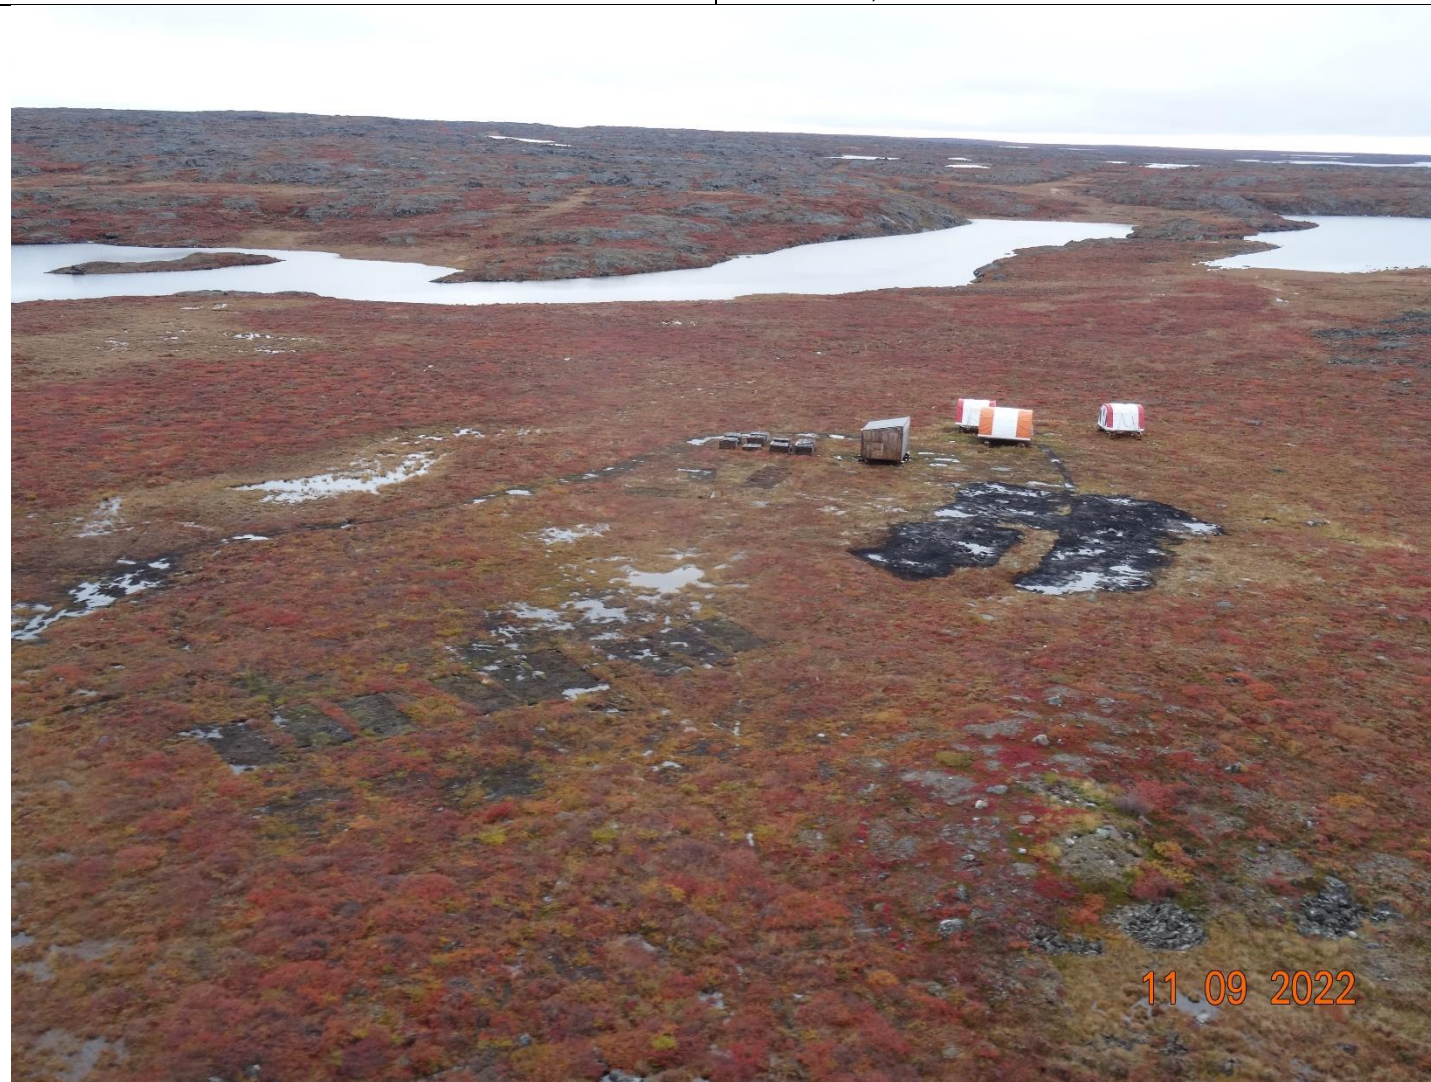
Photo 2

Four remaining structures, core and burn area at Parker Lake Camp.

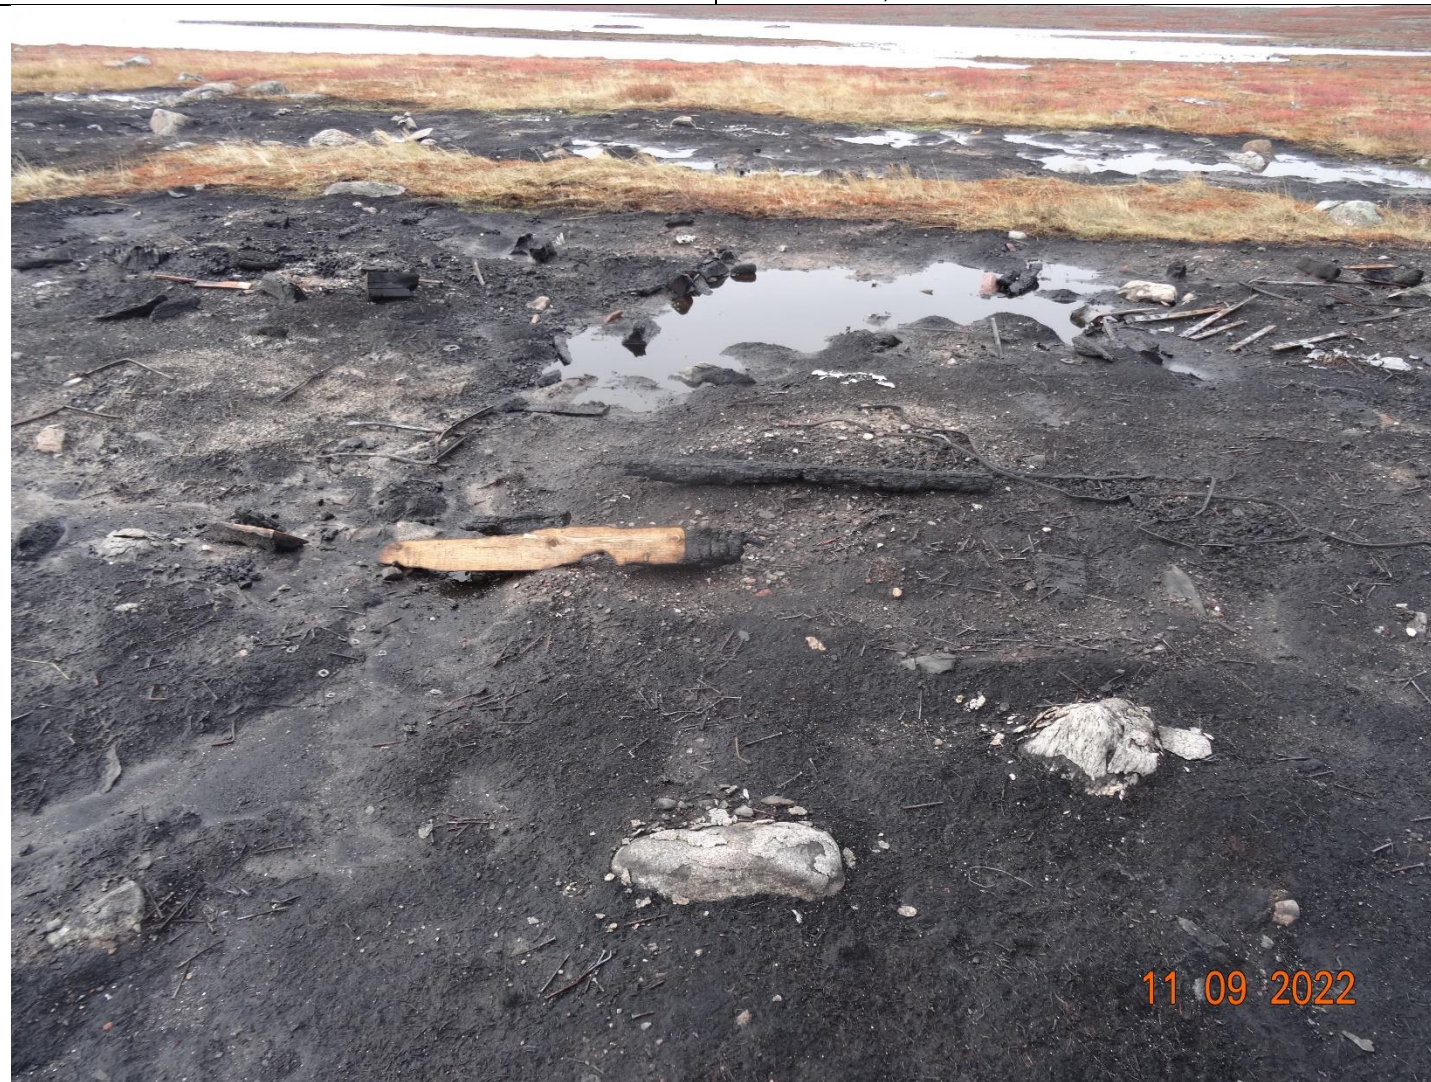
Photo 4

SECTION 1	<input checked="" type="checkbox"/> Comments (s. __)	<input type="checkbox"/> Non-Compliance with Act or Licence (s. __)	<input type="checkbox"/> Action Required (s. __)
<p>An inspection of Agnico Eagle Mines Ltd.'s Parker Lake exploration camp (camp) was completed by Crown-Indigenous Relations and Northern Affairs Canada (CIRNAC)'s, Water Resource Officer, Christine Wilson (Inspector). The inspection was conducted to ensure compliance with applicable terms and conditions of the water licence, no. 2BE-PKR2126.</p> <p>The following report was produced with observations noted by the Inspector at the camp and spill file number 17-263.</p> <p>PRELIMINARY NOTES</p> <ul style="list-style-type: none"> - In 2017, approximate 275L of diesel was spill to the tundra near the camp. Spill report number 17-263 was issued. Remediation was finalized with a follow-up report provided to the Inspector (Appendix 1). - The report indicated that low levels of contamination was found at one of the soil sample locations. The Inspector found no concerns related to the sample result as further reclamation work would require additional impacts to the locations. - The report also indicated that approximately 30 mega bags were removed from the sites (Appendix 2). <p>OBSERVATIONS</p> <ol style="list-style-type: none"> 1. The spill no. 17-263 is generally located at N63° 35' 11.93", W94° 6' 43.79". The excavation is filled with water with no visible sheen. 2. The camp has been removed, only four structures remain (photo 1). 3. There is a large open burning area were the camp (photo 2) was originally located. 4. The burn area has nails (photo 3), partially burn wood and some other metal waste (photo 4).

Burn area.

SECTION 2	<input type="checkbox"/> Comments (s. __)	<input checked="" type="checkbox"/> Non-Compliance with Act or Licence (s. 2)	<input type="checkbox"/> Action Required (s. __)
<p>Concerns related to the terms and conditions of water licence no. 2BE-PKR2126:</p> <p>PART I item 1: AEM will implement the plan titled "Conceptual Reclamation and Closure Plan" as approved by the Board.</p>			
SECTION 3	<input type="checkbox"/> Comments (s. __)	<input type="checkbox"/> Non-Compliance with Act or Licence, (s. __)	<input checked="" type="checkbox"/> Action Required (s. 3)
<p>— Spill report no. 17-263 has been recommended for closure based on the information provided by AEM and the observations made in 2021 and 2022.</p> <p>— AEM representatives indicated that they will be returning to camp in the summer of 2023 to complete the final reclamation which includes removal of the materials noted during the inspection.</p>

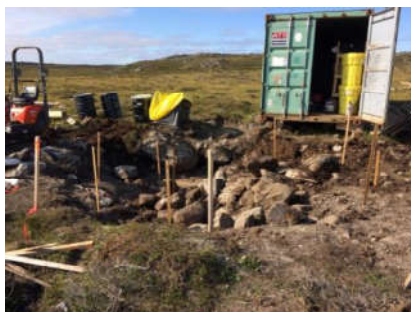
Figure 2, 2018 Excavation and Monitoring

Following the excavation done in August 2018, monitoring of the site was conducted on September 4th 2018. Three of the nine samples taken exceeded the PHC fraction 3 and 4 criteria of the Environmental Guideline for Contaminated Site Remediation of the Government of Nunavut and taking into account that the soil is characterized as a coarse-grained soil.

Part of the contaminated soil was located under a seacan and in order to continue the decontamination, the seacan needed to be moved. The seacan was moved during the winter allowing the excavation of contaminated soil to be continued in August 2018.

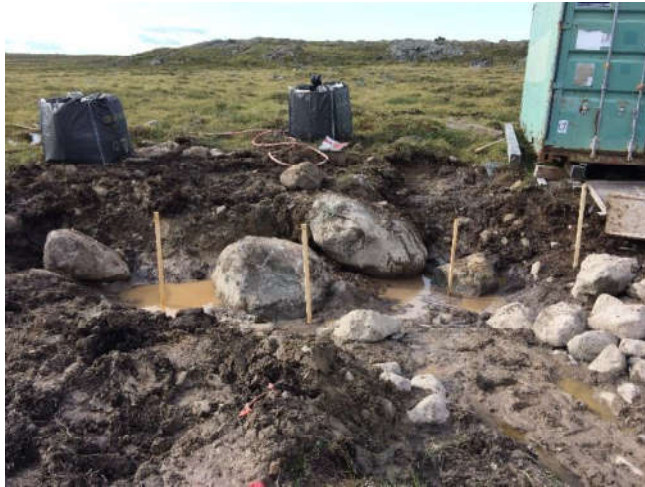
Figure 4, 2019 Monitoring

On August 17th and 18th 2019, using a mini excavator, soil was excavated in the area where the previous samples returned non-compliant results. 2 quatrex bags were filled with contaminated material and 4 soil samples were taken. 2 out of 4 samples returned with contamination above the limits as shown on Table 2.

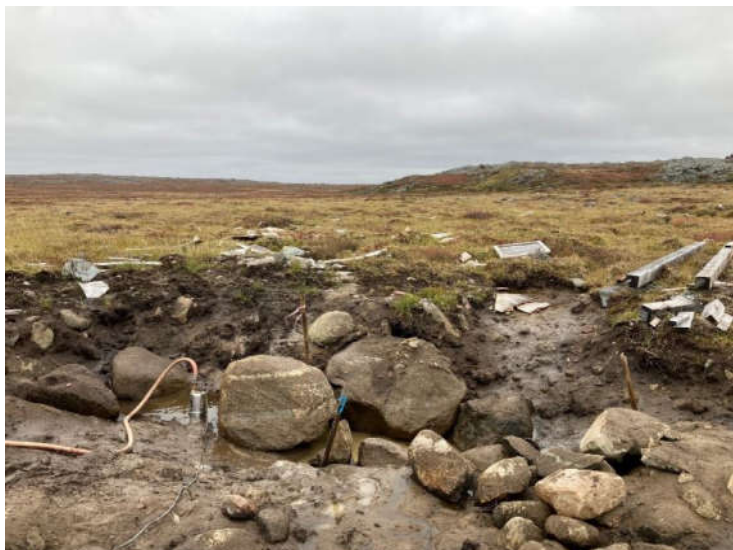
Figure 6, 2021 Monitoring

As final samples were not analyzed following the 2019 decontamination, monitoring was conducted on September 3rd 2021 with samples taken at locations where samples above the limit were located. Results in Table 3 show that the area was decontaminated except at the location of sample #PKL21-02 where the result (160mg/kg) is slightly just above the limit for agriculture/wildlife (150mg/kg), but well under the limit for industrial purposes (260mg/kg). The sample #PKL21-02 was taken between boulders where additional material would be difficult to remove due to the boulders and the remote location of the site reducing the possibility to transport heavier equipment.
