Parker Lake Exploration Project Generator fell from a helicopter spill Spill 17-358

Situation Report on

November 2018

Agnico Eagle Mines Limited, Exploration Division

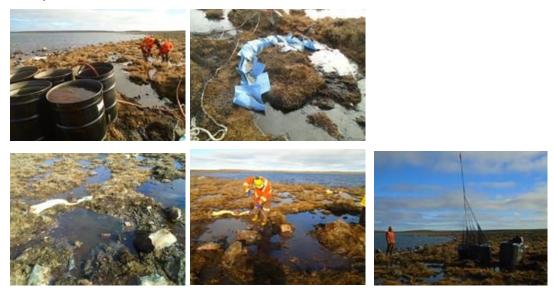
The spill occurred on September 22nd, and immediate actions to limit the impacts were undertaken. With the support of the Meliadine environmental department, remediation actions were conducted between September 22nd and 30th. These actions included the use of absorbent, manual excavation of contaminated soil, pumping of contaminated water and transport of the contaminated material to the Meliadine site.

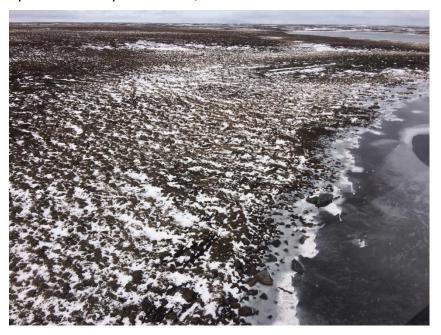
Additional investigation and remediation of the area were planned to be done on September 29th, but the site visit showed that the soil was already too frozen to be excavated so the next actions had to be postponed until next summer.

Spill area on September 29th, 2018

Additional reclamation of the site will be conducted in 2019 in the area where the sample not compliant was taken and an additional sampling event will then be conducted to ensure that the decontamination is completed.
