**WATER LICENCE INSPECTION FORM**☒ Original
☐ Follow-Up Report

Licensee	Licensee Representative
Cameco Corporation	Kevin Parker
Licence No. / Expiry	Representative's Title
2BE-QAM1217/ May 31 st , 2017	Superintendent, Exploration Services
Land Authorization No. / Expiry	Project Name
Aberdeen Camp is on IOL	Turqavik- Aberdeen Project
Date of Inspection	Inspector
August 11 th , 2020	RMO C. Wilson
Activities Inspected	
<input checked="" type="checkbox"/> Camp <input type="checkbox"/> Drilling <input type="checkbox"/> Mining <input type="checkbox"/> Construction <input type="checkbox"/> Reclamation <input type="checkbox"/> Fuel Storage <input type="checkbox"/> Roads/Hauling <input type="checkbox"/> Other: Airstrip <input type="checkbox"/> Other: Bulk Sample

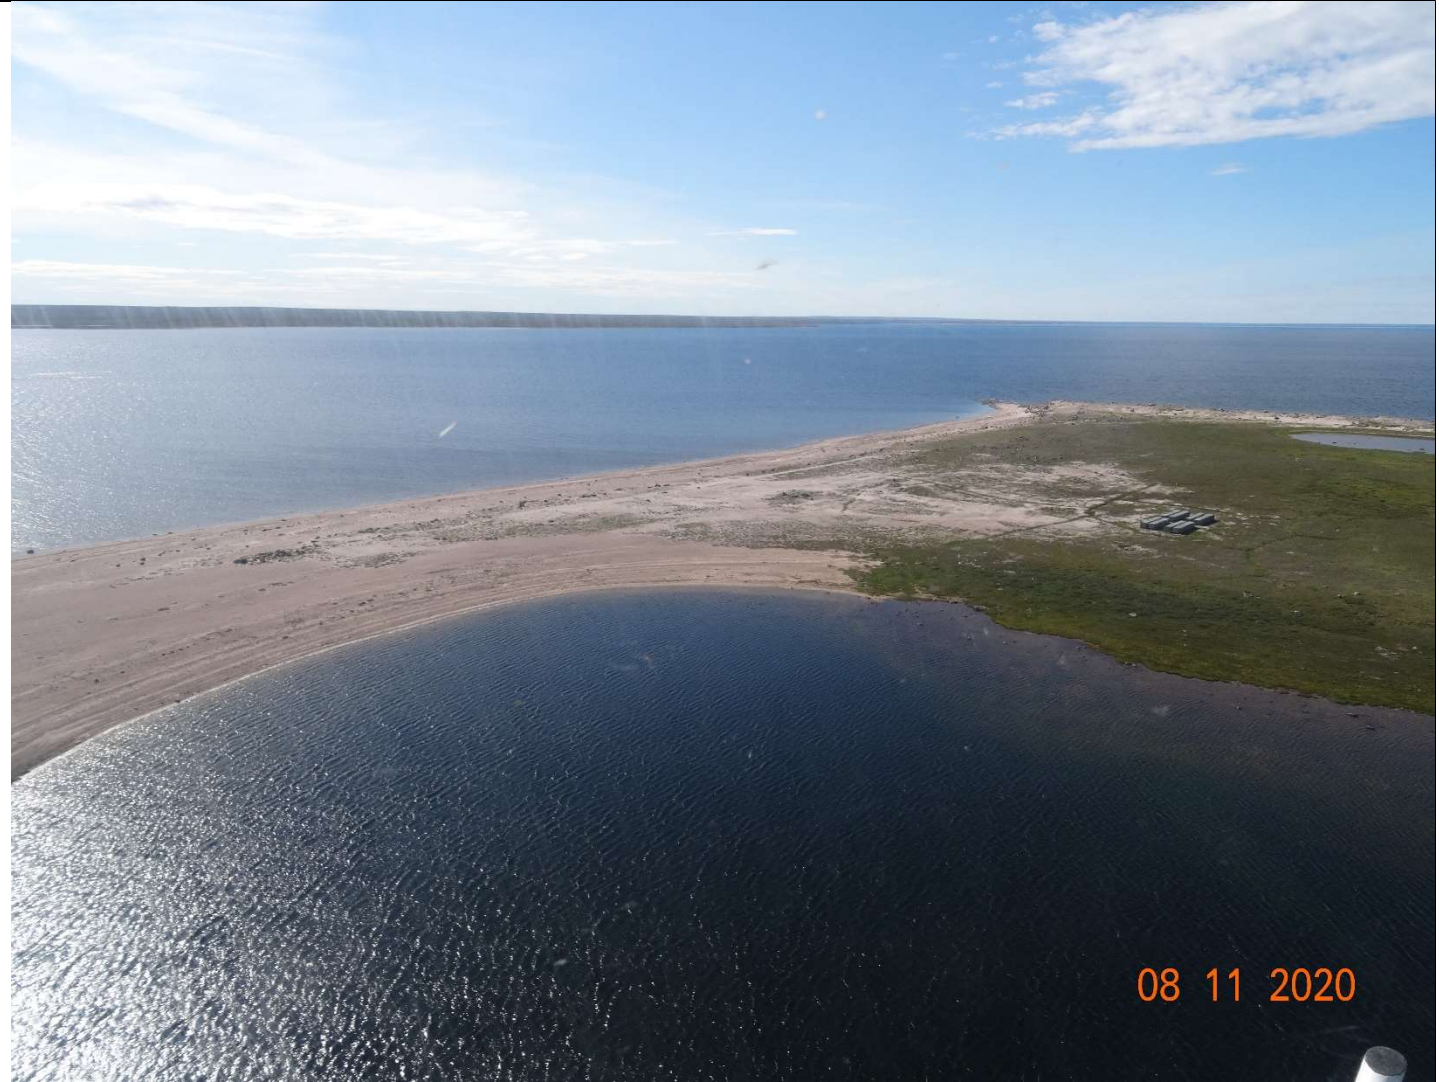
Date:	Authorization Number:	Camera/Model:	Inspector
August 11th, 2020	2BE-QAM1217	Sony DSC-HX50V Cyber shot	RMO Wilson
Photo No.	Lat/Long (DD.MM.SS.SS, NAD83)		
Photo 1	N64° 23' 32.95", W98° 27' 35.03"

Description:
Aberdeen Camp Area.

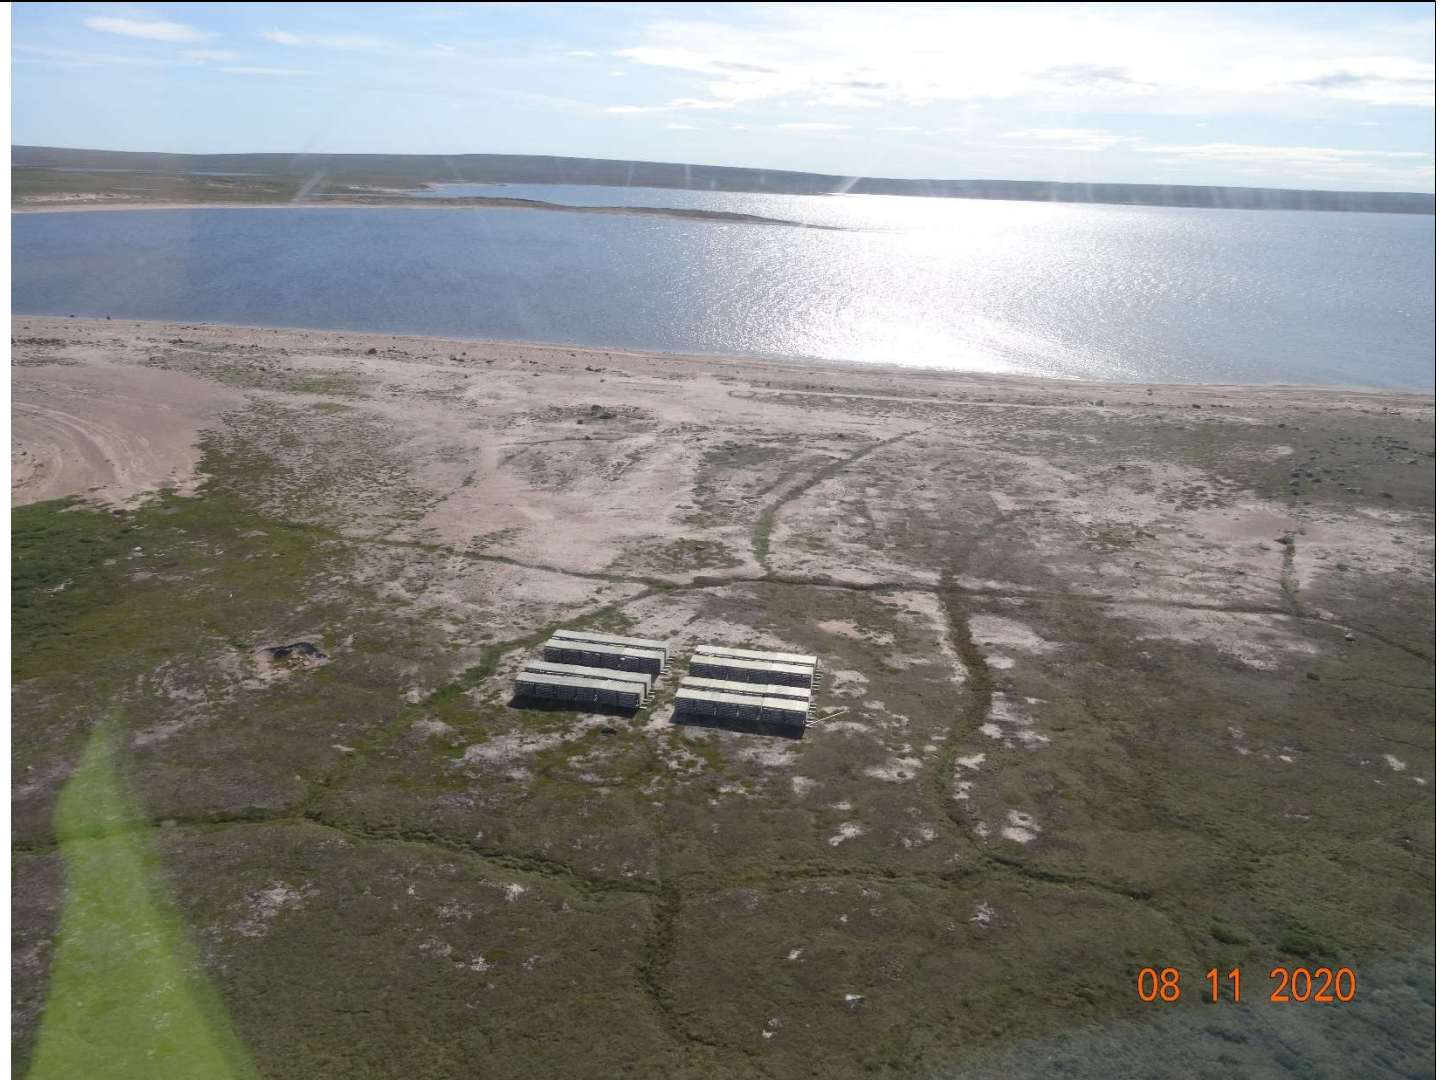
Photo 2

Aberdeen Camp Area.

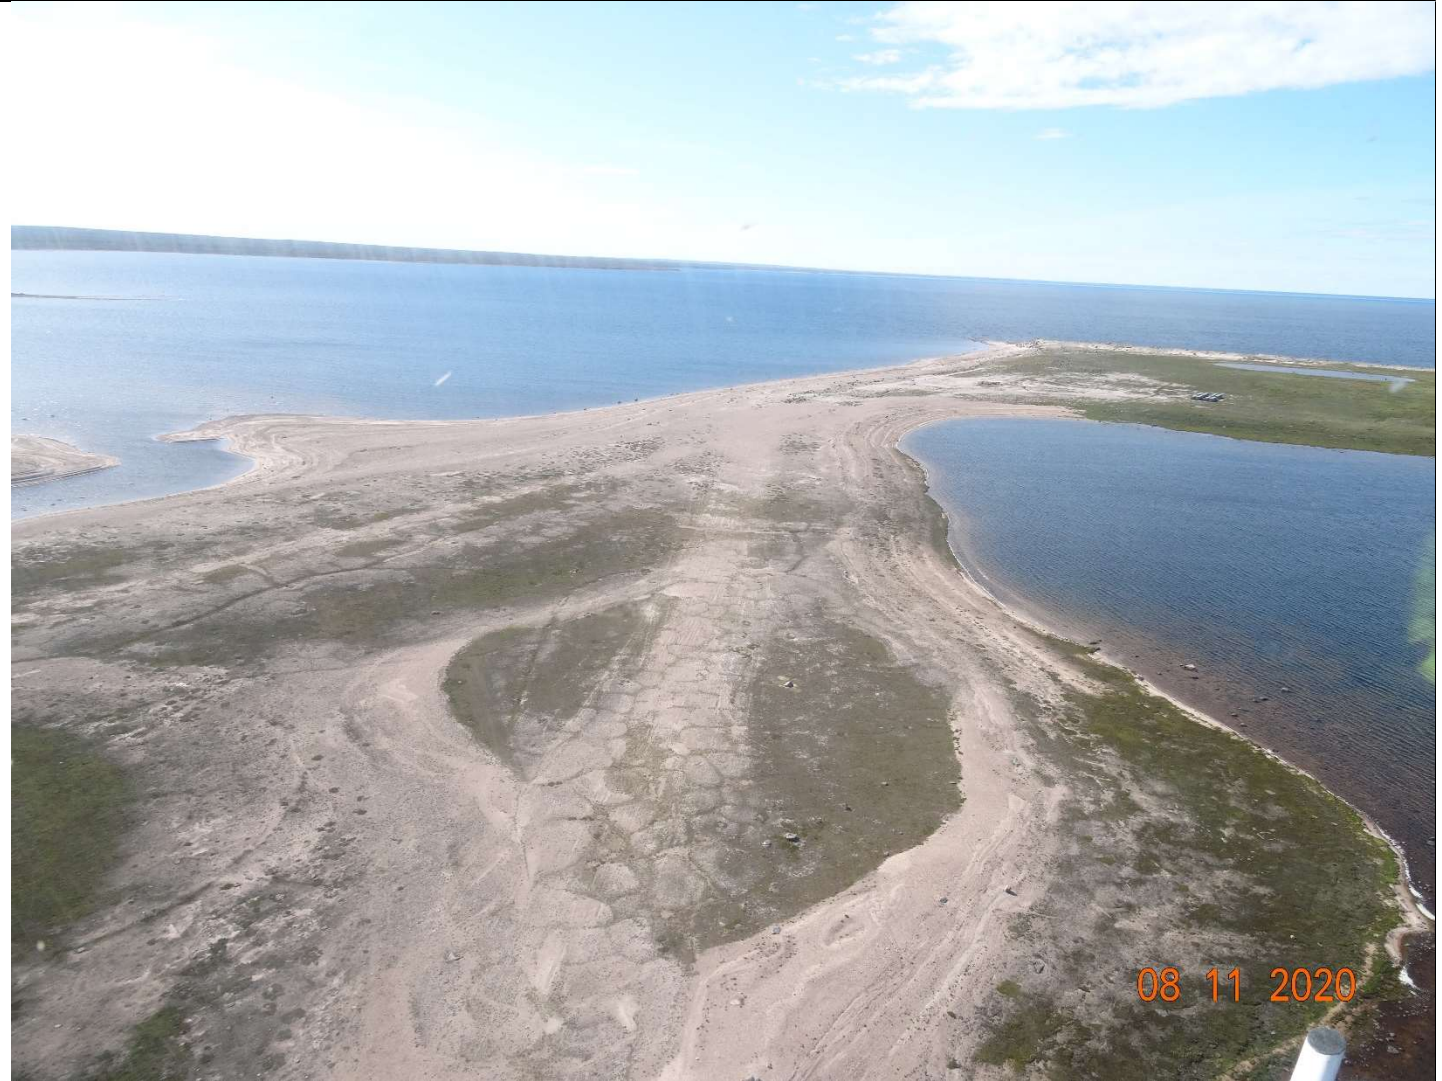
Photo 3

Aberdeen Camp Airstrip
