WATER LICENCE INSPECTION FORM

Licensee		Licensee Representative	
Cameco Corporation		Rebecca Hunter, P. Geo Leon Davis, Site Manager	
Licence No. / Expiry		Representative's Title	
2BE-QAM1217		-----	
Land / Other Authorizations		Land / Other Authorizations	
KVL307C02		N2012C0007	
		Inspector	
		WRO C. Wilson	
Activities Inspected			
<input checked="" type="checkbox"/> Camp	<input checked="" type="checkbox"/> Drilling	<input type="checkbox"/> Mining	<input type="checkbox"/> Construction
<input type="checkbox"/> Roads/Hauling	<input checked="" type="checkbox"/> Other: Water Discharge		<input type="checkbox"/> Reclamation
		<input type="checkbox"/> Other: Spills	<input checked="" type="checkbox"/> Fuel Storage

PHOTO LOG			
Date:	Authorization Number:	Camera/Model:	Inspector
July 17, 2014	2BE-QAM1217	Sony DSC-HX50V Cyber shot	WRO Wilson

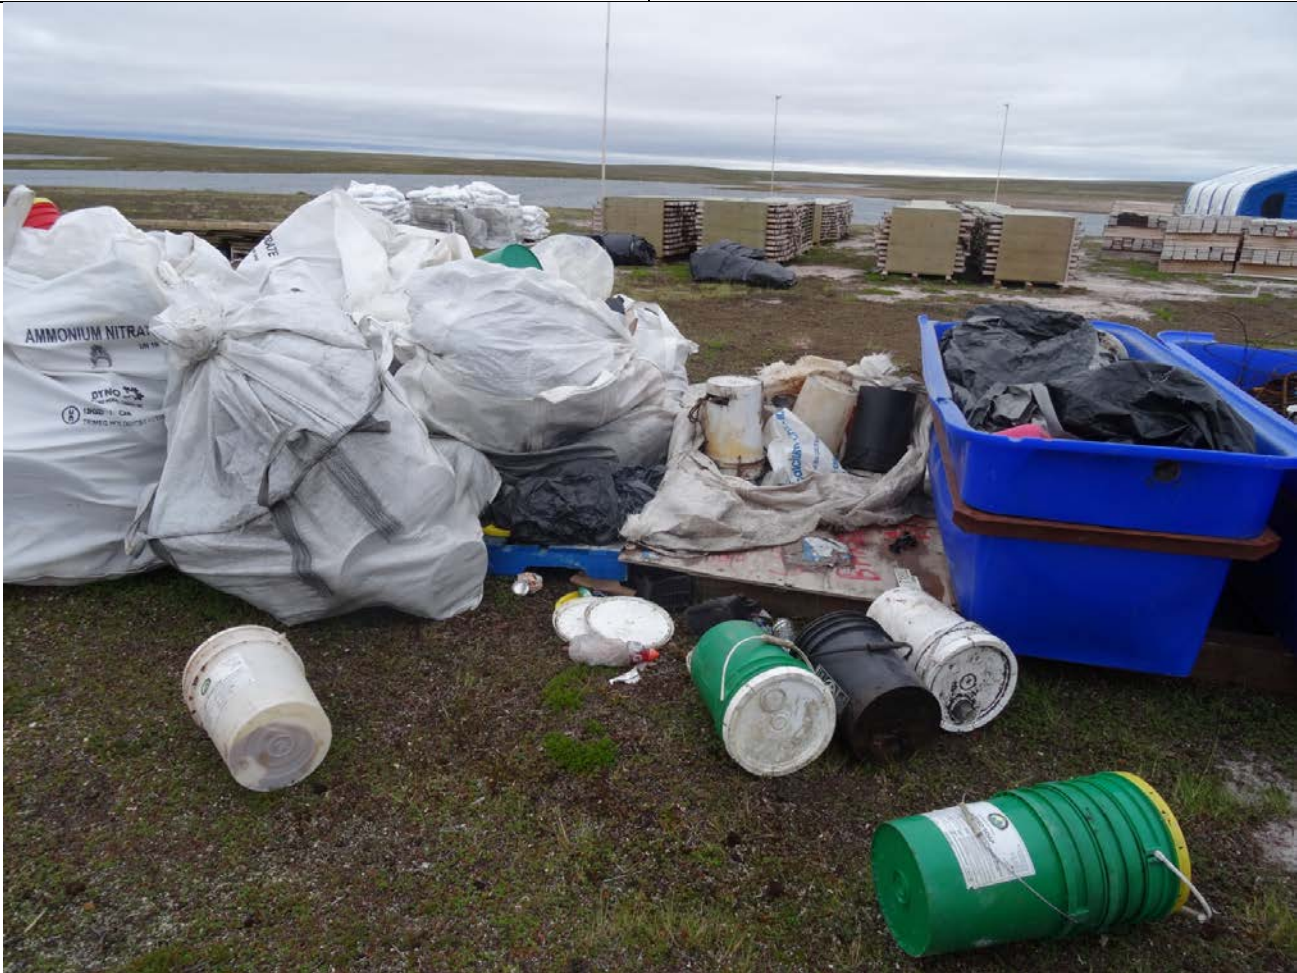
Locations name:	Lat/Long (DD.MM.SS.SS, NAD83)
PHOTO 2	N64 23 30.0 W98 27 54.0

Windblown bulk waste, awaiting back haul

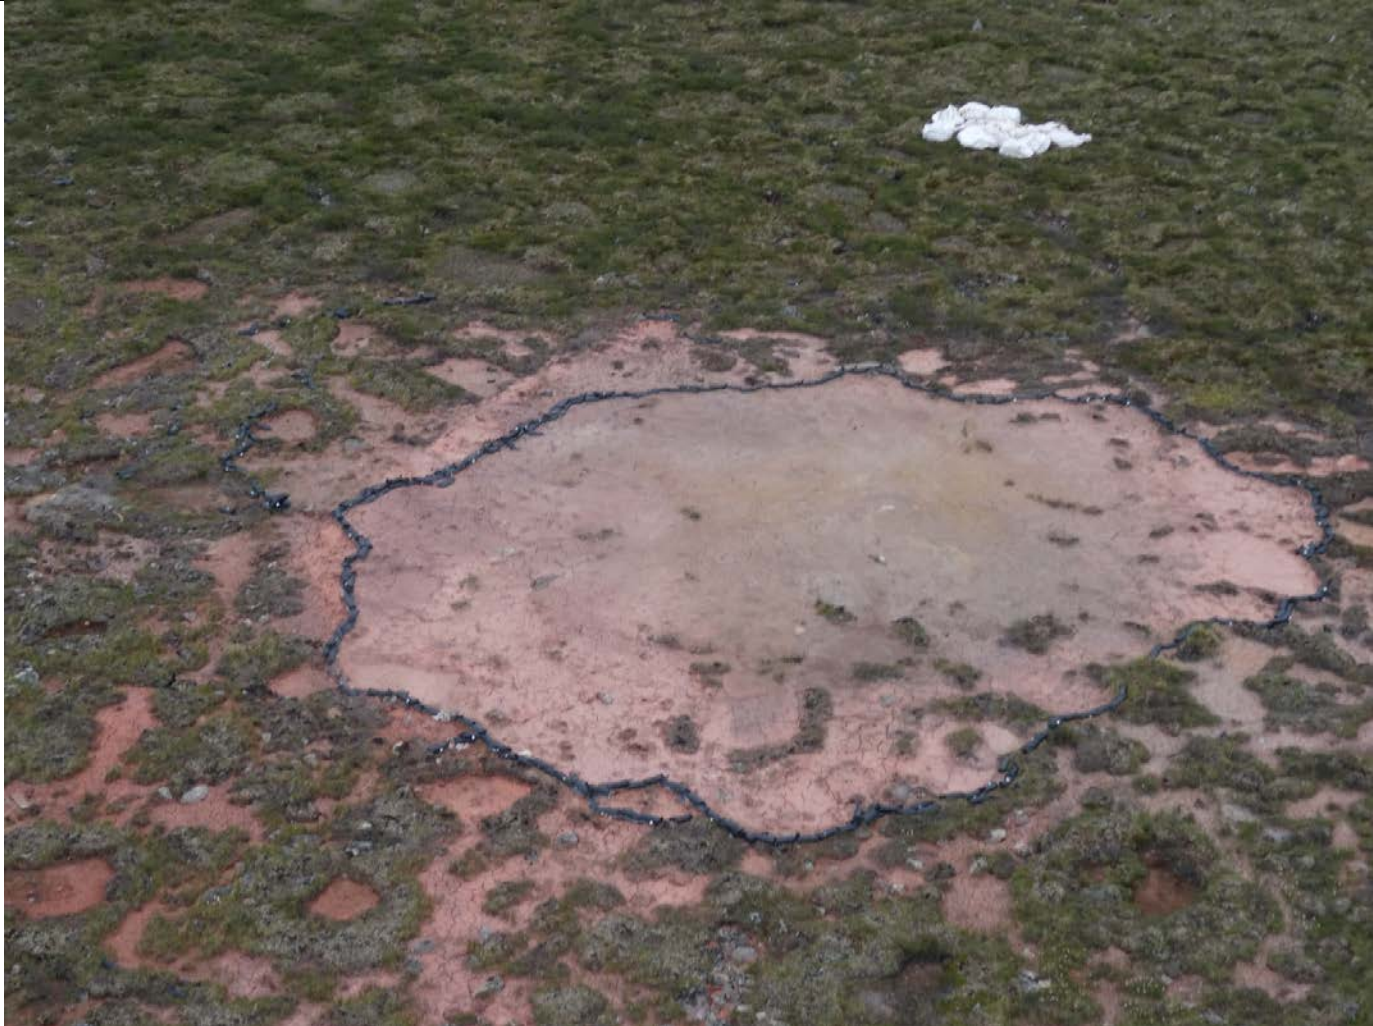
Locations name:	Lat/Long (DD.MM.SS.SS, NAD83)
PHOTO 3	N64 20 28.73, W97 59 5.1

Centralization of cutting waste.
