ENVIRONMENTAL INSPECTION FORM

Licensee		Licensee Representative	
Advanced Explorations Inc.		John Gingerich	
Licence No. / Expiry		Representative's Title	
2BE-RBP1116		President and Chairman	
Land / Other Authorizations		Land / Other Authorizations	
N2012C0013			
Date of Inspection		Inspector	
15/07/2014		Robert SAVARD /Atuat SHOULDICE	
Activities Inspected			
<input checked="" type="checkbox"/> Camp <input type="checkbox"/> Drilling <input type="checkbox"/> Mining <input type="checkbox"/> Construction <input type="checkbox"/> Reclamation <input checked="" type="checkbox"/> Fuel Storage			
<input type="checkbox"/> Roads/Hauling <input type="checkbox"/> Other: Water Discharge <input type="checkbox"/> Other:

Photo Appendix

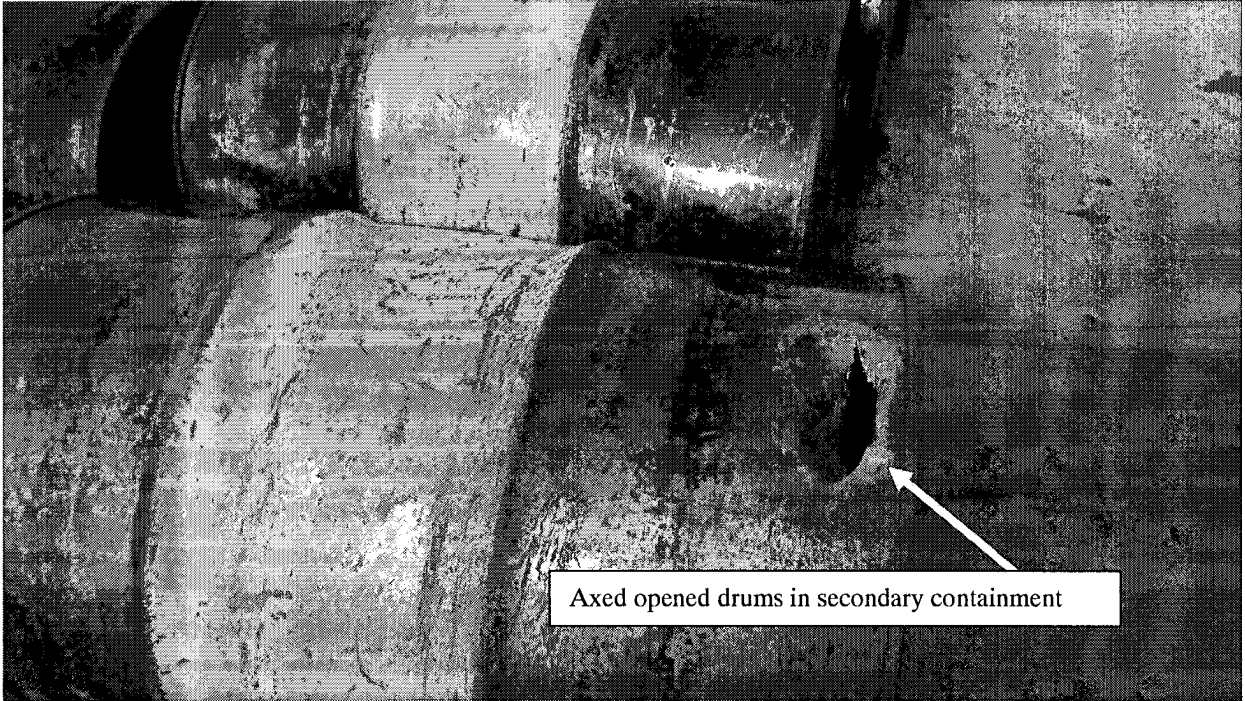
2. In the fuel cache with 19 drums in secondary containment, two of the drums appeared to be breached with an 'axe' or some other tool and were leaking product in to secondary containment. The water drain system on in this secondary containment was not functional at the time of inspection and the end cap appeared to be broken off leaving c. 4 inches of water within the secondary containment.

Axed opened drums in secondary containment

It was discussed that Advanced Exploration Inc. may proceed to the site on or before December 31<sup>st</sup>, 2014 to address minor fuel spills, repair and maintain secondary containment and address other concerns mentioned in the inspection report. The inspector was also informed that drums of fuel would be backhauled on the first barge of the 2015 year or before September 15, 2015. It was noted that the tent camp would be decommissioned at the same time that the other issues on site would be addressed.

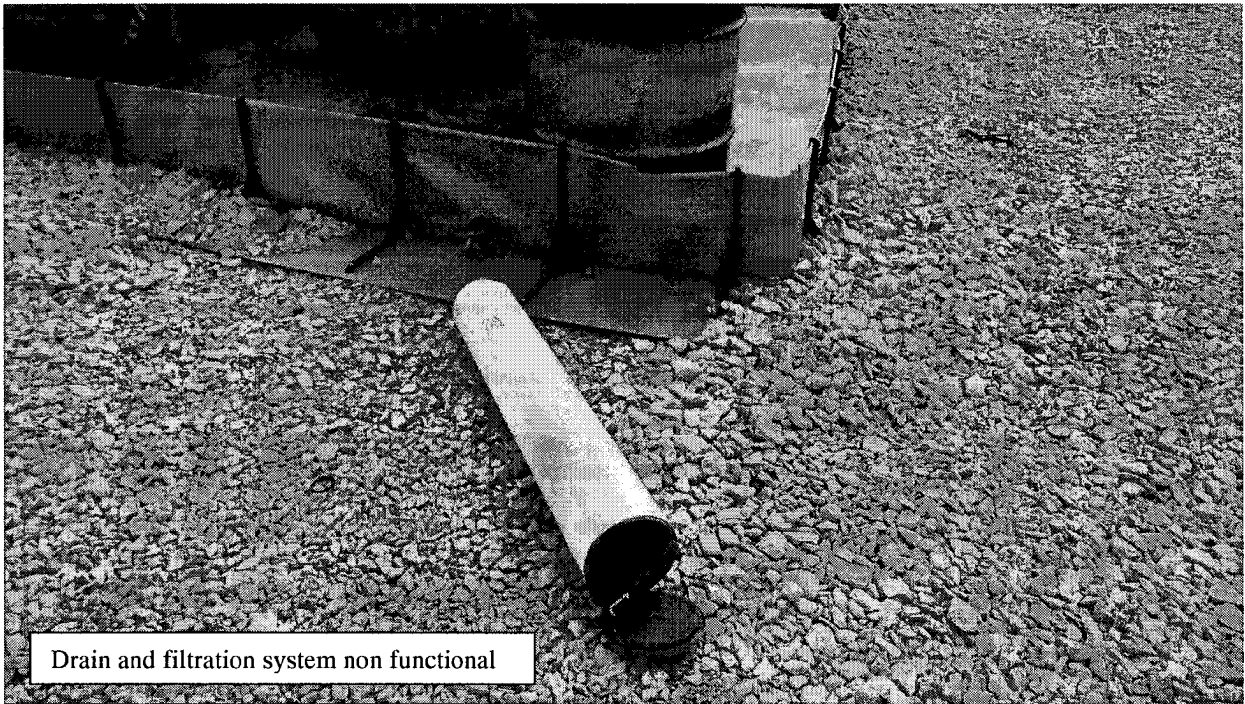
Drain and filtration system non functional

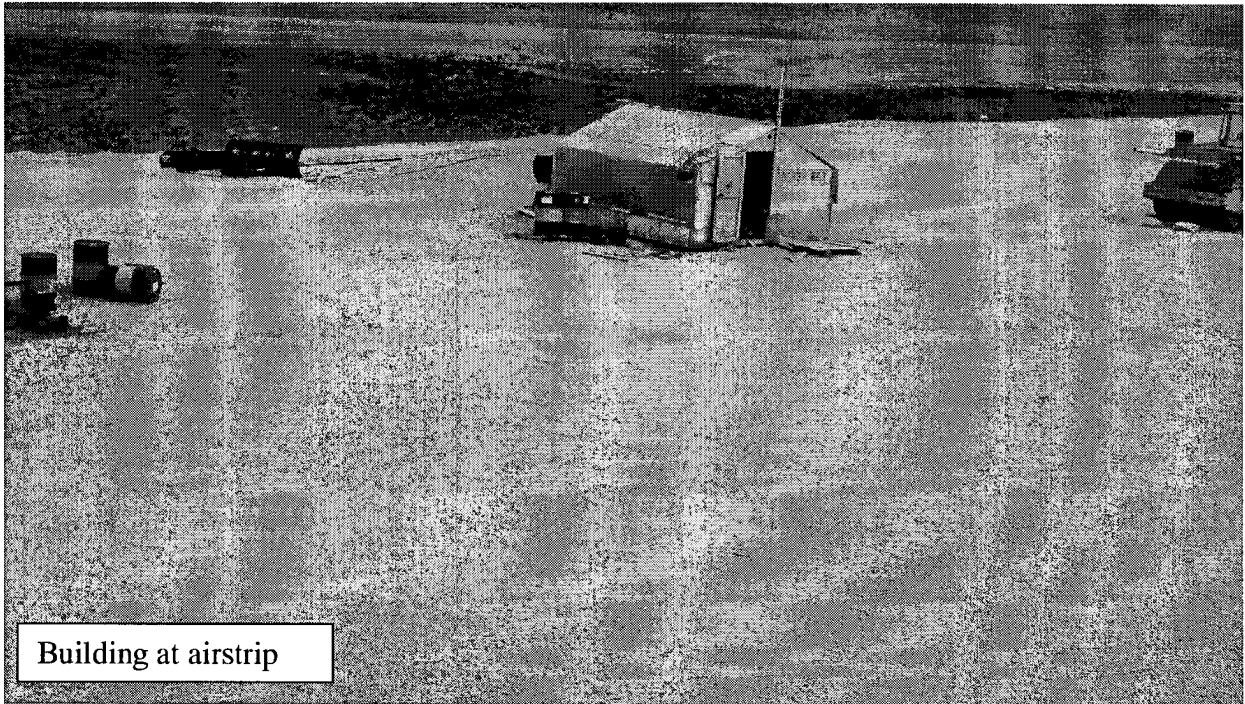
5. There were 4 full drums of fuel product not in secondary containment beside the old building.

Building at airstrip

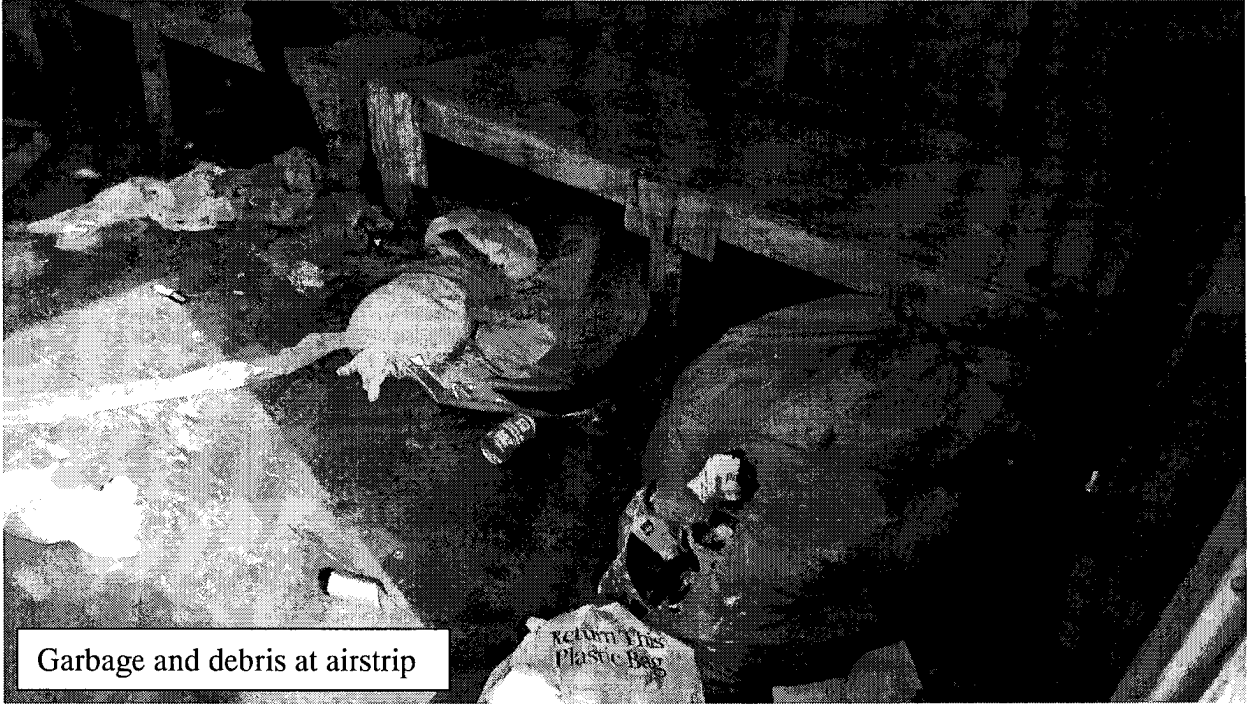
3. About 300-400 empty drums stacked on side of airstrip.
4. Garbage and debris including wood and plastic and general litter debris was in the area and requires clean up.

Garbage and debris at airstrip

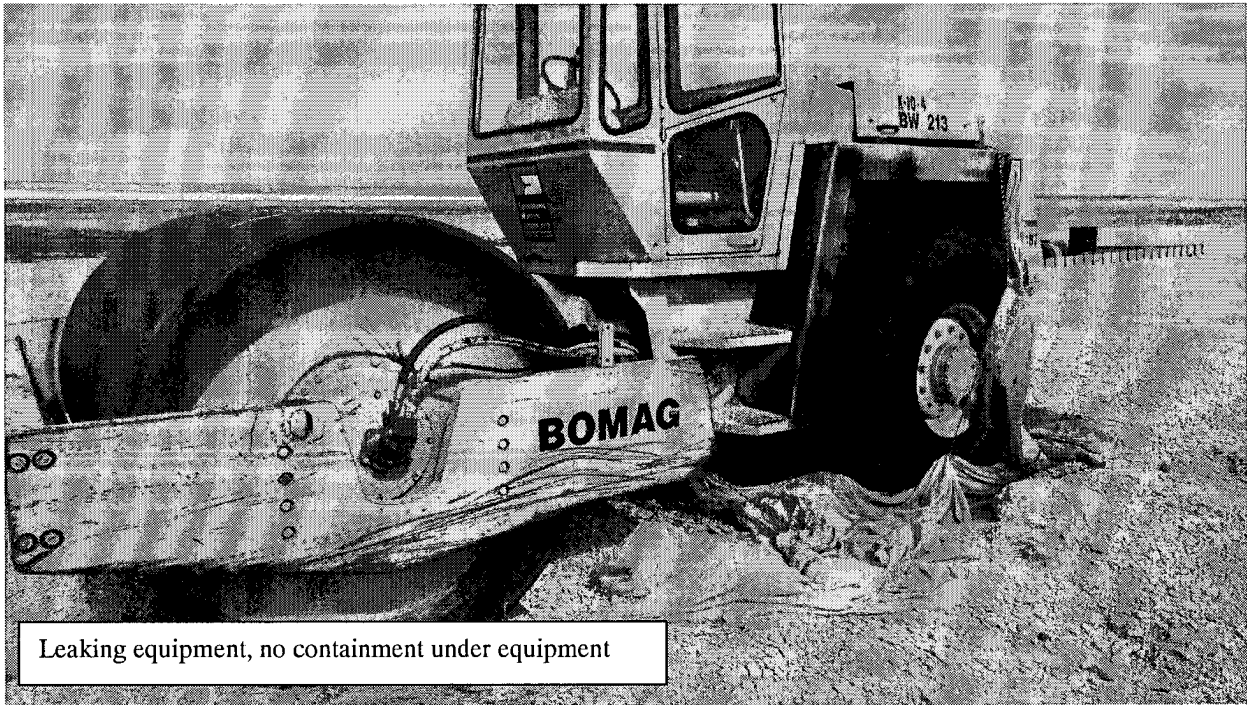
1. The Grader and Packer on the side of airstrip appeared to be dripping fluids on to the ground. A 2012 inspection report mentions that the grader was leaking at that time as well. There was no evidence that 'drip trays' or secondary containment appeared to be in use as required by the permit.

Leaking equipment, no containment under equipment

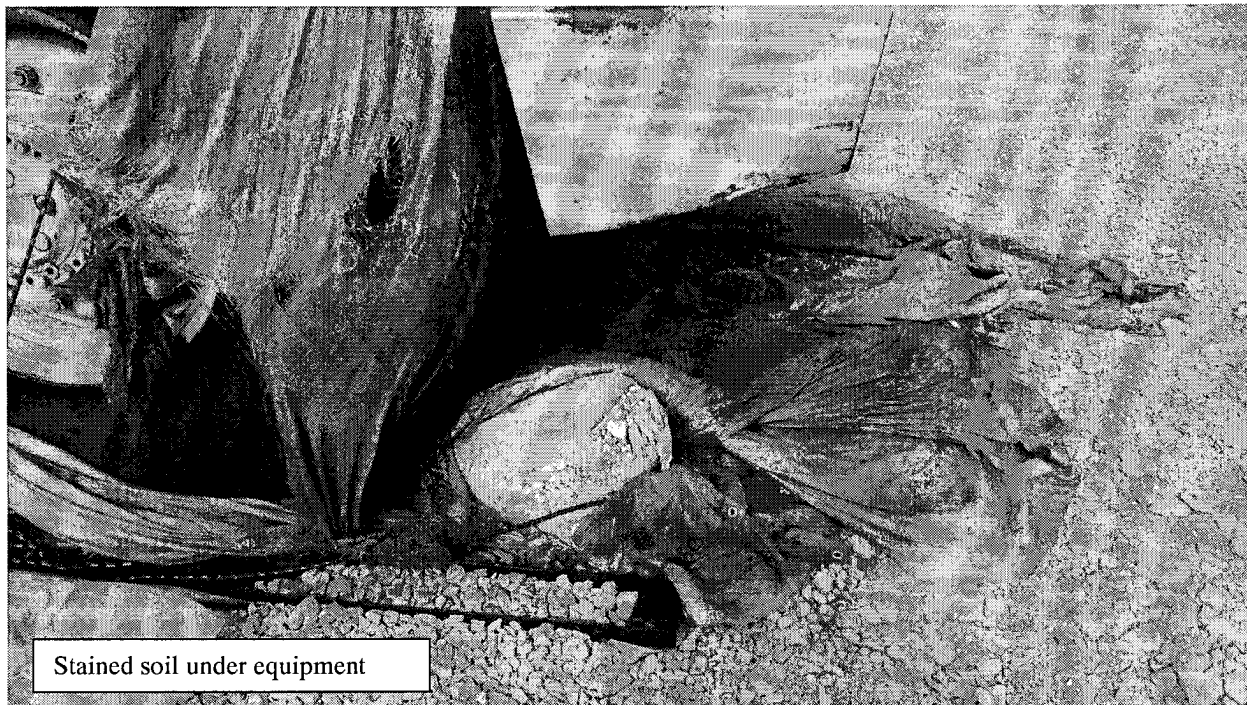
Stained soil under equipment
