WATER LICENCE INSPECTION FORM

☑ Original☑ Follow-Up Report

The Roche Bay Project is located approximately 60 km south of Hall Beach at approximately 68°26' north latitude and 82° 46' west longitude. The site lies on both Crown lands and IOL lands and as such Land Use permits in addition to the Water License were required to access to the site. The Land Use permits expired in 2015 and the Water License expired in March of 2016.

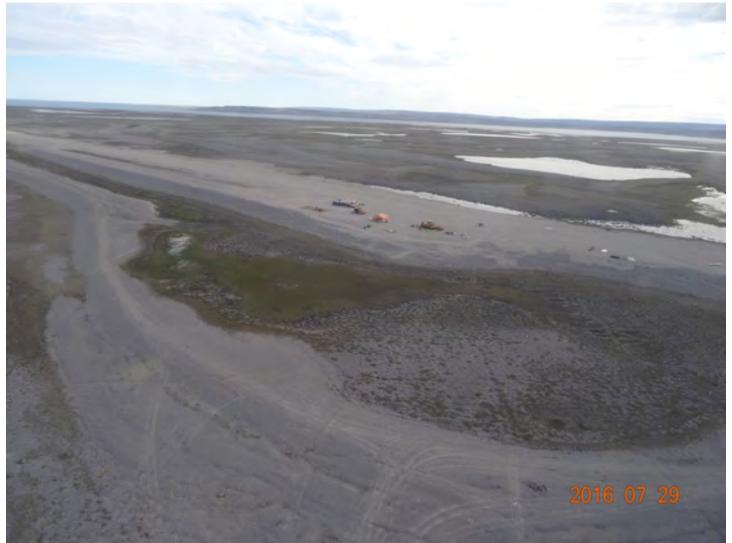
Figure 1- Roche Bay airstrip

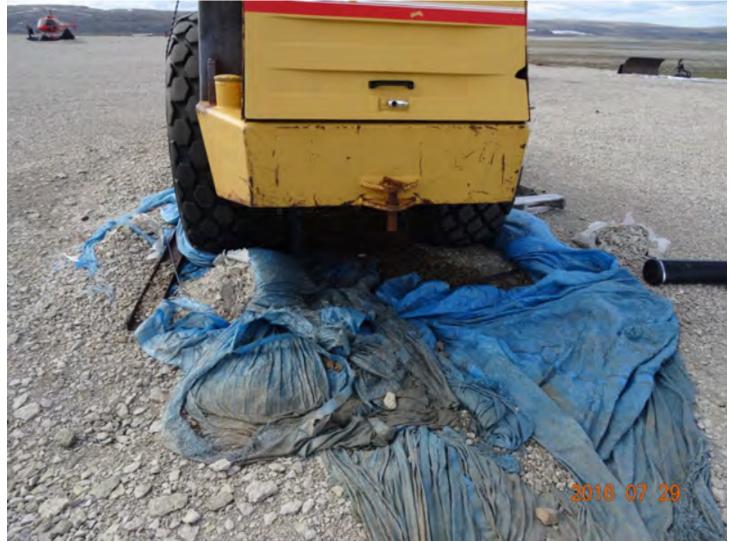
- 17 barrels of unknown contents are in secondary containment
- 500 used barrels are piled on the side of the airstrip.
- A Grader with the engine removed is on site. Evidence of gear oil and other oil leaks is present under the unit
- A BOMAG Roller is on site. Tarps and liner were placed under the unit but have been weathered and moved. Evidence of leaking oil is found under the unit.
- A small shack/building is on site and contains waste materials and garbage.
- Barrels of unknown content are stored beside and behind the building

Figure 2 Roller on airstrip - note oil leaking from under carriage

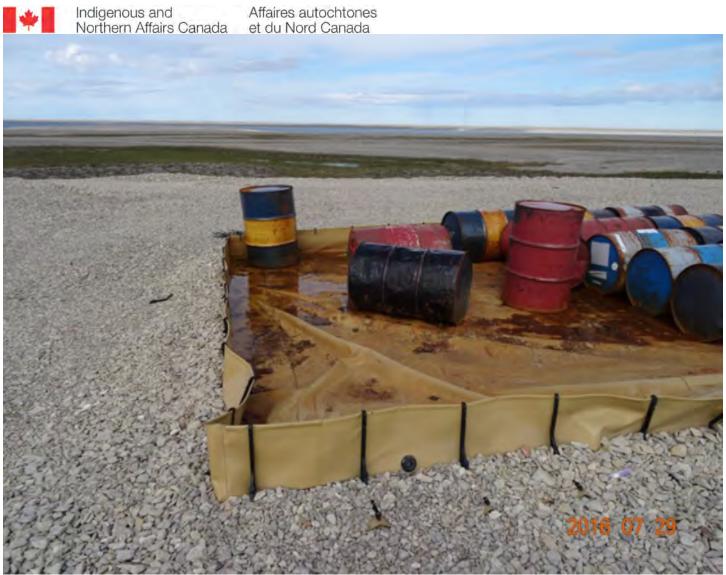
Figure 3 Roche Bay airstrip- barrel of unknown contents in secondary containment

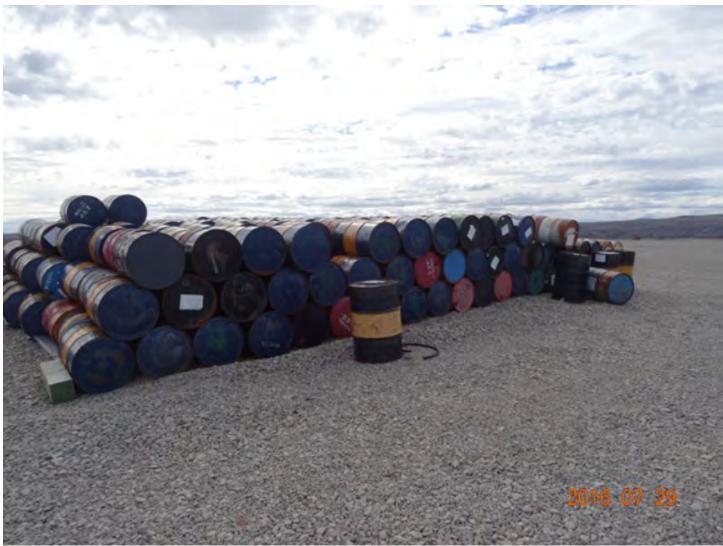
Figure 4 Roche Bay airstrip - used barrel stacked beside air strip

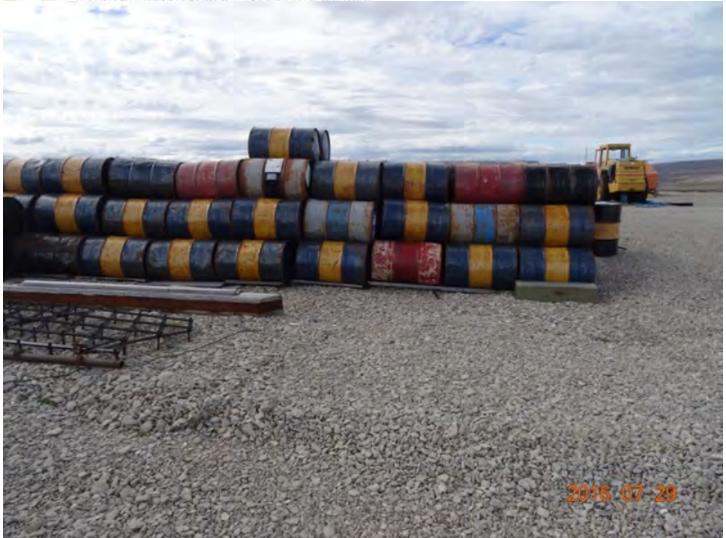
Figure 5 Stacked barrels 2

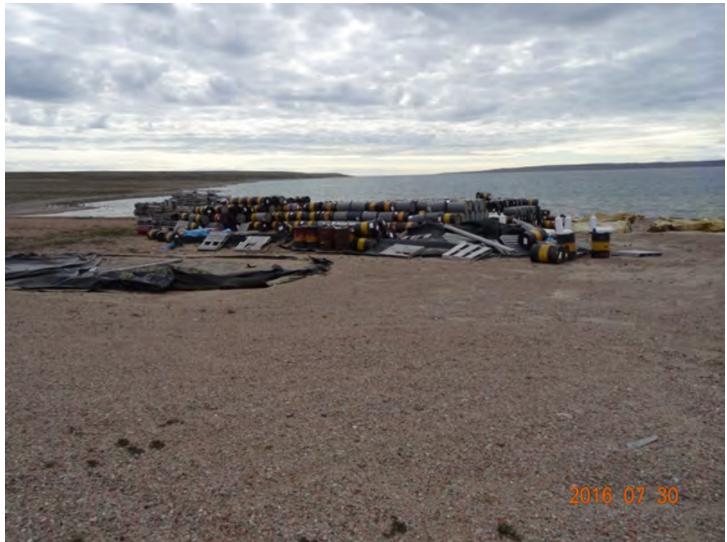
- 1000 plus used drums have been piled on the beach within 100 meters of the high tide mark
- Piles of waste materials including liner, pallets, bags of garbage, insulation nd othr debris are scattered around the site

Figure 6 Roche Bay beach Laydown - Used barrels, pallets and debris all stacked on shoreline

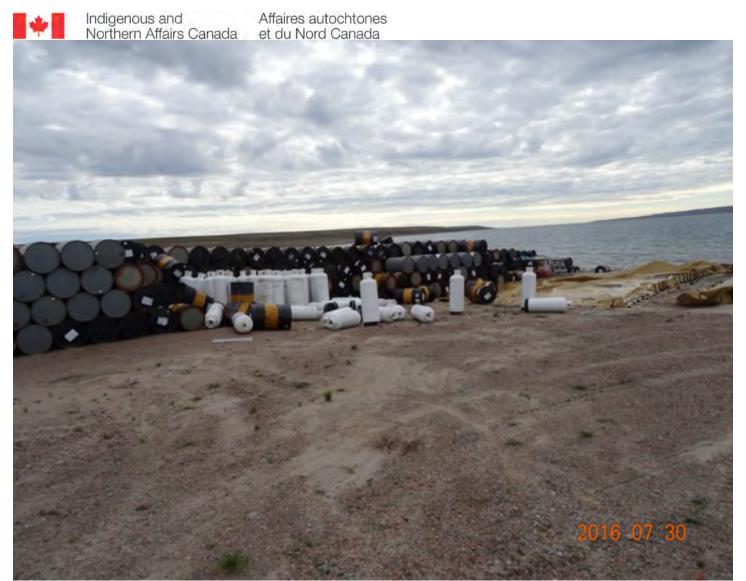
Figure 7 Roche Bay beach - Barrels and propane cylinders on shoreline

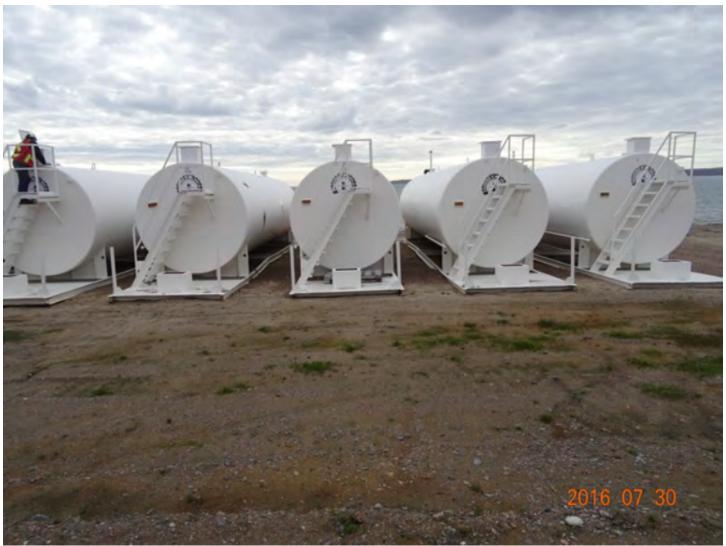
- Wind blown garbage is scattered across the tundra and down to the shore from the Laydown
- Six 50,000 L fuel storage tank remain on the beach
- 20 plus barrels of heating oil

Figure 8 Roche bay Beach laydown - 5 50,000 liter tanks

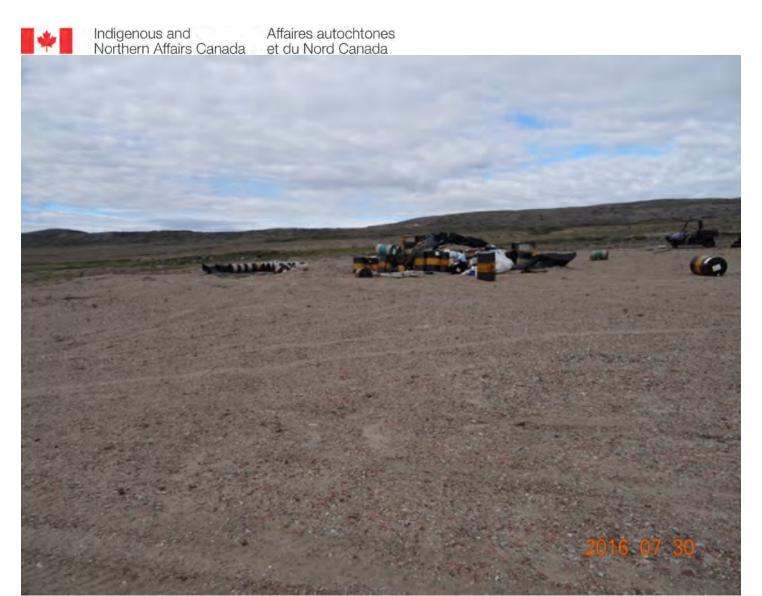
Figure 9 Up hill from shoreline, barrels and debris stacked on sand

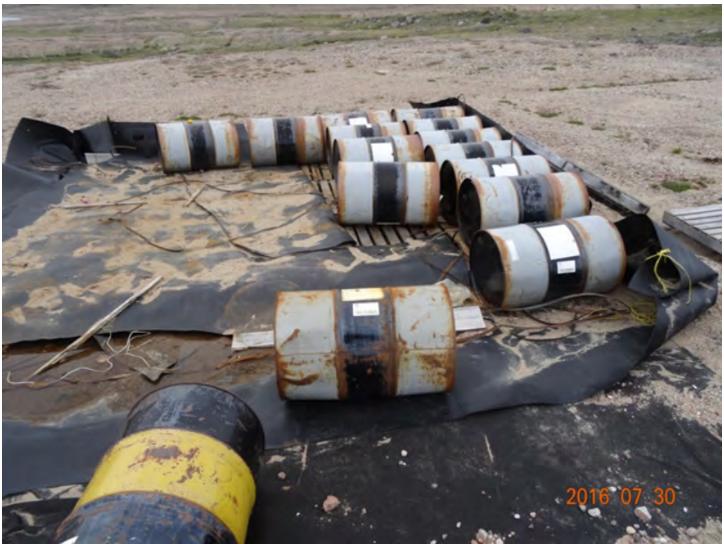
Figure 10 Barrels of fuel oil- heating

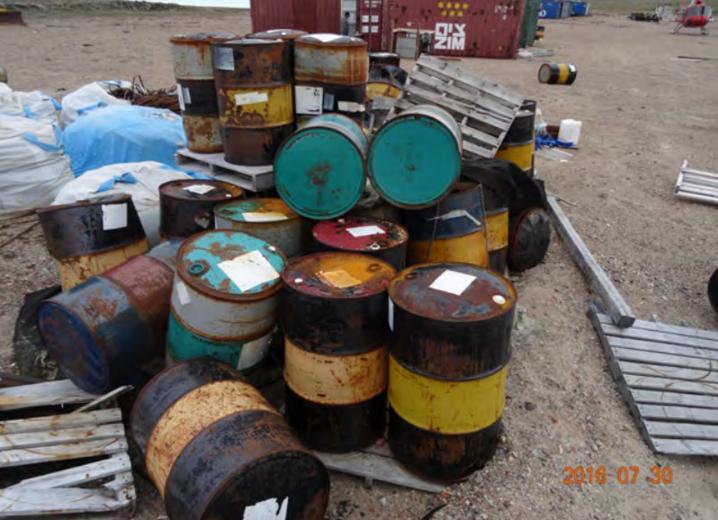
- 40 drums of unknown contents are piled up within a debris pile
- 1 small dozer (Komatsu 37PX) remains on site
- 1 small Kabota loader (R420S) (inside a sea-can) remains on site

Figure 11 Barrels of unknown origin or contents stacked in debris pile on beach

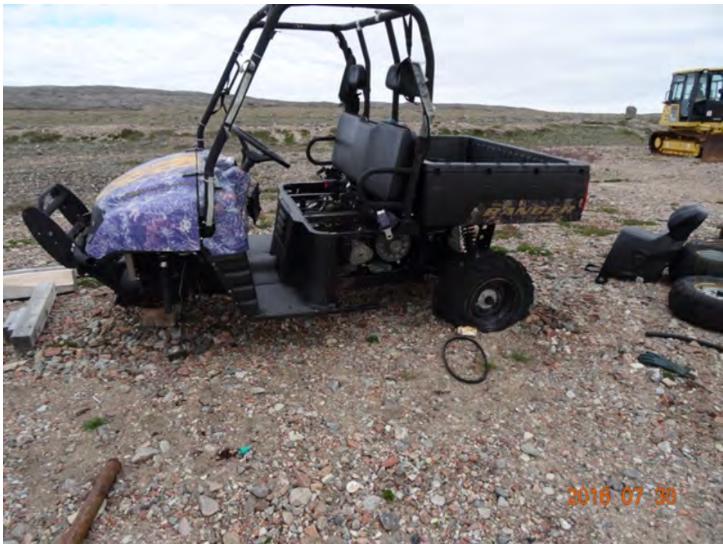
Figure 12 stripped side by side

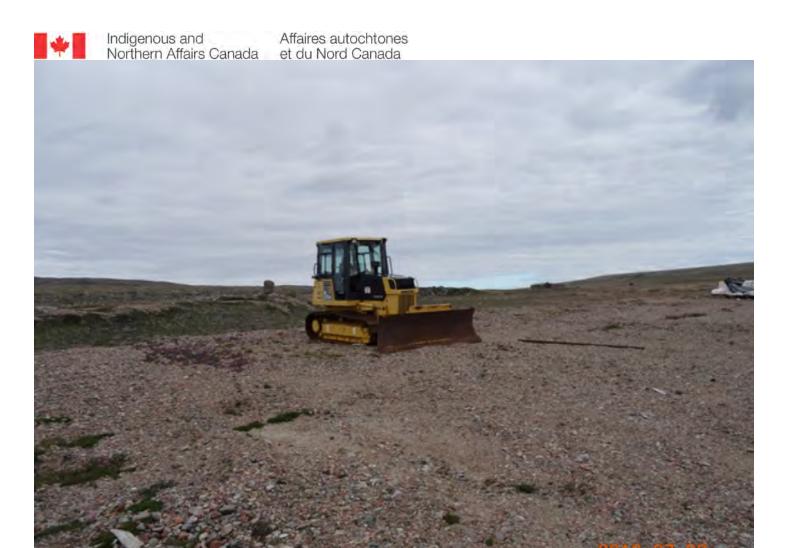
Figure 13 Komatsu dozer on beach

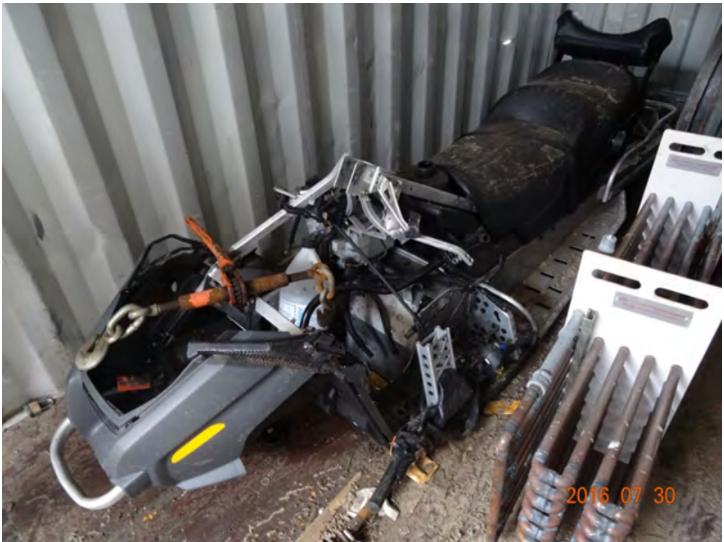
Figure 14 One stripped snow machine

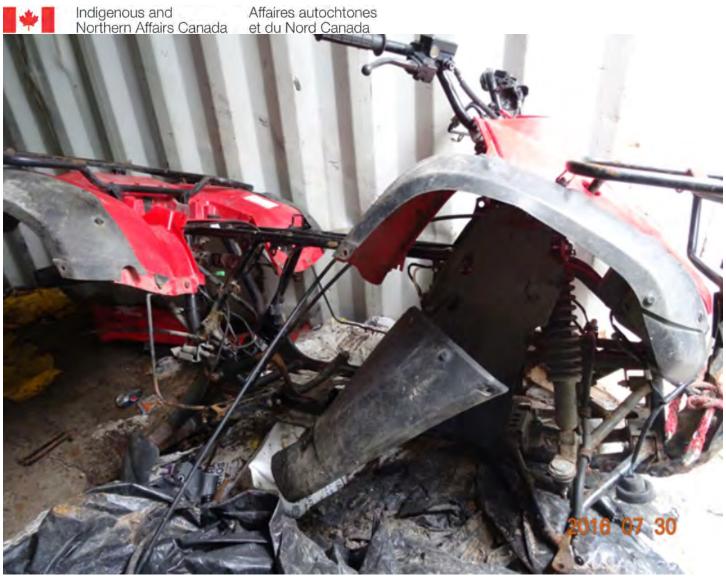
Figure 15 one stripped four wheeler

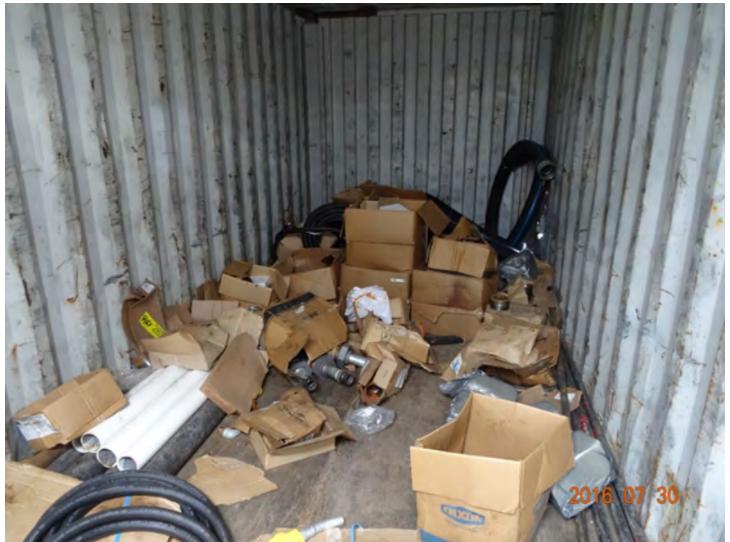
Figure 16 inside one of seven sea cans - Spare parts

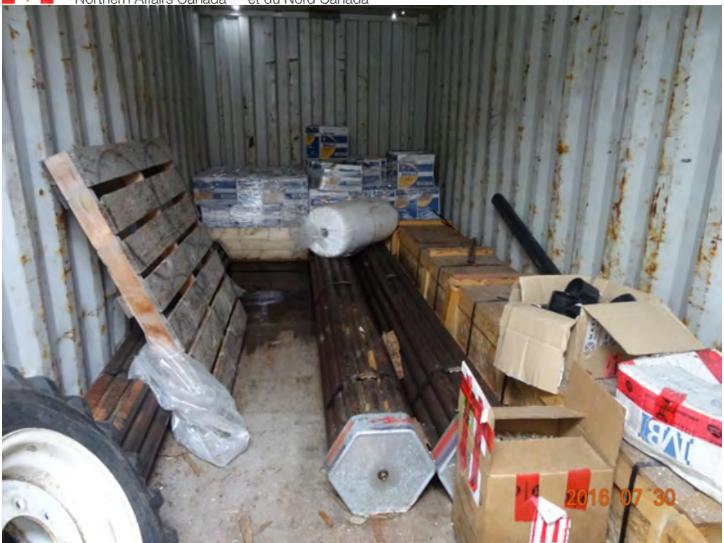
Figure 17 Inside another sea-can - note cases of 2 stroke oil at the back

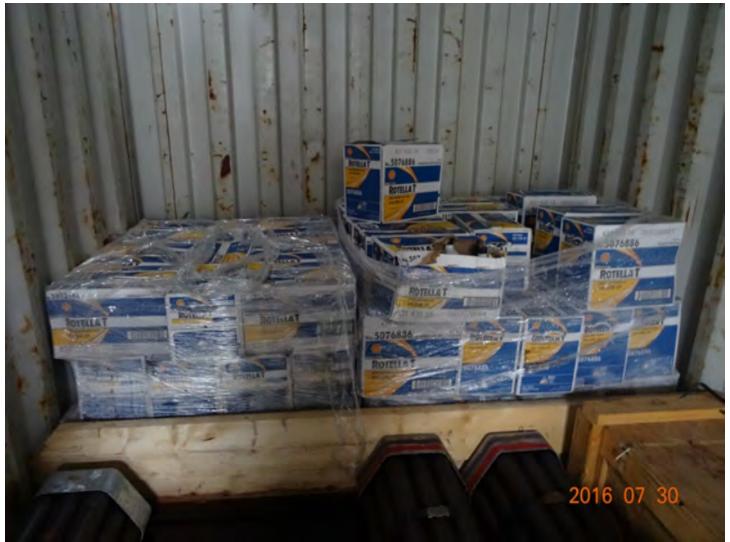
Figure 18 fifty cases of 2 stroke oil.

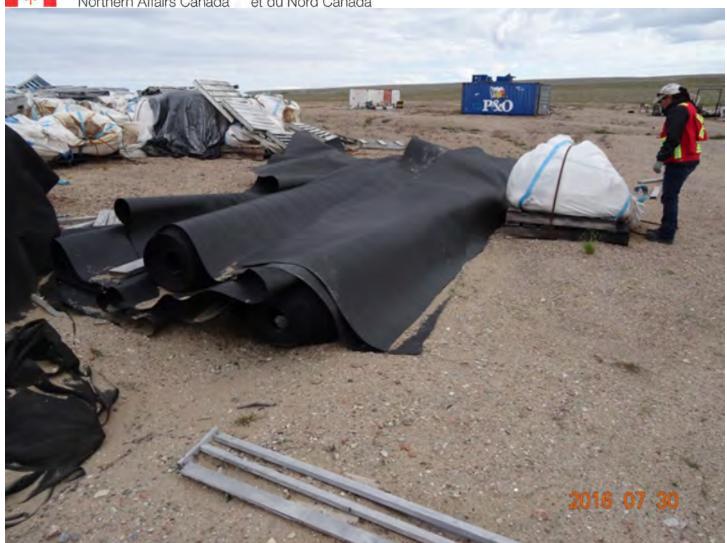
Figure 19 Liner, 24 pallets of bag of drilling salt.

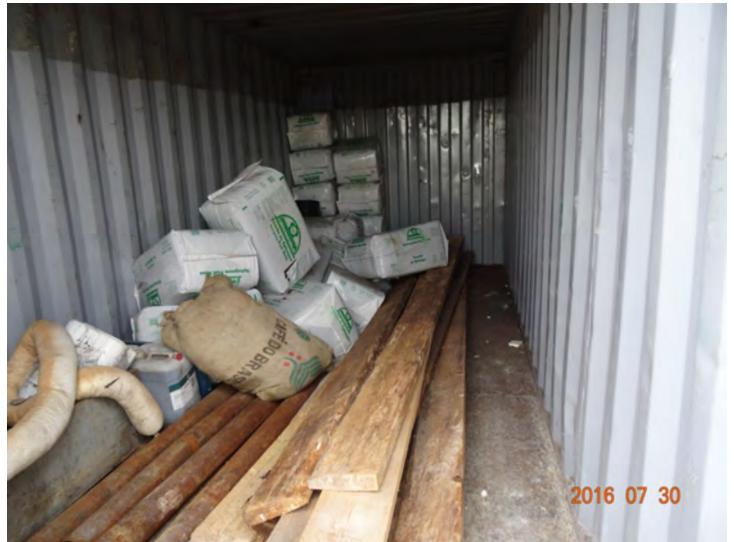
Figure 20 Sea can with wood and peat moss

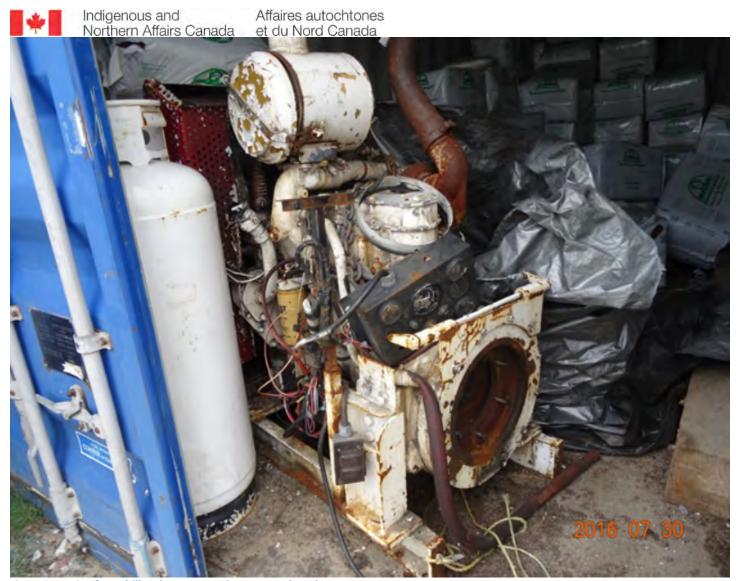
Figure 21 Engine from drill and spare parts & peat moss bags!

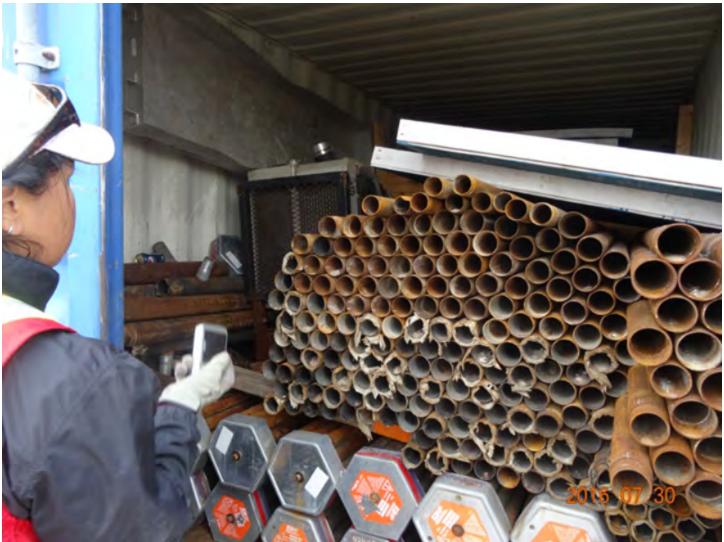
Figure 22 casing... Lots of casing

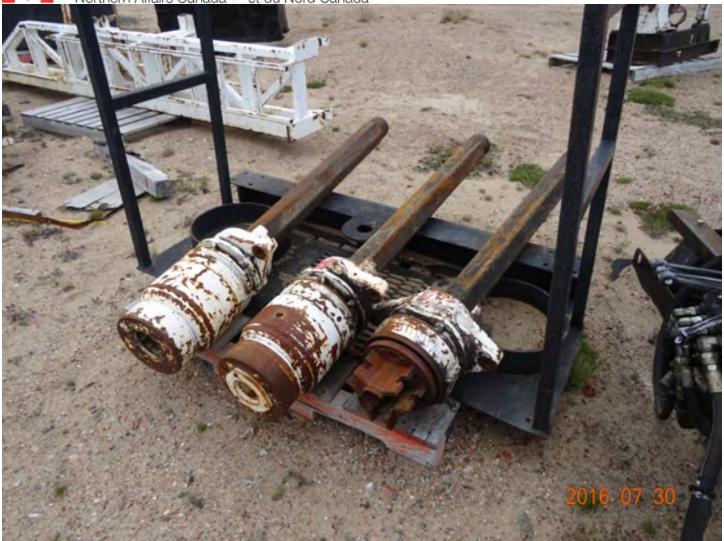
Figure 23 Drill Bits

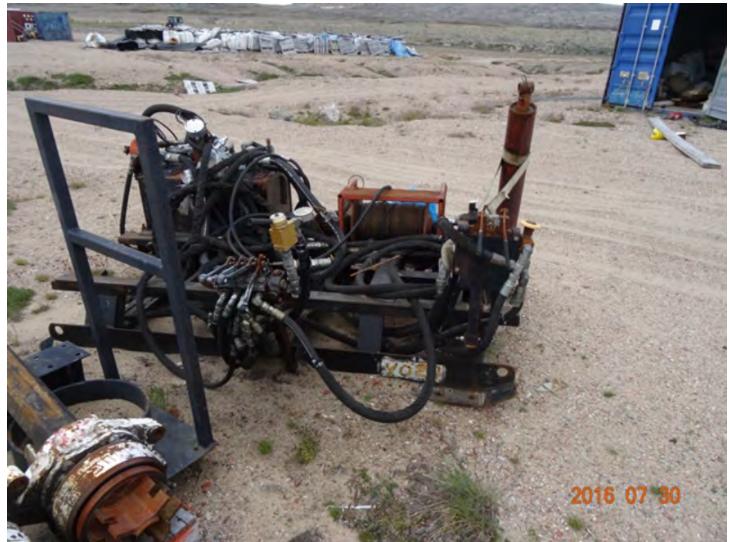
Figure 24 Hydraulic pump

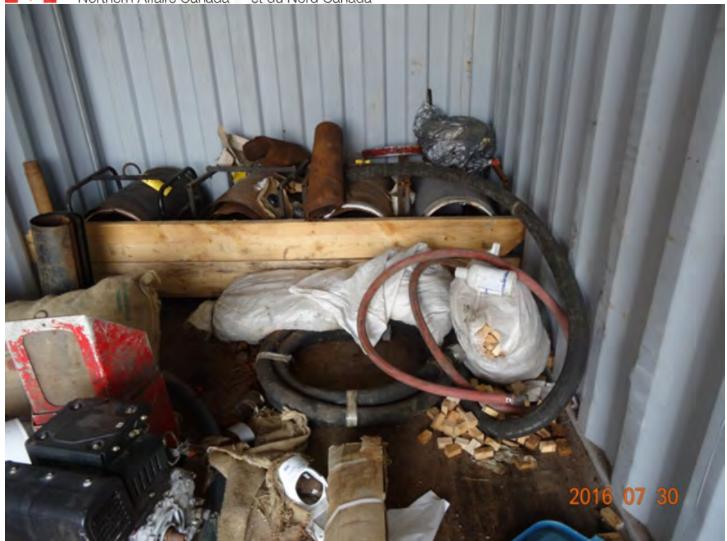
Figure 25 Stoves/ Heaters for water used in drilling

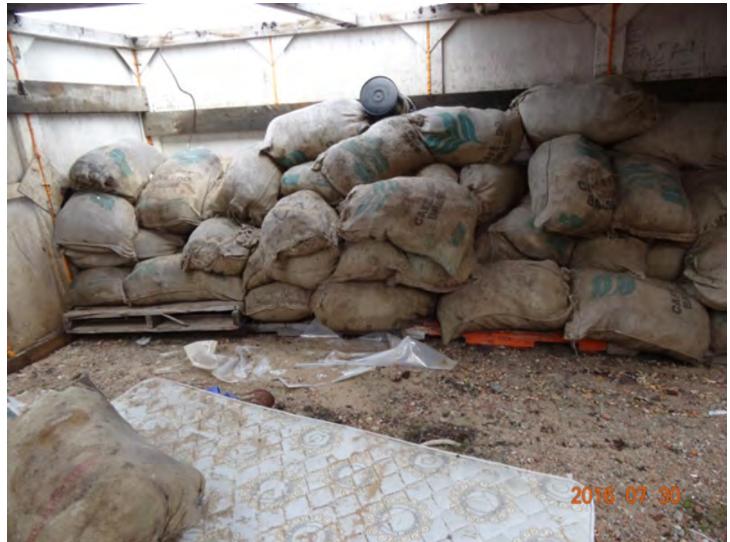
Figure 26 Bags of peat moss

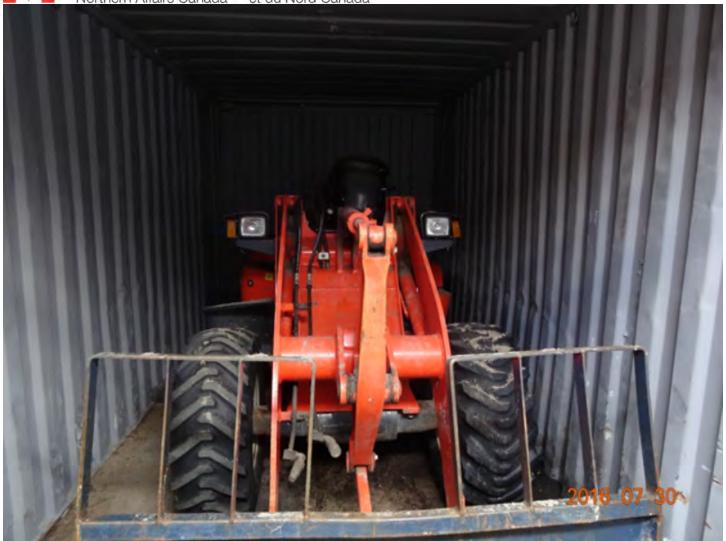
Figure 27 Kaboda loader in sea-can

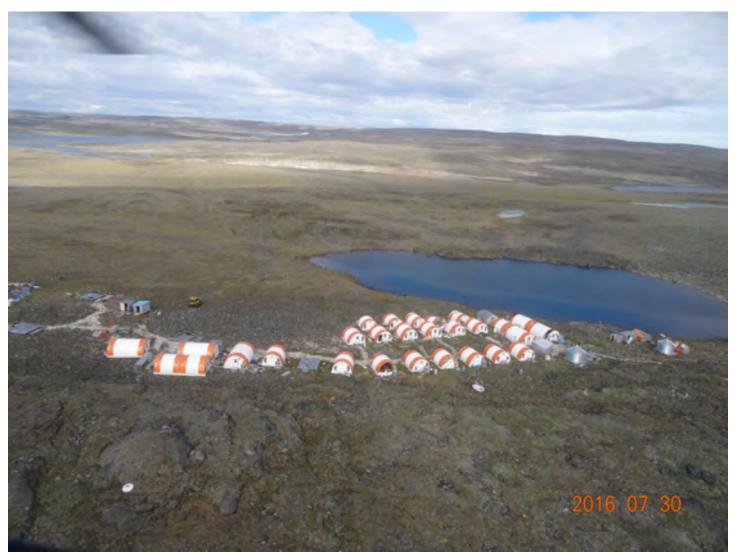
Figure 28 Roche Bay main camp

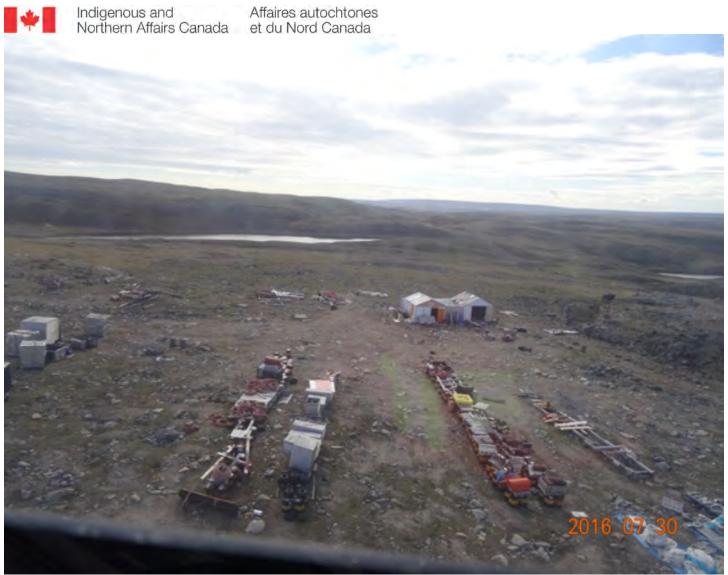
Figure 29 Roche Bay driller lay down beside camp

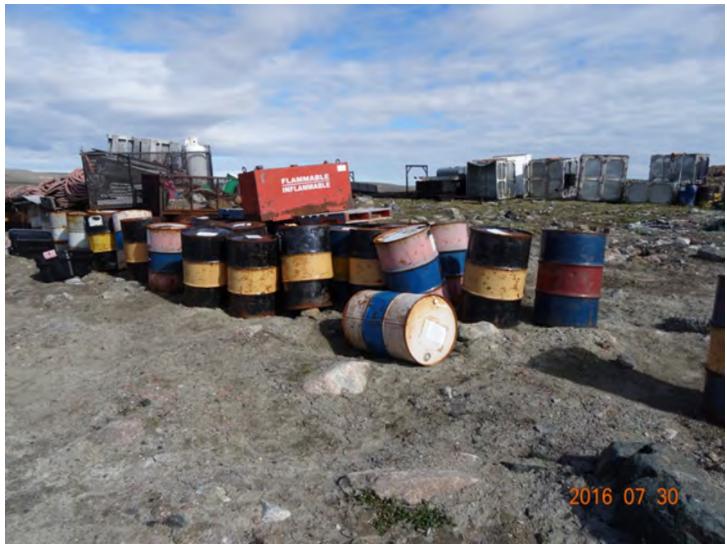
Figure 30 Drillers area

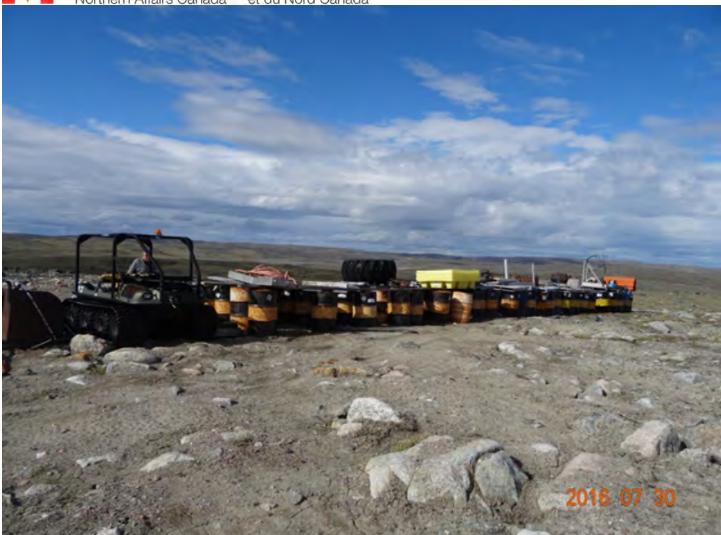
Figure 31 Drillers area - in front of workshops

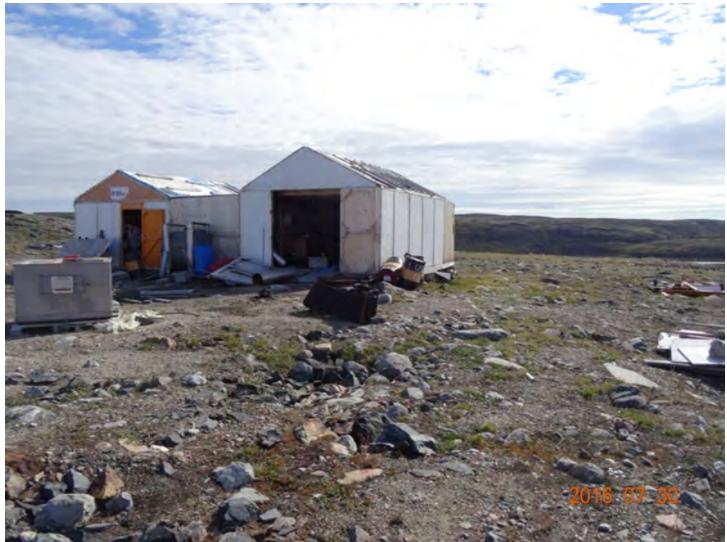
Figure 32 Drillers area workshops and parts storage

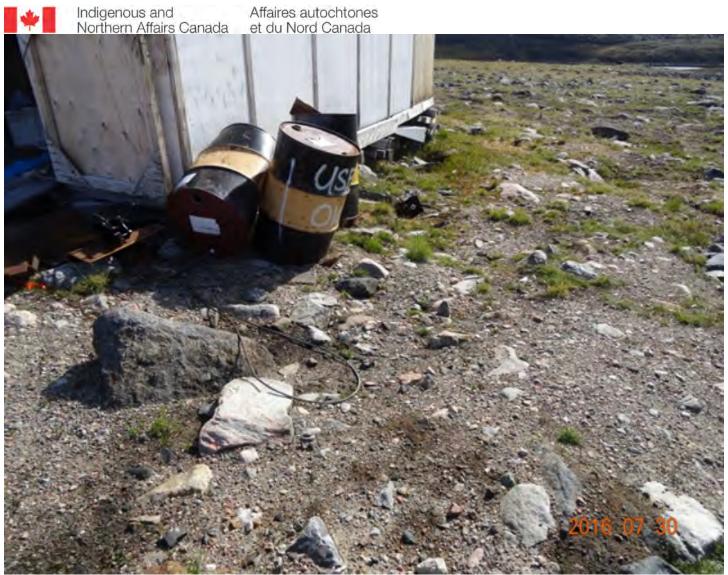
Figure 33 drum of waste oil outside drillers area storage shed/ workshop

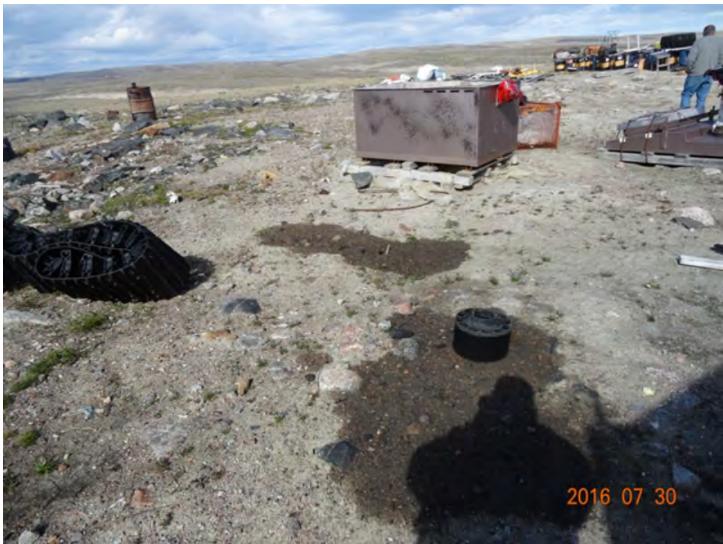
- The ground shows evidence of a number of hydrocarbon spills throughout the site.
- Two maintenance shacks full of parts and equipment are on site.
- Inside the shacks were over fifty buckets of oil and various lube oils for use on the drills

Figure 34 hydrocarbon spills

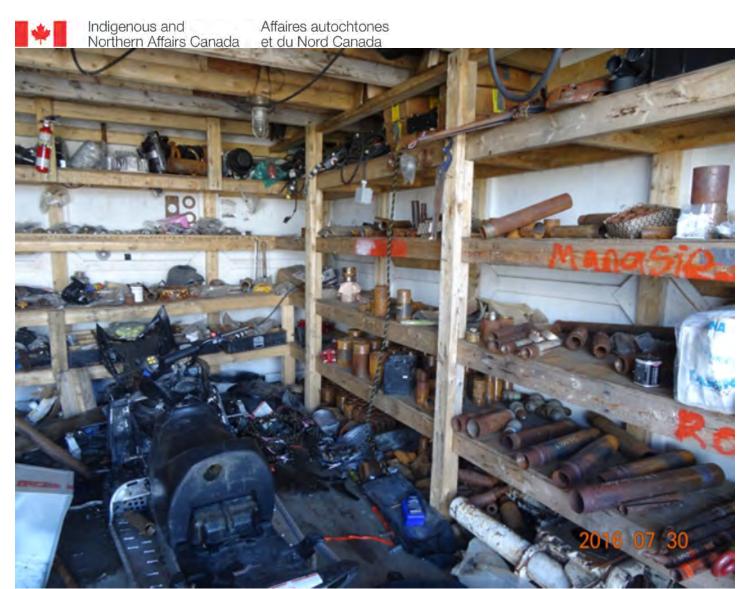
Figure 35 Storage shed/ workshop - note stripped snow machine

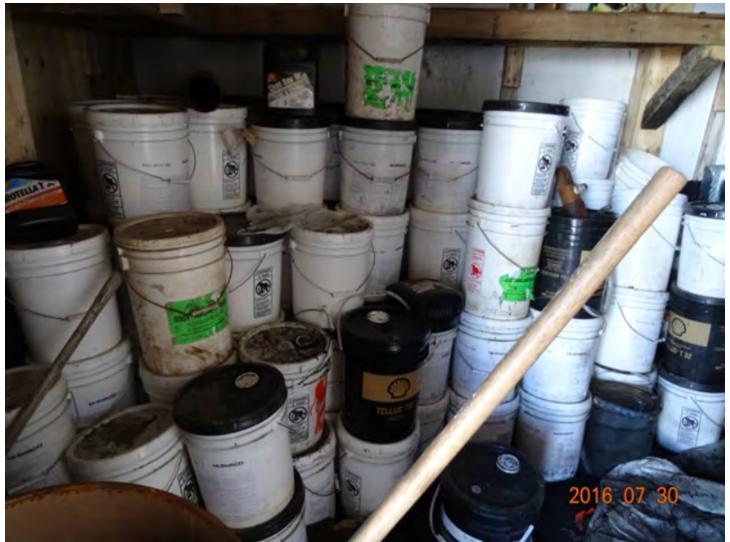
Figure 36 50 5 Gallon pail of drill lube, oil and other

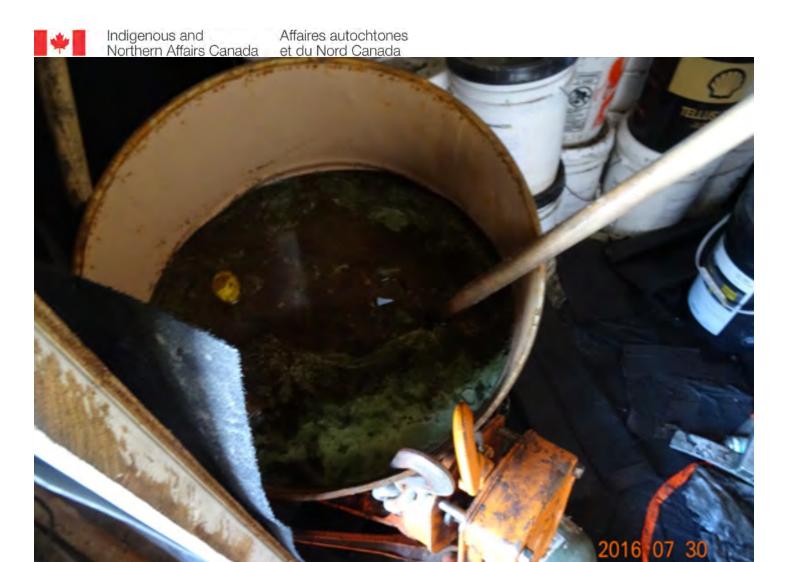
Figure 37 open drum of oil and unknown contents

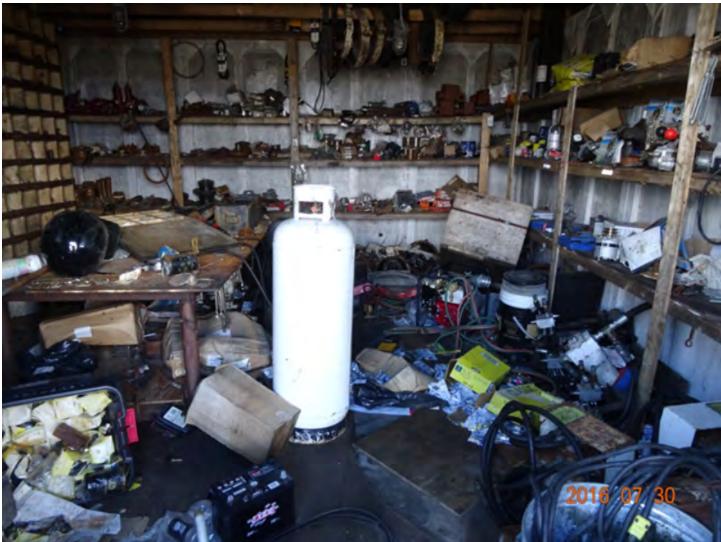
Figure 38 driller workshop

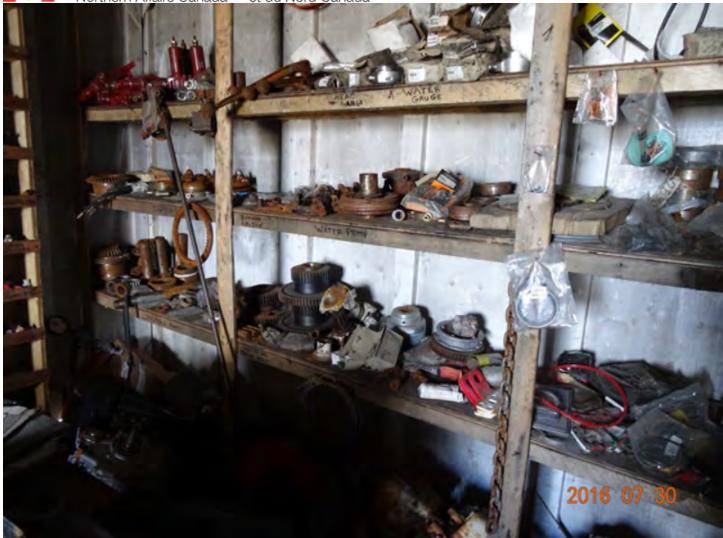
Figure 39 driller workshop

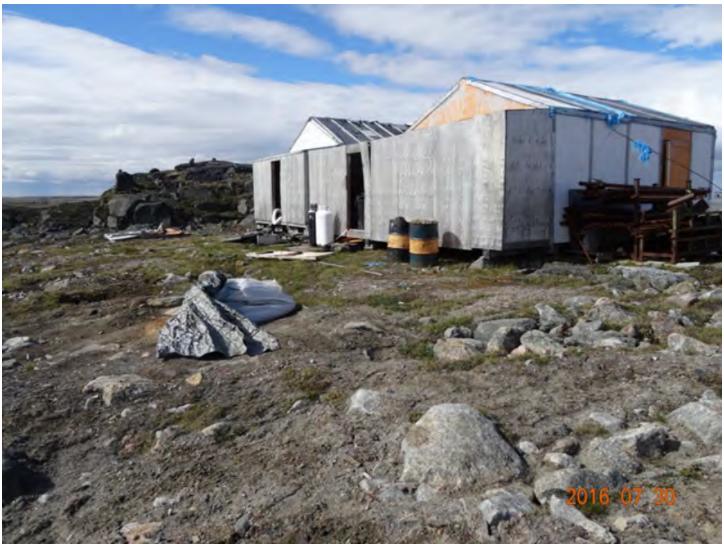
Figure 40 Behind the driller shop - note leaking barrels

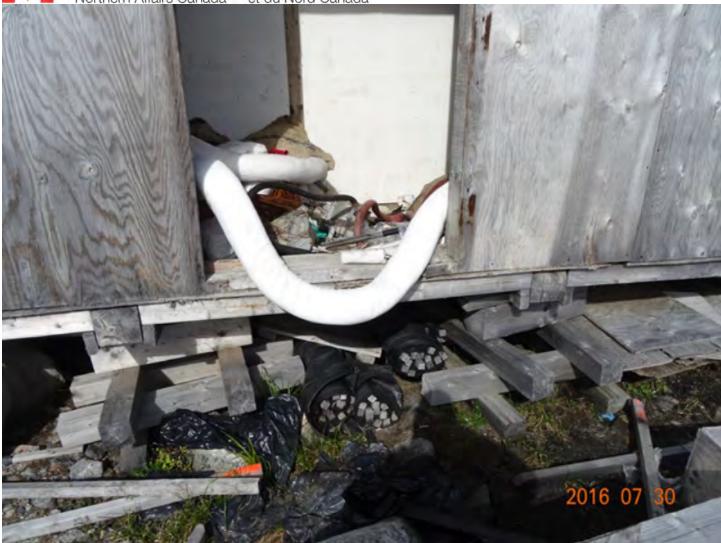
Figure 41 Behind drillers workshop - note absorbent boom.

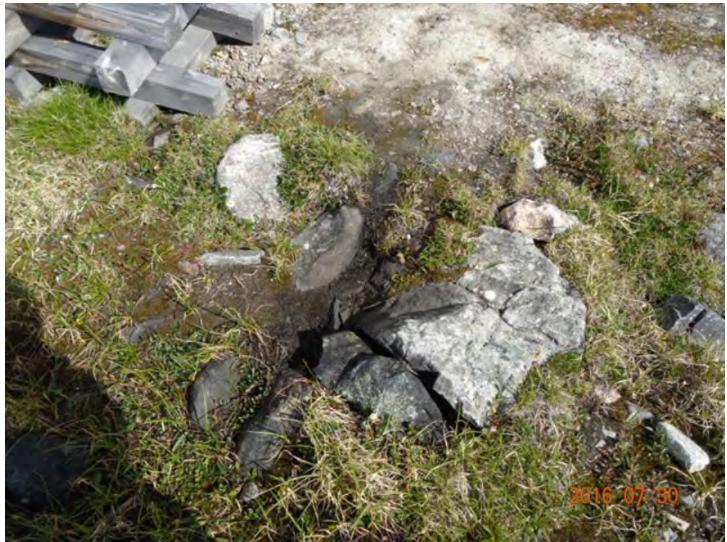
- Open buckets of waste oil were found in the shacks as well.
- Outside and around the shacks there was a very strong smell of hydrocarbon and staining running down from the shack into the overburden and rocks behind the shack.

Figure 42 Hydrocarbon contaminated soils behind workshop

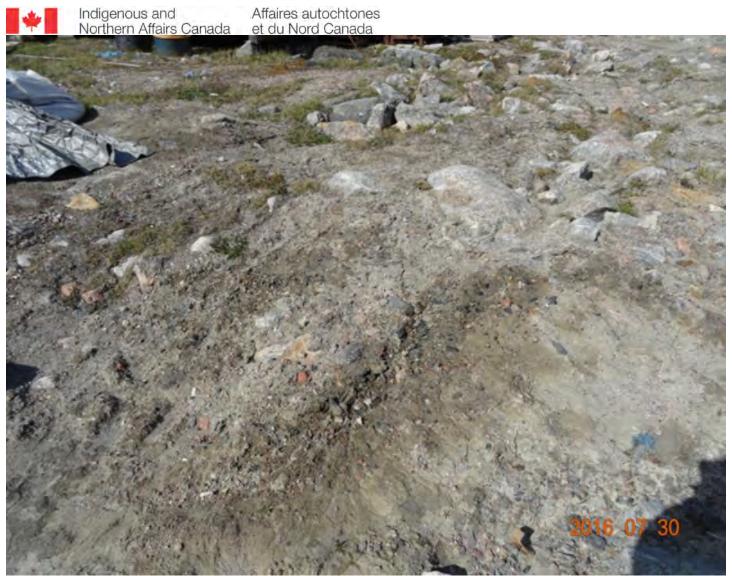
Figure 43 Hydrocarbon contaminated oils 10 M from the Buildings

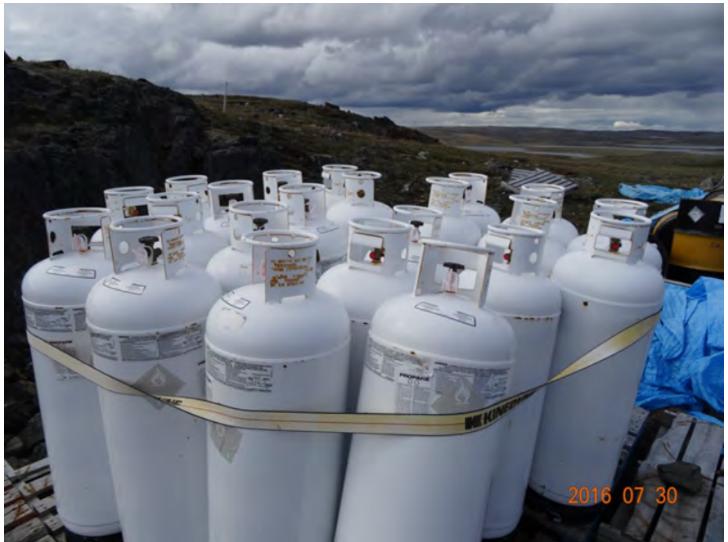
Figure 44 Full propane cylinders at camp

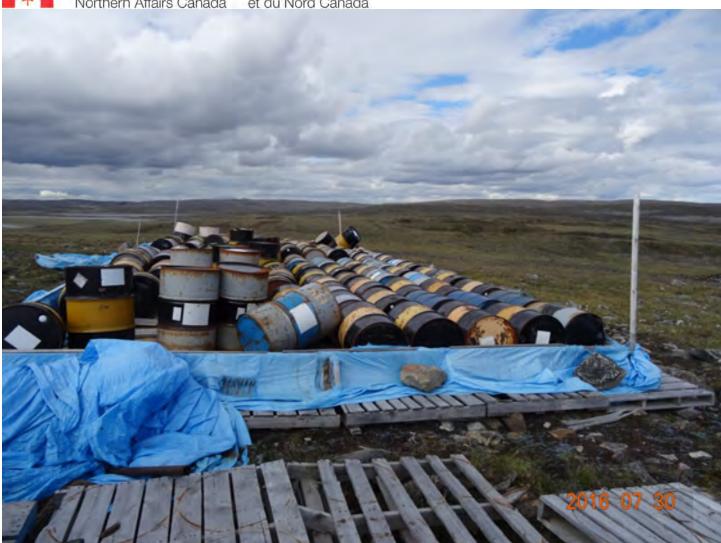
Figure 45 Expired Jet A and Heating fuel at camp

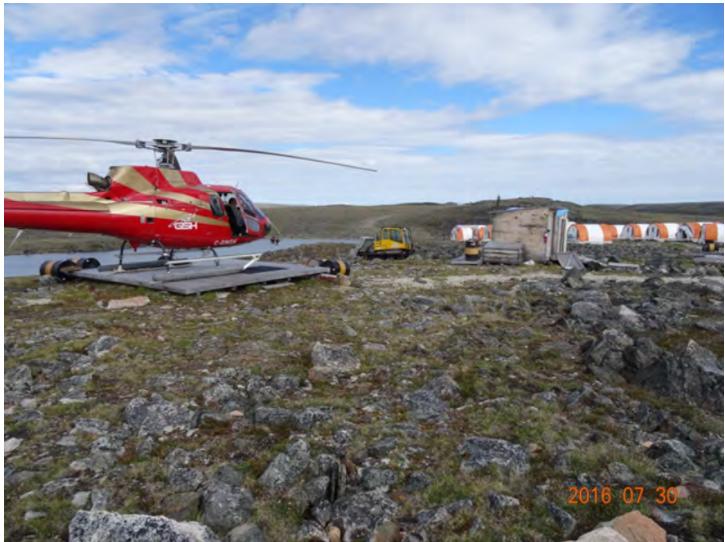
Figure 46 Challenger and fuel barrels (full) at camp

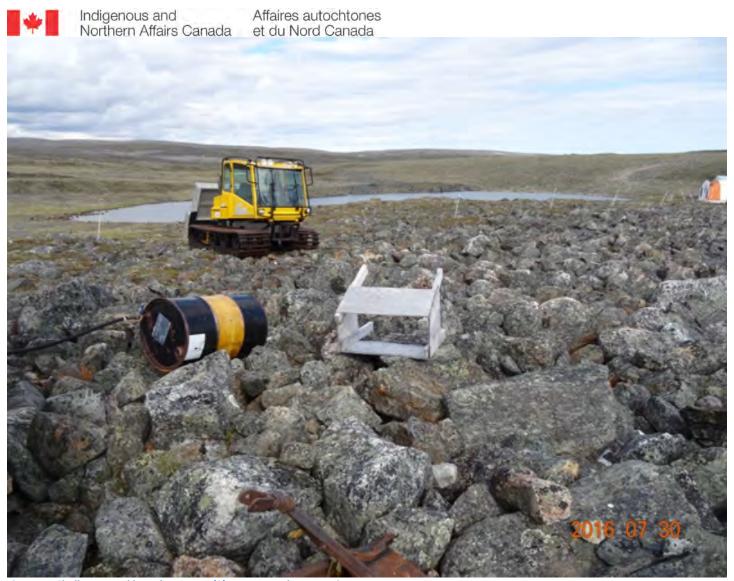
Figure 47 Challenger and barrels at camp (2) – No secondary containment

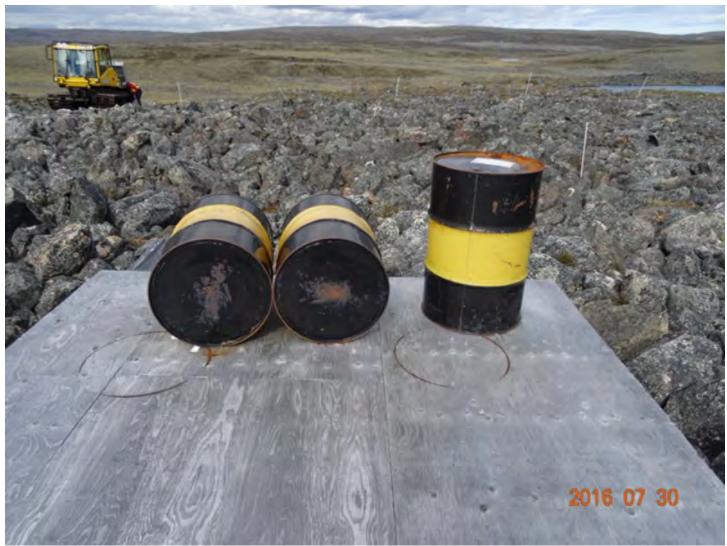
Figure 48 Challenger and barrels at camp (3) – No secondary containment

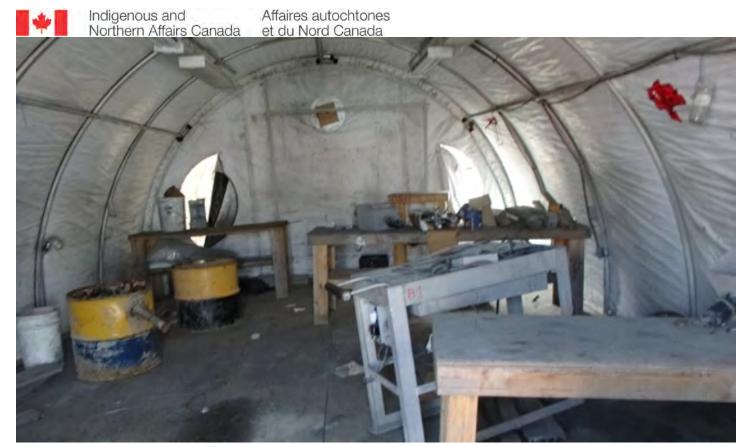
Figure 49 Core shack - ripped walls and frame is broken in places

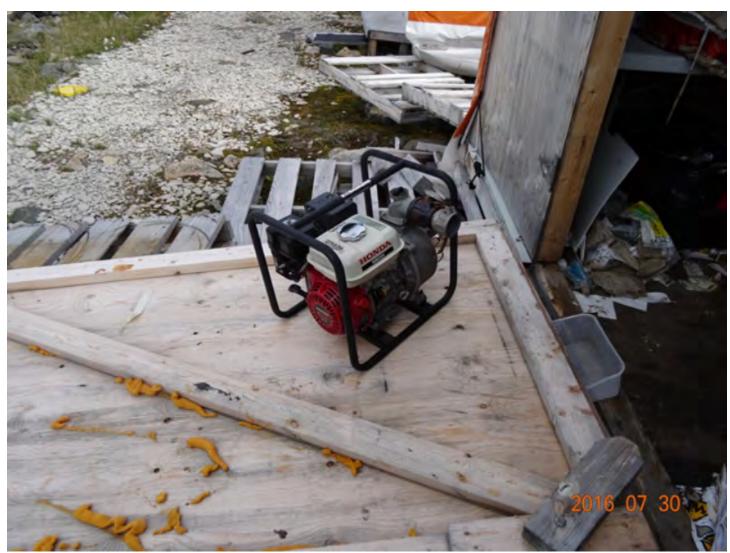
Figure 50 Camp - Water pump left outside

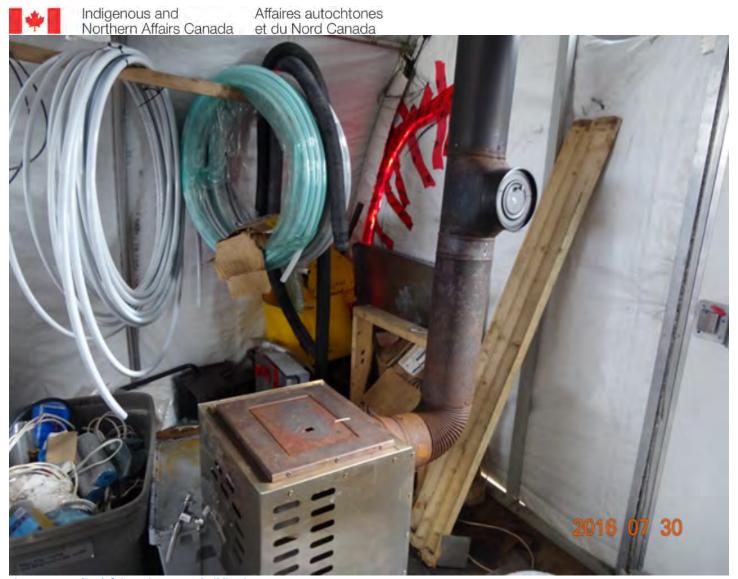
Figure 51 supplies left in maintenance building in camp

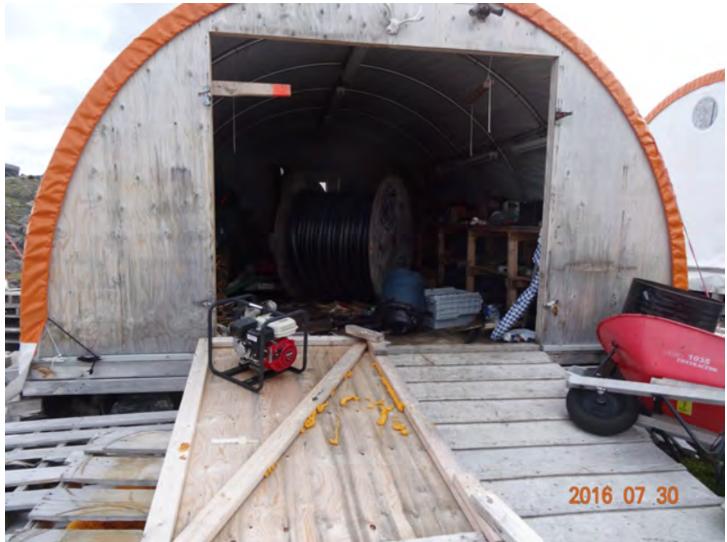
Figure 52 maintenance building at camp

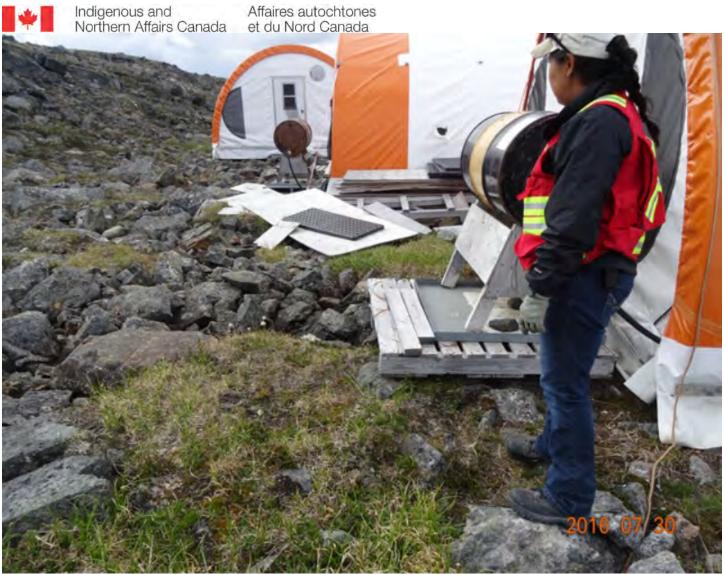
- During the inspection it was noted that all of the hoses that connect the fuel drums o the heater and other equipment are cracked and weathered and in serious need of replacement to avoid a large number of spills.

Figure 53 barrels of heating fuel on stands behind tents - hoses are all weathered and cracking

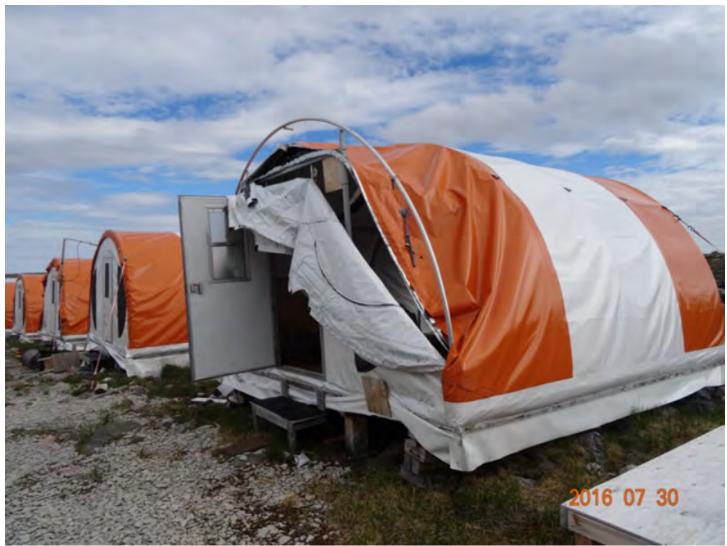
- 25 Weather haven units (2 large kitchen and dry units) were recorded at the camp site. Most units were in need of substantial repair from rips and wind damage. Doors were mostly blown in / broken and unsecured.

Figure 54 weather haven with wind / structural damage
