WATER LICENCE INSPECTION FORM

☑ Original☑ Follow-Up Report

The Roche Bay Project is located approximately 60 km south of Hall Beach at approximately 68°26' north latitude and 82° 46' west longitude. The site lies on both Crown lands and IOL lands and as such Land Use permits in addition to the Water License were required to access to the site. The Land Use permits expired in 2015 and the Water License expired in March of 2016.

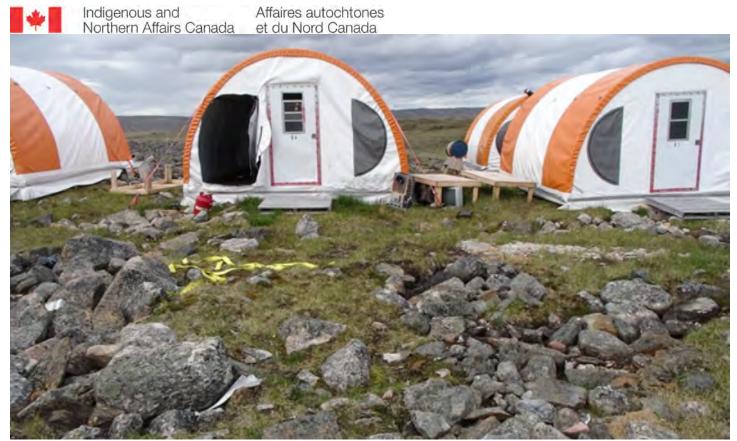
Figure 55 Damaged weather haven

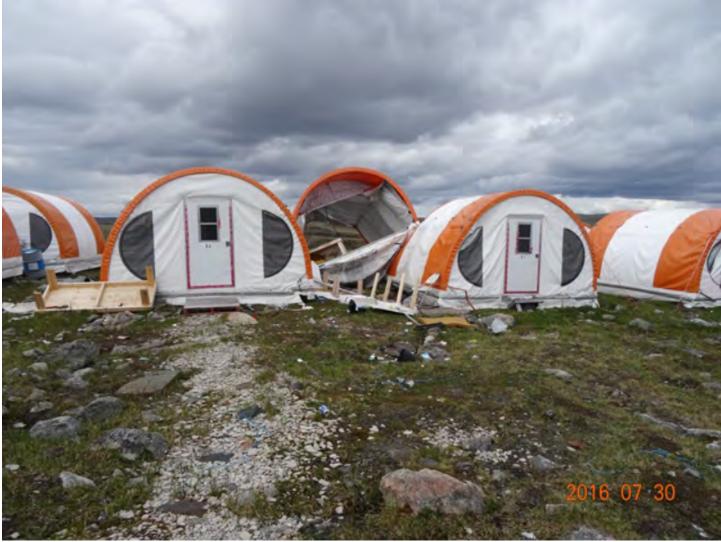
Figure 56 damaged weather haven(s)

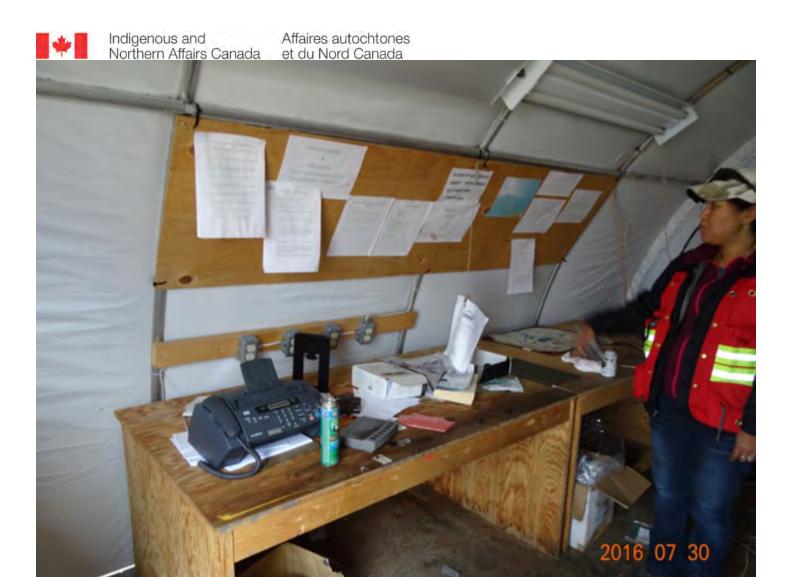
Figure 57 Office tent

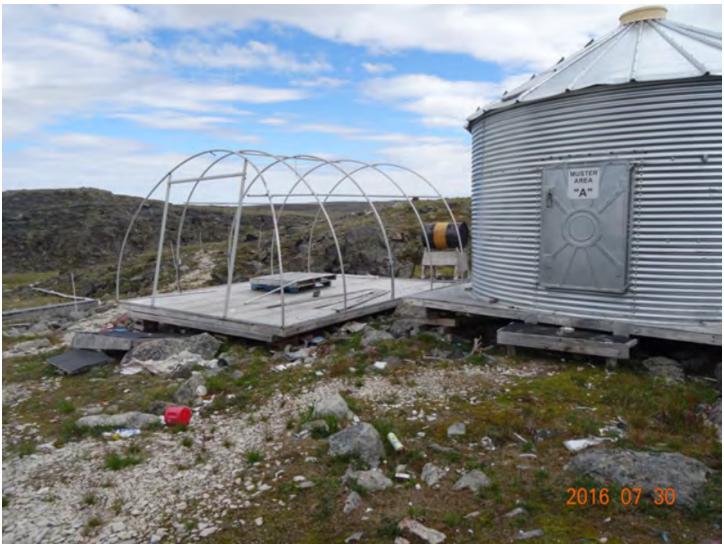
Figure 58 Roche bay camp

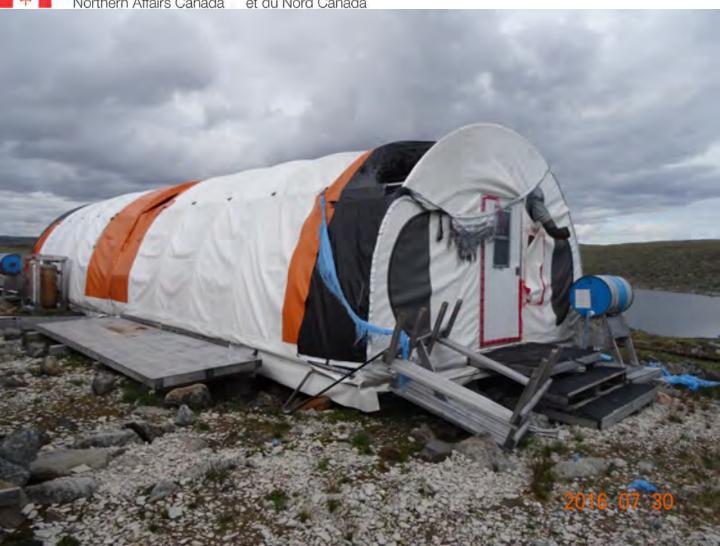
Figure 59 Roche bay camp - cook tent

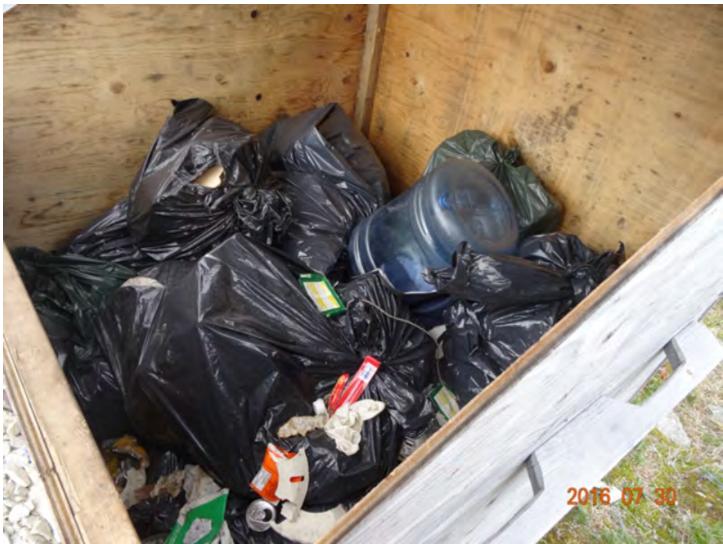
Figure 60 Roche bay camp - garbage in box outside cook tent

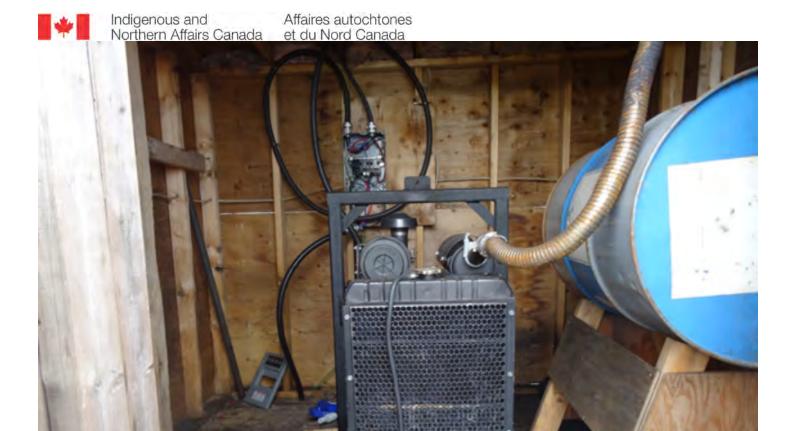
- The incinerator area was found to contain two large boxes of garbage and other wastes. Two smart ash incinerators were found boxed at the site.
- The Generator shack gave off the smell of fuel and staining around the shack was identified during the inspection. The generator remains in place in the shack.

Figure 61 Roche bay camp- gen shack with gen set

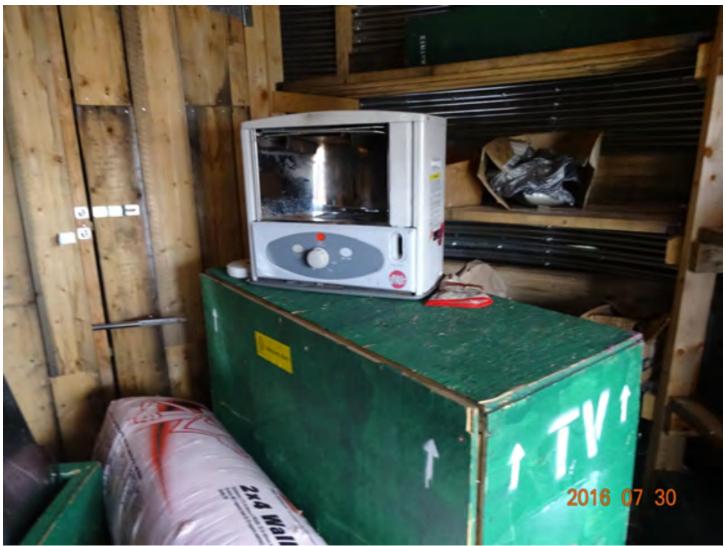
Figure 62 Roche bay camp - supplies found in shack

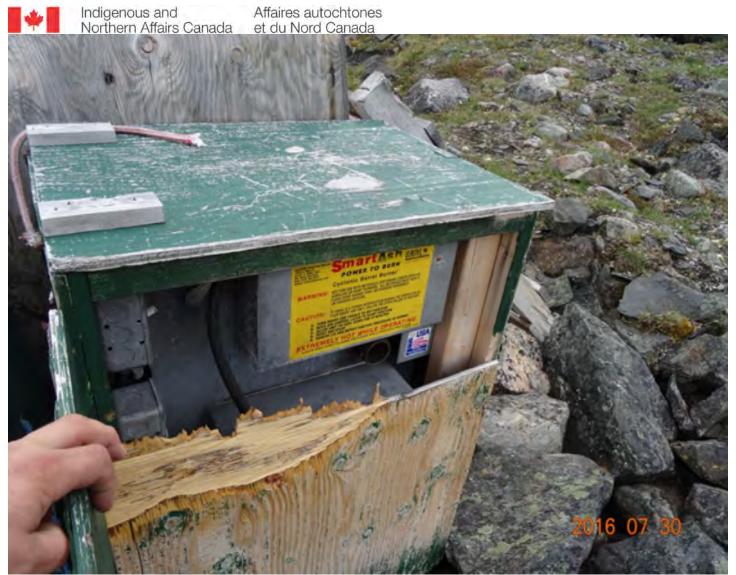
Figure 63 Roche bay camp - waste management area - incinerator site -smart ash

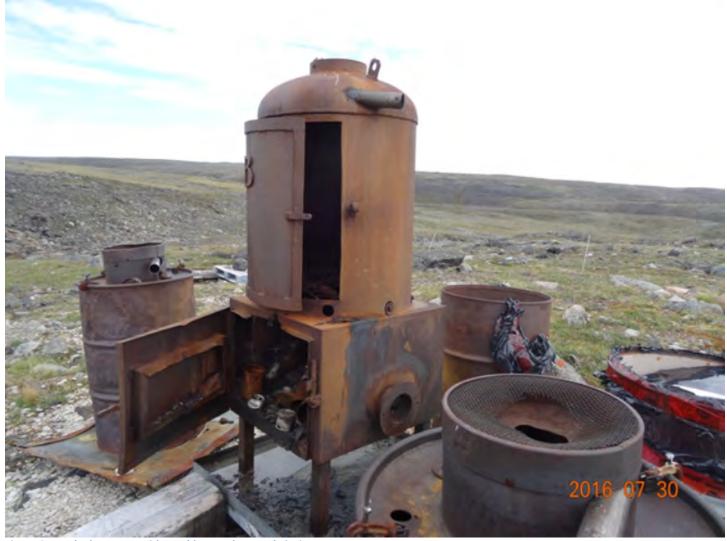
Figure 64 Roche bay camp with an old Burnadette style incinerator

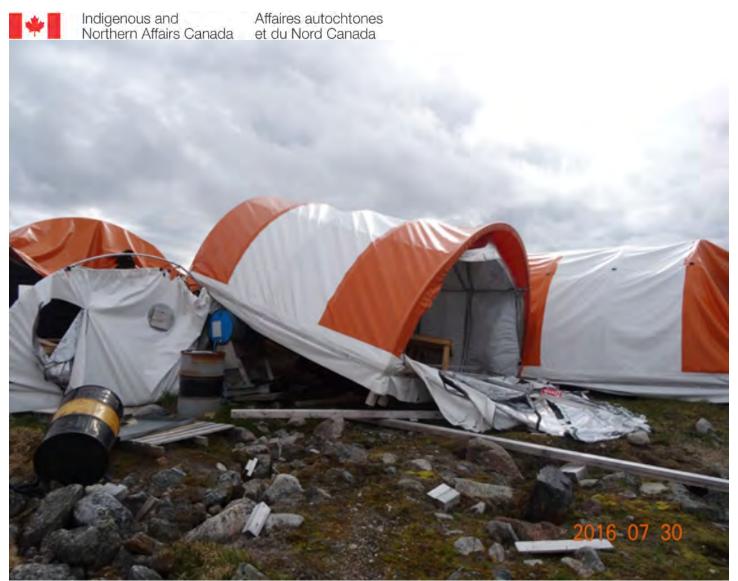
Figure 65 Roche Bay camp - damaged weather havens

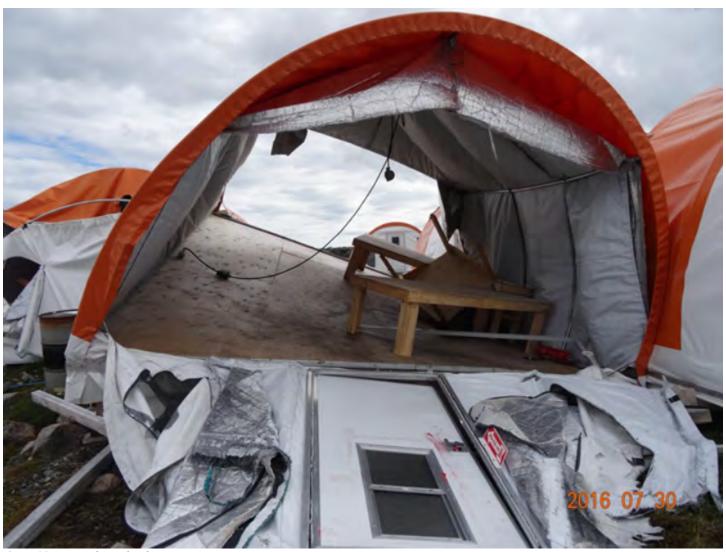
Figure 66 Damaged weather havens

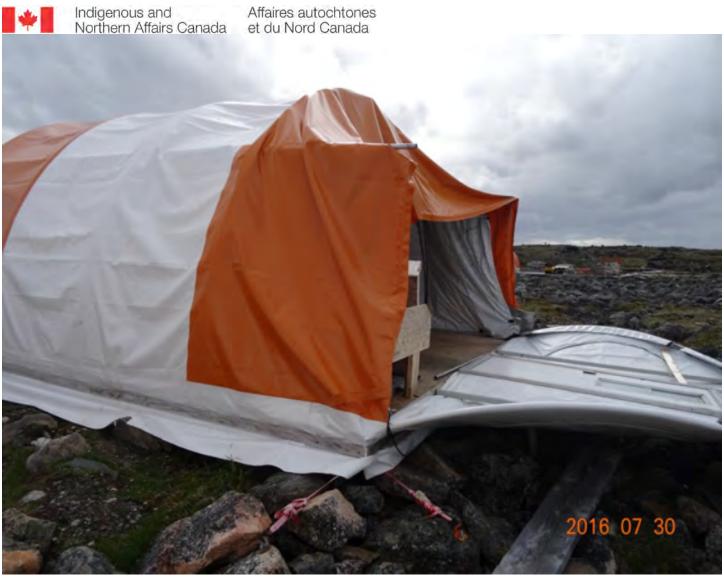
Figure 67 weather haven with end blown off
