**Re: Strongbow Exploration Inc. (Regan Lake Project) Water Licence 2BE-REG0406 Inspection on July 25, 2009**

## WATER USE INSPECTION REPORT

Date: July 25, 2009	Licensee Rep. (Name/Title): David Gale/ VP Exploration
Licensee: Strongbow Exploration Inc.	Water Licence No.: 2BE- REG0608 Land Use Permits: N2004C0019, KTL306C010

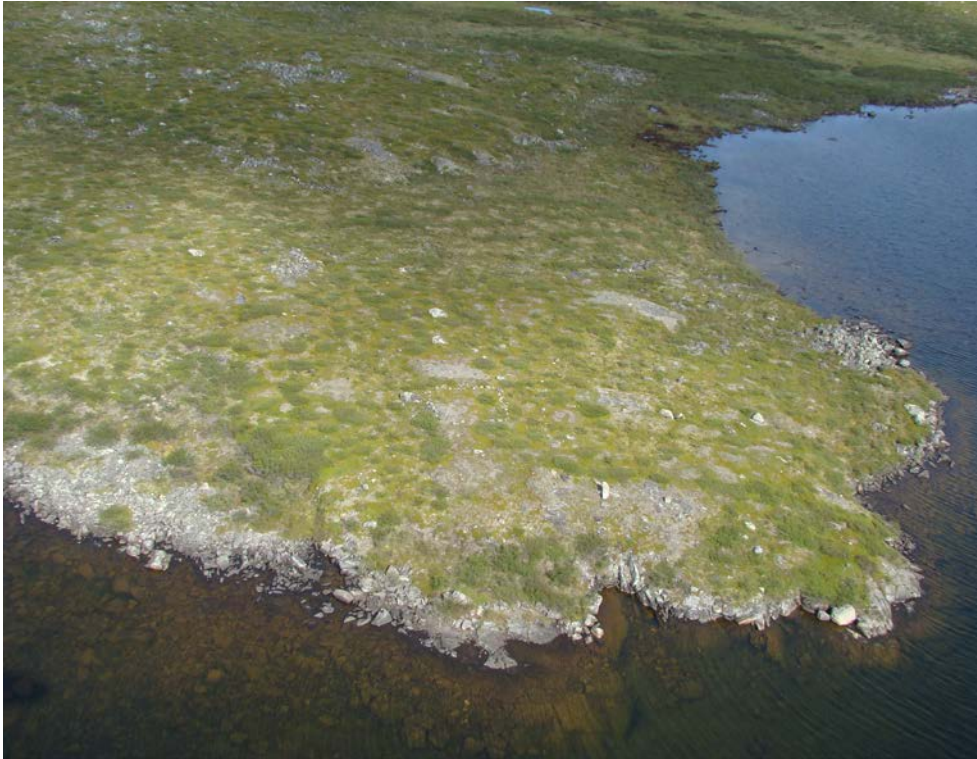
Photograph 1: Aerial photo showing abandoned fly camp location.

Photograph 1:  
Aerial photo  
showing abandoned  
fly camp location at  
65° 07' 39"N and  
107° 50' 05"W (NAD  
83).

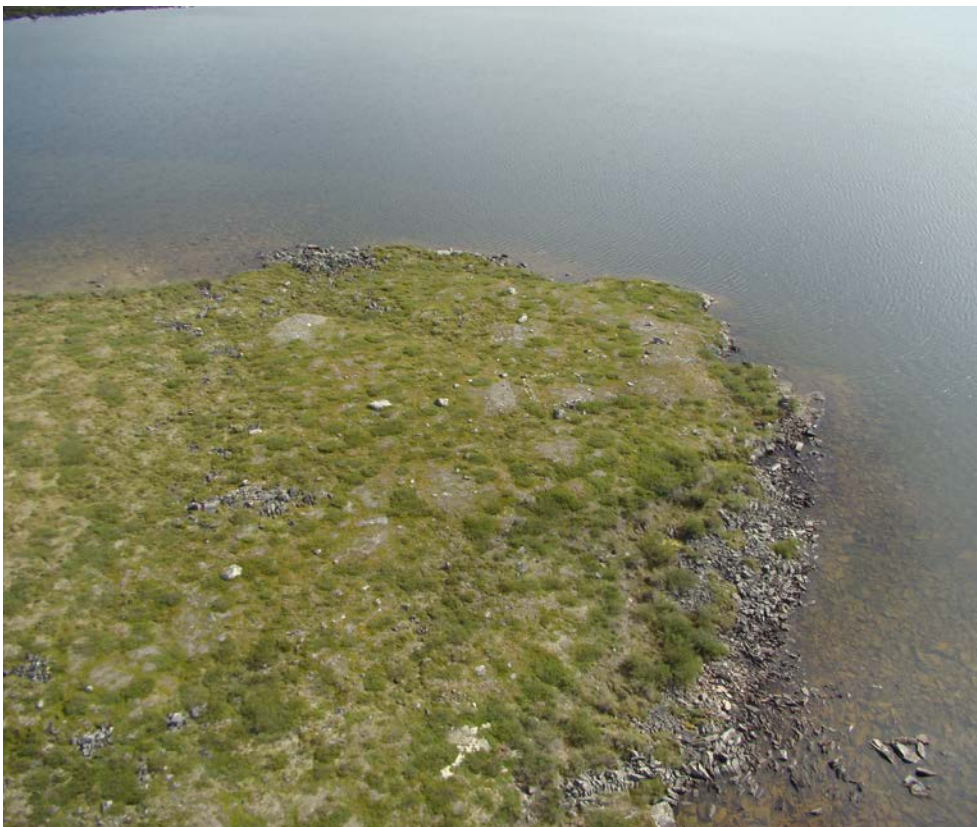
Photograph 2: Aerial photo showing abandoned fly camp location.

Photograph 2:  
Another aerial  
photo showing  
abandoned fly camp  
location at 65° 07'  
39"N and 107° 50'  
05"W (NAD 83).

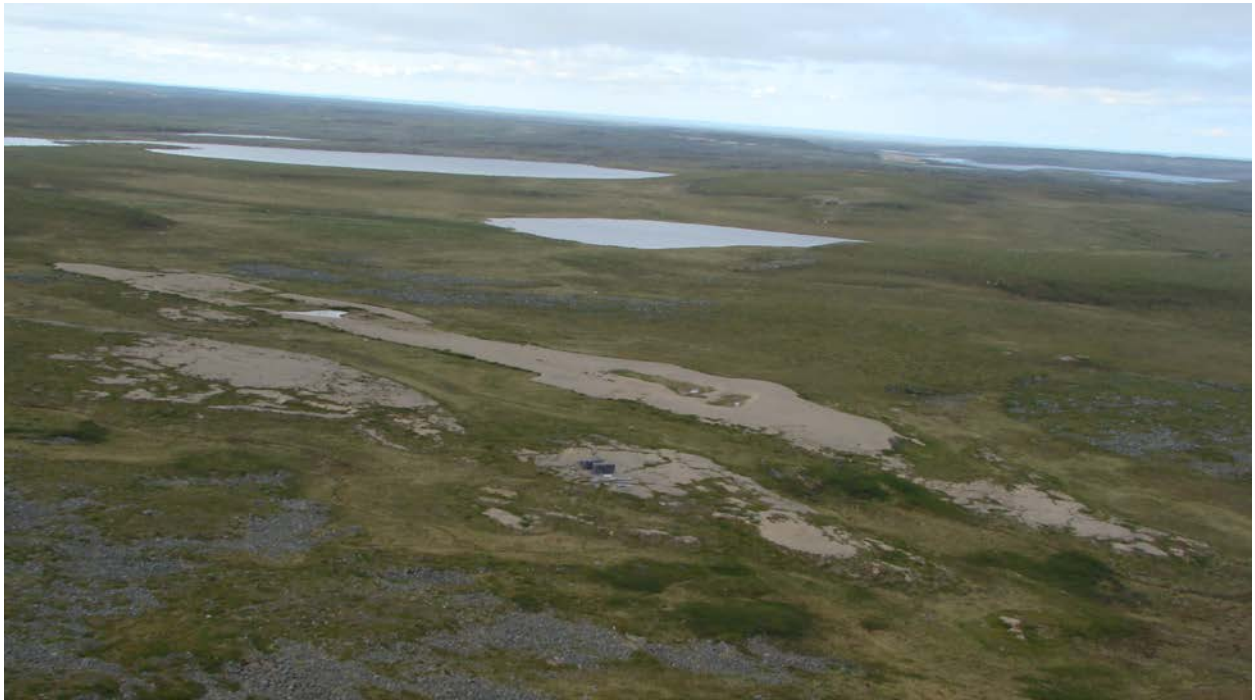
Photograph 3: Aerial view approaching main camp location.

Photograph 3: Aerial view approaching main camp location for 2BE-REG (Regan Lake Project) at 65° 19' 26"N and 107° 38' 07" W (NAD 83).

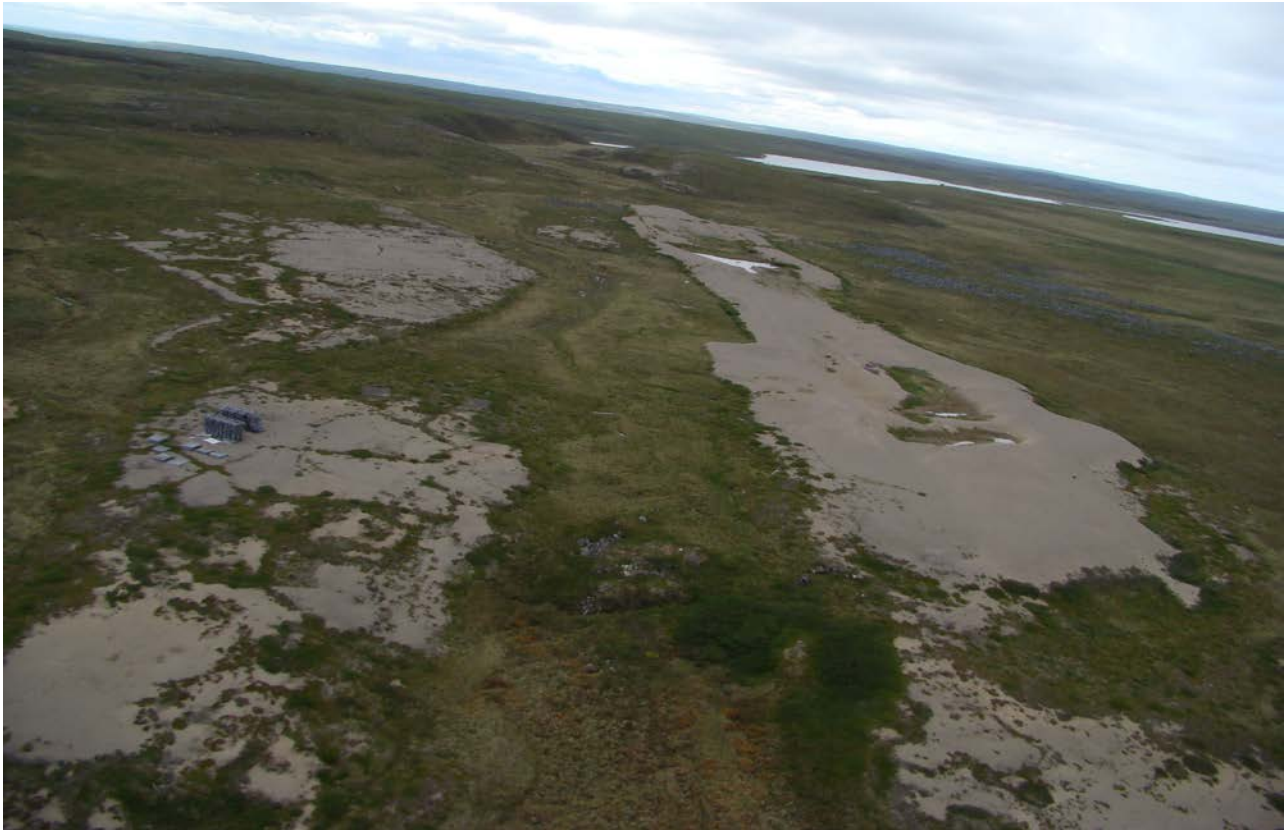
Photograph 4: Aerial view approaching main camp location.

Photograph 4: Aerial view approaching main camp location for 2BE-REG (Regan Lake Project) at 65° 19' 26"N and 107° 38' 07" W (NAD 83).

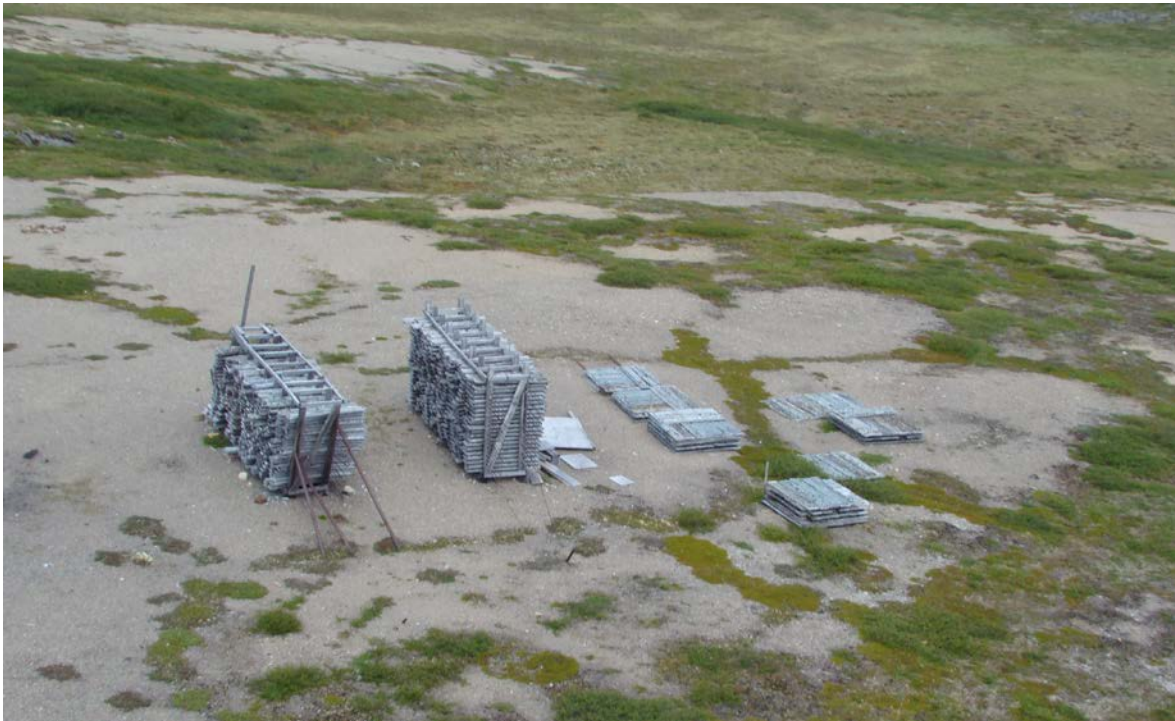
Photograph 5: Aerial view showing drill core storage at main camp location.

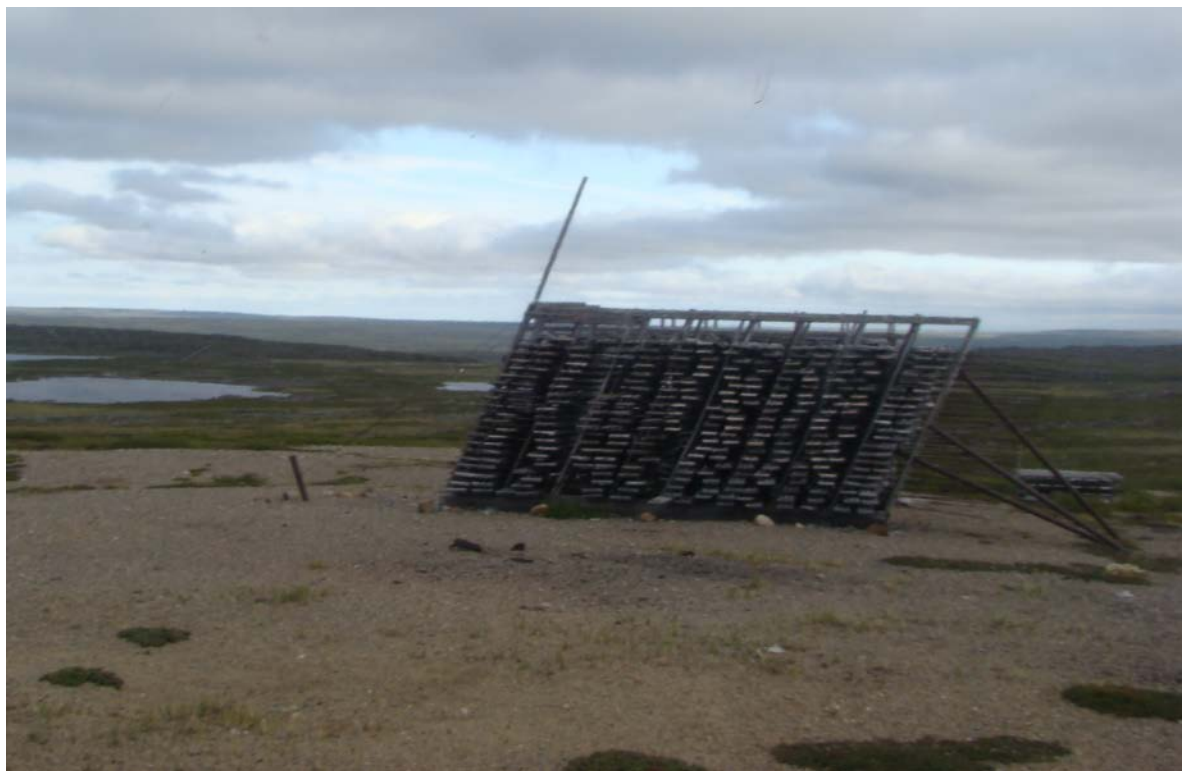
Photograph 6: Drill core storage racks, showing the significant lean to one side.

Photograph 6: View of drill core storage racks, showing significant lean to one side.
