## APPENDIX 1: Photos of July 10 2014 Inspection

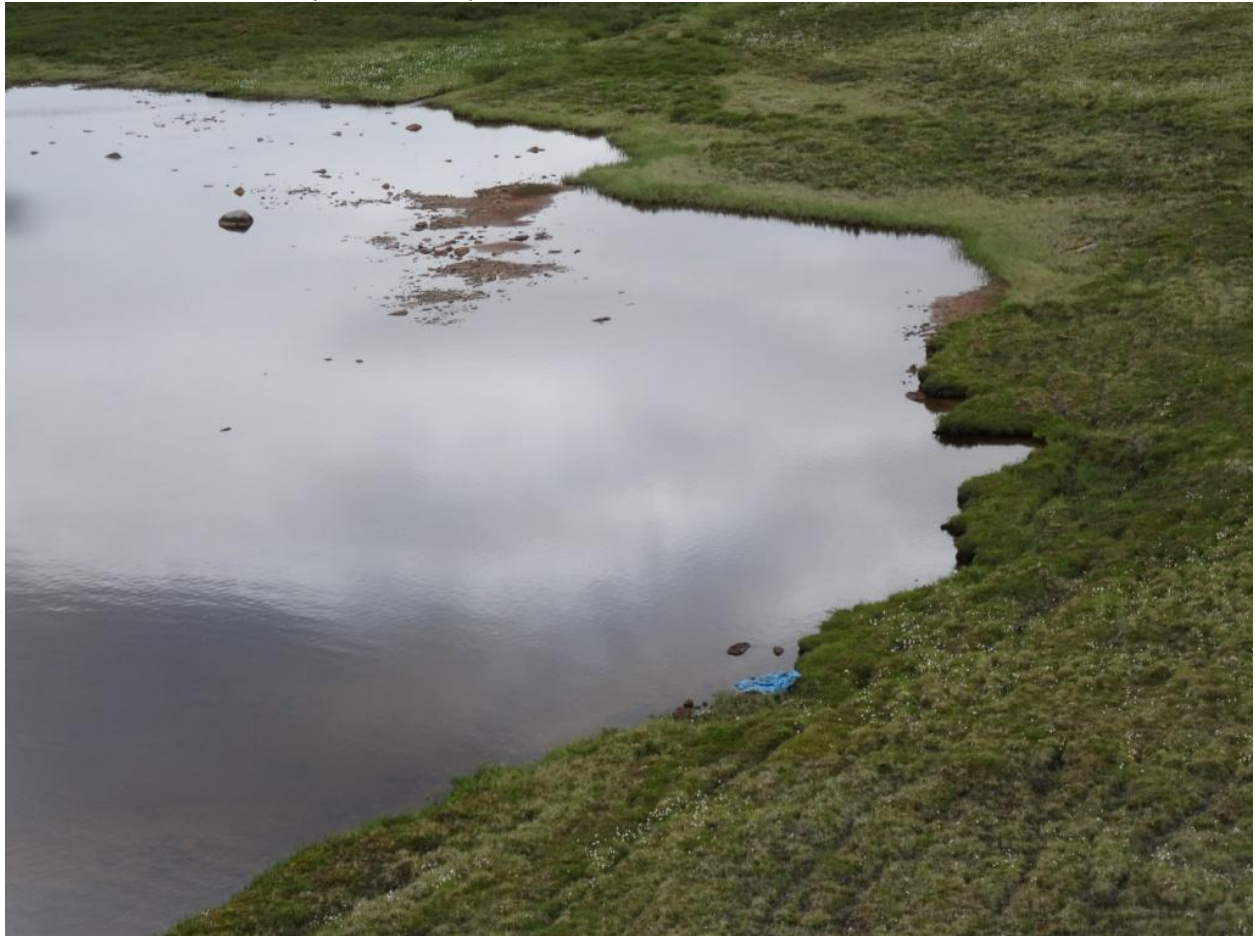
Figure 1. Tarp noted on NE shore of lake.

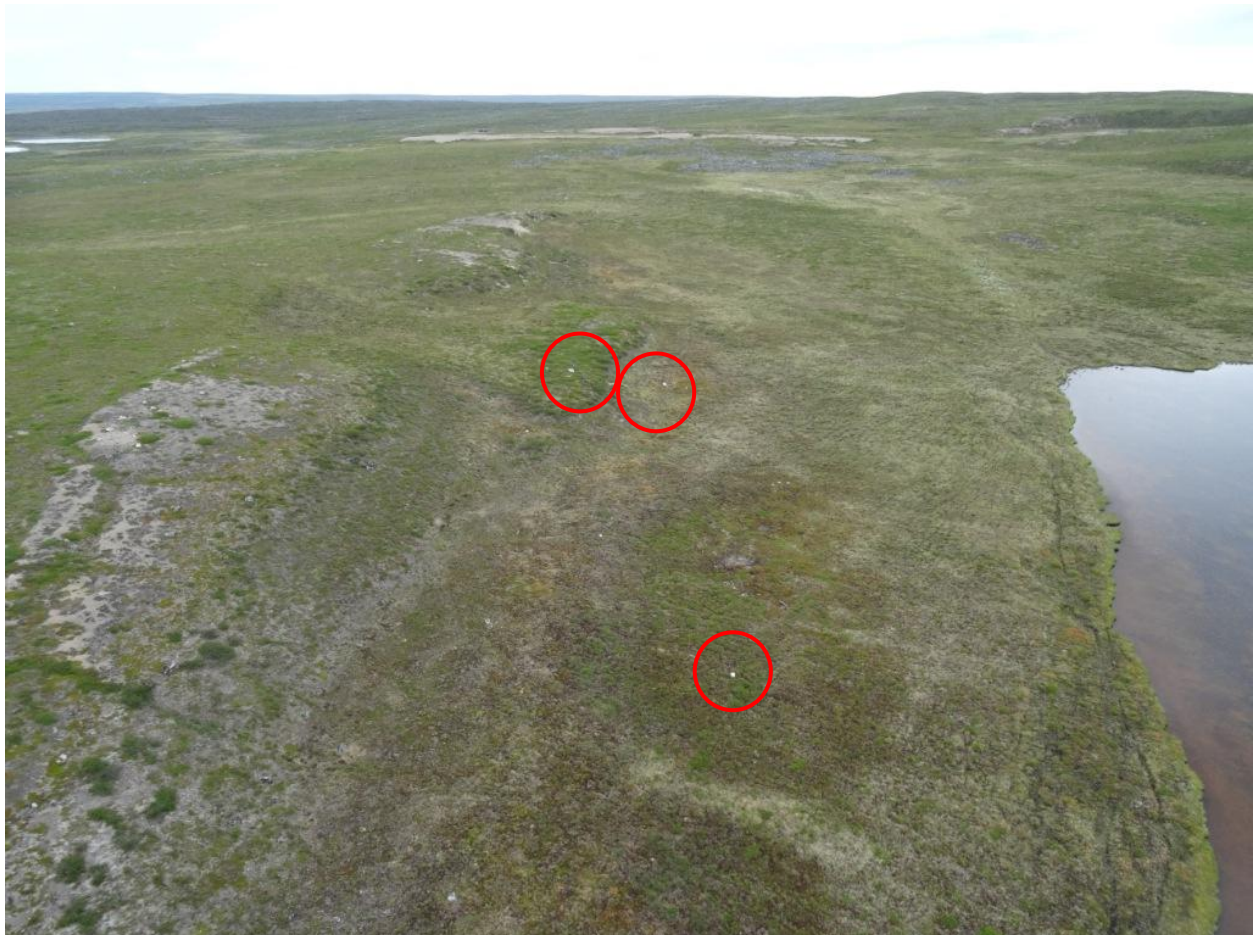
Figure 2. Plastic pails noted on SW side of lake, along with plastic and burnt lumber.

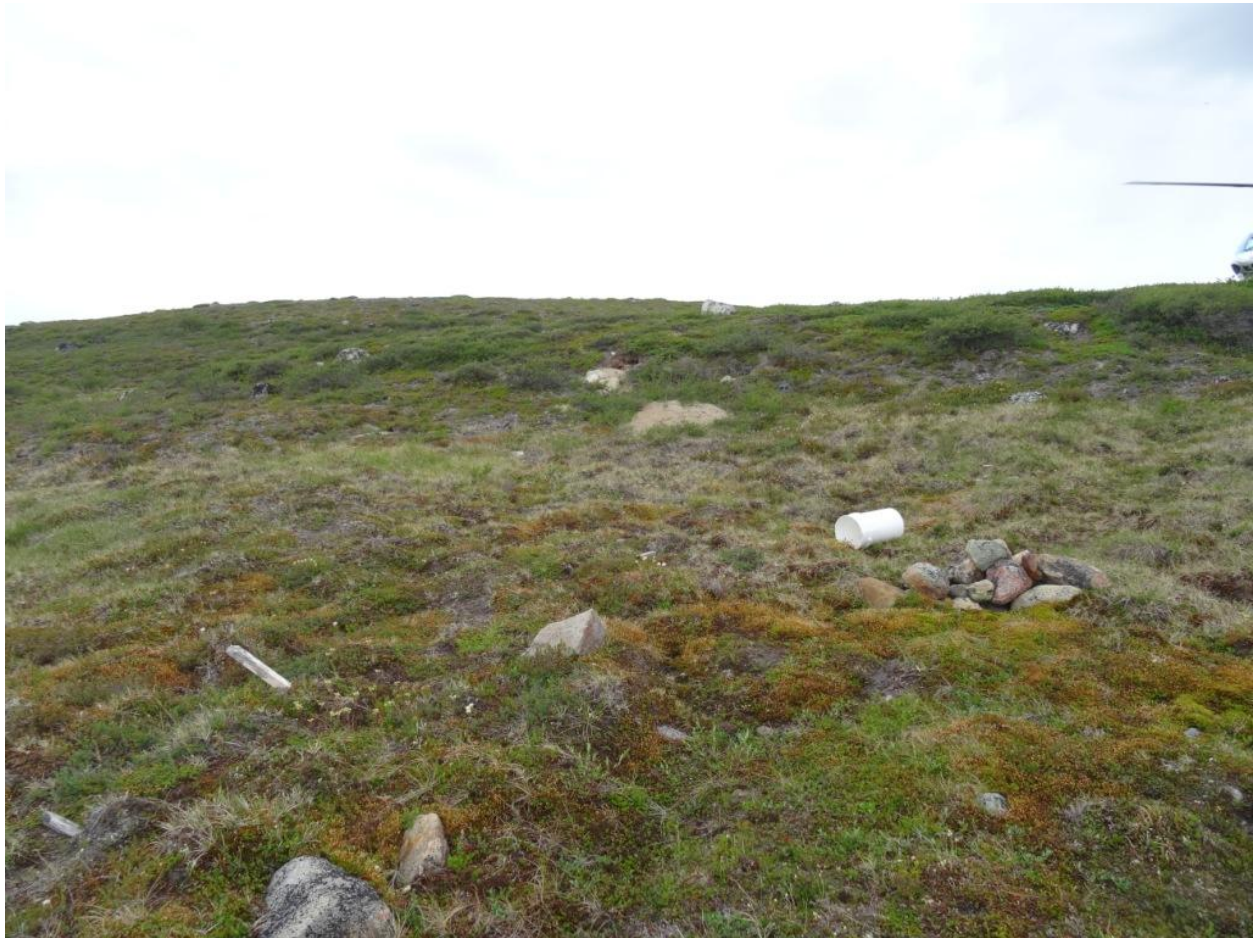
Figure 3. White plastic pail and lumber.

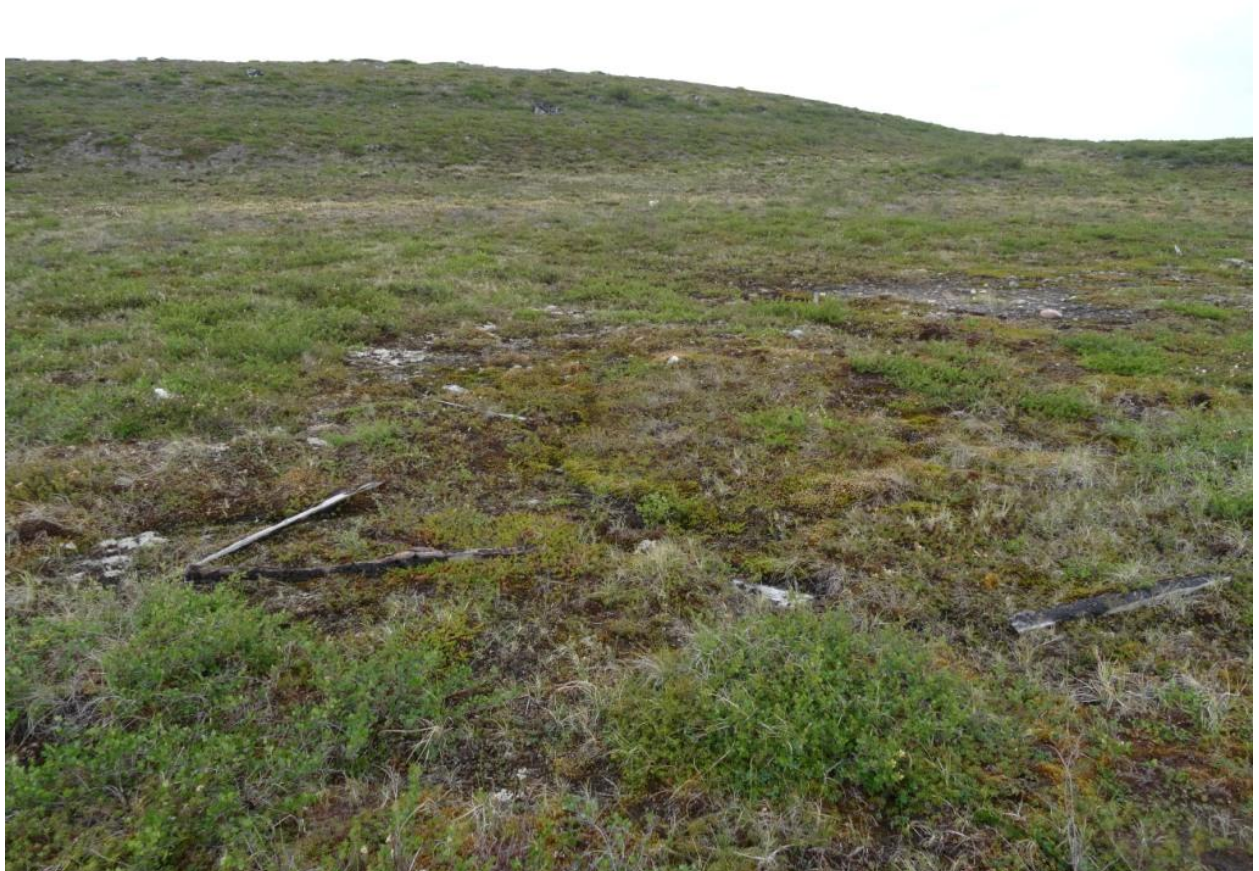
Figure 4. Burnt remains of camp.

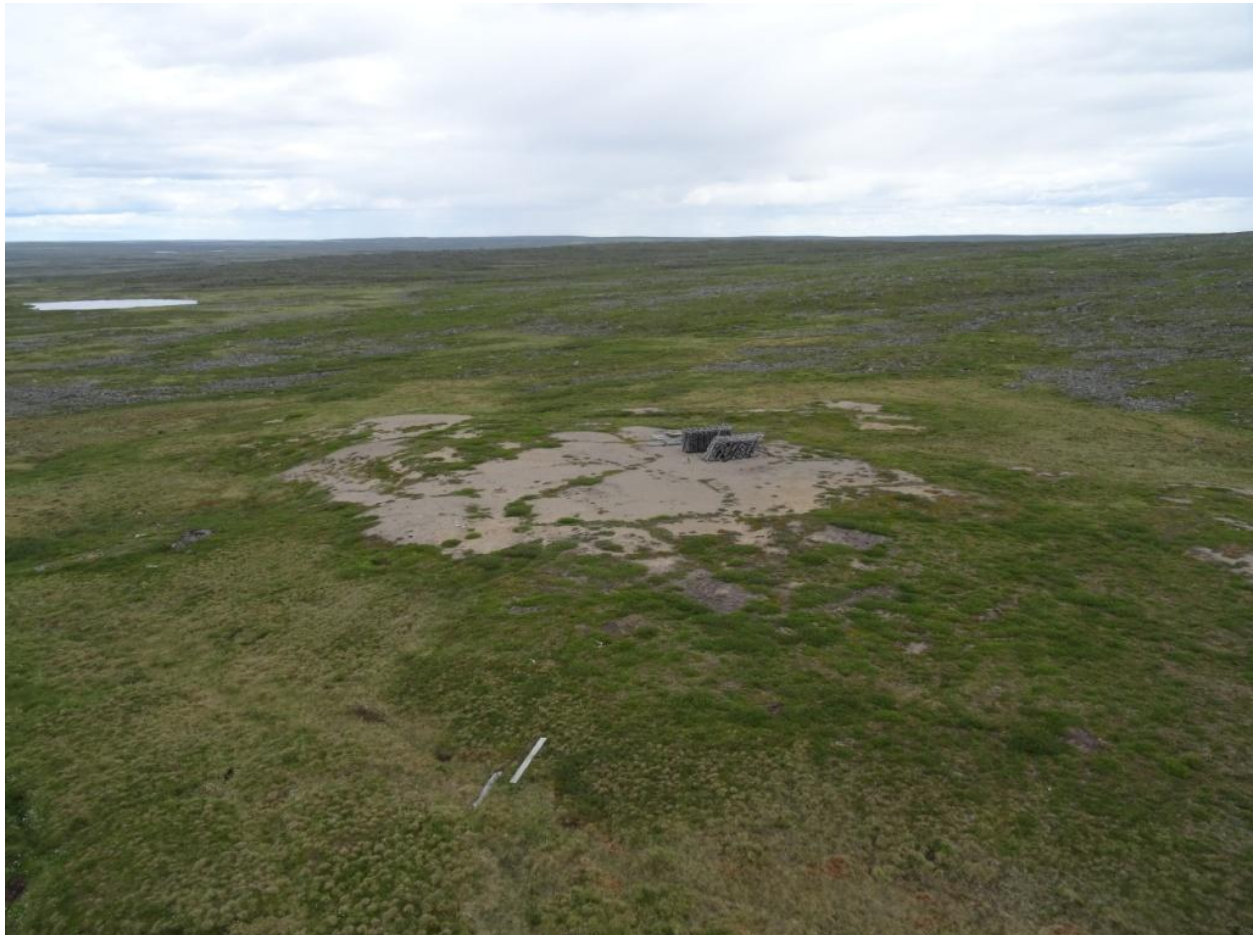
Figure 5. Core racks visible, some debris in fore-ground.

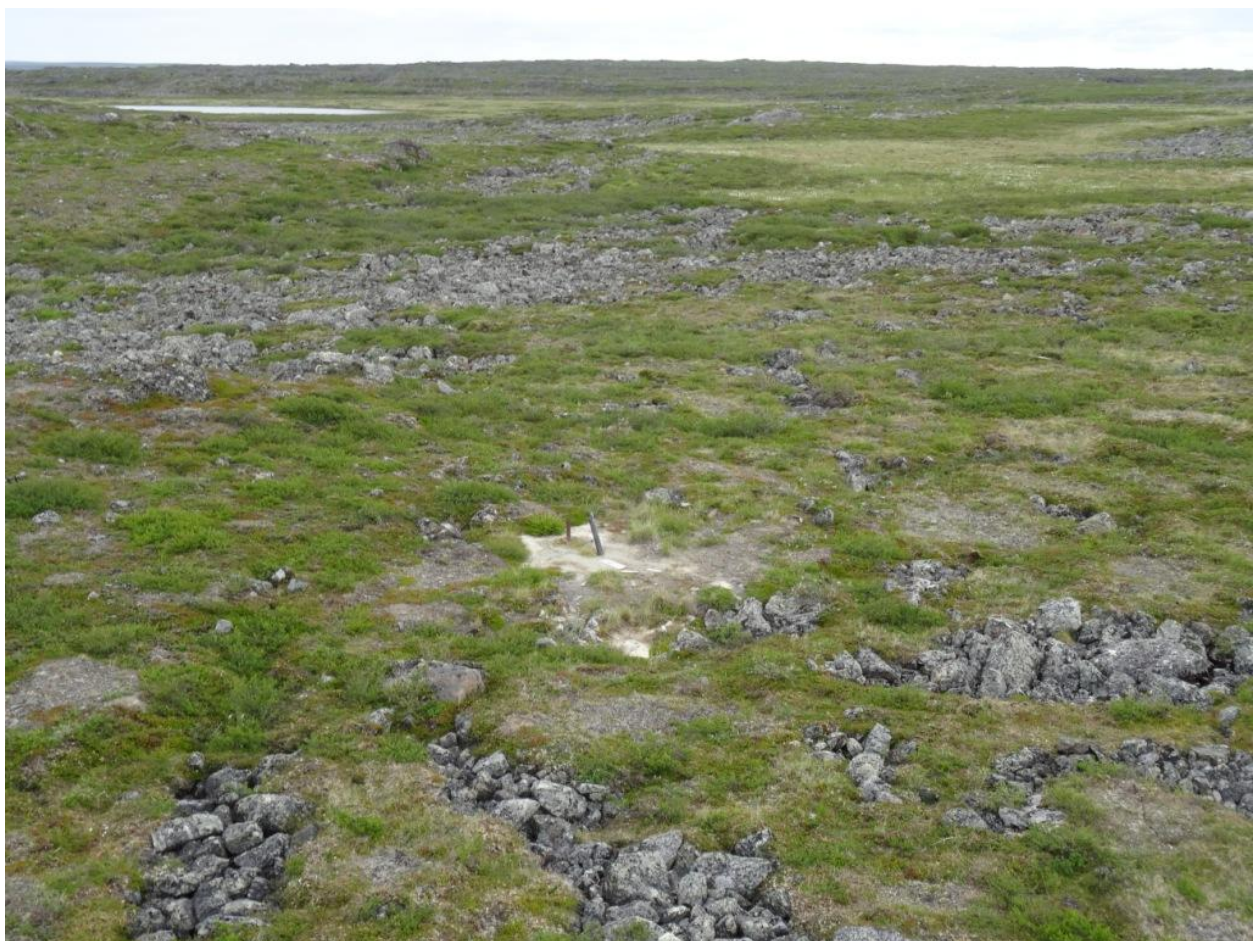
Figure 6. One of several drill sites left un-reclaimed at M-44.

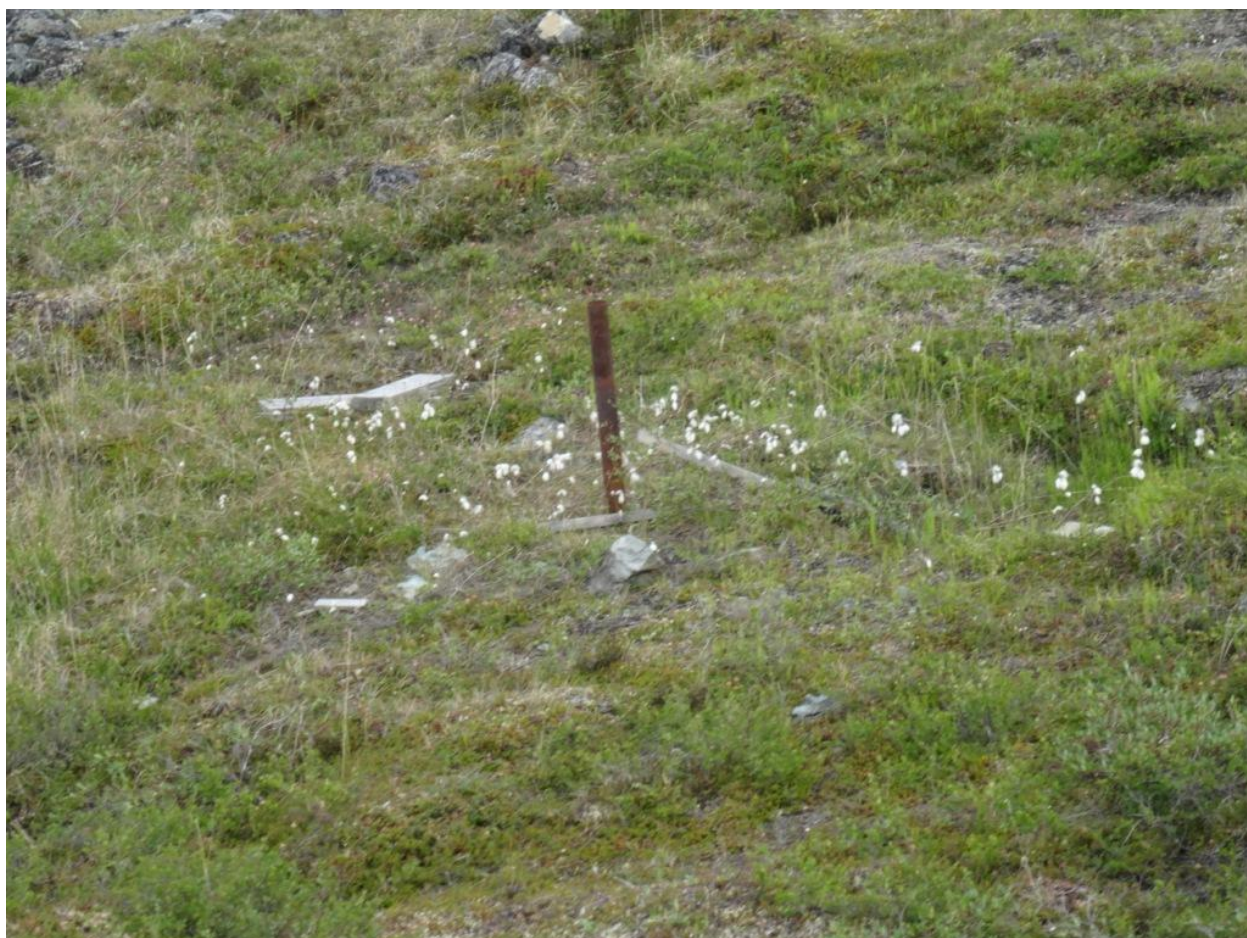
Figure 7. Drill casing/anchor and debris near M-44.

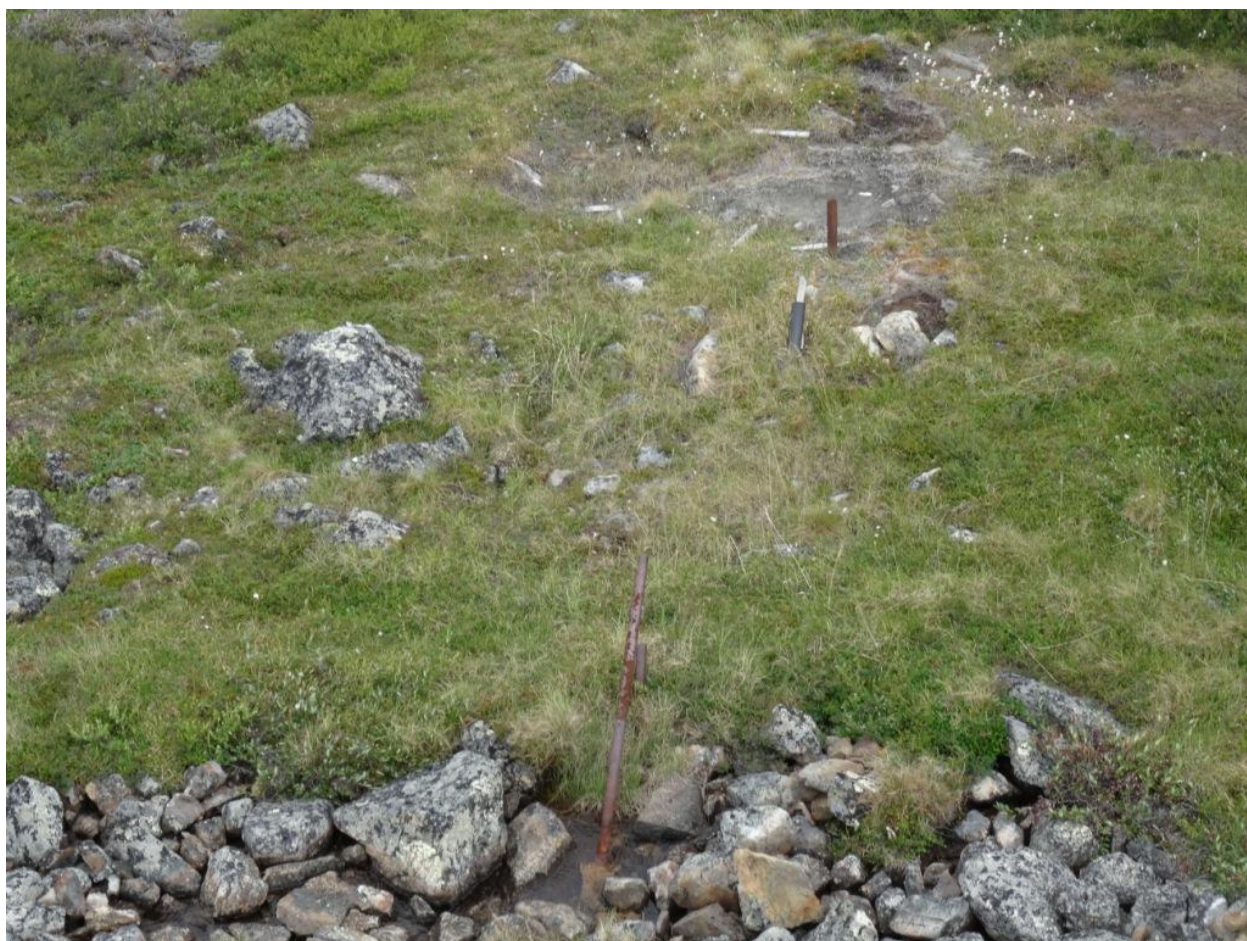
Figure 8. Un-reclaimed drill sites near M-48.
