Silvertip Project Cleanup of Historic Debris - Water Licence 2BE-SIL0709

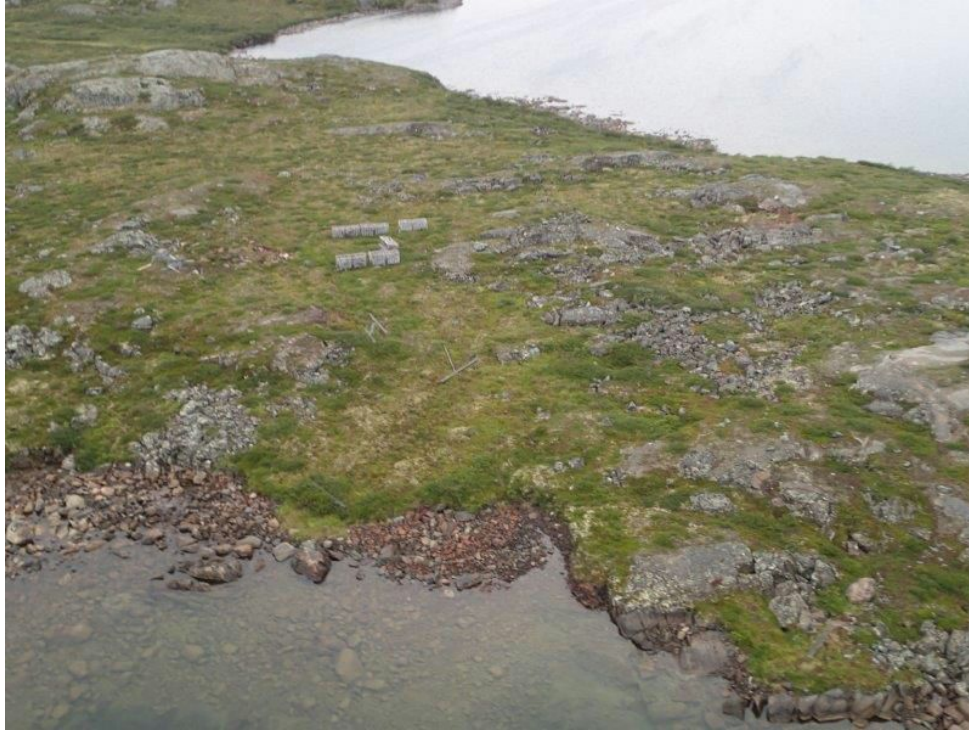
Photo 1: Air photo of timbers and core racks at Mouse Lake before cleanup. Looking south.

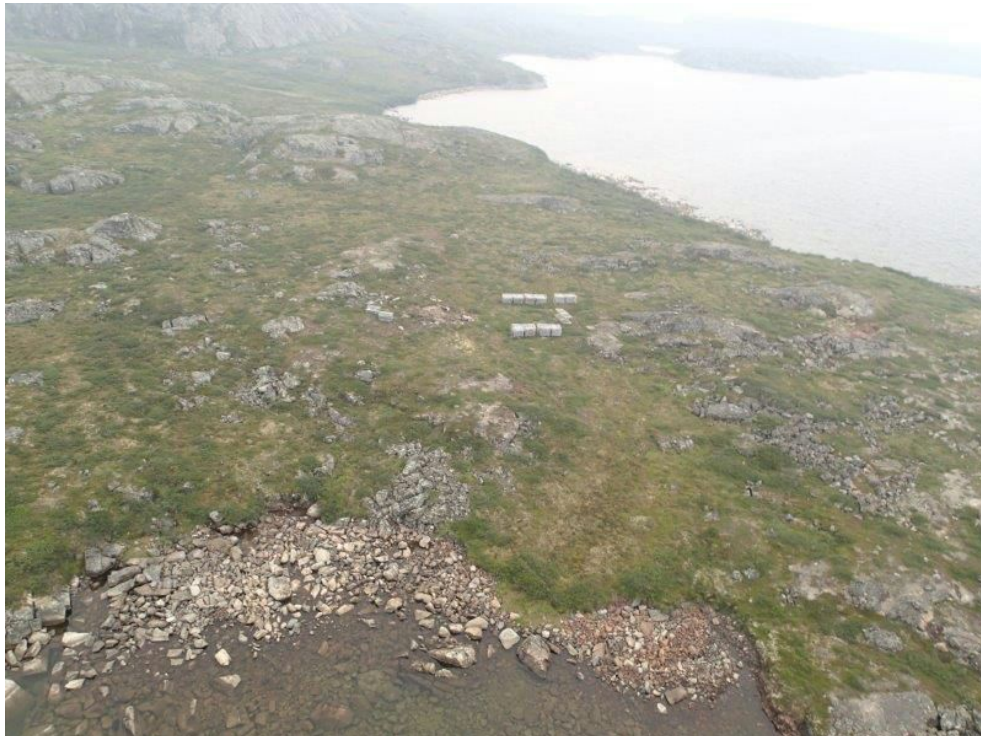
Photo 2: After cleanup photo (timbers removed) at Mouse Lake. Looking south.

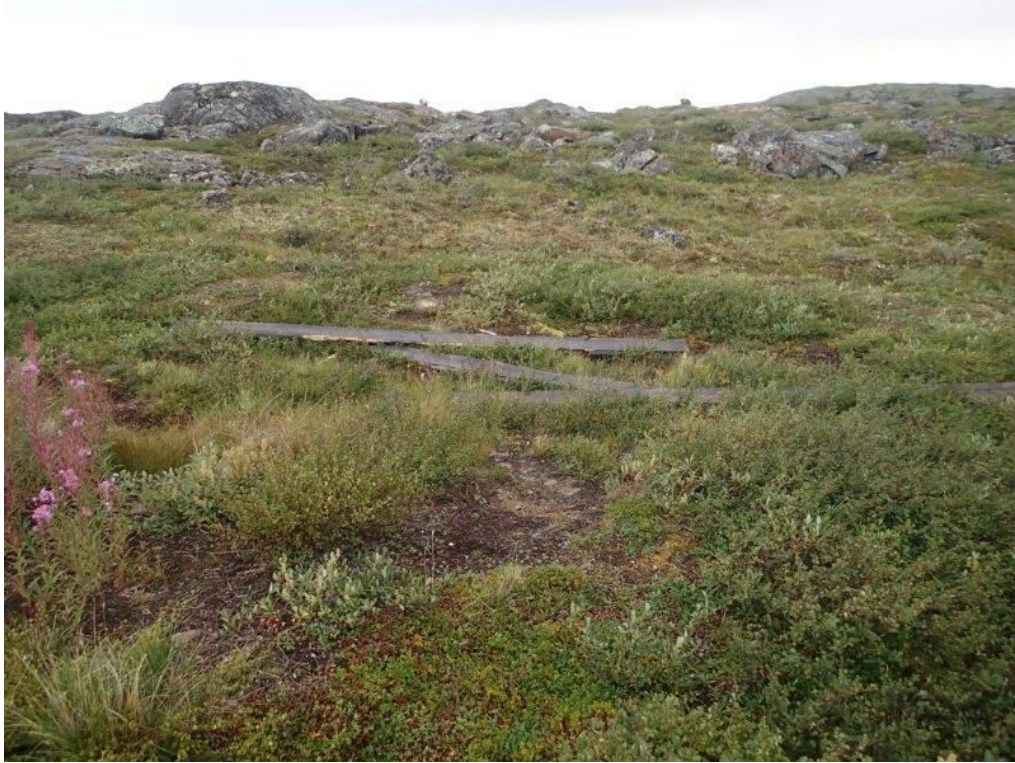
Photo 3: Before photo of planks at Mouse Lake camp. Looking west.

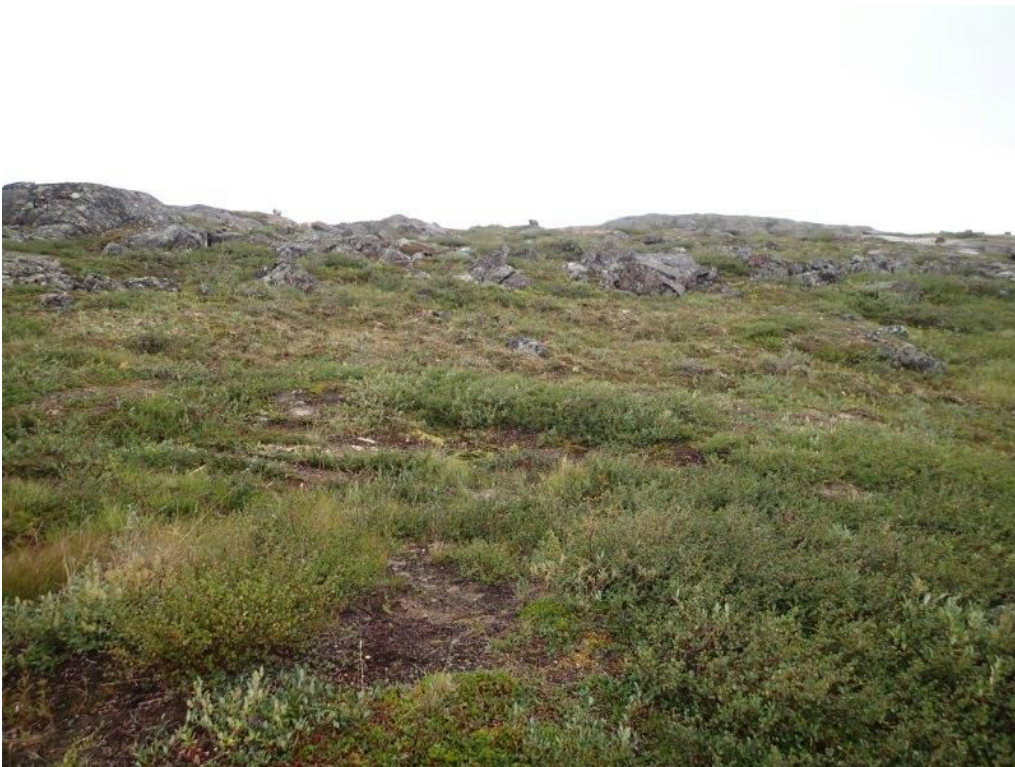
Photo 4: After cleanup photo of planks at Mouse Lake camp. Looking west.

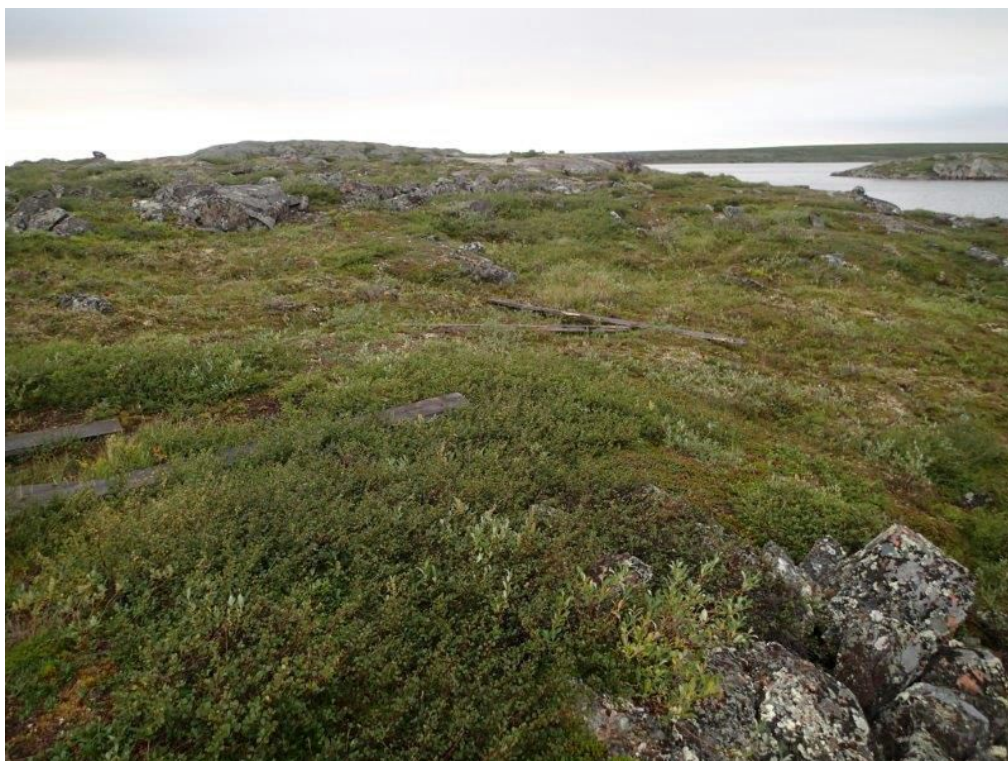
Photo 5: Before photo of planks at Mouse Lake camp. Looking northwest.

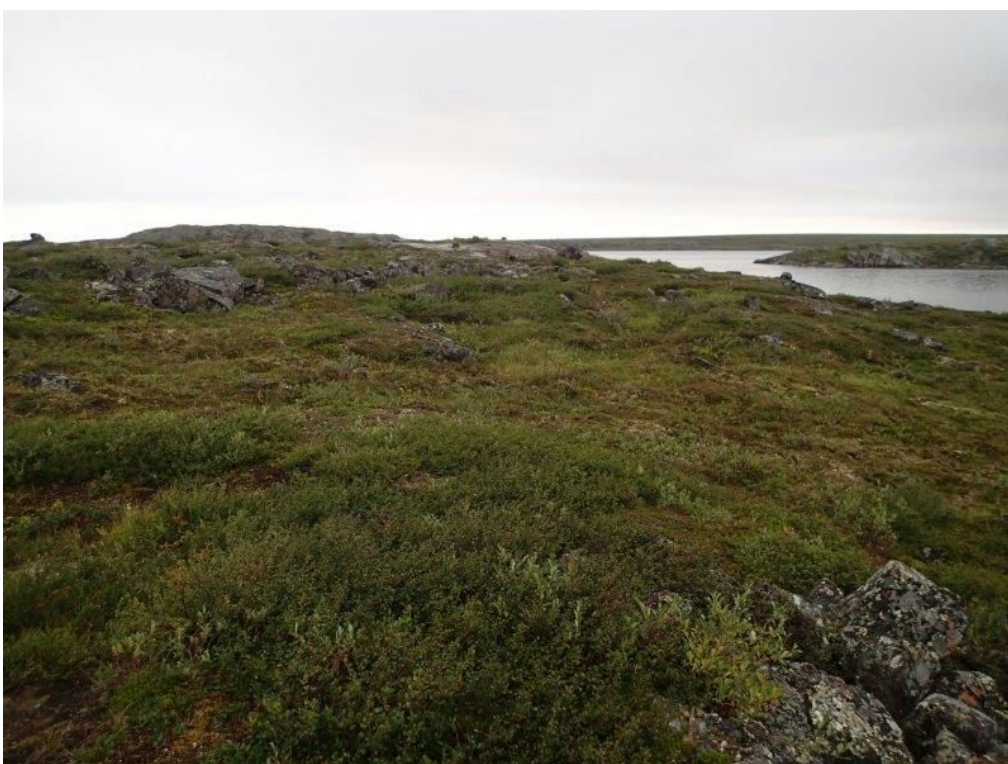
Photo 6: After cleanup photo of planks at Mouse Lake camp. Looking northwest.

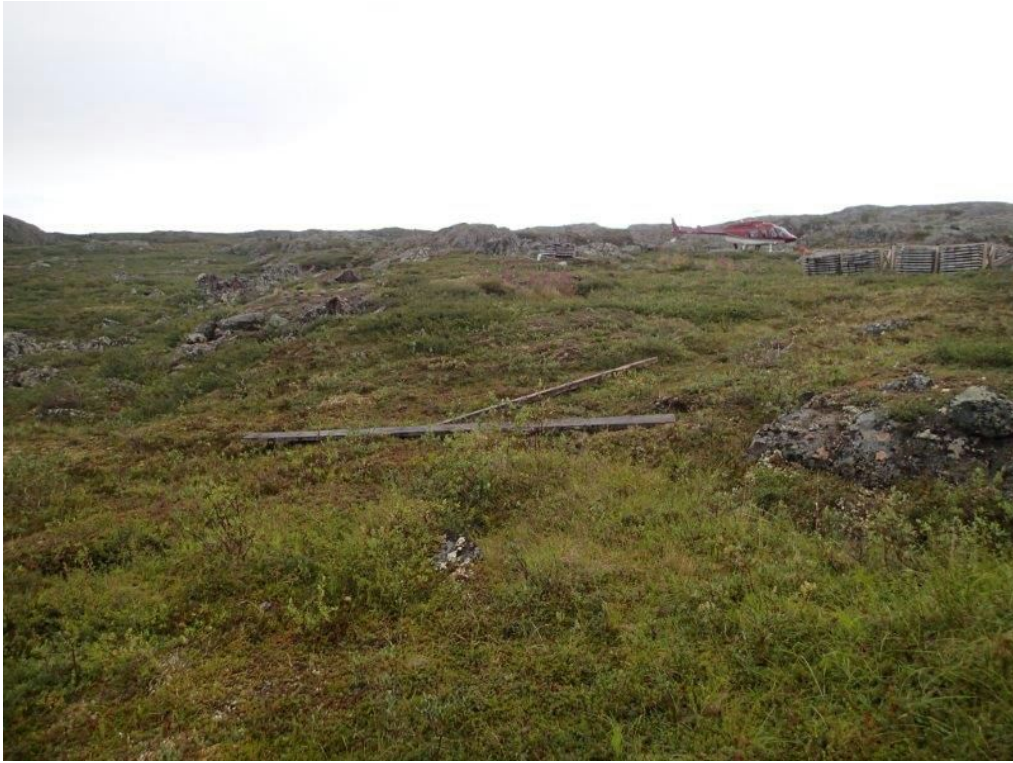
Photo 7: Before photo of planks at Mouse Lake camp. Looking south.

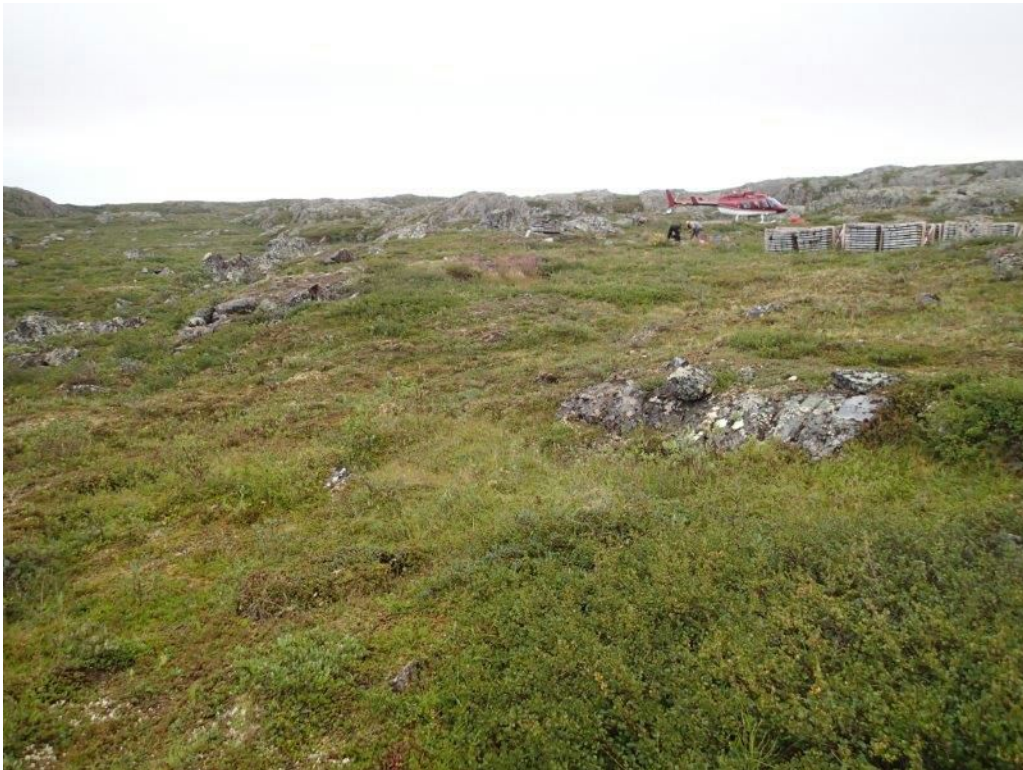
Photo 8: After photo of planks at Mouse Lake camp. Looking south.

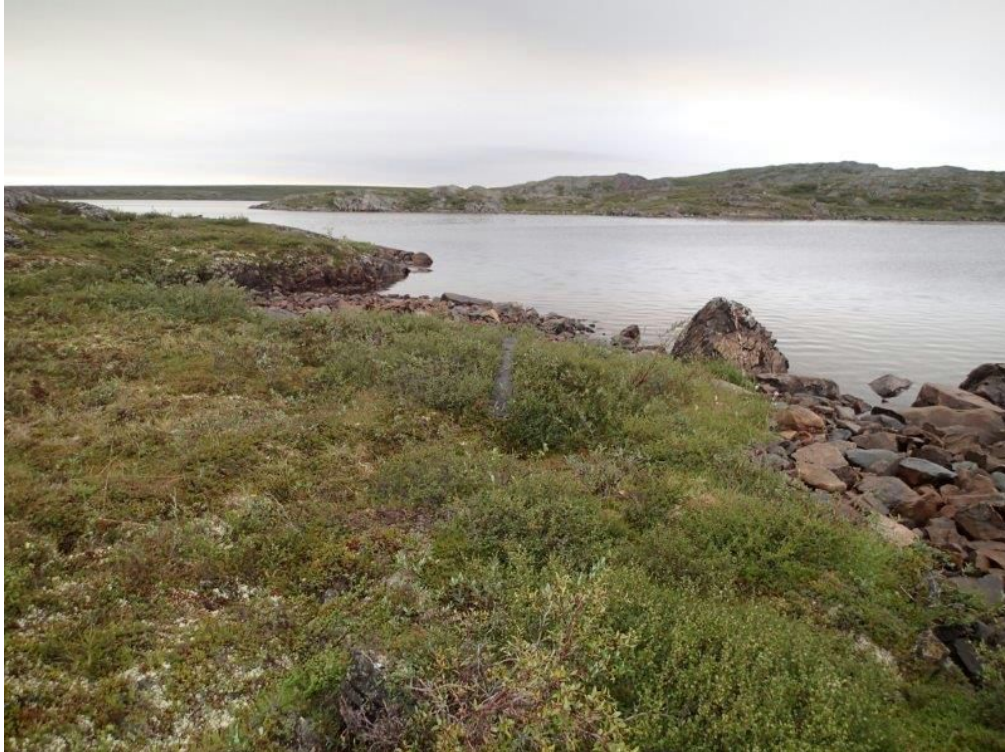
Photo 9: Before photo of plank by lakeshore at Mouse Lake camp. Looking northwest.

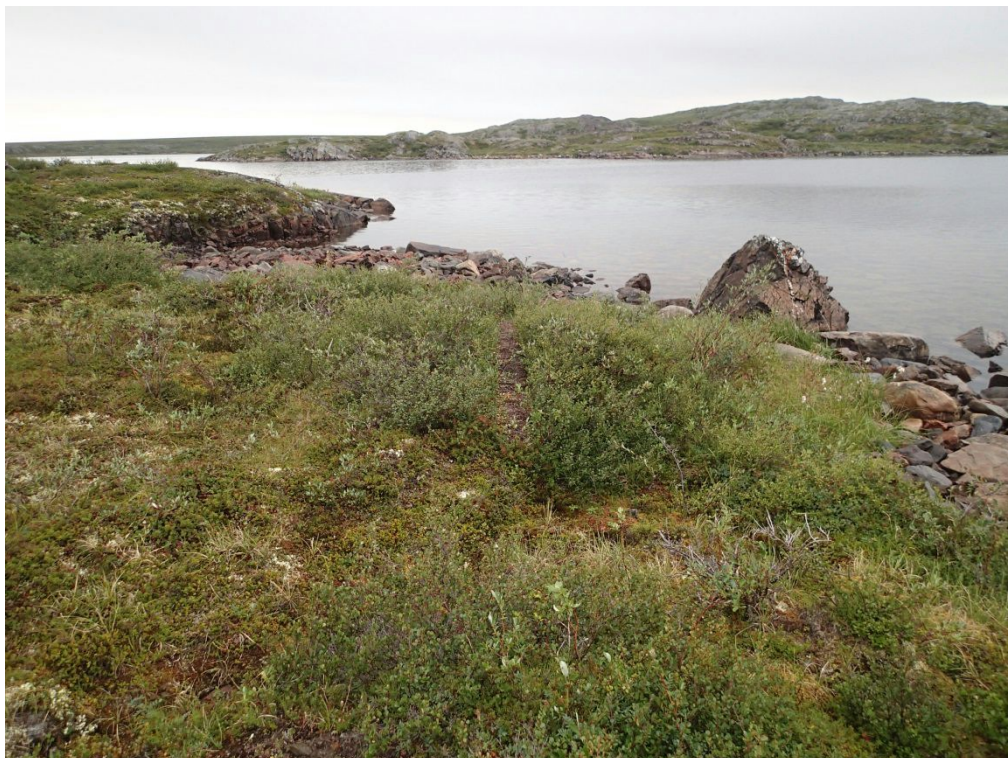
Photo 10: After cleanup photo of plank by lakeshore at Mouse Lake camp. Looking northwest.

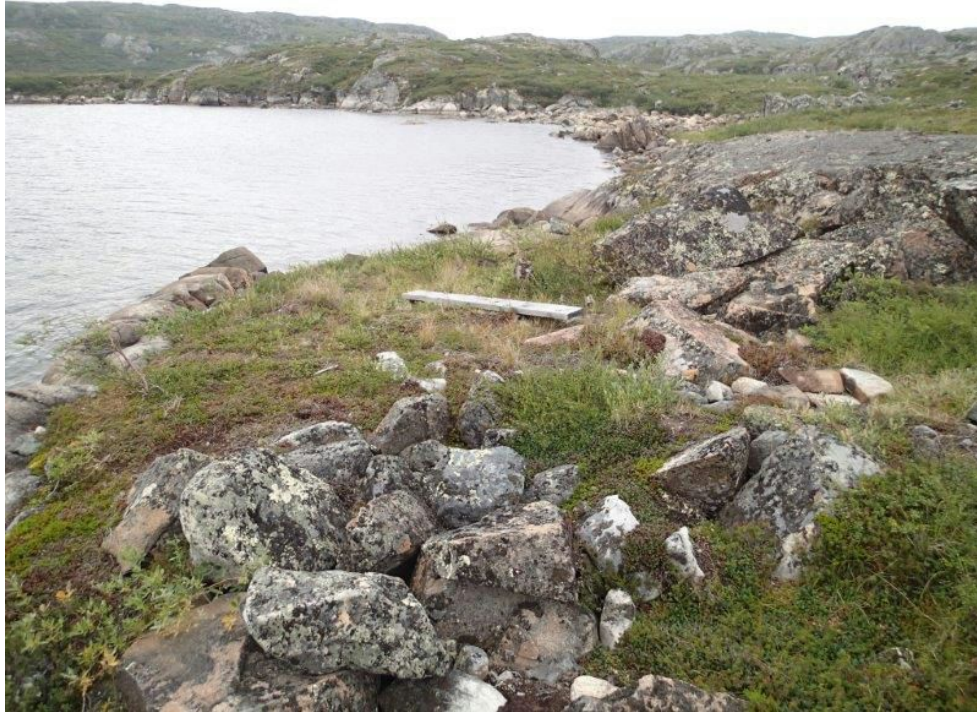
Photo 11: Before photo of 2nd plank by lakeshore at Mouse Lake camp. Looking east.

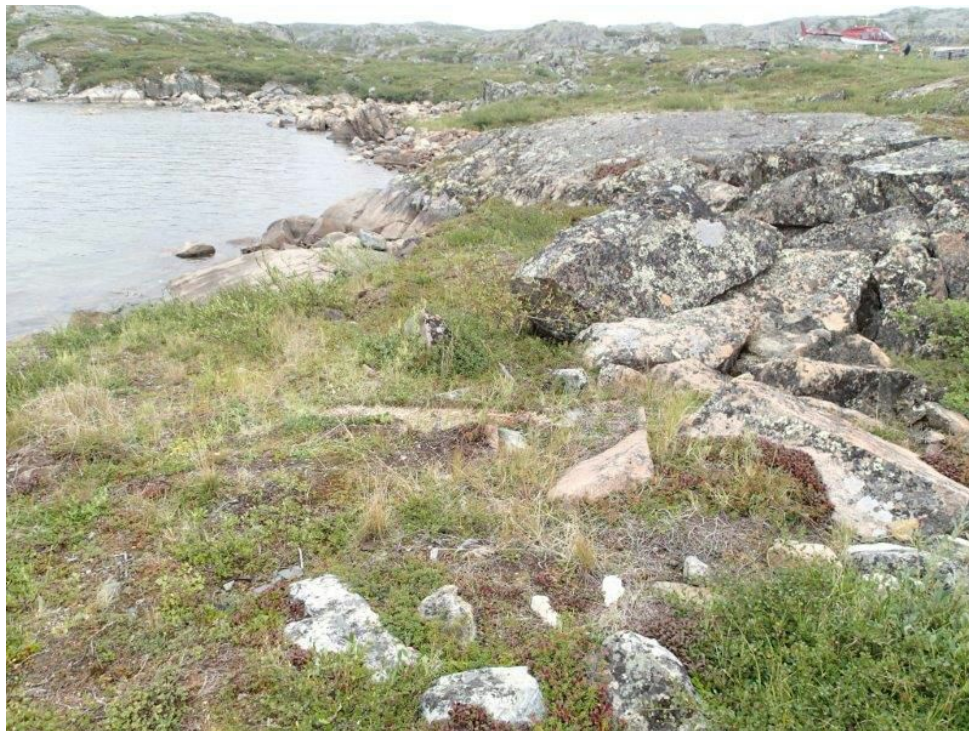
Photo 12: After cleanup photo of 2nd plank by lakeshore at Mouse Lake camp. Looking east.

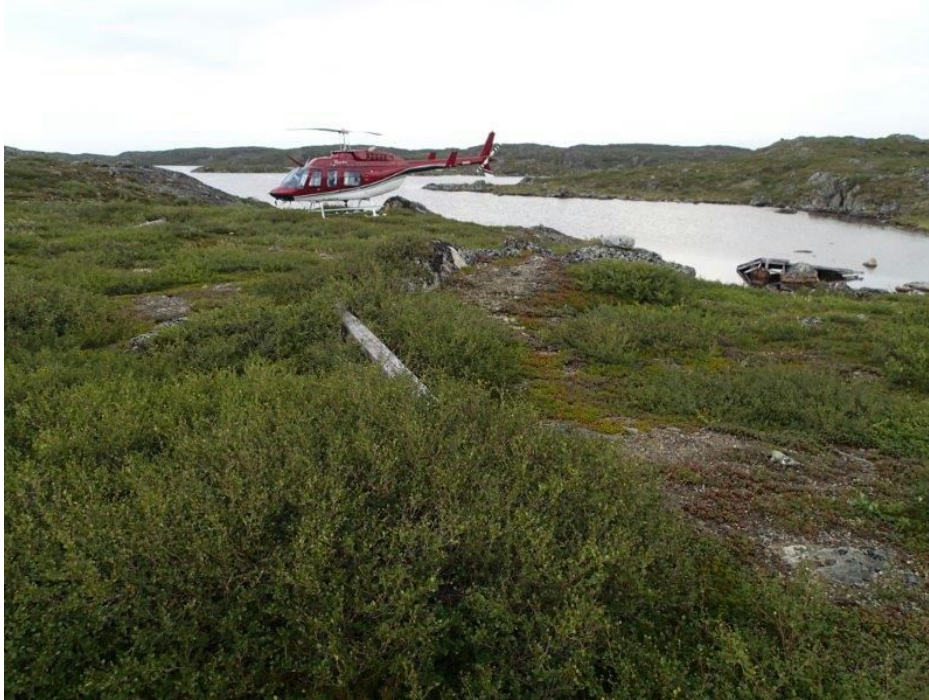
Photo 13: Before photo – example of one of the historic timbers near southwest end of Paleface Lake cleaned up by North Arrow. Looking east.

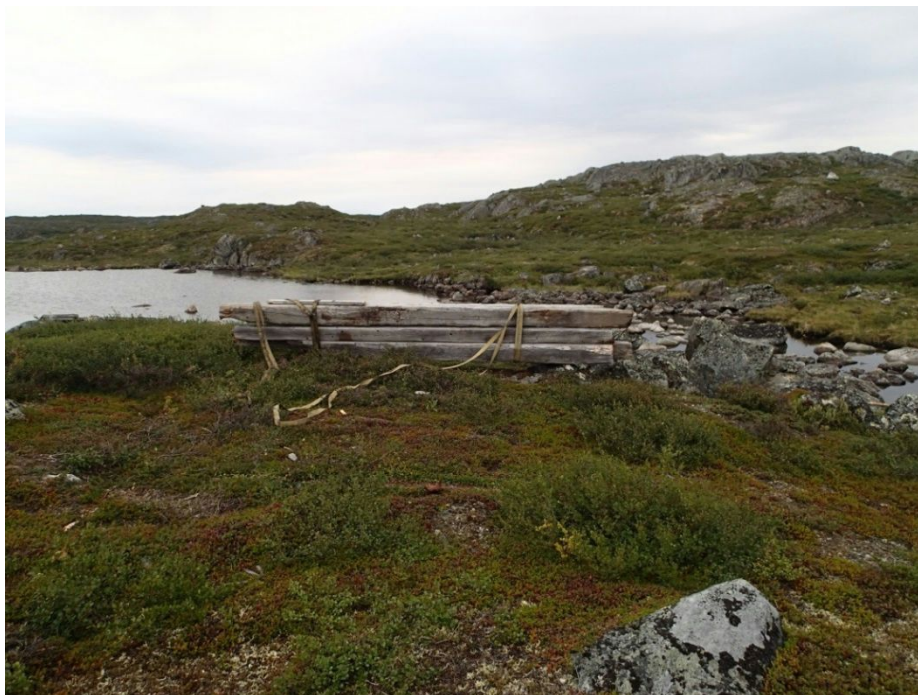
Photo 14: Photo of five historic timbers collected and strapped for removal near southwest end of Paleface Lake. Looking east.

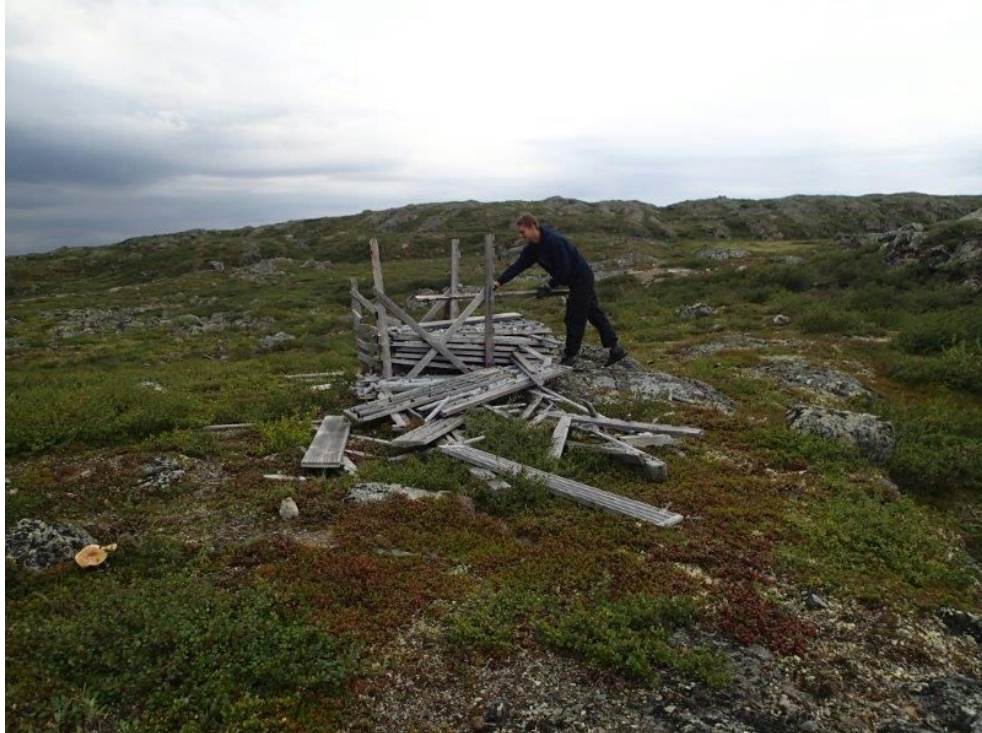
Photo 15: “Before” photo of historic core rack area 1. Looking west.

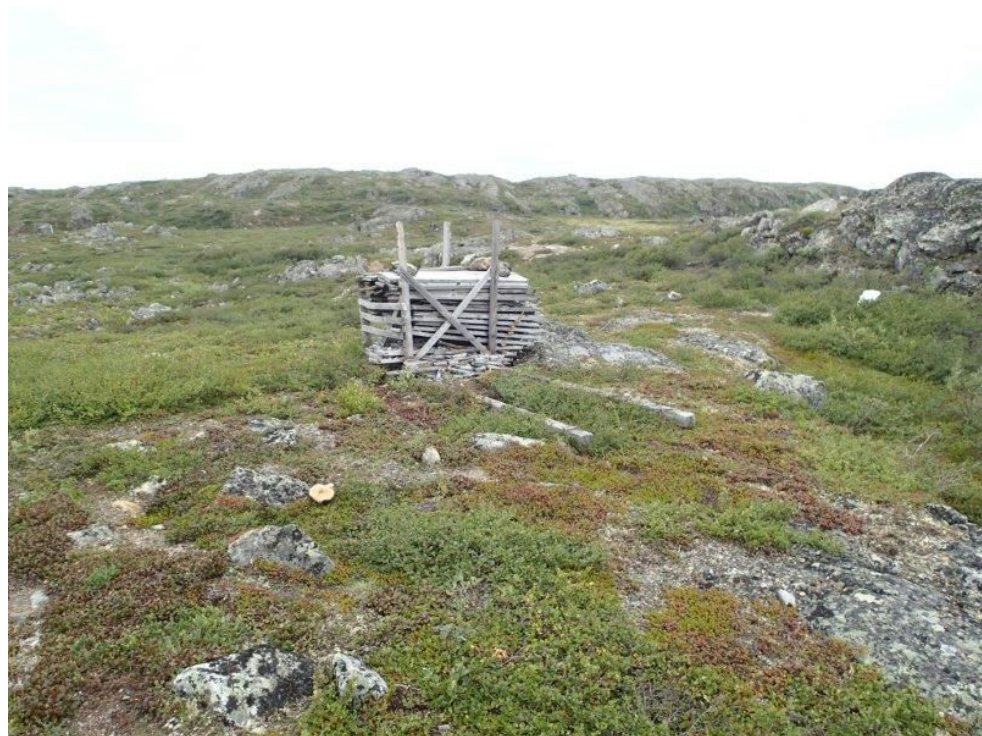
Photo 16: “After” cleanup photo of historic core rack area 1. Looking west.

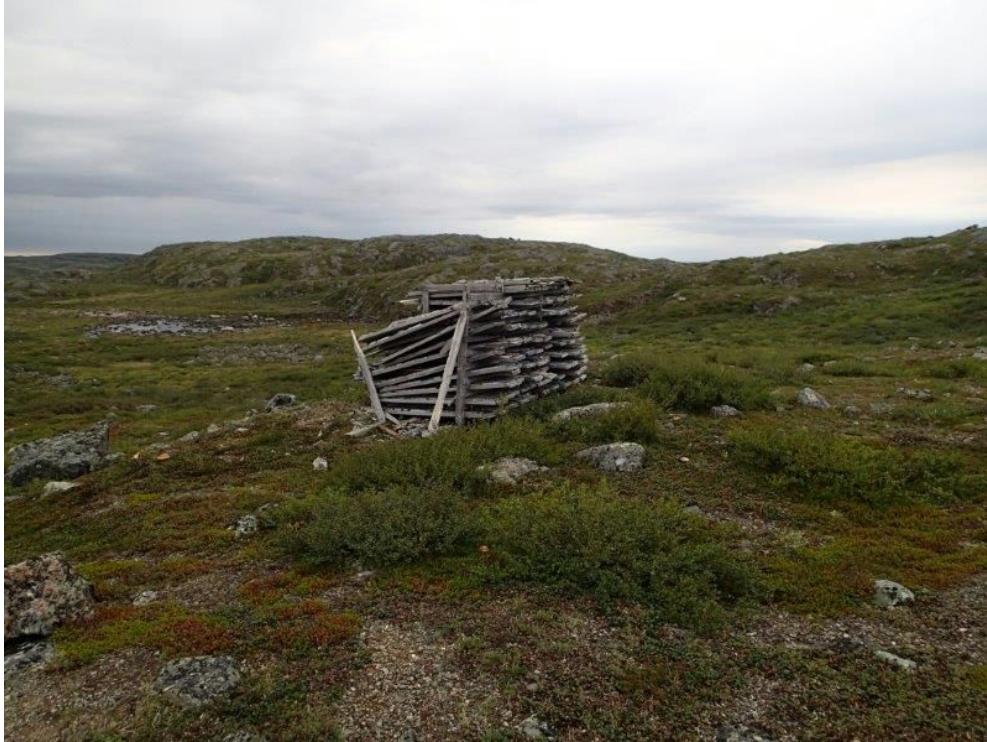
Photo 17: After cleanup photo of historic drill core rack area 2. Boxes and core strewn about were stacked in or on core racks. Note: no before cleanup photo was taken. Looking south.

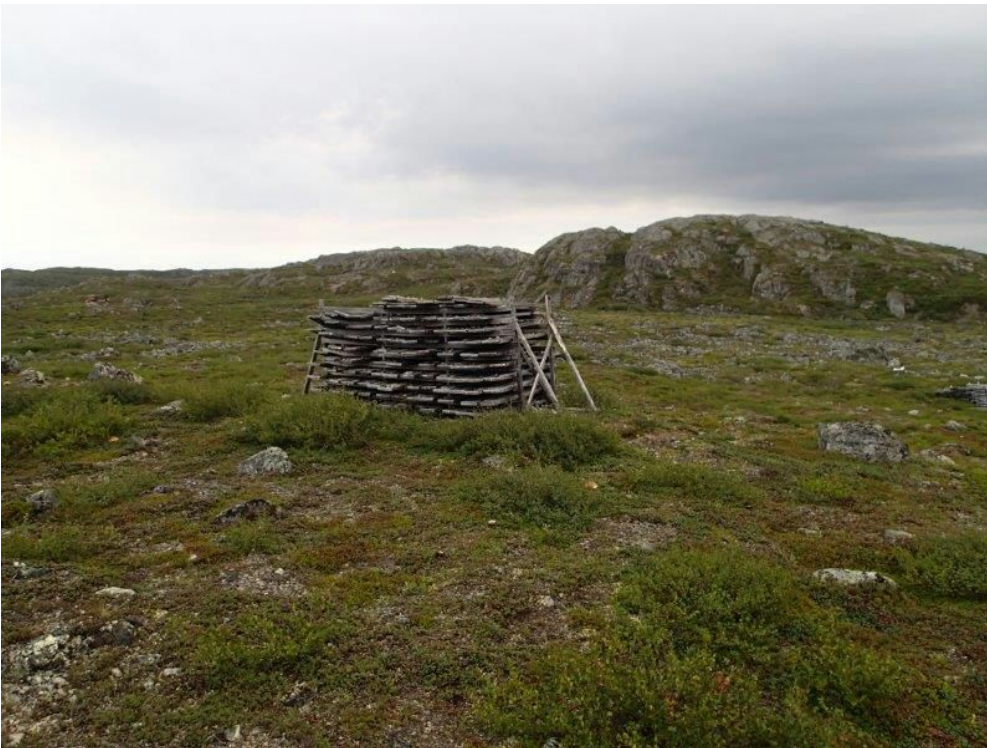
Photo 18: After cleanup photo of historic drill core rack area 2. Boxes and core strewn about were stacked in or on core racks. Note: no before cleanup photo was taken. Looking east.

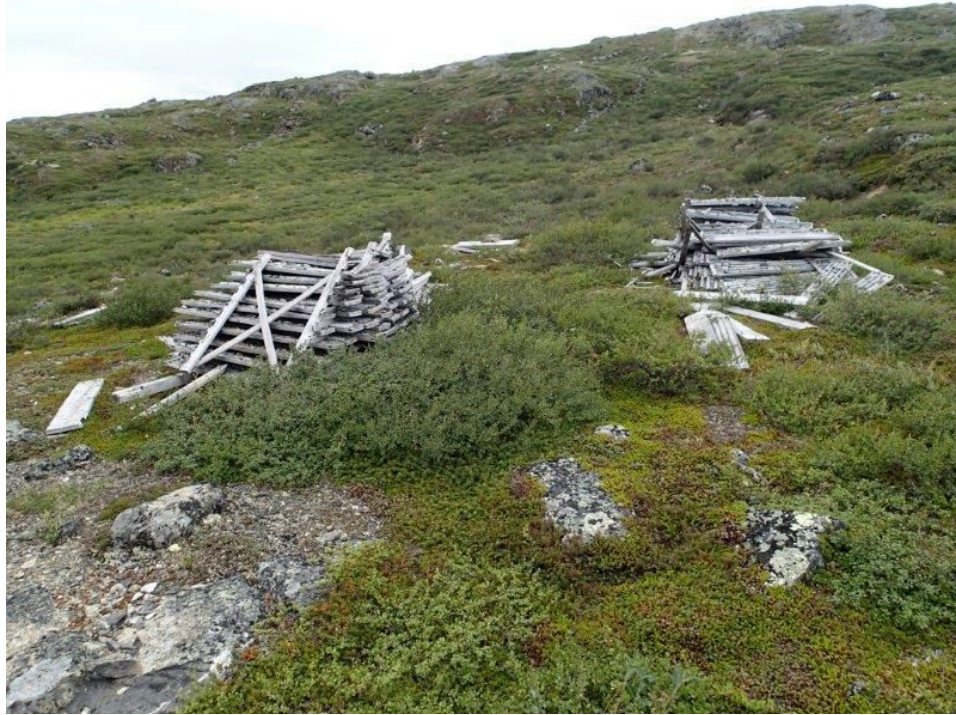
Photo 19: Before photo of historic drill core area 3. Looking west.

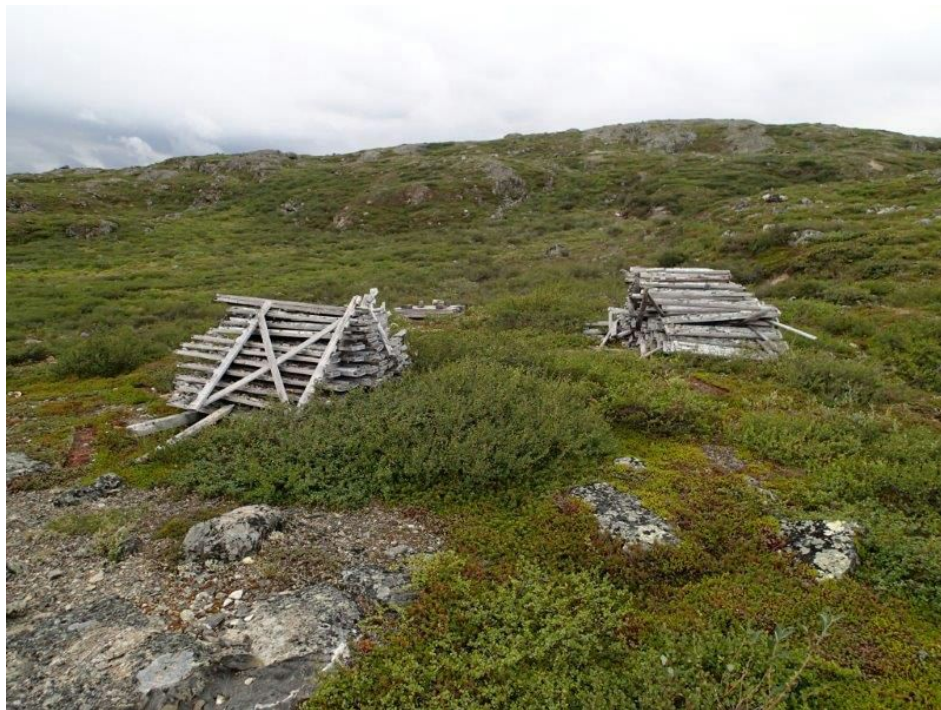
Photo 20: After cleanup photo of historic drill core area 3. Looking west.

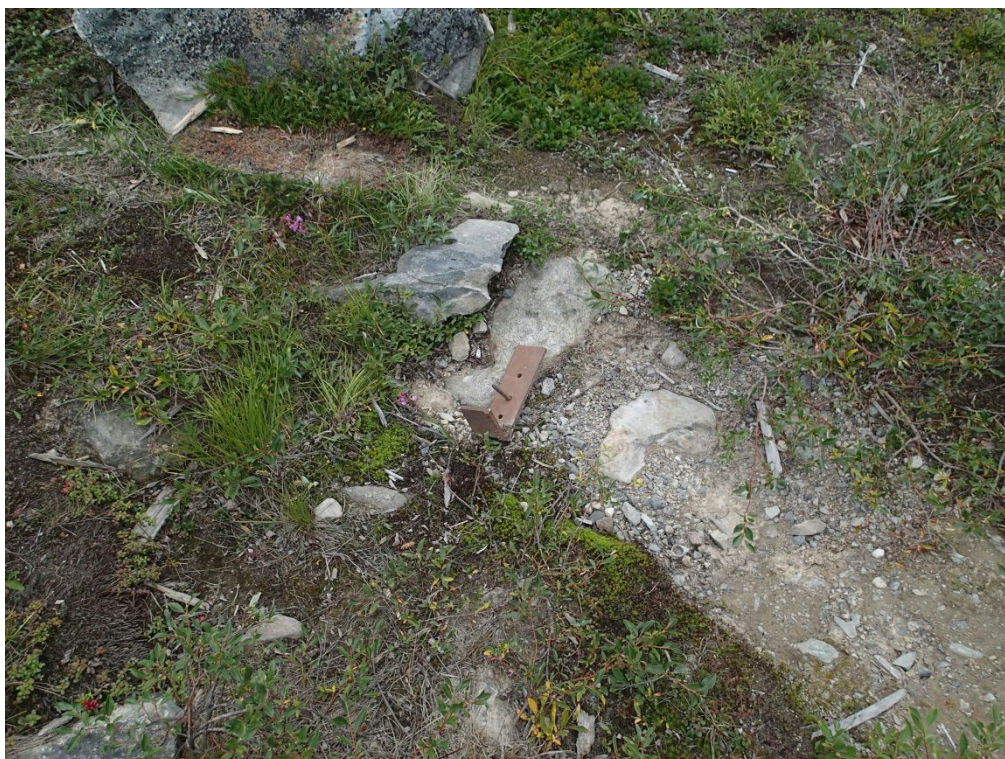
Photo 21: Before photo of historic metal bracket-debris near spot of already cleaned up historic timber.

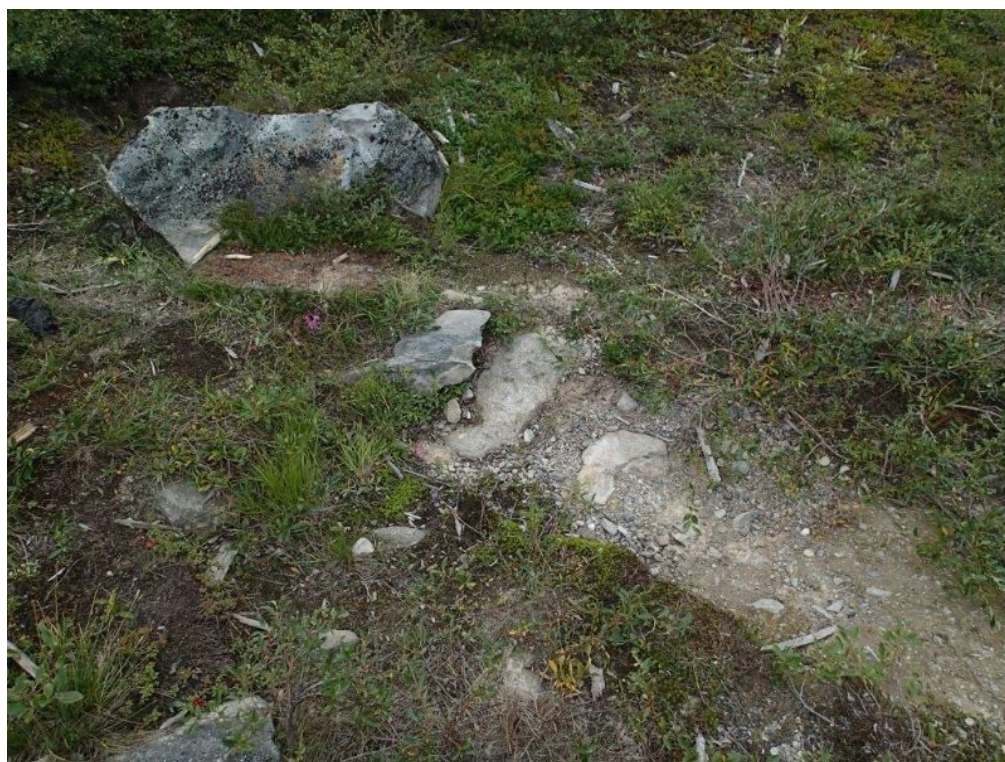
Photo 22: After cleanup photo of historic metal bracket-debris near spot of already cleaned up historic timber.

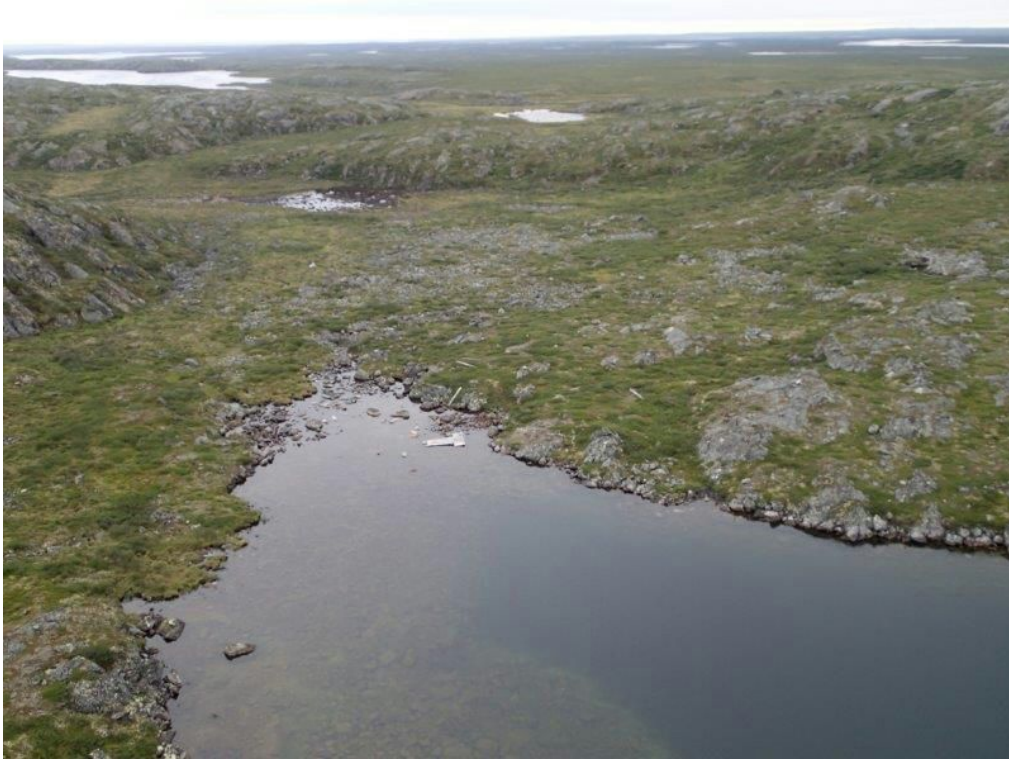
Photo 23: Before photo of historic debris (timbers, dock) at south end of Paleface Lake. Looking south.

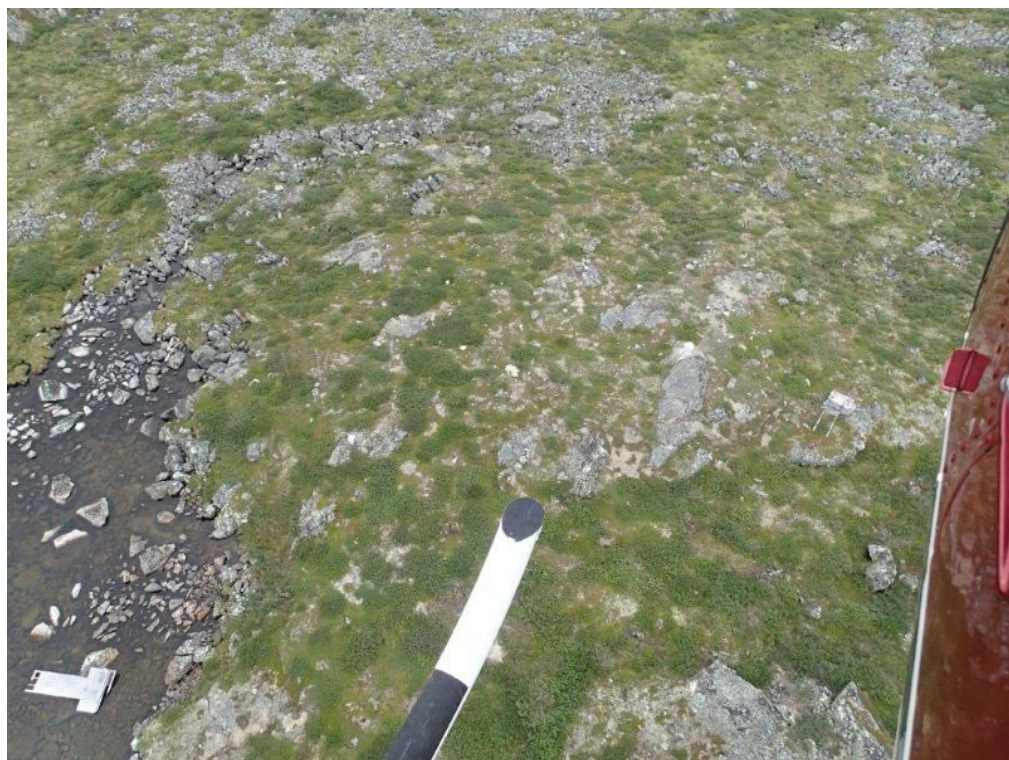
Photo 24: After cleanup photo of historic debris (timbers, core rack) at south end of Paleface Lake. Looking south.
