WATER LICENCE INSPECTION FORM

Licensee Ashton Bay Holdings Inc./Apex Geoscience Ltd.	Licensee Representative Thomas Ullrich/Celine McEachern - Chris Livingstone
Licence No. / Expiry 2BE-STO2025	Representative's Title Senior Project Geologist
Land / Other Authorizations N2015C0014	Land / Other Authorizations
Date of Inspection August 11, 2020	Inspector Joseph Monteith
Activities Inspected	
<input checked="" type="checkbox"/> Camp <input type="checkbox"/> Drilling <input type="checkbox"/> Mining <input type="checkbox"/> Construction <input type="checkbox"/> Reclamation <input checked="" type="checkbox"/> Fuel Storage <input type="checkbox"/> Roads/Hauling <input checked="" type="checkbox"/> Other: seasonal shutdown <input type="checkbox"/> Other:

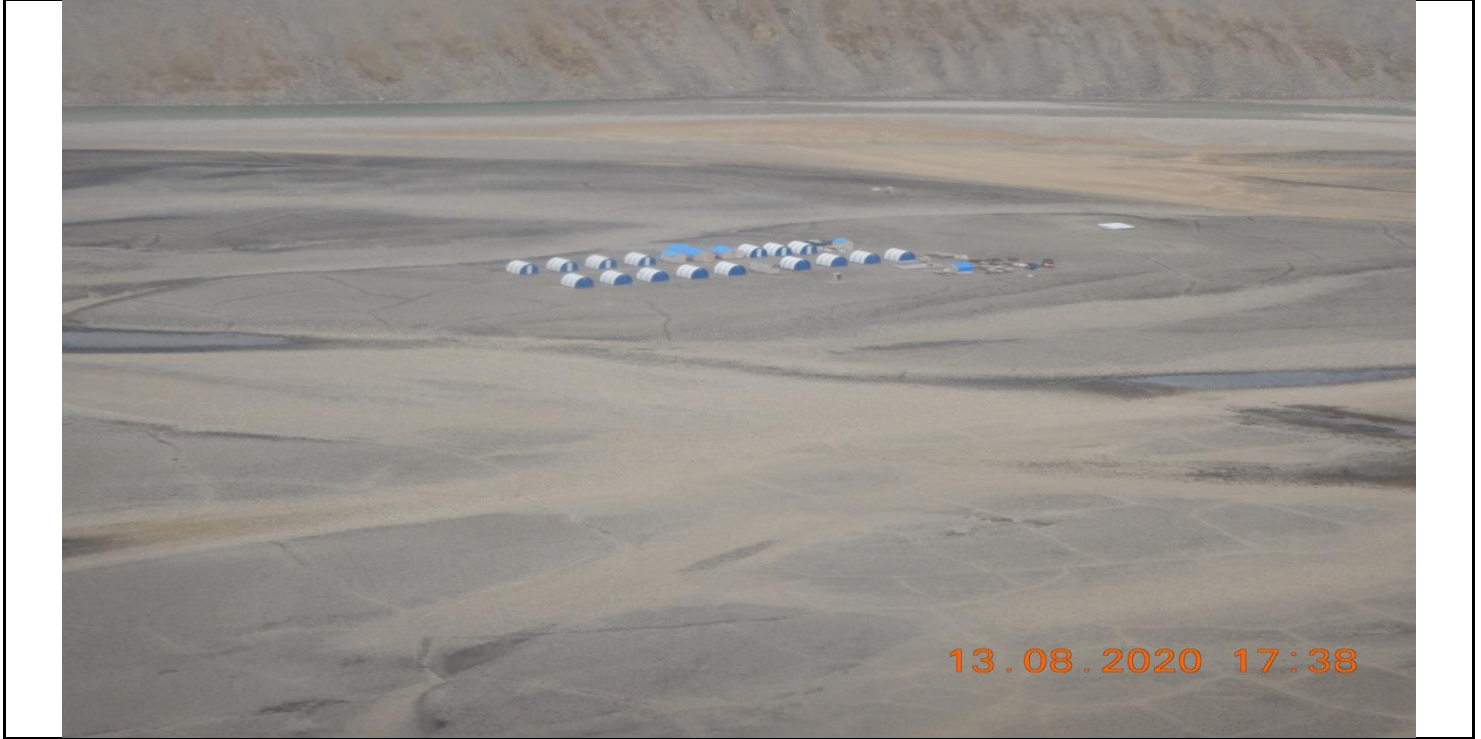
Photo Log #	Location
Photo 1	Ashton Bay, Somerset Island, Qikiqtani Region, NU

Description: Ashton Bay's STORM Project campsite. Water source runs along the base of the mountains in the background.

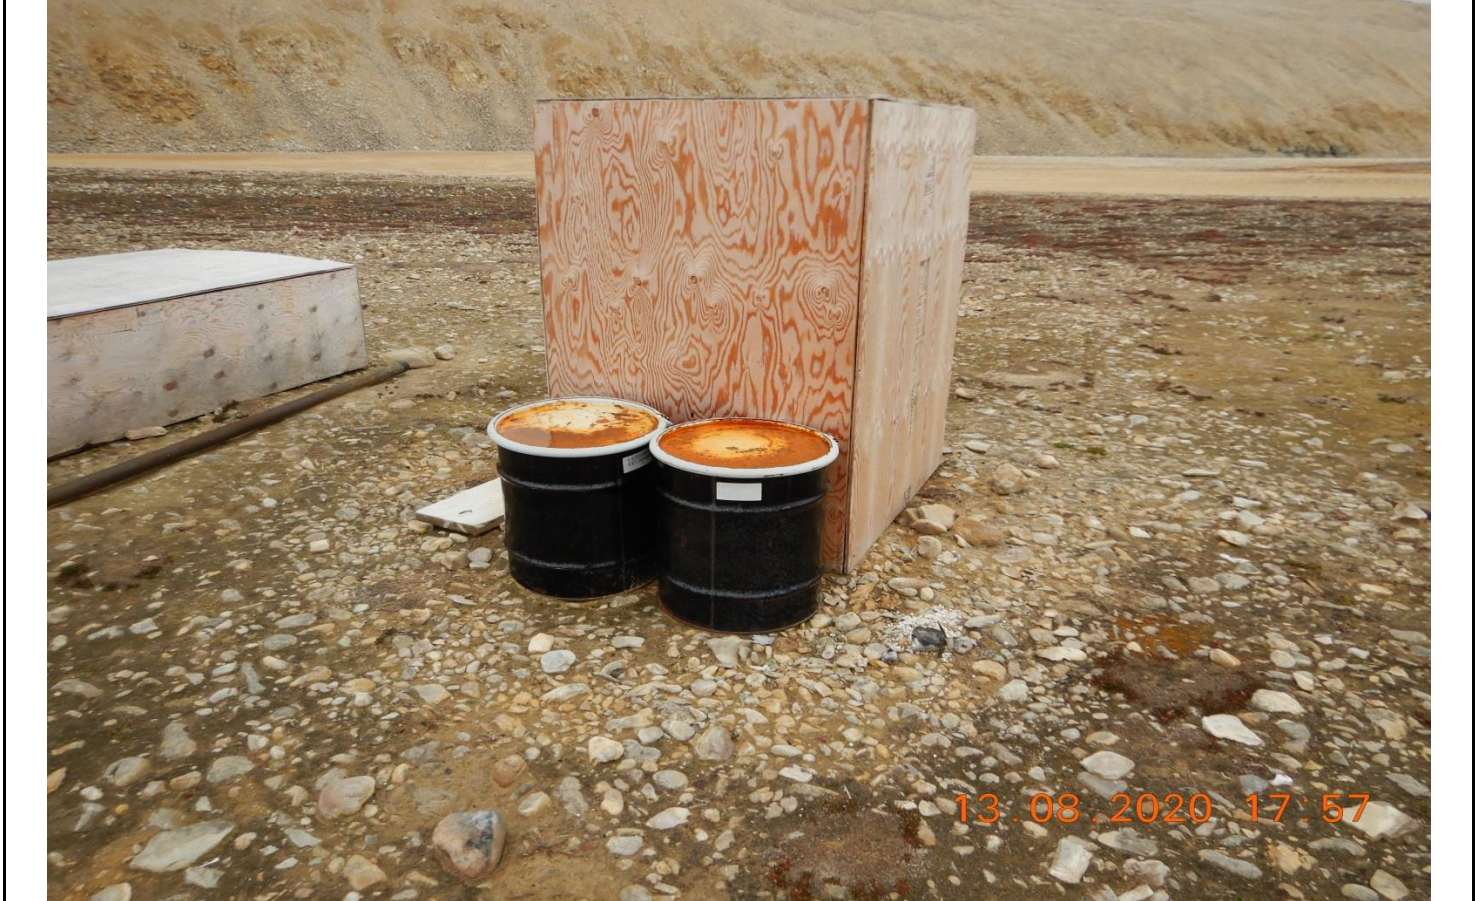
Photo Log #1	Location
Photo 2	Ashton Bay, Somerset Island, Qikiqtani Region, NU

Description: Water withdrawal equipment. The Ashton River runs across the base of the hill in the background.

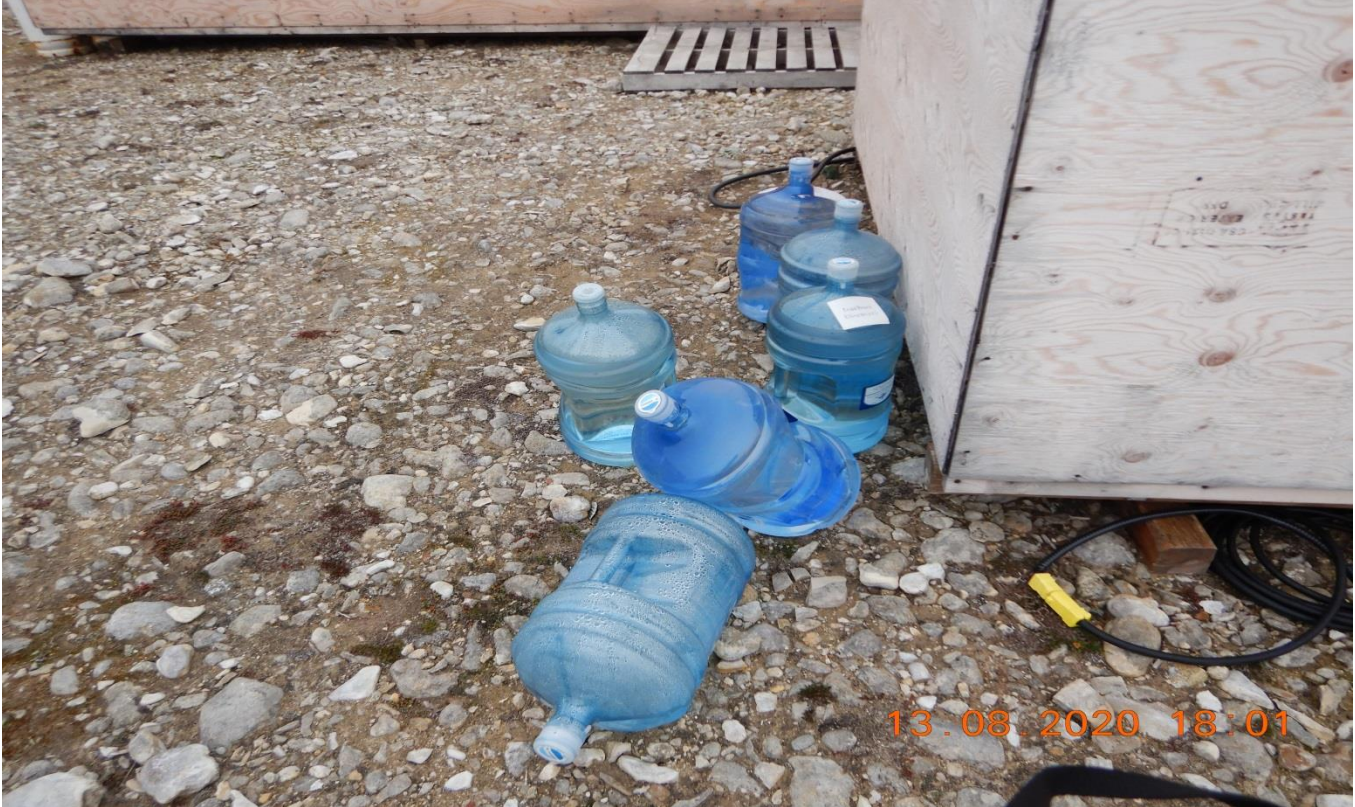
Photo 3

Description: 6 x 18.9 Litre water jugs. Historical Annual Reports indicate that these water jugs are for consumption, flown in from Yellowknife, NT.

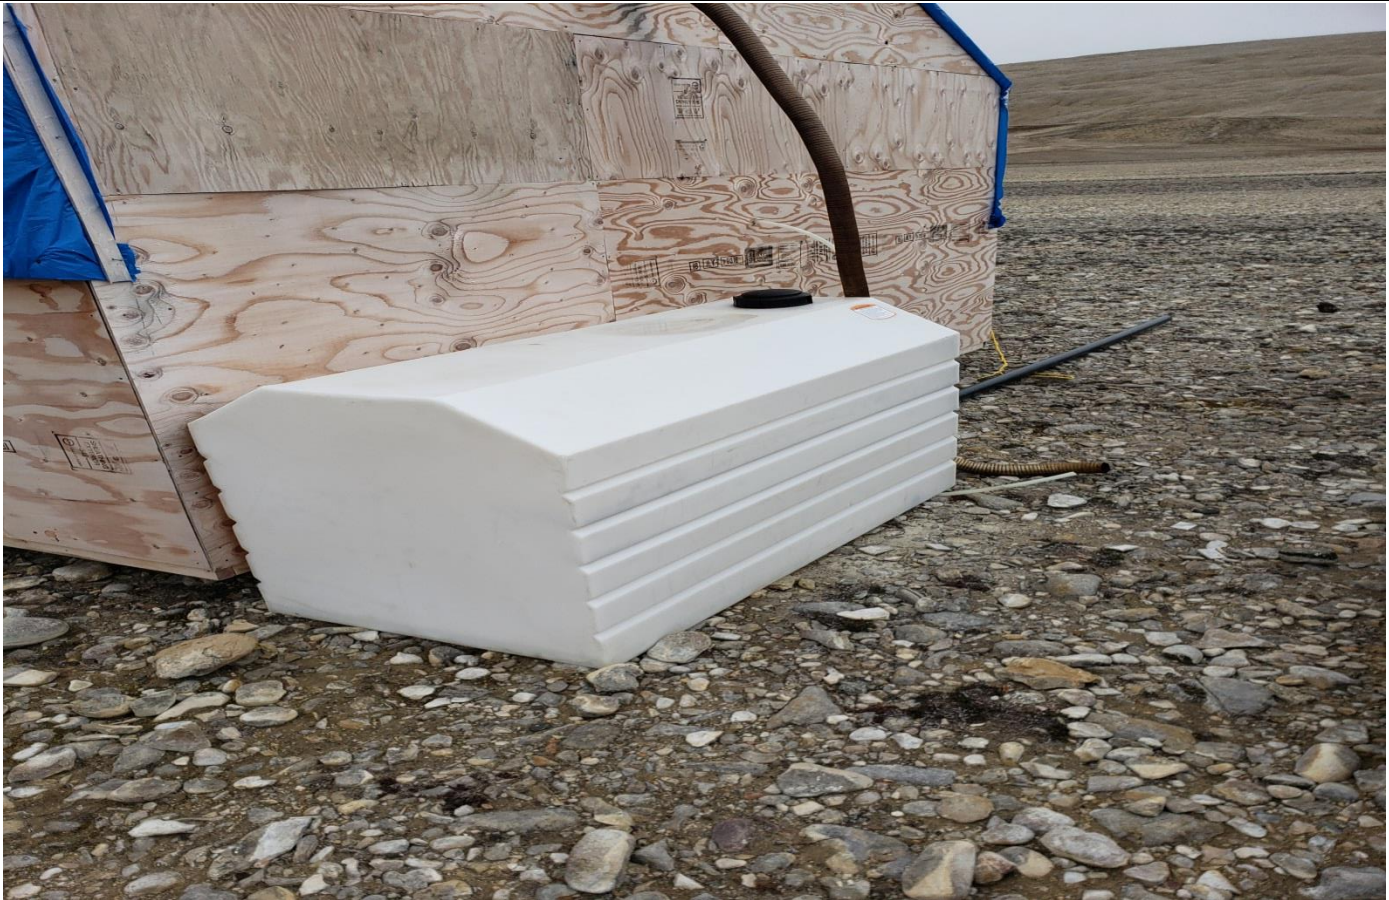
Photo 4

Description: 1 of 2 Water Tanks on site. This may be the 250 Gallon Water tank.

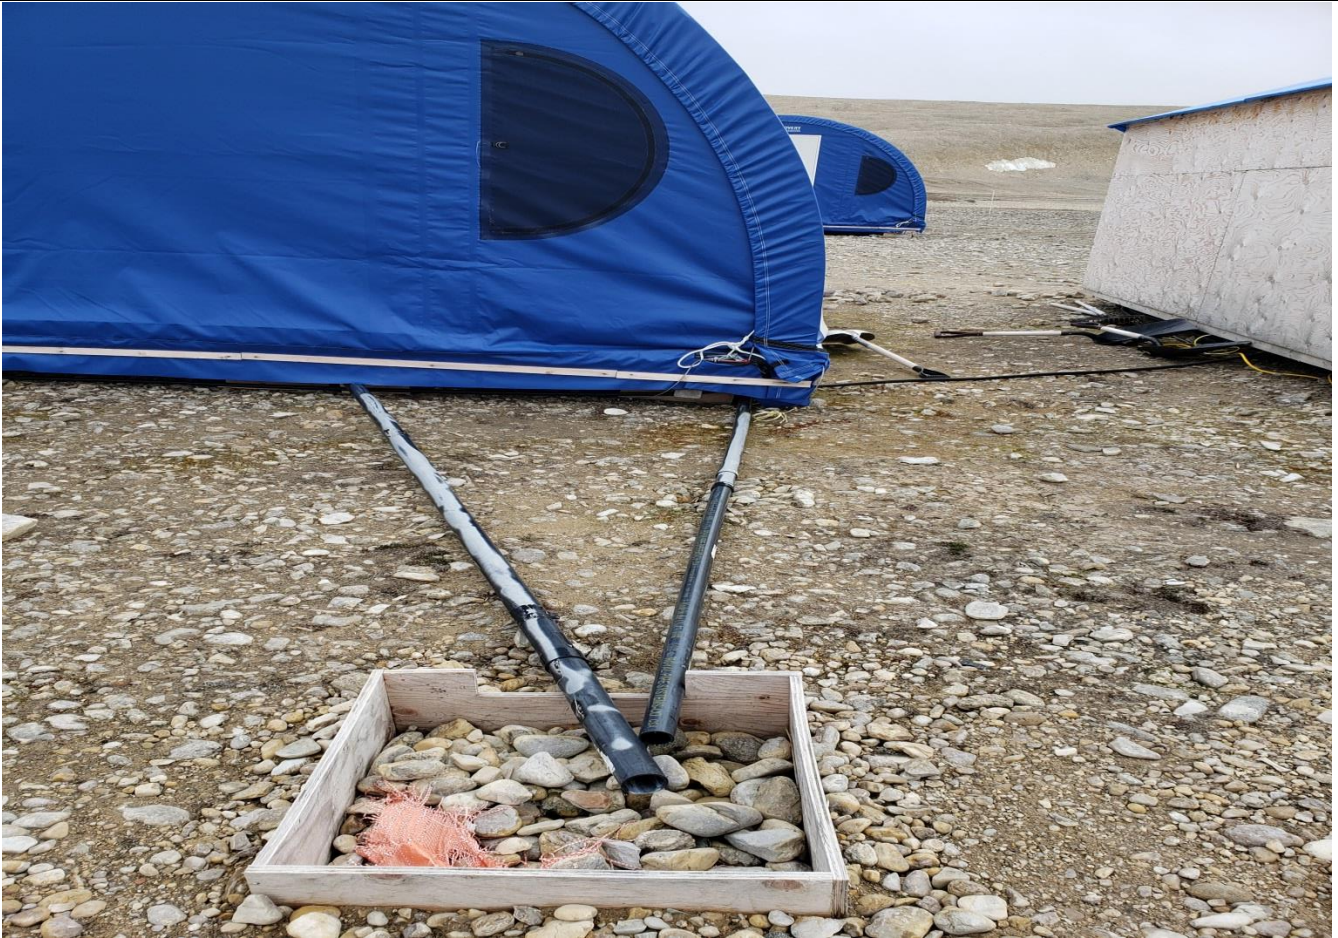
Photo 5

11. 2 x grey water sumps were observed on site, and appears to be operating as intended (Photo 5 & 6).

Description: 2 x piped Sump Pit

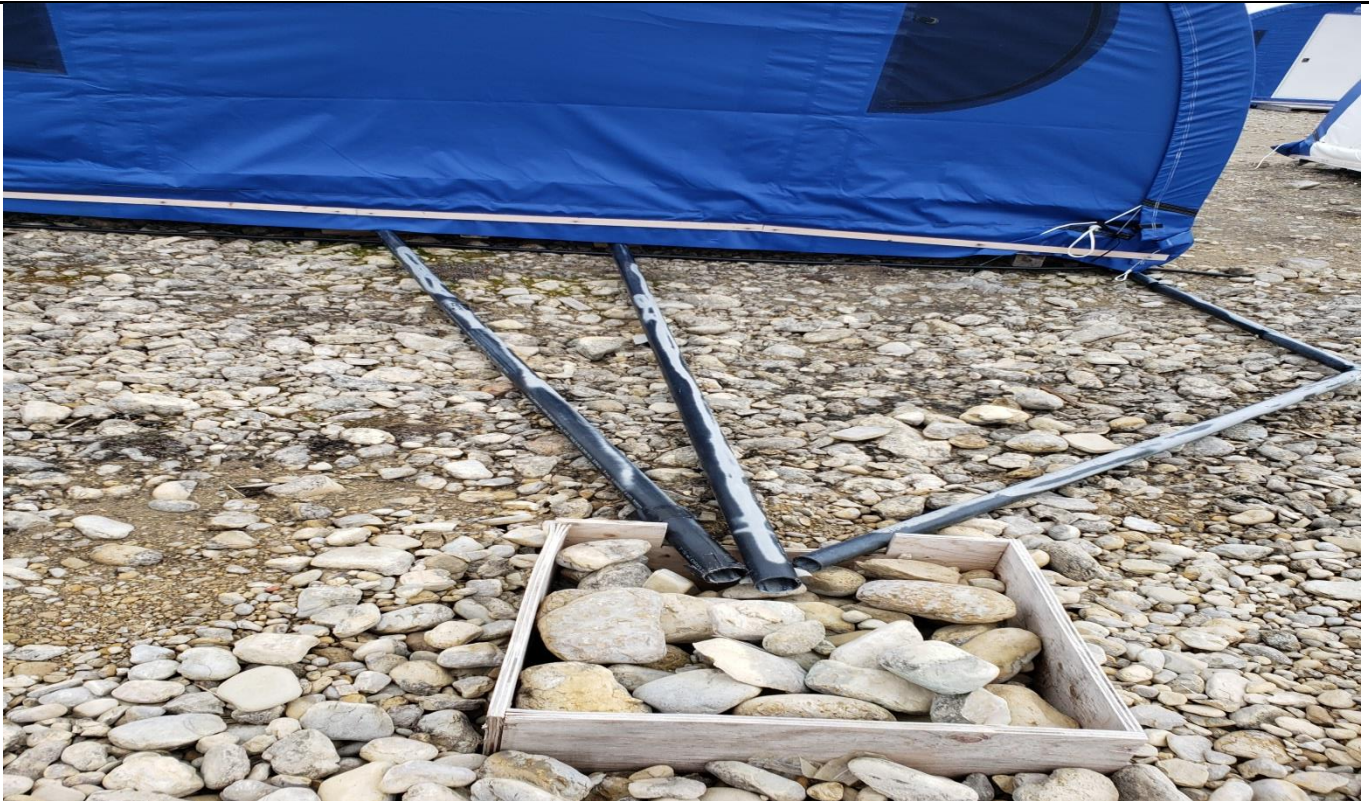
Photo 6

Description: 3 piped sump pit.

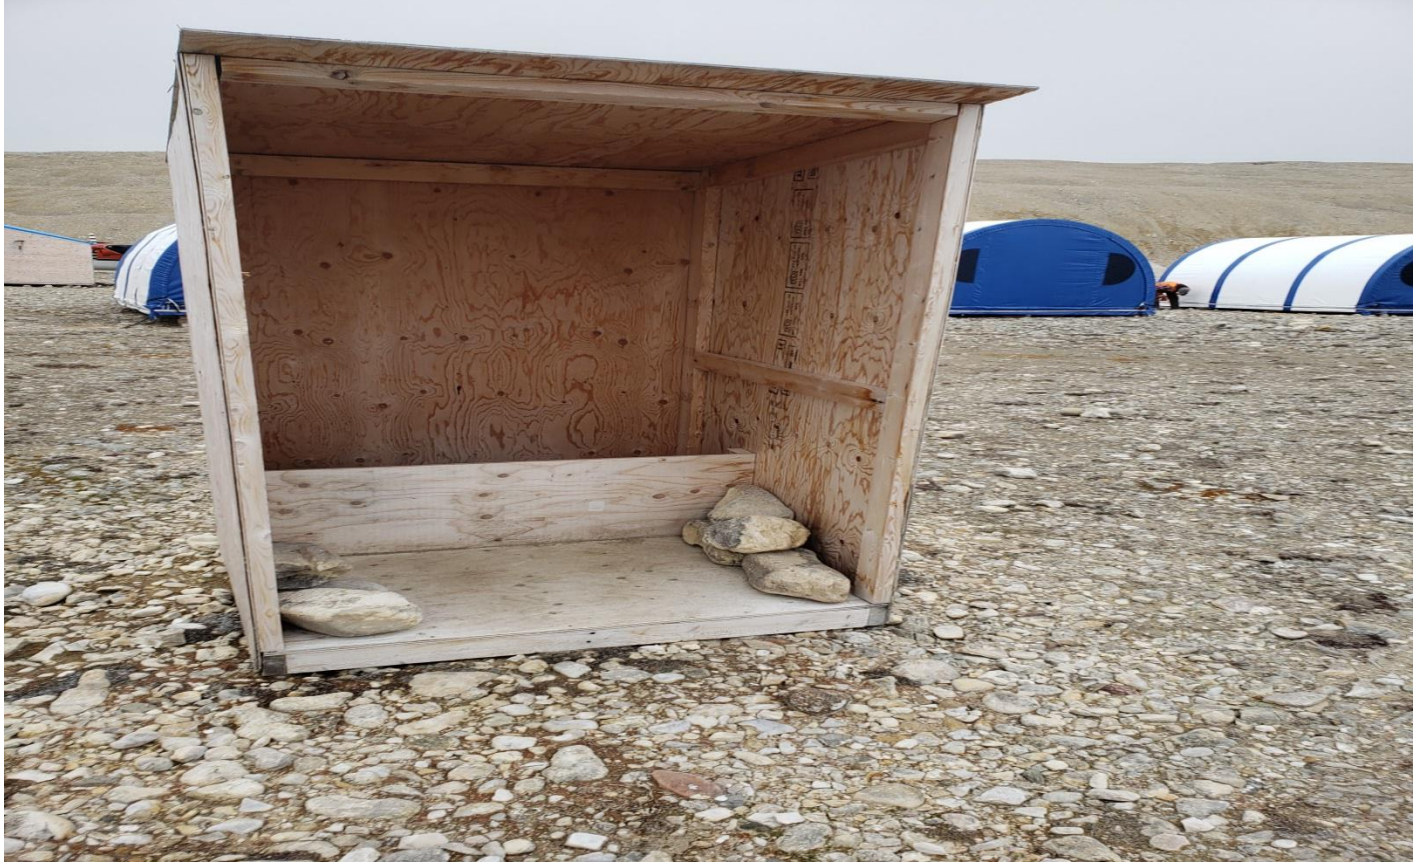
Photo 7

7. 5 Pacto toilets on site. Pacto toilets utilize plastic “sausage” bags to collect and store sewage. All Pacto Bags were incinerated.
8. A stand up open latrine was observed on site. No sump pit. Larger rocks were used to help disperse of liquid human waste (photo 7 & 8).

Description: Number 1 Latrine. Stand up latrine

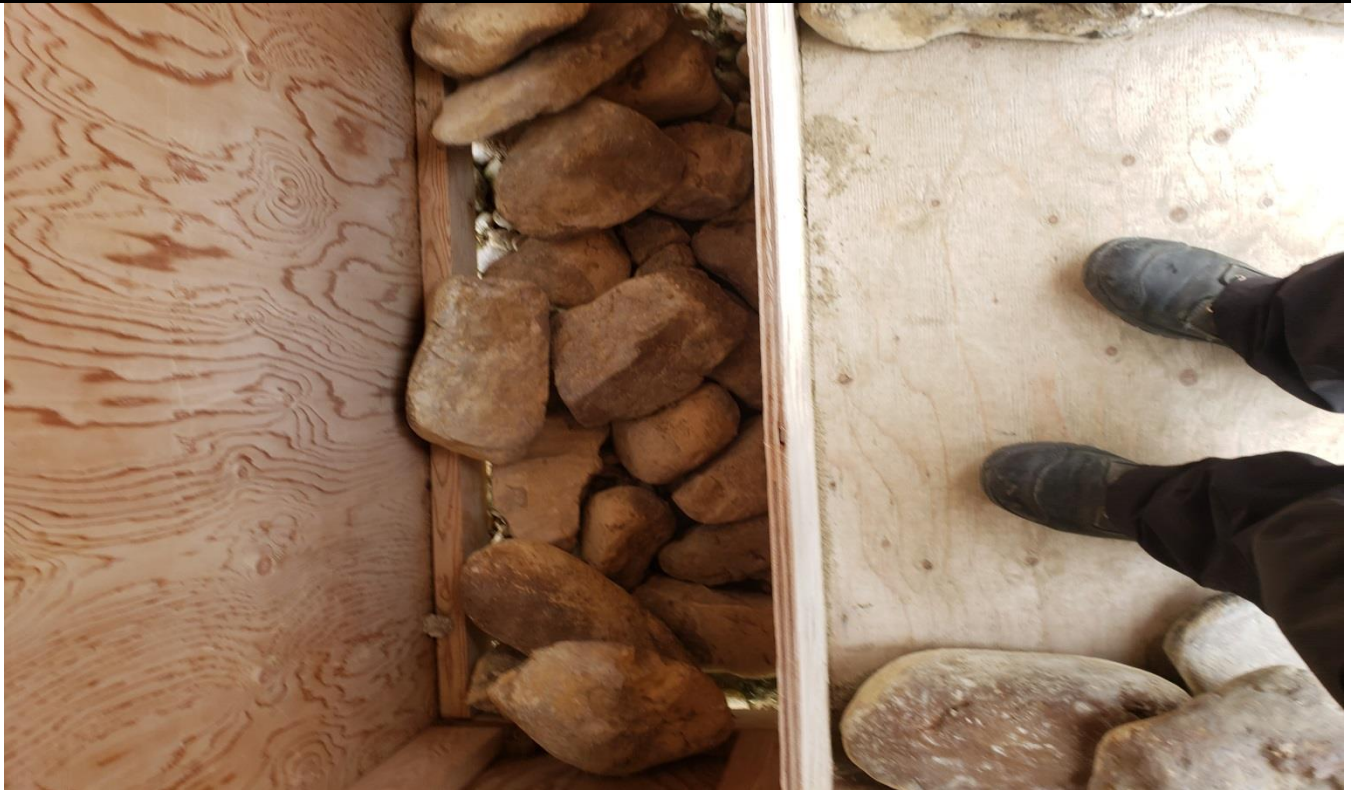
Photo 8

Description: Latrine doesn't appear to be a sump, but larger rocks protruding from the ground up into the latrine.

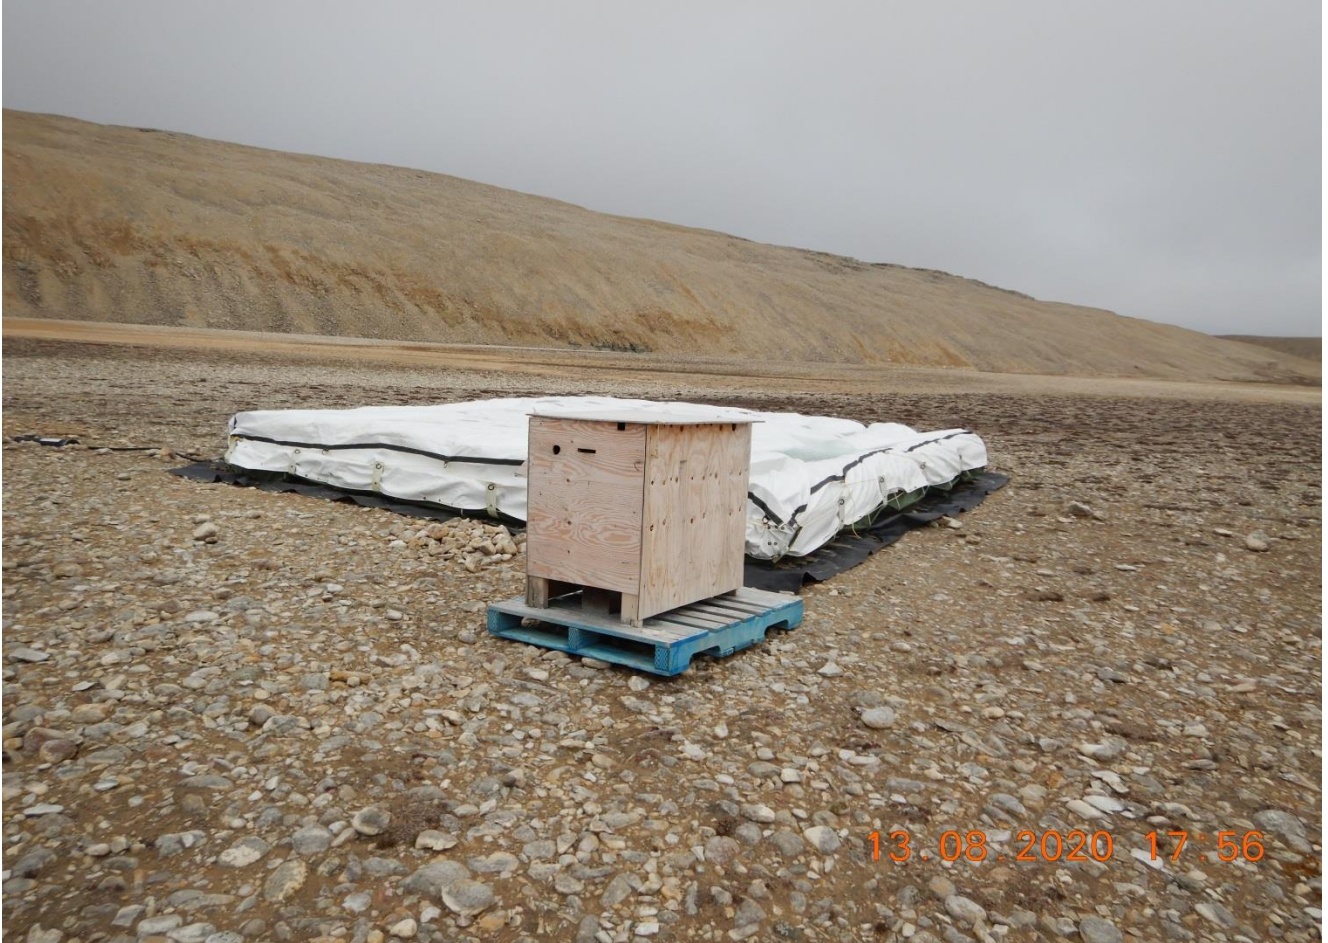
Photo 9

12. 2 fuel caches were observed on site (photo 9 & 10)
13. Another secondary containment structure was observed on site appeared to have a various other products, some may have been hazardous material; other items may not be hazardous. A spill was observed in the secondary containment. The spill overflowed the secondary containment. (photo 12)

Description: Fuel Cache in secondary containment, with a cover.

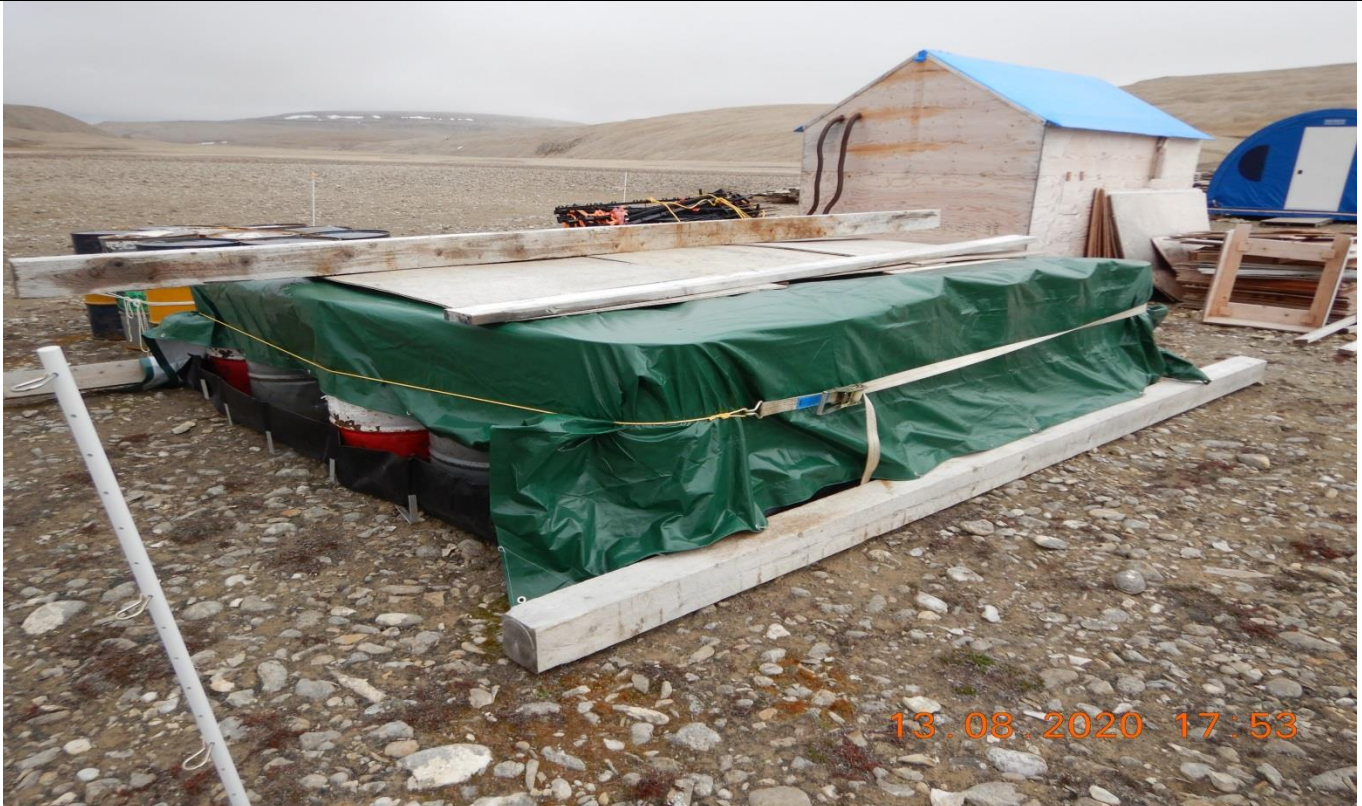
Photo 10

Description: 2nd Fuel Cache, covered

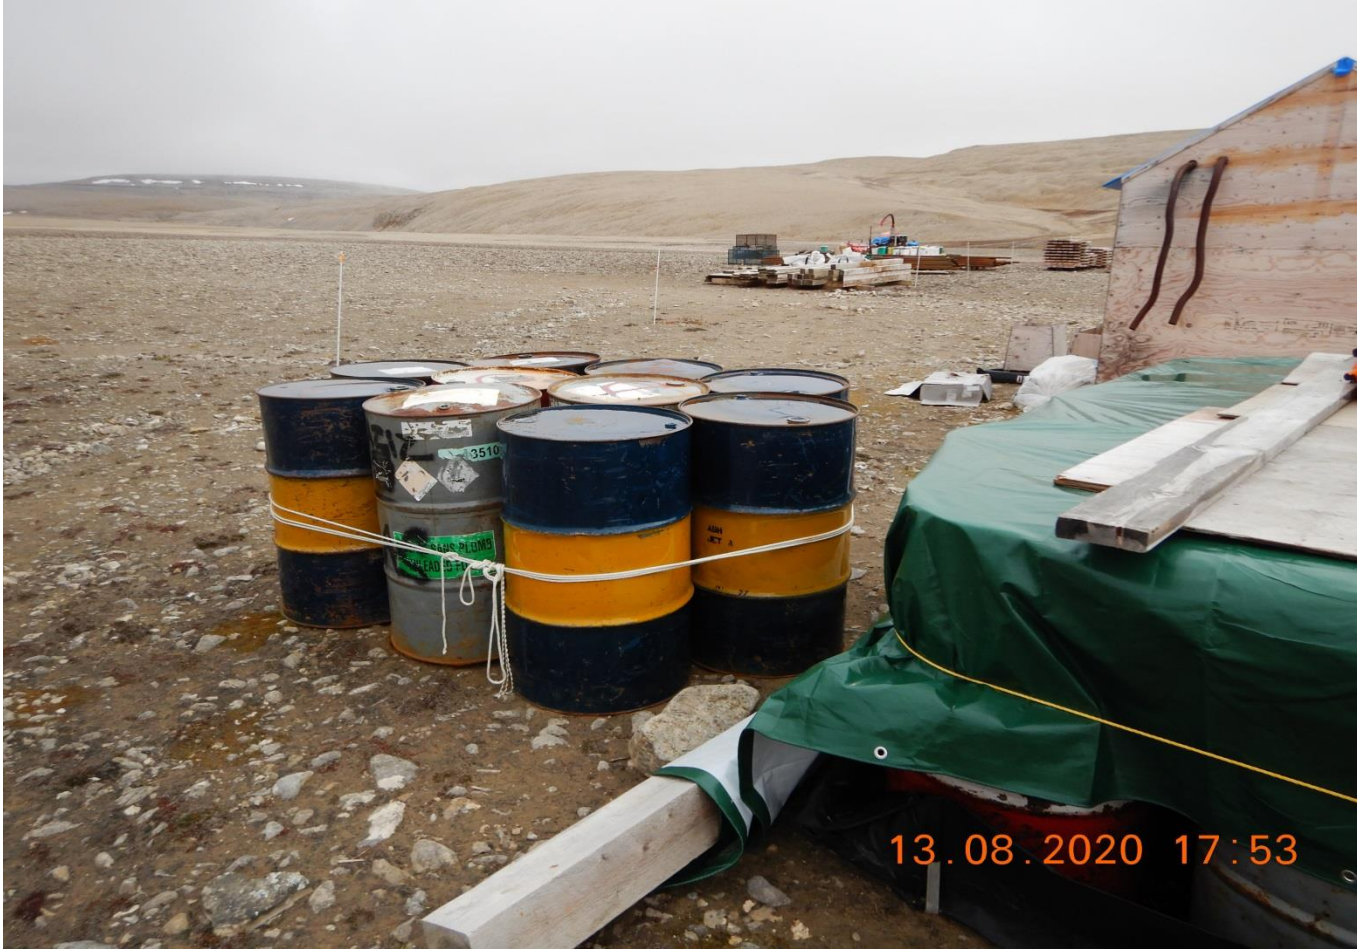
Photo 11

9. All combustible waste was incinerated on site using a batch feed dual-chamber controlled air incinerator. Residual waste (ash) was sealed in metal 5 gallon pails and removed from site for disposal. All non-combustible and hazardous wastes were sealed in appropriate containers and removed from site for proper disposal. A bunch of drums were roped together. The drums may have incinerated waste in the drums (photo 11).

Description: Empty drums bound together and tied up with a rope.

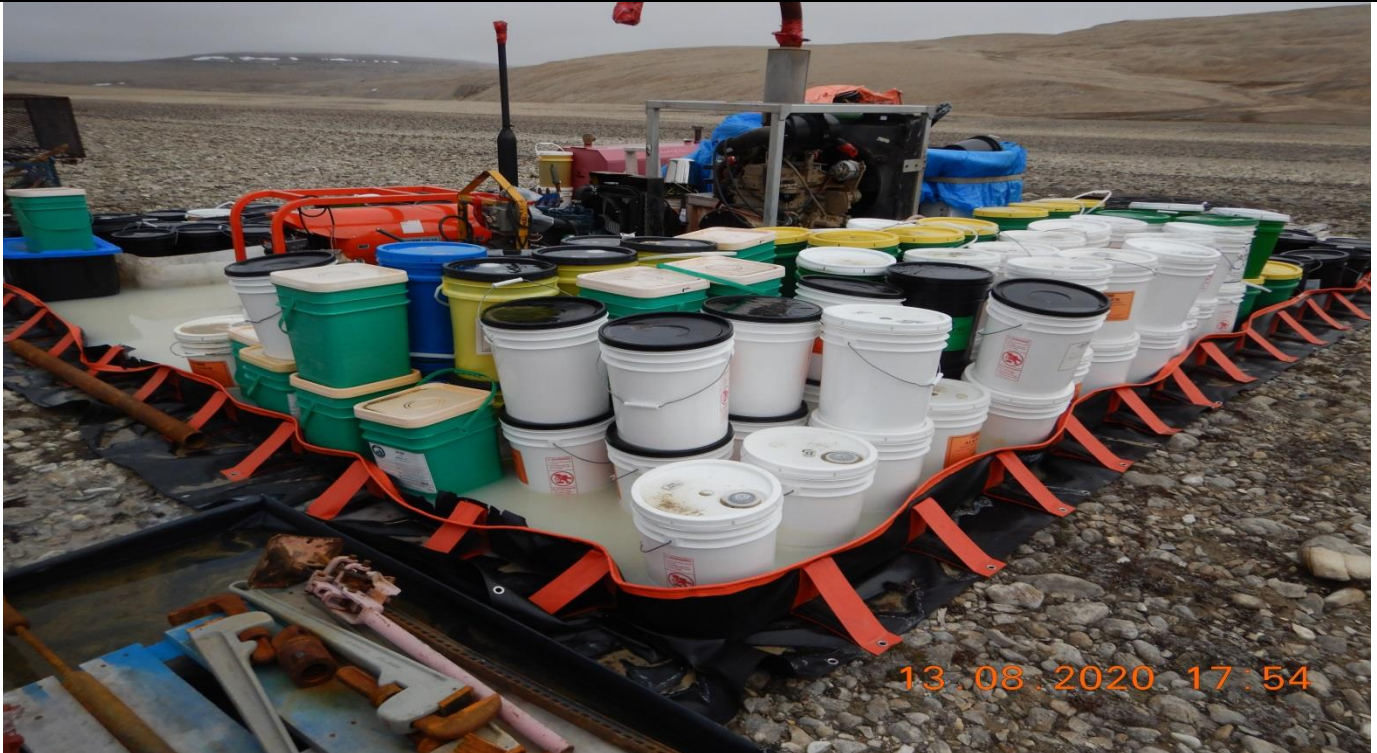
Photo 12

14. A spill report was generated after a spill was observed on site during the inspection. The spill report 2020-418 was requested by the WRO after making the observation while conducting the onsite inspection. Tara Gunson of Apex Geoscience said. “Due to the remote location and time of year I feel the best action would be to send someone up next spring/summer to replace/repair the torn berm do a recon with substance testing to provide us with a recommendation for remediation (e.g. if it is just non-toxic drilling additives should not require more than a quick cleanup, but if it has any hydrocarbons then we can make a plan for additional soil/water testing and soil removal, etc.,)”. A spill kit was observed on site and an attempt was made to use its equipment, but the cover was wedged in and inaccessible at the time of the inspection (Photo 12, 13, & 14).

Description: Hazardous Material in Secondary Containment, secondary containment is full of product. A spill report was generated for this event. Spill Report 2020418.

- Clean up the spill observed at the time of the inspection, Spill Report 2020418
- Submit the 2020 annual report for the Water License 2BE-STO2025. Submitted annual report is for Land Use Permit N2015C0014. Recent correspondence indicated that the tried to submit, and have resubmitted the annual report to the Nunavut Water Board.
- Fix the spill kit, or replace the spill kit so that it is usable.
- Repair 2 weather havens, so the contents don’t spread out to the receiving environment (photo 15 & 16).

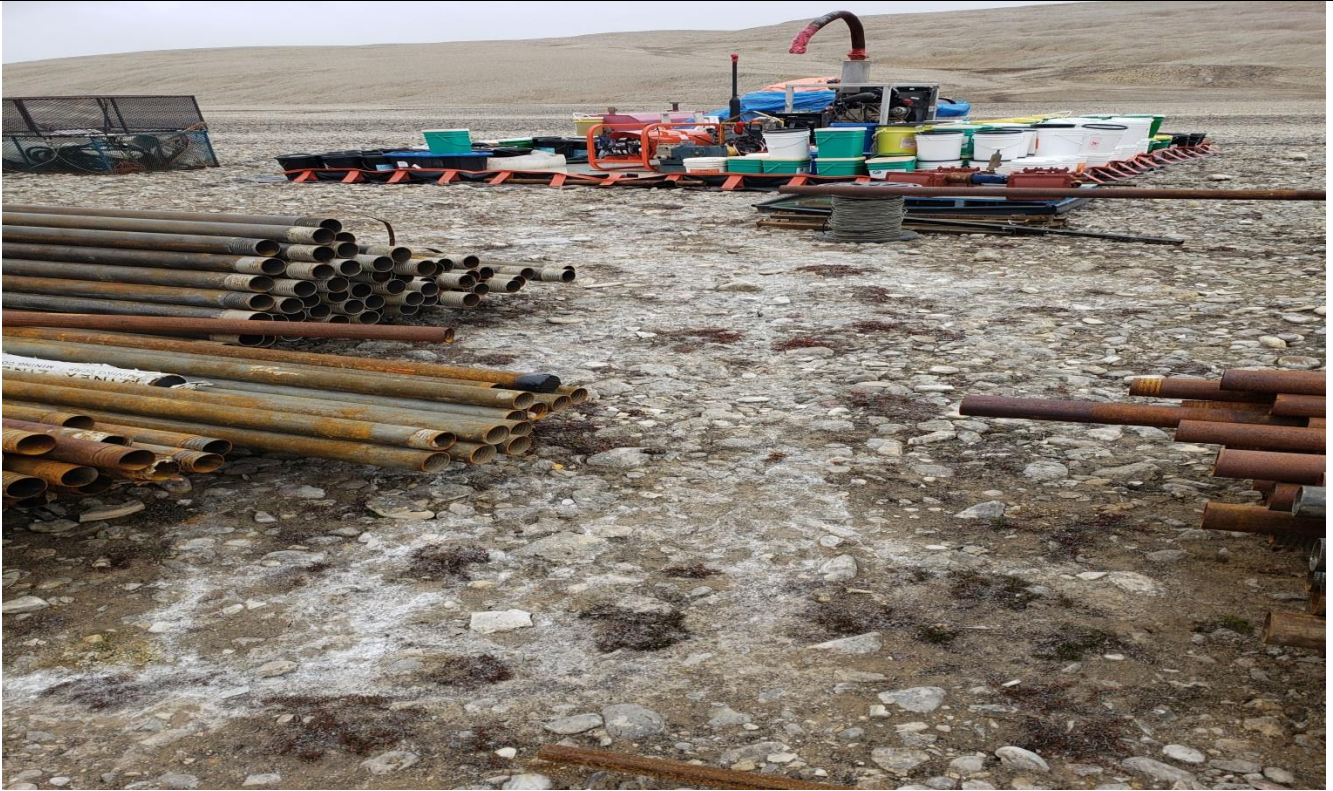
Photo 13

Description: Spill Report 2020418

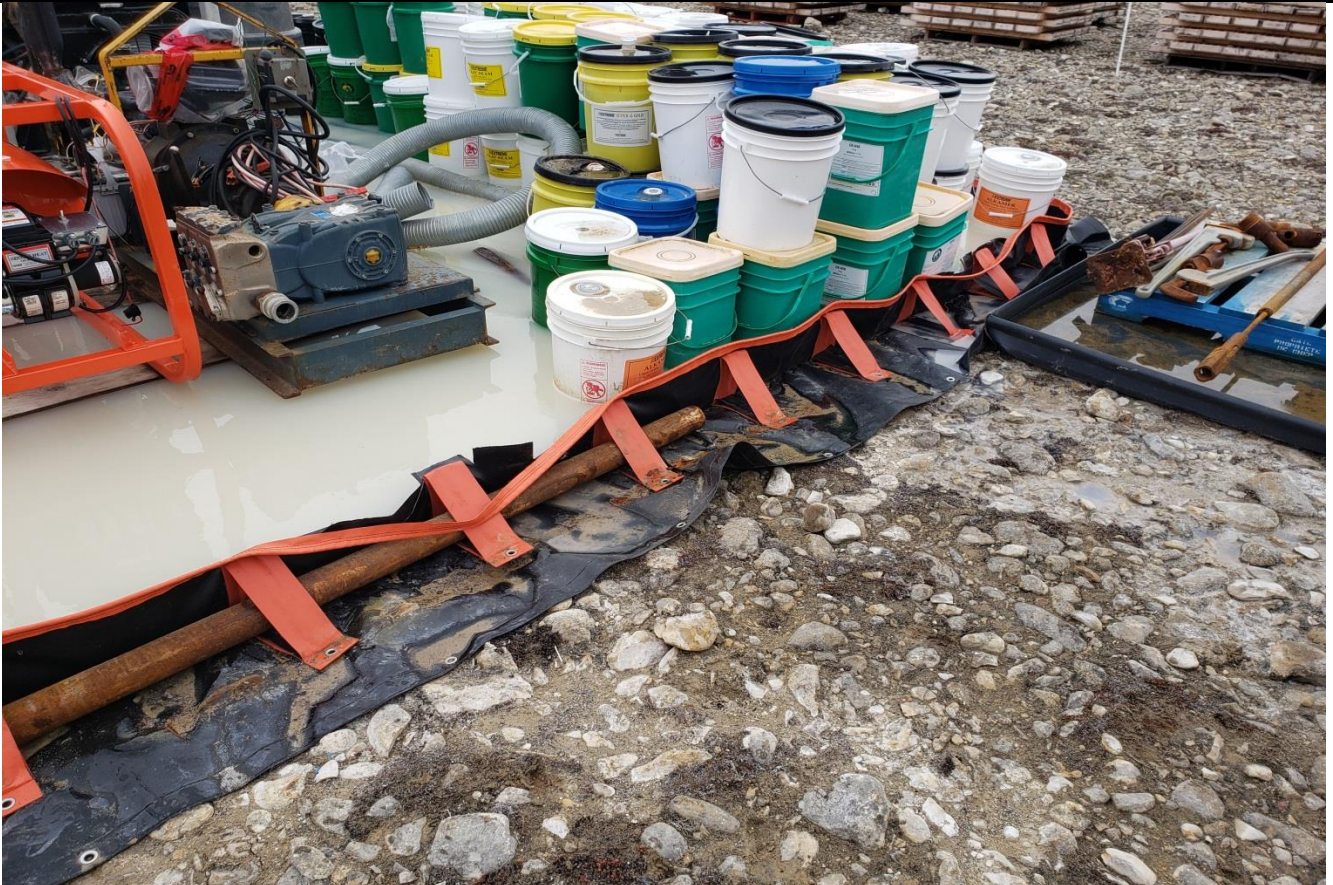
Photo 14

Description: Source of Spill Report 2020418 – unknown substance, suspected

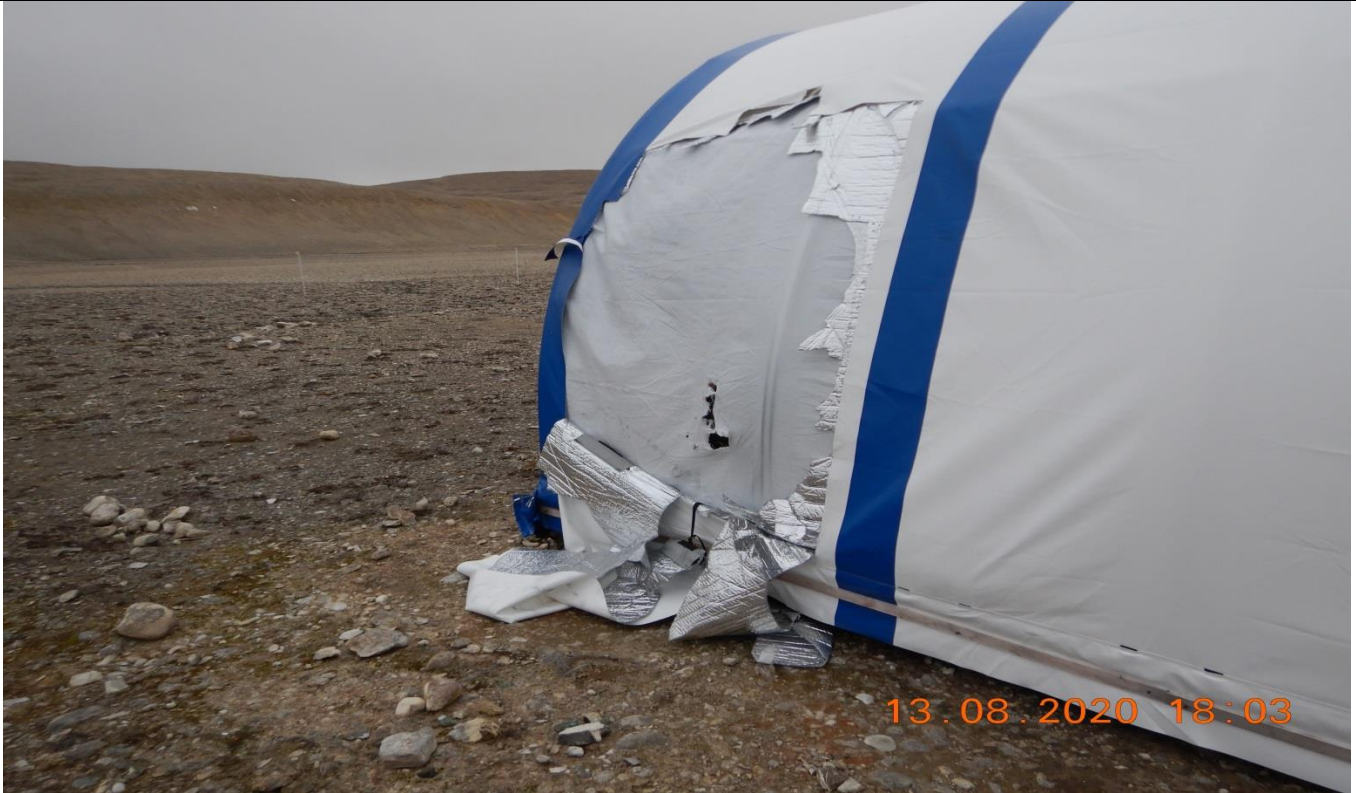
Photo 15

Description: Damage on a weather haven

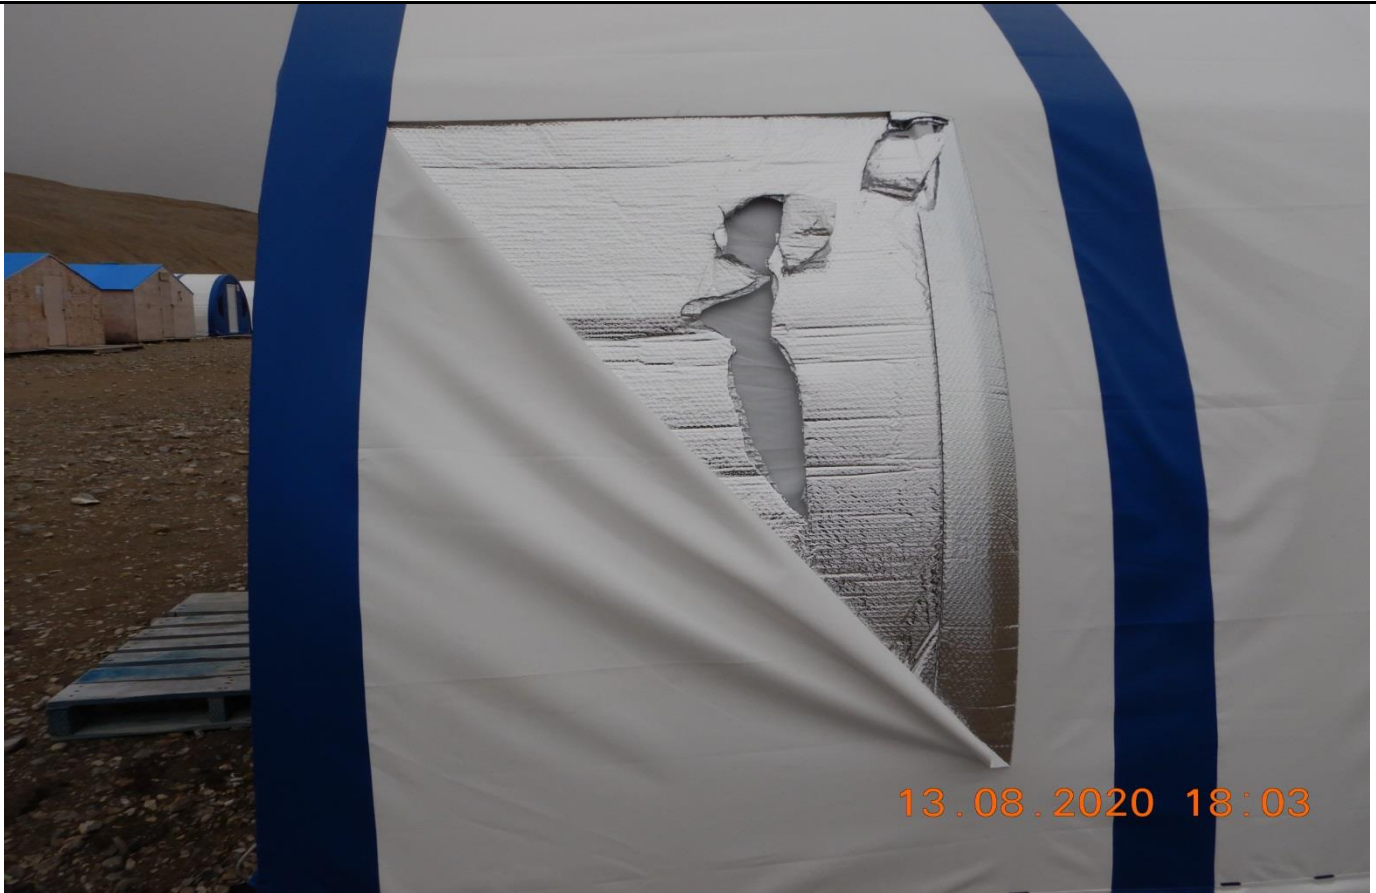
Photo 16

Description: Damage to a second weather haven
