WATER LICENCE INSPECTION FORM

Licensee		Licensee Representative	
John Gingerich President and CEO Advanced Explorations Inc. 50 Richmond Street East, Suite 300 Toronto ON M5C 1N7 Canada E-mail: john@advanced-exploration.com		None.	
Licence No. / Expiry		Representative's Title	
2BE-TUK1015 – EXPIRED		None	
Land / Other Authorizations		Land / Other Authorizations	
N2010C0011 / N2012C0013		QIA – Q12L3CF009	
Date of Inspection		Inspector	
July 29, 2016		A.Keim	
Activities Inspected			
<div><input checked="" type="checkbox"/> Camp<input checked="" type="checkbox"/> Drilling<input type="checkbox"/> Mining<input type="checkbox"/> Construction<input type="checkbox"/> Reclamation<input type="checkbox"/> Fuel Storage</div> <div><input type="checkbox"/> Roads/Hauling<input type="checkbox"/> Other: Water Discharge<input type="checkbox"/> Other: Municipal</div>

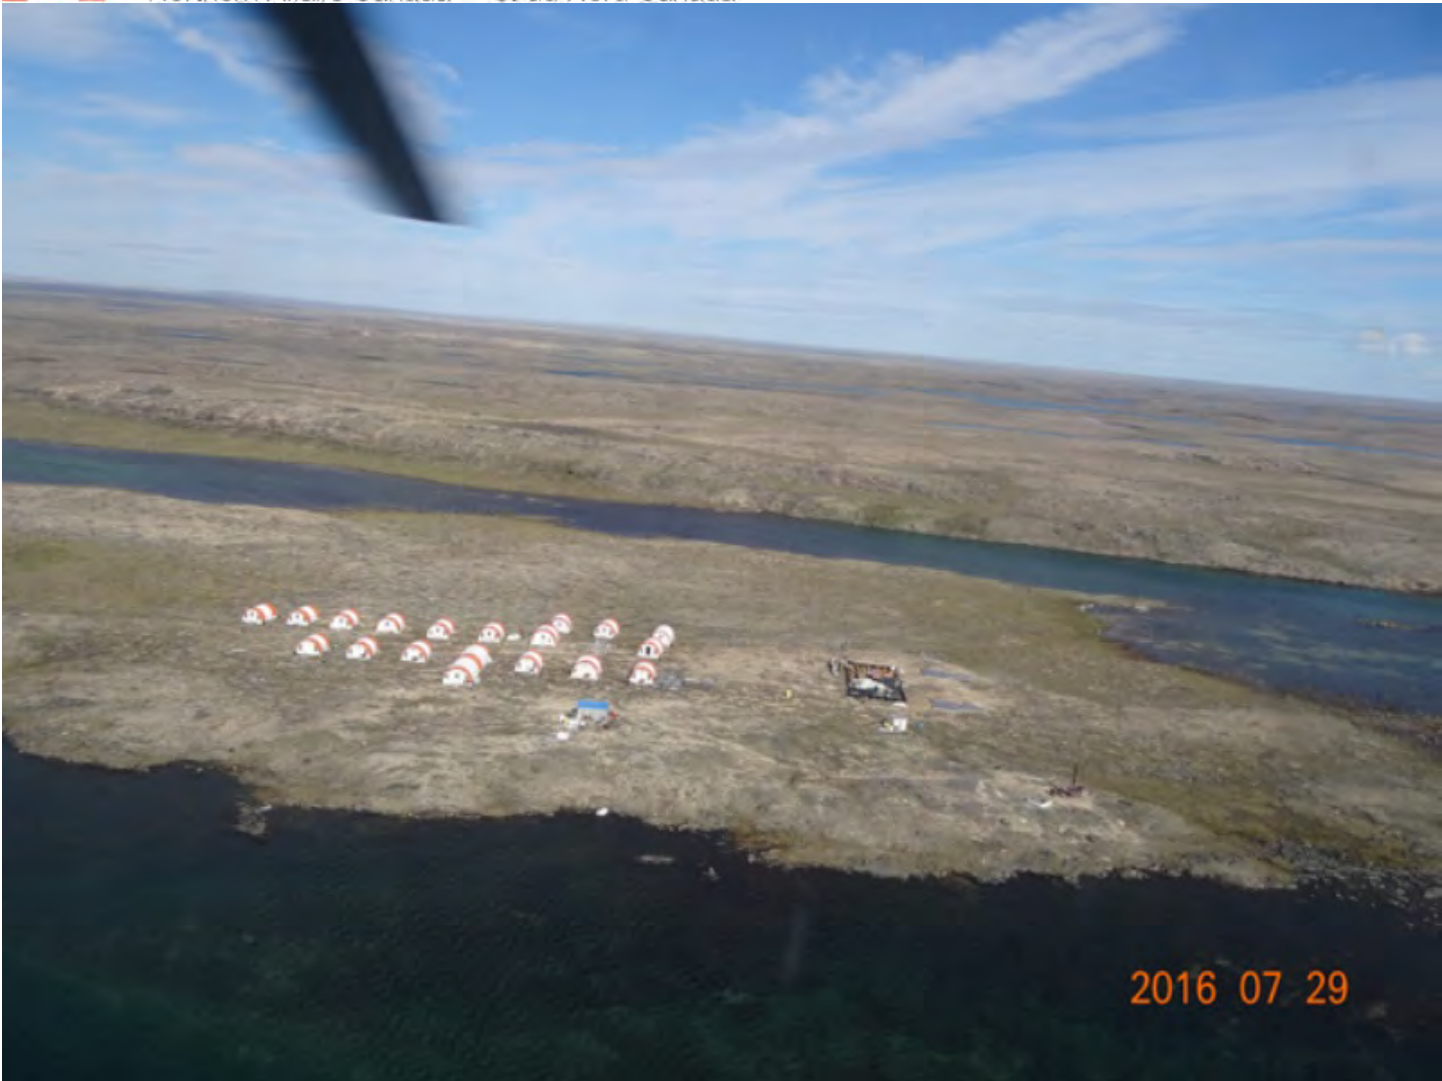
Figure 1 Over view of camp

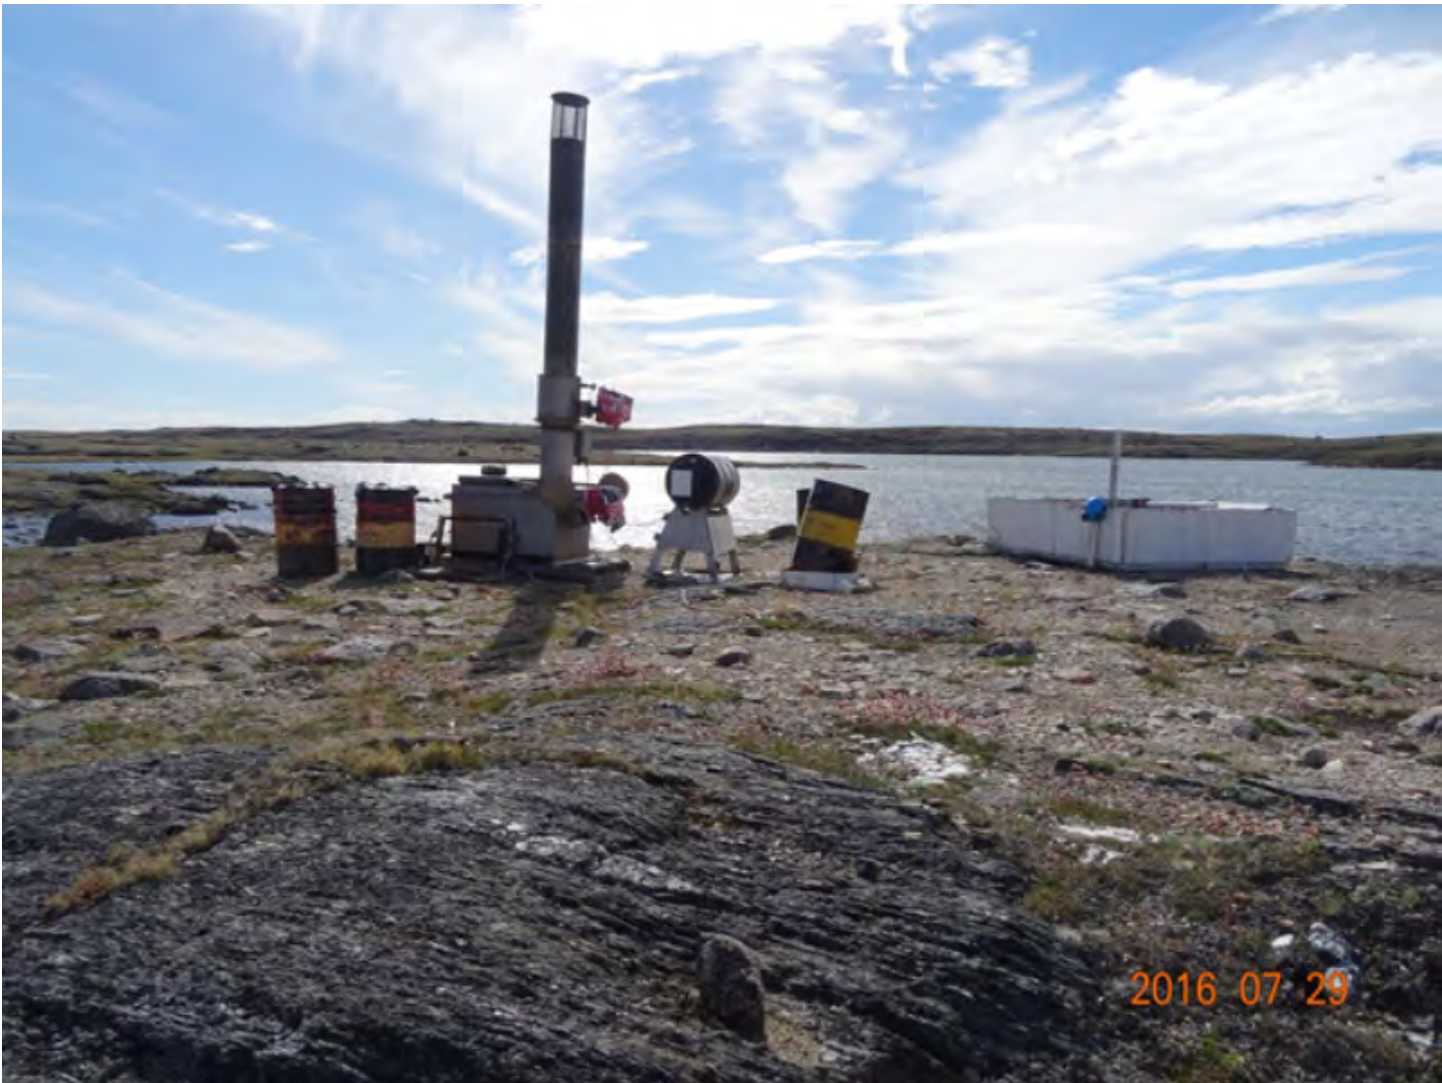
- Heaters remained in all units
- The incinerator area was found to have been sealed for winter storage. Drums of ash and waste remain on site and unburned waste remains both in camp and at the incinerator.

Figure 2 Incinerator with Garbage at the camp.

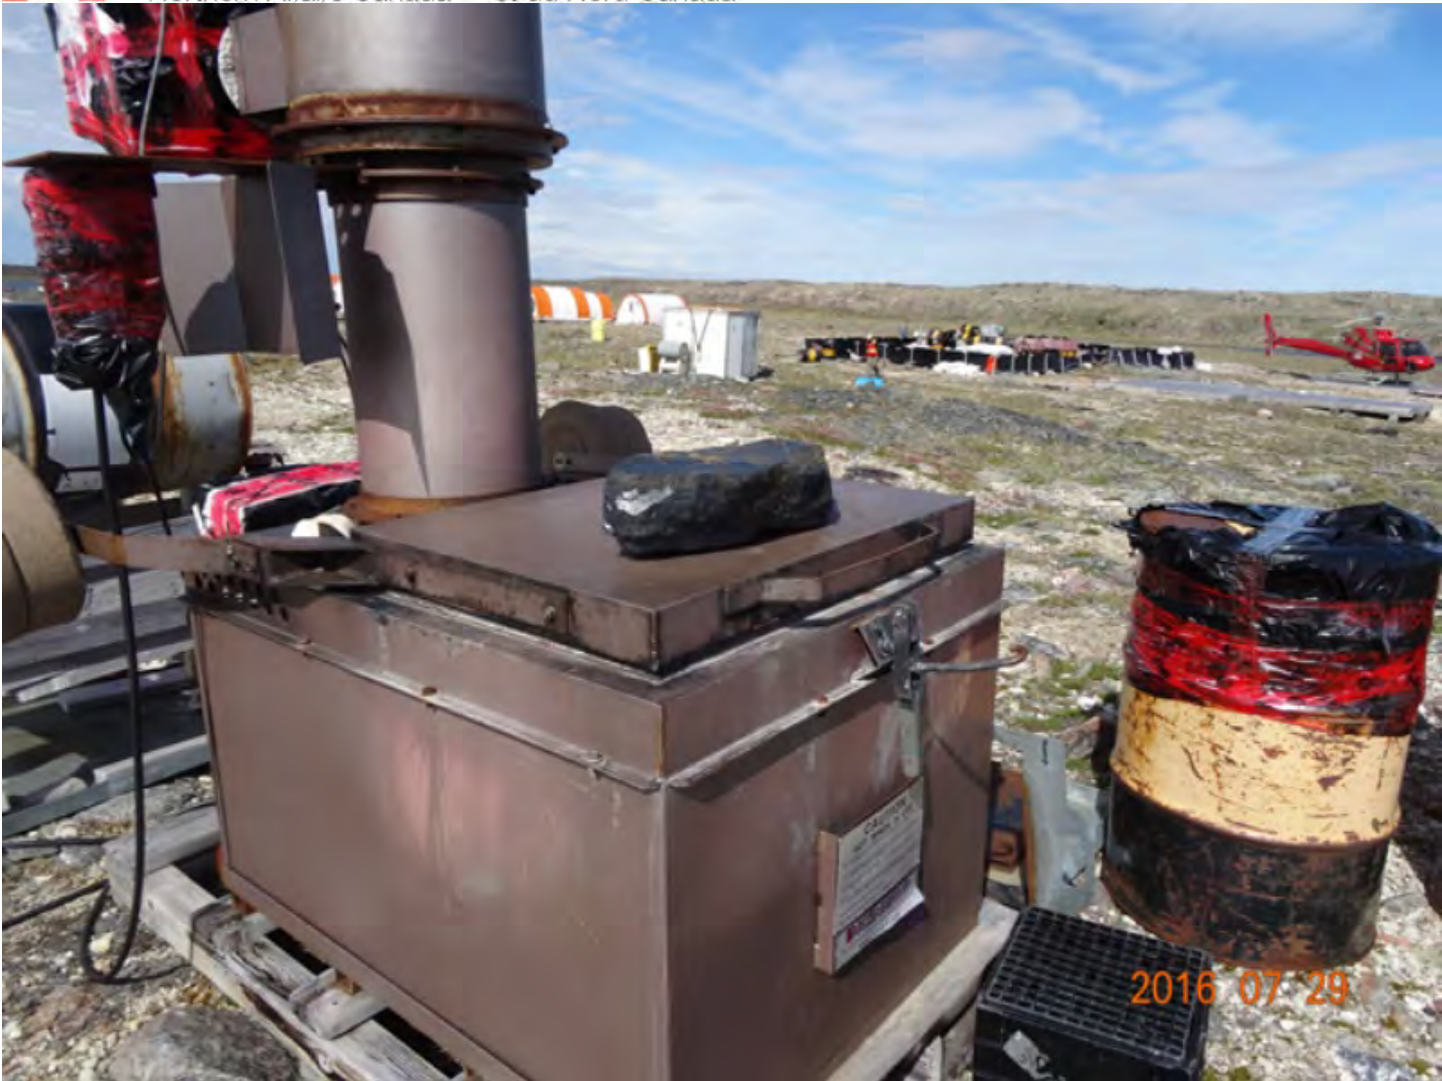
Figure 3 Incinerator . Barrels of ask and other waste materials

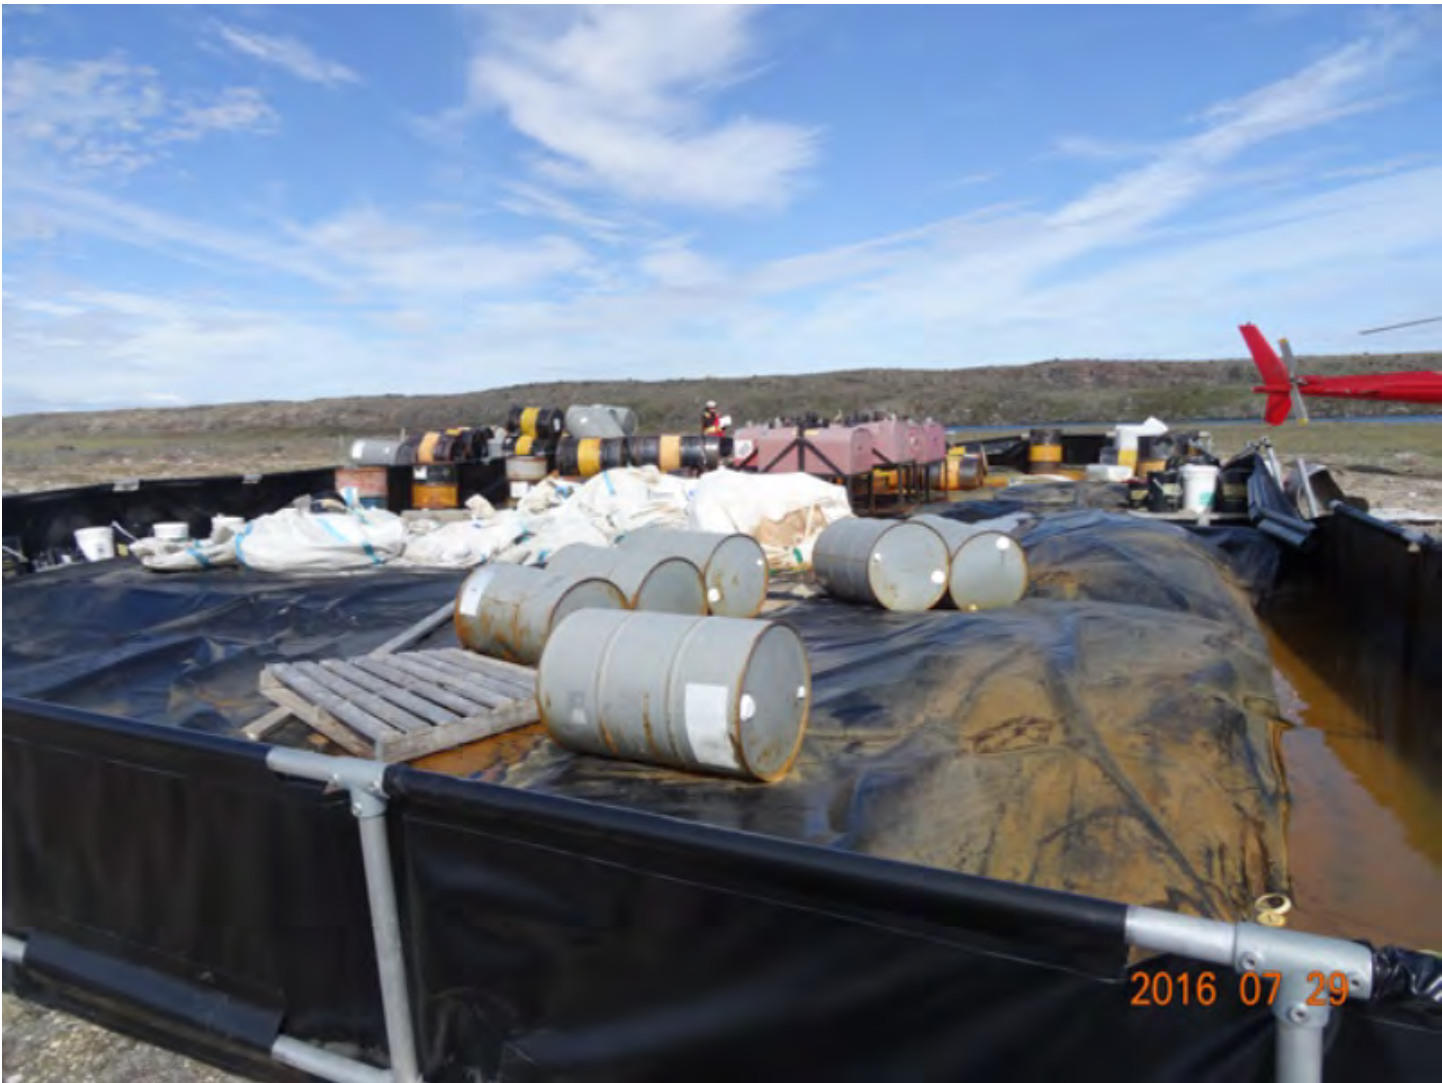
Figure 4 45 gallon drums of Jet A and heating fuel in secondary containment - evidence of leakage from drums

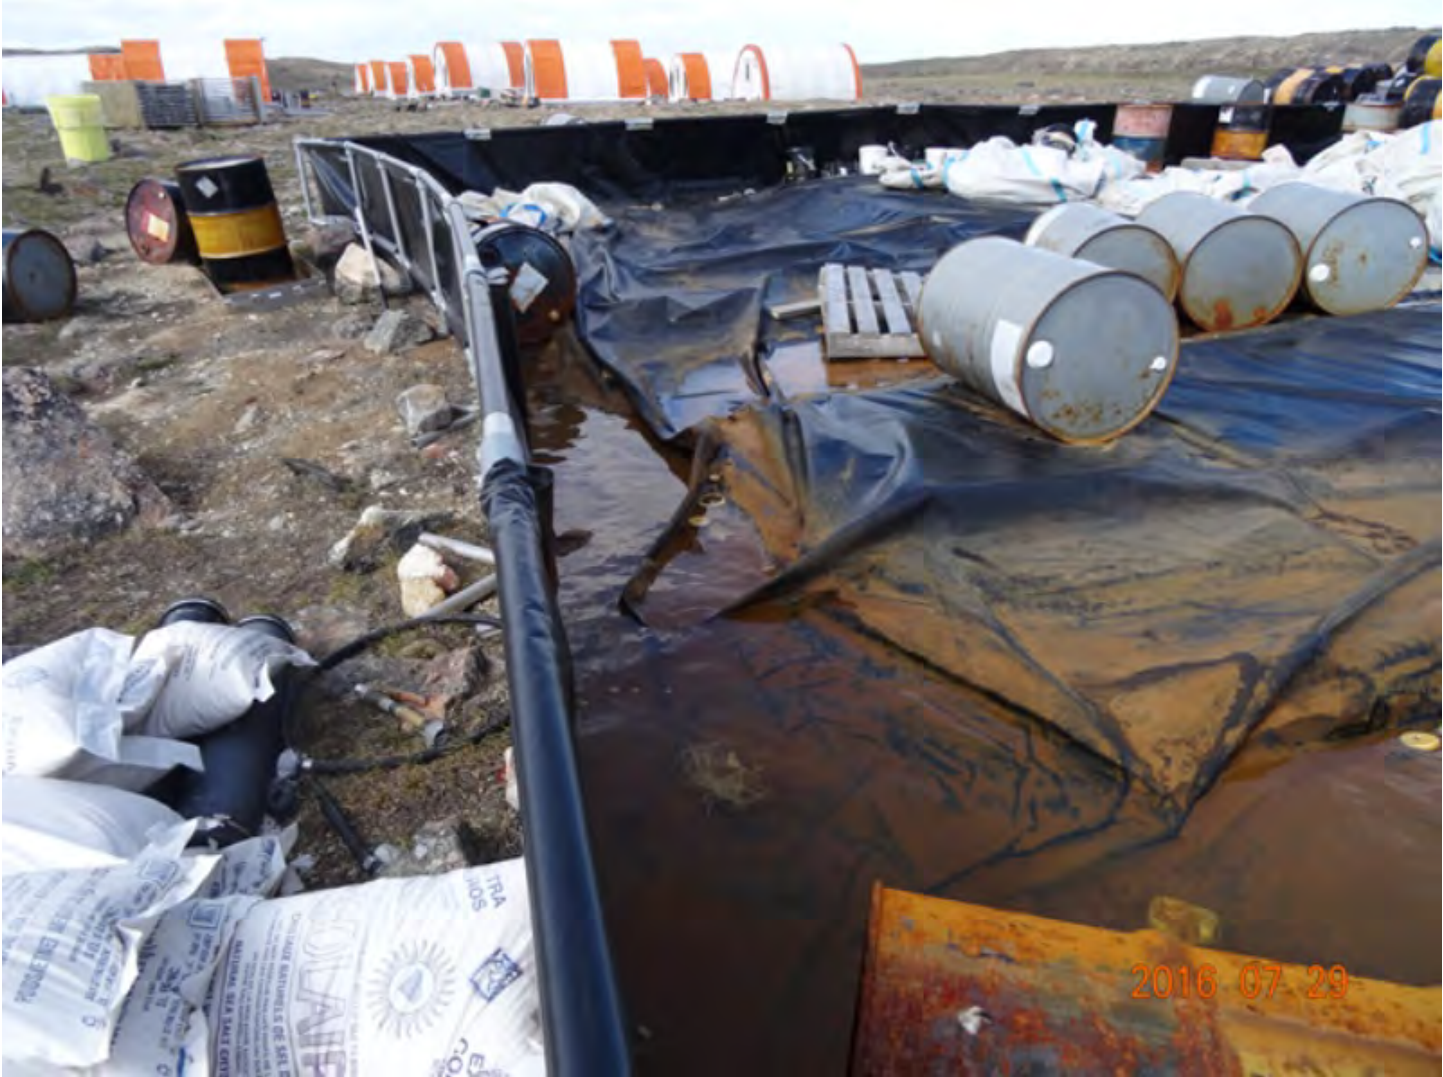
- Secondary containment (4) has been blown/ knocked down in a number of places. (Unserviceable)
- Wind blown garbage is scattered across the tundra and down to the shore from the Laydown

Figure 5 Secondary Containment with water and waste fuel

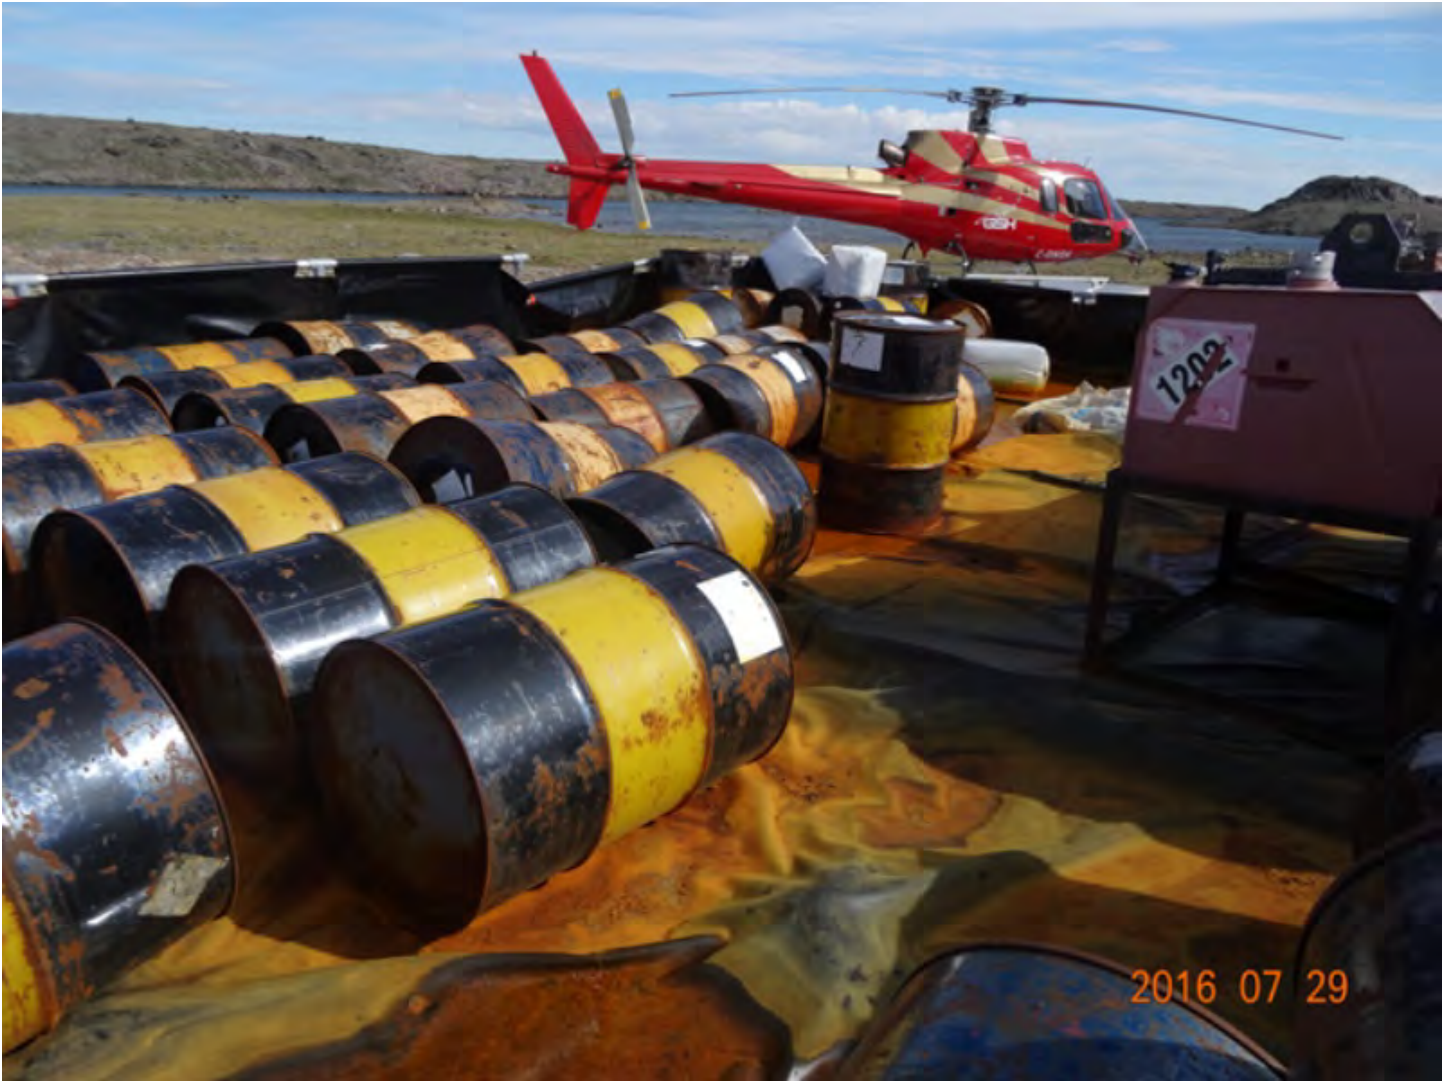
Figure 6 Secondary Containment with barrels of fuel and water

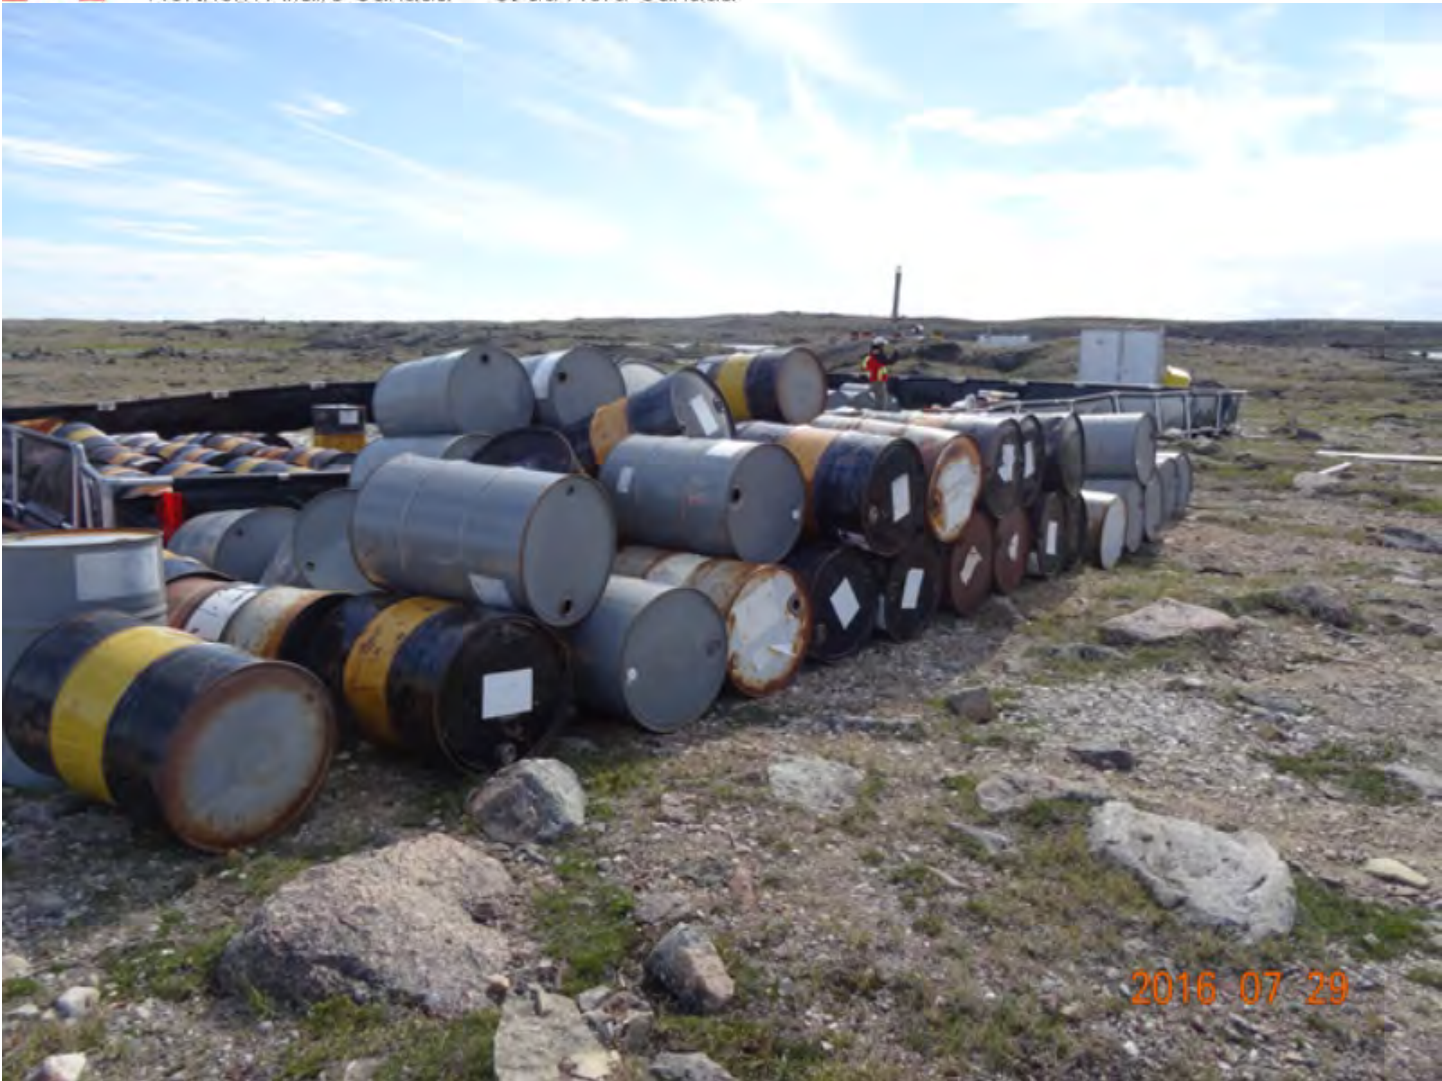
Figure 7 Unsecured drums laying outside secondary containment

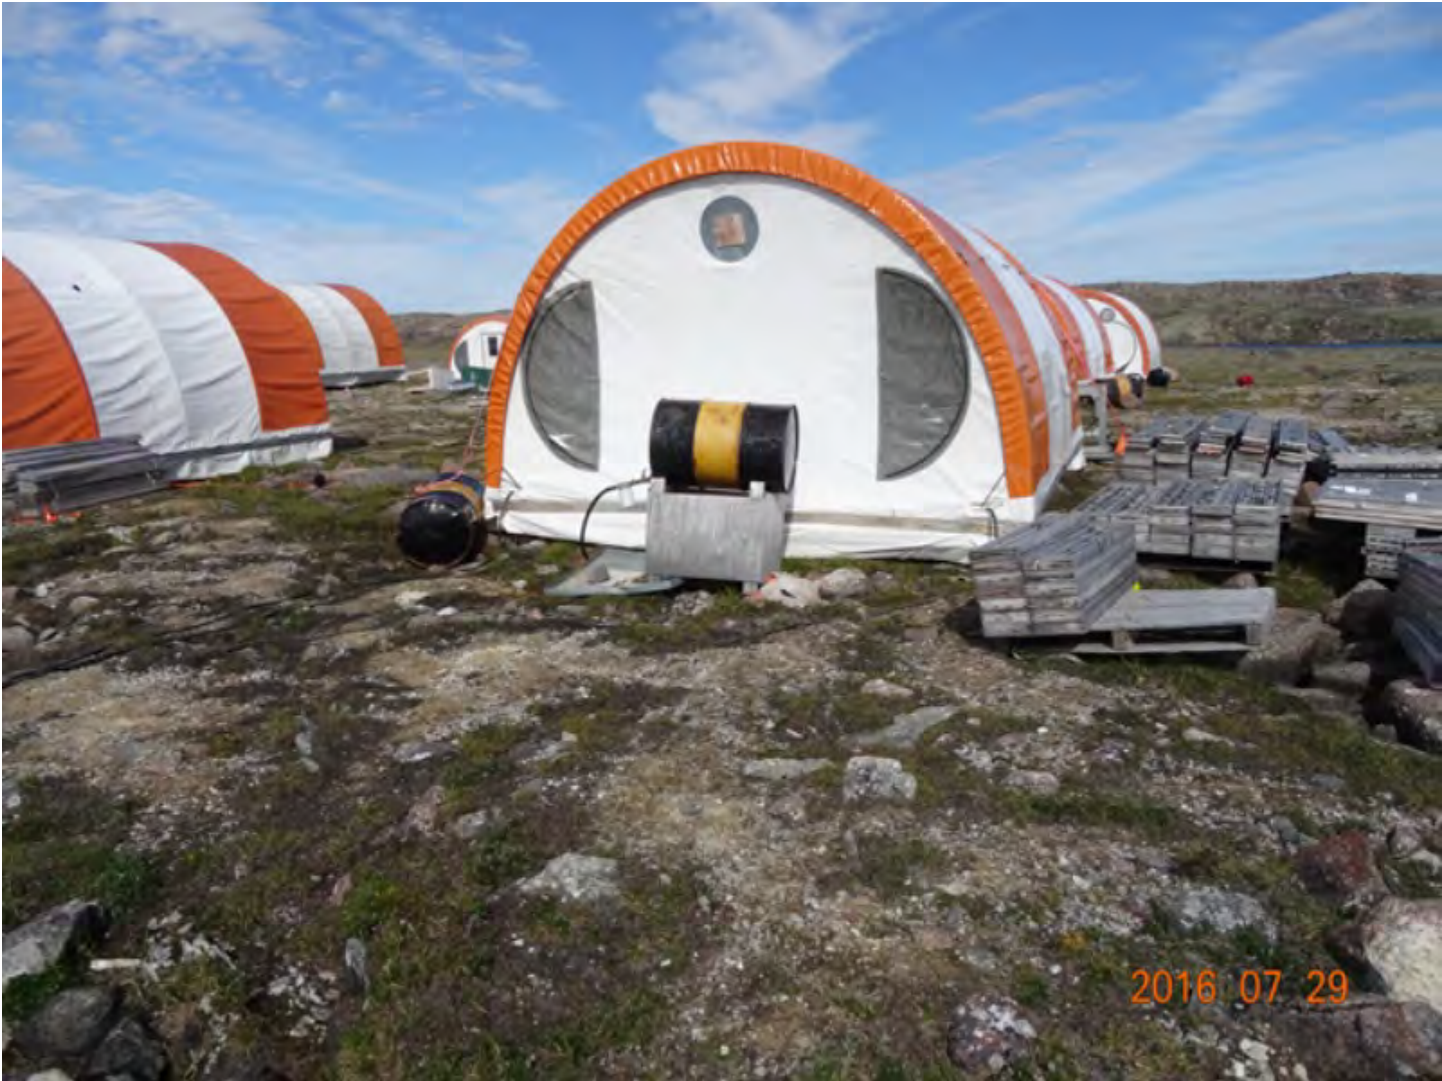
- Barrels of heating fuel were left on wooden stands behind the weather havens. Some have blown off nd lost their contents on the ground around the tents.

Figure 8 45 gallon drum of heating fuel unsecured on a wooden stand behind tent

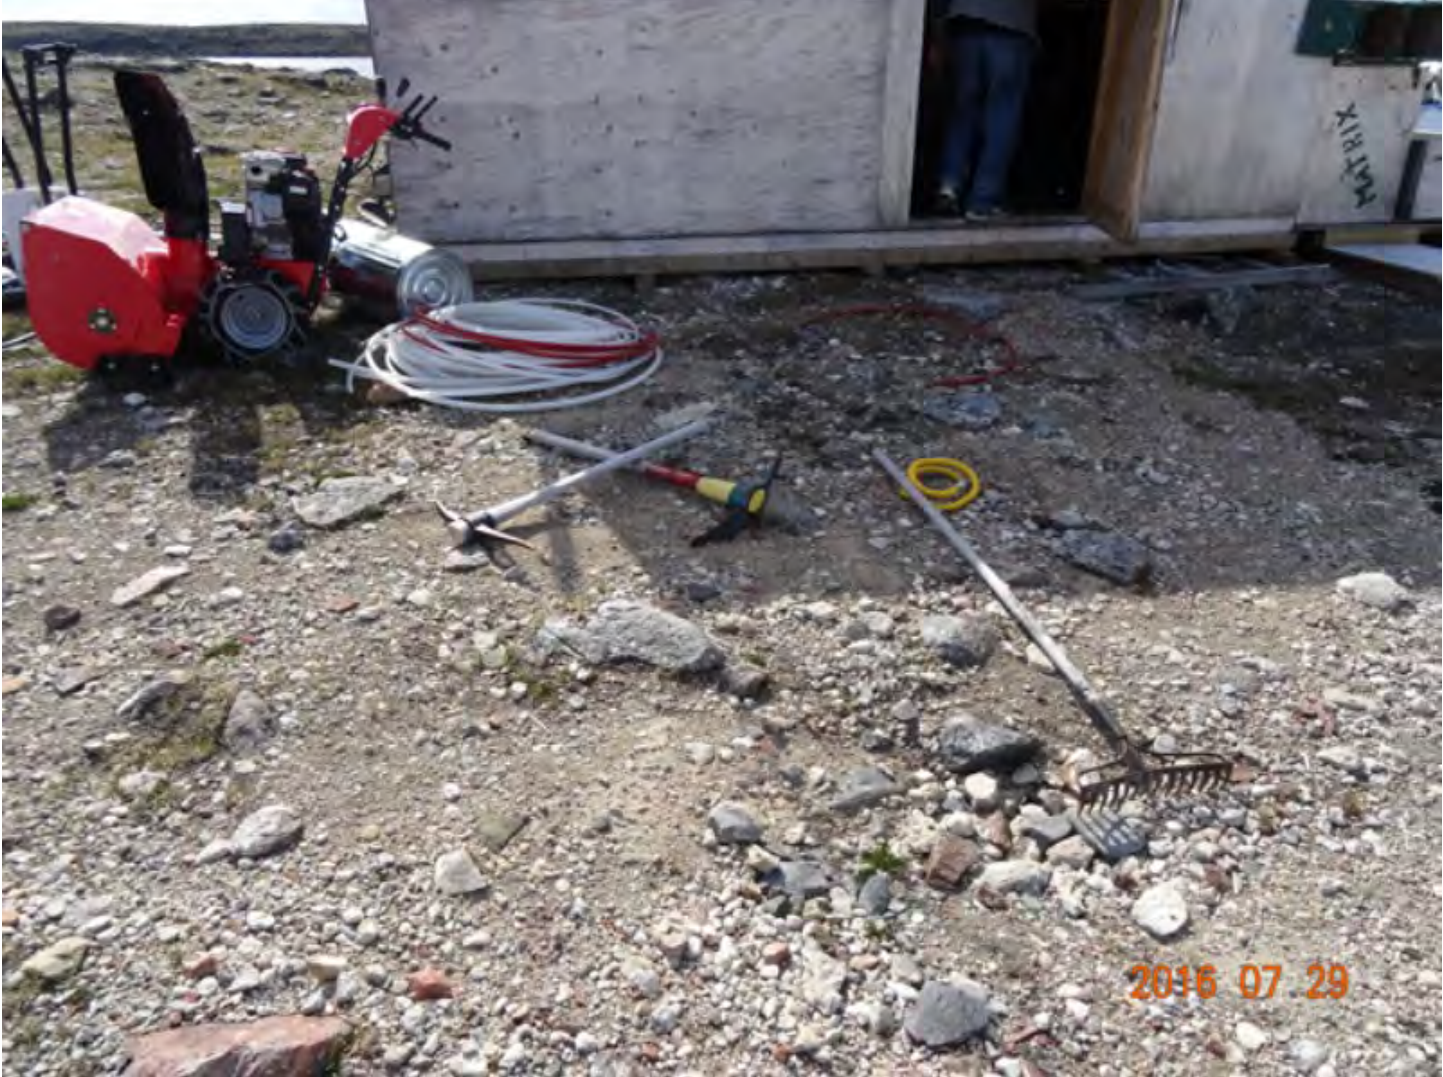
Figure 9 Hand tools and equipment outside storage shed on site

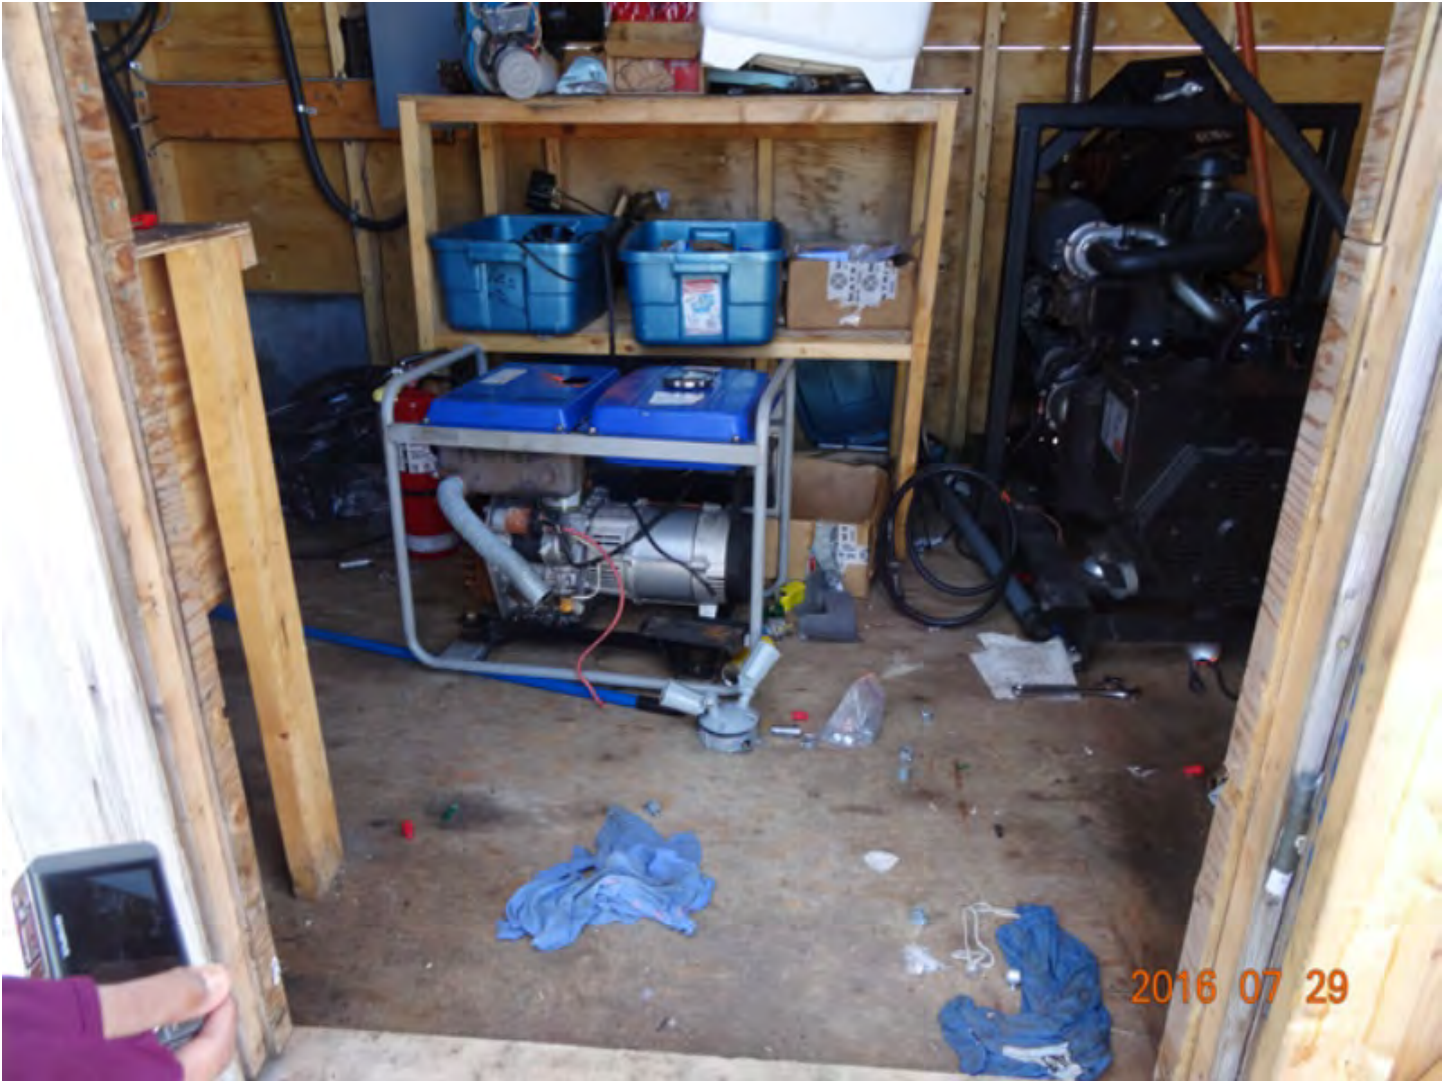
- The Generator shack gave off the smell of fuel and staining around the shack was identified during the inspection. The generator remains in place in the shack.

Figure 10 Gen set on site - tank has fuel

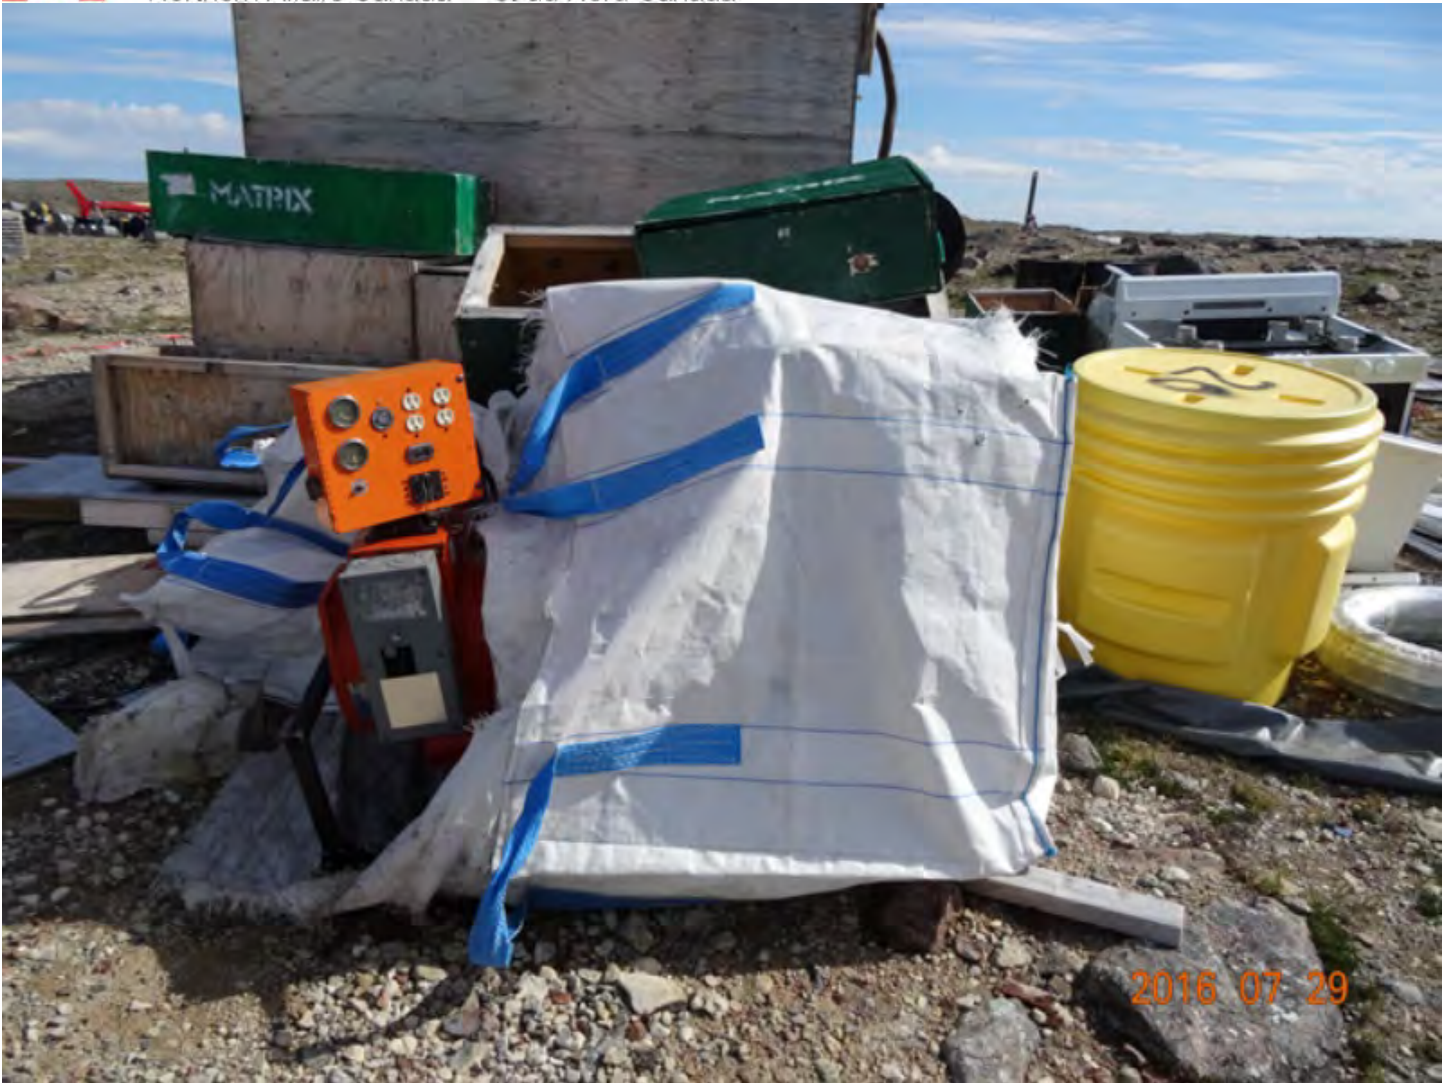
Figure 11 misc equipment and gen set for drillers rig behind main storage shed

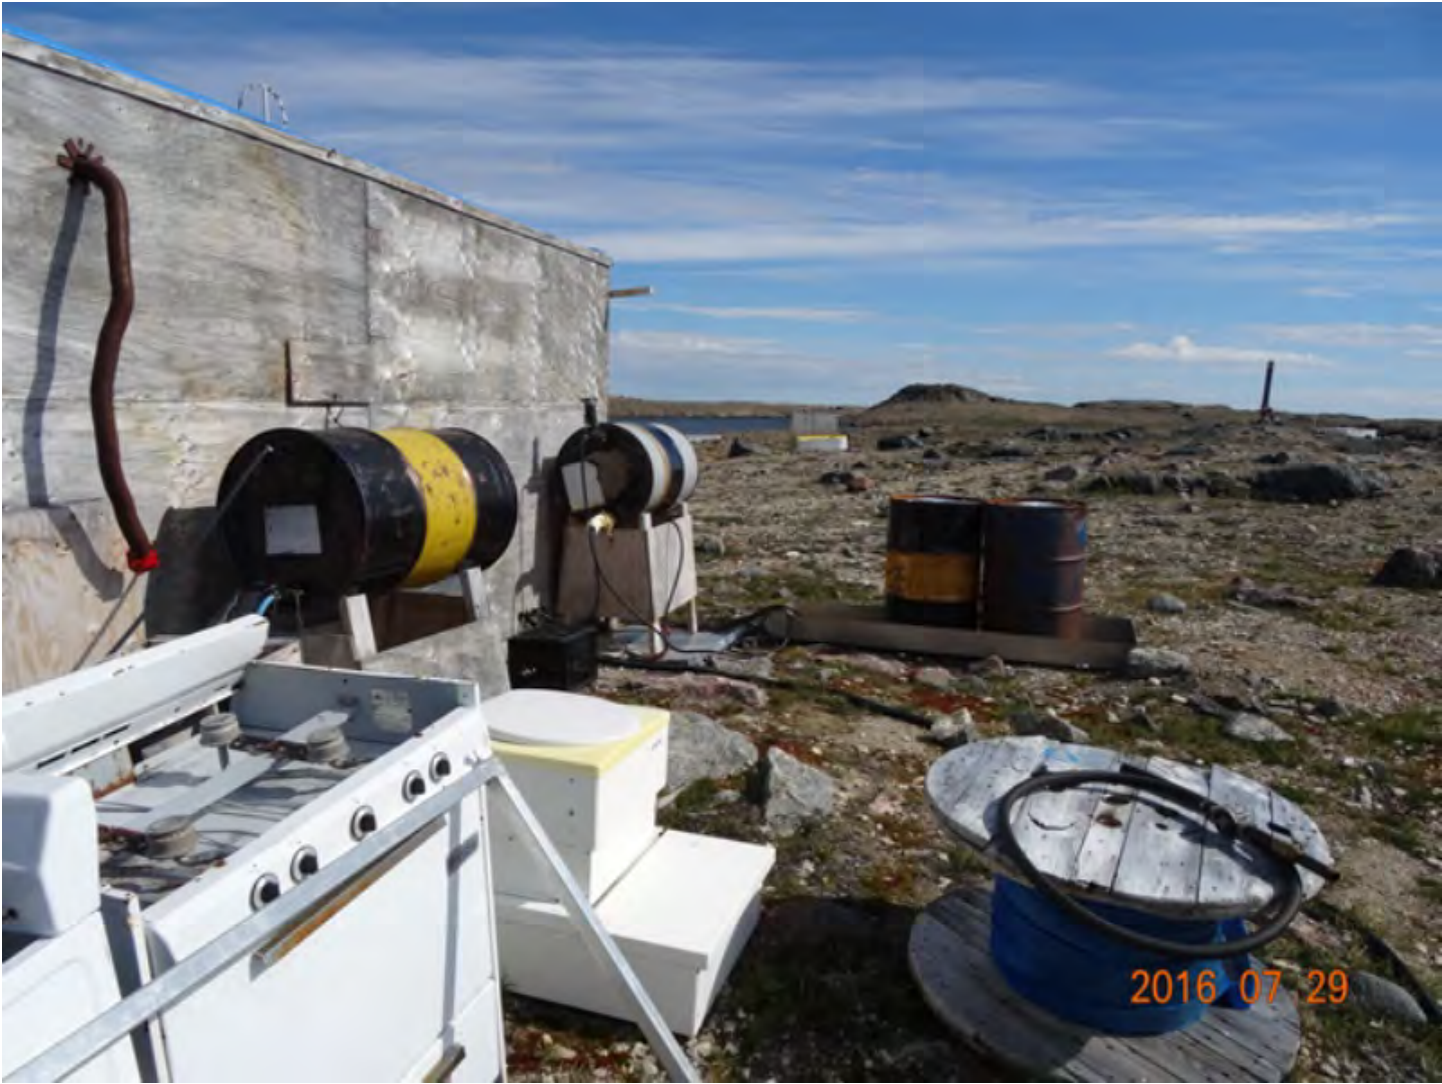
Figure 12 45 gallon drums of fuel , unsecured on wooden stands - no secondary containment

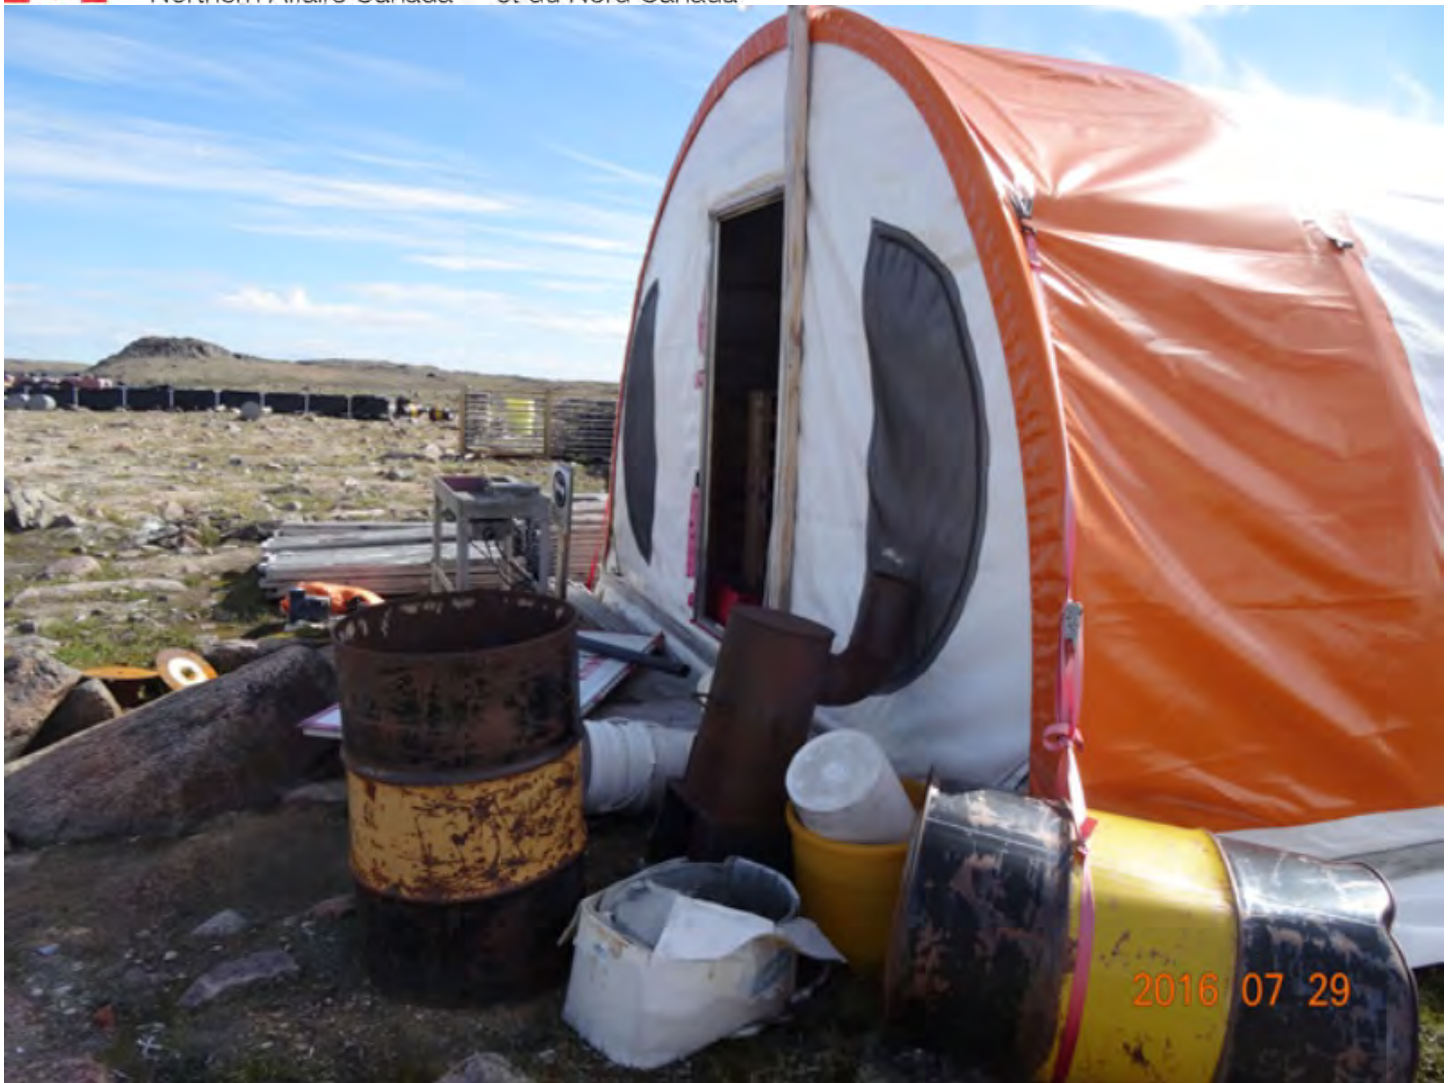
Figure 13 waste materials and broken doors at tents at the Tuktu site

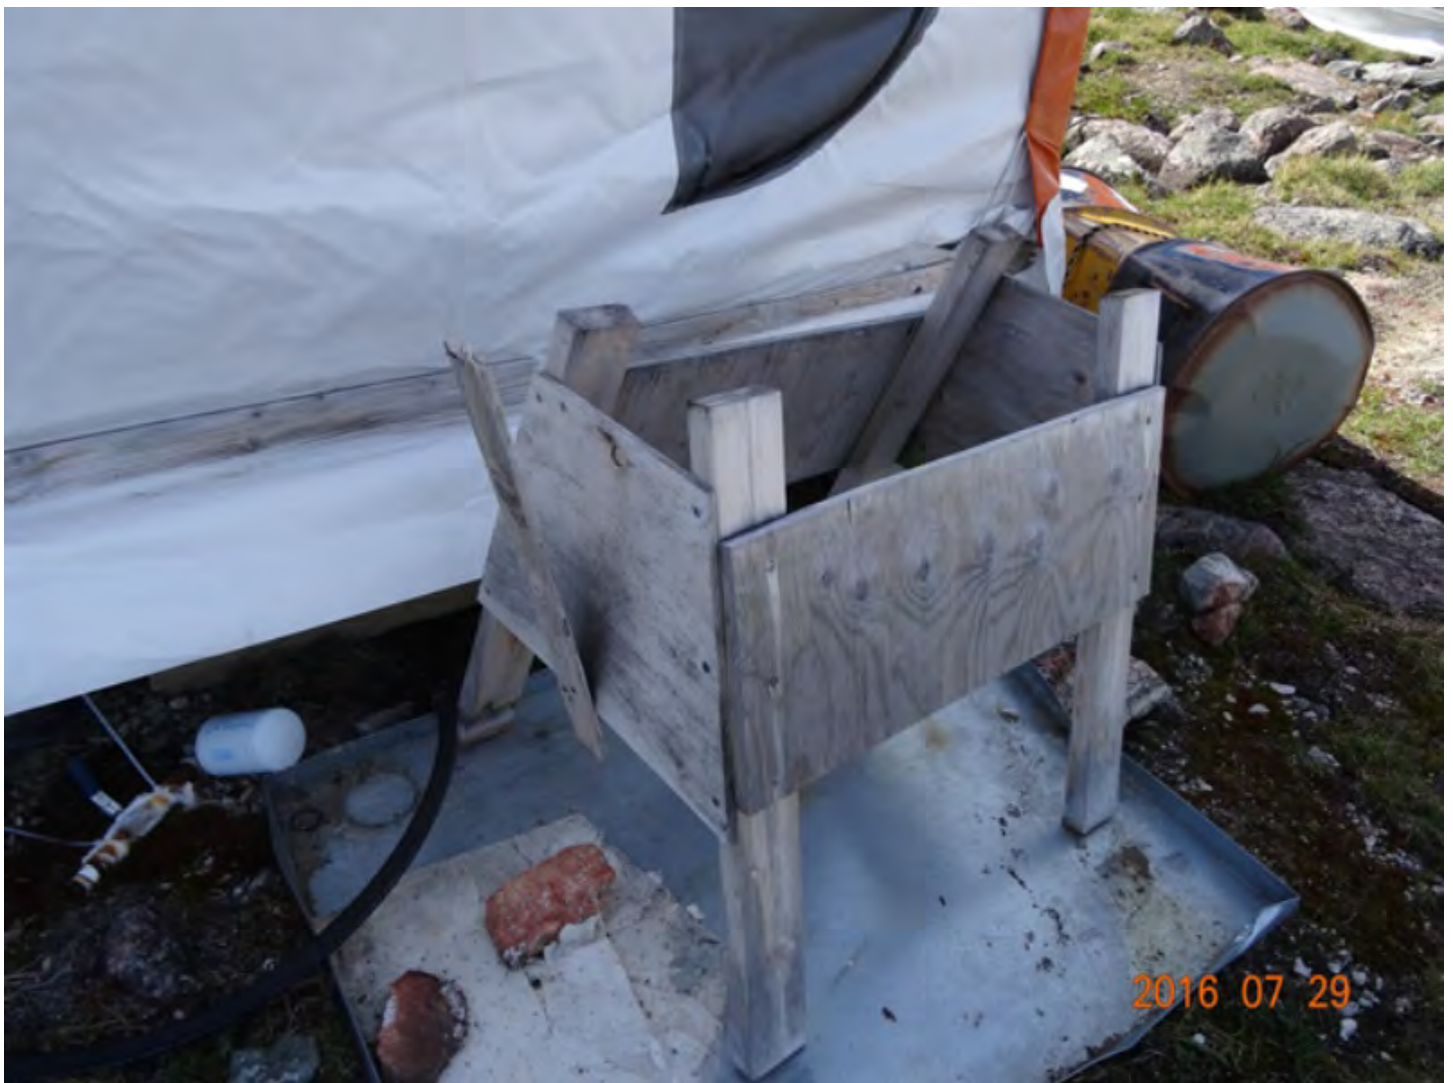
Figure 14 Broken wooden stand
