WATER LICENCE INSPECTION FORM

Licensee		Licensee Representative	
John Gingerich President and CEO Advanced Explorations Inc. 50 Richmond Street East, Suite 300 Toronto ON M5C 1N7 Canada E-mail: john@advanced-exploration.com		None.	
Licence No. / Expiry		Representative's Title	
2BE-TUK1015 – EXPIRED		None	
Land / Other Authorizations		Land / Other Authorizations	
N2010C0011 / N2012C0013		QIA – Q12L3CF009	
Date of Inspection		Inspector	
July 29, 2016		A.Keim	
Activities Inspected			
<div><input checked="" type="checkbox"/> Camp<input checked="" type="checkbox"/> Drilling<input type="checkbox"/> Mining<input type="checkbox"/> Construction<input type="checkbox"/> Reclamation<input type="checkbox"/> Fuel Storage</div> <div><input type="checkbox"/> Roads/Hauling<input type="checkbox"/> Other: Water Discharge<input type="checkbox"/> Other: Municipal</div>

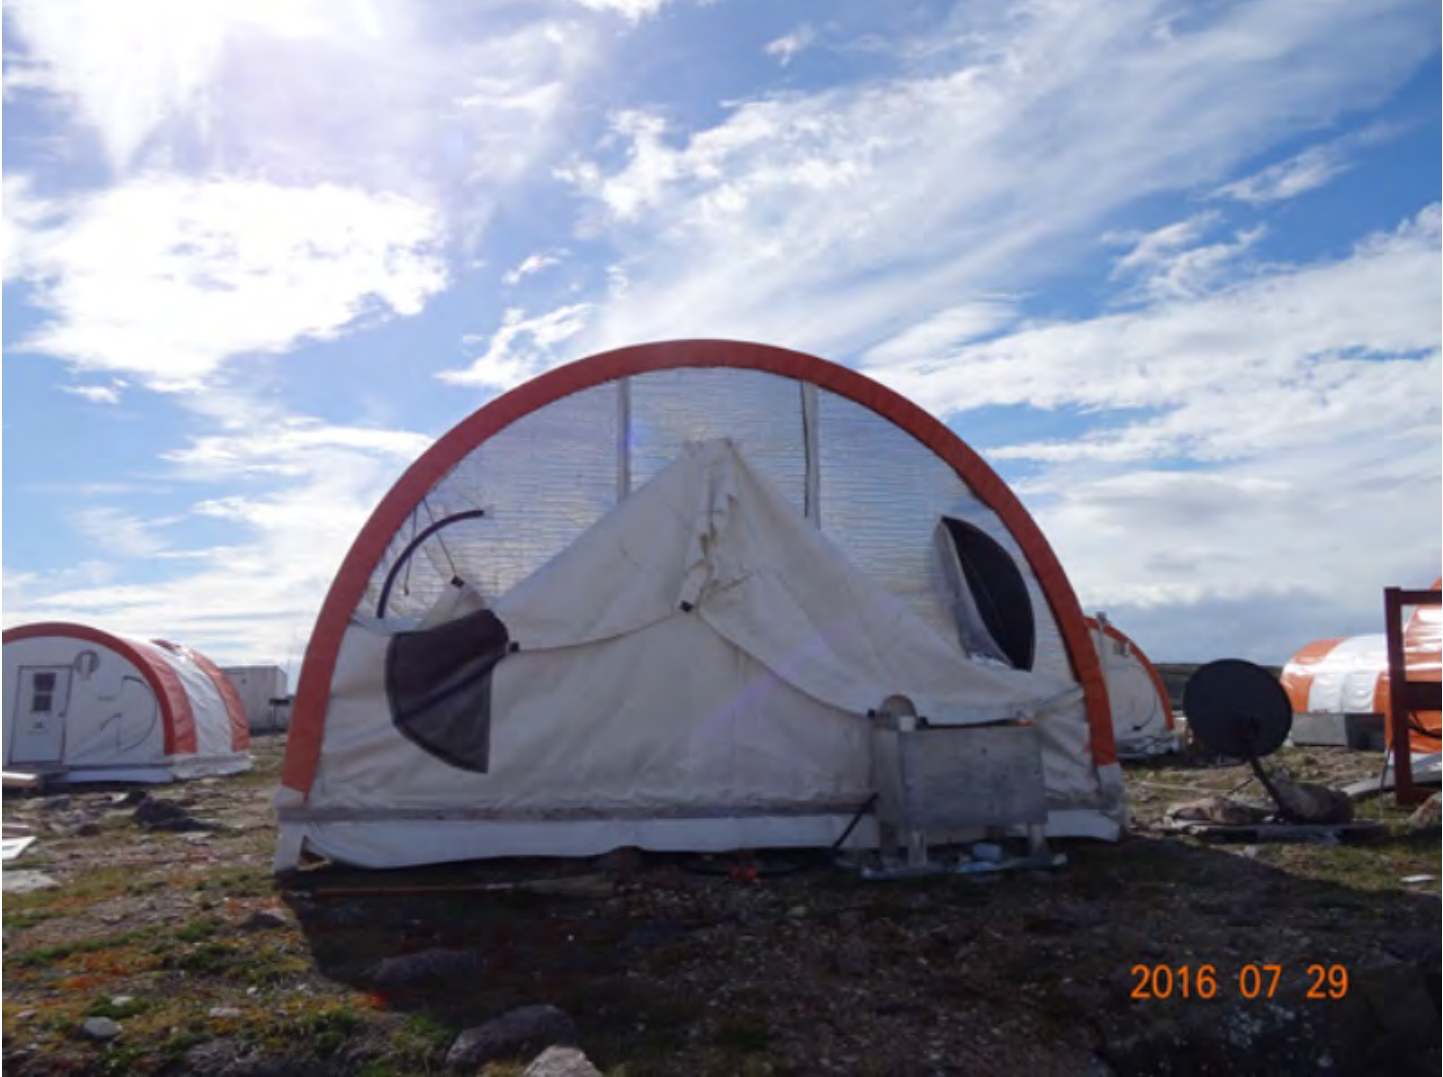
Figure 15 Weather haven tent needs repair

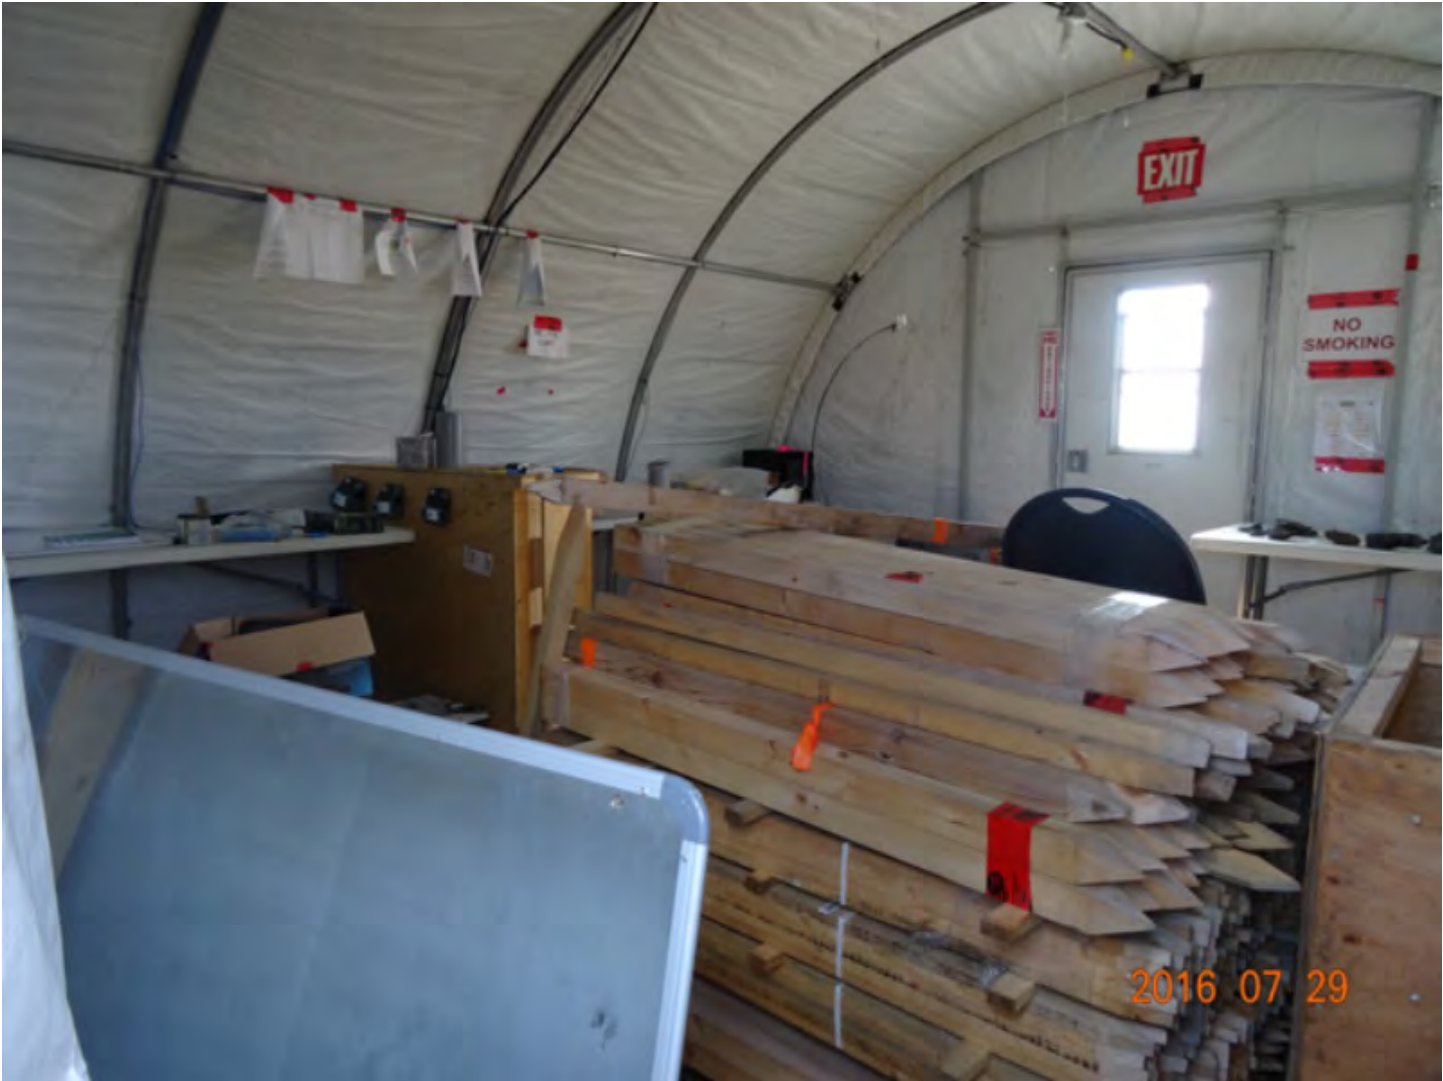
Figure 16 Misc equipment and supplies stored in weather haven tent at tuktu camp

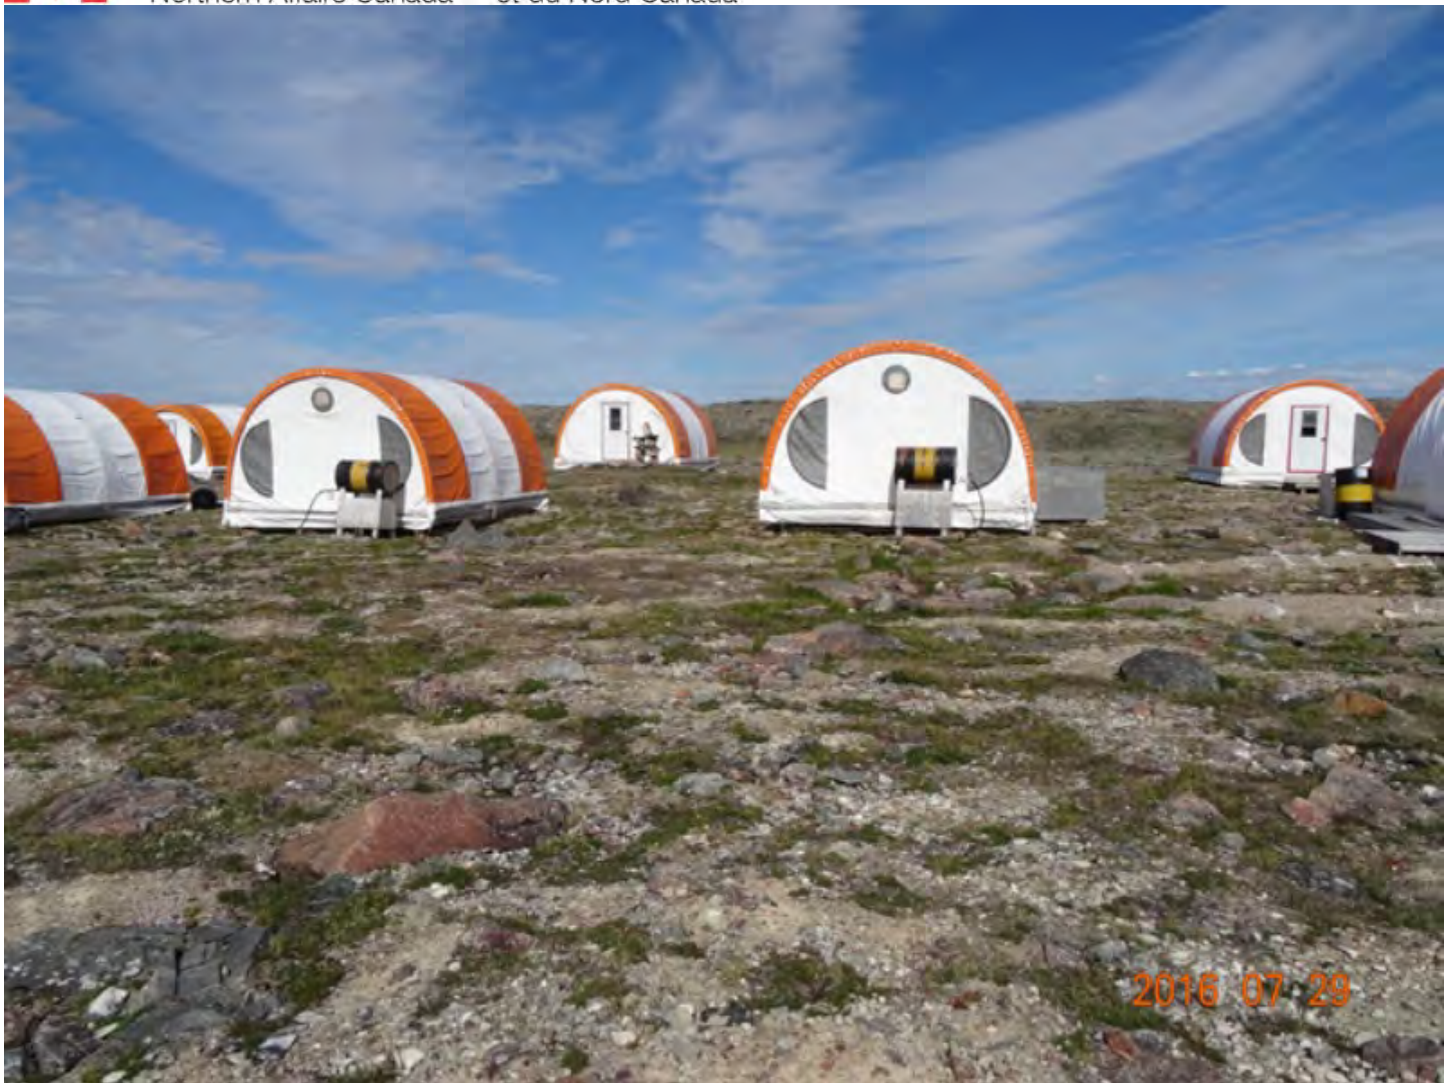
Figure 17 Weather Haven tents with fuel drums on wooden stands

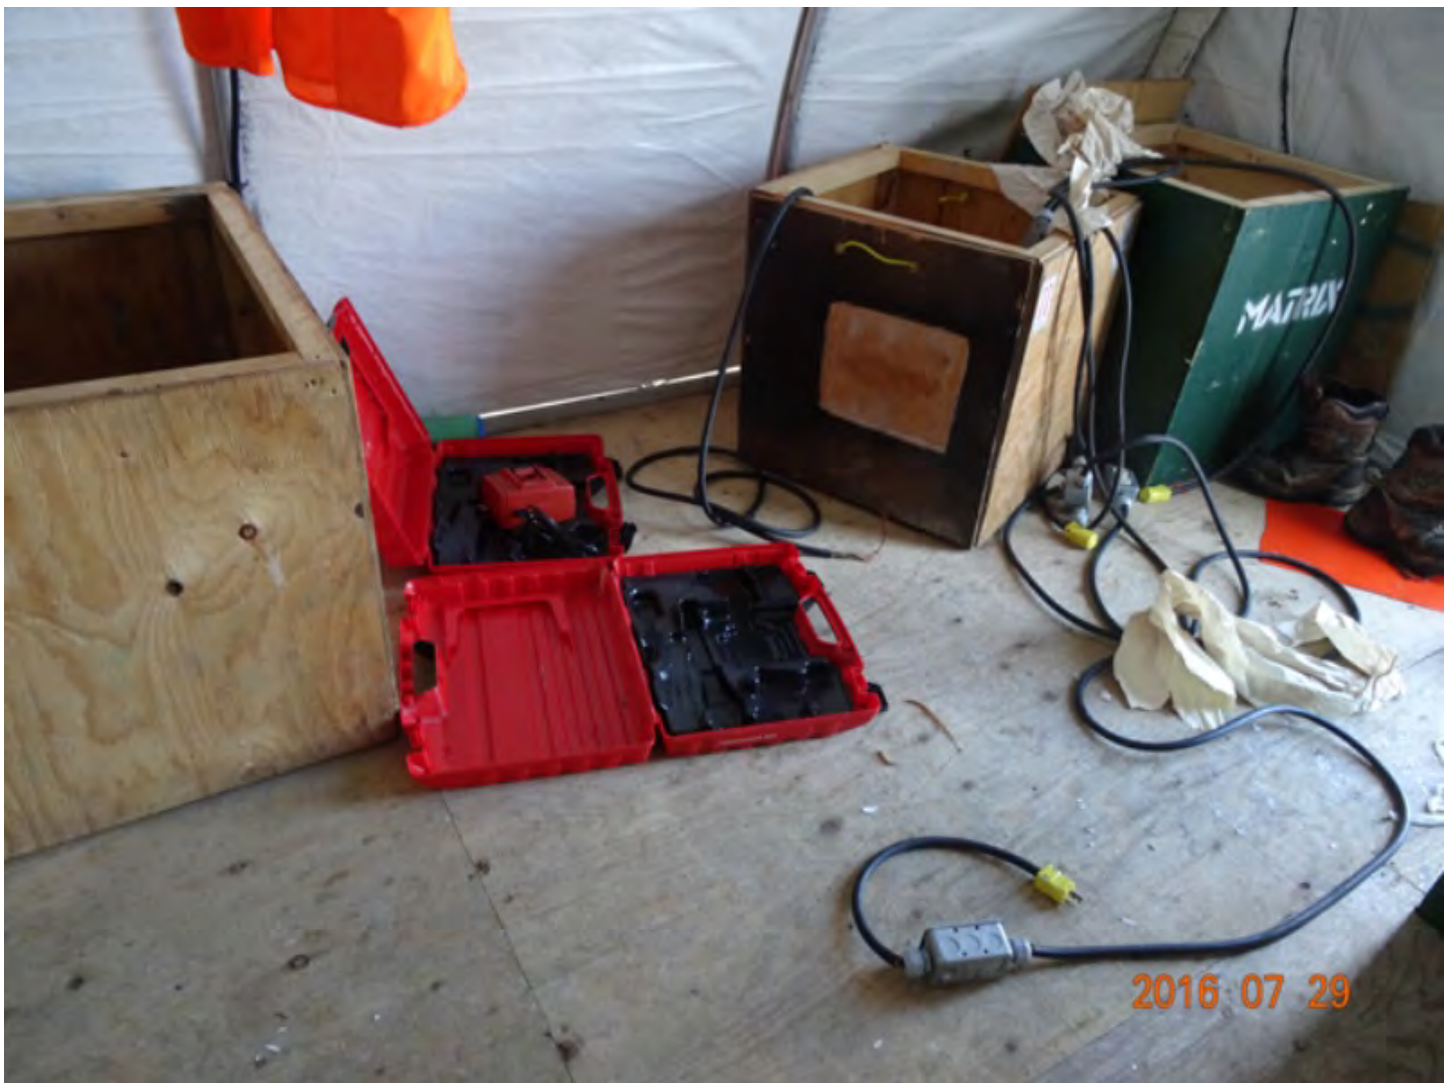
Figure 18 Misc. abandoned camp supplies found inside a weather haven

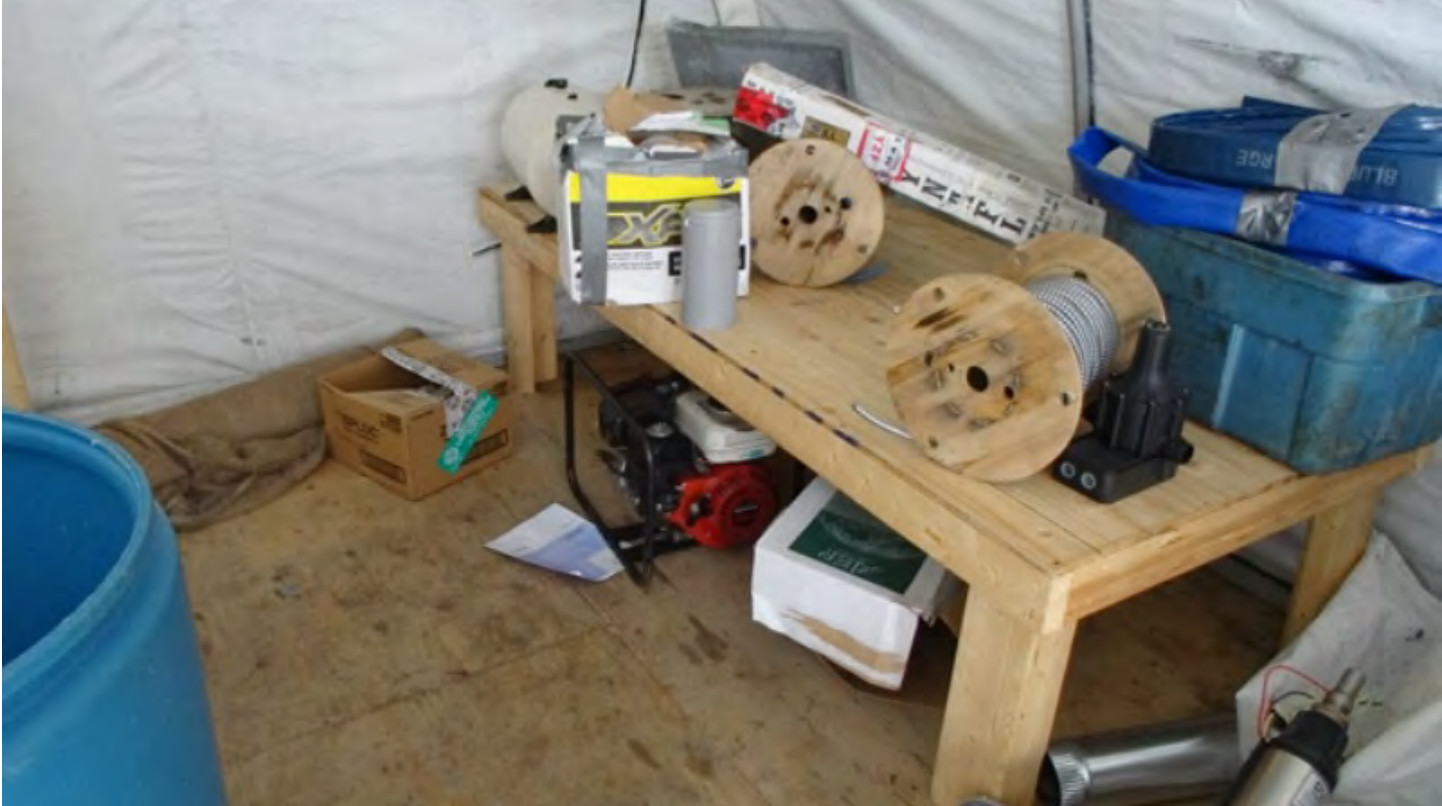
Figure 19 pumps and other tools abandoned at the Tuktu camp

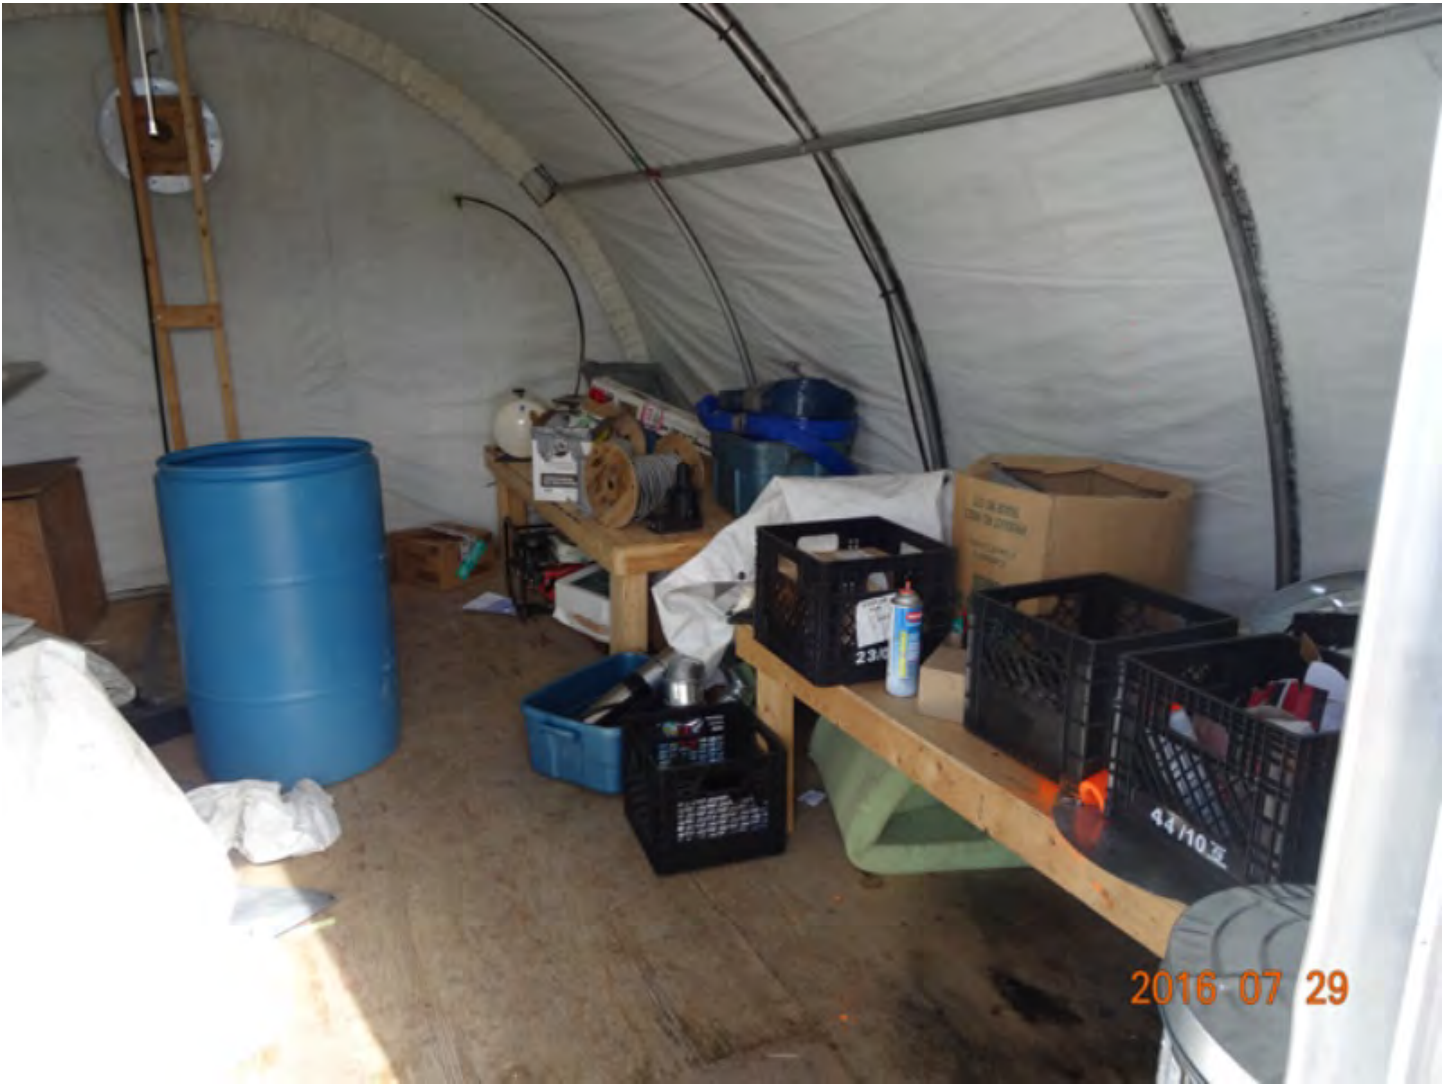
Figure 20 misc. supplies abandoned at the tuktu camp

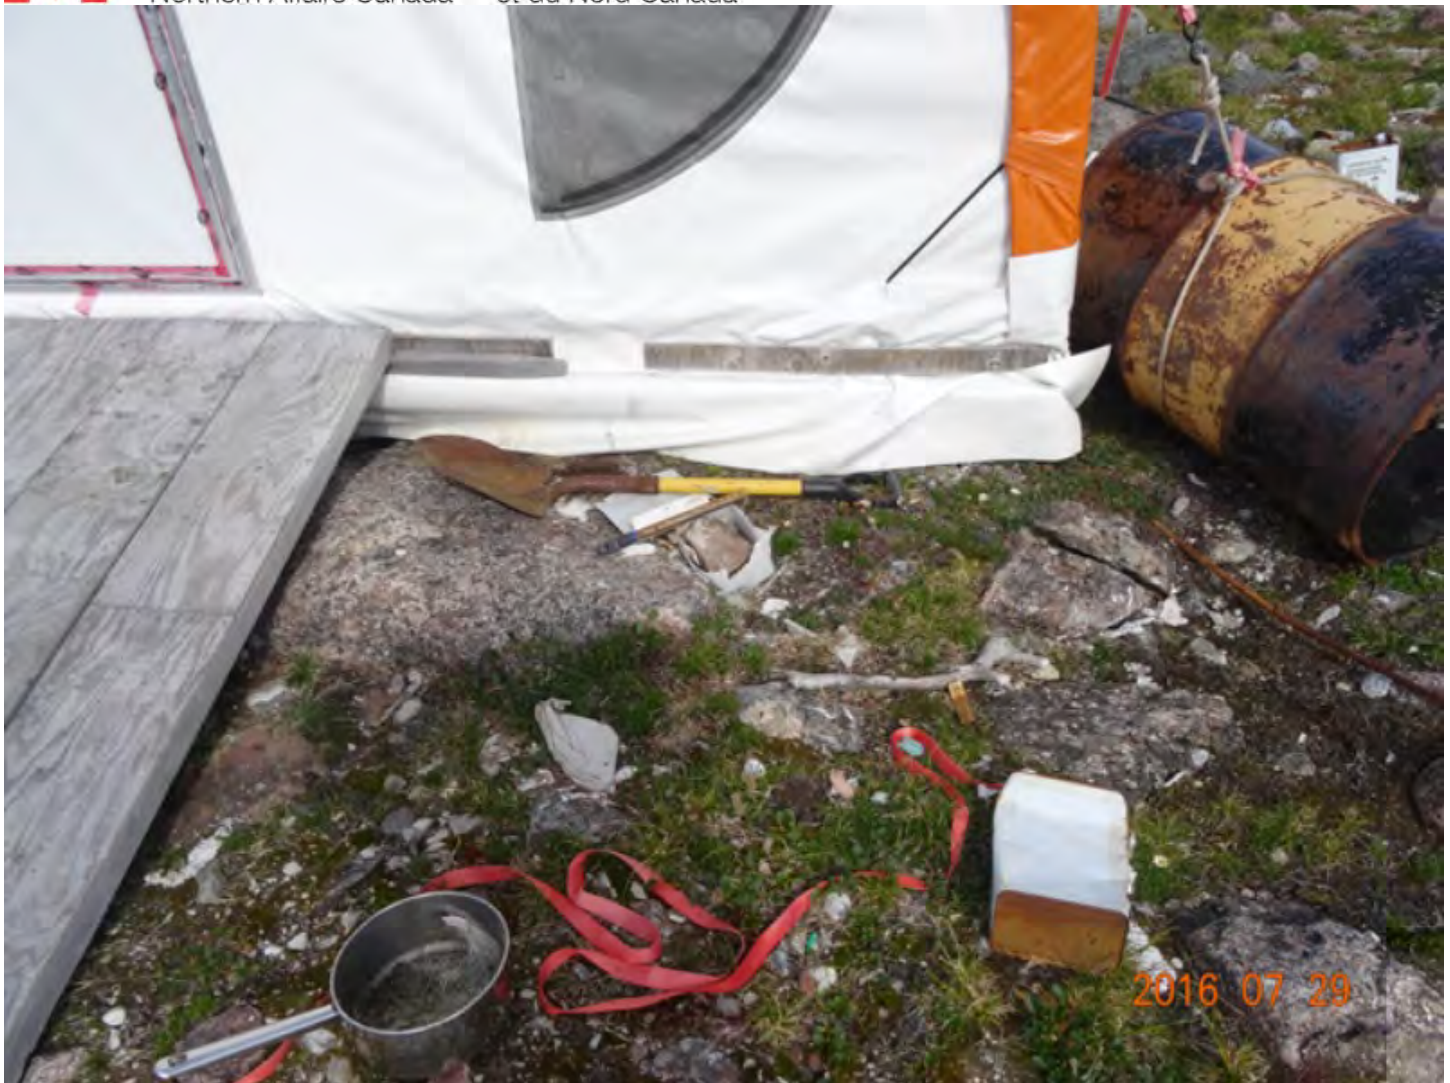
Figure 21 Hydrocarbon staining outside tents at the Tuktu Camp.

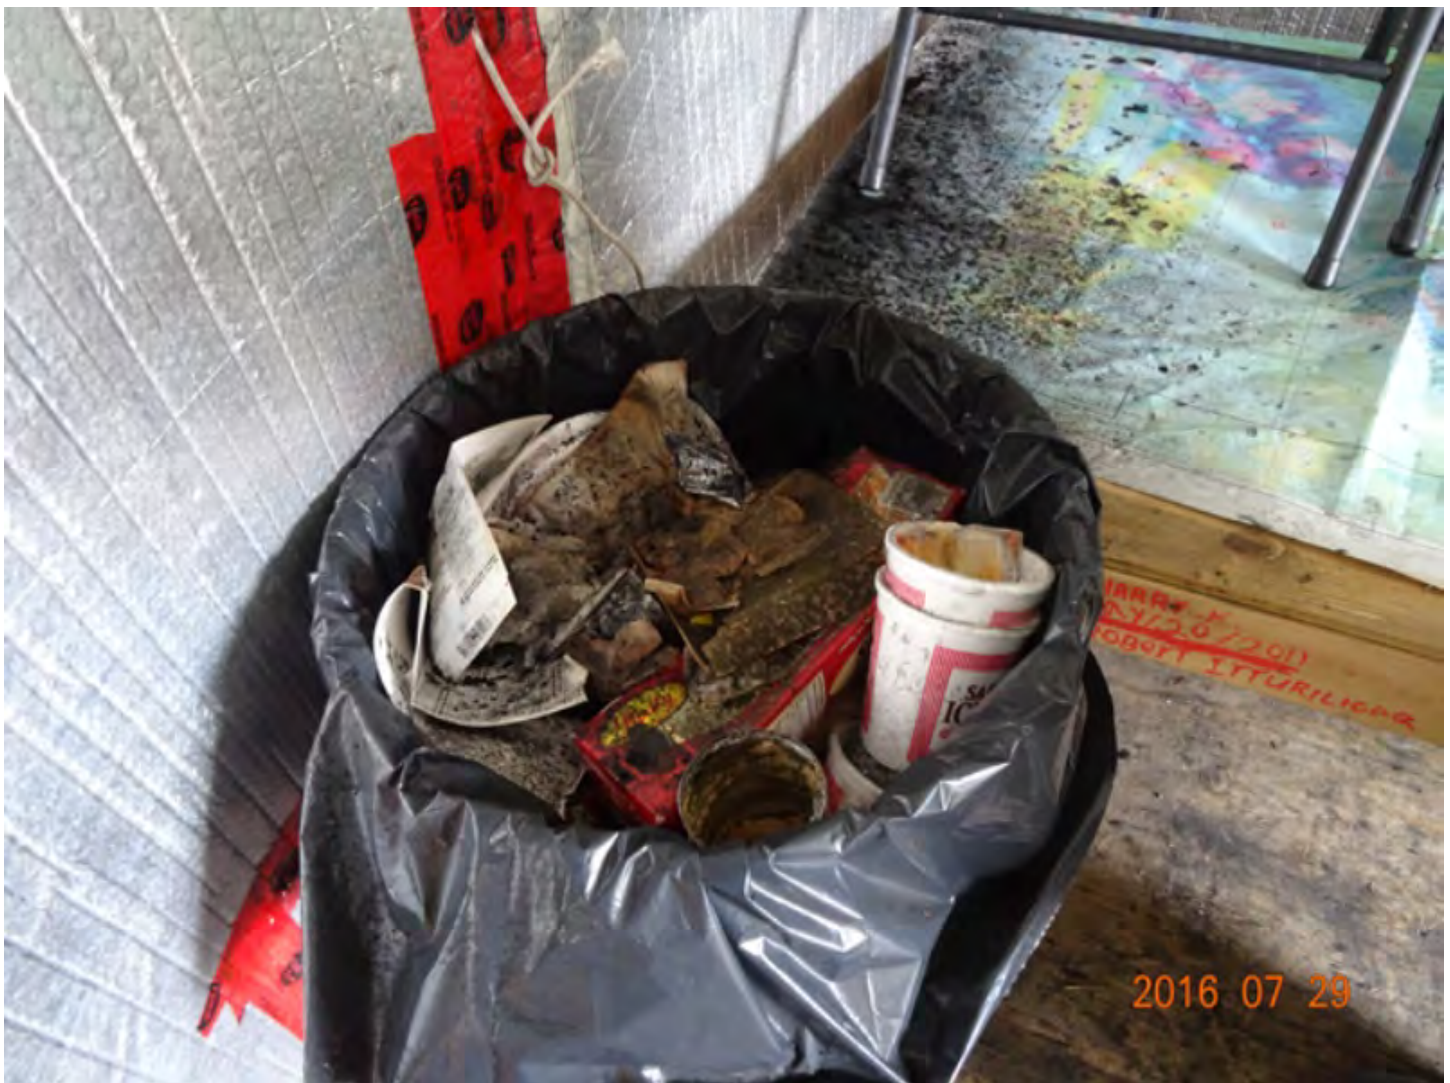
Figure 22 Garbage left on site in the cook tent at Tuktu Camp site

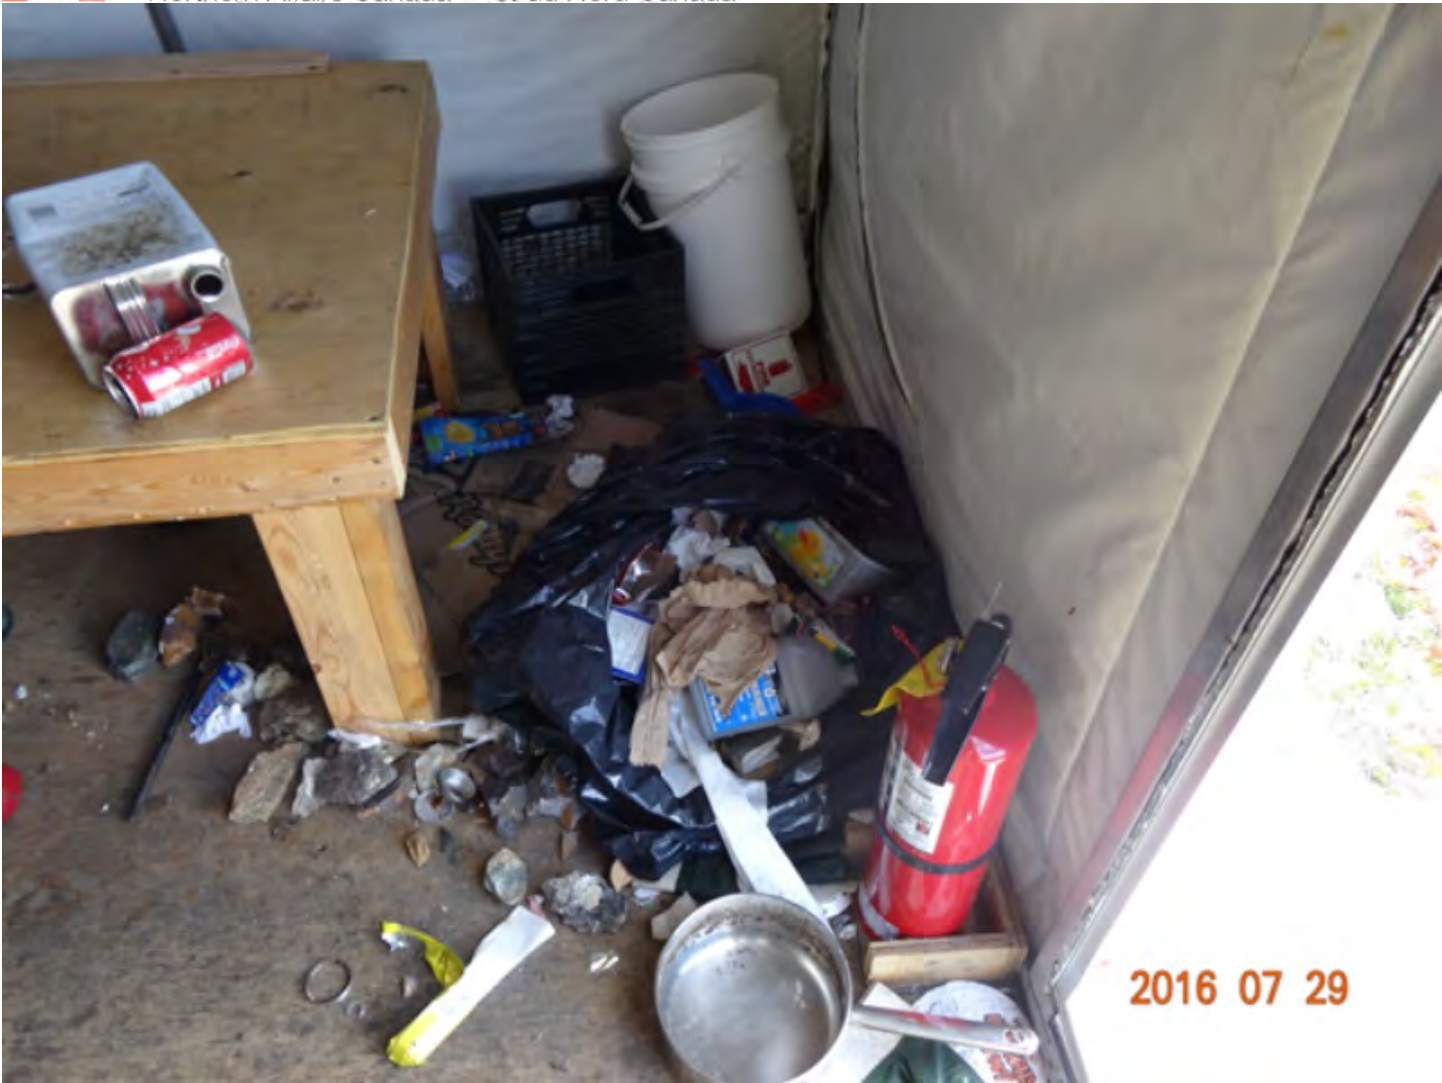
Figure 23 Bags of garbage left behind in the weather haven tents at the Tuktu Camp

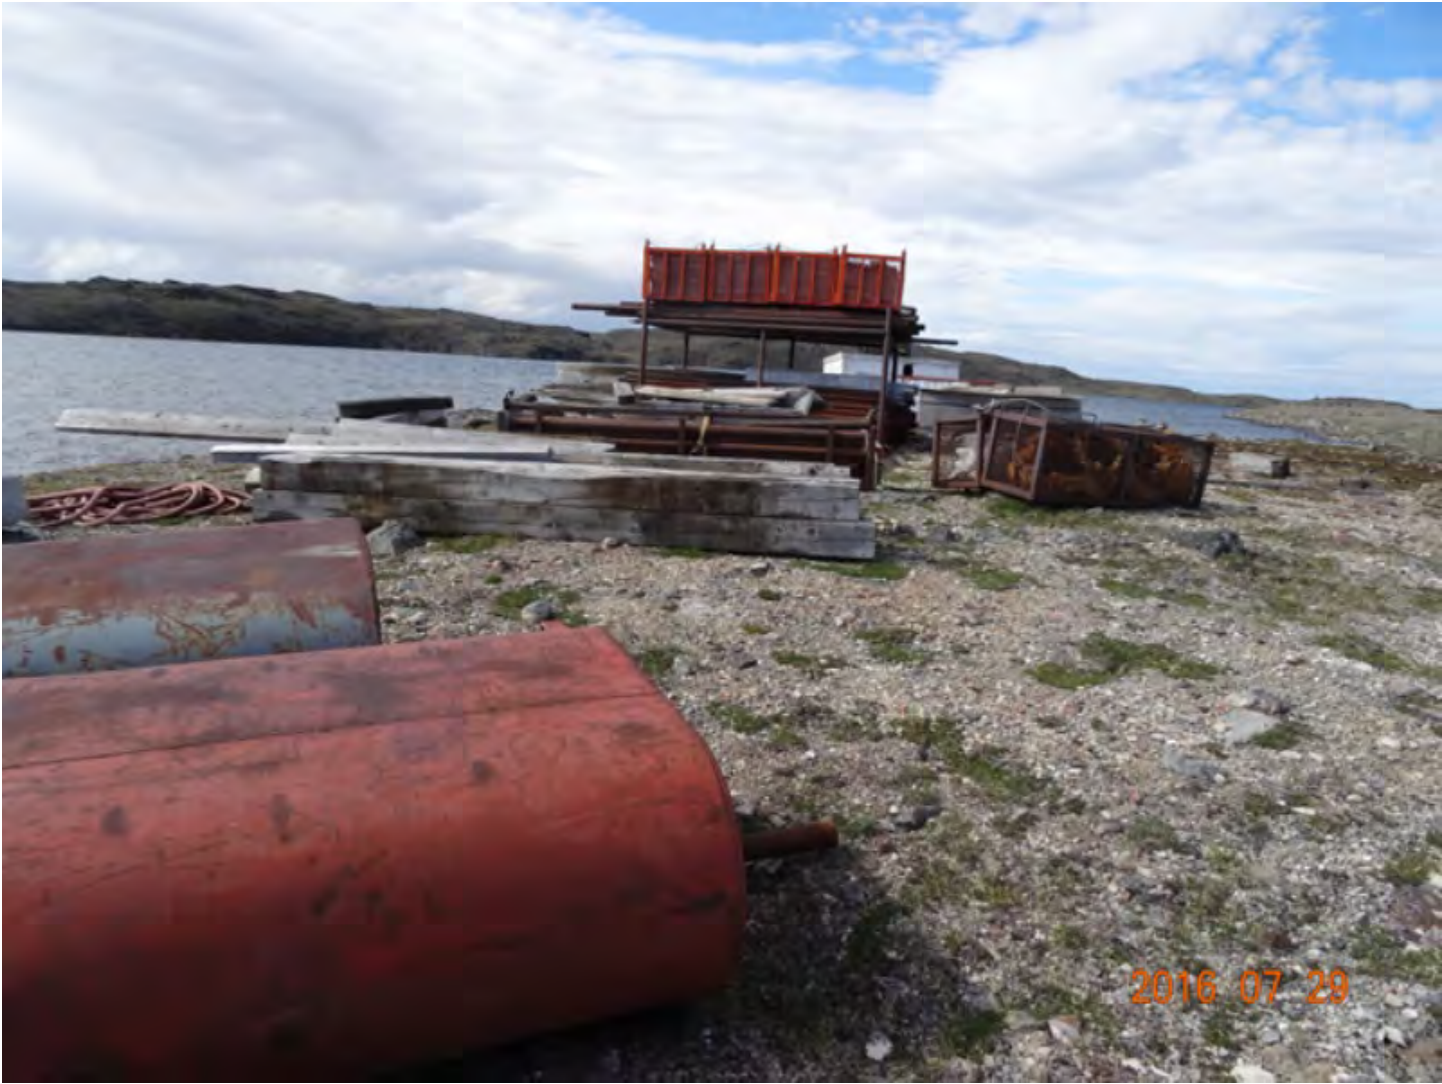
- The ground shows evidence of a number of hydrocarbon spills throughout the site.
- Inside the emergency shelter at the driller’ lay down were buckets of oil and various lube oils for use on the drills

Figure 24 Drillers laydown at the Tuktu Camp

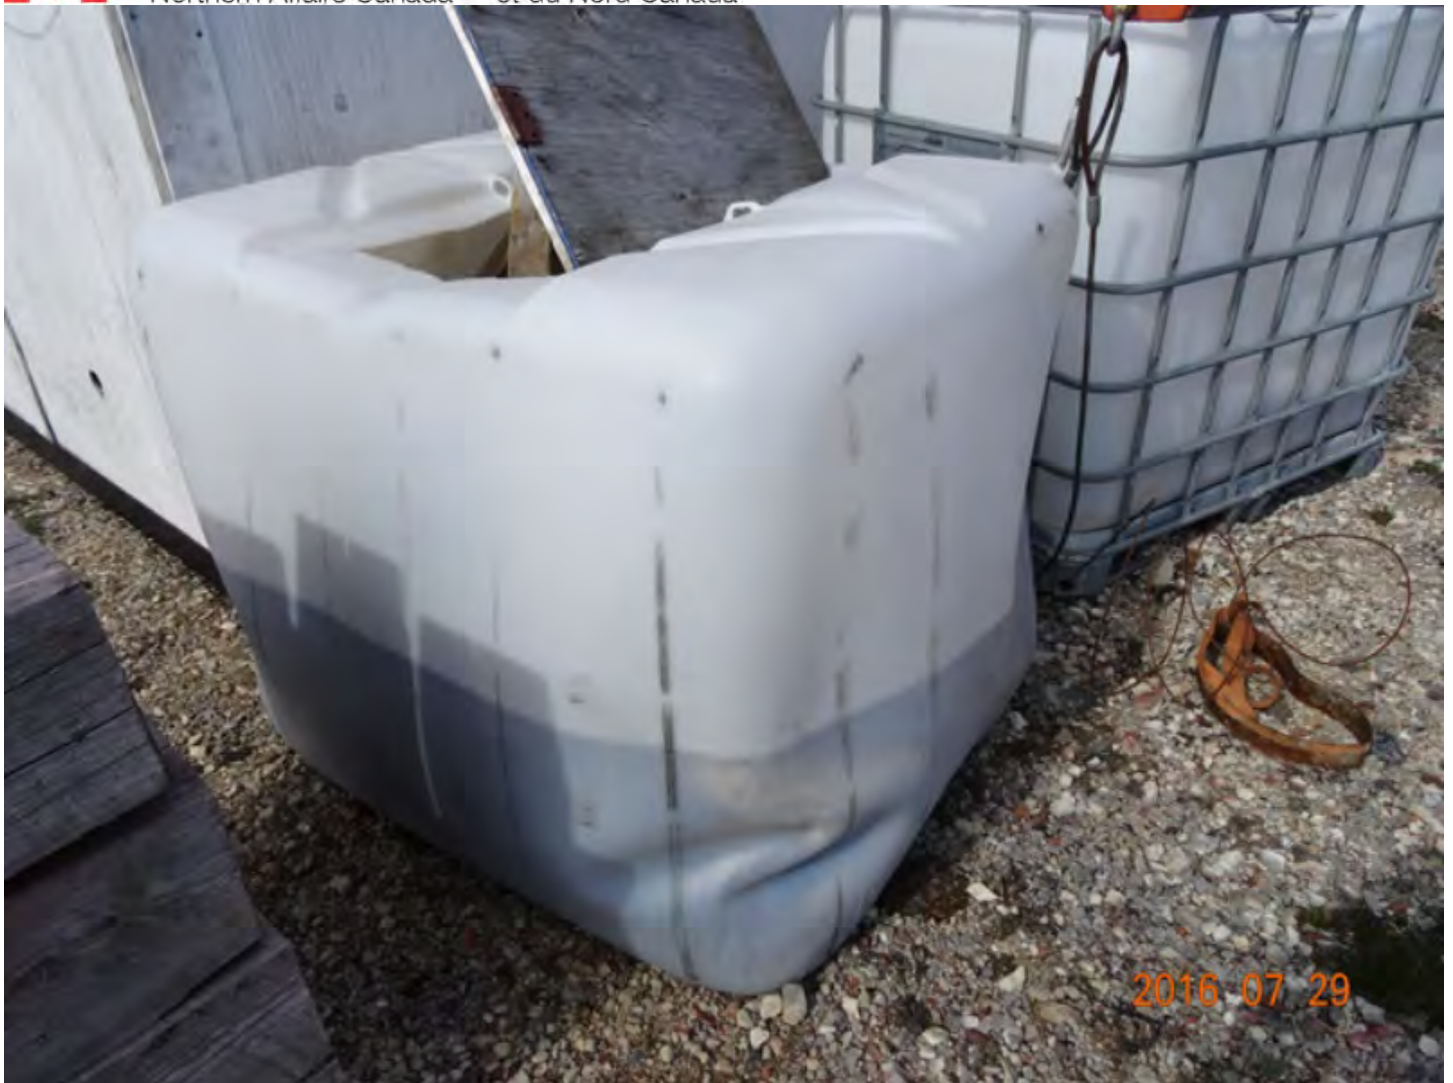
Figure 25 Unknown liquid waste at the driller's lay down at Tuktu Camp

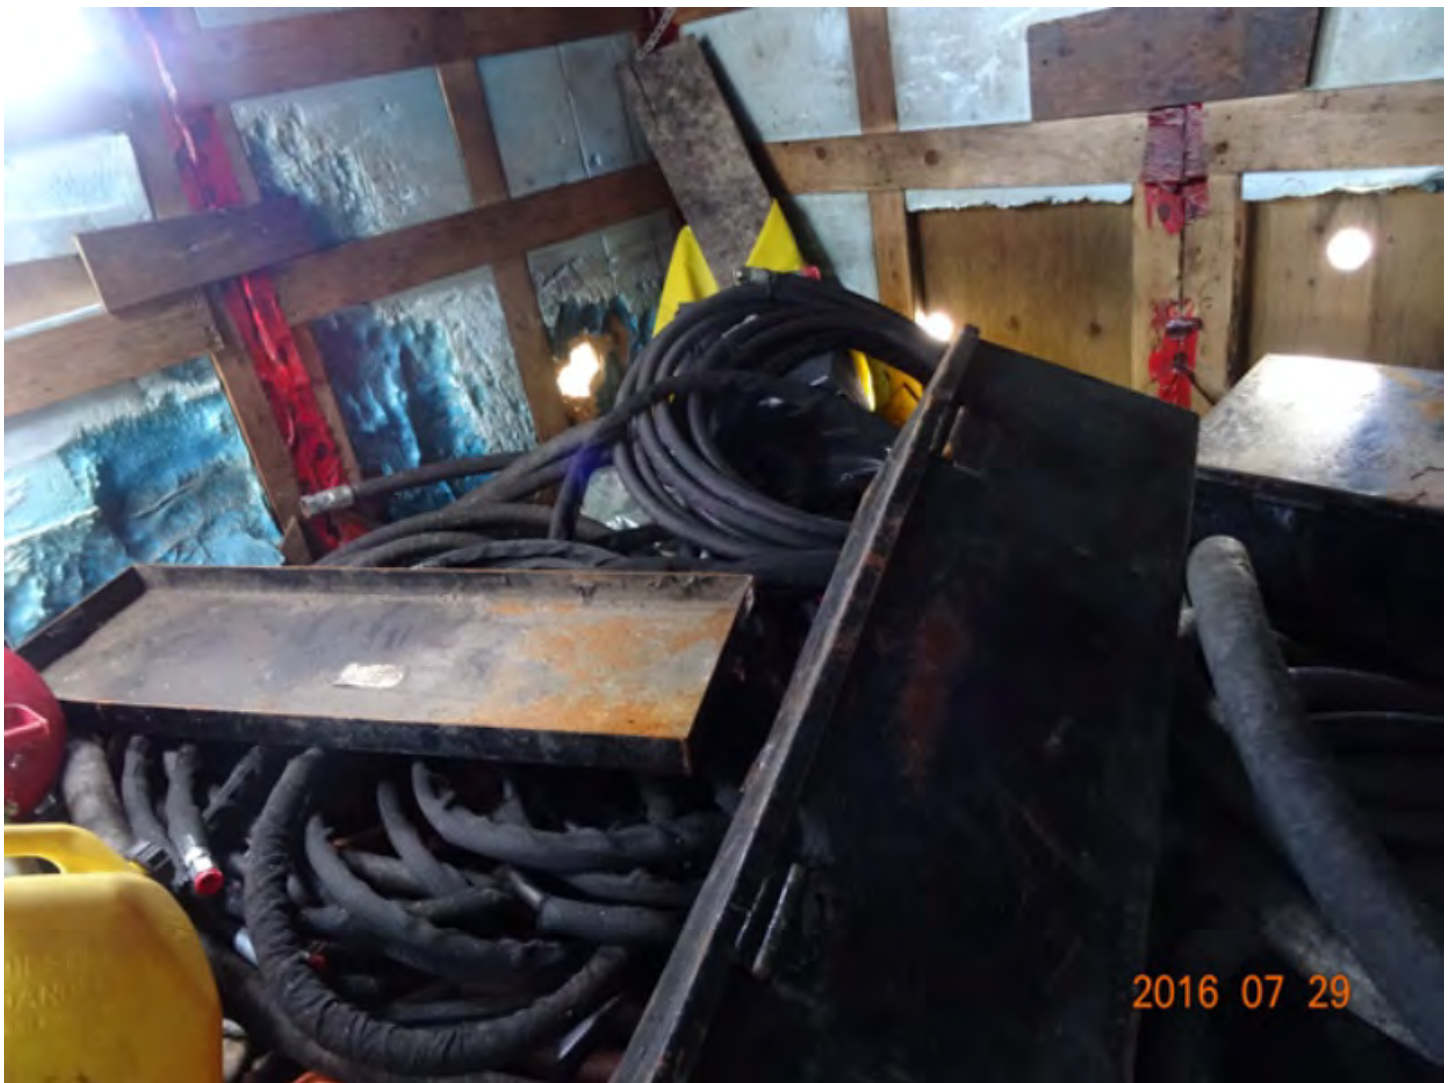
Figure 26 Drill hose at the Tuktu Camp

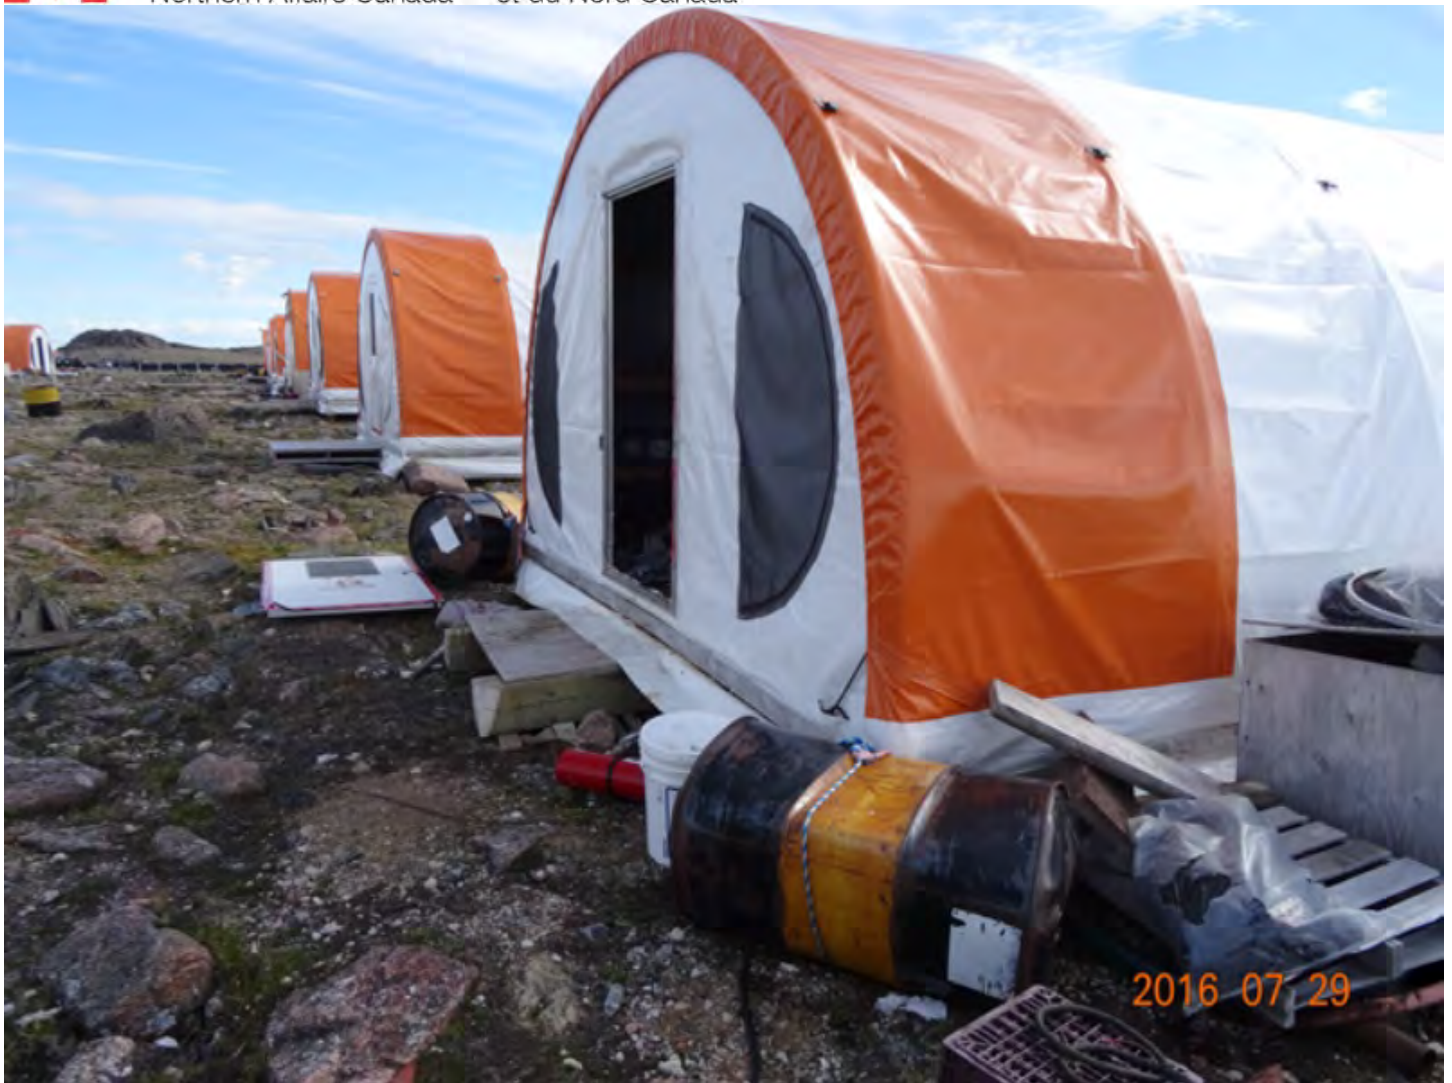
Figure 27 Main camp Tuktuk Camp.. Doors to weather haven have blown open and torn off.

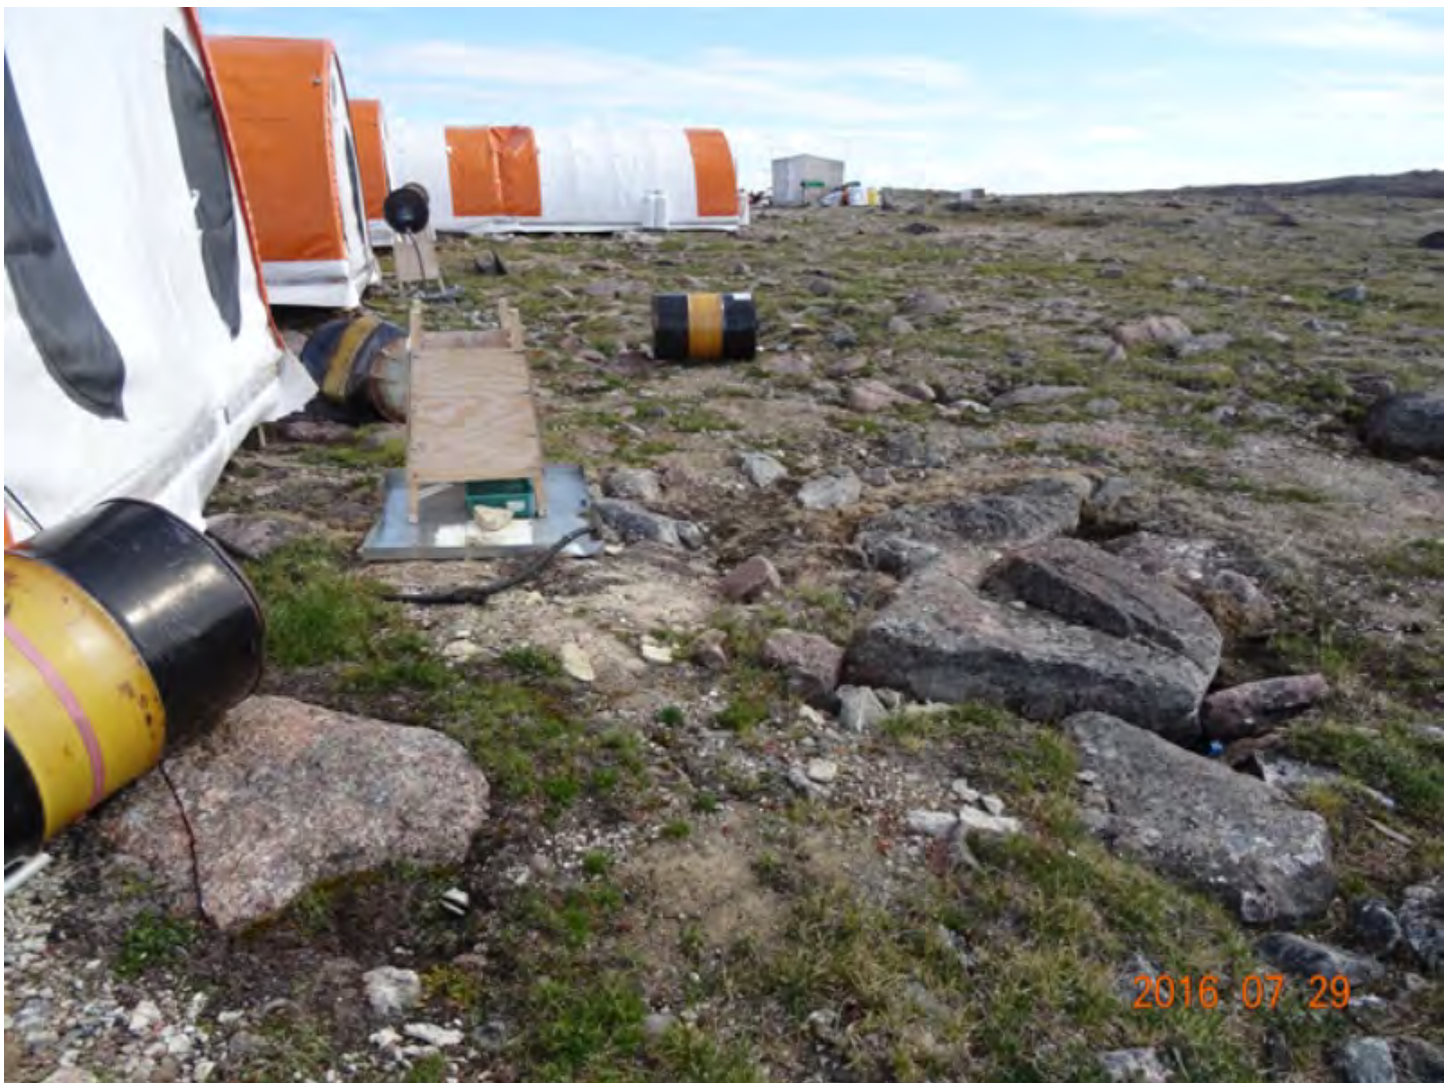
- Barrels of heating fuel were left on wooden stands behind the weather havens. Some have blown off nd lost their contents on the ground around the tents.

Figure 28 45 gallon drums have come off wooden stands and leaked into the ground behind the tents. Hydrocarbon staining very obvious
