WATER LICENCE INSPECTION FORM

Licensee		Licensee Representative	
John Gingerich President and CEO Advanced Explorations Inc. 50 Richmond Street East, Suite 300 Toronto ON M5C 1N7 Canada E-mail: john@advanced-exploration.com		None.	
Licence No. / Expiry		Representative's Title	
2BE-TUK1015 – EXPIRED		None	
Land / Other Authorizations		Land / Other Authorizations	
N2010C0011 / N2012C0013		QIA – Q12L3CF009	
Date of Inspection		Inspector	
July 29, 2016		A.Keim	
Activities Inspected			
<div><input checked="" type="checkbox"/> Camp<input checked="" type="checkbox"/> Drilling<input type="checkbox"/> Mining<input type="checkbox"/> Construction<input type="checkbox"/> Reclamation<input type="checkbox"/> Fuel Storage</div> <div><input type="checkbox"/> Roads/Hauling<input type="checkbox"/> Other: Water Discharge<input type="checkbox"/> Other: Municipal</div>

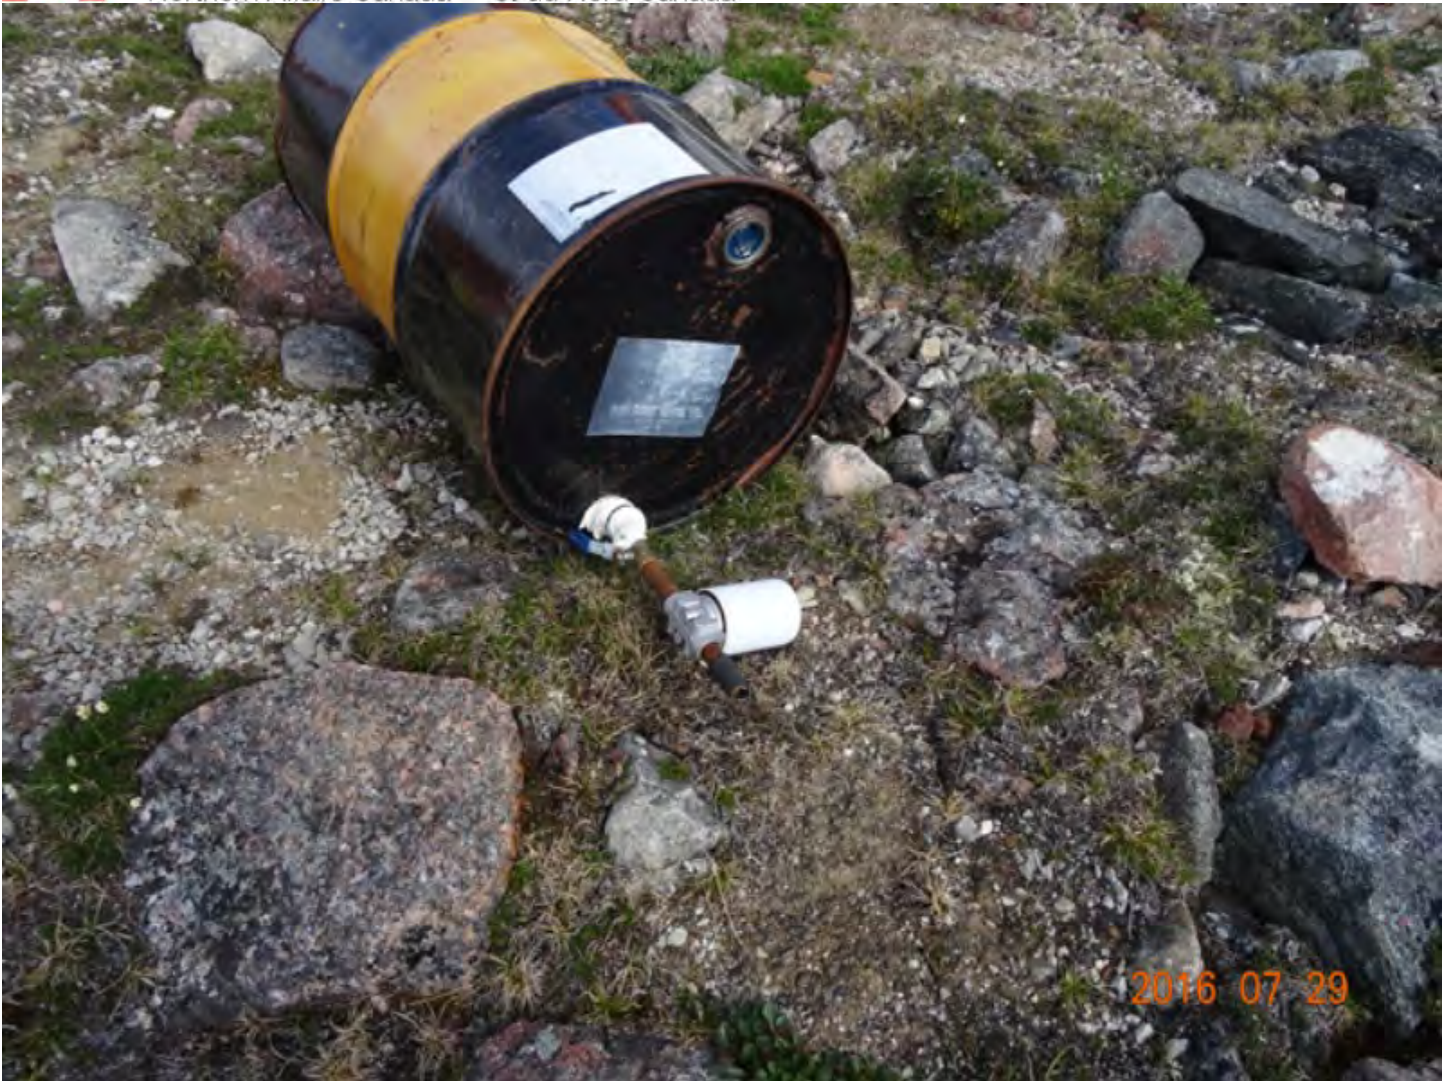
Figure 29 Empty 45 gallon drum from stand

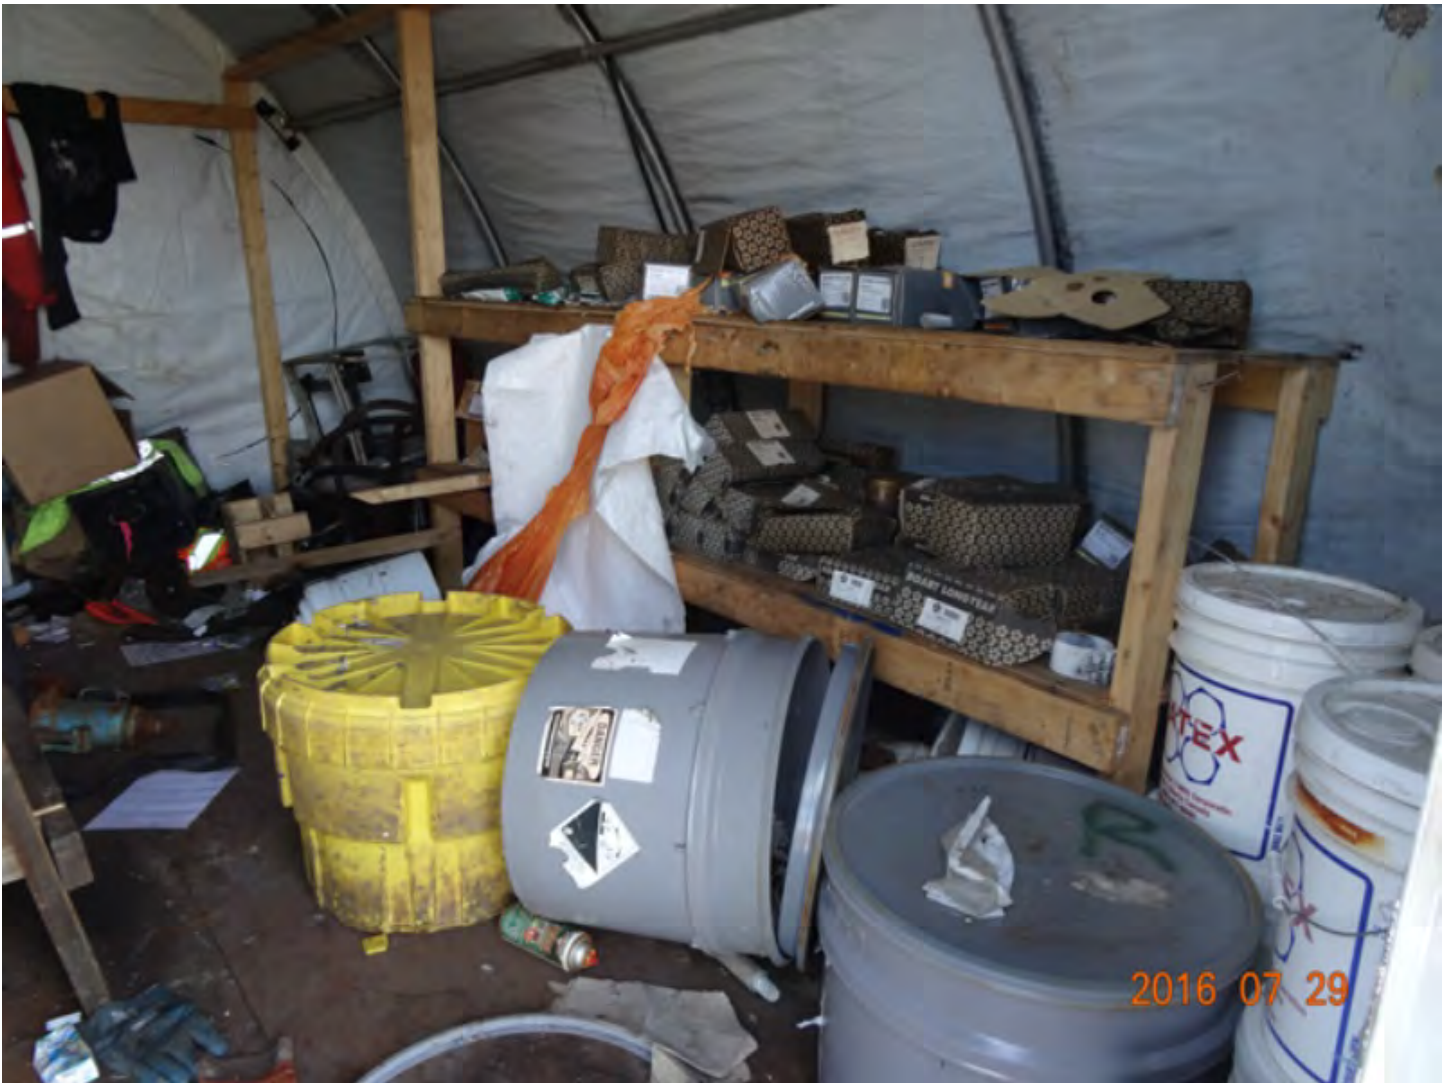
- A maintenance shack full of parts and equipment and barrels of oil and other drilling lube was found at the main camp
- Outside and around the shacks there was a very strong smell of hydrocarbon and staining

Figure 30 Waste oil, drilling lubricants and batteries in shipping containers in storage shed at Tuktu Camp

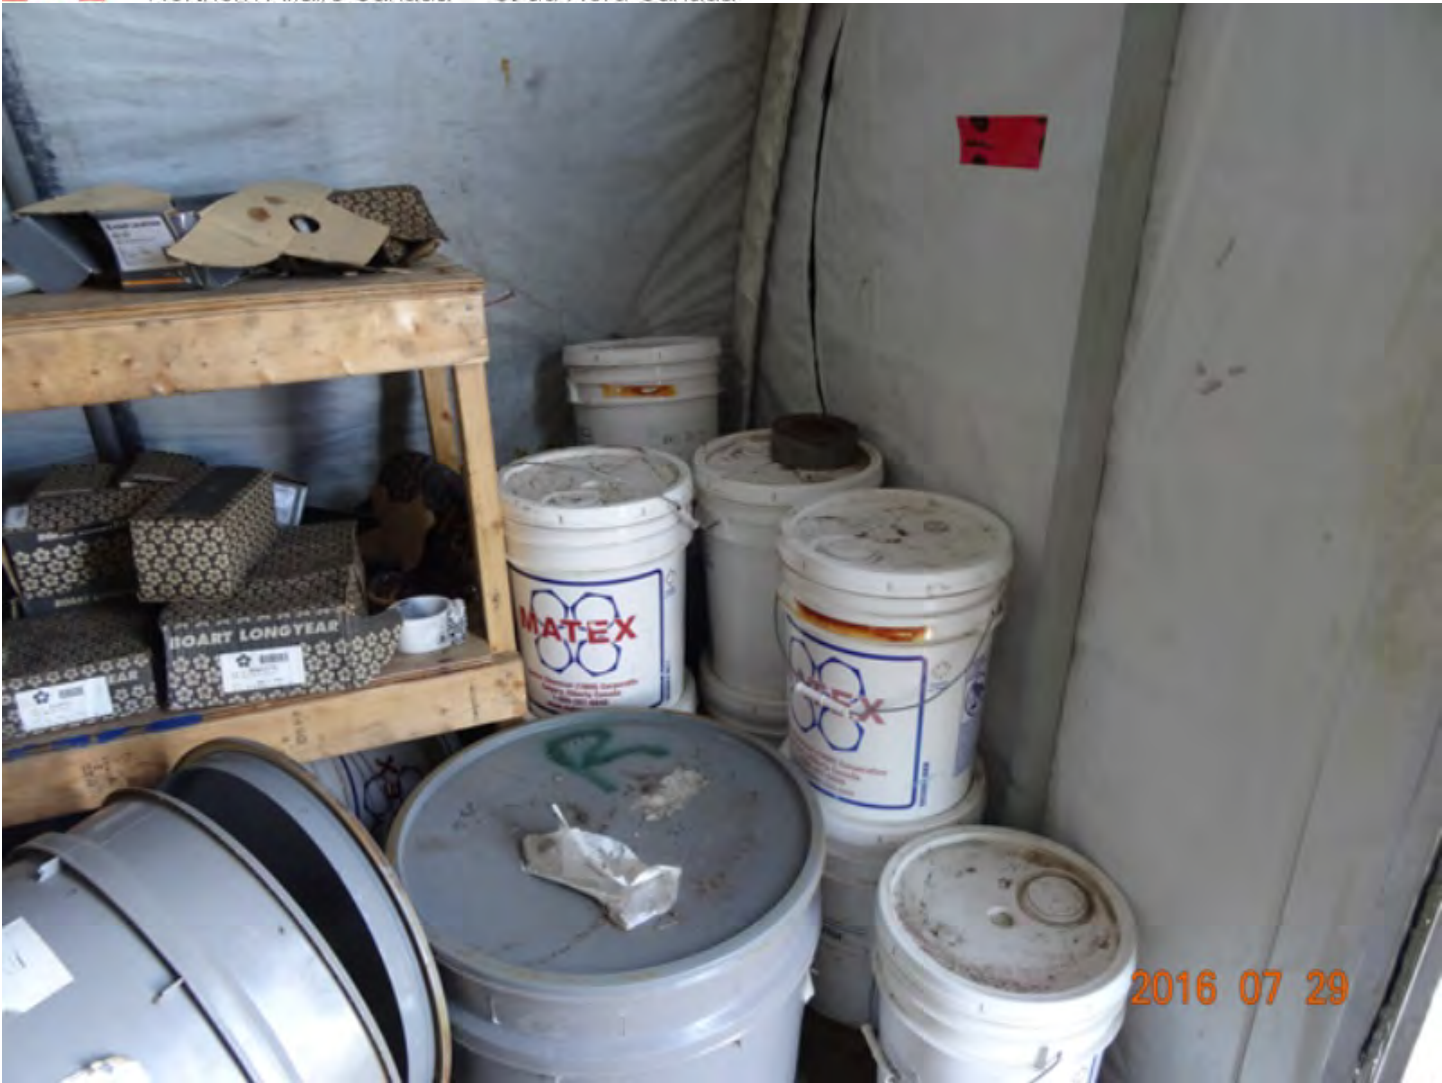
Figure 31 Drums of lube and unknown oil at camp

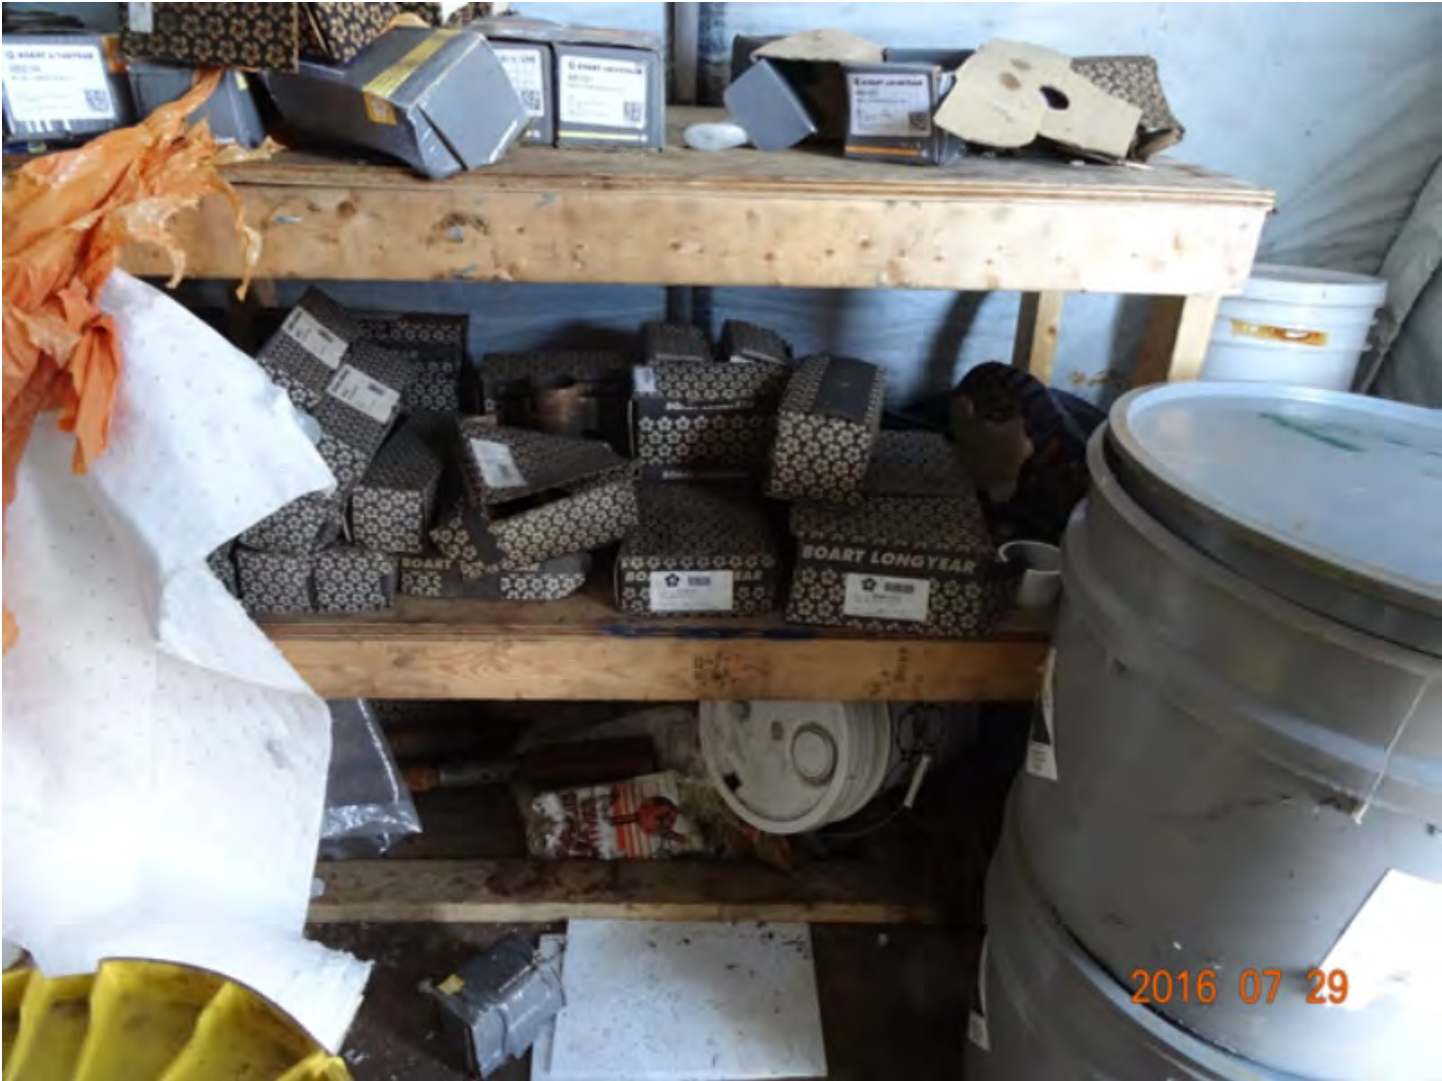
Figure 32 Spare parts for drilling equipment

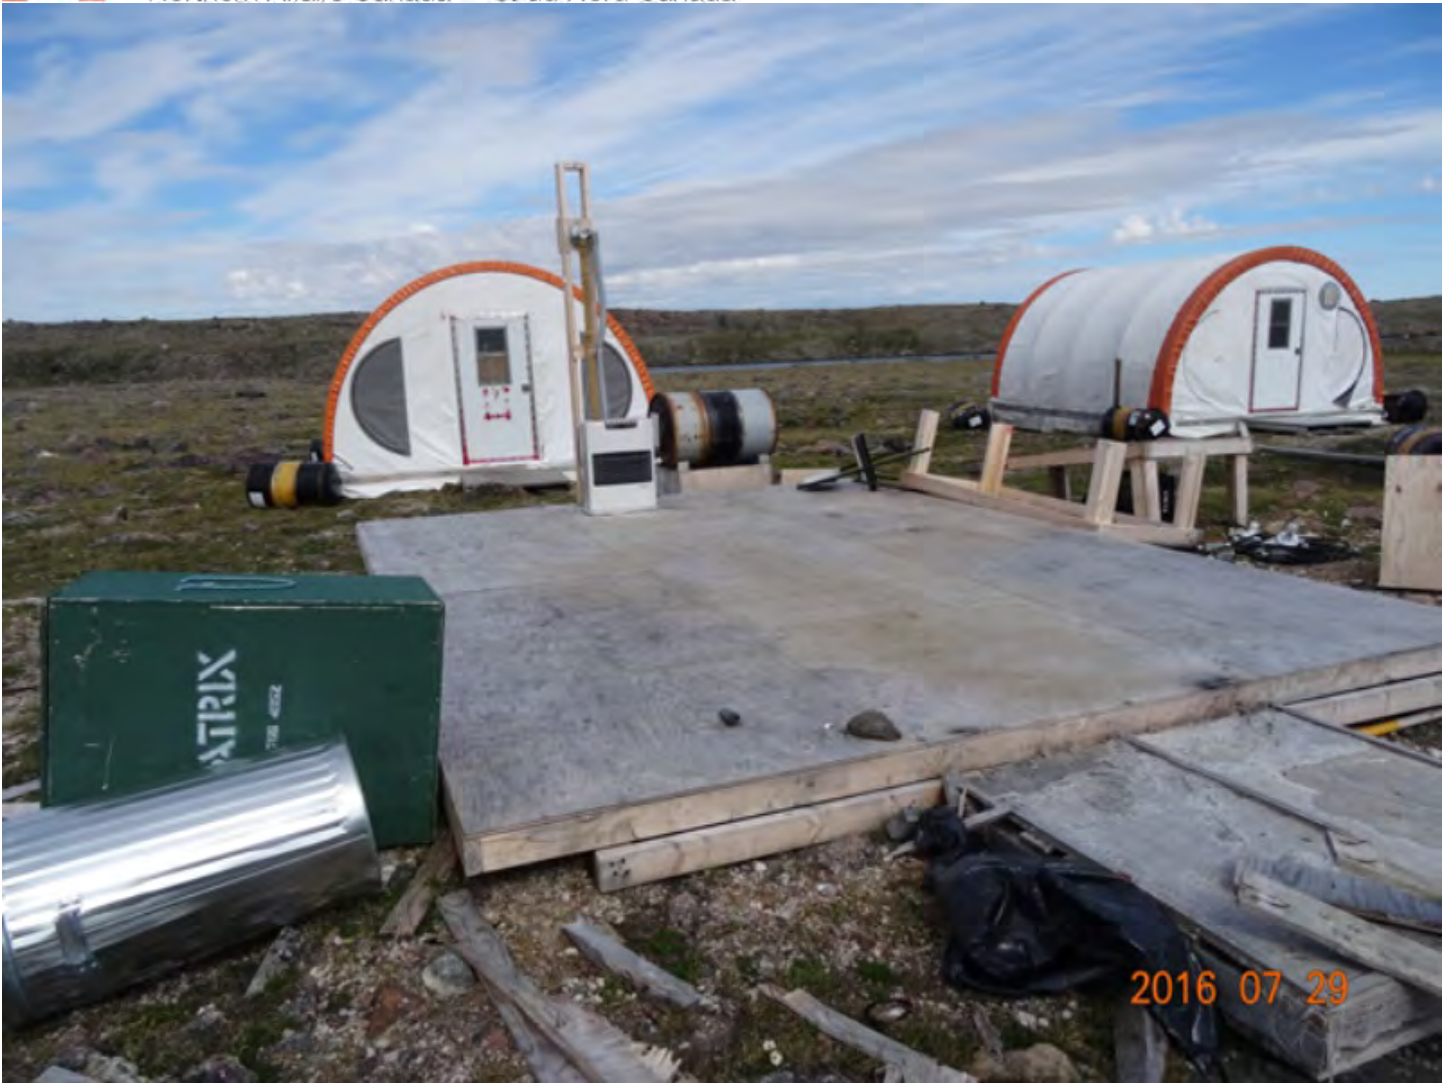
Figure 33 Tent platform.. unknown where the tent is located
