Field Operations  
Nunavut Regional Office  
PO Box 100  
Iqaluit, NU X0A 0H0

RE: NWB Licence No. 2BE-WAL0607 and 2BE-CWL1116

## WATER LICENCE INSPECTION REPORT

<b>Date:</b> August 10, 2012	<b>Licensee Rep. (Name/Title):</b> N/A
<b>Licensee:</b> Golden River Resources/Golden Bull Resources	<b>Licence No.:</b> 2BE-WAL0607 and 2BE-CWL1116

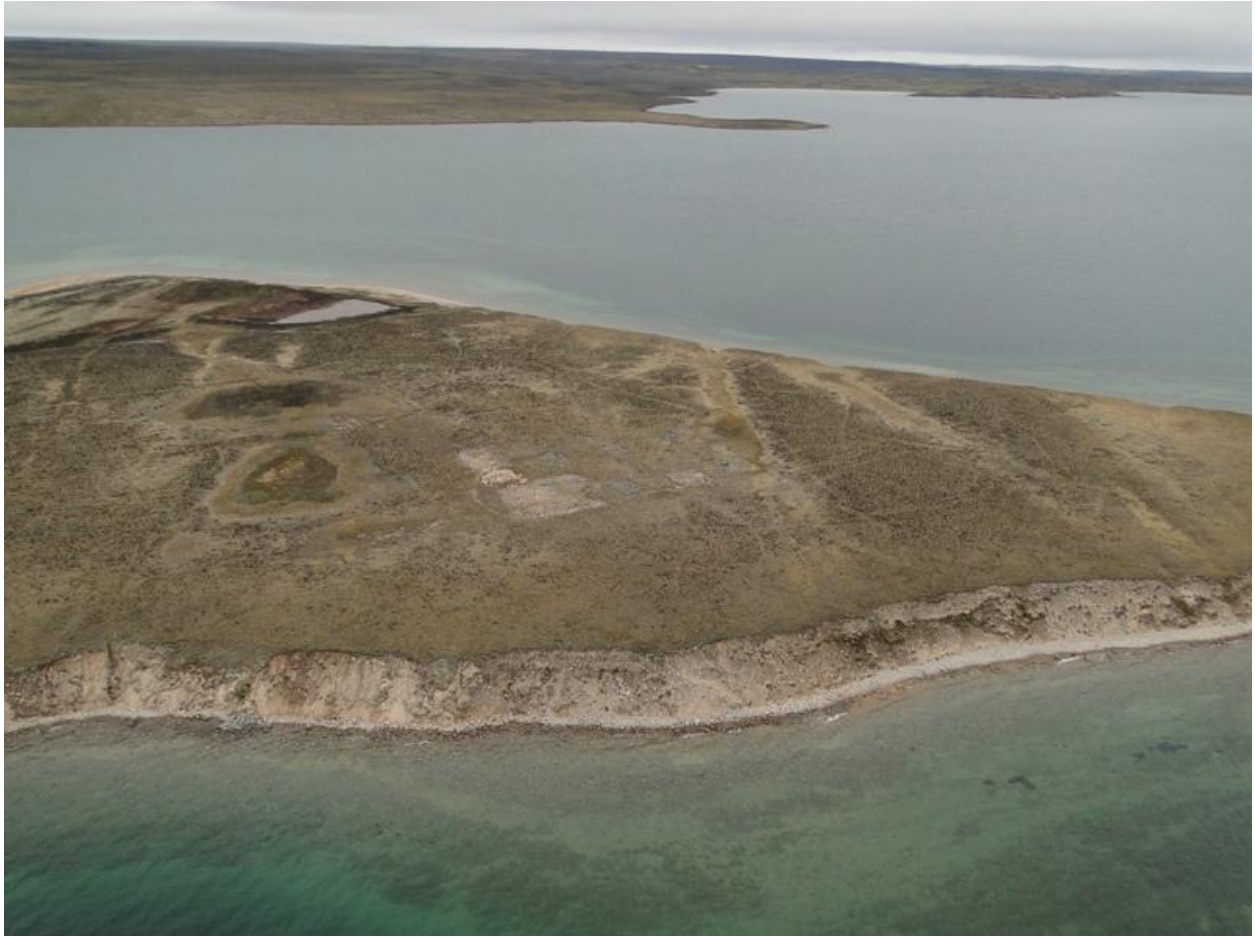
**Comments:** Most evidence of the camp has been removed.

**Figure 1. Site of 2BE-WAL and 2BE-CWL. Camp outlines clearly visible.**

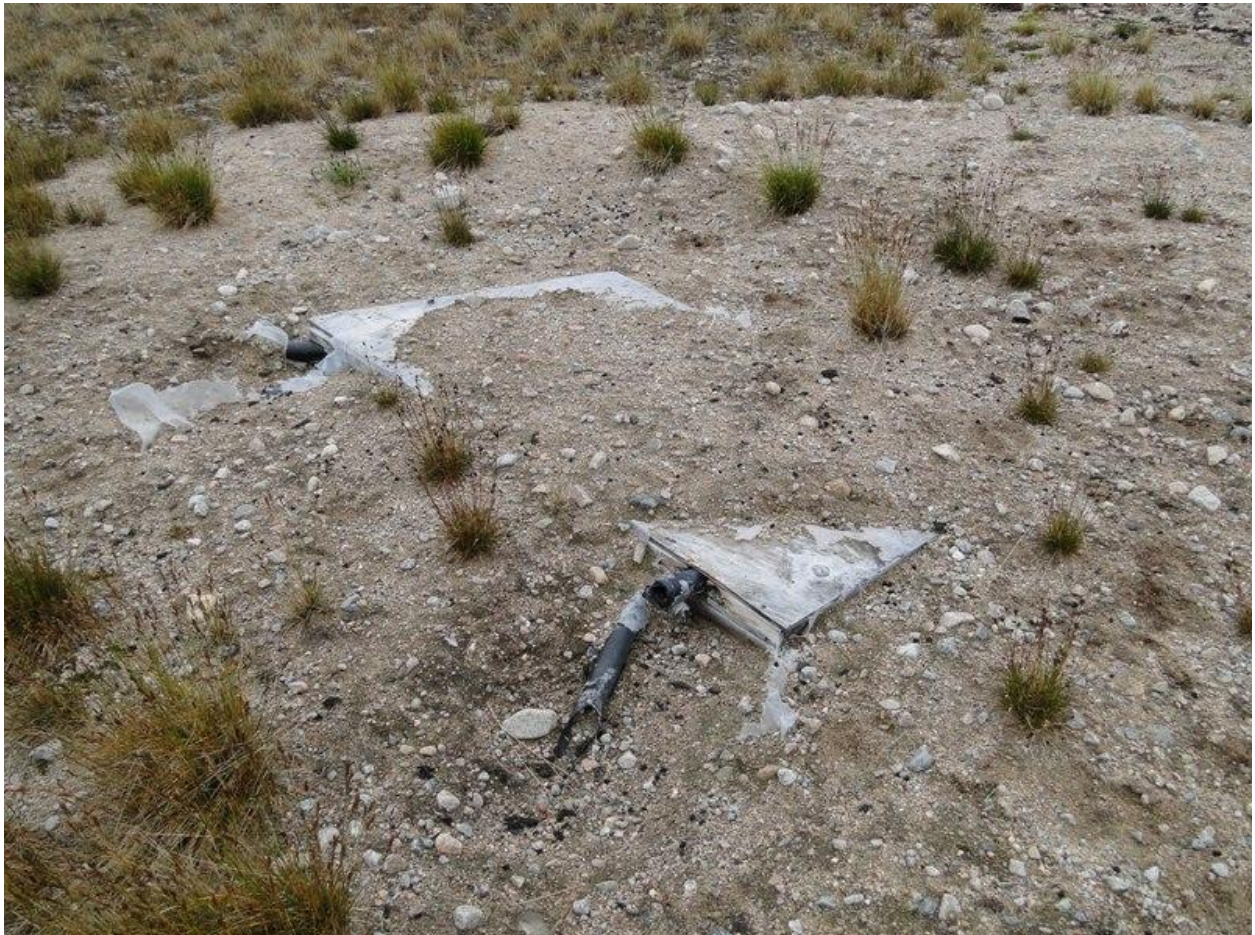
The 2007 remediation of site was incomplete. While on-site I noted that there was a wooden structure with plastic and pipes remains buried in the ground, presumably the sump. Removal of this structure and backfilling of the hole will be required in 2013 as detailed in the inspection report below.

**Comments:** Some piping remains and a constructed sump box with plastic.

**Figure 2. Wooden structure with piping and buried plastic remain on-site.**

**Comments:** The remaining wood, plastic and piping should be removed and hole backfilled.

- Licensee will remove the remaining structure left on-site, backfill the hole, and re-contour to the original state of the site. A report with photos is to be submitted to the inspector by July 31, 2013.
- The licensee will file Annual Reports for each year of each of the licences, Coordinates for all exploration activities that occurred that used water or deposited waste on the land are to be submitted in the appropriate annual reports. The company is required to disclose the extent of their activities associated with this project.

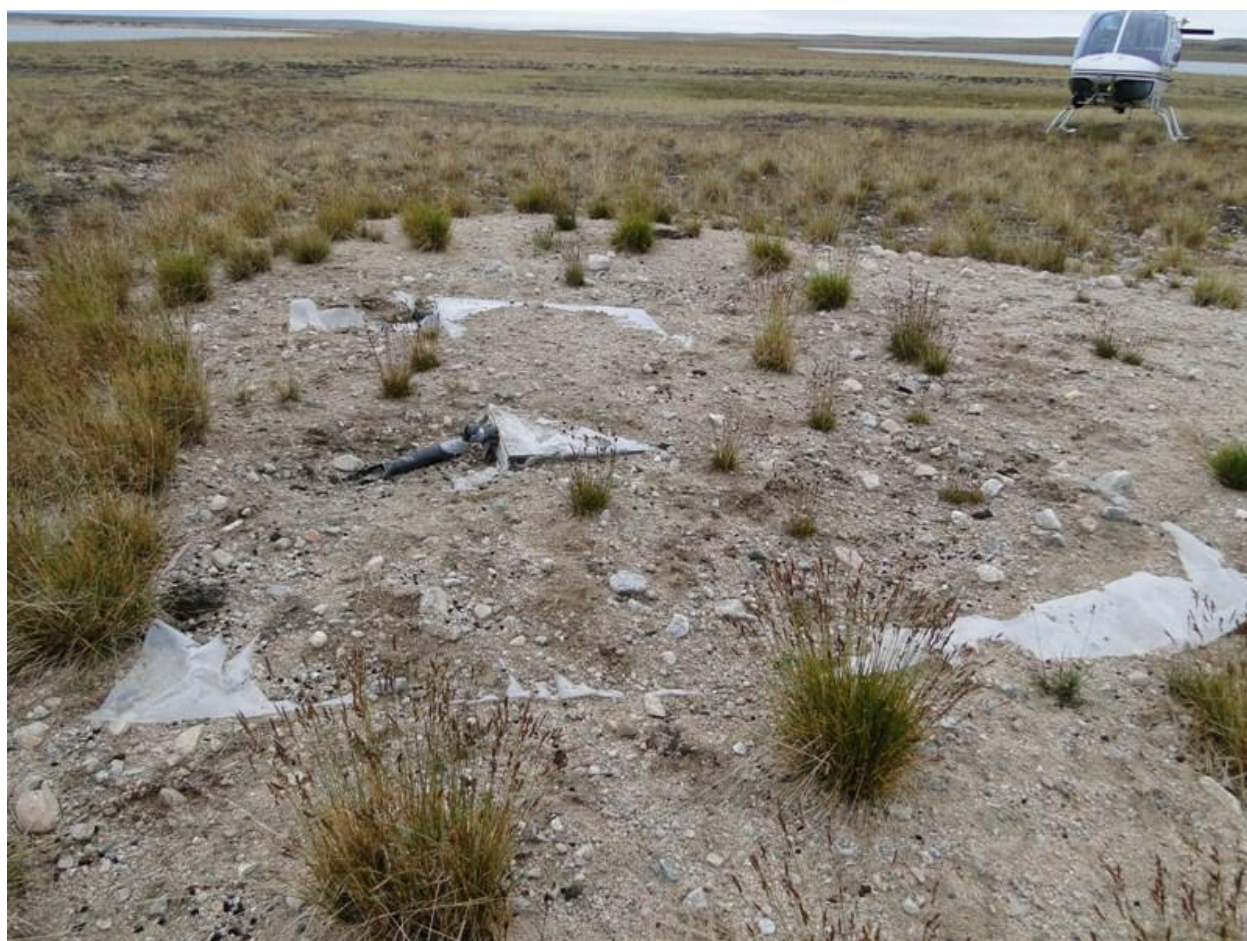
**Figure 3. Plastic sheet surrounding the sump.**
