**Re: 2BM-ULU1520 – Bonito Capital Corporation – Ulu Gold Project – Assignment Application**

Re: Water Licence Assignment Application, #2BM-ULU1520

**RECLAIM Cost Model for the Ulu  
Mine, Nunavut**

**FINAL**  
**RECLAIM Cost Model for the**  
**Ulu Mine, Nunavut**

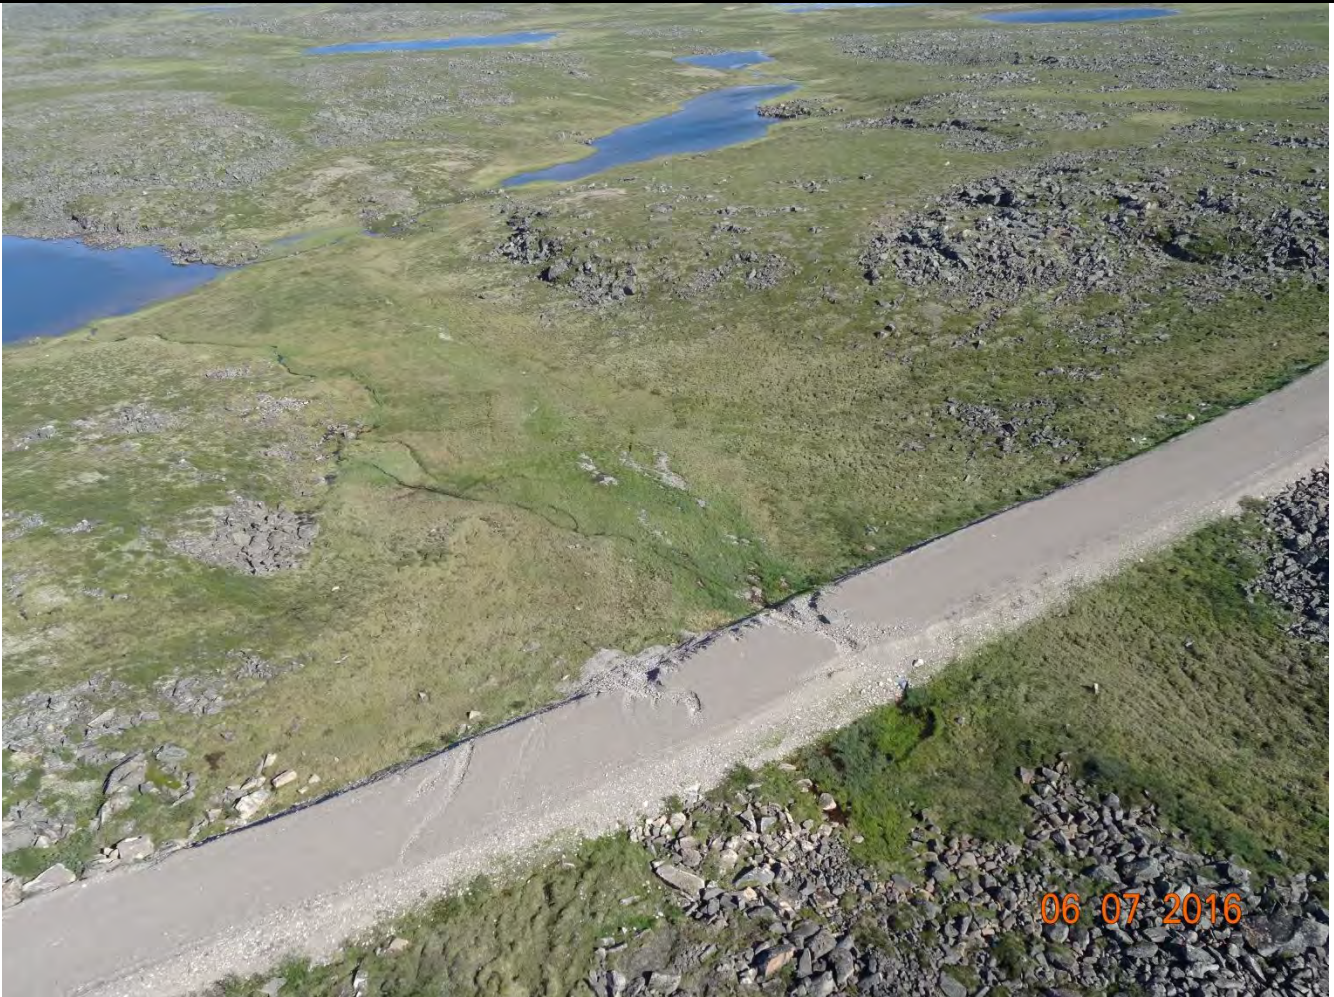
**Description:** As photo 10. No mitigation measures are in place, and no repairs were conducted in 2015 as was proposed in the annual report.

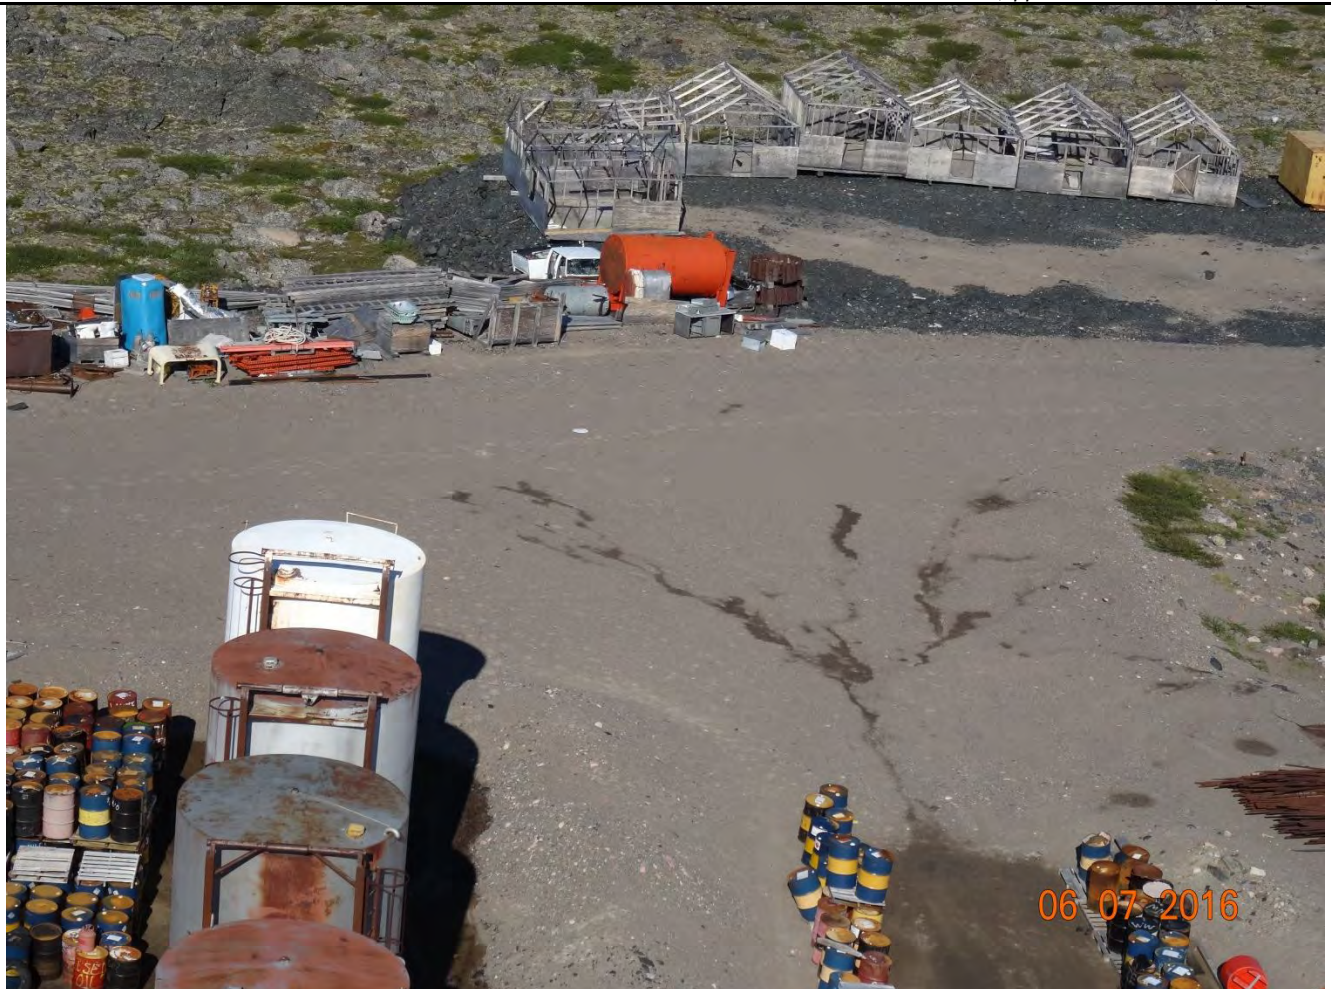
downslope of the fuel storage pad, and confirm F3 (C16-C34) concentrations of 3740 and 9690 mg/kg respectively (2.2x and 5.7x the CCME Tier 1 levels for coarse-grained soils (commercial/industrial)). F4 (C34-C50) concentration of the second sample also surpasses CCME Tier 1 level for residential/parkland at 2970 mg/kg, 32 m downslope of the fuel storage pad. These F3 levels are HIGHER than the samples taken in 2015 which were taken at 13 m downslope of the fuel storage pad. Staining within the storage pad is also more pronounced than in 2015.

**Description:** "Closeup" view of fuel trail spreading from the fuel storage pad.

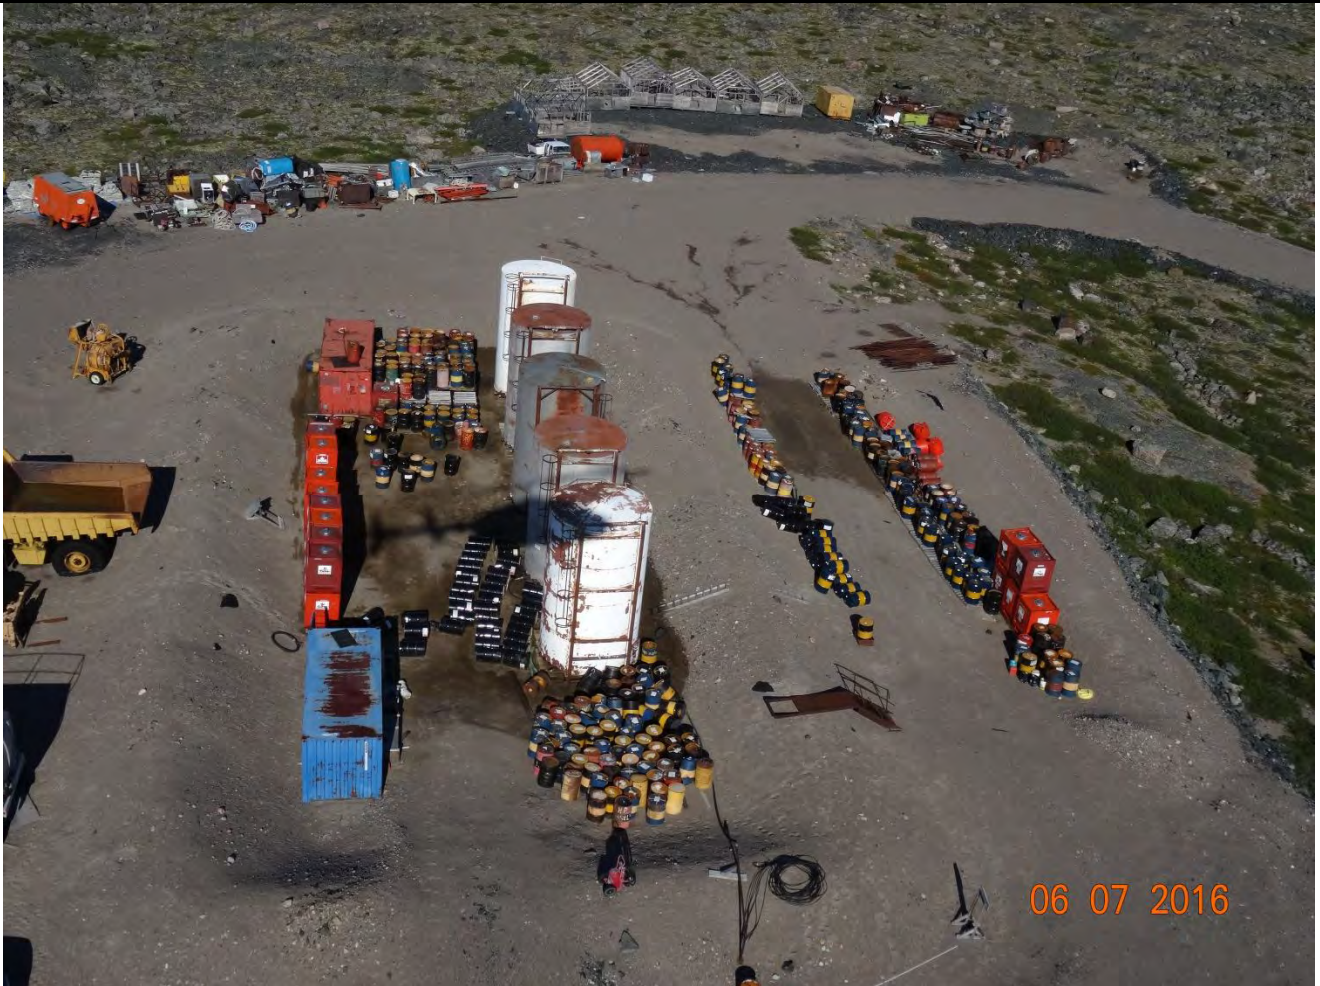
**Description:** Comparative photo of the staining within the fuel storage pad (compare to next photo, taken in 2015).

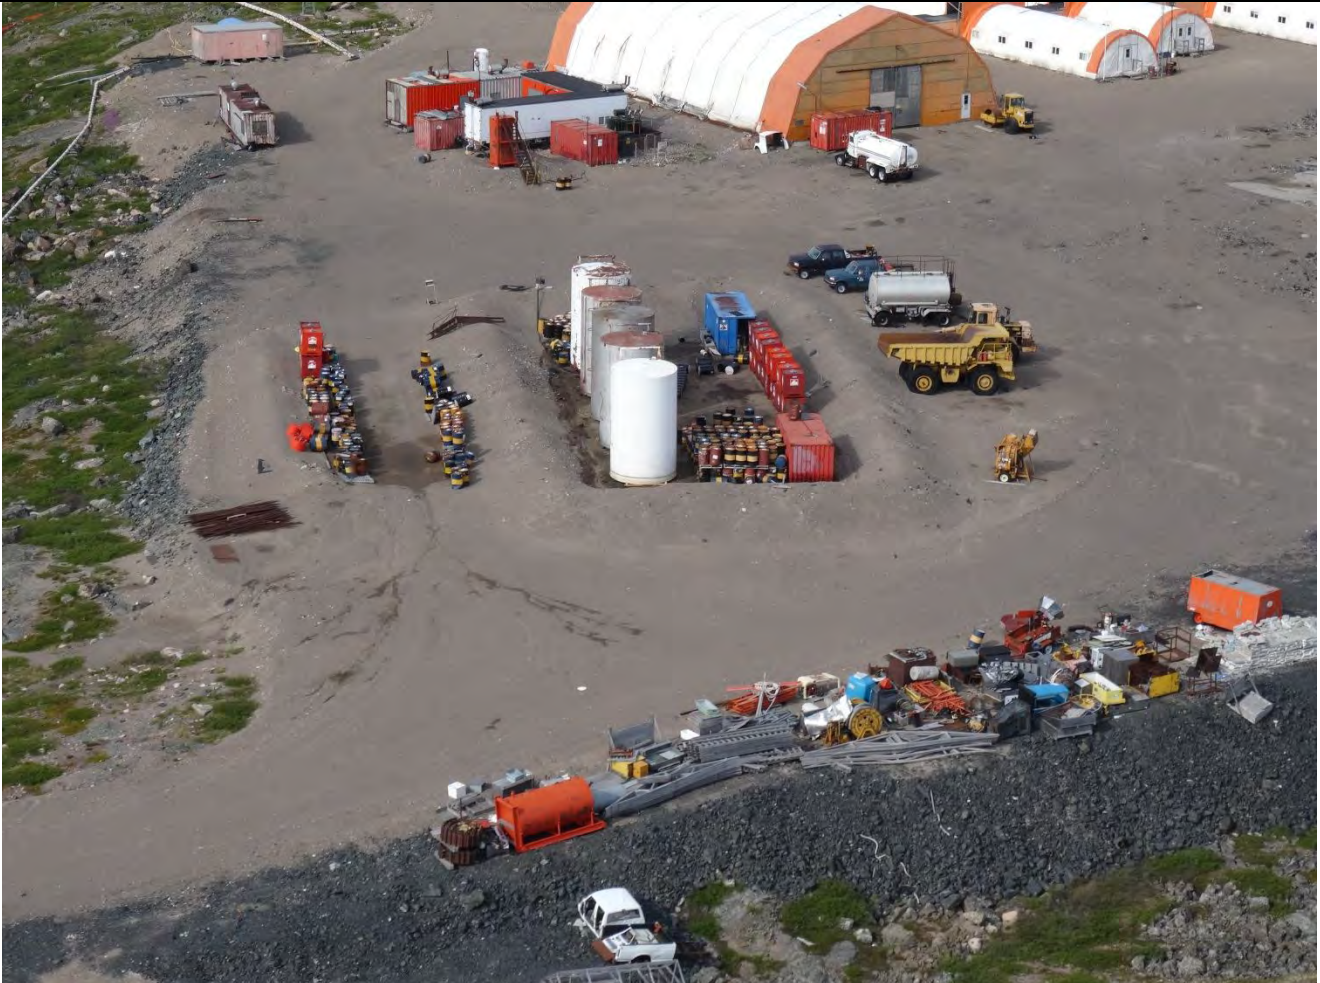
**Description:** 2015 aerial view of the fuel storage pad; staining within the pad is less extensive than this year.
