**Indian and Northern Affairs Canada
Nunavut District Office
Box 100
Iqaluit, Nunavut
X0A 0H0**

**Licence Number
NWB1ULU0008**

**Wolfden Resources Inc.
309 Court Street South
Thunder Bay, ON
P7J 1H1**

Re: Ulu Camp Water Licence Inspection July 14, 2004.

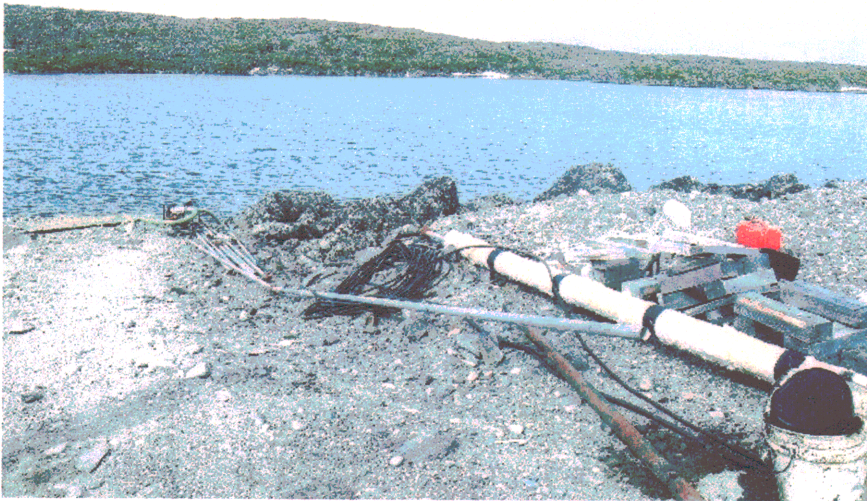
Ulu Camp is withdrawing approximately 2000 gallons of freshwater from West Lake every one and a half days. This amount is well within the licenced limit of 100 cubic metres per day. The intake at West Lake was under repair at the time of inspection (Figure 1). The repaired freshwater intake should include a screen to prevent entrainment of fish and should be situated in deep enough water to prevent increased turbidity. Water use should be metered and recorded in the annual report submitted to the Nunavut Water Board (NWB). Samples taken of the drinking water source for Ulu Camp exceeded Canadian Council of Ministries of the Environment (CCME) Guidelines for turbidity ($2 > 1.0$ NTU). Although elevated turbidity levels should be mitigated by the camps filtration system turbidity levels should be monitored to ensure they are not a problem.

Figure 1. The freshwater intake at West Lake that was under repair at the time of the Inspection.

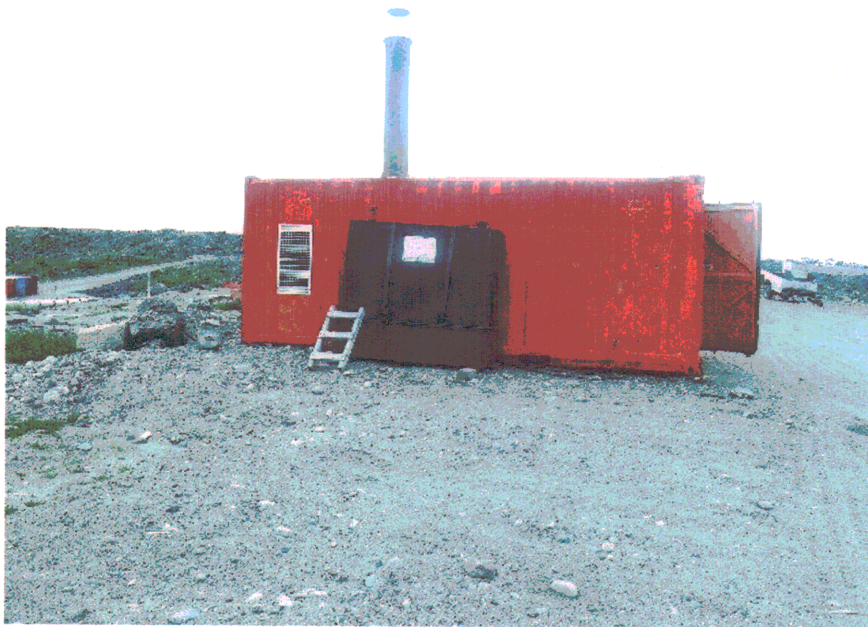
Solid waste is stored onsite until it can be transported south. Burnable waste is open burned and food waste is incinerated (Figure 2). Ash is collected and shipped south in 45-gallon drums (Figure 3). At the time of the Inspection there was not a large build up of waste on site.

Figure 2. The sea lift container containing the incinerator at Ulu Camp

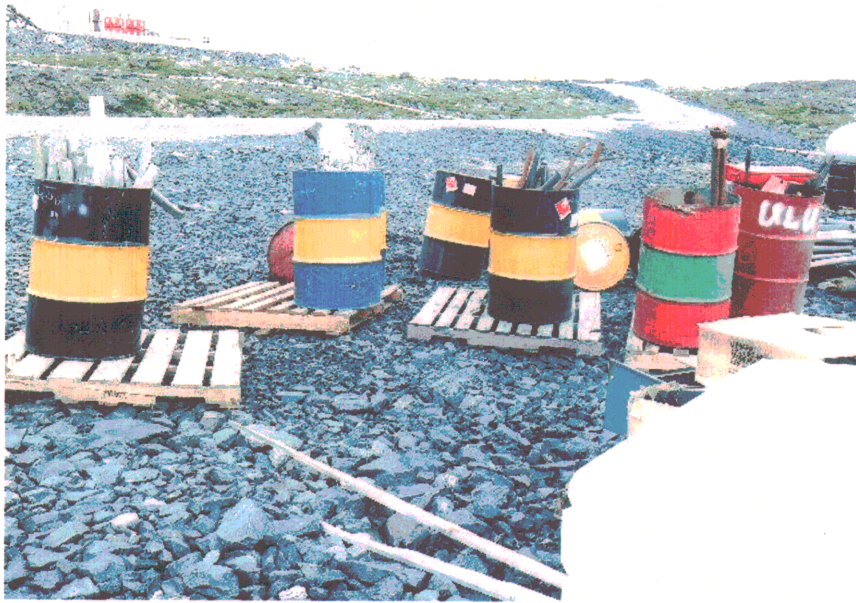
Figure 3. Waste drums at Ulu camp that will eventually need to be shipped south for disposal.

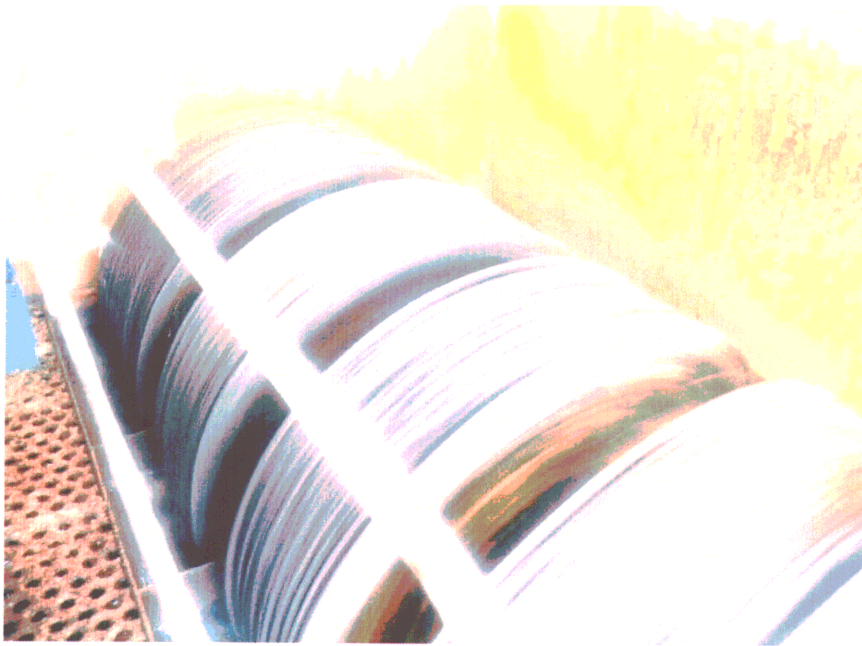
A Rotating Biological Contactor (RBC) (Figure 4) is used to treat sewage at Ulu Camp. At the time of the Inspection effluent was not being discharged from the RBC. Samples were taken from the discharge point at East Lake (Figure 5). All sample results were within licenced Guidelines.

Figure 4. The Rotating Biological Contactor at Ulu Camp.

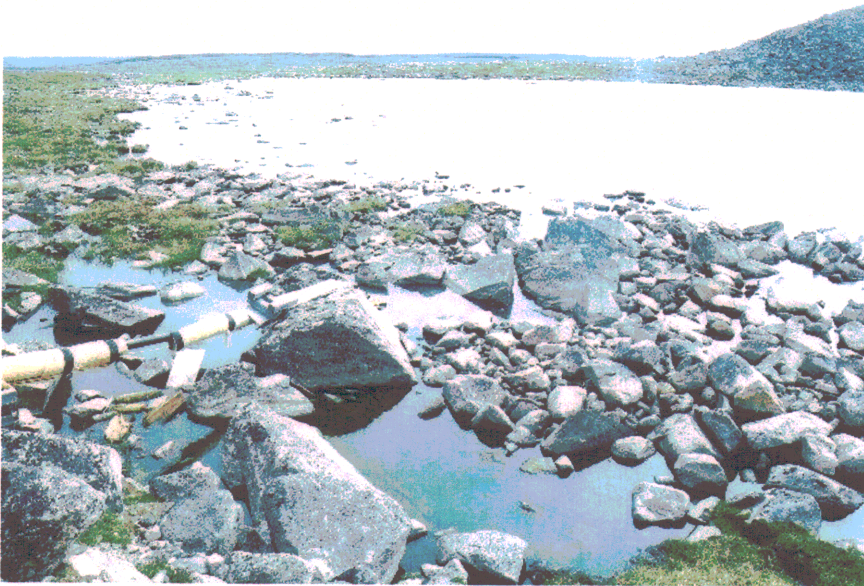
Figure 5. Sewage effluent discharge point for Ulu camp at East Lake.

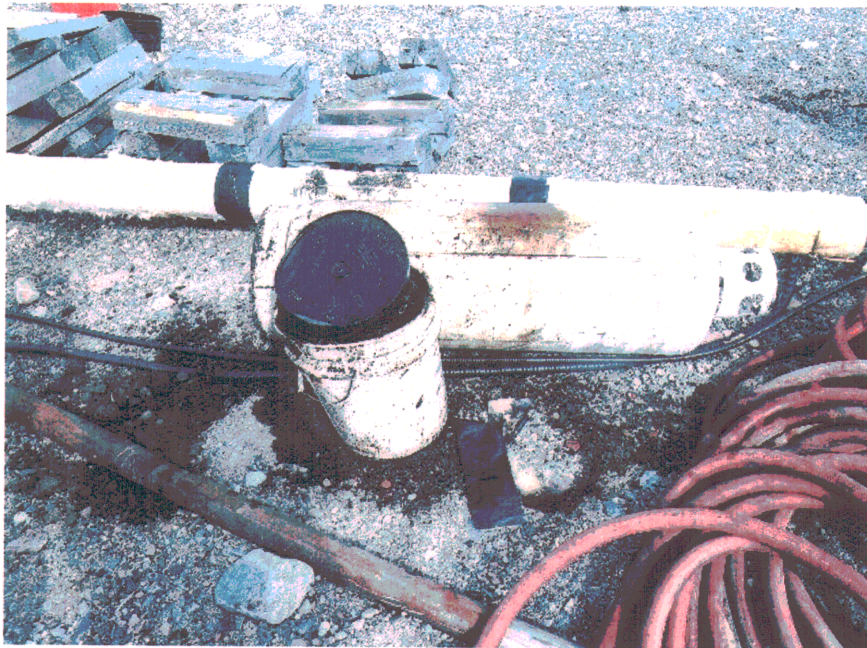
There were a number of spills at the Ulu Camp site that had neither been reported nor cleaned up at the time of the Inspection. An oil (~5L) spill above the pump generator and another, older spill in camp went unreported and were not properly cleaned up (Figure 6 and Figure 7). These spills should have been cleaned up and the generator should be equipped with a spill pan and a spill kit. All spills need to be reported to the Nunavut /NT 24-hour Spill Line (867) 920-8130 and cleaned up as soon as possible.

Figure 6. An oil spill just above the freshwater intake at West Lake.

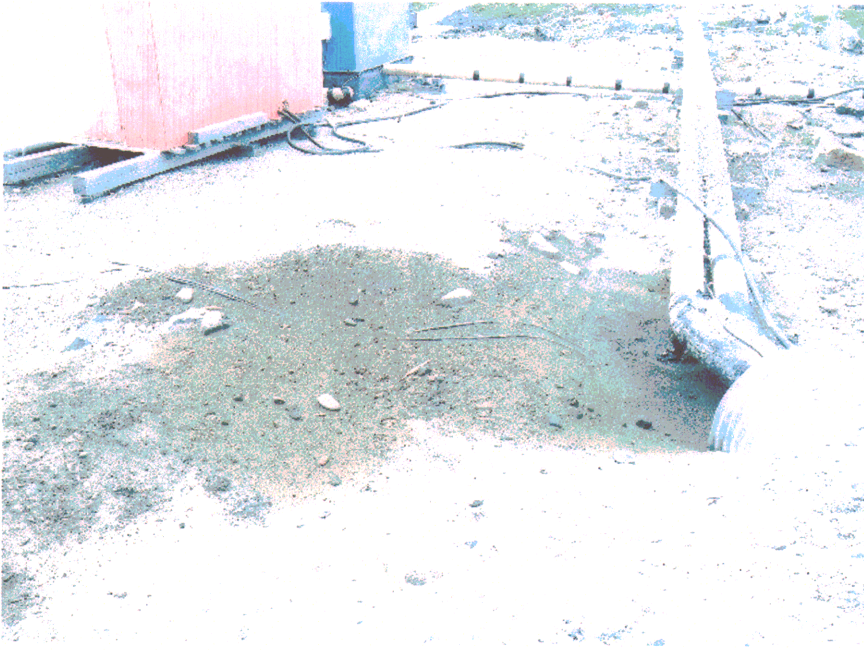
Figure 7. An unknown spill at Ulu Camp that was neither reported to the spill line nor cleaned up in a timely fashion.
