WATER LICENCE INSPECTION FORM

| 2BM-ULU1520 | | - | |
| 15/07/2015 | | Eva Paul | |

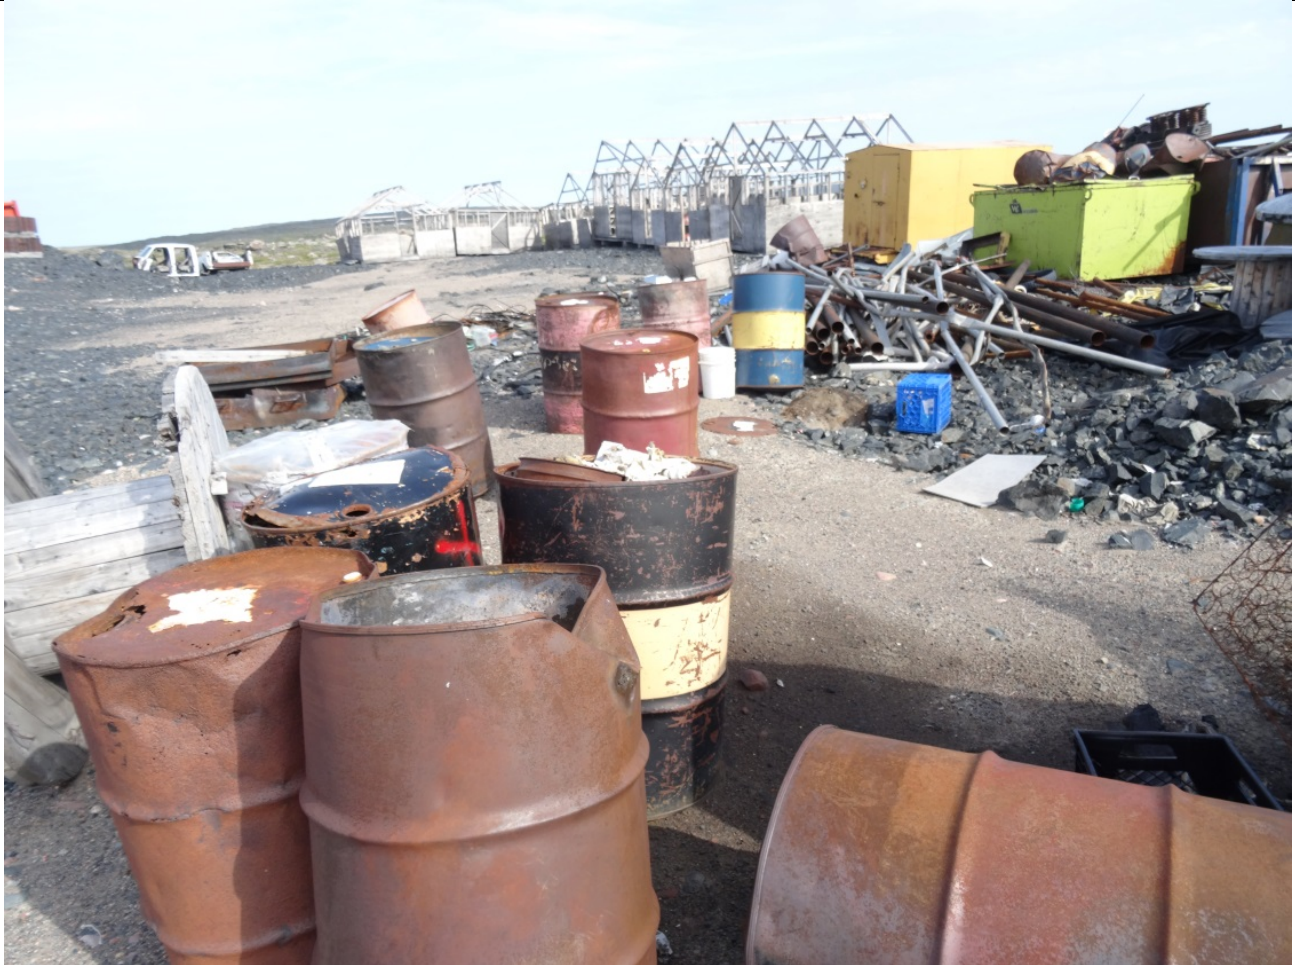
| Date | Camera | Inspector | Authorization |
|---|---|---|---|
| Photo Log # 1 | | Location (NAD 83 DD MM SS.SS) | |

Description: Barrels of unknown waste and staining on the ground found east of the heli-pad.

All hazardous (and unknown) waste is to be moved into SOUND secondary containment that meets the definition of ‘secondary containment’ in the current licence 2BM-ULU1520. This is to be completed by June 30, 2016.
6.

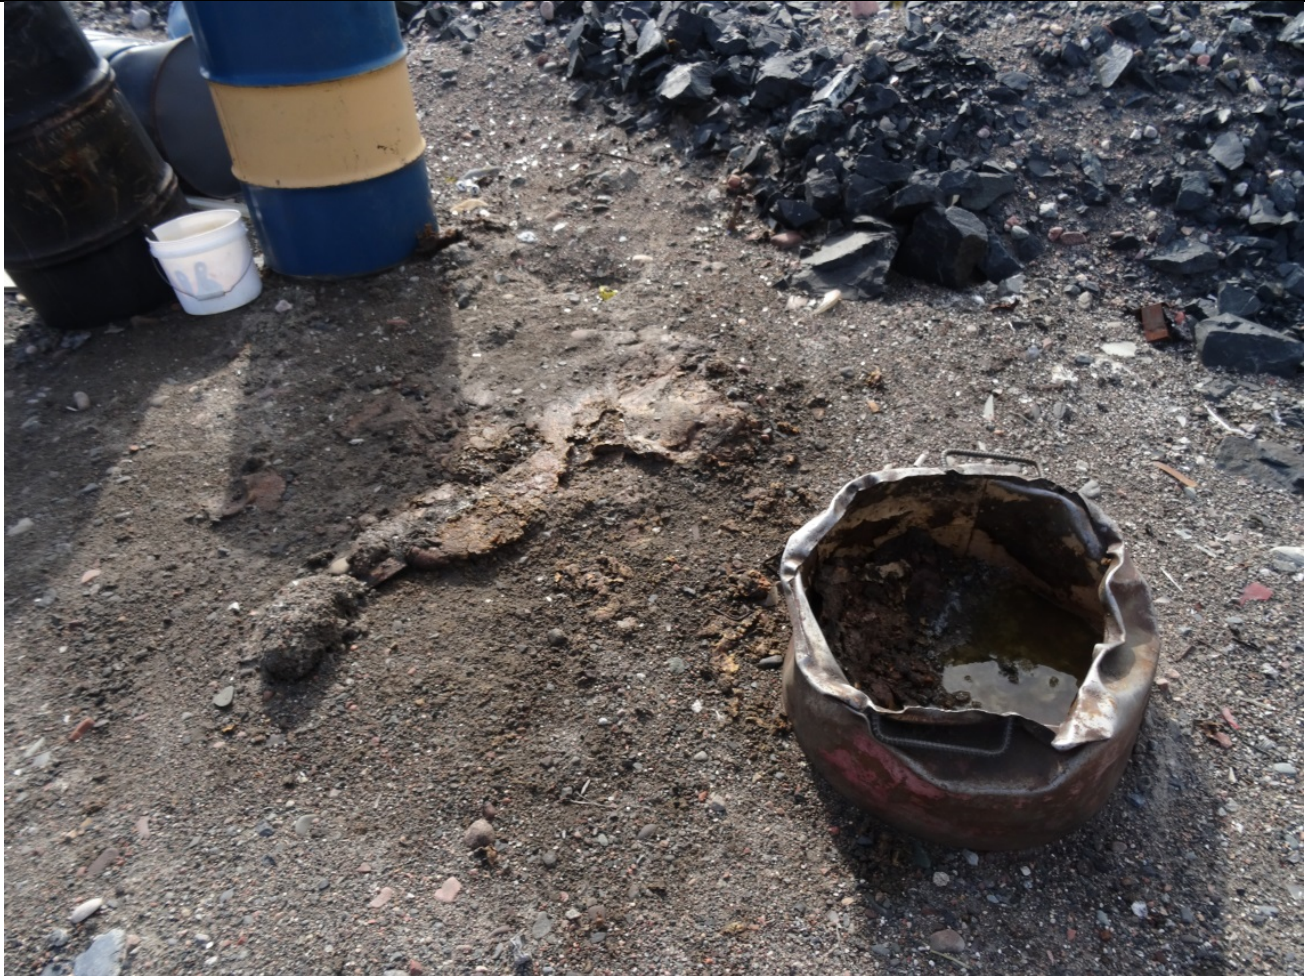
| Photo Log # 2 | Location (NAD 83 DD MM SS.SS) | |

Description: Unknown waste east of the heli-pad.

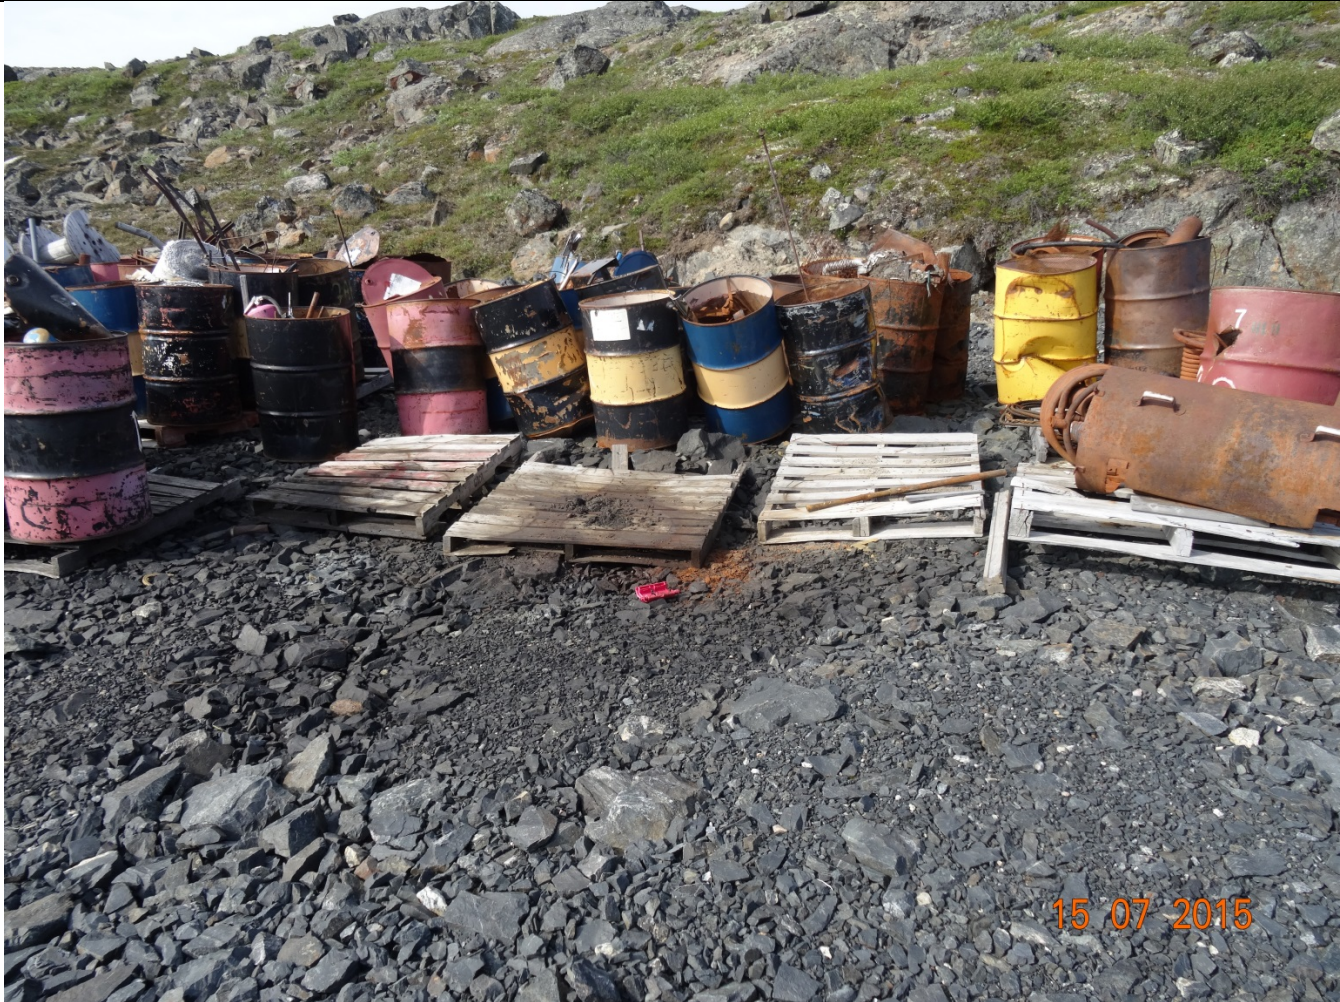
Photo Log # 3

Description: Barrels and staining of the ground seen at the mine storage pad. See Photos 5 and 6 for aerial extent.

All barrels of fuel are to be moved into SOUND secondary containment that meets the definition of ‘secondary containment’ in the current licence 2BM-ULU1520. This is to be completed by June 30, 2016.
7.

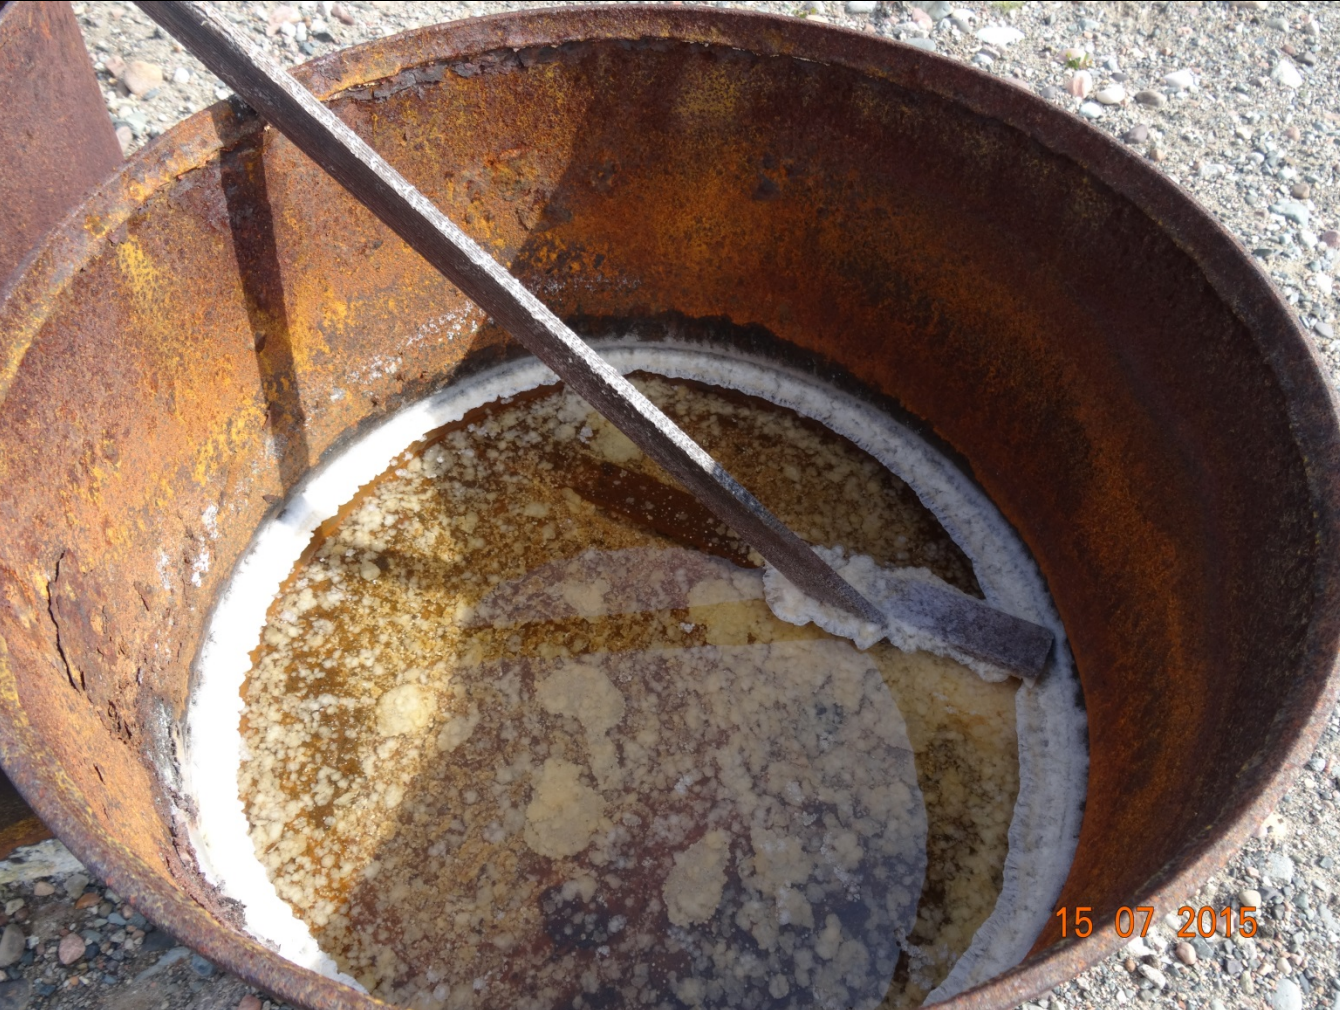
Photo Log # 4

Description: One of three barrels of a salt-like substance found by the road at the above coordinates.

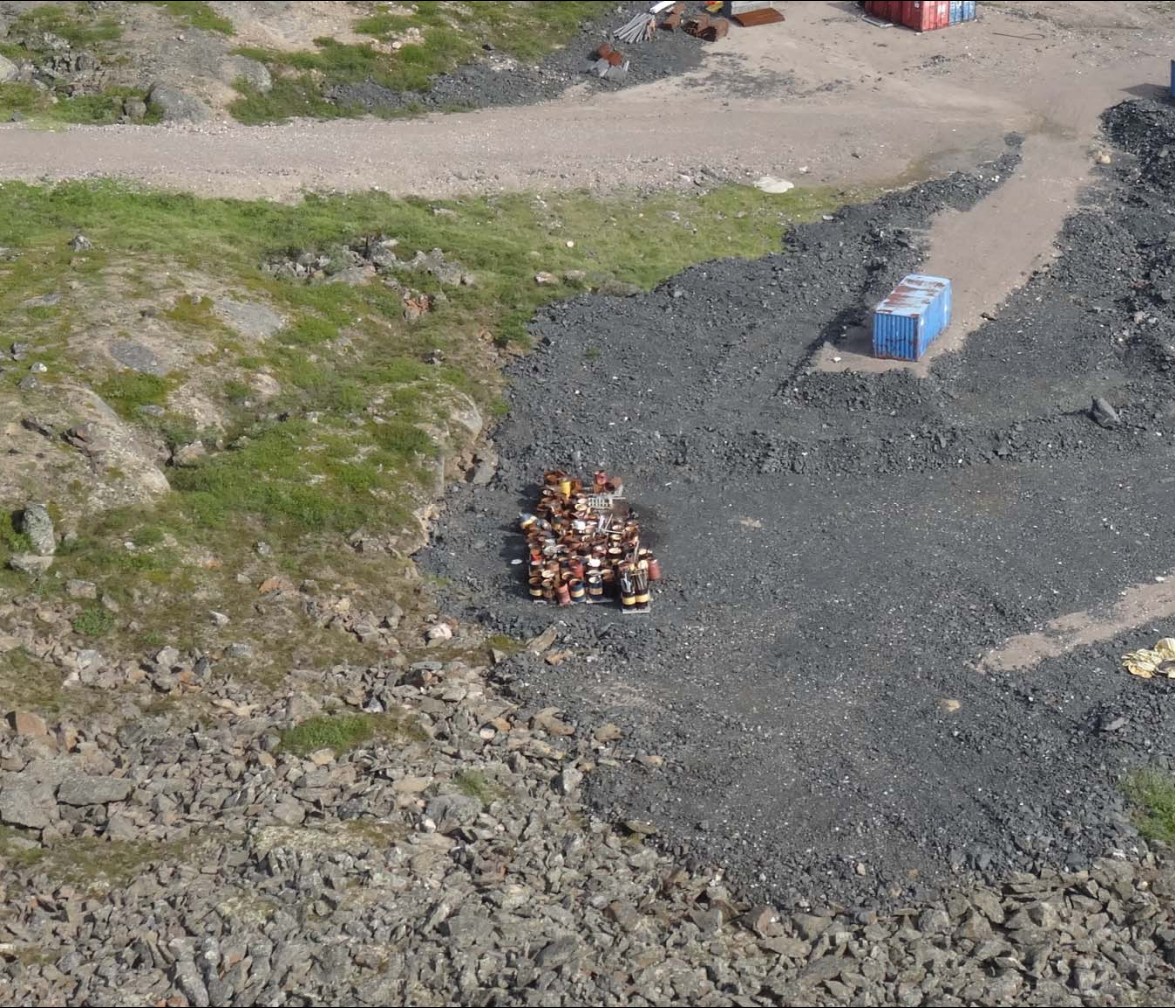
Photo Log # 6

Description: 2015 aerial photo of the mine storage pad. Also see photo 3.

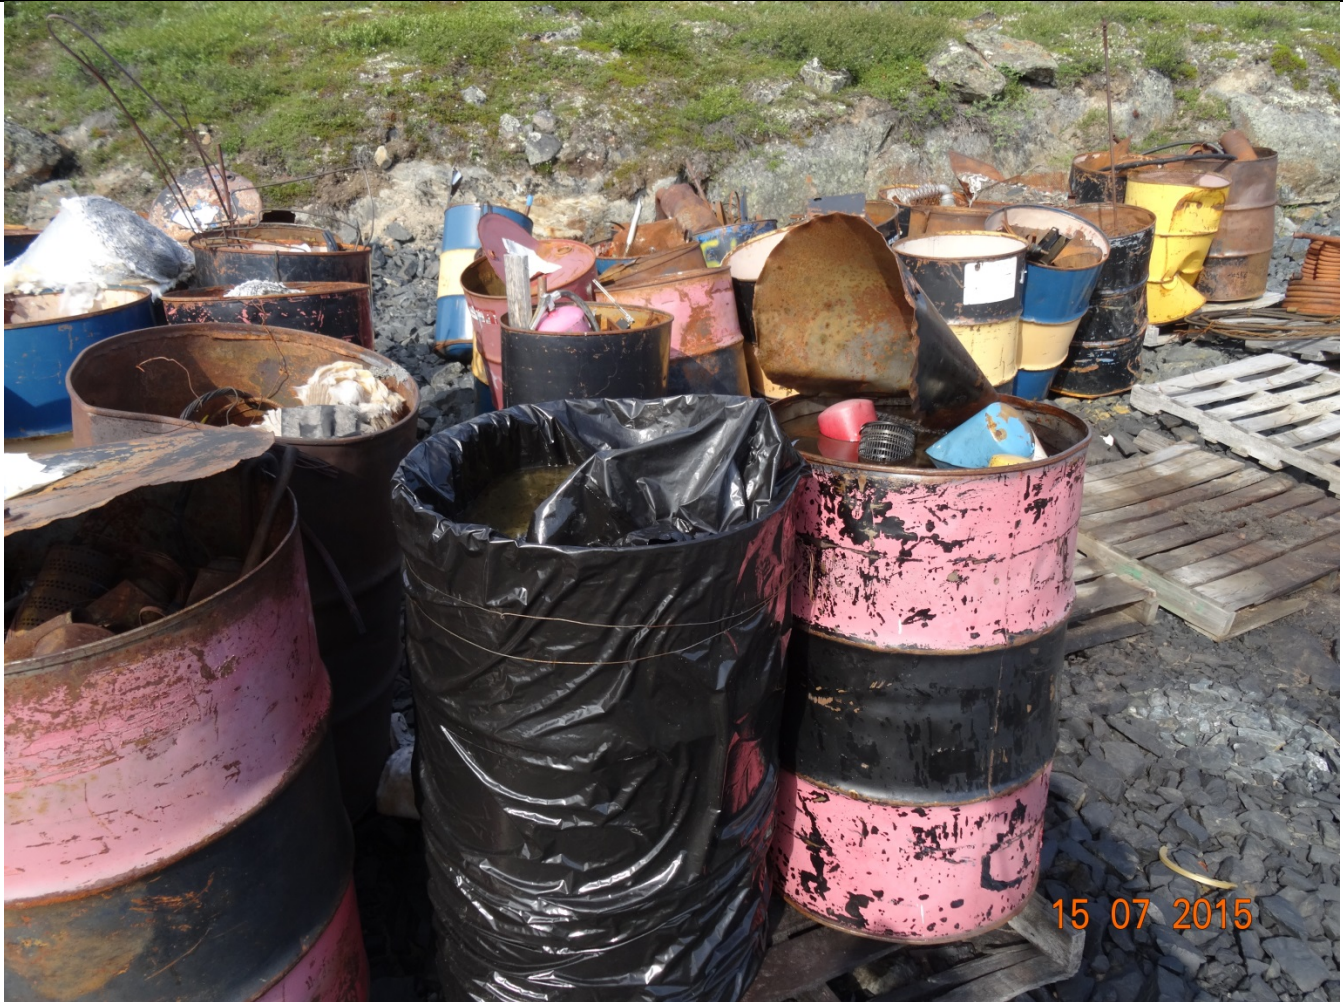
Photo Log # 7

Description: Waste barrels at the mine storage pad. Unknown covered waste, oil filters, pallets where waste was removed, and staining is visible on the ground.

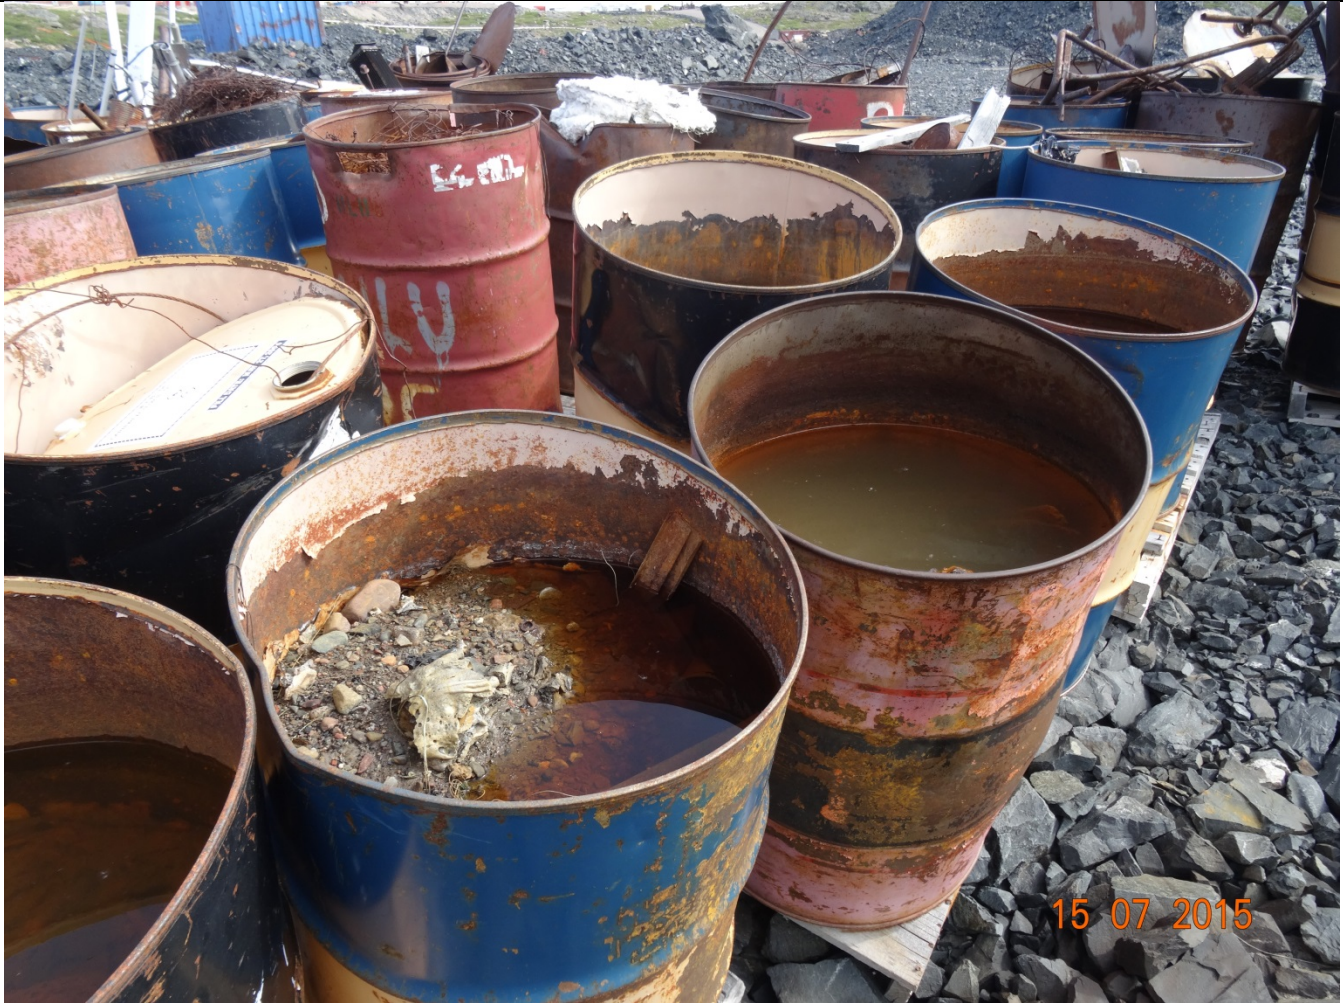
Photo Log # 8

Description: Waste barrels at the mine storage pad. Several barrels of soil (possibly contaminated) and metal waste.

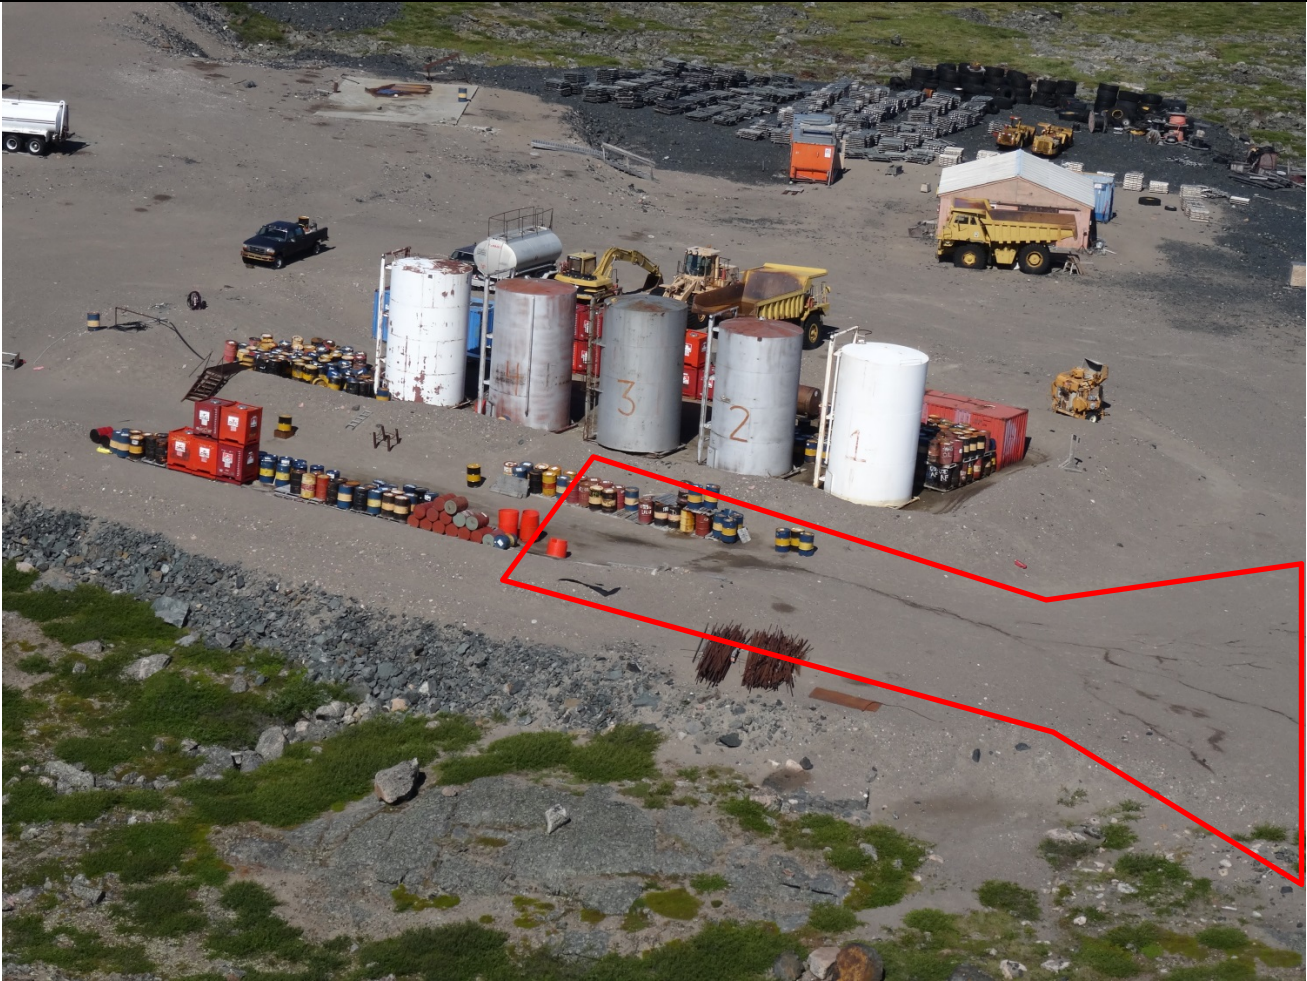
Photo Log # 10

Description: Fuel storage pad July 12 2014 (photo by Eva Paul). Hydrocarbon trail from the fuel storage pad was greatly increased from the previous inspection. It was raised as an issue in the 2014 report, and BCC was instructed to remedy the spill according to the spill contingency plan.

Spills are to be reported and addressed according to the approved Spill Contingency Plan. Steps are to be taken to a) stop the flow of hydrocarbons from the fuel storage pad, b) prevent any further migration of hydrocarbons down-slope from the fuel storage pad, and c) remediate the affected area. This work is to be completed by July 31, 2016 and a confirmatory report submitted to the inspector by August 15, 2016.
