WATER LICENCE INSPECTION FORM

Licensee		Licensee Representative	
Bonito Capital Corp. / Mandalay Resources		Karyn Lewis	
Licence No. / Expiry		Representative's Title	
2BM-ULU1520			
Land / Other Authorizations		Land / Other Authorizations	
IOL			
Date of Inspection		Inspector	
July 06-07, 2016		Eva Paul	
Activities Inspected			
<input checked="" type="checkbox"/> Camp	<input type="checkbox"/> Drilling	<input type="checkbox"/> Mining	<input type="checkbox"/> Construction
<input checked="" type="checkbox"/> Roads/Hauling	<input checked="" type="checkbox"/> Other: Care + Maintenance		<input type="checkbox"/> Reclamation
		<input type="checkbox"/> Other:	<input checked="" type="checkbox"/> Fuel Storage

PHOTO LOG

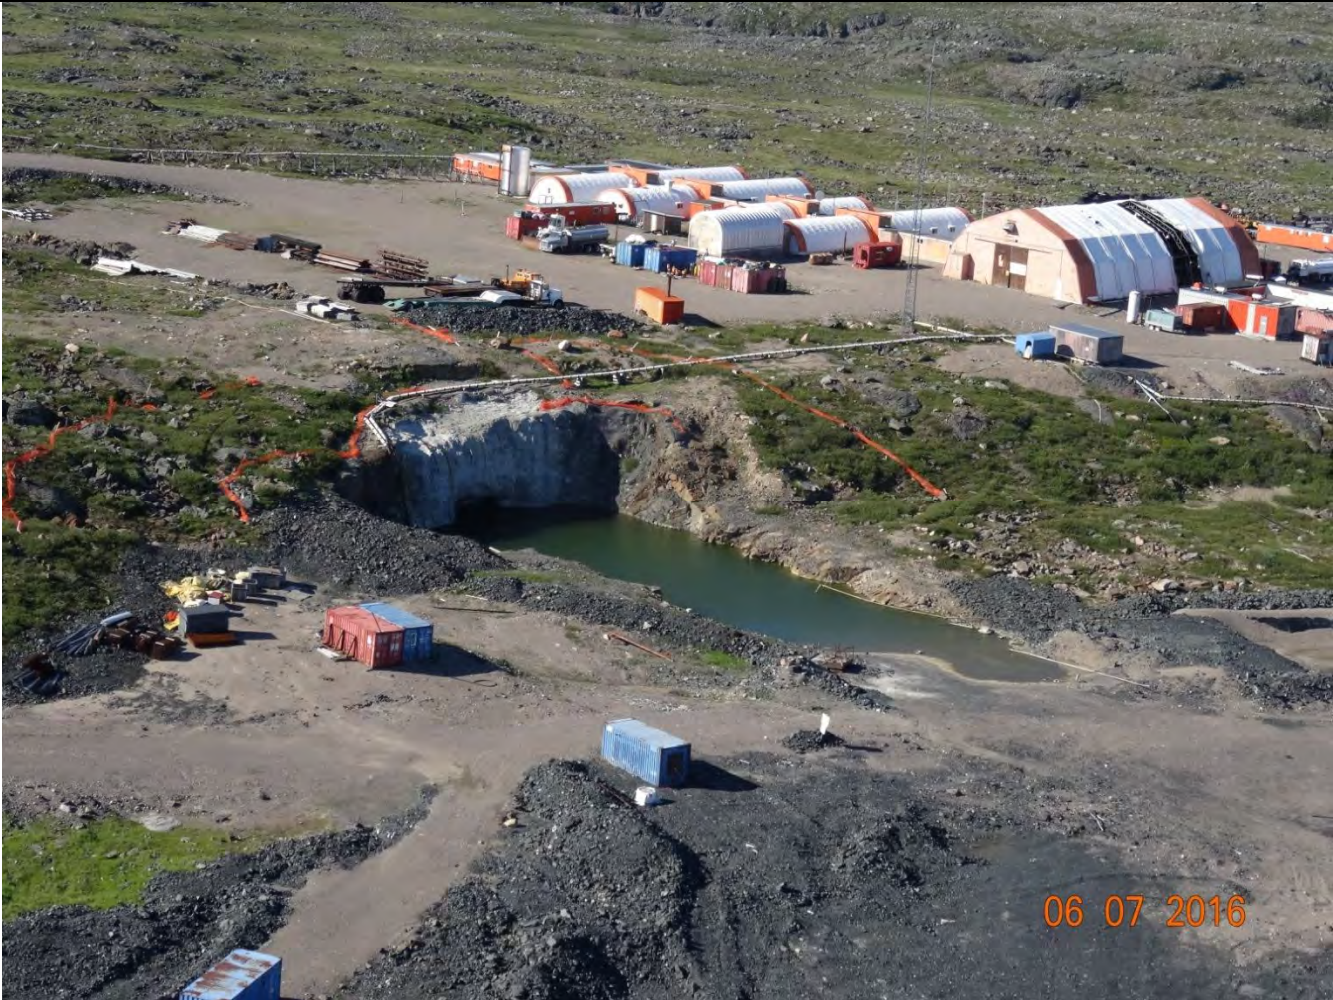
Date	Camera	Inspector	Authorization
July 6 2016	SONY DSC-HX50V	Eva Paul	2BM-ULU1520
Photo Log # 1		Location (NAD 83 DD MM SS.SS)	
Photo DSC05610		N66 54 26	W110 58 04

**Description:** Ulu portal with appreciably more water than in recent years. Also note the large Quonset (upper right) is torn open.

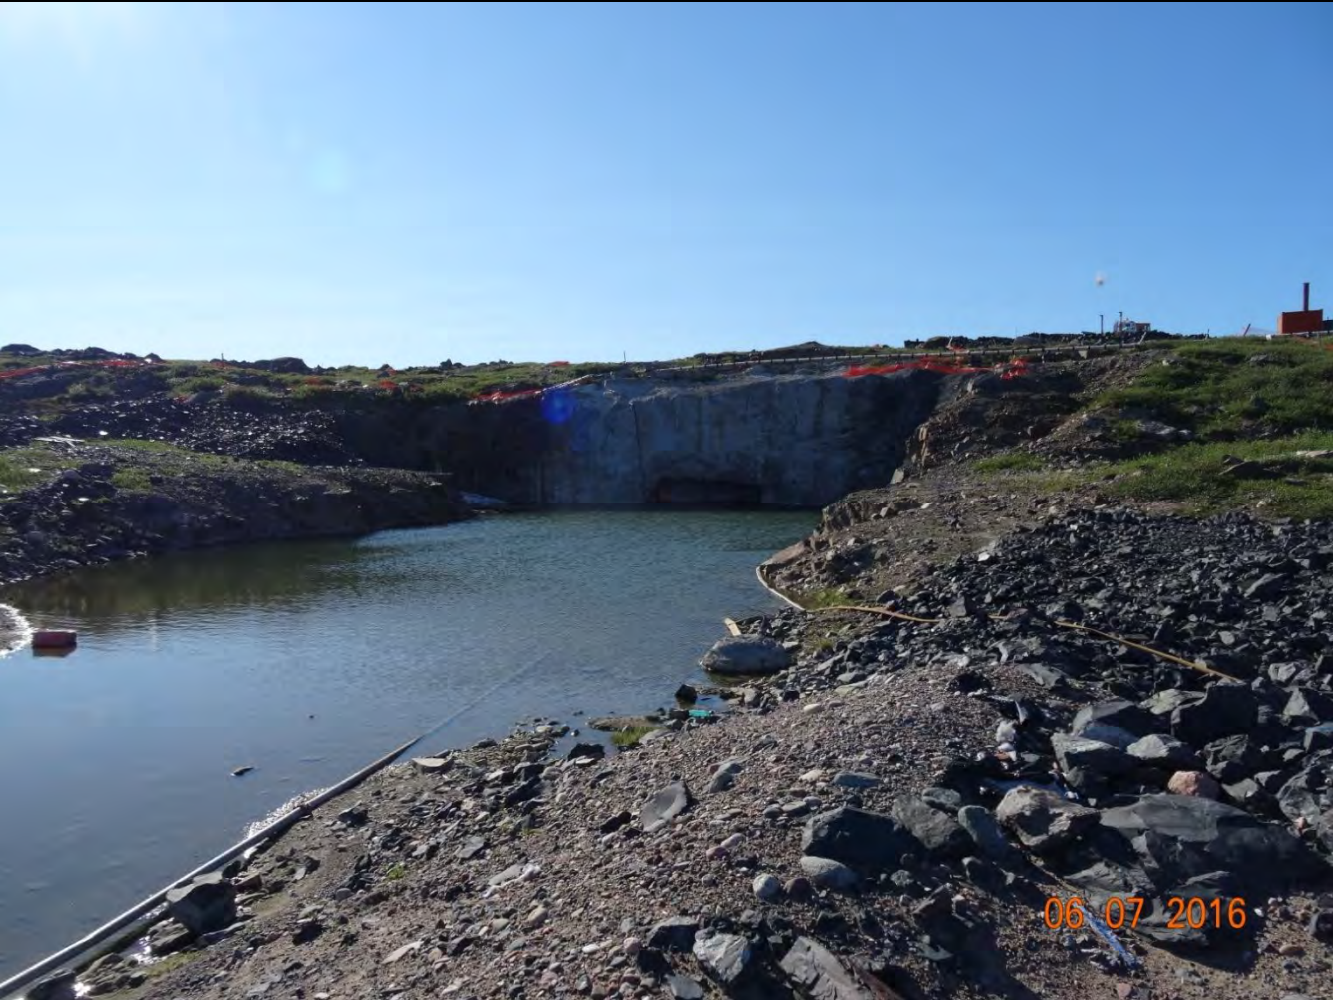
Photo Log # 2	Location (NAD 83 DD MM SS.SS)
Photo DSC05632	N66 54 26      W110 58 04

**Description:** Ulu portal, with piping and hoses visible, assumedly set up for a discharge.

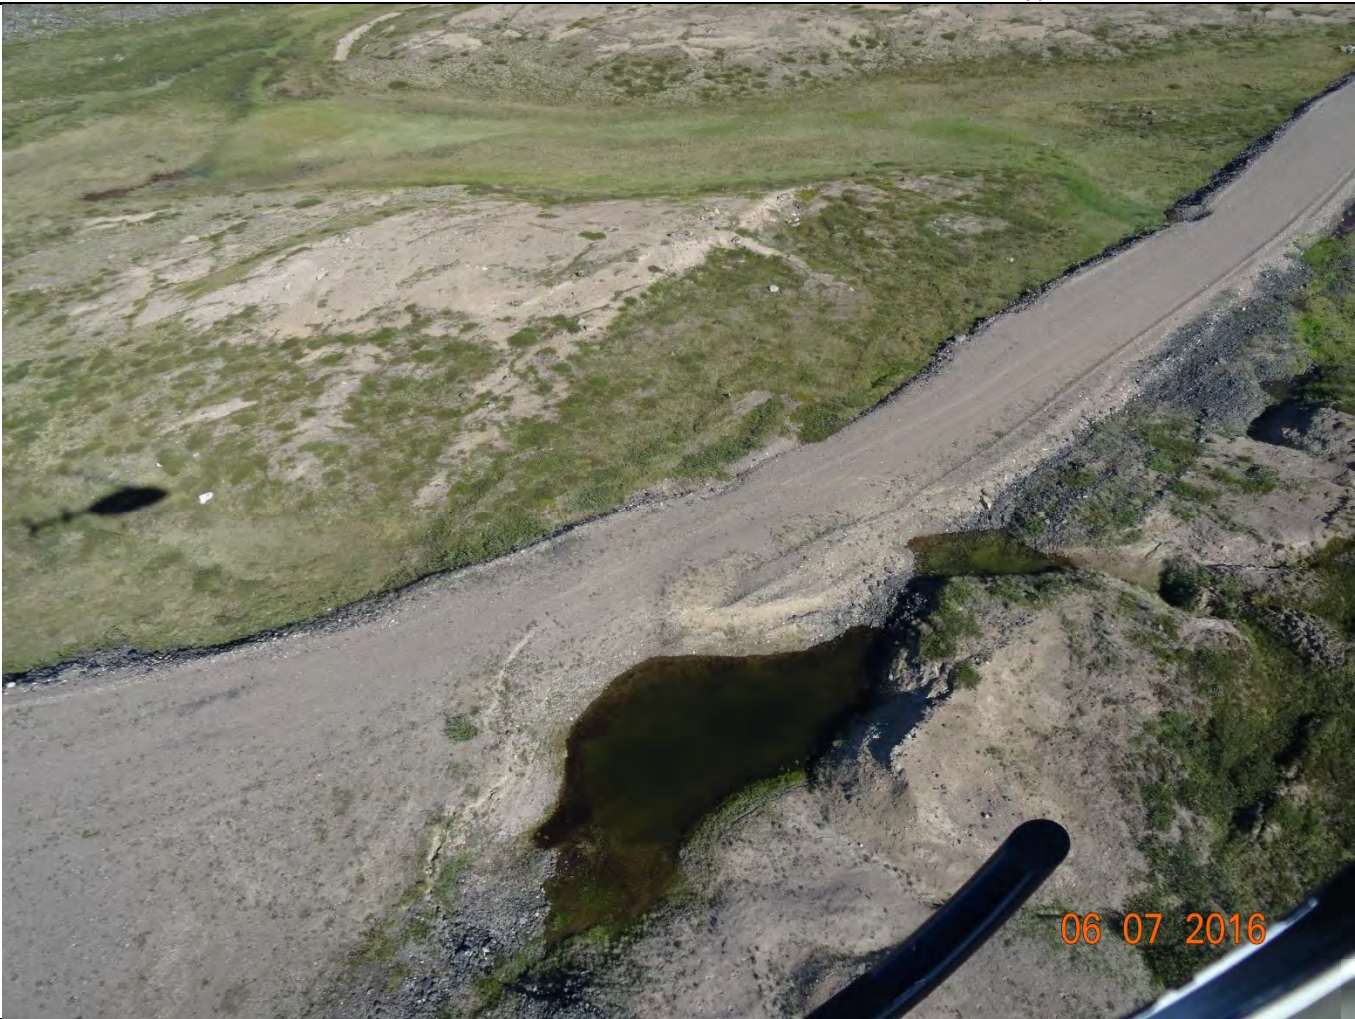
Photo Log # 9

Description: Ponding beside the road is causing slumping; potential permafrost degradation.

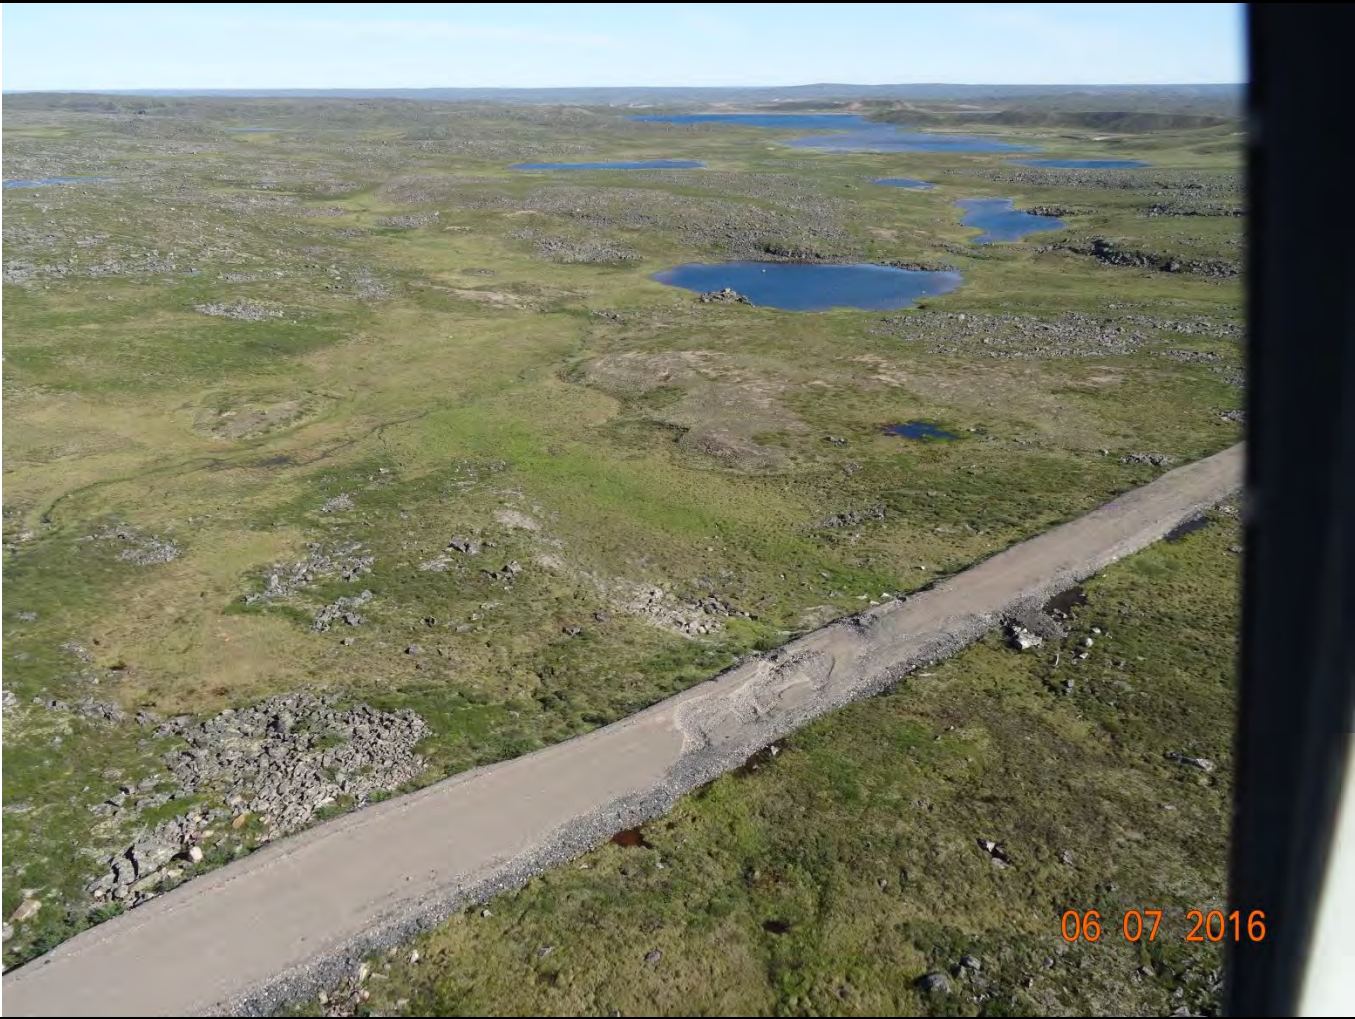
Photo Log # 10

Description: Washed out sections of road as discussed in 2015. No silt fencing or mitigation has been put in place.

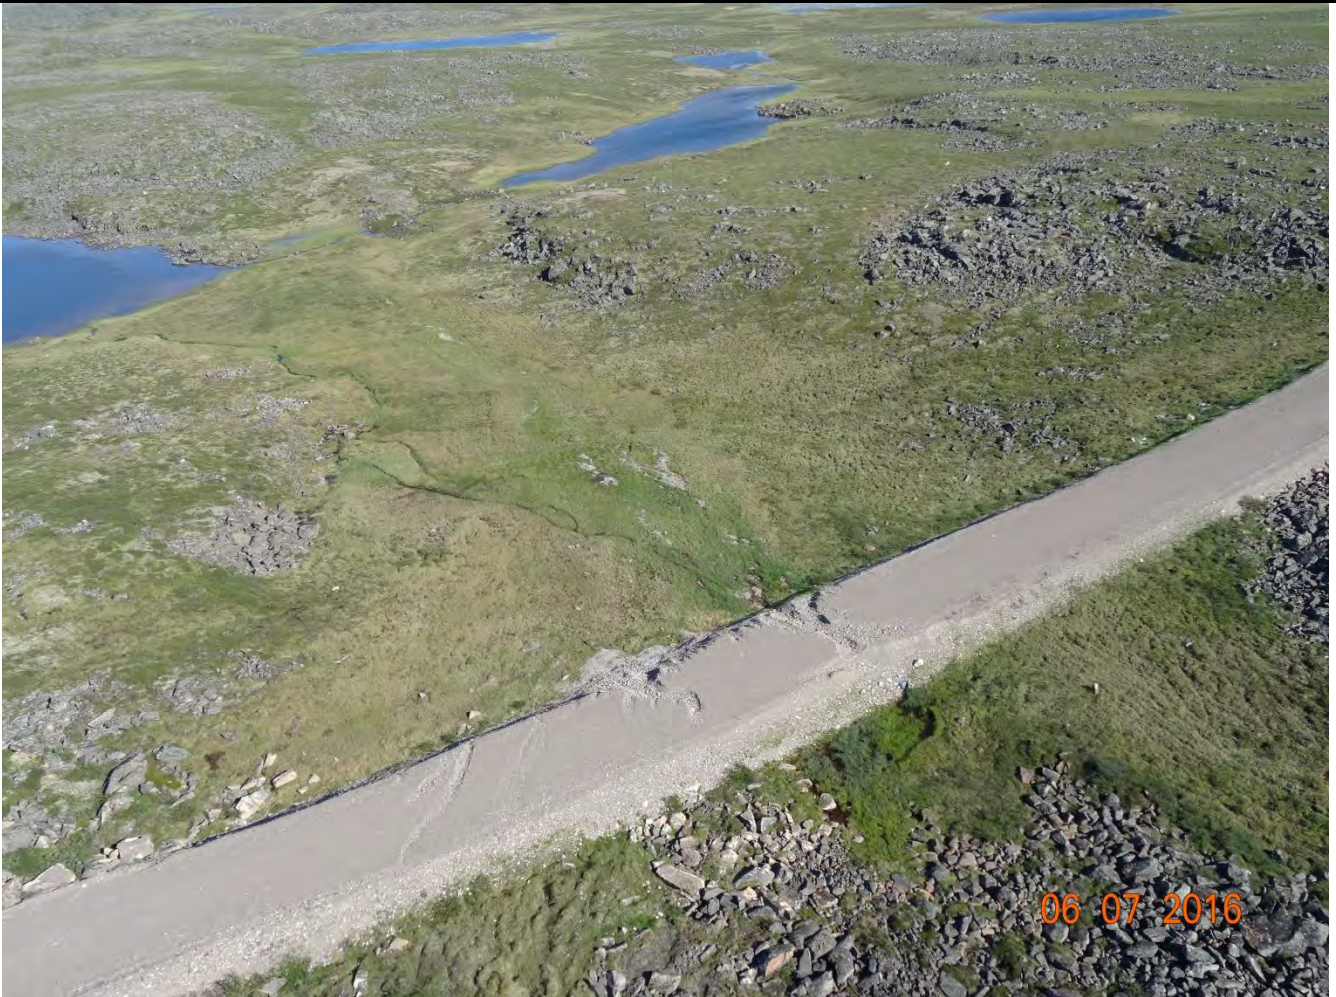
Photo Log # 11

**Description:** As photo 10. No mitigation measures are in place, and no repairs were conducted in 2015 as was proposed in the annual report.

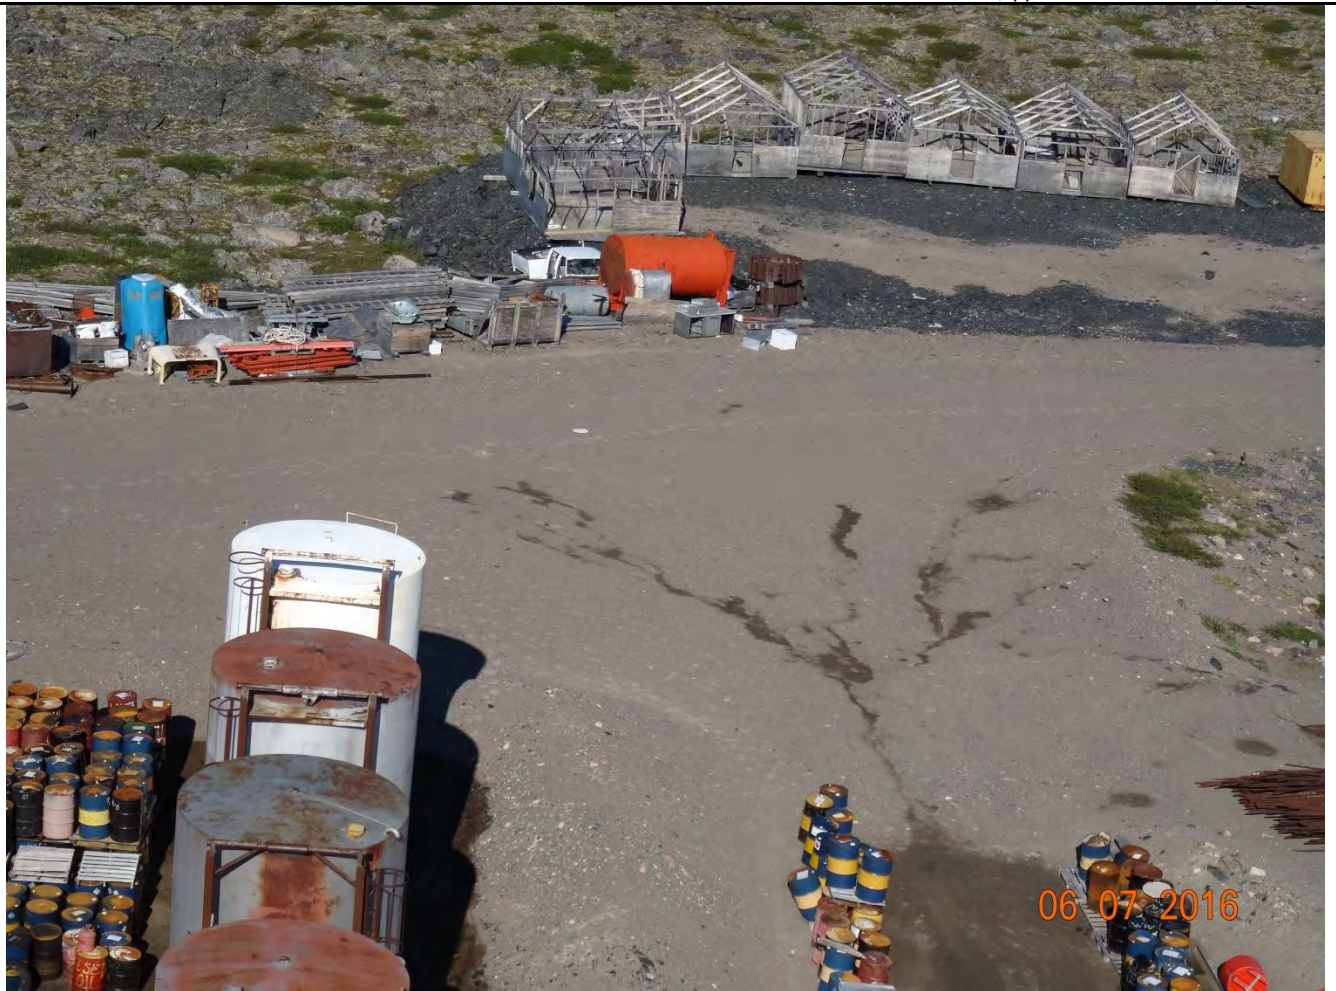
Photo Log # 12

downslope of the fuel storage pad, and confirm F3 (C16-C34) concentrations of 3740 and 9690 mg/kg respectively (2.2x and 5.7x the CCME Tier 1 levels for coarse-grained soils (commercial/industrial)). F4 (C34-C50) concentration of the second sample also surpasses CCME Tier 1 level for residential/parkland at 2970 mg/kg, 32 m downslope of the fuel storage pad. These F3 levels are HIGHER than the samples taken in 2015 which were taken at 13 m downslope of the fuel storage pad. Staining within the storage pad is also more pronounced than in 2015.

**Description:** "Closeup" view of fuel trail spreading from the fuel storage pad.

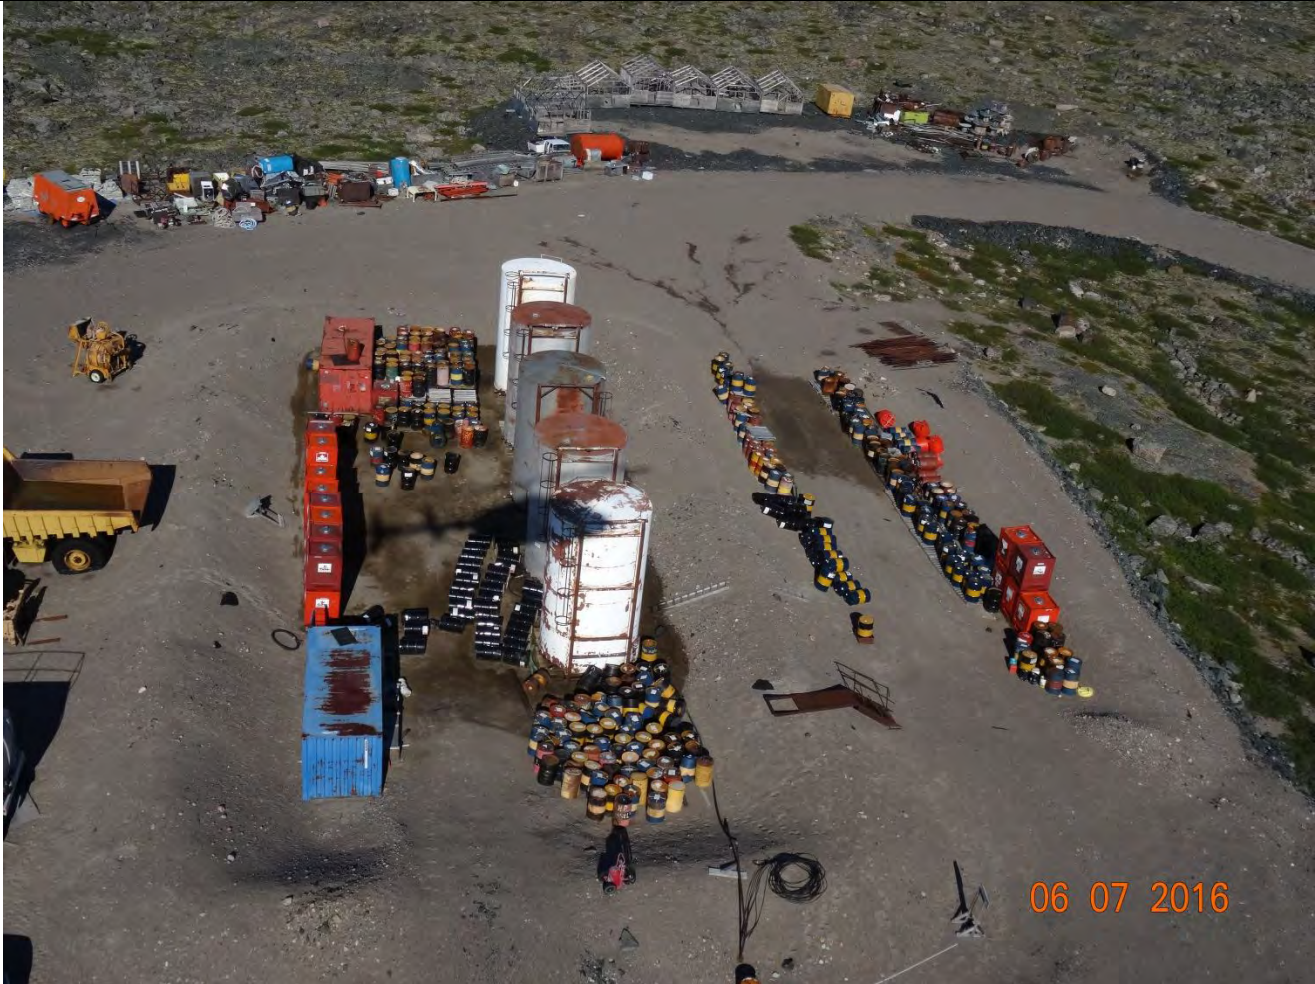
Photo Log # 13	Location (NAD 83 DD MM SS.SS)	
Photo DSC05618	N66 54 30	W110 58 01 (approximate, from air)

**Description:** Comparative photo of the staining within the fuel storage pad (compare to next photo, taken in 2015).

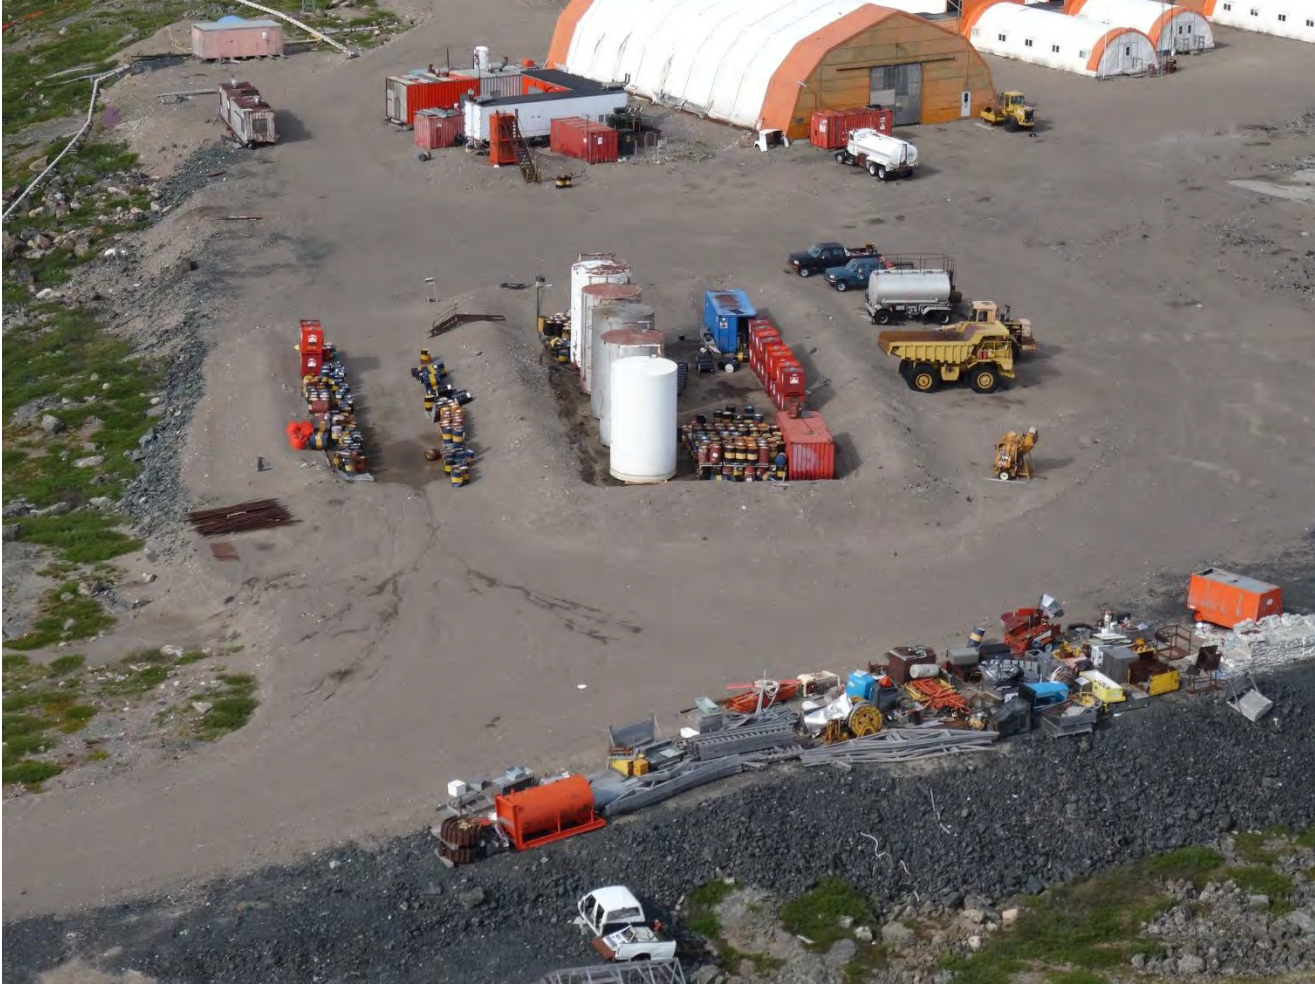
Photo Log # 14	Location (NAD 83 DD MM SS.SS)	
Photo DSC03376 (July 15 2015)	N66 54 35	W110 57 44 (approximate, from air)

**Description:** 2015 aerial view of the fuel storage pad; staining within the pad is less extensive than this year.
