WATER LICENCE INSPECTION FORM

Licensee		Licensee Representative	
Bonito Capital Corp		Mathieu Beaudoin (Discovery Mining Services)	
Licence No. / Expiry		Representative's Title	
2BM-ULU1520		Contractor	
Land / Other Authorizations		Land / Other Authorizations	
Date of Inspection		Inspector	
11/07/2017		Eva Paul	
Activities Inspected			
<input checked="" type="checkbox"/> Camp	<input type="checkbox"/> Drilling	<input checked="" type="checkbox"/> Mining	<input type="checkbox"/> Construction
<input checked="" type="checkbox"/> Roads/Hauling	<input type="checkbox"/> Other:	<input type="checkbox"/> Other:	<input checked="" type="checkbox"/> Reclamation
<input checked="" type="checkbox"/> Fuel Storage

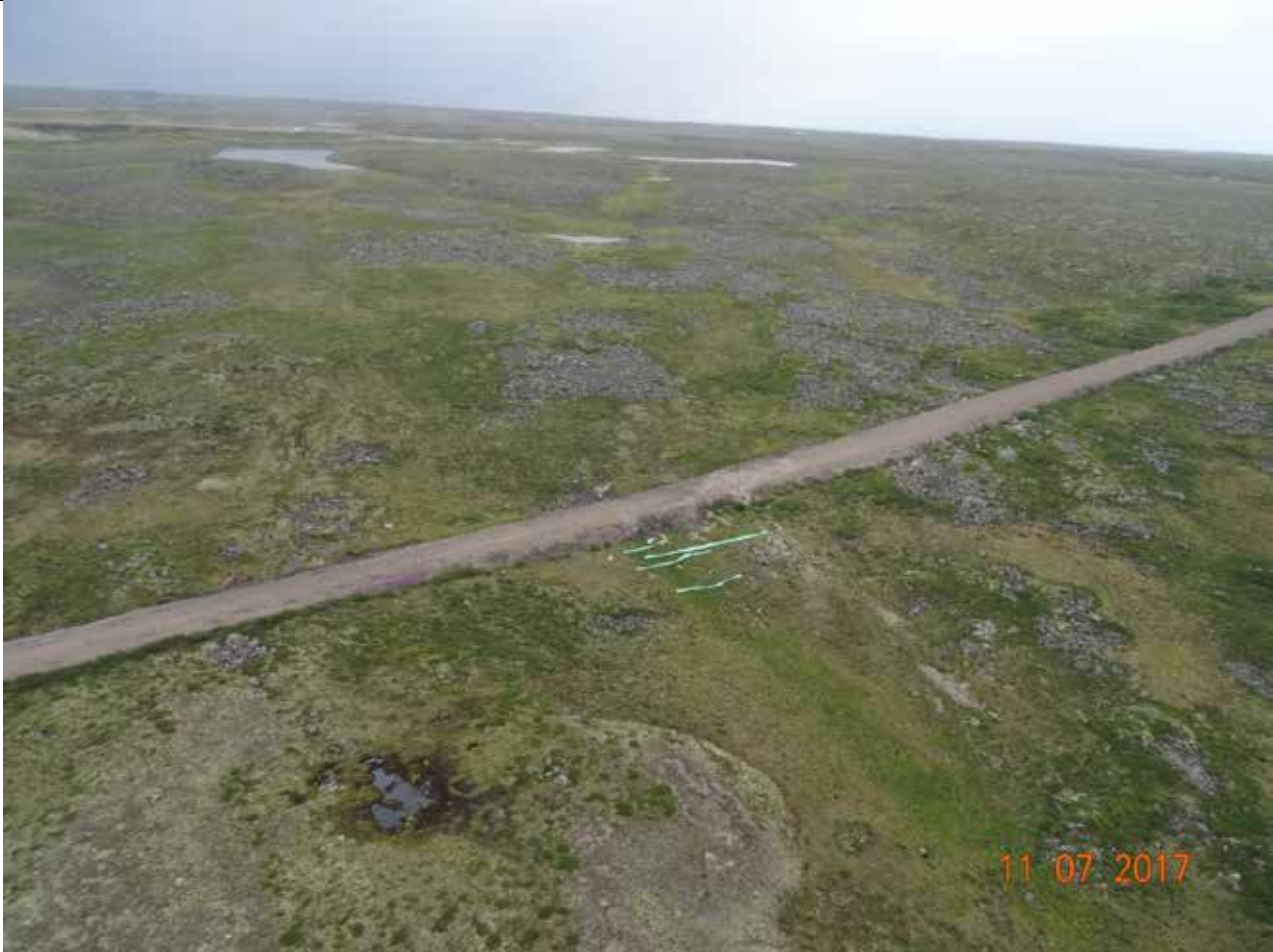
Date	Camera	Inspector	Authorization
July 11 2017	SONY DSC-HX50V	EVA PAUL	2BM-ULU1520
Photo Log # 1		Location (NAD 83 DD MM SS.SS)	
Photo DSC07388		N66 52 15.3	W111 00 23.8

**Description:** Aerial view of one wash-out on road to Camp 3. Silt fences were installed in 2016, to limited avail. Reasons for the road washing out must be addressed. I believe the drainage up-slope is compromised. There is a culvert at the main channel, but not all overland flow is able to report to that culvert (see next photo)

- C. Maintenance issues with respect to the roads should be examined in light of site drainage issues, and in conjunction with the report on culverts to be submitted by September 30, 2017. If possible, before the end of the season, implement the recommendations of the engineer that will improve the integrity of the roads and reduce erosion and sediment issues.

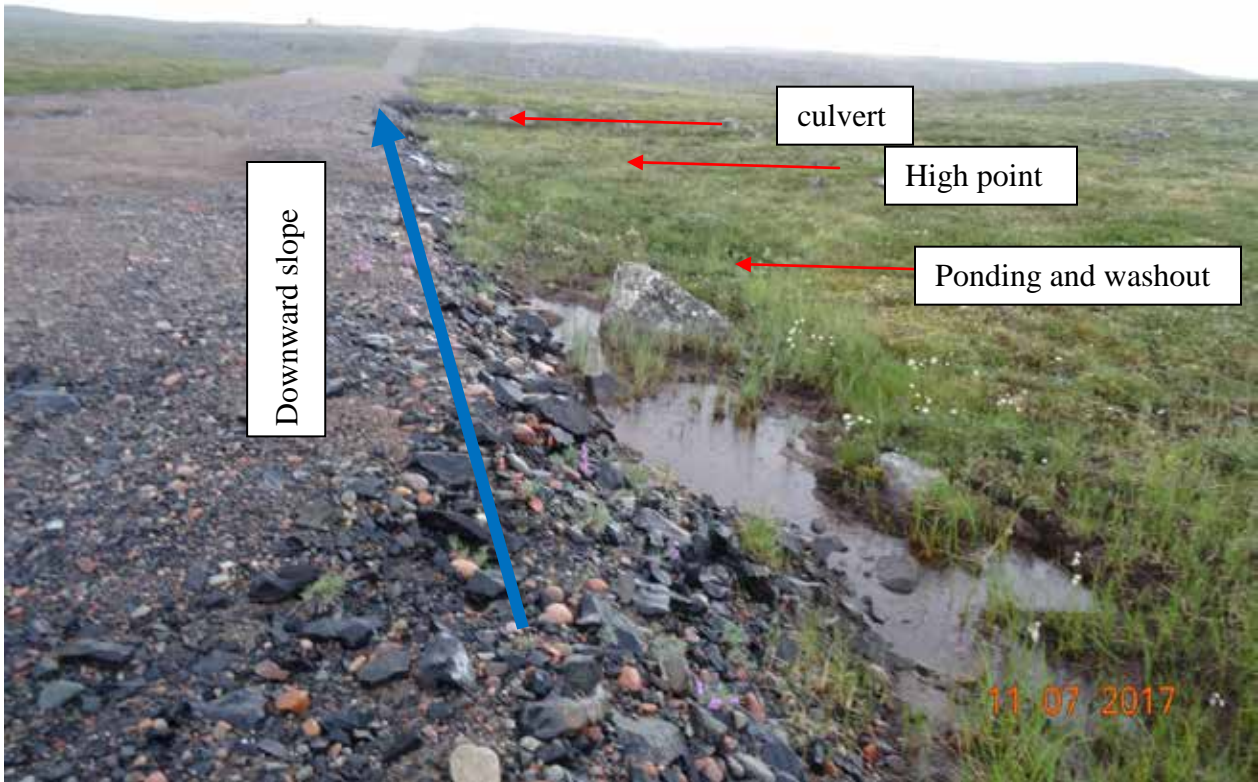
Photo Log # 2	Location (NAD 83 DD MM SS.SS)
Photo DSC07469	N66 52 15.9      W111 00 24.3

**Description:** Water ponding upslope of the road at the point where the wash out occurs. There is a high area that prohibits this water from reporting to the nearby culvert.

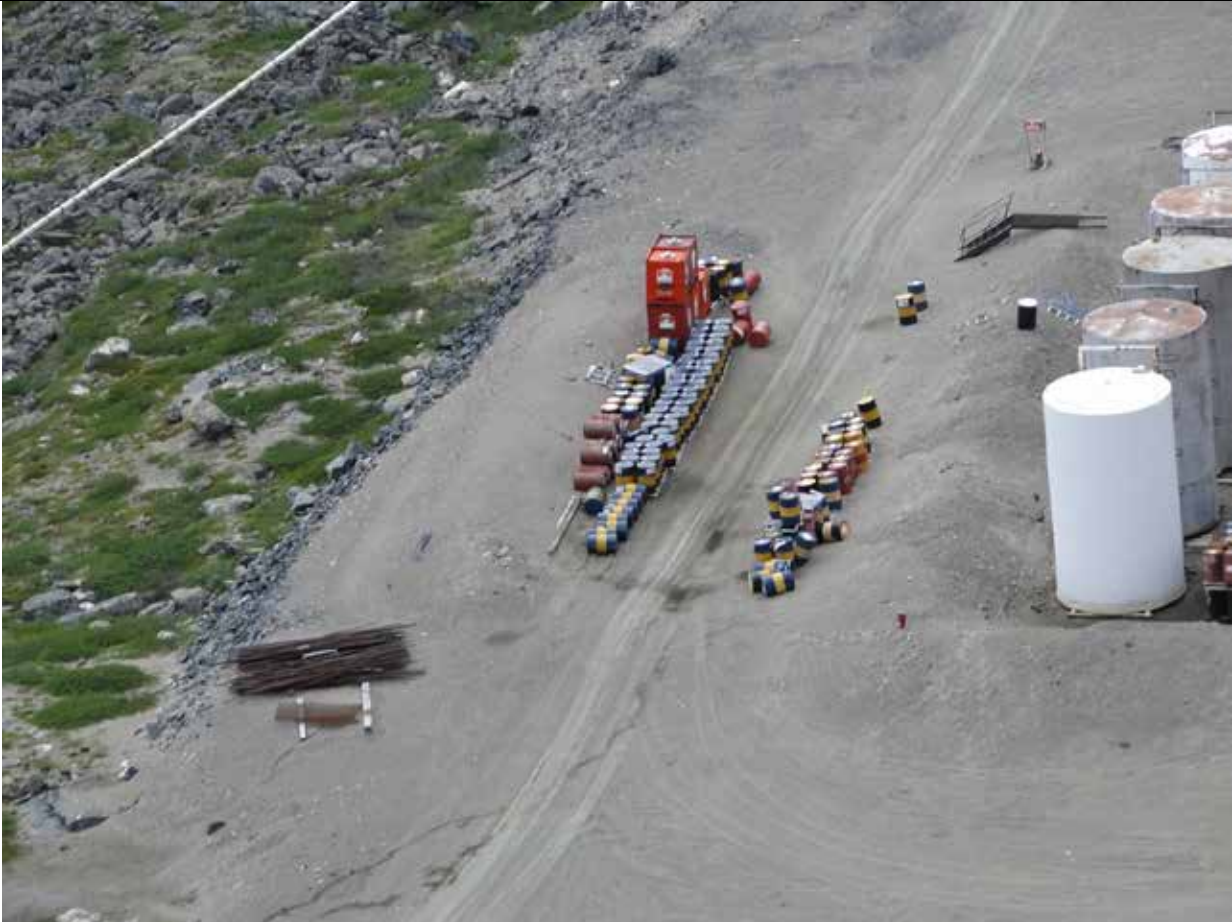
Photo Log # 3

7. The hydrocarbons spreading from the above-mentioned apron have been in evidence since my first inspection at Ulu in 2012 (see attached photo). It has been noted specifically in my reports since 2014 that the Spill Contingency Plan was to be employed in respect of this issue. The employment of an absorbent boom at the toe of the apron in September 2016, and the removal of hazardous waste from the pad was the first action taken in more than 2 years. However, the Licensee has still failed to file a spill report despite being repeatedly told to do so. I have informed Ms. Lewis that if a spill report is not filed by July 31 2017, I will file the report on behalf of the Licensee. When I arrived to site for this inspection, the boom was removed and sitting off to the side, however, the contractors on-site had put stakes in the ground at the bottom visible edge of the contamination, and had already filled 12 205L drums of contaminated soil.

Description: 2012 was the first year I inspected this site. In reviewing my photos, I can see that this hydrocarbon flow was already present in 2012.

- D. Immediately discontinue use of the apron beside the tank farm that has been used for barrel storage. Contaminated soil is to be removed and managed according to the SCP. Further contamination resulting from this facility is unacceptable; any water ponding on the pad should be treated as contaminated and not allowed to flow off the pad.

- E. A spill report addressing the issue of contamination on the apron and the resulting downslope flow is to be filed by **July 31, 2017**. It should fully describe the scope of the issue, which clearly pre-dates my first inspection in 2012, and the action to be taken. Soil sampling to determine the full extent of the impacted area is to be conducted immediately, and should inform the remediation efforts. Numerous small stains around the entire site should also be shovelled up as soon as practically possible.

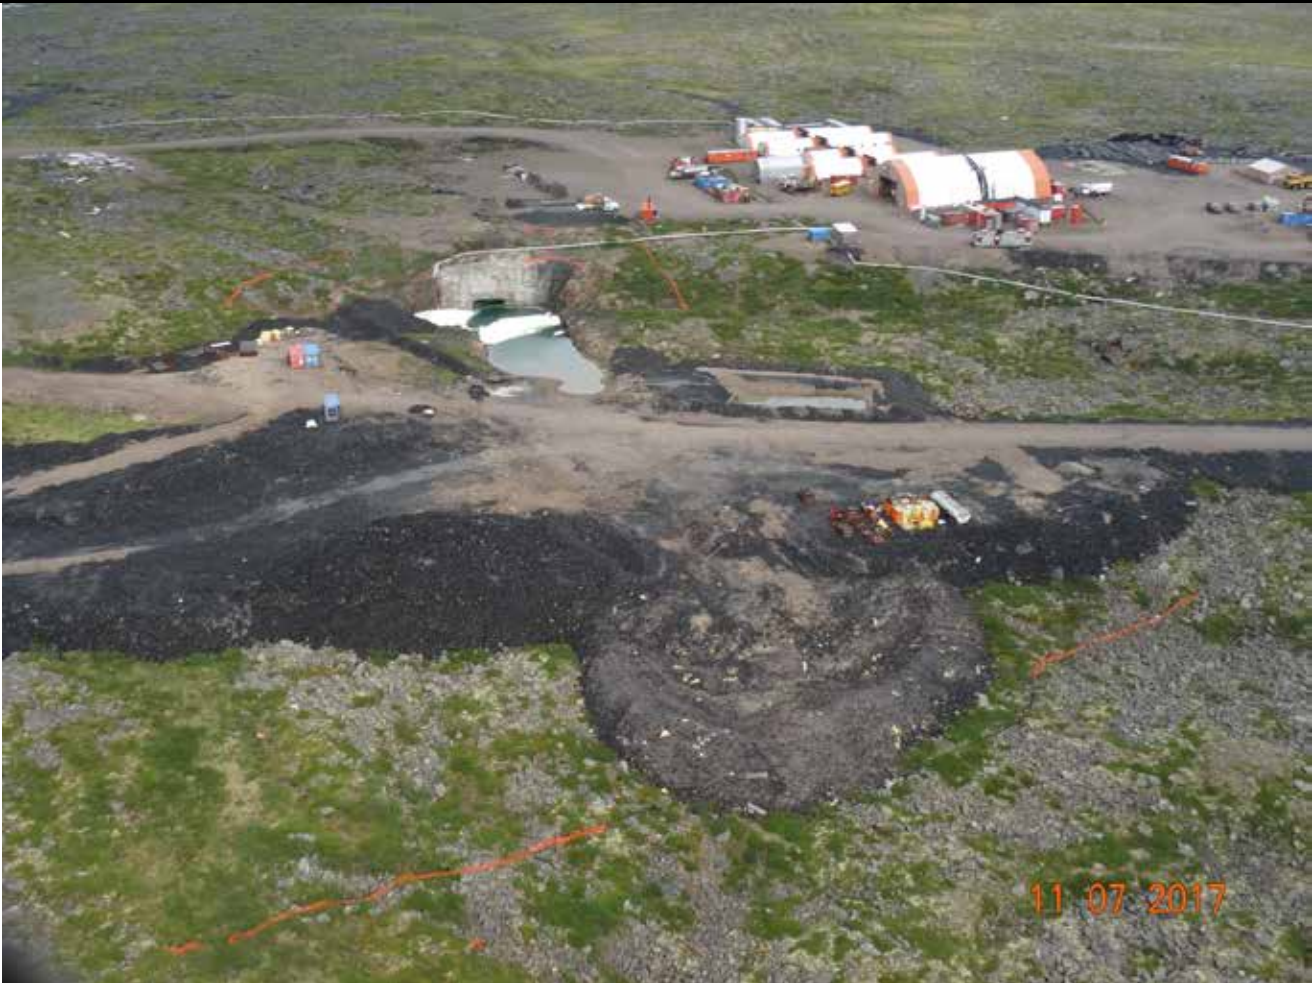
Photo Log # 7

Description: Water ponding in the portal is near to the road.

- B. Conduct sampling of the portal water to verify compliance with discharge criteria, and undertake discharge (with notification to the Inspector) before the end of this season.
