WATER LICENCE INSPECTION FORM

Licensee	Licensee Representative
Bonito Capital Corp	Jay – Discovery Mining Services
Licence No. / Expiry	Representative's Title
2BM-ULU1520	Contractor
Land / Other Authorizations	Land / Other Authorizations
Date of Inspection	Inspector
20/08/2017	Eva Paul
Activities Inspected	
<input checked="" type="checkbox"/> Camp	<input type="checkbox"/> Drilling
<input checked="" type="checkbox"/> Roads/Hauling	<input type="checkbox"/> Other:
<input checked="" type="checkbox"/> Mining	<input type="checkbox"/> Construction
	<input checked="" type="checkbox"/> Reclamation
	<input checked="" type="checkbox"/> Fuel Storage
	<input type="checkbox"/> Other:

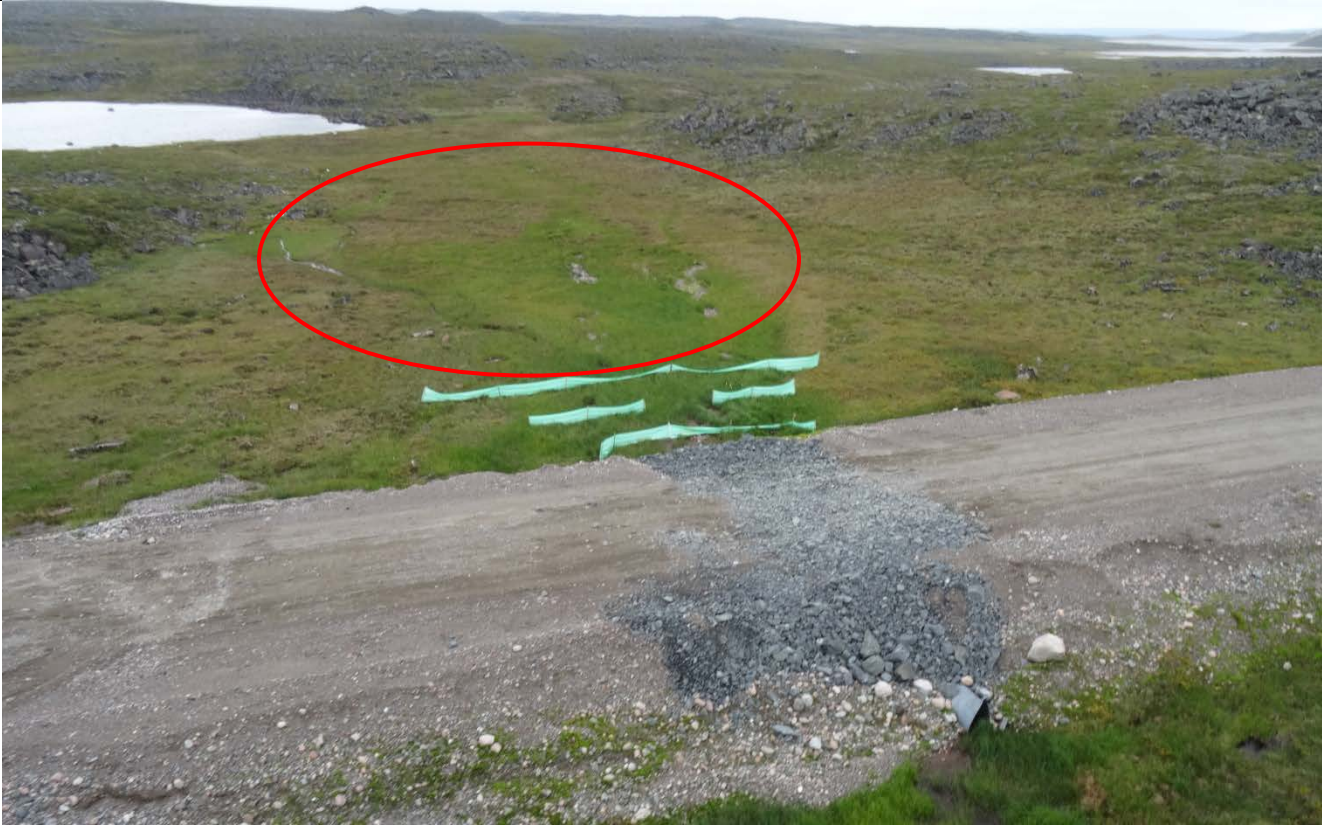
Date	Camera	Inspector	Authorization
August 20 2017	SONY DSC-HX50V	EVA PAUL	2BM-ULU1520
Photo Log # 1		Location (NAD 83 DD MM SS.SS)	
Photo DSC08157		N66 52 15 03.1	W111 00 23.9 (approx.. from air)

7. Ms. Lewis informed me during the inspection that ore was used to backfill the washouts on the road to Camp 3. The licence prescribes that fill or quarry material must be obtained from approved sources, and be free of metal leaching and acid generating potential.
8. A plan for the remediation of all historic drilling of the project was requested as a result of the 2016 inspection. A report on the reclamation efforts to date was due for submission to the Inspector by September 30, 2017 but has not been received at the time of this writing.

Description: Aerial view of one large wash-out area that has been backfilled (presumably with ore based on Ms. Lewis' information). Silt fences may mitigate further sediment from the road, but none are present between the existing sediment trail and the pond.

- B. Water use records are to be maintained, even when use is small.
- C. Further silt fencing is to be installed in the spring, to mitigate sediment deposition as a result of the road washouts. A plan for sediment that has migrated downslope is to be submitted to the inspector for approval by May 15, 2018 and implemented for 2018 freshet.

- G. Please provide confirmation to the Inspector and the Board that the materials used for road repairs were from an approved source, free of metal leaching and acid generating potential.

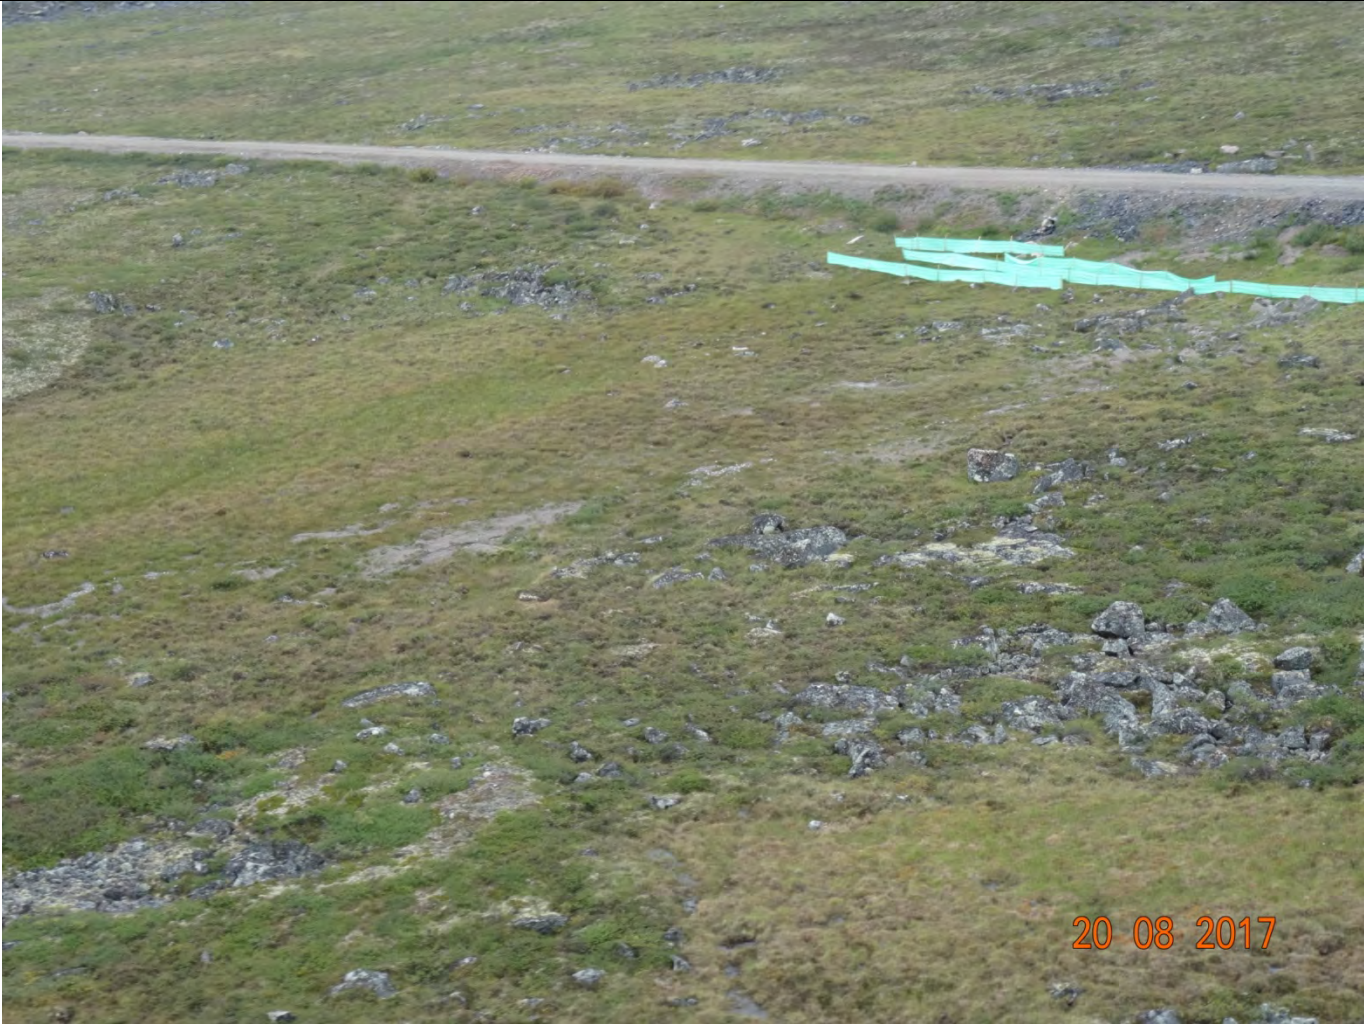
Photo Log # 2	Location (NAD 83 DD MM SS.SS)	
Photo DSC08170	N66 52 17	W111 00 10 (approx.. from air)

Description: Downslope view of sediment trail deposited from the road washout.

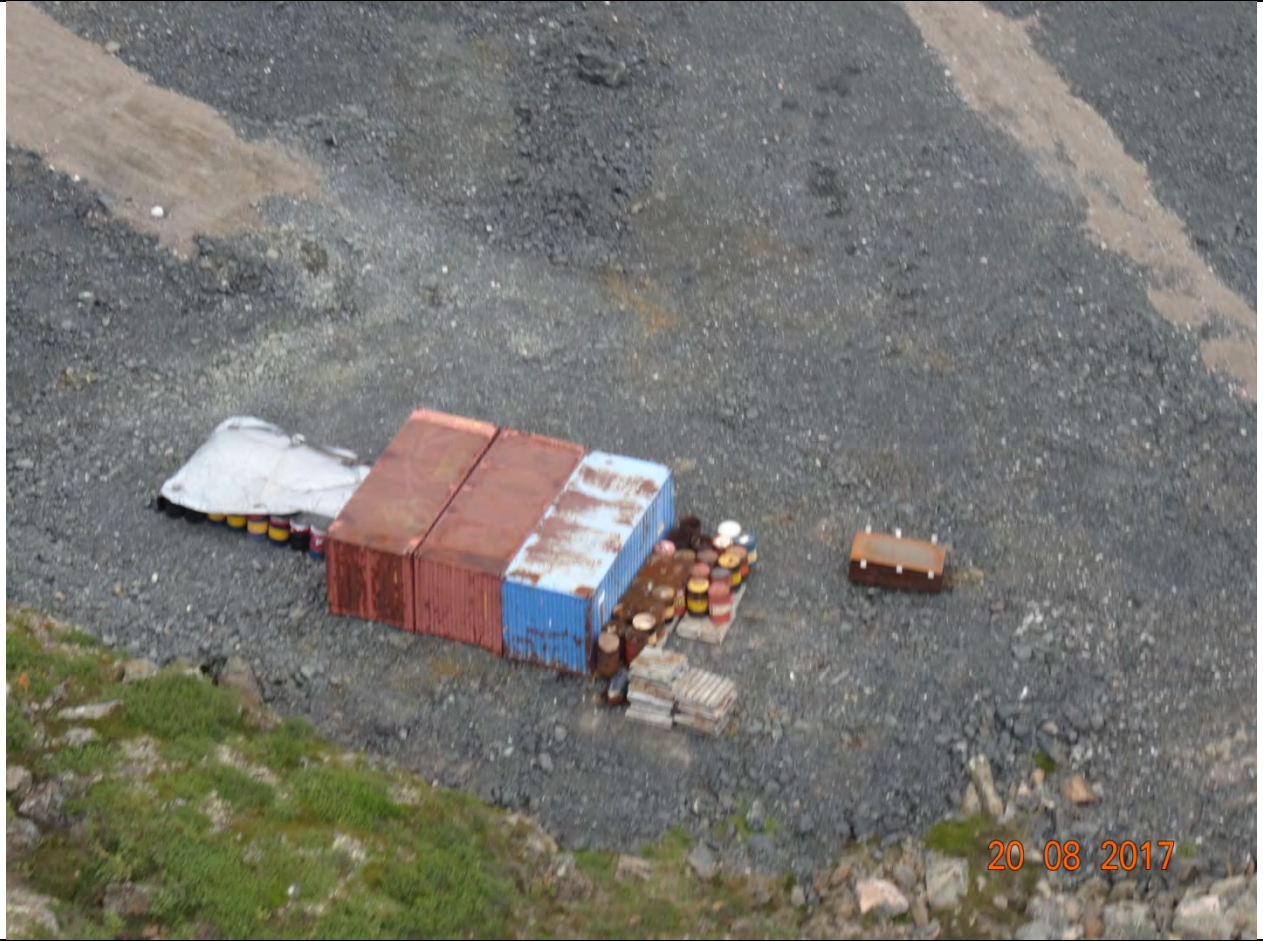
Photo Log # 4

Description: Barrels of contaminated soil stored on the mine storage pad.

- E. Please clarify what the intent is to manage toilet wastes and greywater in 2018 and throughout the proposed reclamation.
- F. A follow-up report detailing all remedial actions for spill 17-275, with photographs and sampling results (before and after), and including the management of the contaminated materials, is to be provided to the inspector by December 1, 2017.

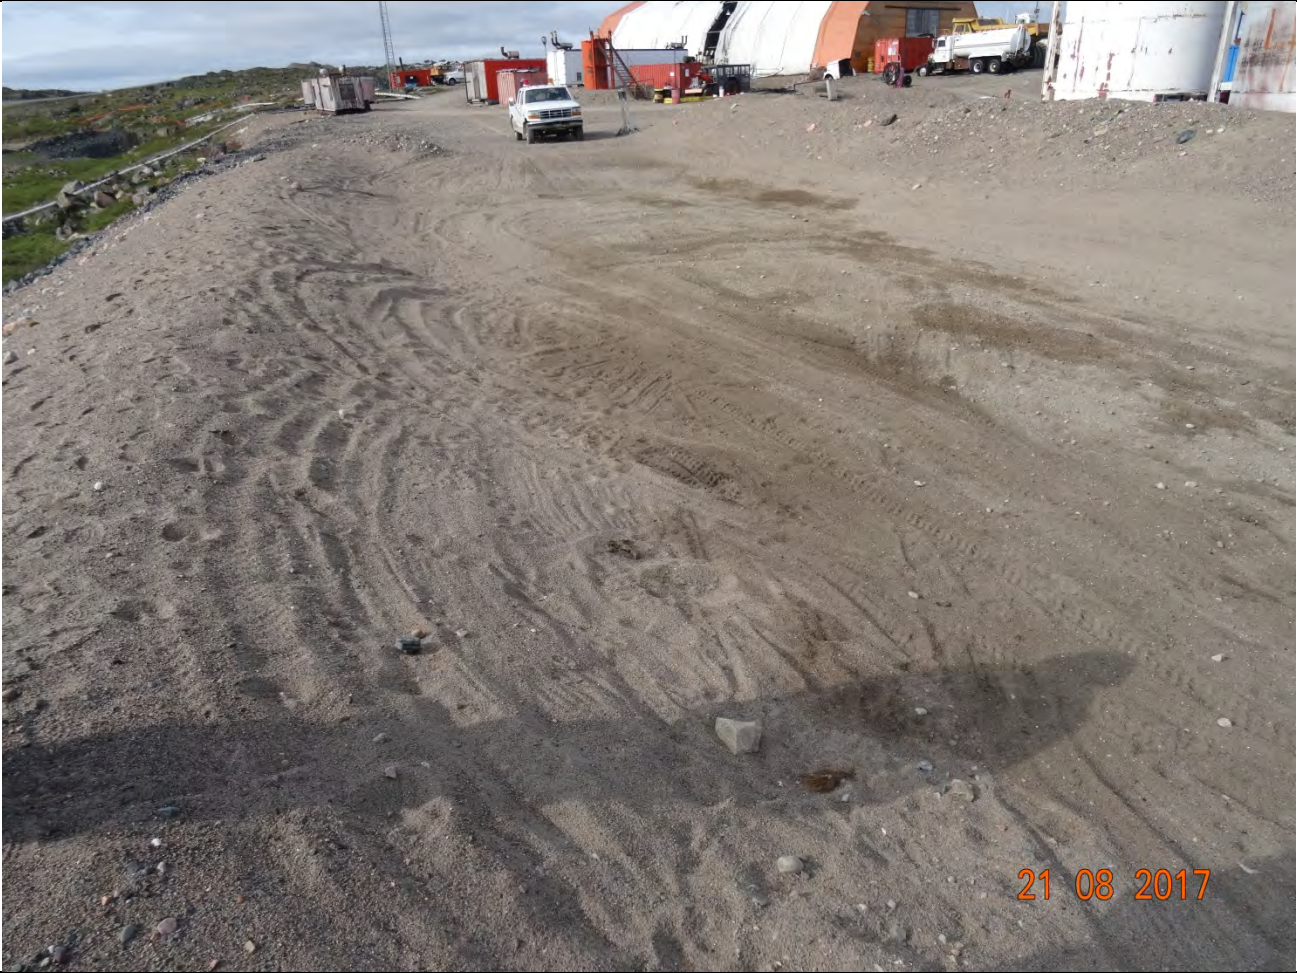
Photo Log # 5

Description: Staining within the apron.

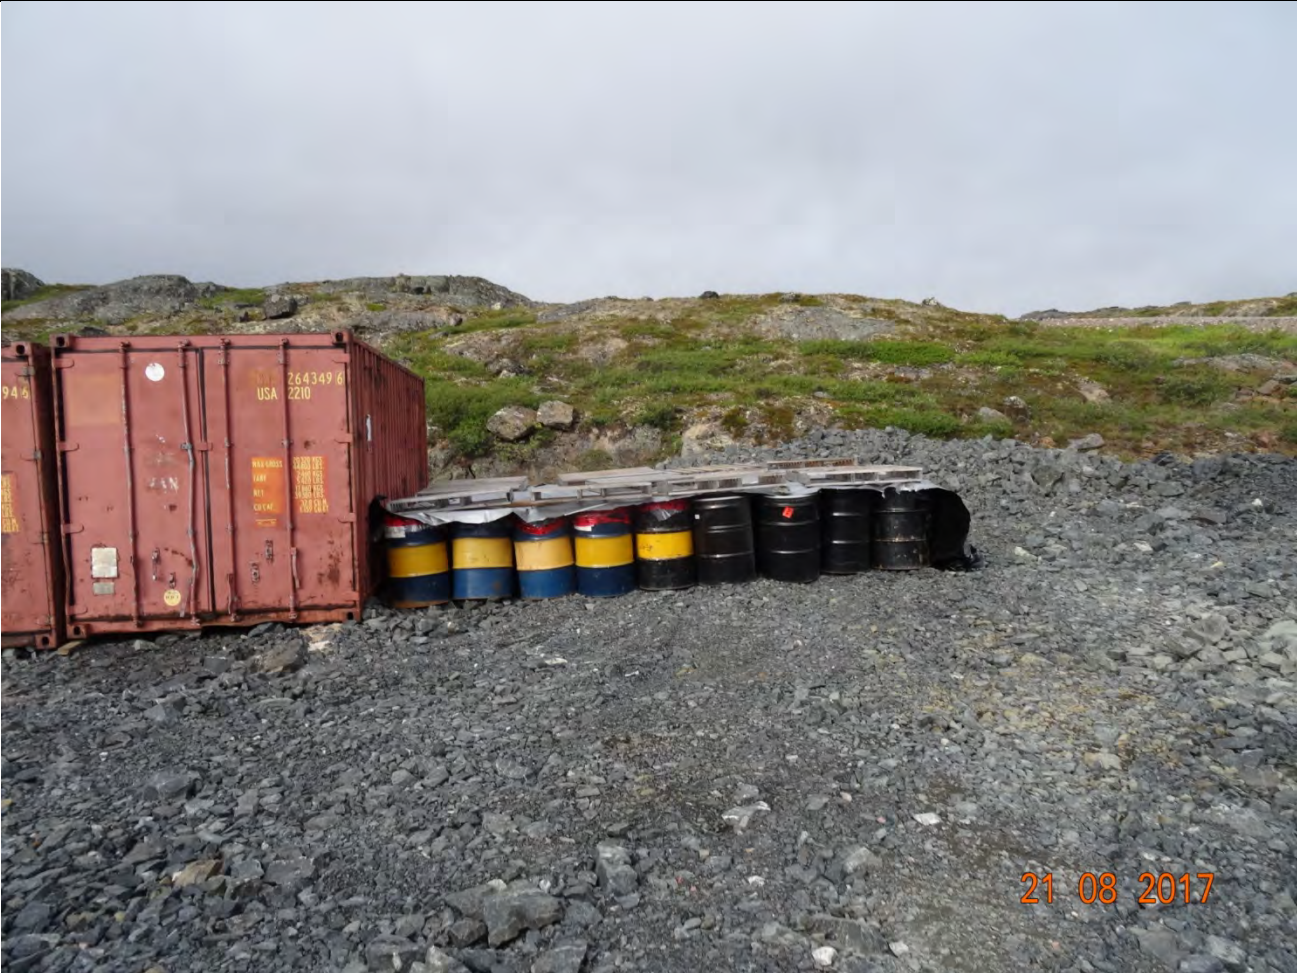
Photo Log # 6

Description: Barrels as seen in photo 4.
