Memorandum

To	Karyn Lewis (LMI)	Project #	924-3
CC	Sara Wilkins (Norwest)	Date	November 30, 2017
From	Alvin Tong, P.Eng.		
Subject	Ulu Access Road Maintenance

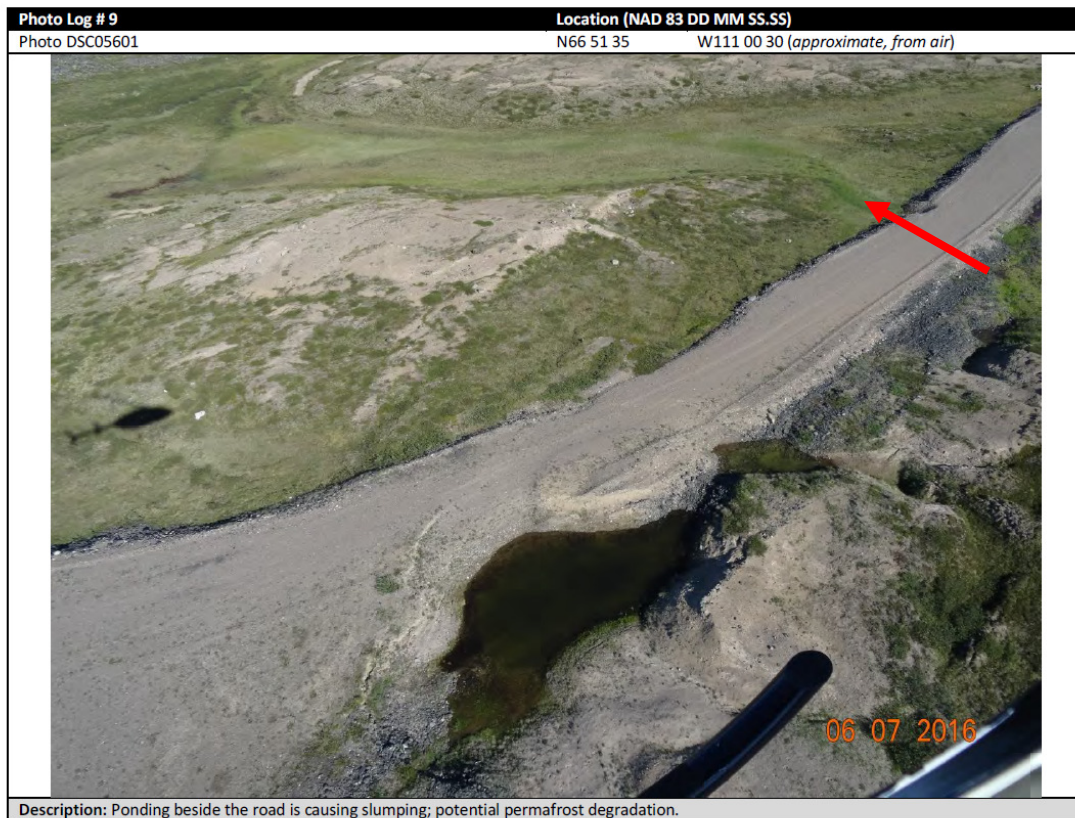
Photo 9 shows the ponding on the upstream side of the road near Camp 3 and near the branch off to the borrow area. Norwest field observation indicate that there is a culvert located nearby downstream (red arrow).

Photo#9: The water ponded upstream of the road should be drained to limit the presence of standing water. Channels should be excavated within the road fill to allow water to drain toward the nearby culvert and minimize the potential for future ponding. Until the drainage is established, the water should be pumped and discharged to the culvert.

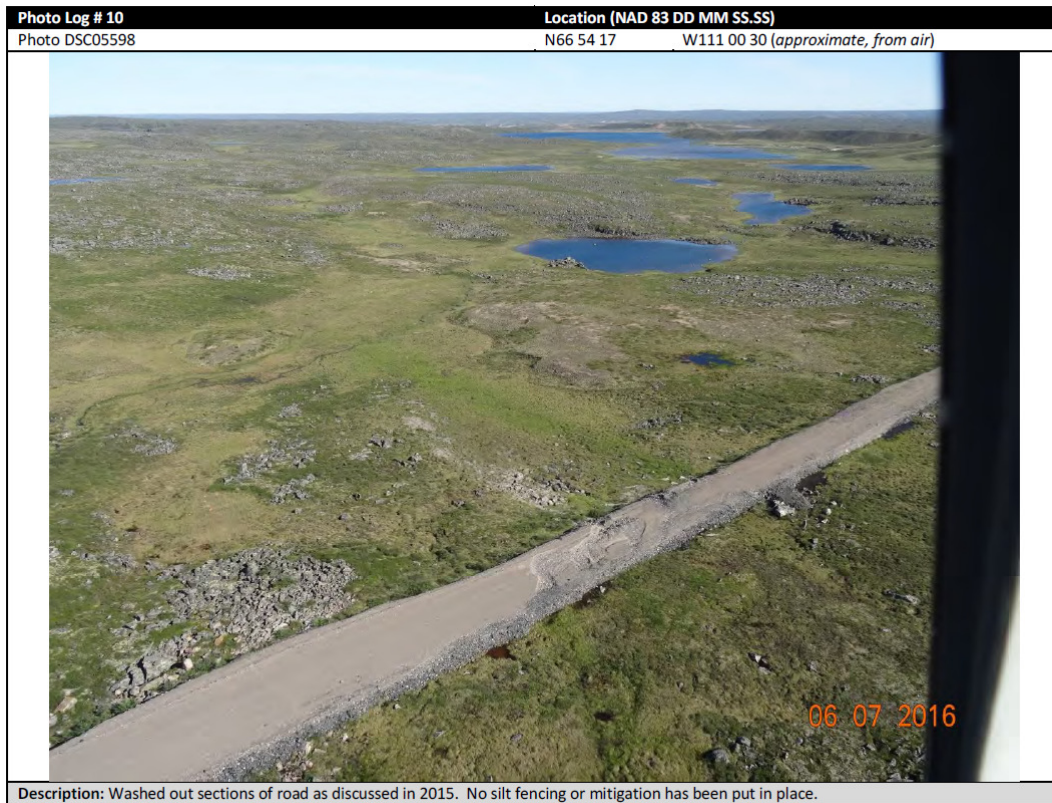
Photo 10 and 11 show braided erosion gullies across the road in various locations and origins. A culvert is not confirmed within the section of the road shown in Photo 10. There is a culvert along the section of the road shown in Photo 11 (red arrow).

Photo#10 and 11: The erosion on the road was observed during the geotechnical engineer's visit, and based on experience at similar sites and anecdotal evidence from the care and maintenance personnel, is assumed to be caused by snowmelt over heavy snow drifts that formed up against the road. The braided erosion gullies were likely caused by snowmelt sheet flow over snow drifts on the upstream side of the road. The nature and location of the gullies is not evidence of concentrated flow from the backup and spillover of water (e.g. from a blocked culvert). The capacity and functionality of the existing culverts would not mitigate these erosional features as massive snow drifts or heavy snow pack generally render the culverts ineffective since they impede flows through during early freshet. It is impracticable to remove the snow drift during care and maintenance as active snow management cannot be done during the winter.

The placement of coarse fill material is most effective solution available under care and maintenance to minimize erosion to the existing road caused by overflow over irregular heavy snow drifts. Monitoring should be done when possible to determine the snow drift locations and snowmelt flow direction during freshet to better evaluate the issue and associated silt fencing required.

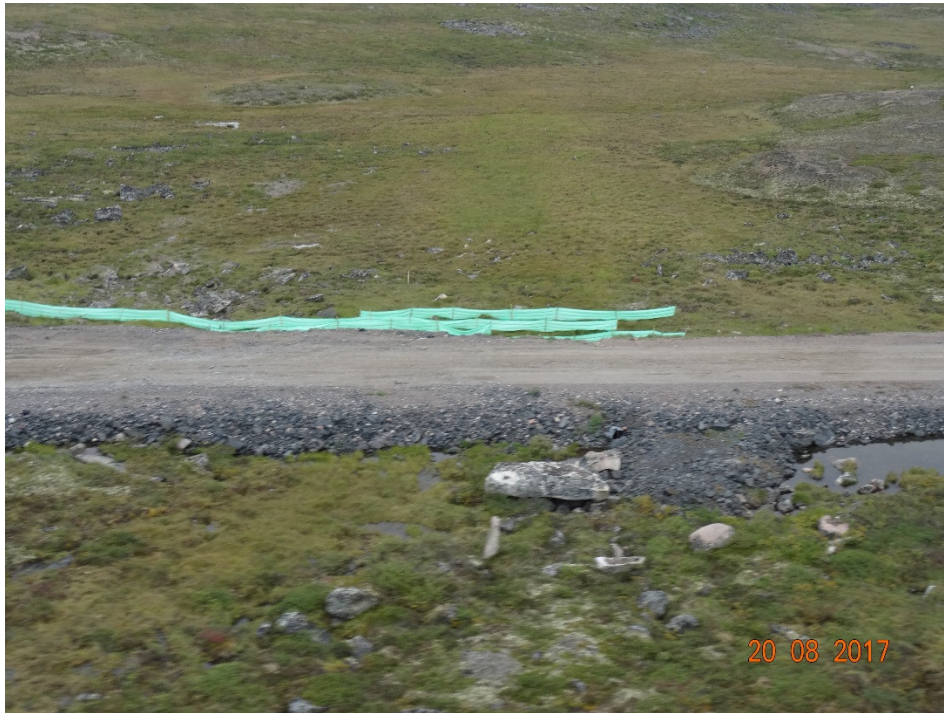
Photo 1: Silt Fences installed downstream of repaired road at the location shown in Culvert 6

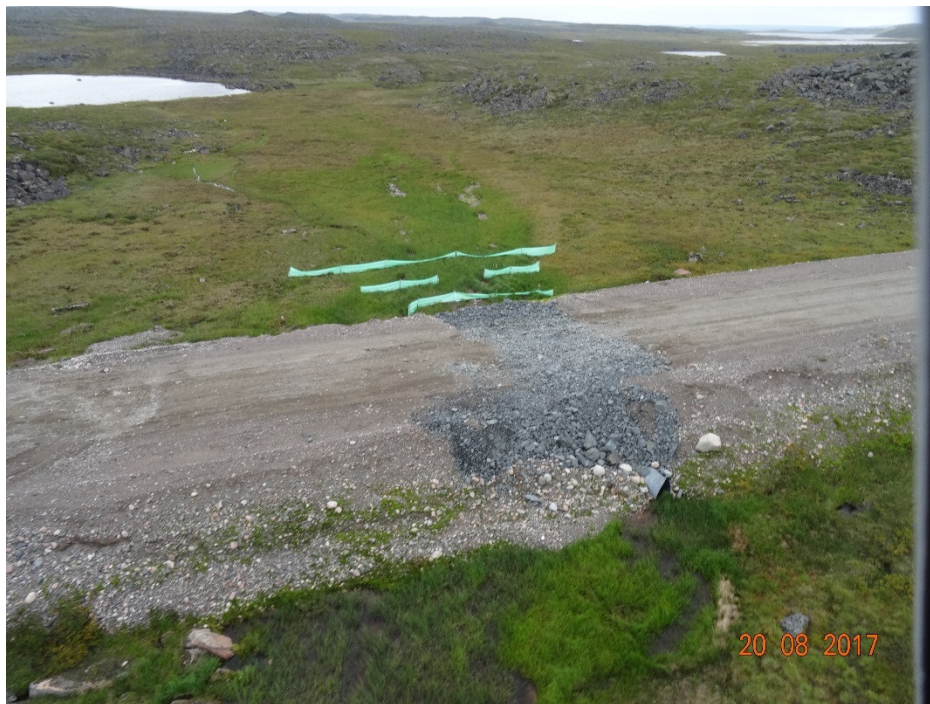
Photo 2: Silt Fences installed downstream of repaired road at the location shown in Culvert 7

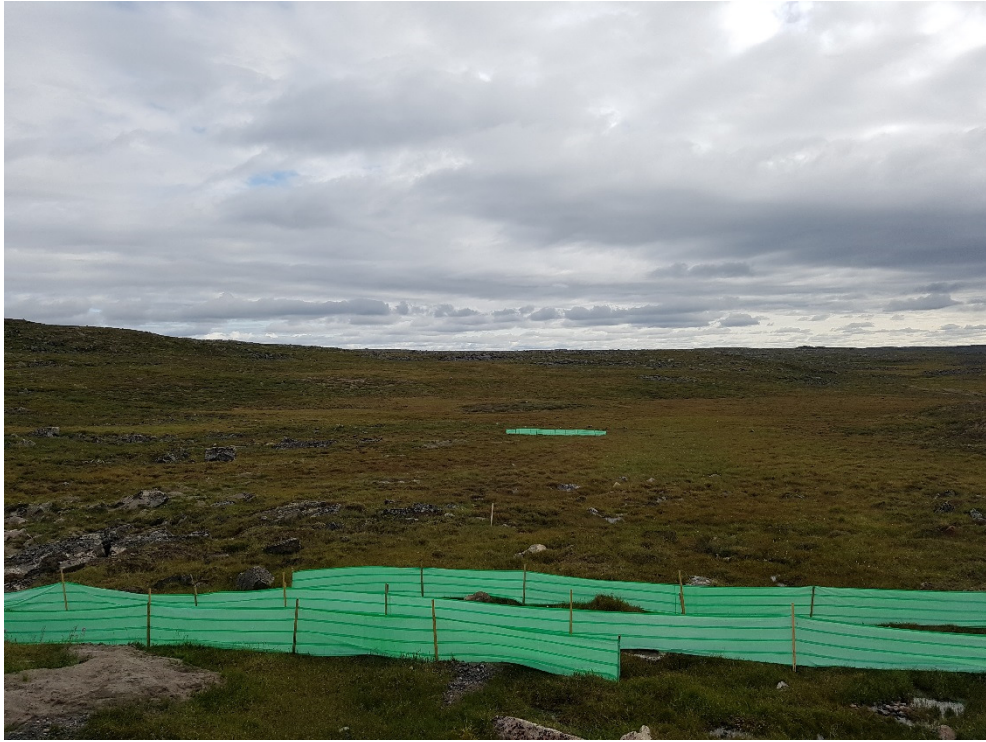
Photo 3: Additional silt fence installed further downstream at Culvert 6 as requested by the INAC inspector
